2018 ANNUAL REPORT

INDUSTRIAL WASTE PRETREATMENT PROGRAM

COUNTY SANITATION DISTRICTS OF LOS ANGELES COUNTY

APPENDIX H
INDUSTRIAL WASTE REPORTS ON INCIDENTS

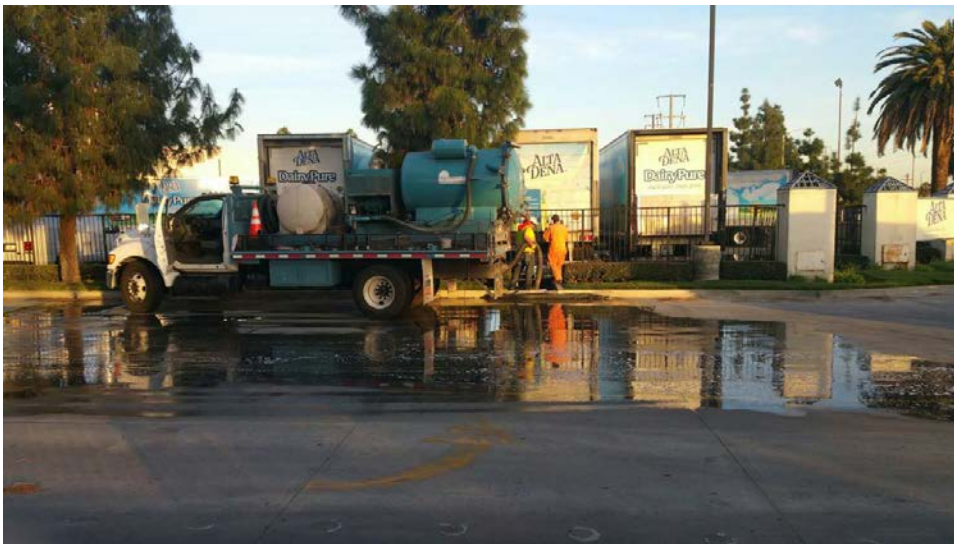
Figure 5: United Stormwater Inc. vacuum truck removing spilled wastewater from a storm drain on Valley Boulevard in front of the Alta Dena facility on 1-24-18.

Night Team Senior IW Inspector Kent McIntosh responded to the report, arriving on-site at the Alta Dena facility at 1630 hours on 1-24-18. He discovered that the volume of the spill was almost certainly much larger than had been reported, estimating it was up to several thousand gallons. He noted an outside contractor, United Stormwater Inc., was on-site conducting cleanup operations of the storm drains and creek downstream of the Alta Dena facility that were impacted by the spill. The spill was caused by a sewer line collapse and resulting line blockage inside the facility which caused wastewater containing milk residual to

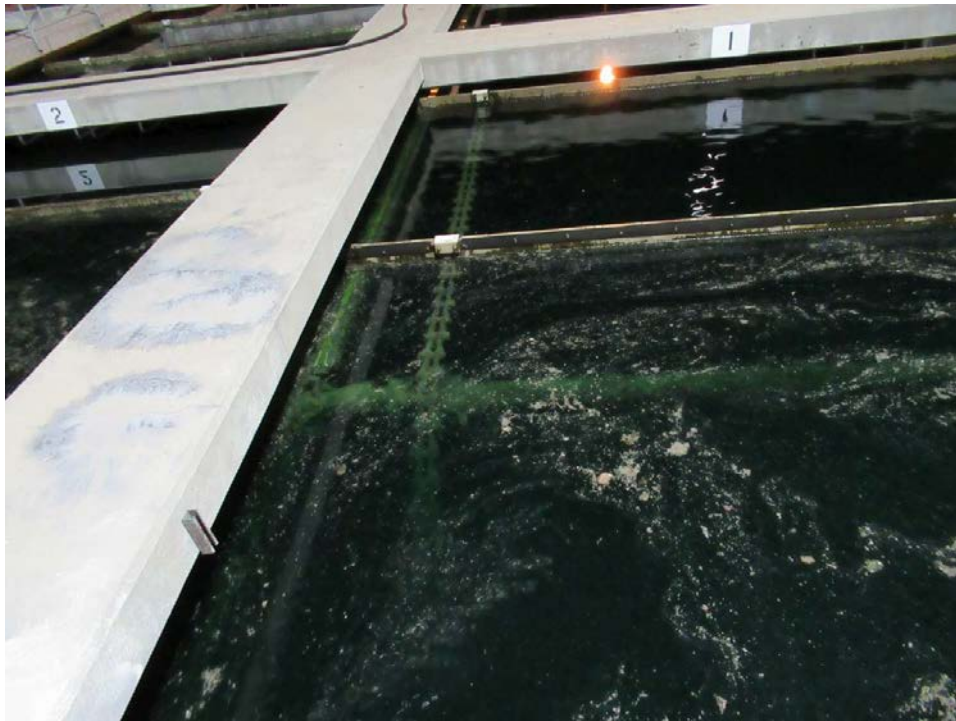
On Friday, 3-9-18 at 0030 hours, San Jose Creek East WRP TPO II Abel Martinez telephoned IW Inspector David Joh and reported WRP operators were observing green colored wastewater in the secondary tanks. Martinez noted that other than the green color being present treatment plant operations were normal, i.e., no unusual pH, dissolved oxygen levels, flow rates, and odors.

Figure 1: Photo taken at 0315 hours on 3-9-18 at the San Jose Creek East WRP secondary settling tanks showing the distinct green color present in the wastewater.

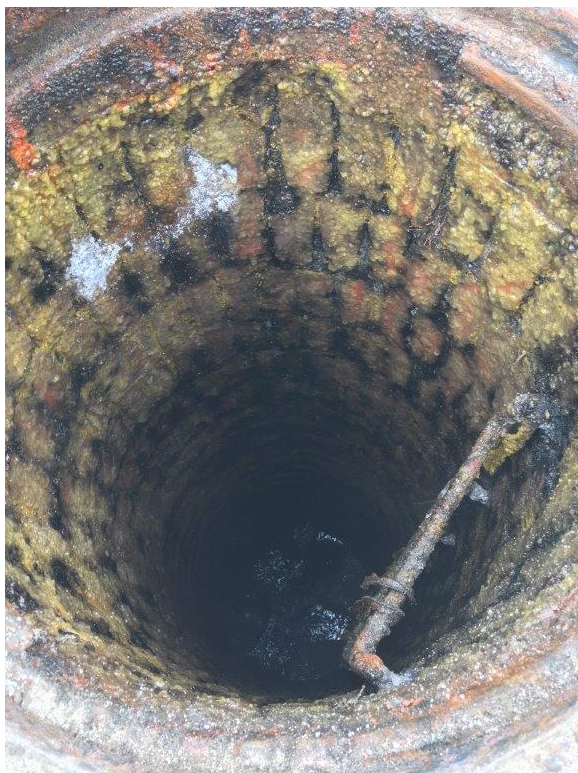
Figure 5: MH 08 0150 riser on 3-14-18. Note the layer of biological slime growth.

Cleaver’s investigation revealed that the conditions noted in MH 08 0150, which are also present at the three next manholes located immediately upstream on the same trunk sewer, are due to the industrial wastewater discharge from the large Swisstex California textile processing and dyeing facility located immediately upstream of this part of the Figueroa Street trunk sewer. The facility operates 24 hours per day, 7 days per week. The wastewater being discharged by Swisstex typically has the odor of the non-toxic chemicals and dyes used in the dyeing processes that are not unlike that of some industrial organic solvents. Also, the temperature of the

wastewater being discharged, while within the Districts' 140°F limit, is much warmer than a typical industrial wastewater discharge. Review of temperature data available from Swisstex samples taken since January 1st 2010, comprising 14 data points, indicates an average wastewater discharge temperature of 98°F with a peak of 110°F. The presence of this warm wastewater on an essentially continuous basis is the likely cause of the slime growth noted. There is also another permitted industrial facility located just upstream of MH 08 0150, Rosecrans Energy. This facility is a small oil production lease, permitted to discharge 800 gallons per day of brine water. This discharge is unlikely to cause or contribute to the slime issue, but the odor of any minor petroleum residual present in the brine being discharged could contribute to the solvent odor noted.

Ultimately, there is no evidence that either Swisstex or Rosecrans Energy was or has been in violation of any of their permit limits and neither was cited due this report. Should Districts' sewer maintenance staff wish to pursue the issue further, the next logical next step would be for IW Permit Engineers to evaluate temperature limits at Swisstex.

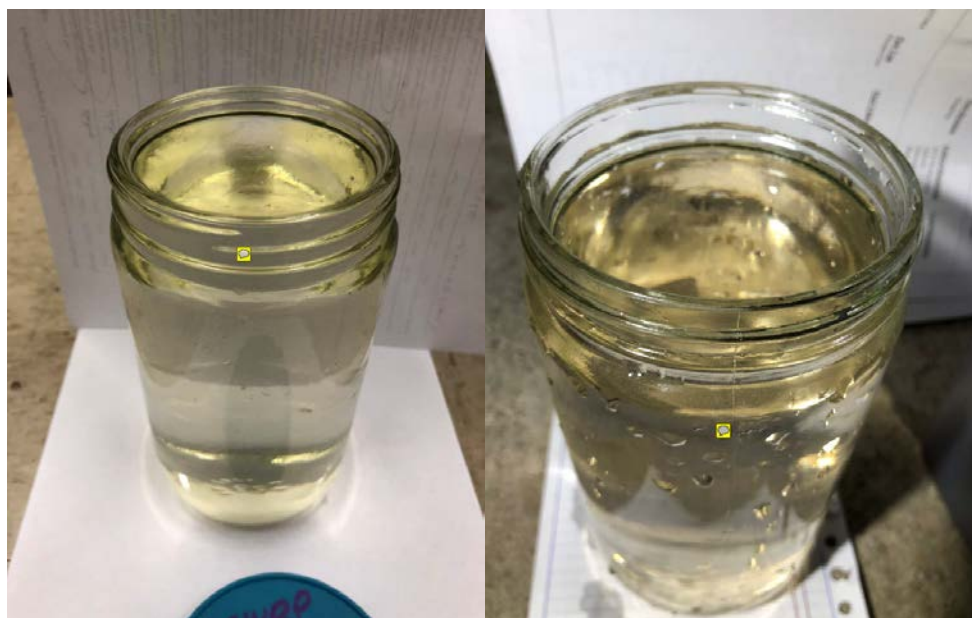
Figure 7: Side by side comparison of a grab sample of LCWRP final effluent on the left (taken at 00050 hours on 3-21-18 by Night team IW Inspector David Joh) and on the right a 50:1 diluted sample of the 1100-1200 hours 3-20-18 composite sample of effluent from Tri-Star Dyeing and Finishing.

Luu issued a Notice of Violation to Tri-Star for failing to comply with their permit requirements and IW Inspectors are confident the company caused this incident. Subsequent review of Tri-Star’s records and discussions with the company’s managers indicated their operators were aware the discharge in question had failed their own internal dilution test but had failed to cease the discharge and further treat the wastewater to remove the color as their

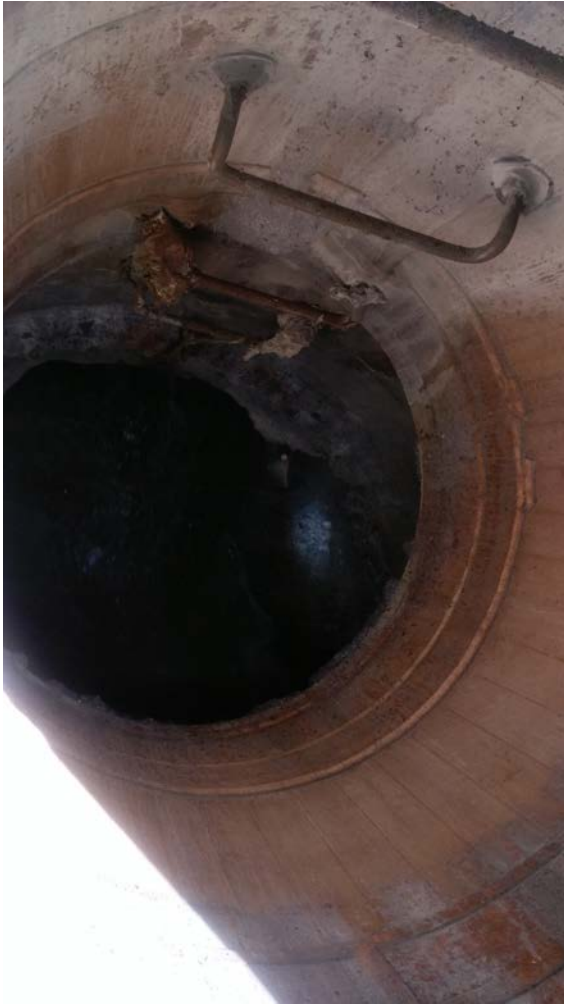
Figure 13: 3-30-18, 1330 hour photo of the MH A1087 riser. Note that at that time only a small residual of the white foam remained on the manhole shelves. In order to escape through the pick holes it must have completely filled the riser earlier.

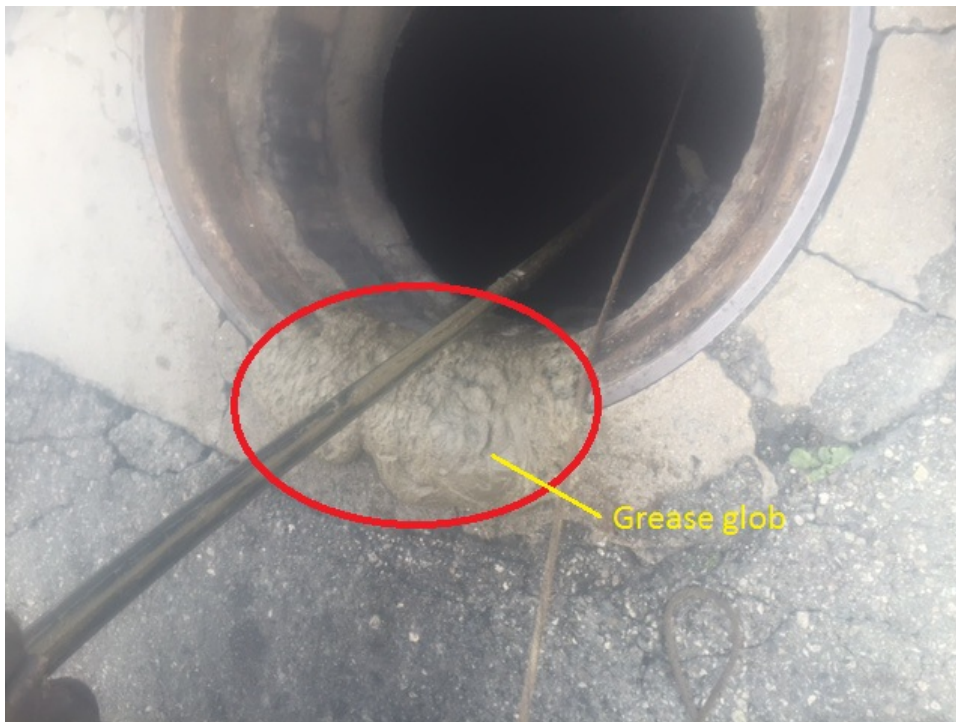
Figure 1: Glob of grey grease removed from the 21" J.O. 'H' unit 2F trunk sewer in Vernon on 4-2-18.

Note that a sewer overflow occurred on a nearby City of Vernon local line on Bonnie Beach Place on August 16, 2016 that was ostensibly caused by similar heavy greasing in this trunk line at essentially this same location. Note that following that SSO incident a "smart cover" was installed by the Districts at Manhole (MH) H 250 in order to help prevent another SSO.

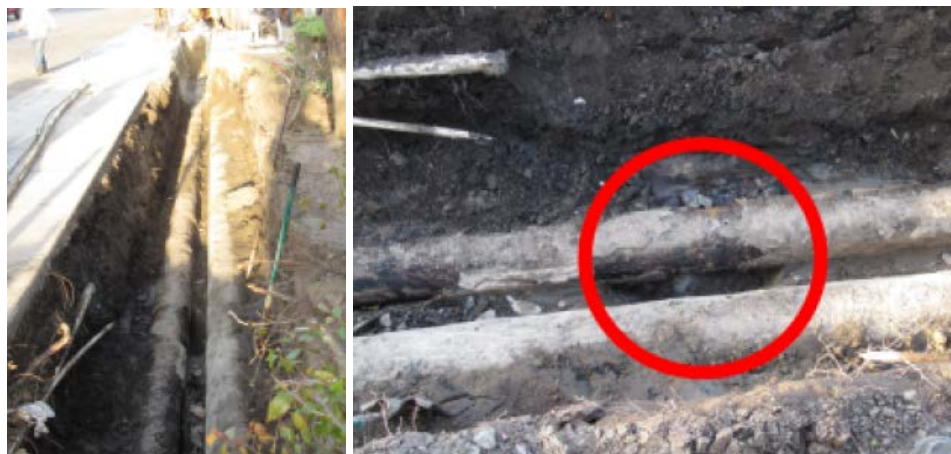
Figures 4 and 5: Excavated pipeline and small hole in the pipeline that was the source of the leak/spill.

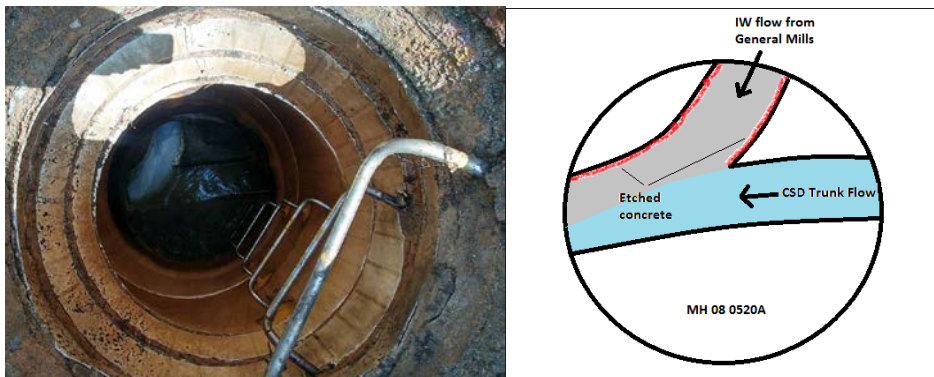
Figures 8 and 9: Photo and diagram indicating the flow condition and presence of etching at MH 080 0520A on 4-25-18.

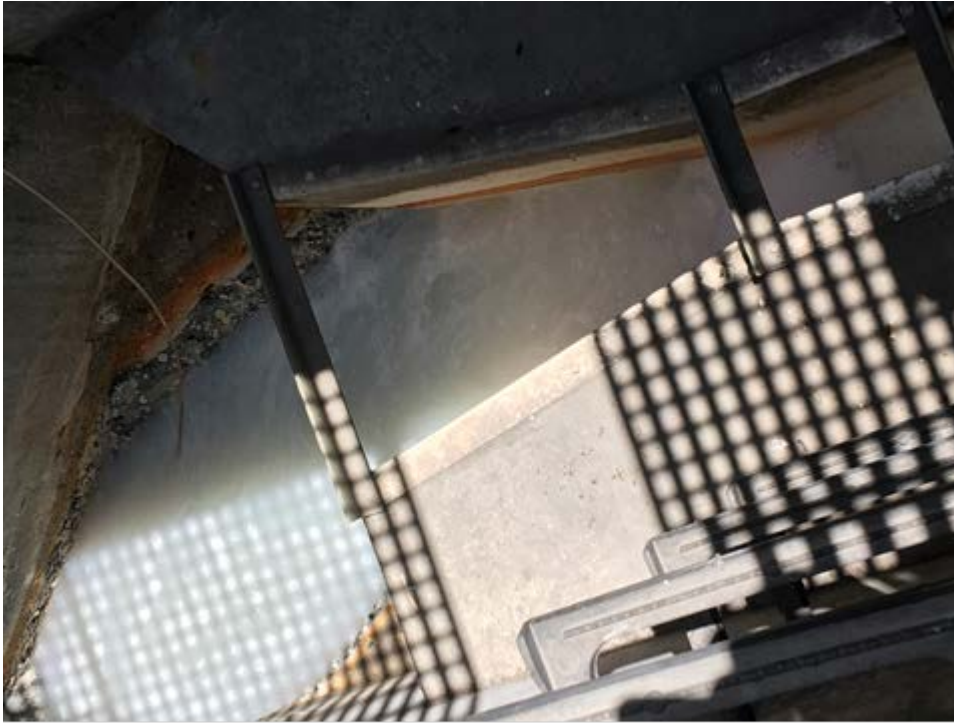
Figure 11: The industrial wastewater sampling location (tailwaters of the flume) at General Foods. Note the heavy etching present in the walls of the concrete channel immediately downstream of the fiberglass flume which indicates acidic discharges are likely occurring frequently.

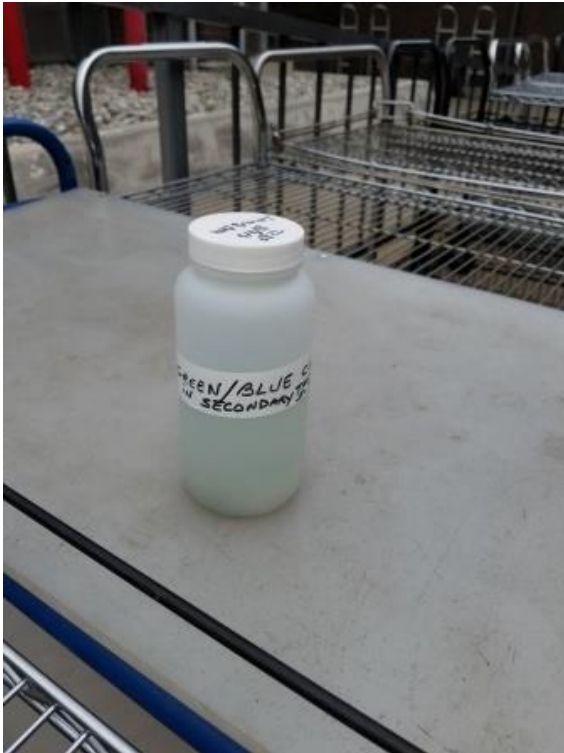
Figure 3: 5-9-18 WNWRP secondary tank grab sample. Note the blue green tint.

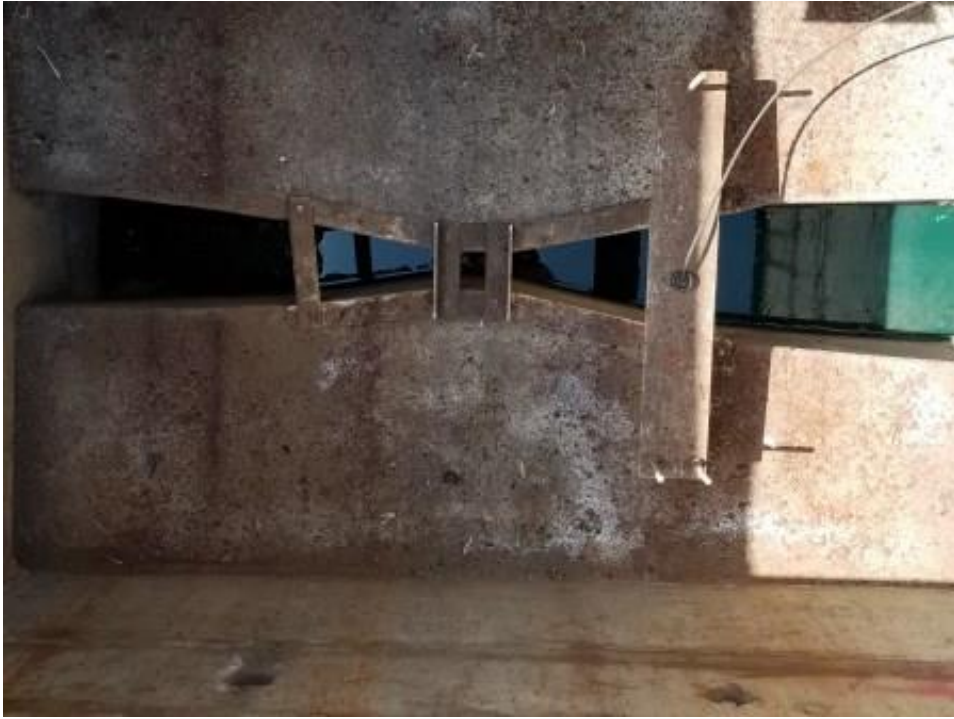
Figure 4: United Site Services residual industrial wastewater in their discharge flume on 5-10-18, note the deep blue-green color of the wastewater.

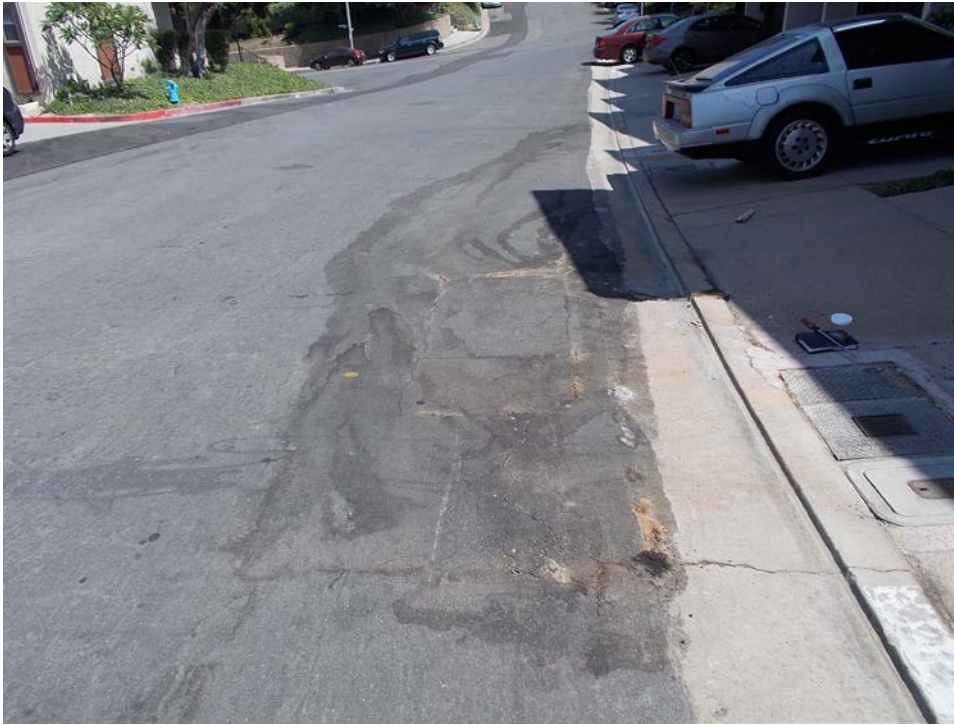
Figure 2: Photo taken on 6-26-18 by Finn of the street cracks with whitish/yellowish powder residue in the asphalt where he noted the odorous (sulfide) gas was emanating. Note the staining indicating that either some liquid is also coming out or that someone is periodically washing down the area.

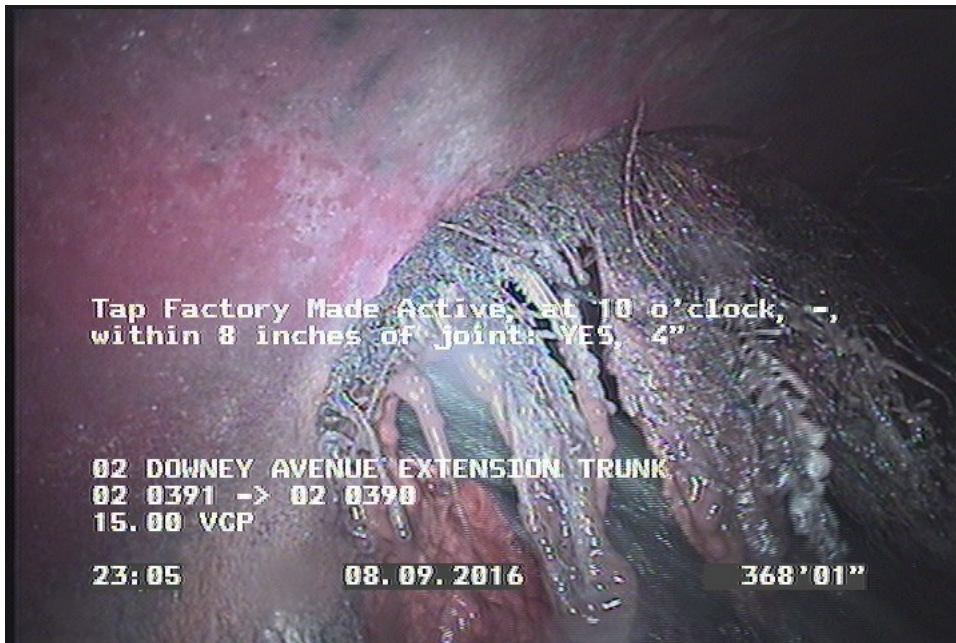
Figure 9: August 9, 2016 Districts' CCTV showing roots at the company's connection point into the trunk sewer line.

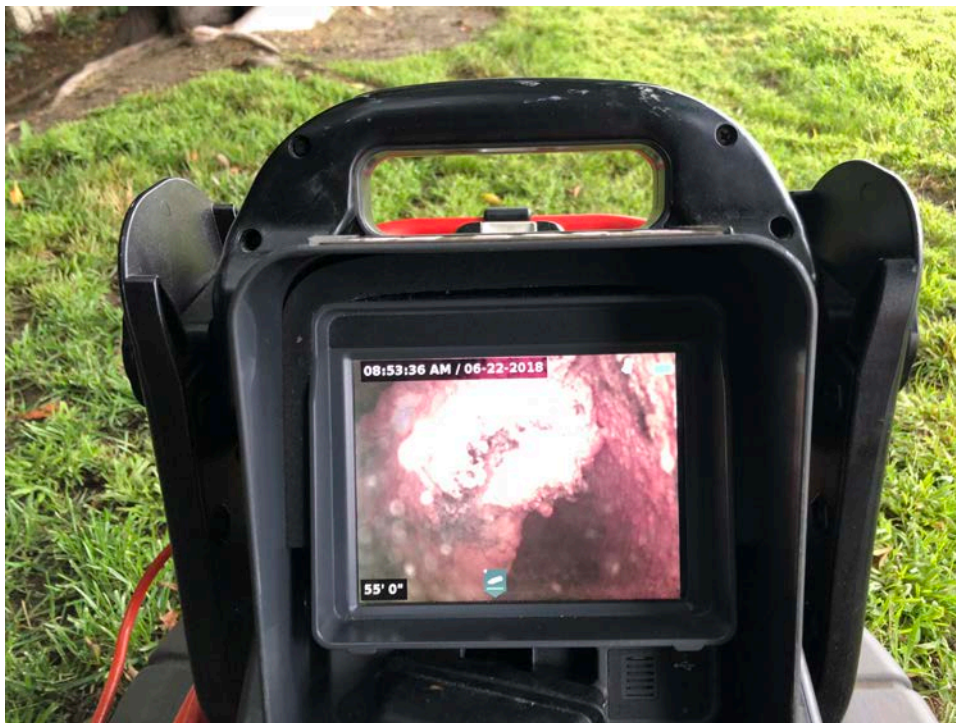
Figure 10: 6-22-18 contractor CCTV view of scale in the private line.

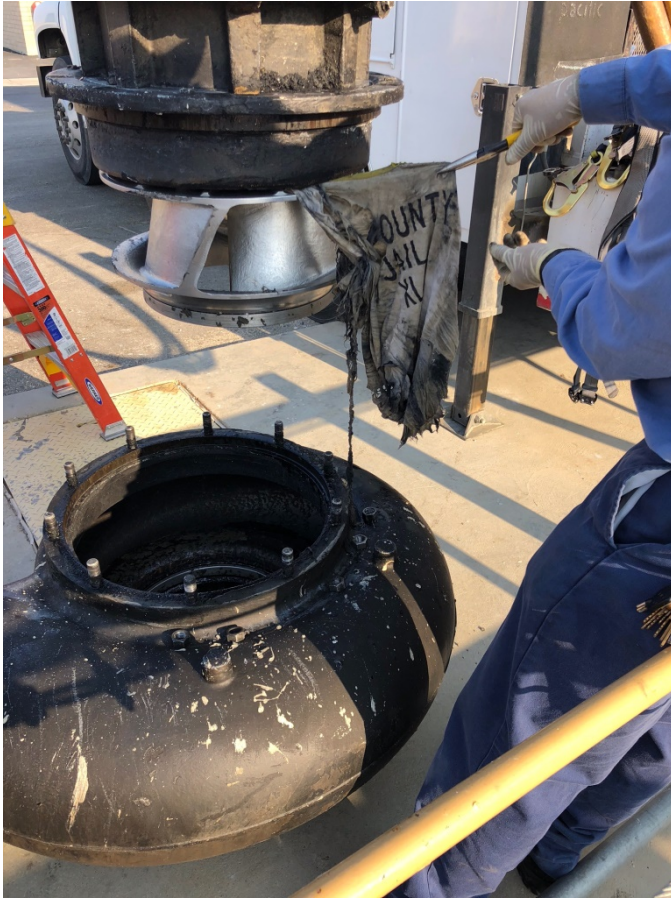
Figure 4: 7-21-18 photo of the rag removed from the influent pump.

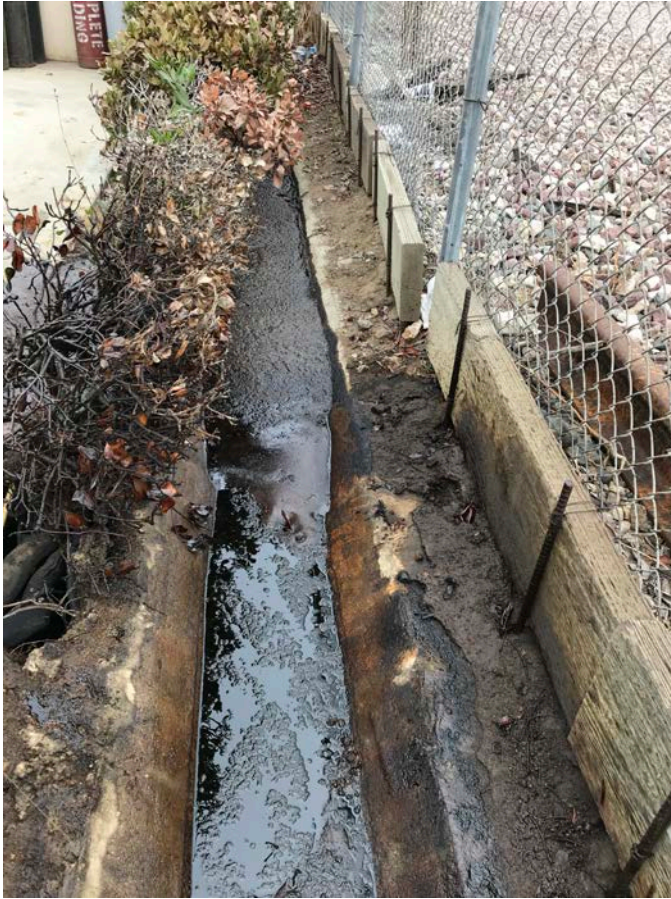
Figure 1: 10-29-18 photo taken by Inspector Finn of the oily residue from the spill. Note that its appearance matches that of the locally produced crude oil. The brine/oil came out of the ground from the broken underground line at the “hole” under the bush seen on the left side of the photo.

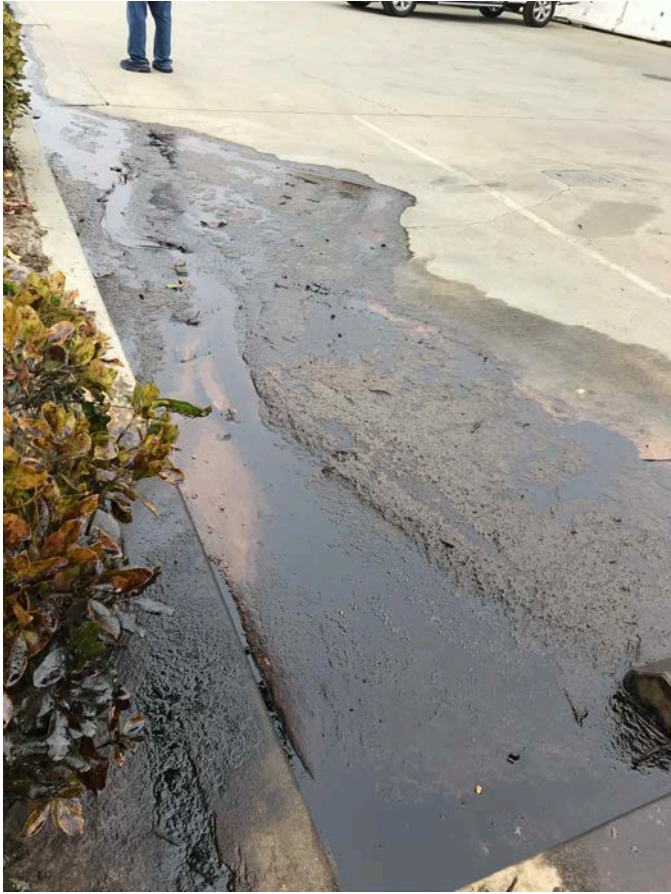
Figure 2: 10-29-18 photo of crude oil residual in a parking area adjacent to the spill source.

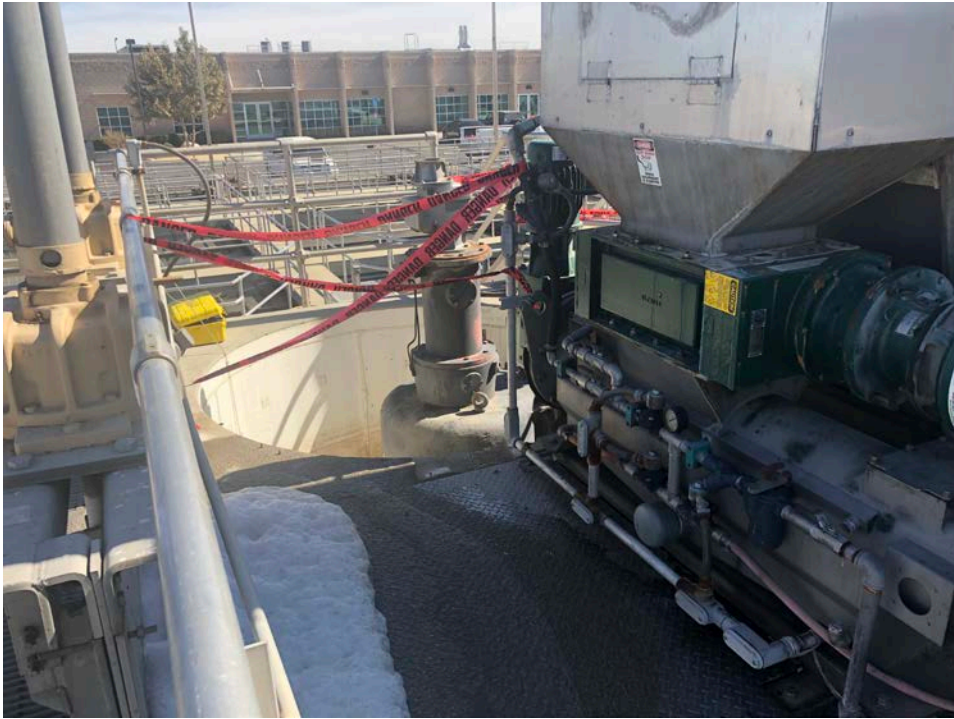
Figure 4: 10-29-18 photo of the foam at the Palmdale WRP headworks.

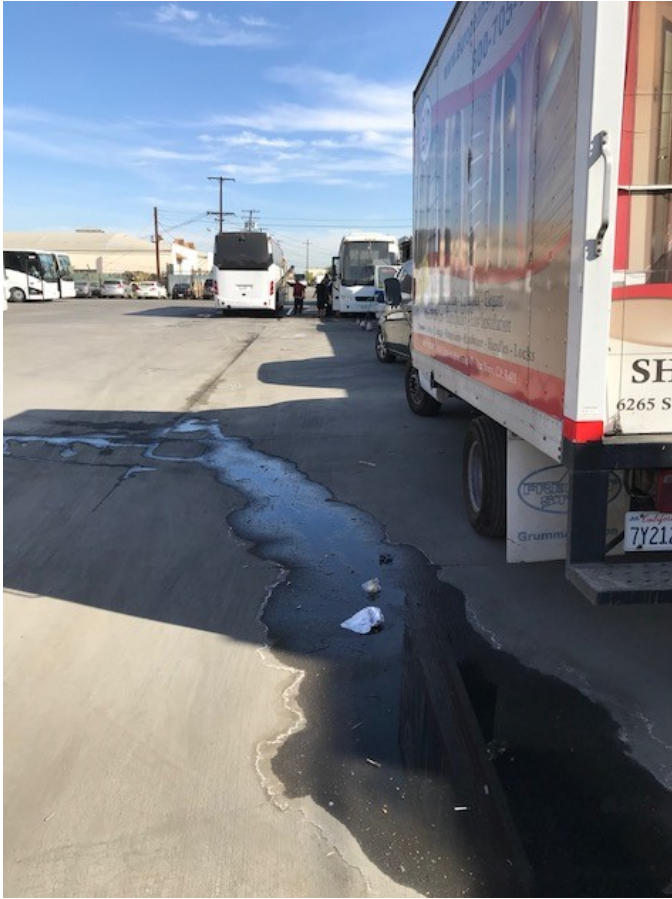
Figure 1: Photo at Randy's Tire Service taken by Greg Neunsinger on 11-15-18. Although difficult to see in the photo, Neunsinger observed sanitary tissue adhering to the bus wash drain and pump system shown.

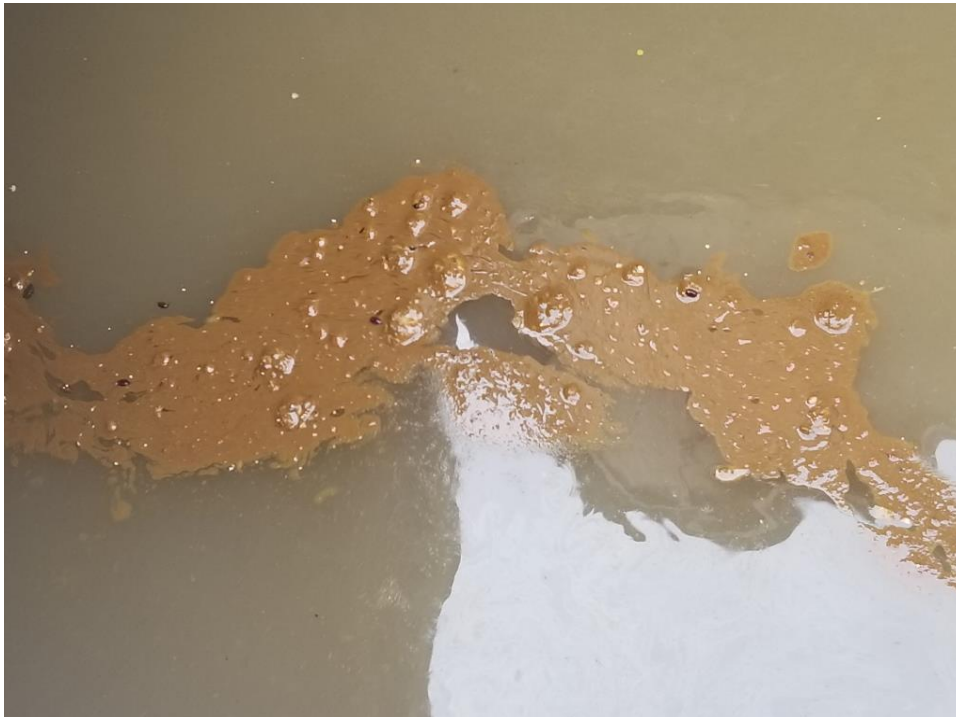
Figure 2: Brown oil in the primary tanks at Saugus WRP on 11-19-18.

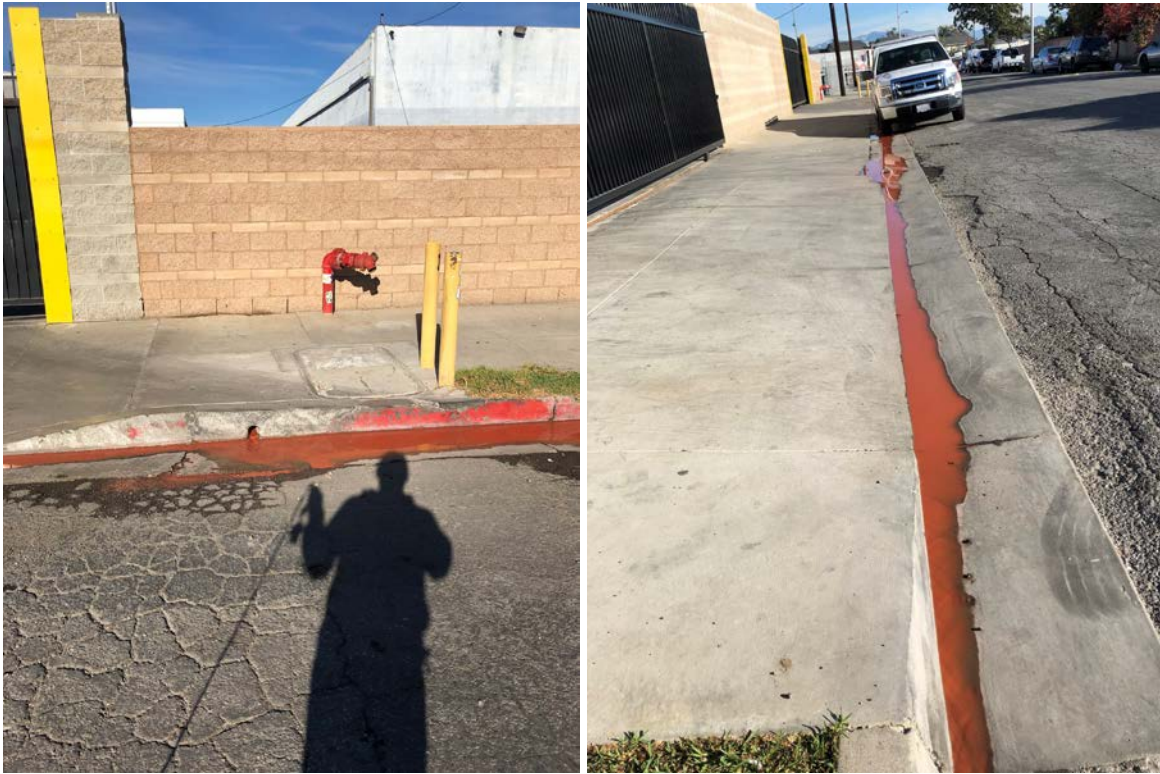
Figures 4 and 5: Citizen photos of the red liquid observed in the street gutter at 1300 hours on Tuesday, 11-27-18.

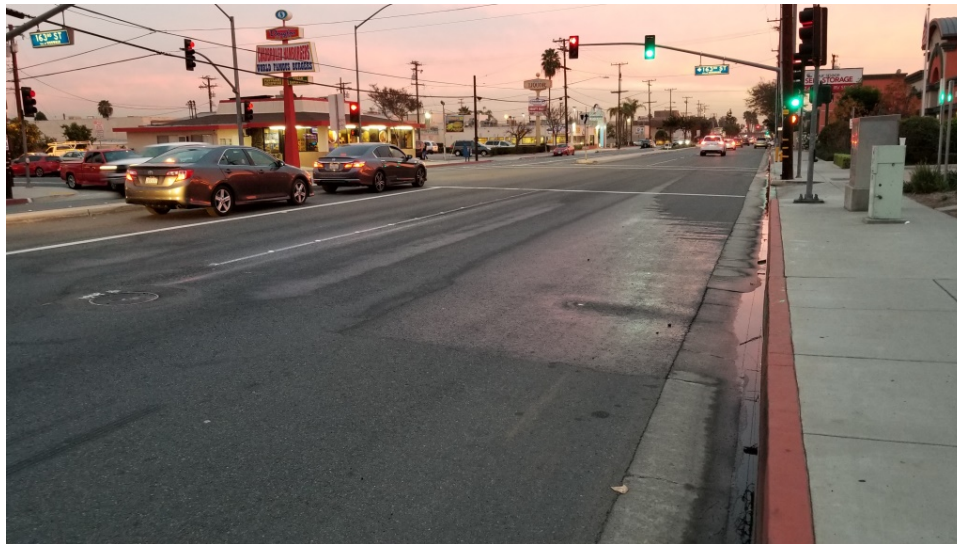
Figure 1: Jose Ruiz photo of the location of the sewer spill on 12-14-18 at 1645 hours. Note the wastewater in the gutters.

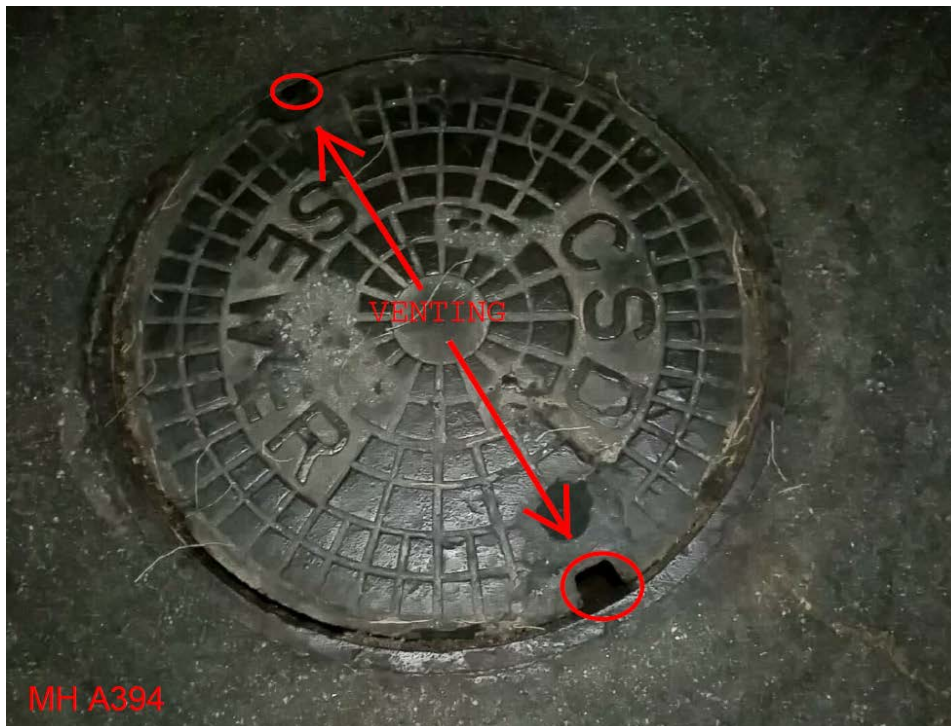
Figure 3: 12-14-18, 1720 hours photo of MH A394. Note the open pickhole notches that were found to be venting sewer headspace gas.
