2017 ANNUAL REPORT

INDUSTRIAL WASTE PRETREATMENT PROGRAM

COUNTY SANITATION DISTRICTS OF LOS ANGELES COUNTY

APPENDIX H
INDUSTRIAL WASTE REPORTS ON INCIDENTS

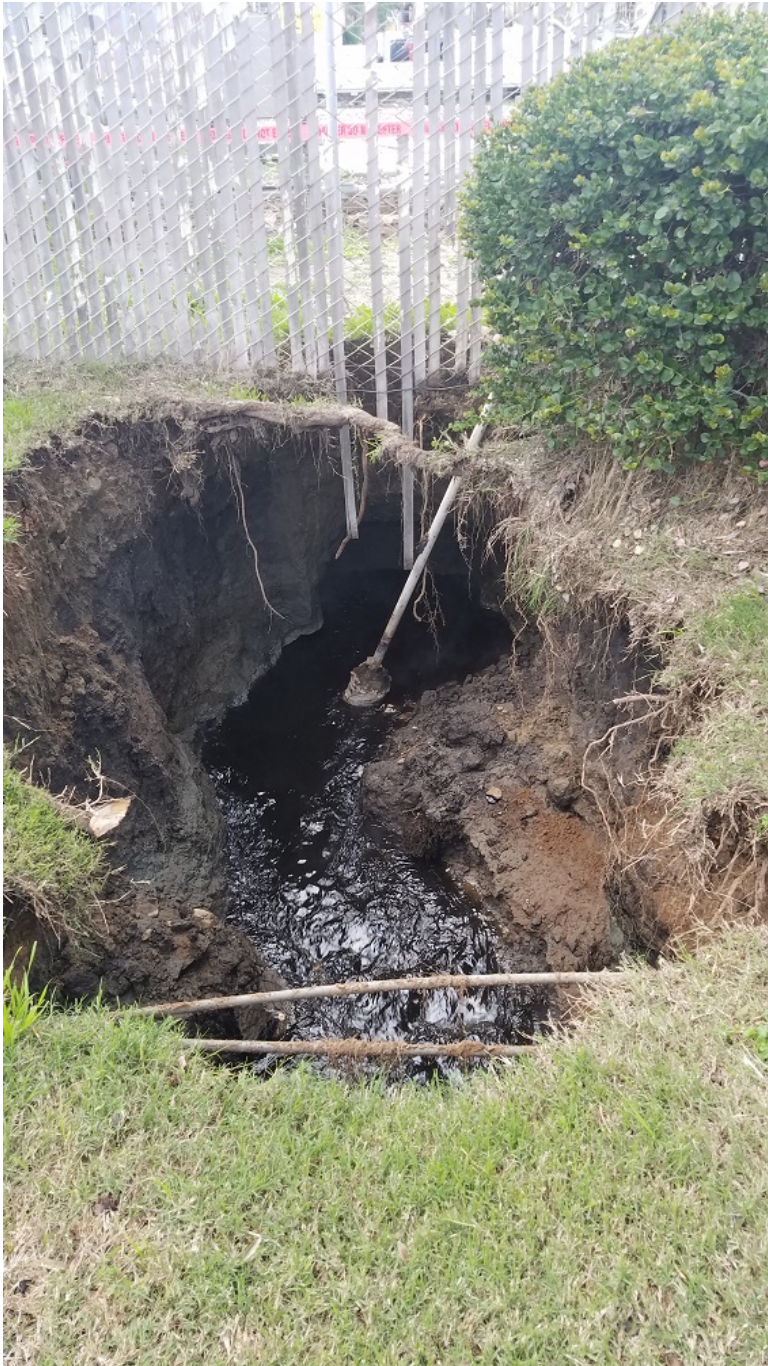
Night Team Industrial Waste Inspectors Kristopher McGinnis and Helen Luu responded, arriving on-site at 1645 hours. They noted that the sinkhole was relatively small and located several hundred yards north of the Districts' trunk line on Crenshaw Boulevard about halfway between 190th Street and Del Amo Boulevard (see Figure 4 above). Contact Steve Courney, Environmental Team Lead at the Torrance Refining Company, stated that the sinkhole had been discovered around 1140 hours earlier that day and that it was caused by a ruptured 30" concrete pipe which the refinery uses to convey wastewater from the refining operations on the west side of the facility to the API oil/water separator unit at the facility's large industrial wastewater pretreatment system located on the east side of the facility. See Figure 5 below for a photo of the sinkhole. Wastewater in the sinkhole was being conveyed successfully from one end of the broken pipe into the other end without any spillage to the storm drain system occurring.

Figure 5: View of the sink hole at the Torrance Refining Company on 1-24-17.

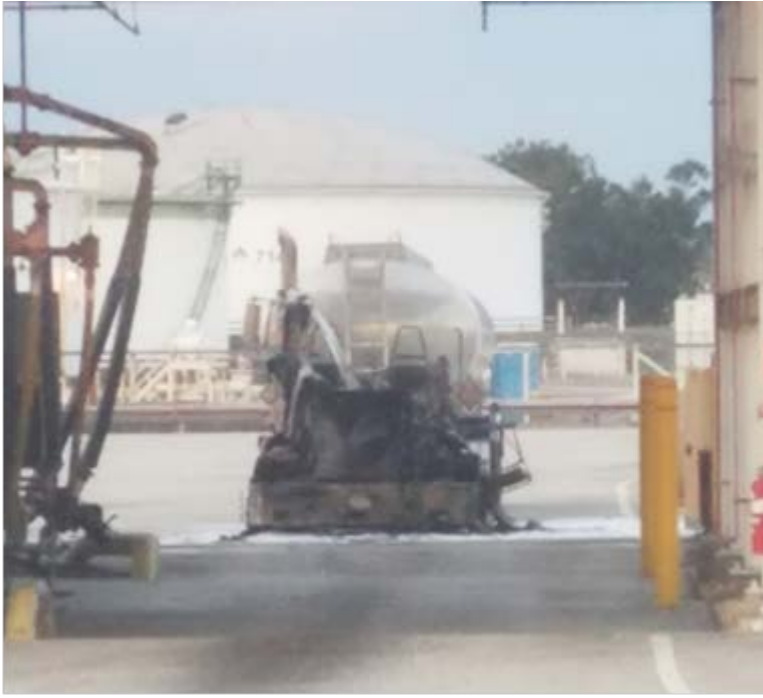
After McGinnis arrived on scene, both IW inspectors walked over to the north gate entrance of the facility and met with the Tesoro facility's Operations & Maintenance Team Lead Darron L. Cunningham. All three then walked directly to the area north of the fire, which by then had been put out. Cunningham stated that the driver of the tanker truck that burned had noticed smoke coming from the truck's engine while waiting for entry into the staging area at the terminal. It appeared that transmission oil had caught on fire, causing the cab of the tanker truck to catch on fire as well. Fortunately only the cab of the ruck burned. A larger fire involving the fuel to be transported did not occur. There were no injuries or fatalities due to the fire. Neither was there any observable damage to the staging or loading areas/bays.

Figure 1: Burned truck cab at the Tesoro-East Hynes terminal truck loading facility.

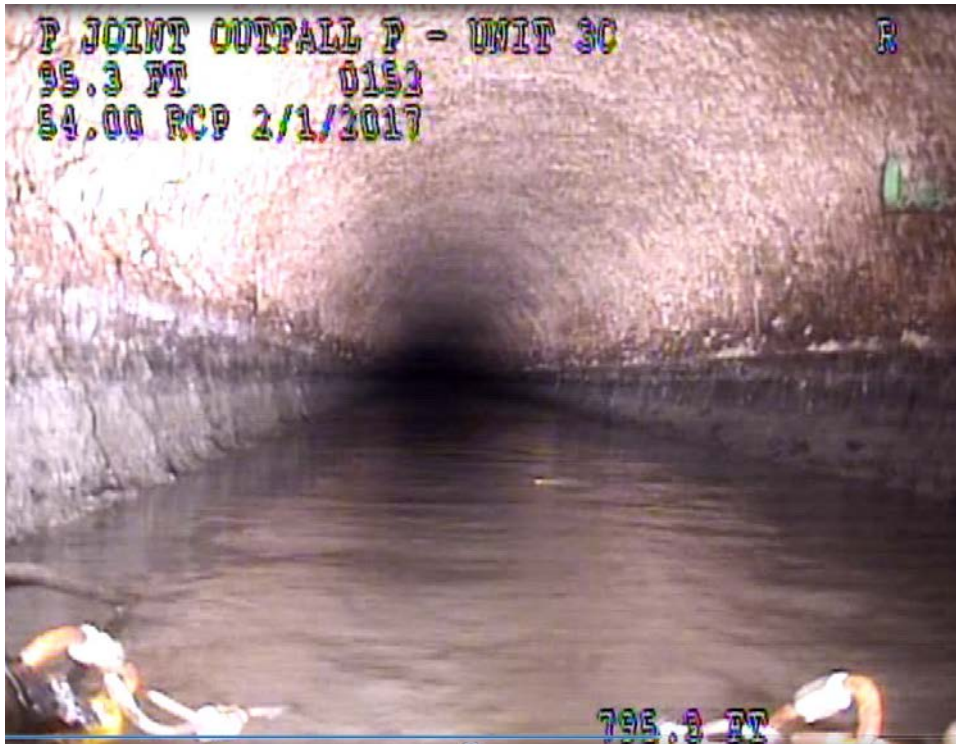
Figure 1: 2-1-17 CCTV photo grab of the illicit connection into the J.O. 'F' Unit 3C Trunk in Cerritos approximately 500' north of MH F 0152. The illicit connection pipe is located in the upper right of the photo.

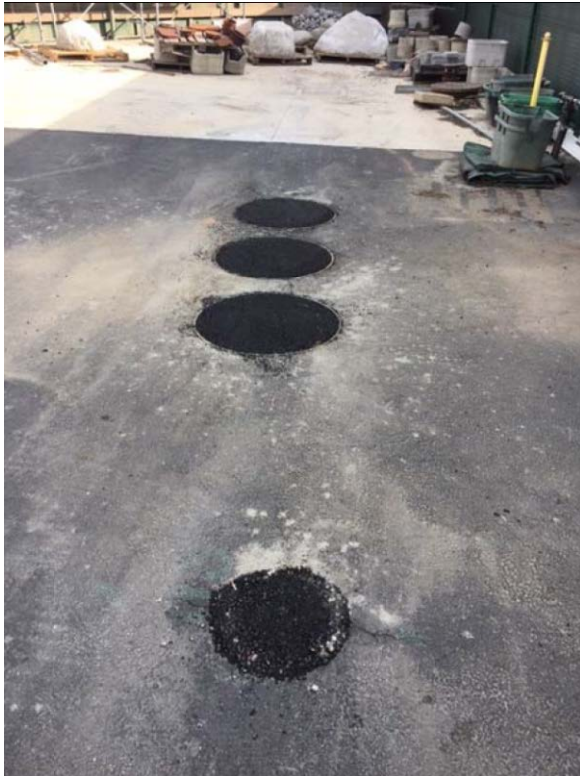
contractor to construct the washpad with the intent that vehicles would be washed there. The washpad though has not been used for that purpose, instead functioning as an equipment storage area due to the subsequent construction a different washpad when a new facility building was constructed. Mr. Kaveney didn't dispute that the connection was made illegally, but stated it predated both his and the current Facility Director's employment at the College. McCurdy issued a written Notice of Violation to the College for the violation. Kaveney agreed to immediately seal the connection and eventually properly abandon the drain and clarifier. A follow-up inspection conducted by McCurdy on 4-25-17 revealed that the illicit drain and clarifier had been sealed and abandoned in place, effectively closing the issue.

Figure 5: 4-25-17 photo of the sealed and abandoned washpad drain and clarifier.

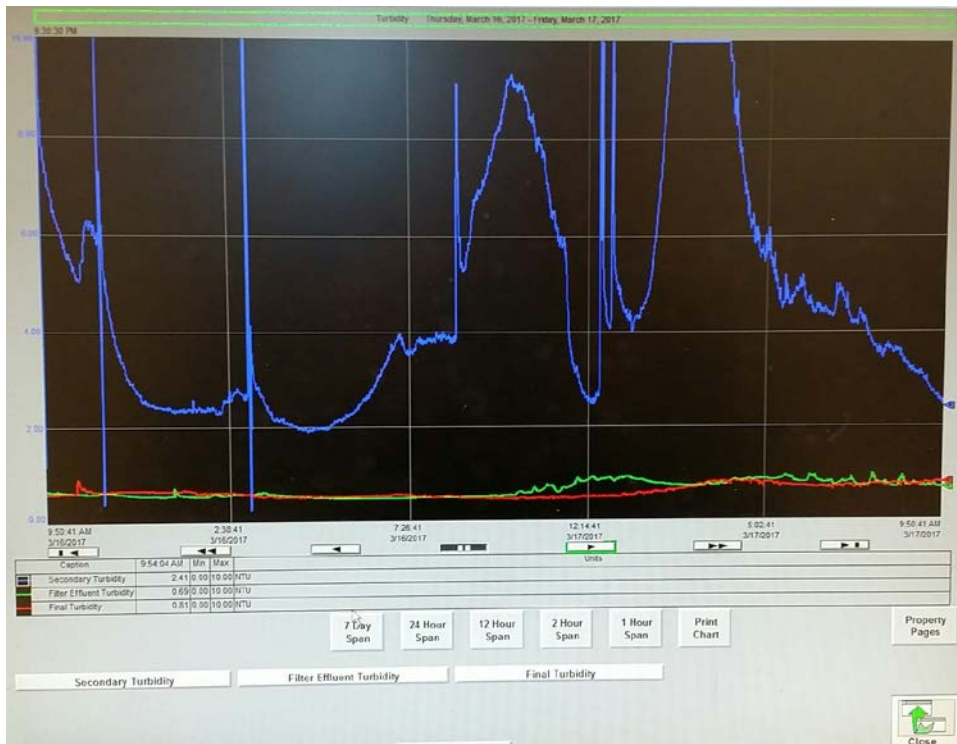
On Friday, 3-17-17 at 0705 hours, Superintendent of WRP Operations Stephen "Junior" Johnson called Supervising IW Inspector John Boyd and reported that the Lancaster WRP had experienced two elevated secondary effluent turbidity and high dissolved oxygen level incidents on the evenings of Wednesday, 3-15-17 and Thursday, 3-16-17. He said the secondary turbidity began rising during the day each time at 1200-1300 hours, with the conditions persisting, on and off, into the evening hours. Johnson said he thought the condition, which has now occurred at about this time of the year for the last 4 years running, could be related to the annual air show at the nearby Fox Field municipal airport. Johnson said no grab samples had been taken by WRP operators, but raw and primary effluent composite bucket samples were available for testing.

Figure 6: Lancaster WRP 24-hour secondary effluent turbidity trend (blue line) on 3/16/17-3/17/17 from 0950 hours-0950 hours.

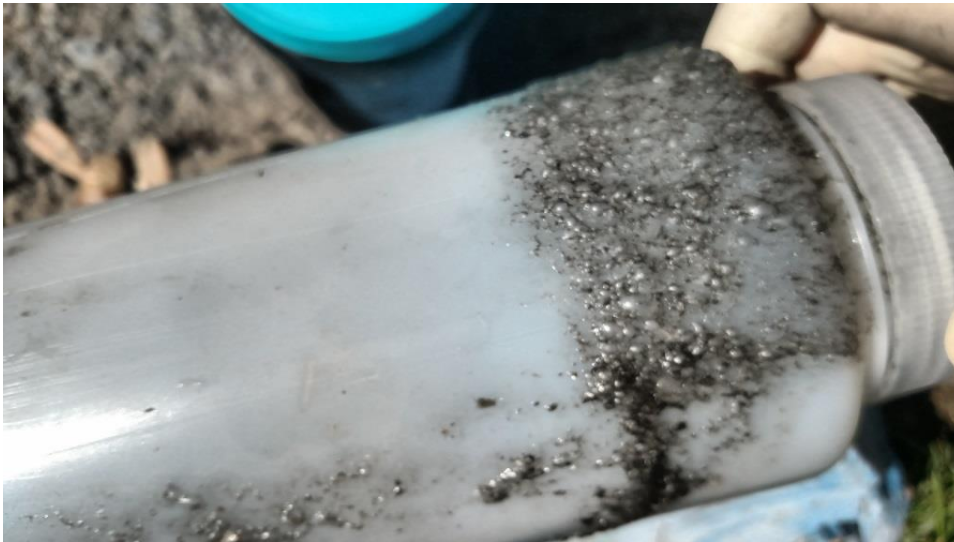
Figure 8: Close up of the foam when skimmed onto a plastic Nalgene bottle. Note how darkly colored the material appears versus when it's seen floating in the tank.

Area IW Inspector Tanna Pekin responded to the treatment plant immediately to observe the foam and to gather more information. Inspections were conducted at several permitted discharges upstream of the Valencia WRP. No evidence was observed at any of the companies

that indicated they were responsible for the bubbles and solid material observed in the primary tanks at Valencia WRP. An inspection was also done at the Saugus Liquid Waste Disposal Station as well as the Saugus WRP. Saugus WRP has the ability to divert a portion of their flow to the Valencia WRP. Saugus WRP Supervising TPO Ron Foster said flow diversion had been normal and nothing unusual was sent to Valencia. According to Valencia WRP Supervising TPO Matt Linn, no other aspects of the treatment plant's operations were adversely affected during this incident and there were no NPDES violations due to the incident. The bubbles and solids eventually dissipated after a few days and the primary tanks returned to their normal appearance. IW Inspectors did not identify a source for the material, but will maintain communication with Valencia WRP Operators in case the issue returns.

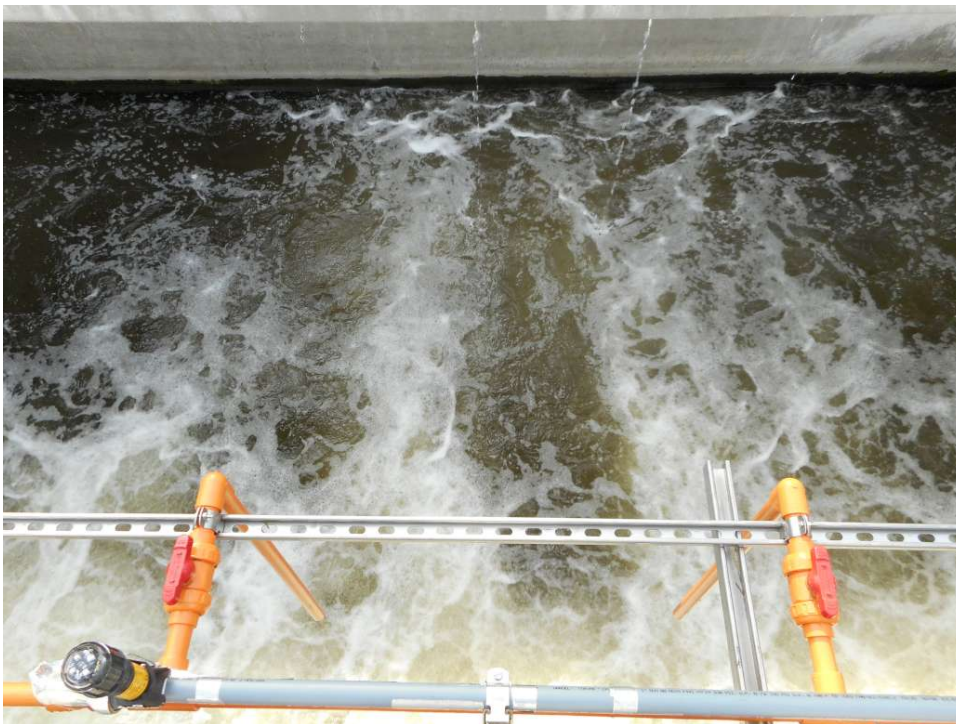
On Friday, 3-24-17 at 1400 hours, Team 2 IW Inspector Jason Finn was informed by Los Coyotes WRP TPO II Tom Jauregui of a brown or "tea" color in the final effluent forebay, as well as a solvent odor in the plant that WRP operators had observed at 1300 hours earlier that day. Jauregui stated they had been noticing the solvent odor for a few days now. At the time of the notification WRP operations appeared otherwise unaffected by the color and odor.

Figure 9: Los Coyotes WRP final effluent at 1415 hours on 3-24-17.

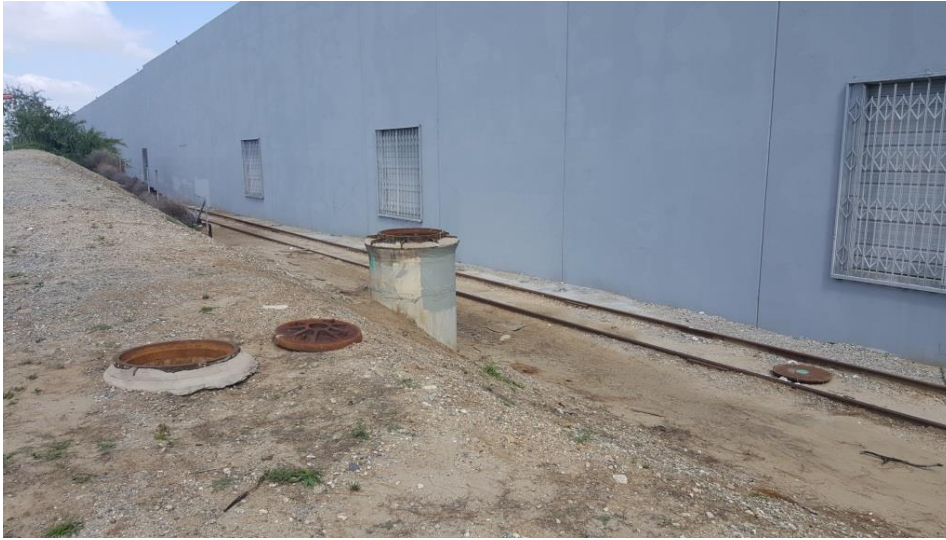
Sealy arrived at the location at 1130 hours on 3-27-17 and confirmed that the covers for downstream siphon structure Manhole (MH) A 1047 and the associated siphon airline manhole had been removed and were each lying several feet from the manhole risers (see Figure 11). Sealy noted that there was no evidence the covers had been blown off by an explosion in the sewer. Instead it appeared the covers had been removed intentionally. Sealy was careful not to disturb the area around the manholes in case this turned out to be a crime scene due to someone trying to dump a body or an illicit discharge there. Note that the remains of a female murder victim were found in late October 2013 at both the JWPCP and San Jose Creek East WRP inlet works. It appeared that body had been dumped into a sewer manhole upstream of the SJC-East WRP, but despite Lee and Sealy working closely with Los Angeles County Sheriff's Department Detectives, the exact location of that manhole was never identified.

Figure 11: MH A 1047 riser (on the right) and the associated siphon structure airline manhole (on the left).

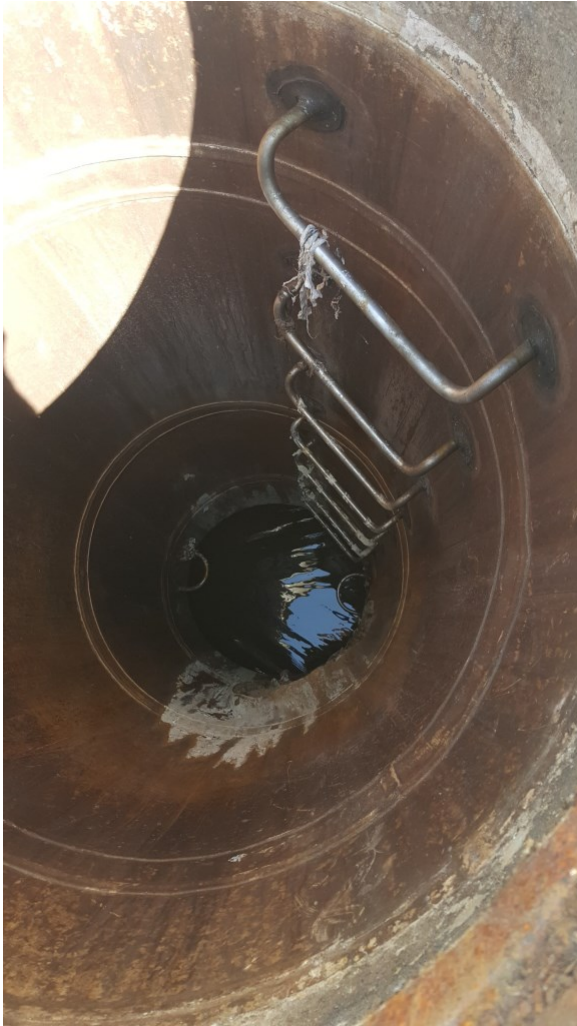
During this investigation, Sealy found no drag marks or other evidence that a body had been dumped into the either of the District 21 Interceptor manholes. He did see some minor rags hanging from manhole ladder rungs, as well as what appeared to be the remnants of magnesium hydroxide crown spray slurry (see Figure 12). The District 21 Interceptor flows to the JWPCP, not the San Jose Creek East WRP. Sealy and Lee contacted Supervising TPO John Dyer at JWPCP who reported that no unusual objects, including body parts, had been seen at the plant headworks over the 3/24-3/27 time period. Dyer also reported the plant had been operating normally throughout the same period. Sealy was able to replace the siphon airline manhole cover himself, but due to the height of the manhole riser for MH A 1047, Superintendent of Sewer Maintenance Operations Doug Walton was contacted and asked to send out a crew with a boom truck to replace that cover. By 1430 hours both covers were back in place. It remains a mystery as to who opened the manhole and for what purpose.

Figure 12: View into MH A 1047 on 3-27-17.

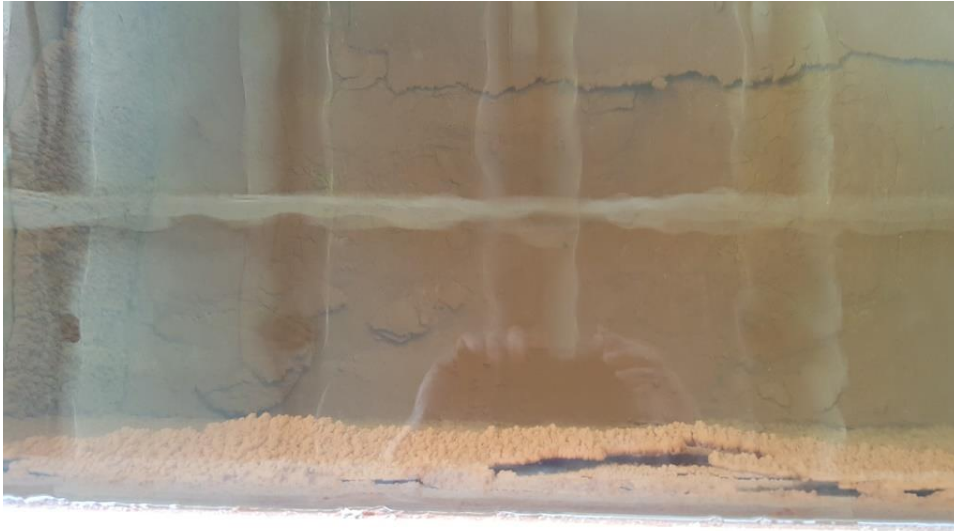
Figure 2: Calcium scale in the weir box at Davis Wire Corp. on 4-7-17. This is the same type of scale noted at MH 22 1214A.

Senior IW Inspector Steve Sealy conducted an inspection at Davis Wire Corp on 4-7-17, arriving on-site at 0900 hours. The scaling at MH 1214A was verified to be due to the industrial wastewater discharge from Davis Wire. It occurs as a result of the company's use of lime slurry to pH neutralize their industrial wastewater. Lime slurry is a safer and cheaper material to use versus the more commonly used sodium hydroxide solution. But its use means the wastewater has a much higher tendency to result in calcium scaling. This issue was noted several years ago and it had been planned that the company would conduct periodic cleaning of their sewer line and MH 1214A to remove the scale. Unfortunately, a change in management at the company, as well as the Districts' Area IW inspector due to normal rotation, resulted in the cleaning not being accomplished as anticipated. Company contact Tony Gallegos was very cooperative and expressed their willingness to clean the scale. He also stated they would investigate switching to using sodium hydroxide solution to neutralize their industrial wastewater in order to greatly reduce or eliminate the scaling. Additionally, he said that he would create an annual preventative maintenance task to insure the line is cleaned from their sample box to the Districts' trunk. He was informed that he must not open the Districts' manhole cover at MH 1214A and that Districts' personnel must be contacted prior to, and be onsite for, the event. Gallegos said he would contact Sealy as soon as he could arrange the cleaning this year so that all concerned can be in coordination. Sealy issued a written Notice of Violation to the company for causing the scaling.

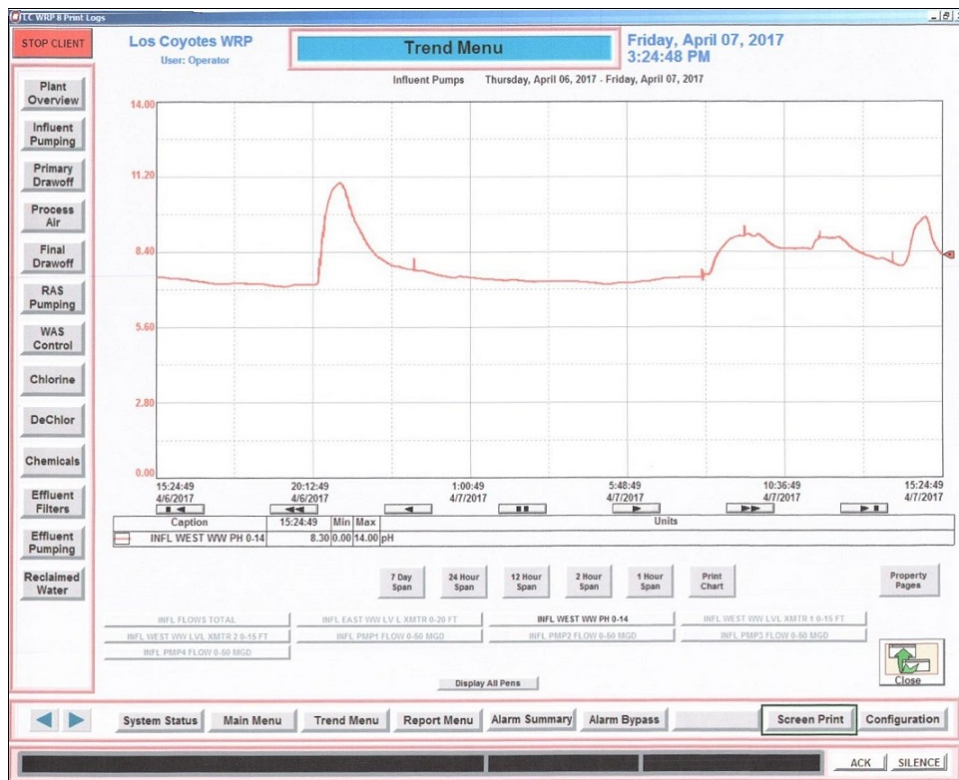
Figure 4: Los Coyotes WRP influent wastewater pH trend for 4/6/17 at 1525 hours to 4/7/17 at 1525 hours.

The investigation of this incident, along with a series of 3 subsequent high pH influent “bumps” the next day (see Figure 4 above), ultimately concluded that the most likely cause was scheduled crown spray activity upstream of the WRP. However, it was noted that the WRP influent during these incidents lacked the slight whitish color that inspectors normally associate with crown spray activity and samples taken at both the WRP and from sewers upstream lacked the elevated magnesium concentration that one would be expected if the elevated pH were due to the magnesium hydroxide crown spray slurry. IW Inspectors conducted inspections at 11 potential high pH industrial wastewater dischargers located upstream of the WRP, but no evidence indicating that any caused or contributed to these incidents was found. Inspectors also attempted, unsuccessfully, to trace the high pH in the sewers to a source. Inspectors continue to be vigilant in looking for an industrial source for these incidents.

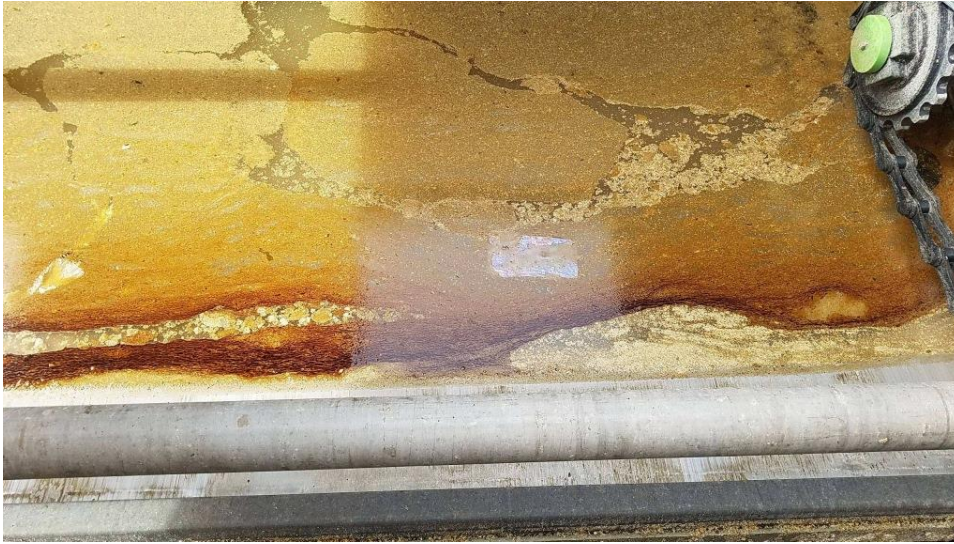
Figure 6: Floating brown oil in the Saugus WRP primary tanks at 0930 hours on 4-25-17.

Area IW Inspector Tanna Pekin and fellow IW Inspector Kristopher McGinnis arrived onsite at the Saugus WRP at 0920 hours on Tuesday, 4-25-17. Some of the oil reported was still present in the primary tanks (see Figure 6 above). Pekin and McGinnis conducted inspections at two permitted industrial wastewater dischargers upstream of the Saugus WRP, as well as at six unpermitted auto repair shops with waste oil on-site. No evidence was found at any of the companies that they were the source of the oily discharge found in the primary tanks at the Saugus WRP. An inspection at the Saugus WRP liquid waste disposal station that included a review of load logs, tanker samples from the loads brought in on 4-24-17, and speaking with the attendant, did not find any evidence the oil came from a load dumped there. Ron Foster said that no other processes were affected and the plant did not violate any NPDES limits due to the incident. The oily residue was skimmed off the primary tanks the following morning. Per Foster, the tanks are skimmed Monday, Wednesday, and Friday mornings. IW Inspectors continue to be vigilant in looking for a source for this incident, but acknowledge that finding the source for such a limited volume of relatively common material, i.e., waste oil, is unlikely.

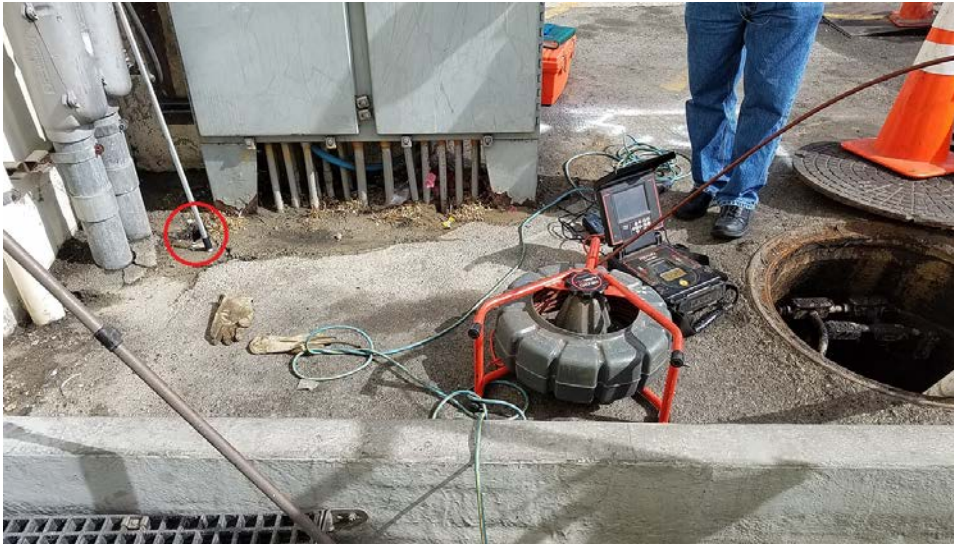
McGinnis arrived on-site at the Seven-Up facility at 0915 hours on 4-27-17. He met with the company's Environmental, Health, and Safety (EHS) Manager, Mr. Tom Wells. Wells confirmed that the facility lost about 900 gallons of untreated wastewater containing sugar to the local storm drain and Los Angeles River due to a ruptured underground wastewater conveyance pipe. Around 0030 hours on 4-27-17 an employee noticed water bubbling up from the ground and flowing into a nearby storm drain. An investigation determined there was a rupture in an underground pipe which conveys wash water from the production line to the central sump located immediately upstream of the pretreatment system on the southeast side of the building (see Figures 8-10 below). At the time of the incident the facility was in the process of washing down a production line that had just completed a run filling cans with Cherry 7UP. Due to the location of the leak, the facility was forced to cease operations until repairs could be made. During McGinnis' inspection repairs were ongoing and the contact was not sure when production operations would be resumed. The contact stated that representatives from the city of Vernon had been out earlier and had measured the residual spilled liquid at a "neutral" pH. Inspection of the area noted no residual traces of the spilled wastewater. There was no flow through the legal sample point while McGinnis was on-site. It was noted that there was no attempt made to recover the spilled wastewater from the river due to the large volume of water flowing in the river. The collapsed pipe was uncovered and repaired on Friday night, 4-28-17. Normal production operations and industrial wastewater discharge resumed the next morning. The cause of the rupture remains under investigation. This incident had no negative impact on the sewer system.

Figure 8: Rupture area. Note the approximately 5" hole in the pavement inside the red circle where the spilled wastewater came up and overflowed.

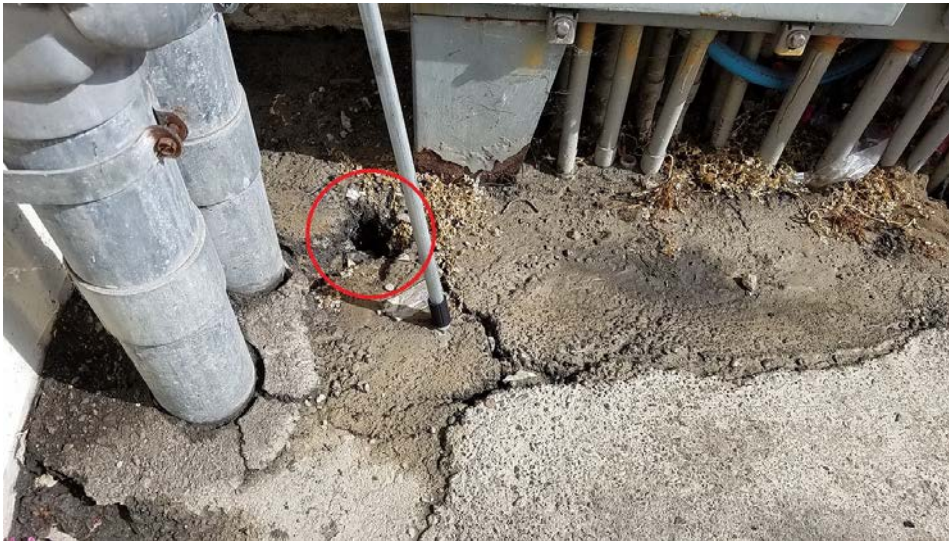
Figure 9: Close-up photo of the rupture hole.

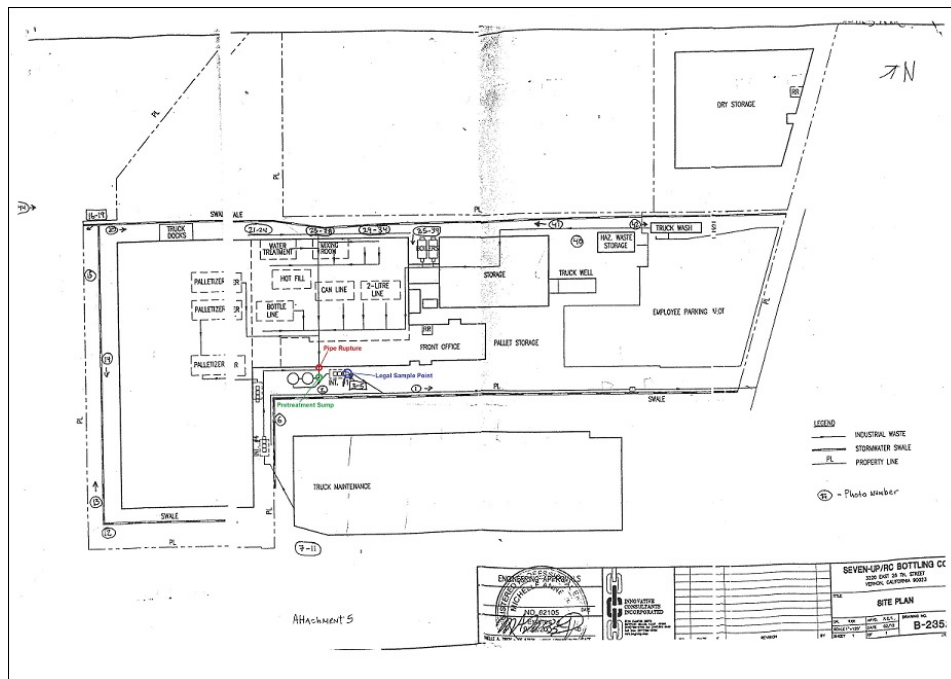
Figure 10: File drawing of the Seven-Up Bottling facility indicating the location of the ruptured wastewater pipe.

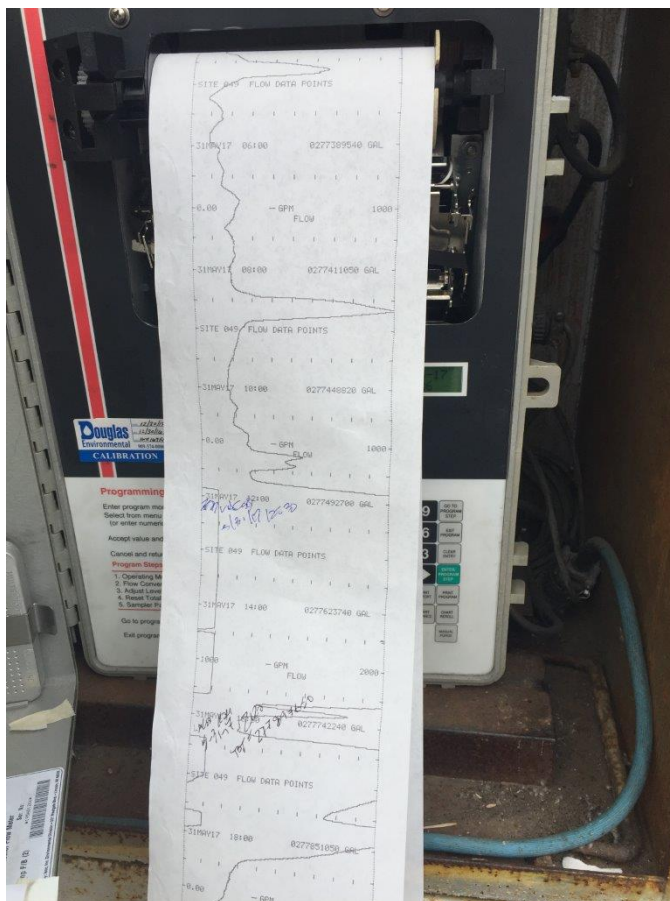
Figure 5: Flow chart recorder at AST textile on 5-31-17 indicating 6+ hours of a surcharged condition at the industrial wastewater flow meter from about 1145 hours until 1700 hours on 5-31-17.

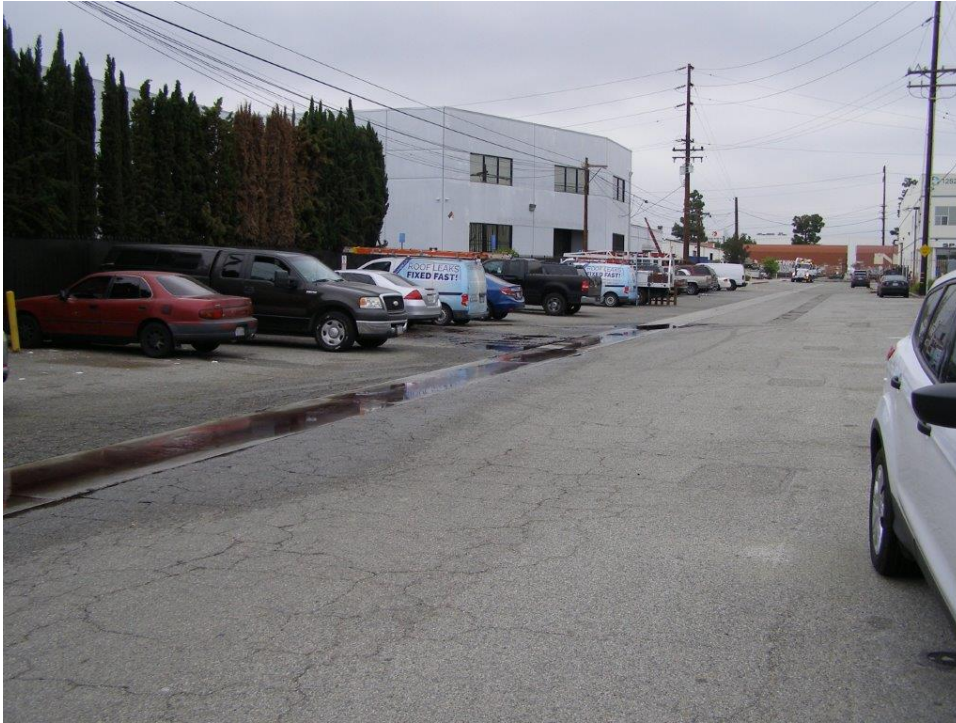
On Wednesday, 5-31-2017 at 1235 hours, during a routine inspection at the facility, Senior IW Inspector Bill Barnum observed industrial wastewater overflowing an 18,000 gallon industrial wastewater clarifier at the AST Textile Group in Hawthorne. The facility is a large cotton textile dyehouse operation. Barnum had noted at 1145 hours during the initial phase of his inspection that the company's industrial wastewater flow meter was submerged. He then quickly went to the downstream receiving sewer line to observe its condition. This check revealed that the line was surcharged. Barnum decided to immediately advise the company to reduce their discharge flow rate to prevent a possible sewer overflow. As Barnum was returning into the facility to notify the company's Plant Manager of the situation and suggest the flow reduction, he noted that the clarifier was now overflowing into the adjacent Cerise street gutter (see Figure 6 below). Barnum immediately notified the City of Hawthorne Public Works Department of the release and of a potential sanitary sewer blockage. After speaking with Barnum, company Plant Manager Mahmood Akhtar proceeded to work toward reducing the discharge rate to stop the overflow. This was accomplished within 15 minutes. Barnum monitored the receiving sewer manhole until the City Public Works crew arrived with a vactor truck and other equipment to contain and mitigate the spill (see Figures 6 and 7 below).

Figure 6: IW Spill on Cerise Street. Note the pink-red color of the spilled wastewater.

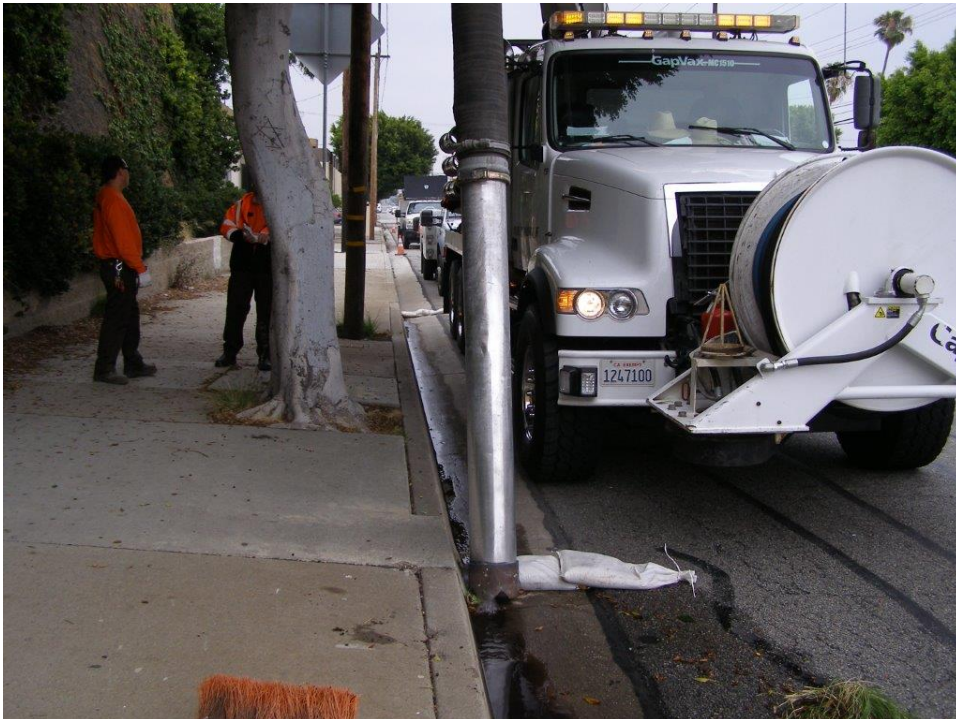
Figure 7: City of Hawthorne maintenance crew Jet Vac truck and sand bag containment.

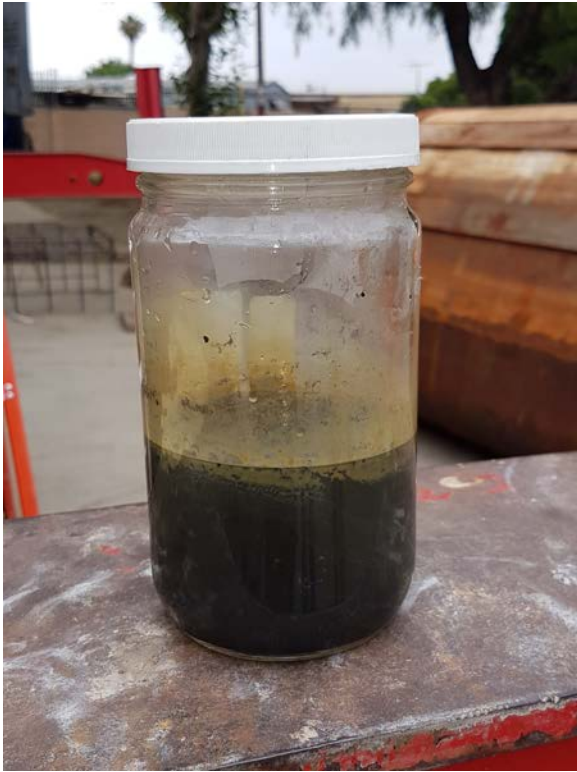
Figure 3: Sample of the oily sheen material taken on 6-7-17.

IW Inspectors led by South Teams Supervising IW Inspector David Sanchez, Woods, and Night Team Senior IW Inspector Kent McIntosh, expended significant time and resources attempting to identify the source of the oily sheen by tracing it upstream in the sewer and by inspecting known industrial wastewater sources. Thus far these attempts have failed to identify a source. Laboratory analysis of samples of the oily sheen material failed to identify any petroleum compounds in it. Laboratory analysts stated that their attempts to isolate the compounds of interest were unsuccessful due to the large amounts of interfering compounds normally present in raw sewage. Inspectors believe that the oily material may be entering the J.O. 'A' Unit 7 trunk sewer somewhere between Artesia Blvd and Alondra Blvd in North Long Beach and Paramount (between Manholes (MHs) A76 and A1112-see Figure 1 GIS diagram above). Should further reports of the oily sheen be received, IW Inspectors will pick up the attempt to trace it from there. In the meantime, IW Inspectors continue to be on the lookout for the source of this material as they conduct routine inspections.

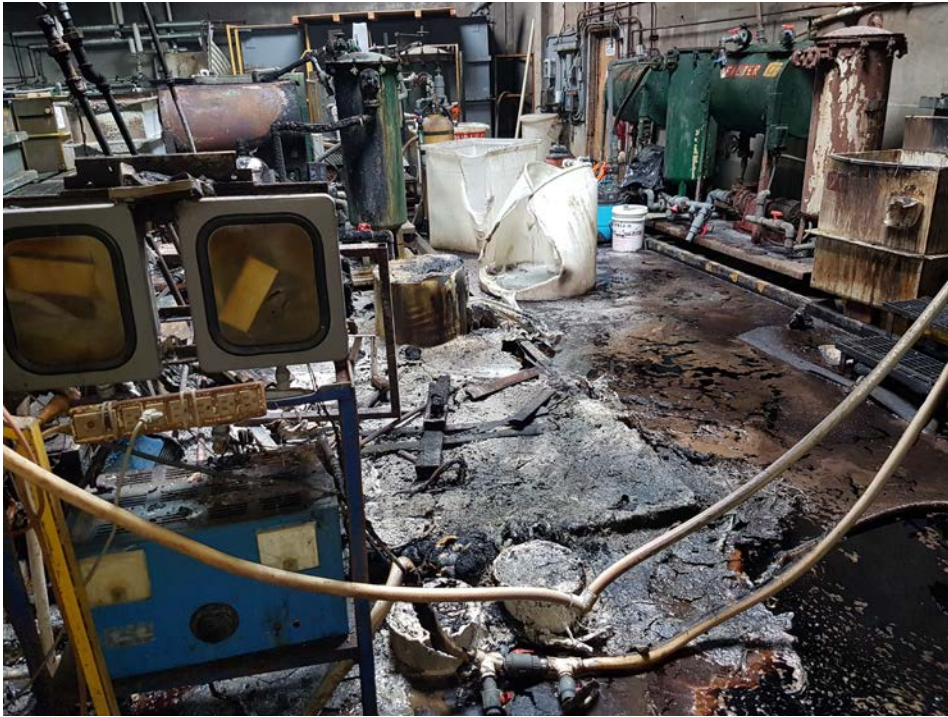
Figure 4: Aftermath of the 6-8-17 fire at Cal-Tron Plating in Santa Fe Springs. Note the melted white poly rinse tanks.

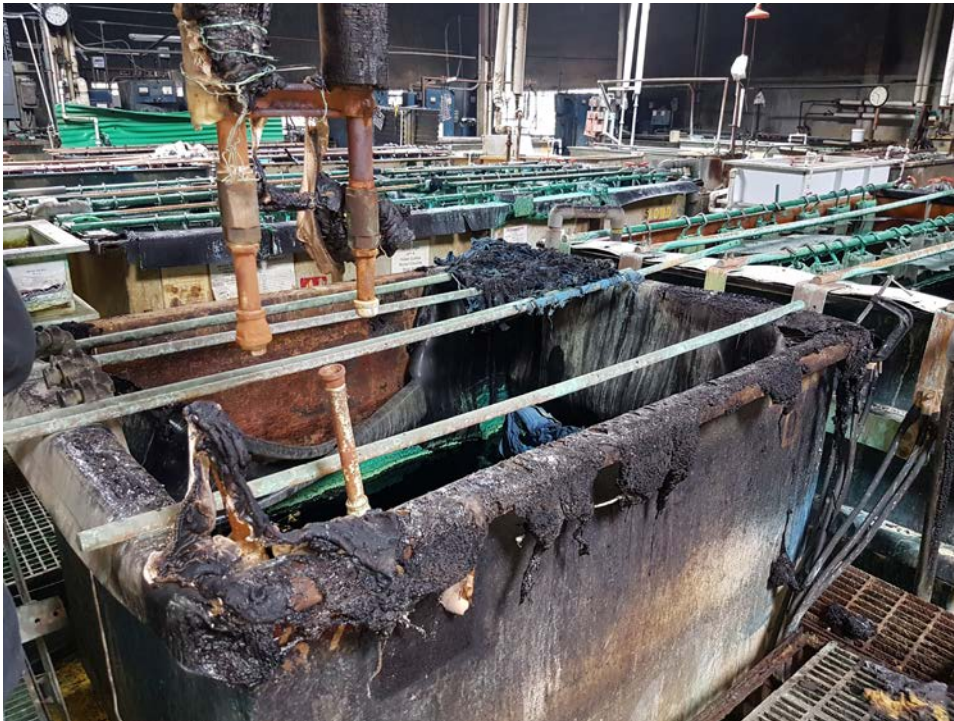
Figure 5: Aftermath of the 6-8-17 fire at Cal-Tron Plating in Santa Fe Springs. Note that the tanks containing the concentrated plating solutions remained essentially intact.

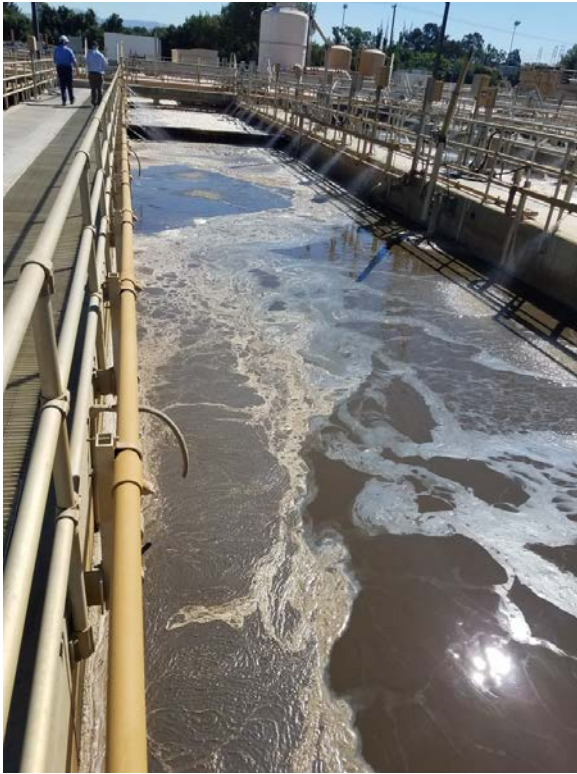
Figure 10: 6-15-17 Valencia WRP secondary treatment tank with floating material.

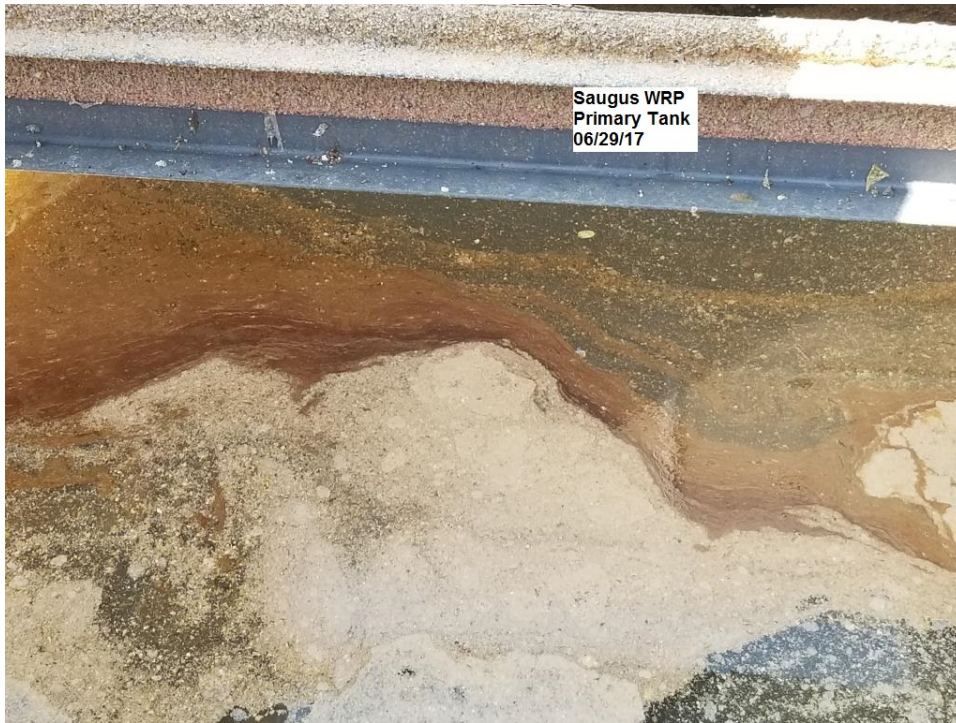
Figure 12: Oily material in a Saugus primary tank on 6-29-17.

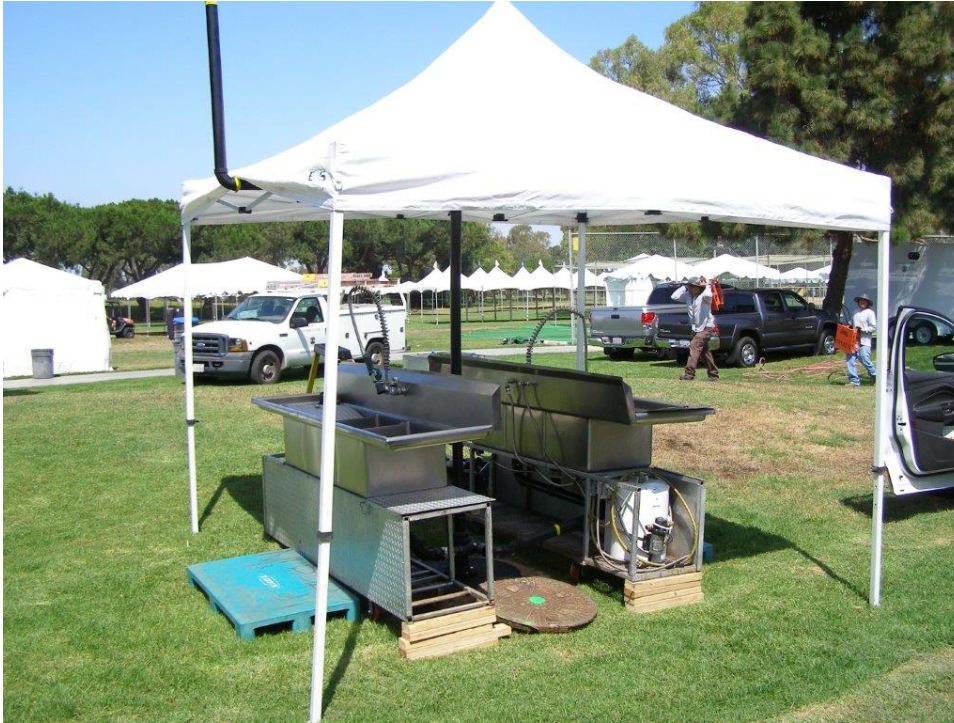
Figure 2: 7-14-17 dishwashing sinks illicitly plumbed into MH 05 0084. Note that the installation even included a vent pipe!

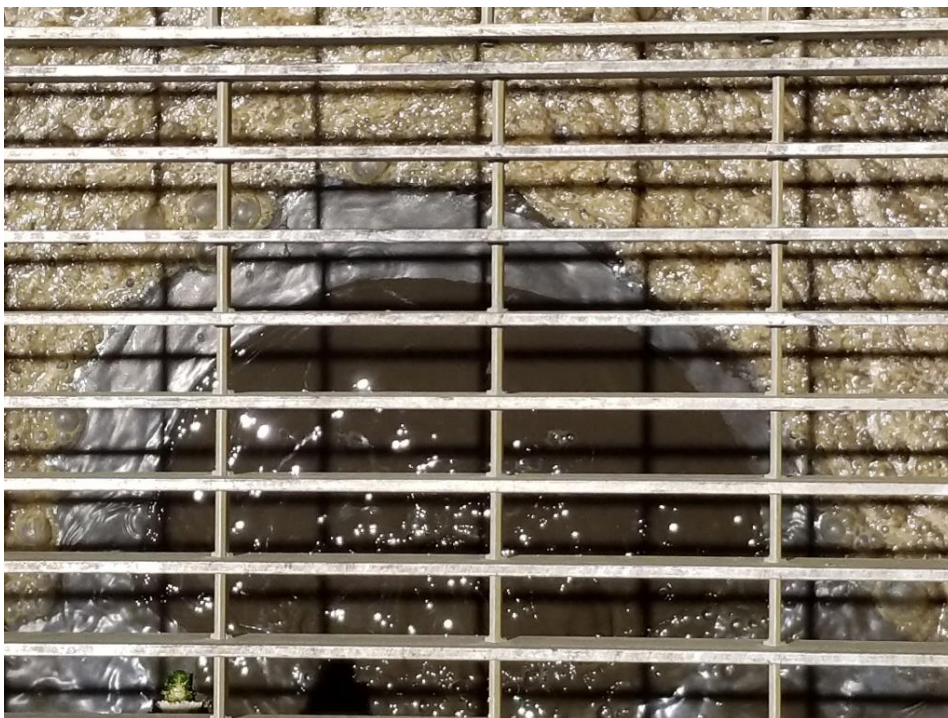
Figure 6: 6-15-17 Valencia WRP secondary treatment tank bubbles showing the slight sheen reported both on 6-15-17 and again on 7-28-17.

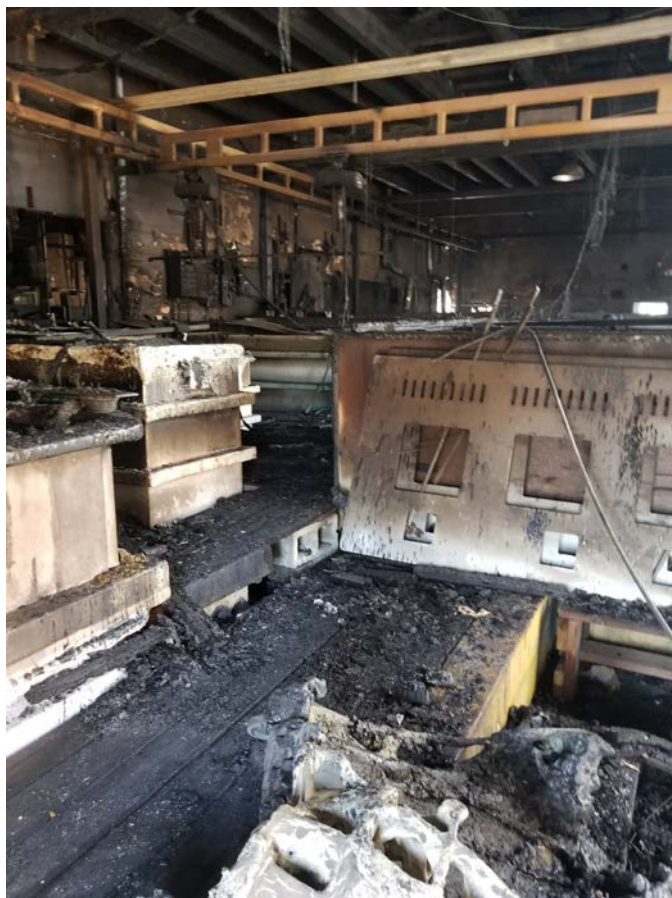
Figure 1: Interior of the processing building of Gardena Specialized Processing post fire on 8-14-17.

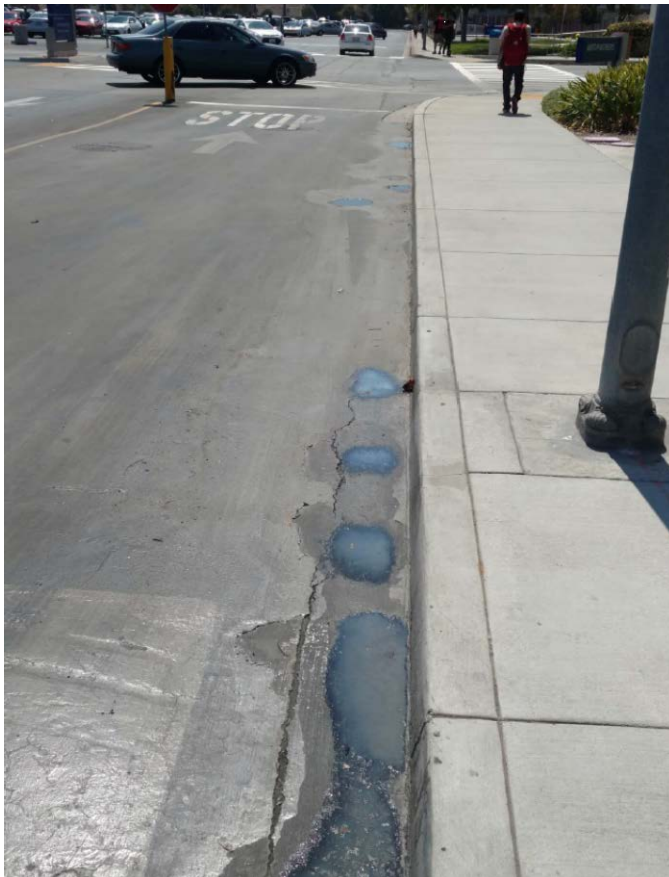
Figure 1: Small puddles of milky-white colored liquid noticed at 1235 hours on 9-6-17 by IW Inspector McCurdy at Cerritos College.

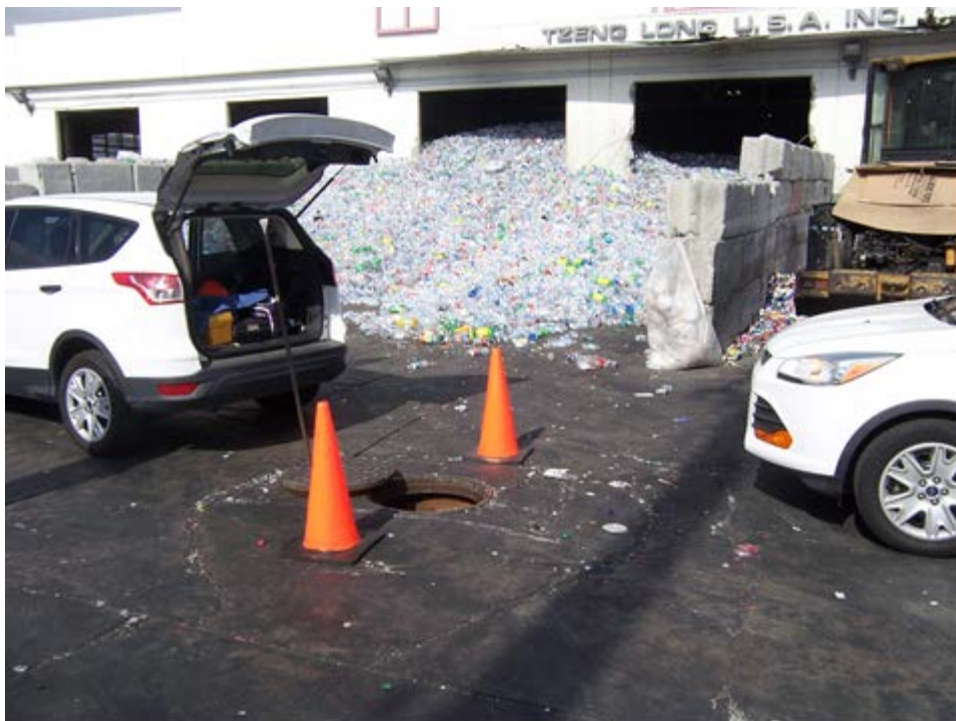
Figure 5: MH 02 0994 on the property of Tzeng Long USA. Note the proximity of the large pile for plastic bottles to the manhole.
