2017 ANNUAL REPORT

INDUSTRIAL WASTE PRETREATMENT PROGRAM

COUNTY SANITATION DISTRICTS OF LOS ANGELES COUNTY

APPENDIX H
INDUSTRIAL WASTE REPORTS ON INCIDENTS

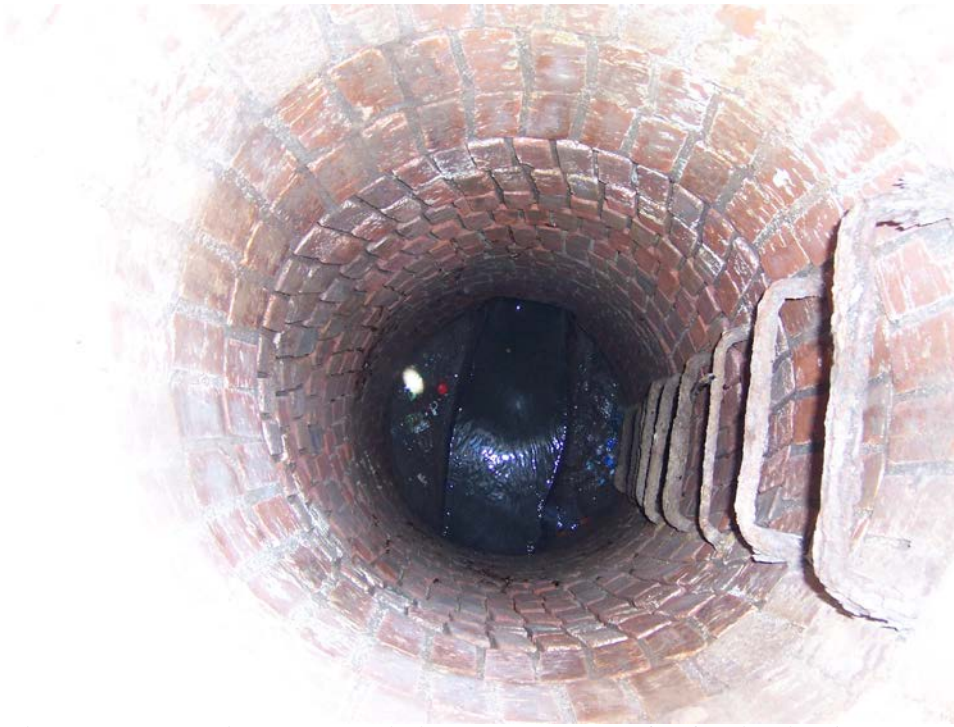
Figure 6: Plastic bottles sitting on the shelf of Districts' sewer MH 02 0994.

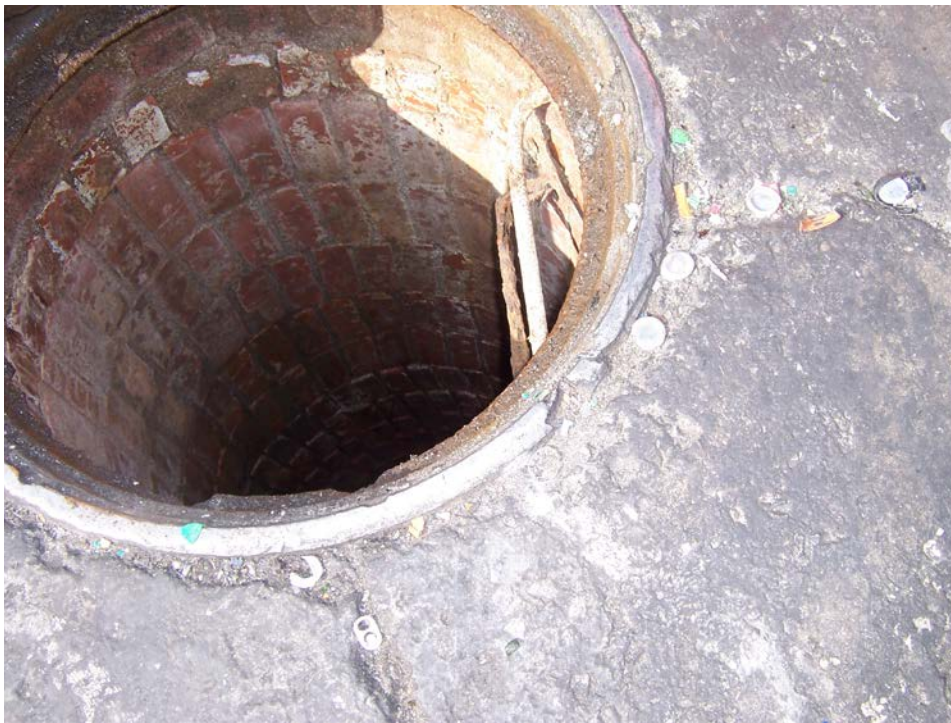
Figure 7: Damaged frame of MH 02 0994 indicating it is subjected to frequent "heavy hits." Note that the manhole cover is a non-locking type.

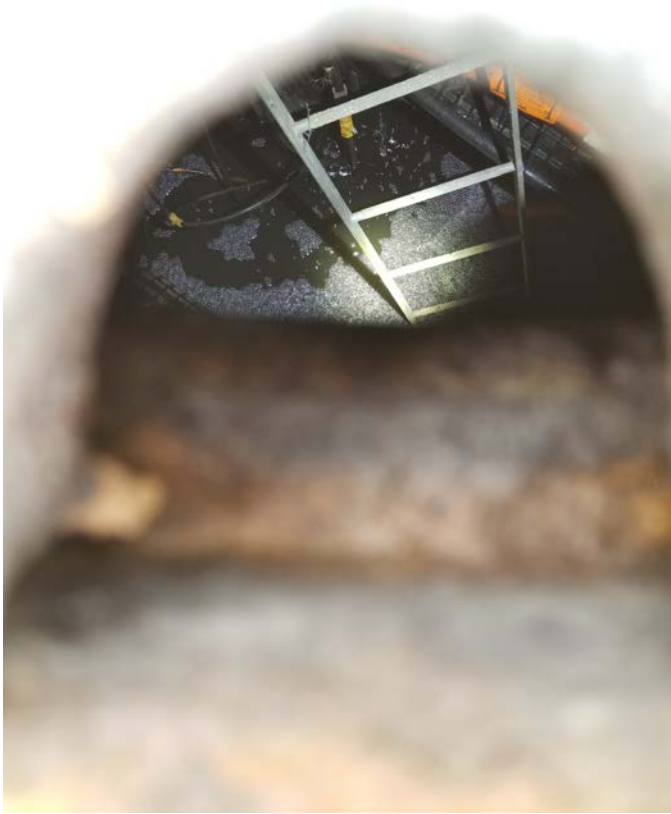
Figure 3: 10-19-17 photo of the AT&T vault interior through the vault cover pick hole. It was noted the water visible inside was not flowing, but that there were bubbles present, likely coming from the AT&T lines, through which air is fed to keep moisture out.

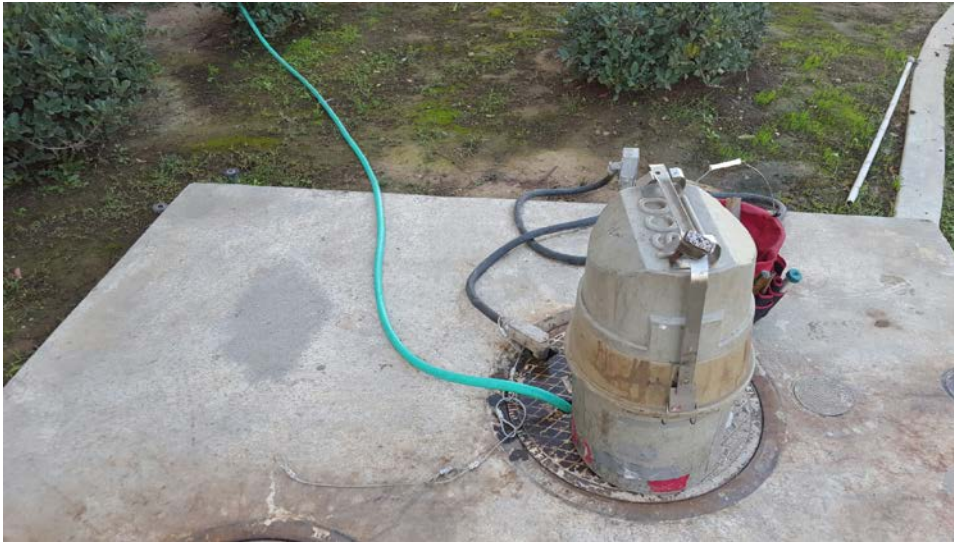
Figure 4: Potable water hose stuck through the sample box cover at La Amapola Inc. in Santa Fe Springs at 1000 hours on 10-26-17. Note the Districts' 24-hour composite sampler. Also note the effluent pH probe conduit and housing immediately adjacent to the hose.

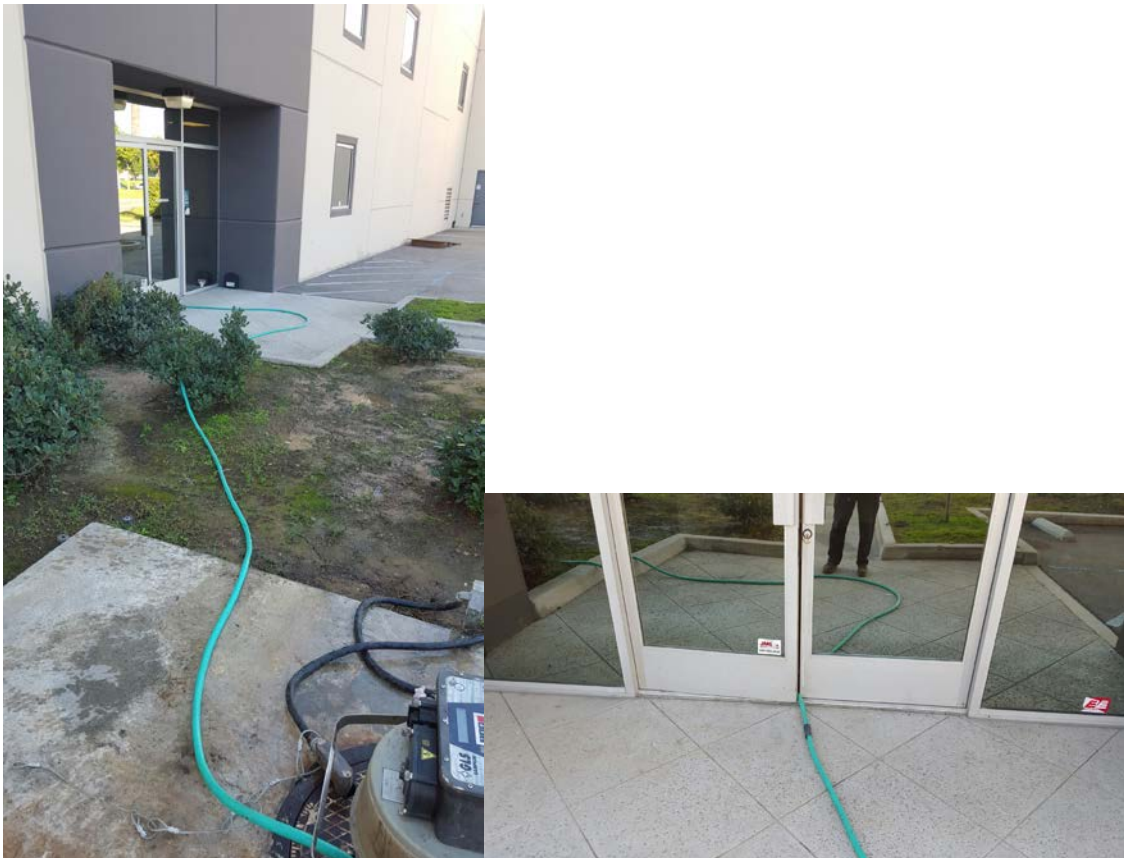
Figure 5: Hose running from the sample box to the lobby doors of La Amapola Inc.

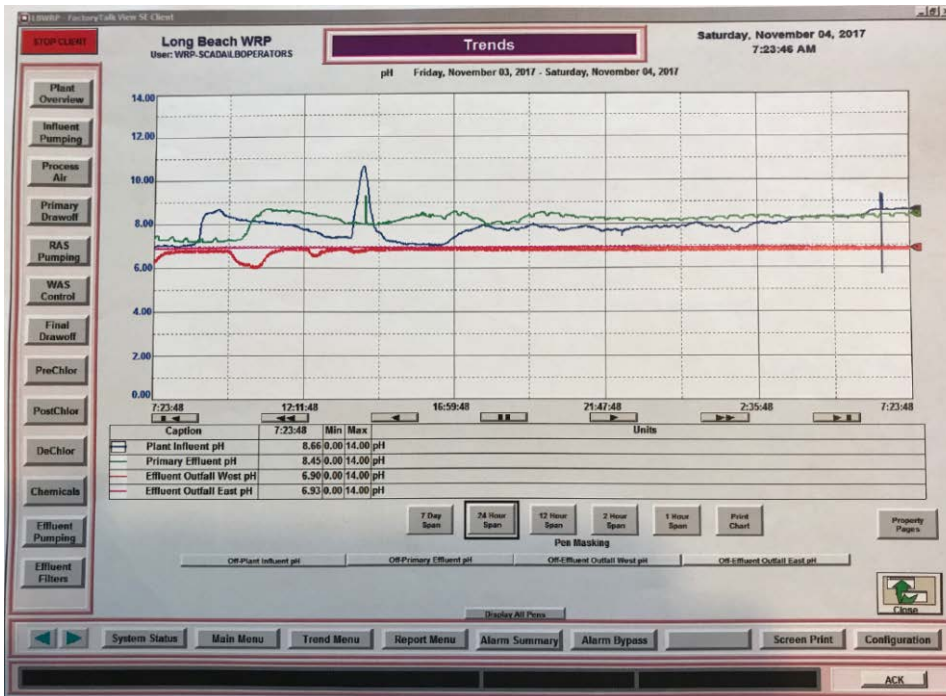
Figure 1: Long Beach WRP pH data trends for the 24-hour period of 0723 hours on 11-3-17 to 0723 hours on 11-4-17. The influent pH is the blue data line.

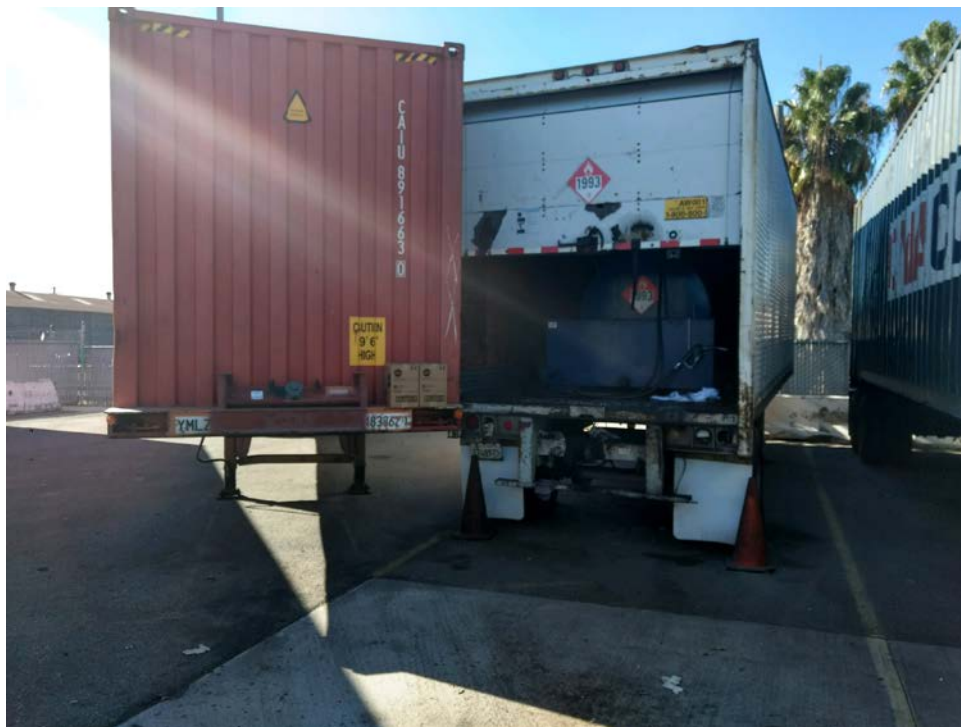
Figure 3: 11-7-17 photo of the diesel fuel storage tank located inside a trailer at Performance Team.

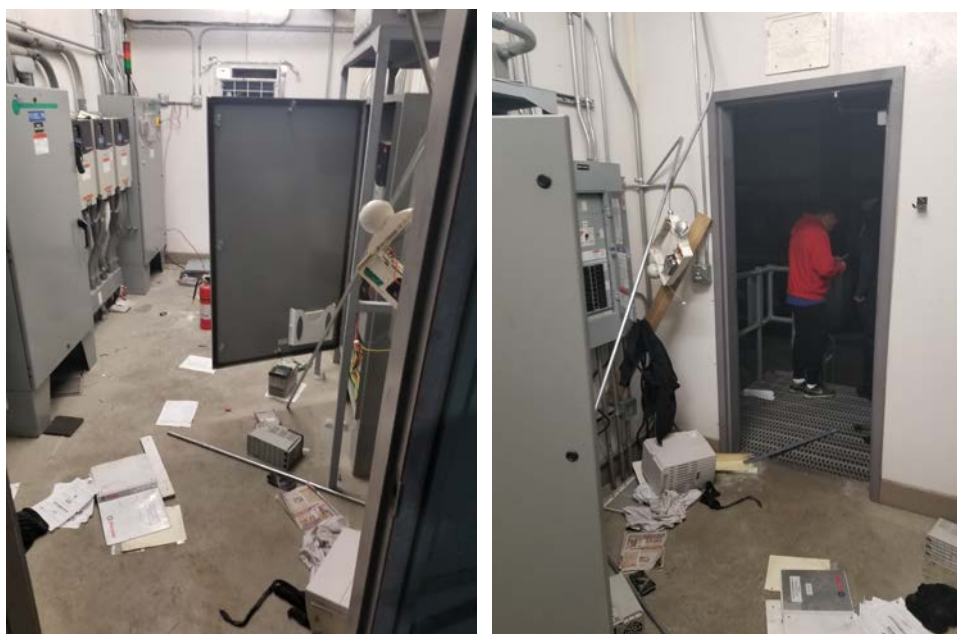
Figures 6 and 7: Photos showing the damage inside the White Wave Foods wastewater pretreatment system control room.

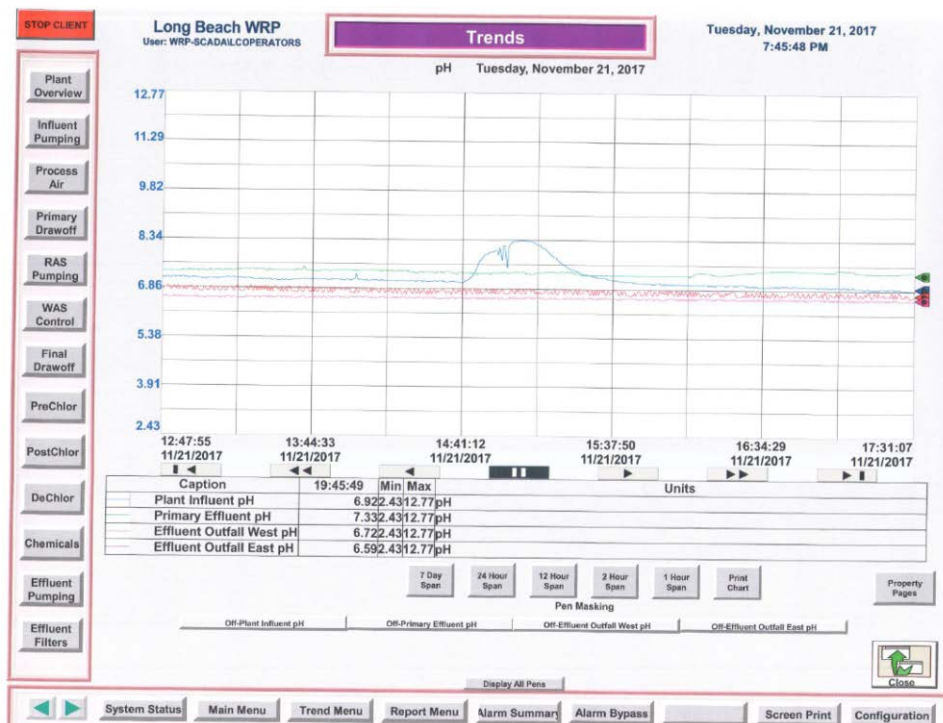
Figure 8: Long Beach WRP pH data trends for the approximate 4 hour, 45 minute period from 1247-1731 hours on 11-21-17. The influent pH is the blue data trend line.

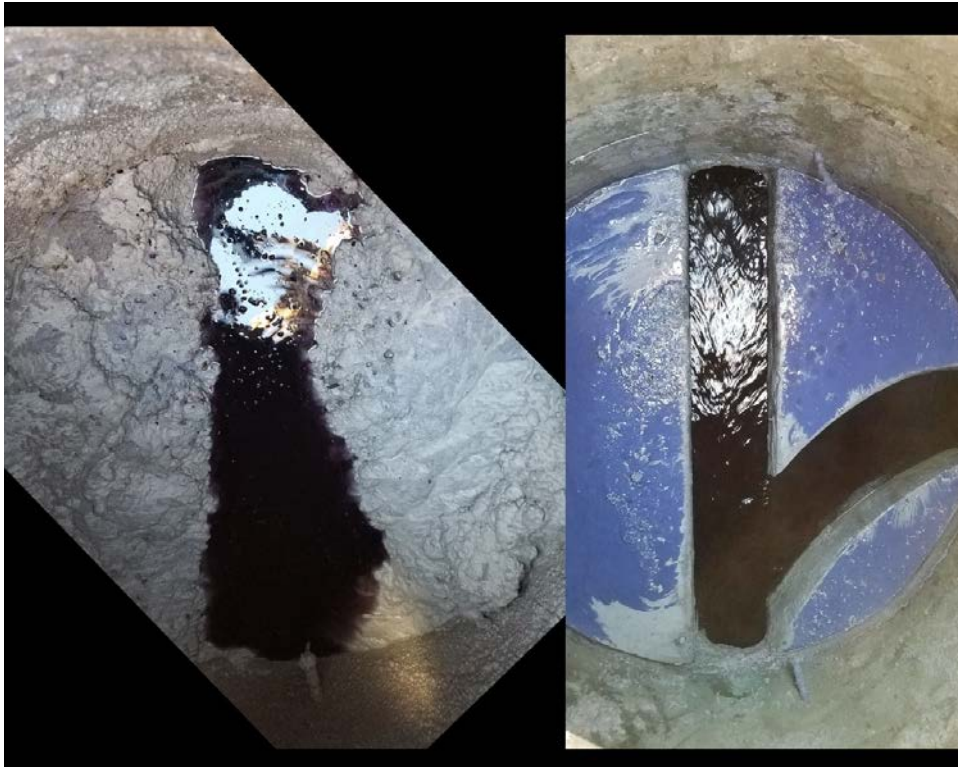
Figure 2: Comparison of the lateral line at the manhole cover 2 location. Left side is before cleaning and the right side is after cleaning and pumping.

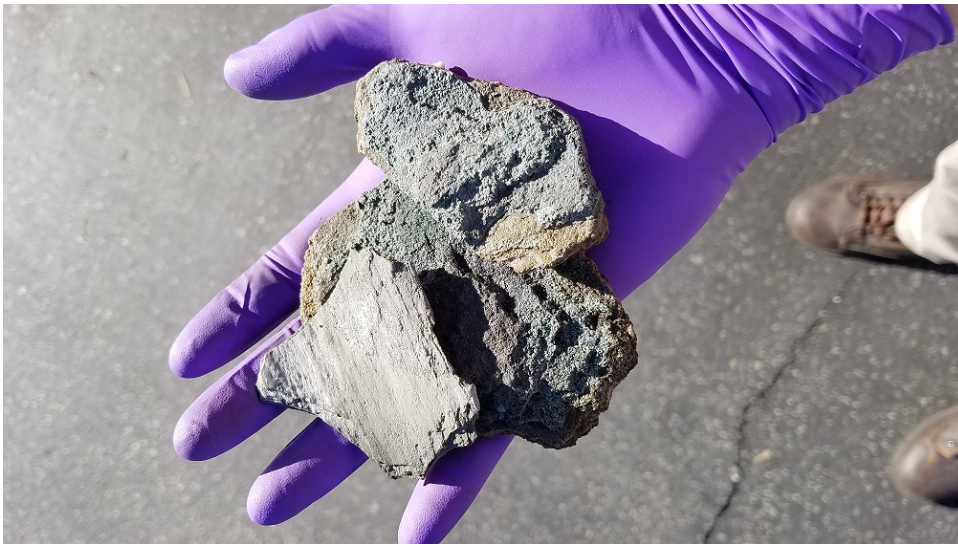
Figure 3: Pieces of stone debris found in the lateral line at the discharge location of A's Match Dyeing Company.

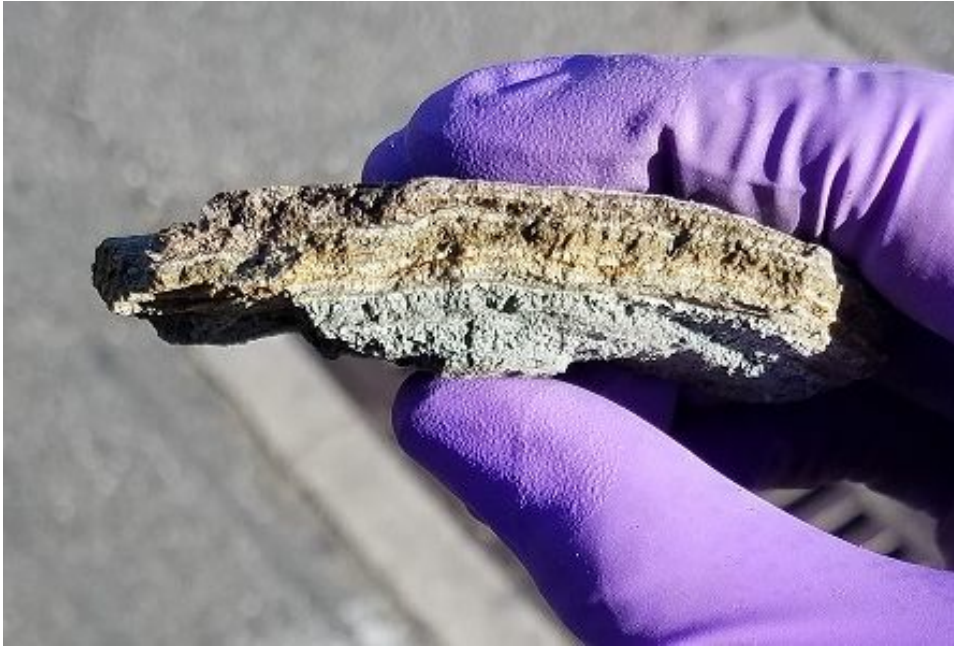
Figure 4: Profile view of one of the stones in Figure 3. Note the stratification that indicates long term scale build-up.

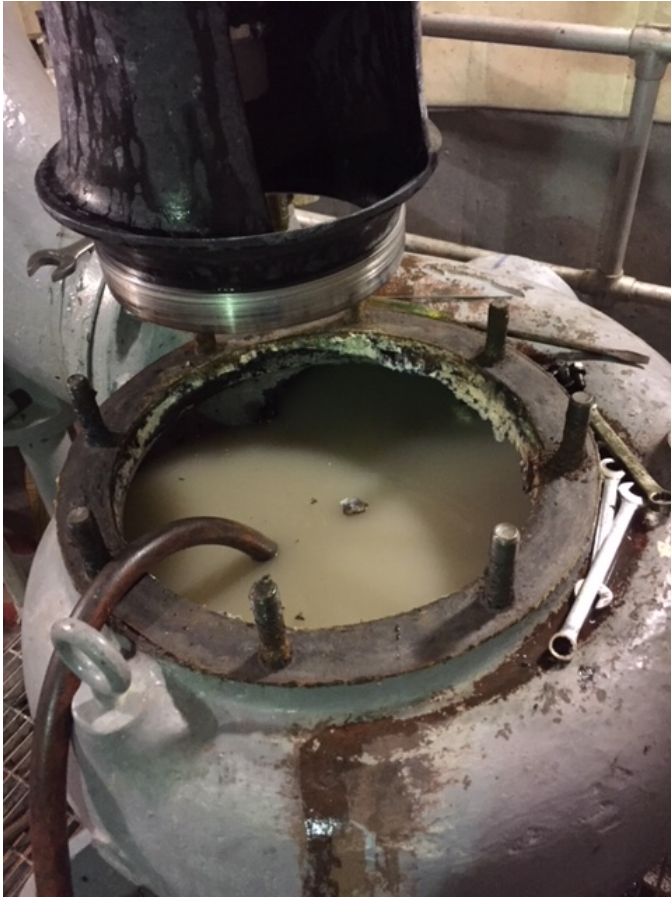
Figure 5: 12-17-17 photo of the Coyote Creek pumping plant pump taken by PP maintenance staff. Operators stated the grease shown inside the pump housing/chest was at least several inches thick.

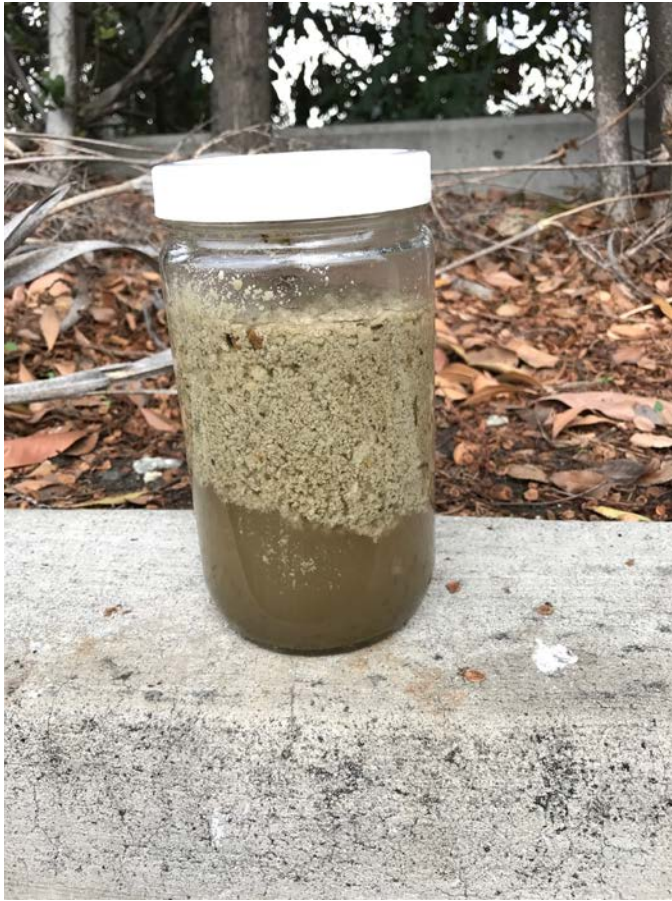
Figure 6: Floating grease in a sample taken from the Coyote Creek pumping plant.
