2022 ANNUAL REPORT

INDUSTRIAL WASTE PRETREATMENT PROGRAM

LOS ANGELES COUNTY SANITATION DISTRICTS

APPENDIX H
INDUSTRIAL WASTE REPORTS ON INCIDENTS

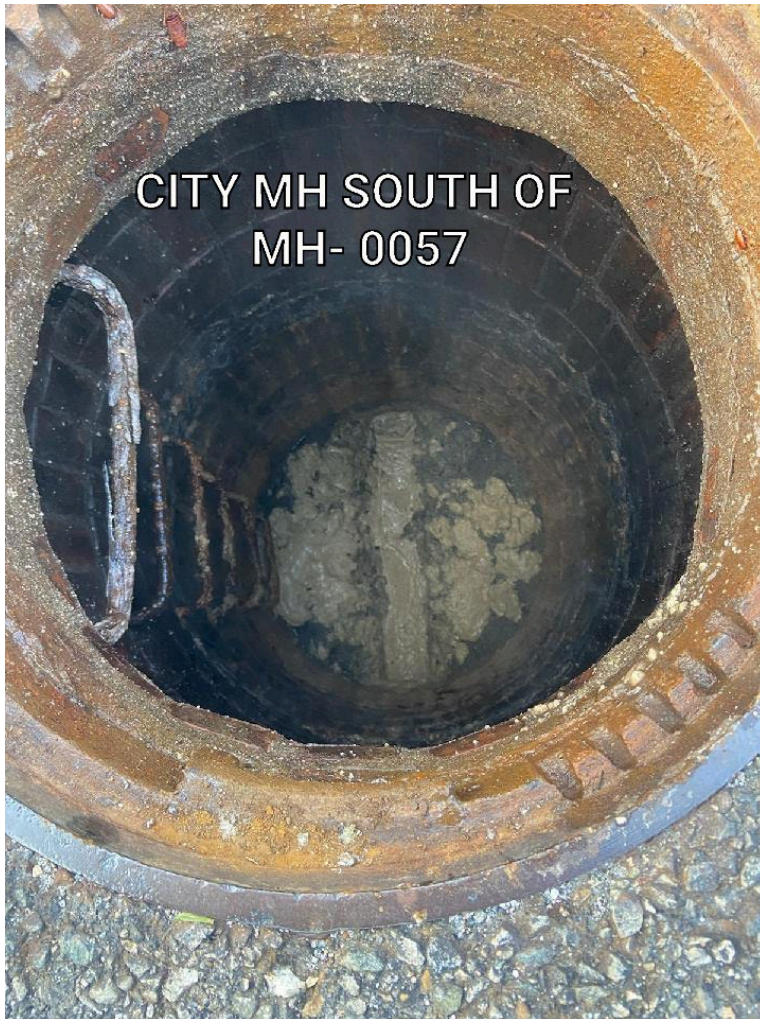
Figure 2: Grease observed by IW Inspectors in the local line just upstream of MH 15 0057. Note that the grease is present on the manhole shelves, indicating surcharging has occurred.

Both day and night shift Industrial Waste Inspectors investigated the report. It was determined that the source of the grease was Evans Food Group, Ltd., aka Gayton Foods, a large manufacturer of chicharrones (fried pork skins/rinds) that was discharging excessive amounts of grease, generally during after-hours clean-up operations. The Evans facility holds IW permit #22180 and has a permitted flowrate 16,000 gpd. The facility was found to have an inadequate pretreatment system to remove the grease from their industrial wastewater discharge.

A Notice of Violation (NOV) was issued to the facility on 1-26-2022 for causing excessive greasing in the downstream sewers and a requirement was issued to cease the discharge of the excessive grease immediately. Additionally, after contacting the local sewer agency (the Los Angeles County Department of Public Works Sewer Maintenance District, aka the LACDPW SMD), the local sewer line was hydrojetted by the SMD to remove residual grease. A compliance meeting with Sanitation Districts' enforcement managers and Evans Food Group facility representatives may be scheduled to address these issues.

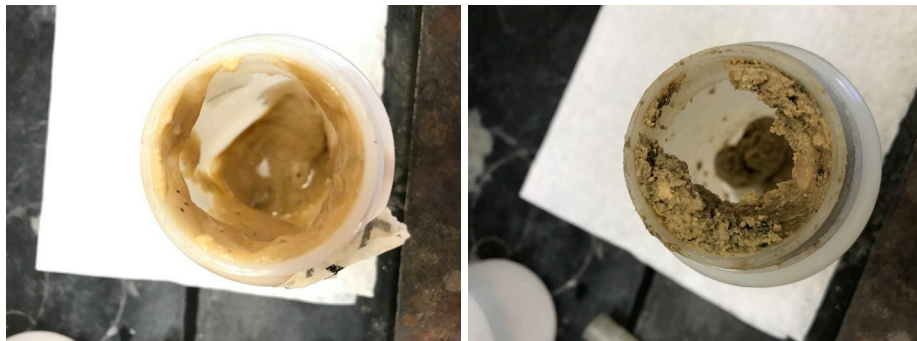
Figures 3 and 4: Grease Samples taken from the local line sewer just downstream of Evans Foods and from MH 15 0057. Note the similarity, though the sample from MH 15 0057 is more weathered and contains mixed in grit from the sewers.

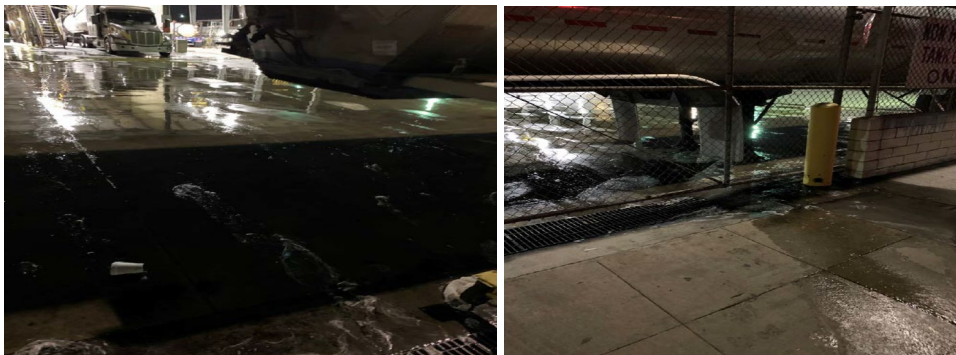
The subsequent investigation revealed that a transfer pump had failed causing xylene-based resin-laden wash water to spray into the wash rack area and outside the trench containment. L.A. Wash Rack workers treated the spill with sodium hydroxide and attempted to use potable water to wash it upgrade into the trench containment. However, an unknown amount left the property and collected in the street gutter and a downstream city storm water catch basin. The pH of the material in the street was between 10 and 11. Districts' IW Inspectors immediately contacted the City of Vernon's 24-hour Control Center and spoke with The Director of Health and Environmental Control, who sent a crew to respond to the spill. IW Inspectors remained on-site for several hours to coordinate with the city responders and to verify that none of the spilled material was discharged to the sanitary sewer. The incident resulted in a clean-up effort by a contractor hired by the city, Ocean Blue Environmental. Fortunately, it was determined that none of the spilled resin containing wastewater, or subsequent wastewaters generated from the initial response to the spill or cleanup, reached the nearby Los Angeles River. Ultimately, 250 gallons of waste generated from this incident were hauled off-site for proper disposal according to waste manifests, but the sanitary sewer and downstream Districts' facilities were not impacted.

Figures 5 and 6: Pictures taken at L.A. Wash Rack at 1930 hours on 1-21-2022. Note the spilled material running from the truck washing area, across the sidewalk and then into the street gutter.

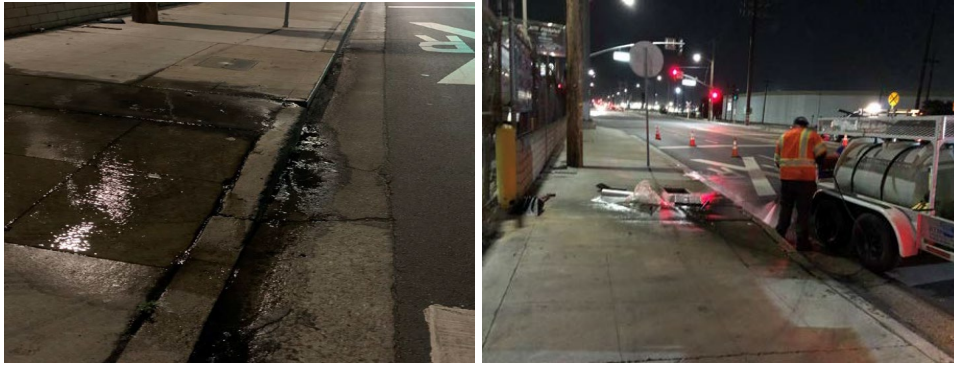
Figures 7 and 8: Another picture of the spilled material in the street gutter at 1930 hours on 1-21-2022 hours and then a photo a couple hours later of personnel from contractor Ocean Blue Environmental cleaning up the spill on 1-21-2022.

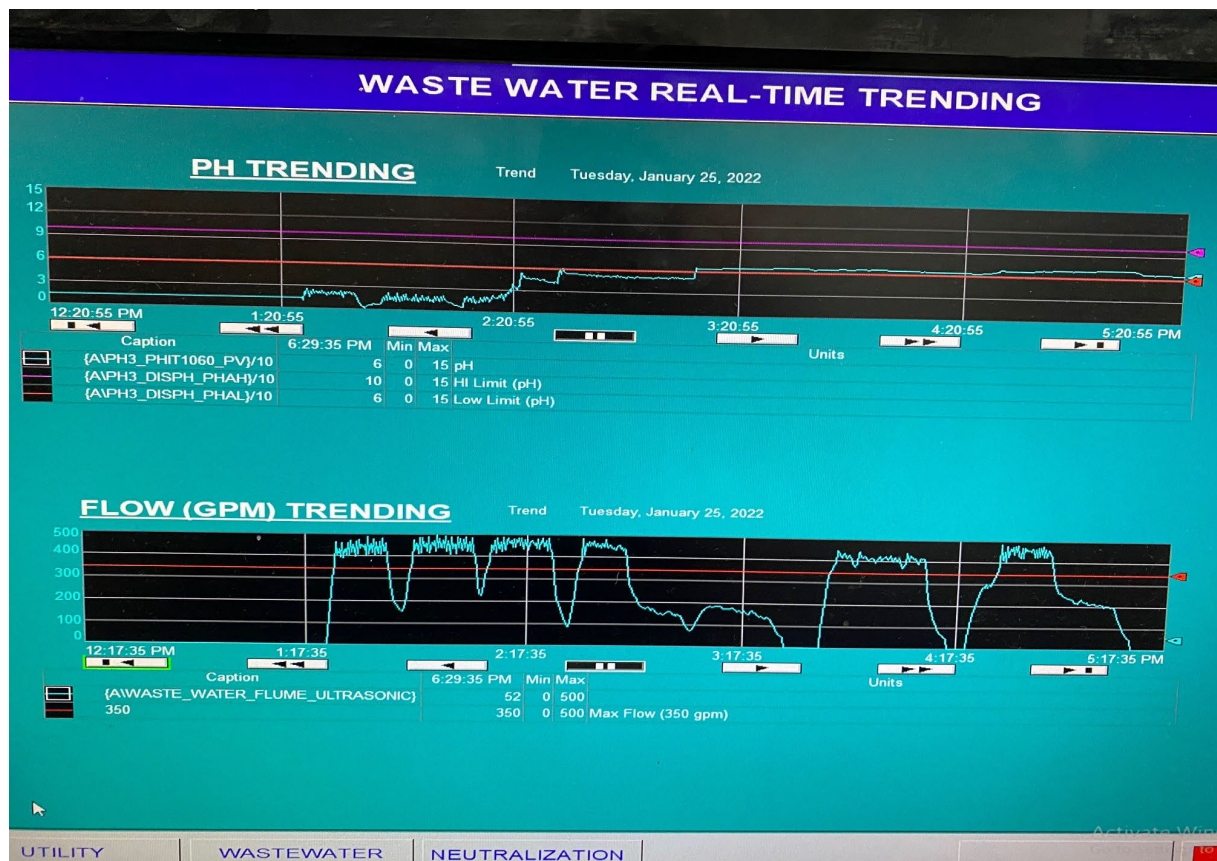
Districts’ night team inspectors arrived on-site at 1600 hours that same day to perform the requested follow-up inspection. Operations at the facility appeared normal but a review of the facility’s discharge data (see Figure 9 below) indicated that the low pH discharge had resumed almost immediately following the earlier inspection. Record review indicated the facility discharged wastewater with a pH of between 0 and 3 between 1325 and 1420 hours at approximately 450 gpm. Inspectors estimated that approximately 36,000 gallons of low pH wastewater had been discharged in violation of both permit requirements and the explicit order from the IW Inspector earlier that day not to do so. When asked why they had ignored the instructions of the inspector, the contact simply stated, “I know it’s not right, but management

said, “f#%* it, we will deal with the fine later.” When queried as to why they felt the illicit discharge was needed, it was explained that the facility had recently changed ownership and that as part of this change facility managers had been required to switch to new chemical suppliers effective that day, including a new supplier for the sulfuric acid used in their CIP process. Thus, they needed to empty the previous CIP chemical supply tanks in order to receive a delivery later that day of new chemical from the new supplier, including the sulfuric acid used in the CIP system. Instead of either using the rest of the old, but still good, sulfuric acid properly or having it hauled off-site for proper disposal, due to the lack of time available to pursue either option, managers decided to just dump it to the sewer instead.

Figure 9: Industrial wastewater discharge pH and flow data at Tropicana Manufacturing Company on 1-25-2022 indicating that the facility discharged wastewater with a pH of between 0 and 3 between 1325 and 1420 hours at approximately 450 gpm.

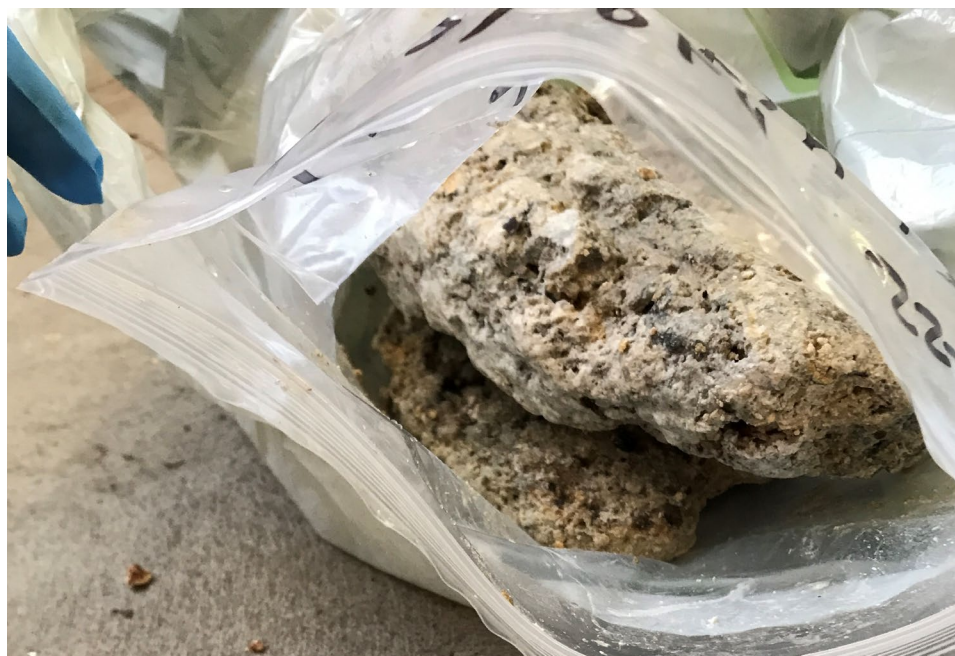
Figure 1: Sample of grease from the siphon structure at manholes 18 0434A and 18 0434.

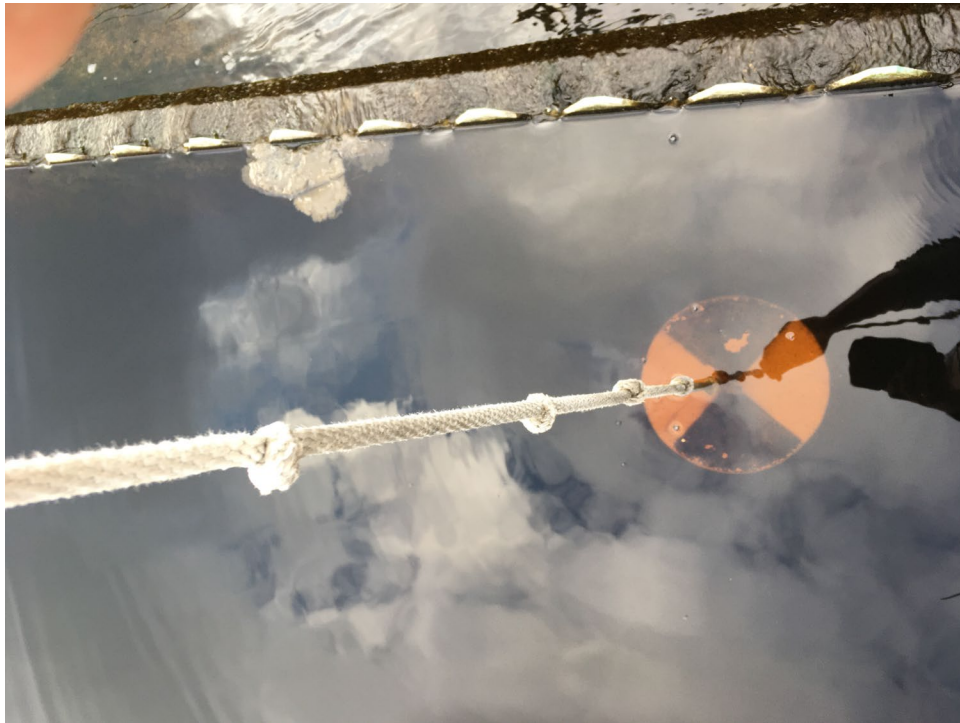
Figure 2: Los Coyotes WRP Forebay on 2-21-22. Note the red color as shown against the white Secchi disc surface.

IW Inspectors determined that the source of the red color was Tri-Star Dyeing and Finishing Inc., a large textile washing and dyeing facility with a permitted flowrate of 450,000 gpd. A notice of violation for exceeding their effluent 50:1 color dilution limit and adversely impacting the downstream WRP was issued on February 22, 2022. This facility has been the source of many such color incidents and associated Districts' enforcement actions over the past 2 plus years. Efforts by company managers, as a result of the previous enforcement activity conducted by the Districts, does appear to be finally having a positive effect on reducing the number of these incidents though as evidenced by the fact that this is first color incident at Los Coyotes WRP since October 2021. IW inspectors and Section managers continue to monitor this situation very closely.

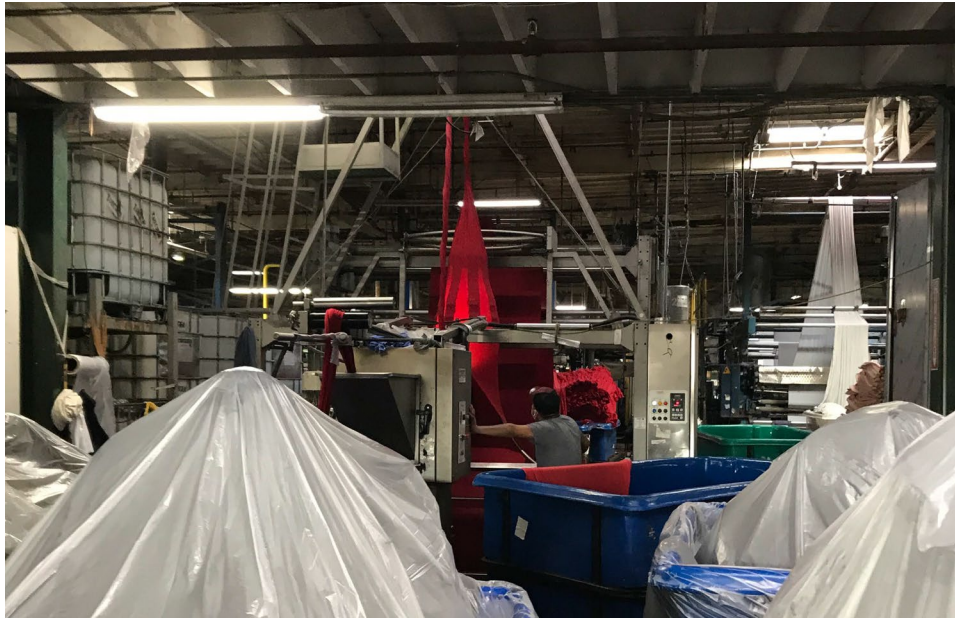
Figure 3: Picture taken at Tri-Star Dyeing & Finishing on February 22, 2022 showing an example of the red fabric being processed that likely caused the February 21, 2022 red color incident at the Los Coyotes WRP.

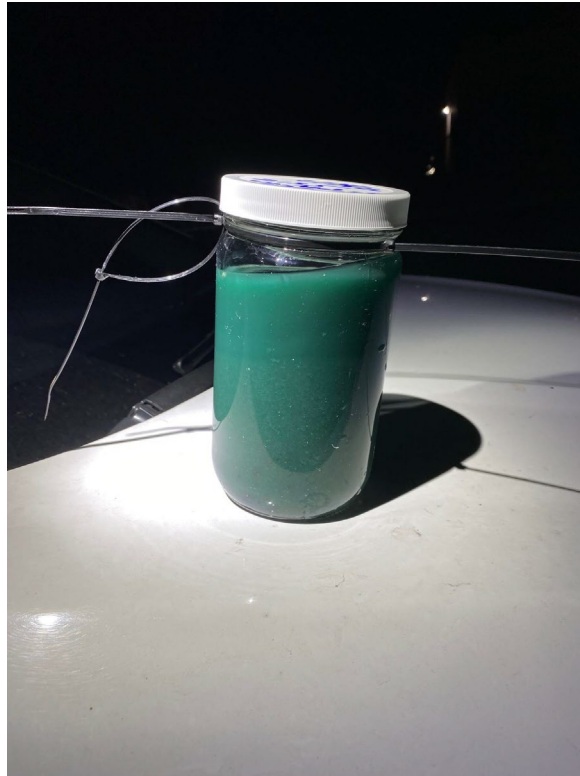
IW inspectors determined that the most likely source of the color and dissolved oxygen drop-off incidents during early a.m. hours at the Whittier Narrow WRP are discharges from the United Site Services facility in El Monte. This facility discharges concentrated, high strength, portable toilet wastewater and has a permitted daily discharge rate of 22,700 gpd. Of note is the fact that they typically discharge after 2000 hours into the early morning hours to minimize the odor impacts of their discharge on their neighbors, who typically have gone home by that time. Inspectors also noted that the facility has recently switched to a new portable toilet dye packet that is added to the water used in the portable toilets, however it has the same color intensity as the dye previously used. Inspectors will continue to monitor the facility to ensure their permit requirements are being met.

Figure 4: United Site Services effluent sample taken at 2135 hours on February 24, 2022.

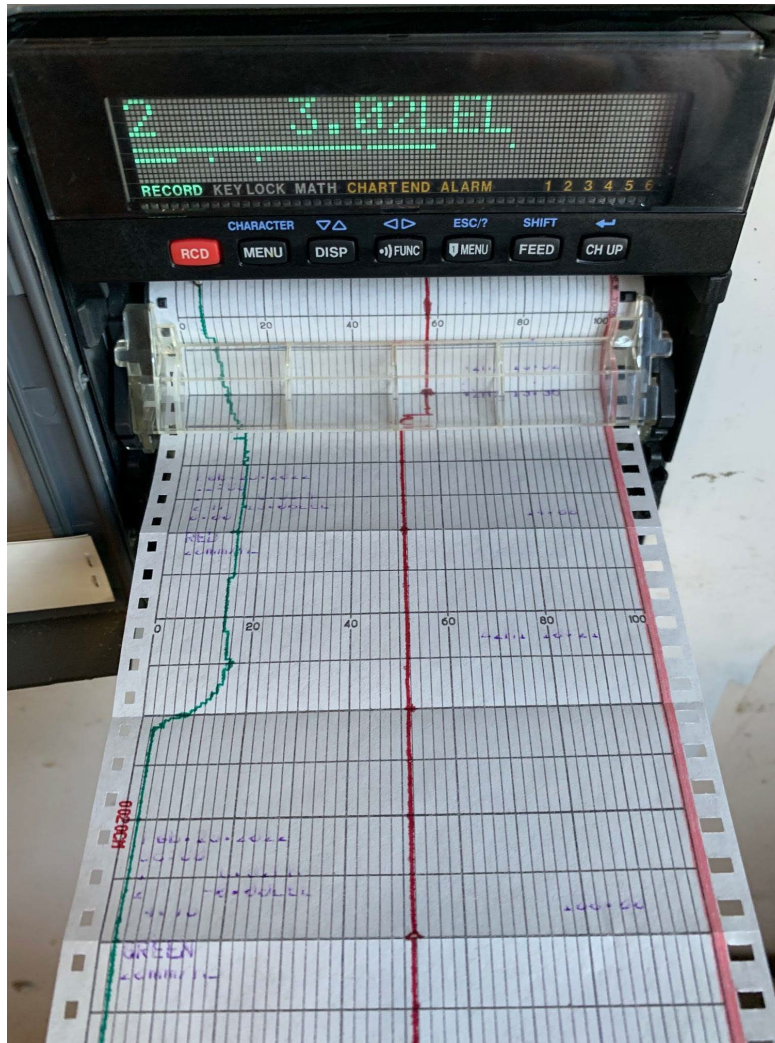
noticed at the JWPCP. The facility has a permitted daily discharge rate of 32,000 gpd. The facility was issued a notice of violation for causing adverse impact to the JWPCP, failing to meet their permit limits, and failing to properly maintain their industrial wastewater monitoring equipment. The cause of the excessive oily discharge was a problem in the facility's pretreatment system, likely in the gas floatation unit. IW inspectors reminded refinery managers to make proper notifications when they become aware of a discharge limit exceedance. In this case refinery operators were aware their discharge was not meeting the 75 mg/l limit at 82 mg/l based on a 0930 hours sample, the results of which they were aware of by 1100 hours, and which caused them to cease discharging.

Figure 5: Explosivity “LEL” monitoring chart recorder at the Valero asphalt refinery in which the discharge of oily wastewater is indicated by the increase in the LEL reading (green trend line on the chart) from 0% to 16% on February 25, 2022 from 0800-1300 hours.

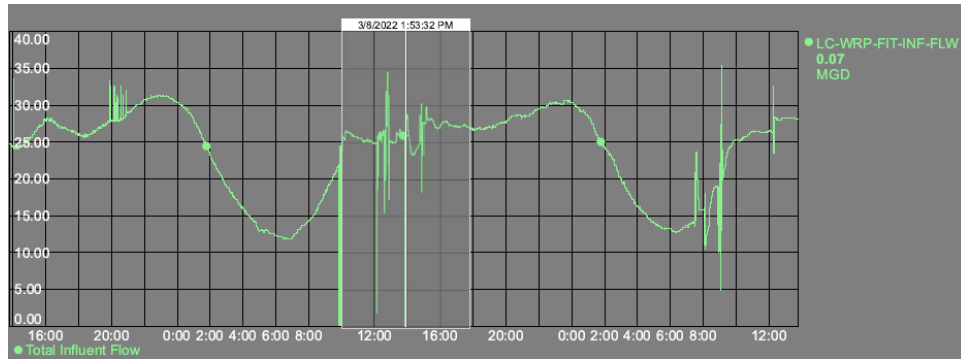
Further examination of LCWRP OSI Pi data provided by LCWRP operators indicated that the high turbidity reading and slight tea color was likely attributable to the influent pump being cycled on and off several times on 3-8-22 at around 1000 hours just prior to the increase in turbidity being observed (see Figure 2). It is thought the action of cycling the pump may have caused material in the plant' secondary settling tanks to be stirred up. No NPDES violations were caused by the incident and no further follow-up on this incident is anticipated by IW

Figure 2: LCWRP 3/7/22-3/9/22-8-22 total influent flow as determined by influent pump rate.

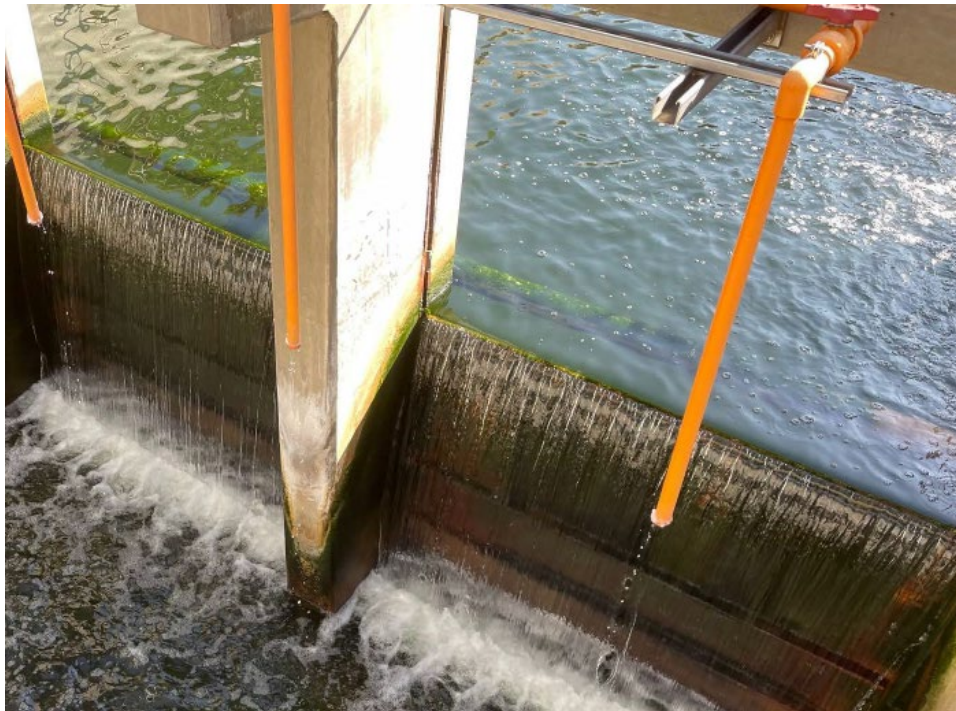
Figure 3: 3-15-22, 0800 hours LCWRP final effluent forebay. Note the green color.

hue of green was essentially identical to the WRP final effluent hue, failed the facility's 50:1 color dilution test limit. The facility was issued a notice of violation with two violations: failure to comply with the permit color limit and for discharge of colored wastewater negatively impacting WRP operations. IW inspectors continue to monitor the Tri-Star facility closely and encourage managers there to meet the color limit by controlling their wastewater generating operations and operating their color removal pretreatment system as required.

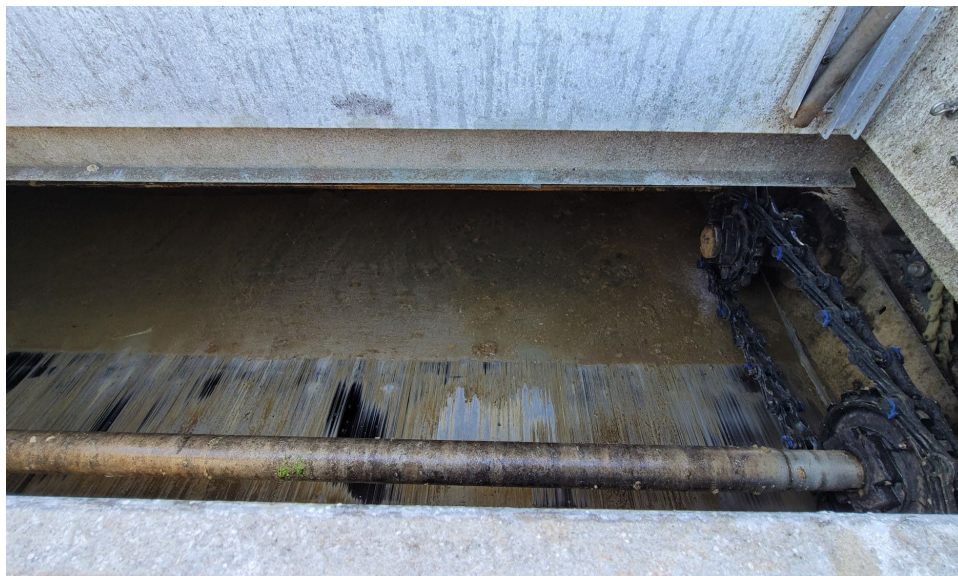
Figure 4: WNWRP primary tank skimmer. Note the brown oily material which was sampled and tested with FTIR scan analysis.

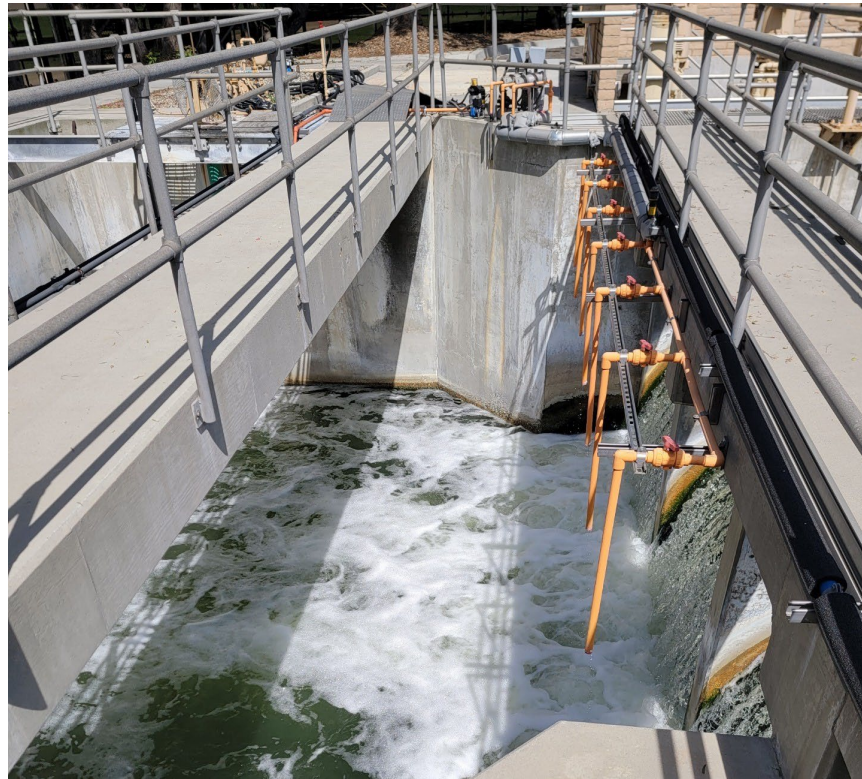
Figure 5: LCWRP Final effluent forebay at 1230 hours on 3-17-22. Note the floating white foam.

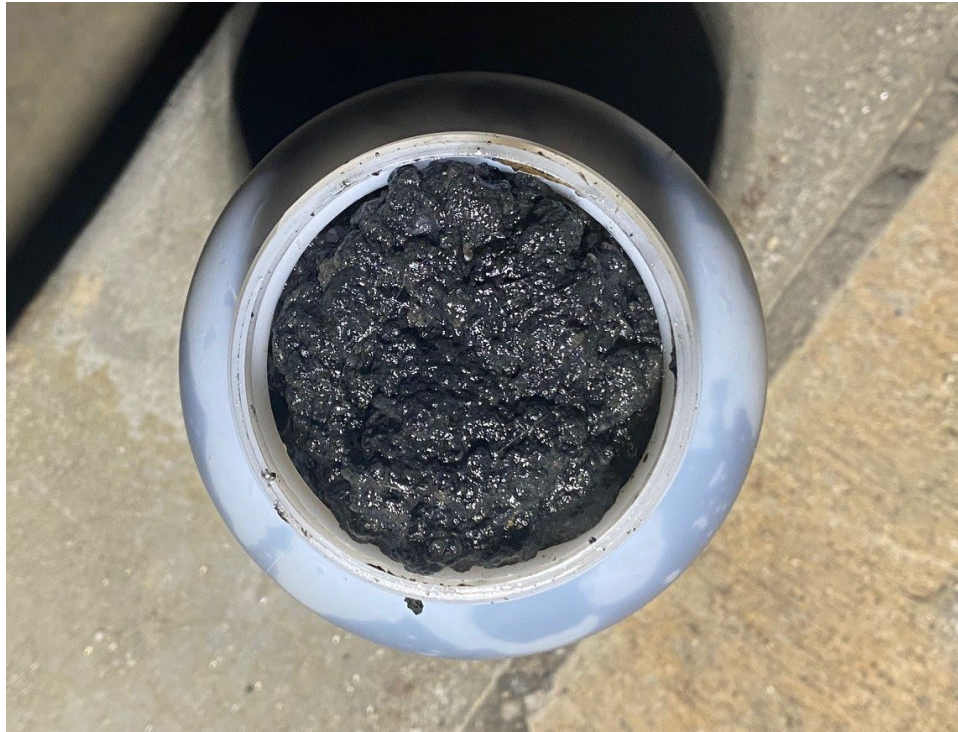
Figure 6: Sample of the black sludge collected from the compactor skimmings by JWPCP operators on 3-17-22 at 1730 hours.

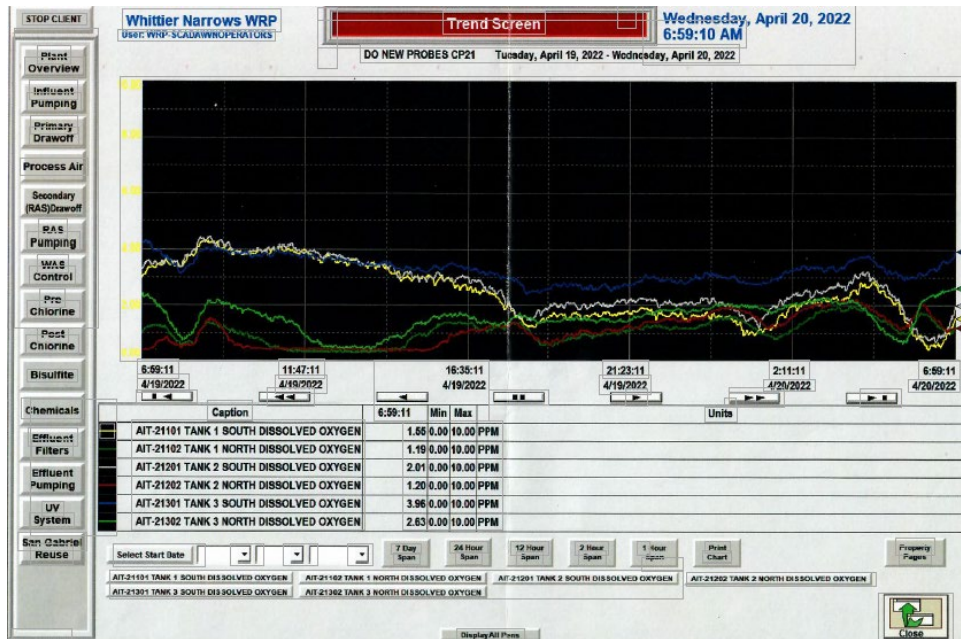
Figure 1: WNWRP trend data for 4/11/22-4/12/22. Note the dissolved oxygen drop offs in secondary aeration tanks.

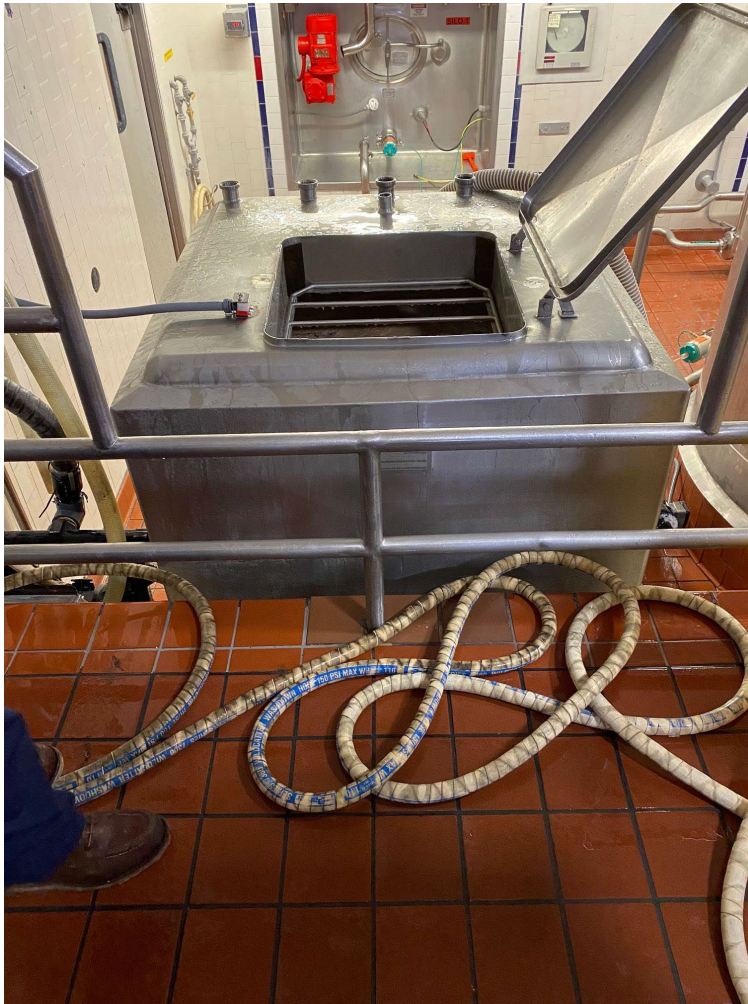
Figure 2: The 10,000-gallon capacity high BOD waste tank at Thrifty Ice Cream which is referred to by company employees as the “pig tank”.

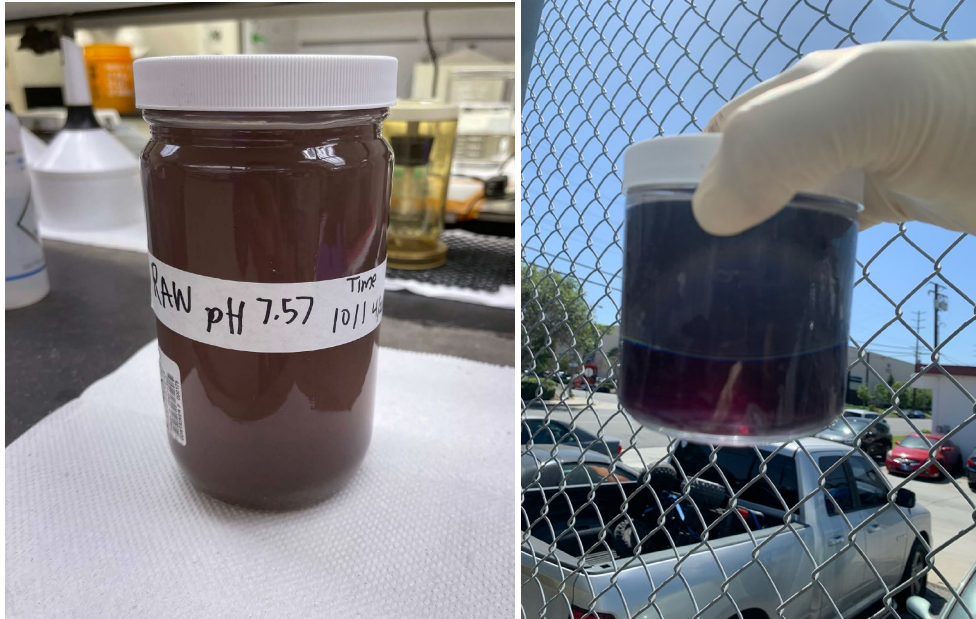
Figures 5 and 6: On the left is the LCWRP influent sample taken on 4-21-22 at 1011 hours. Note the deep purple-brown color. On the right is a sample of the wastewater being discharged that same morning by Tri-Star Dyeing and Finishing. Note the same color as was present at the WRP.

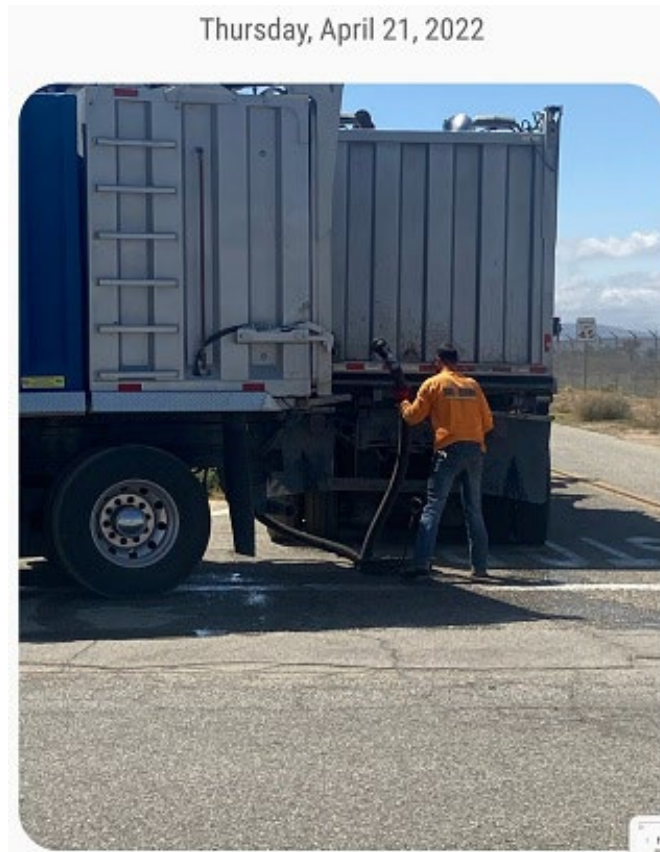
Figure 7: Photo provided by Palmdale Code Enforcement of a Cal Stripe Inc. worker discharging wastewater directly into MH 20 0100 at about 1500 hours on Thursday, 4-21-22.

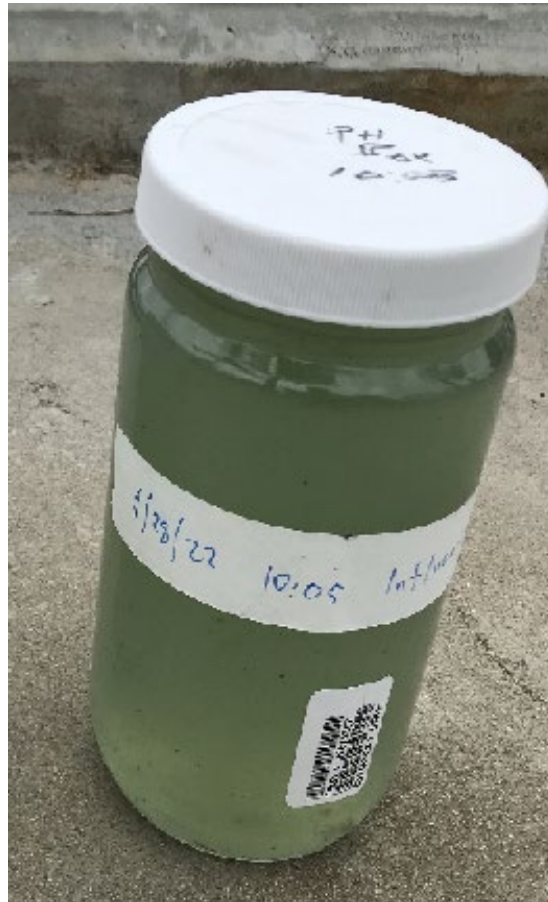
Figure 8: LCWRP raw influent sample taken on 4-28-22 at 1005 hours. Note the blue-green color.

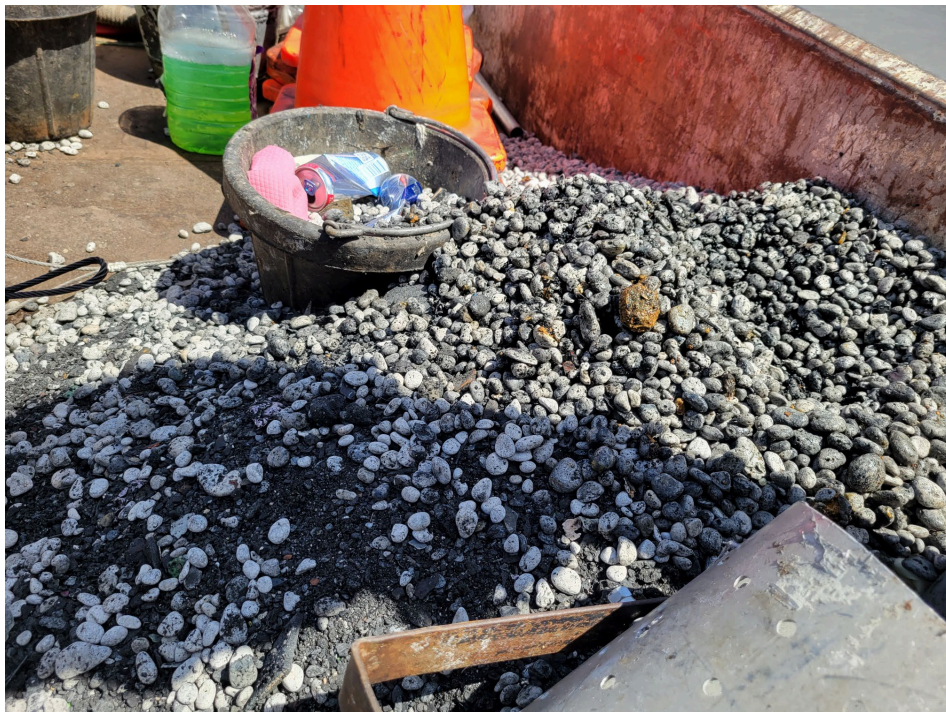
Figure 1: Pumice stone removed by Districts' sewer maintenance crews from two siphon structures in Carson on the Main Street relief trunk sewer on May 9, 2022.

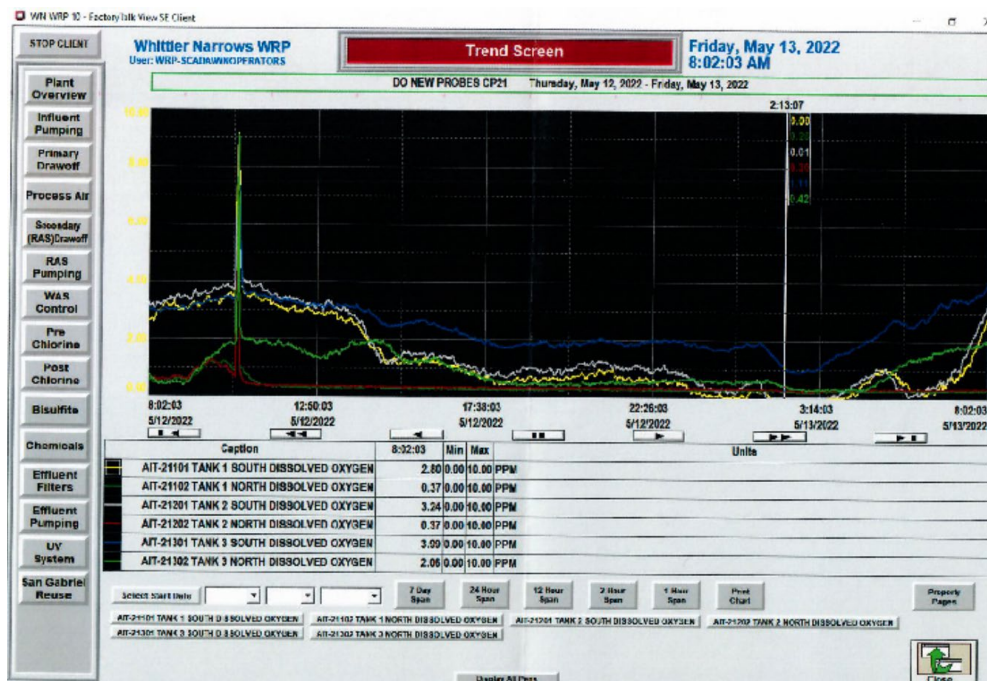
Figure 2: WNWRP control system screen shot showing dissolved oxygen levels in the secondary aeration tanks on May 12-13, 2022.

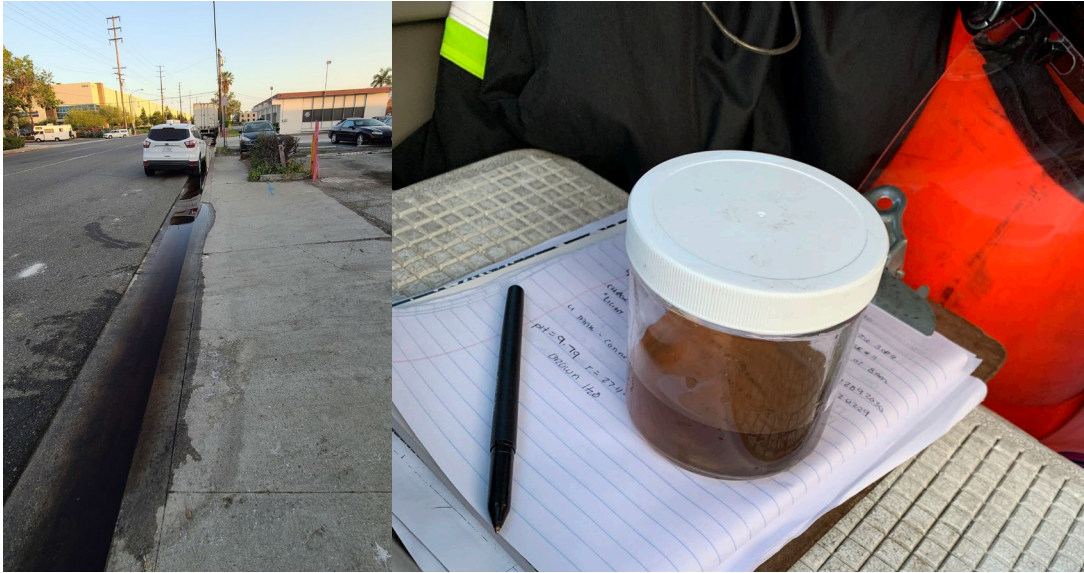
Figures 3 and 4: Spilled plum-colored wastewater in the Marquardt Avenue street gutter in Santa Fe Springs on May 17, 2022 and a sample of that water.

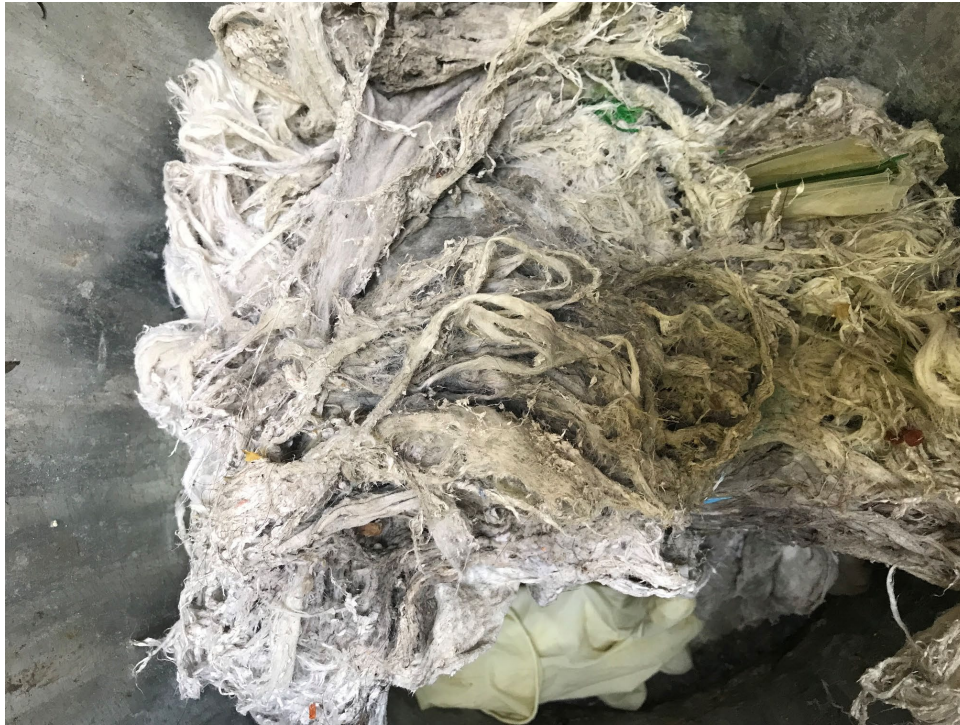
Figure 6: May 26, 2022 Rags removed from Saugus WRP influent pumps.

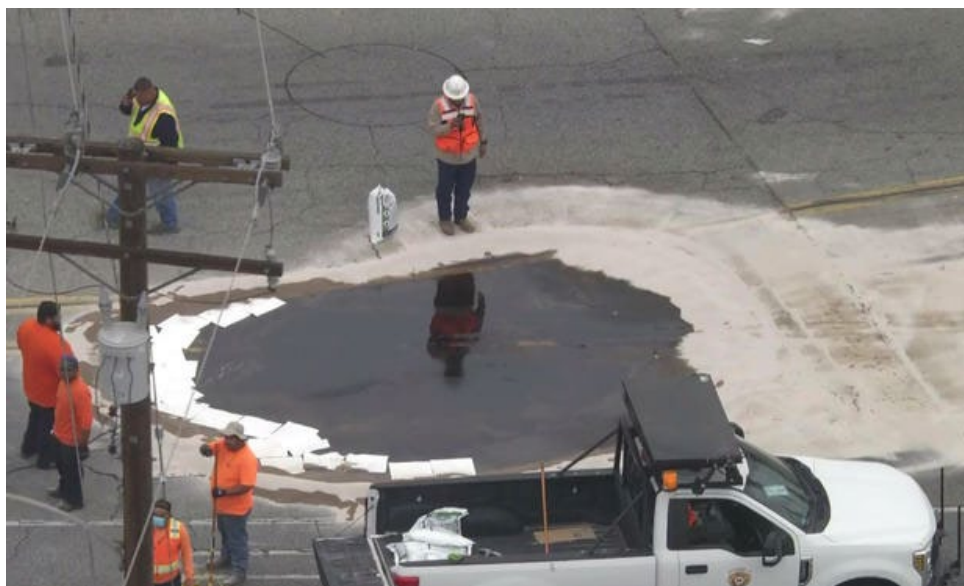
Figure 1: CBS Channel 2 Skycam June 16, 2022, picture of the pooled crude oil.

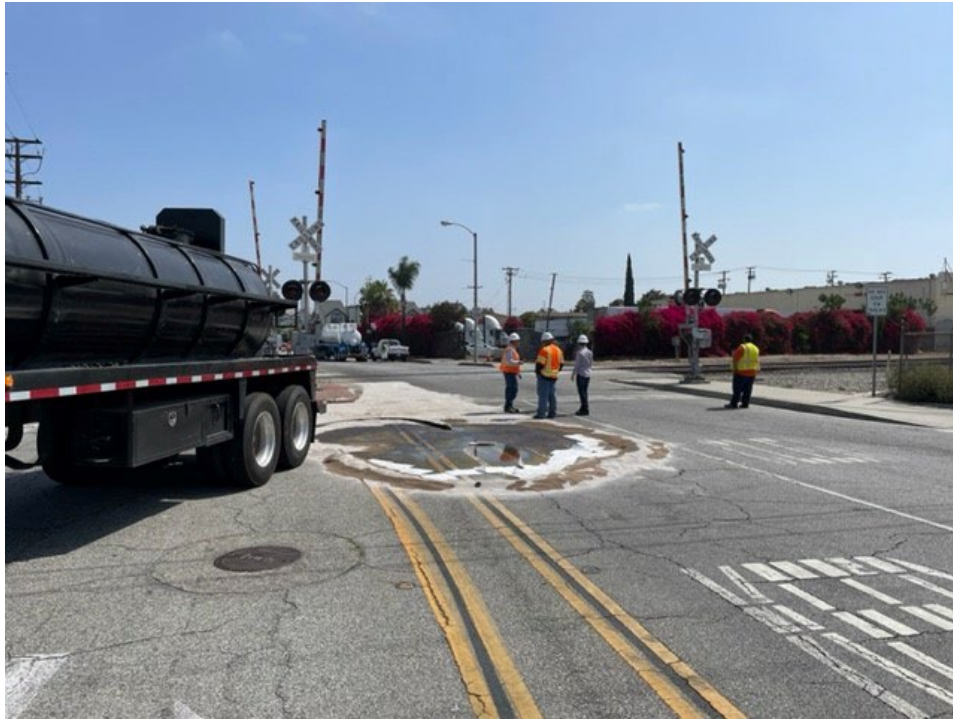
Figure 2: 6-16-22 photo taken by L.A. County Fire Department Health/Hazmat responders to the spill report. Note the local sewer line manhole and the fact that the spill did not reach the manhole.

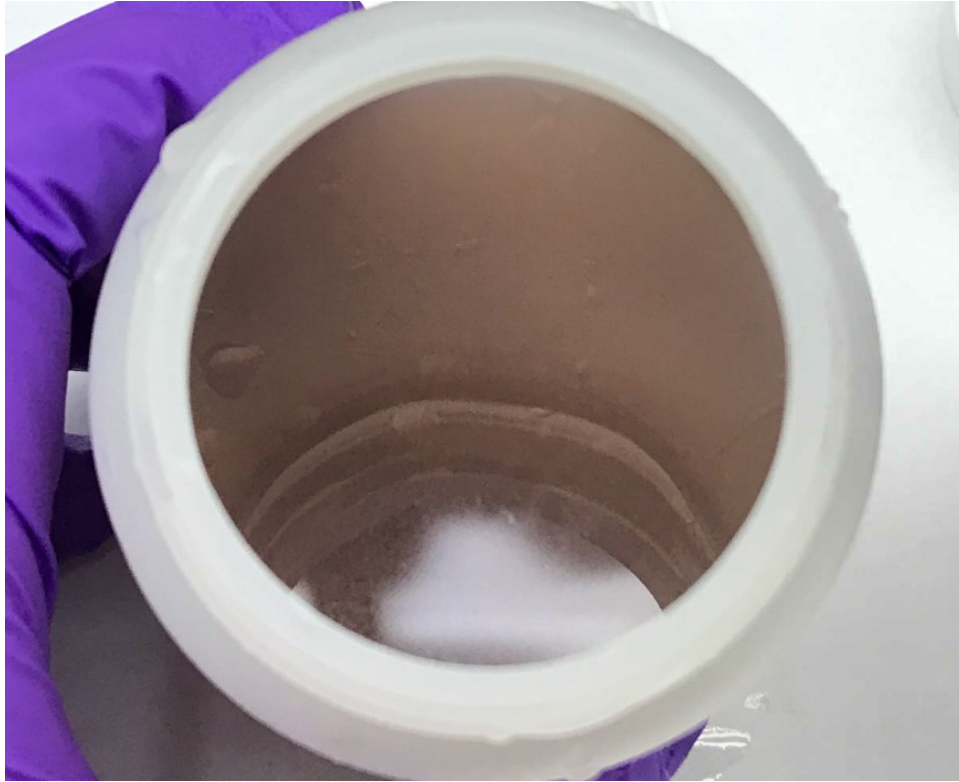
Figure 3: LCWRP secondary effluent grab sample taken on June 26, 2022, at 0830 hours. Note the light pink color.

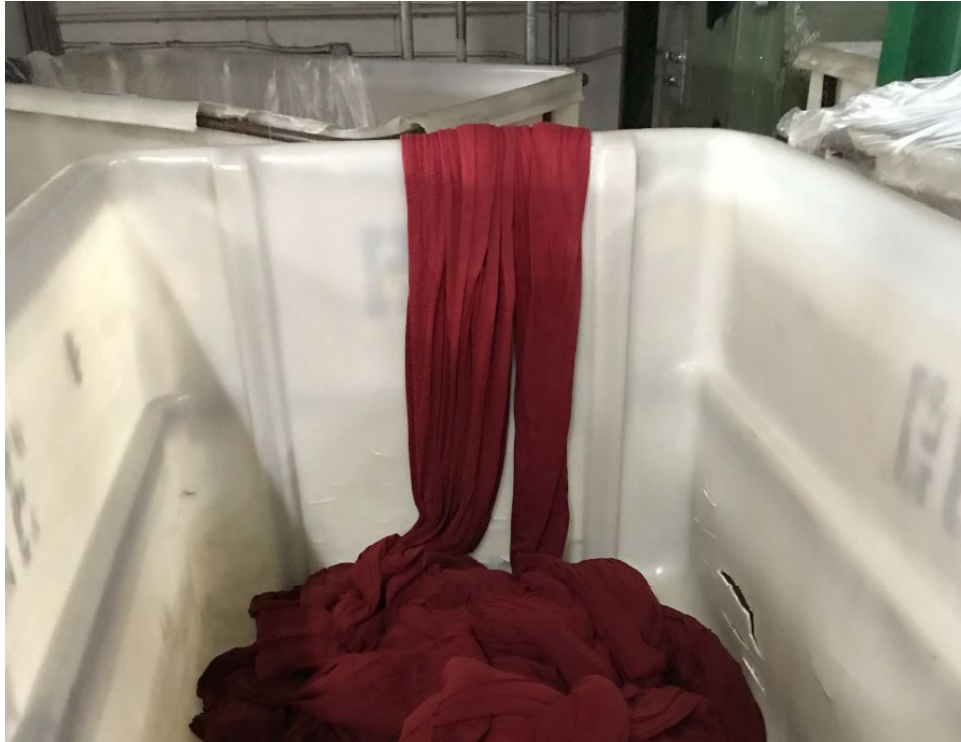
Figure 4: Photo taken on June 26, 2022, at about 1130 hours at Tri-Star Dyeing and Finishing. This is a bin of recently dyed deeply colored, red fabric that is representative of the kind of work that

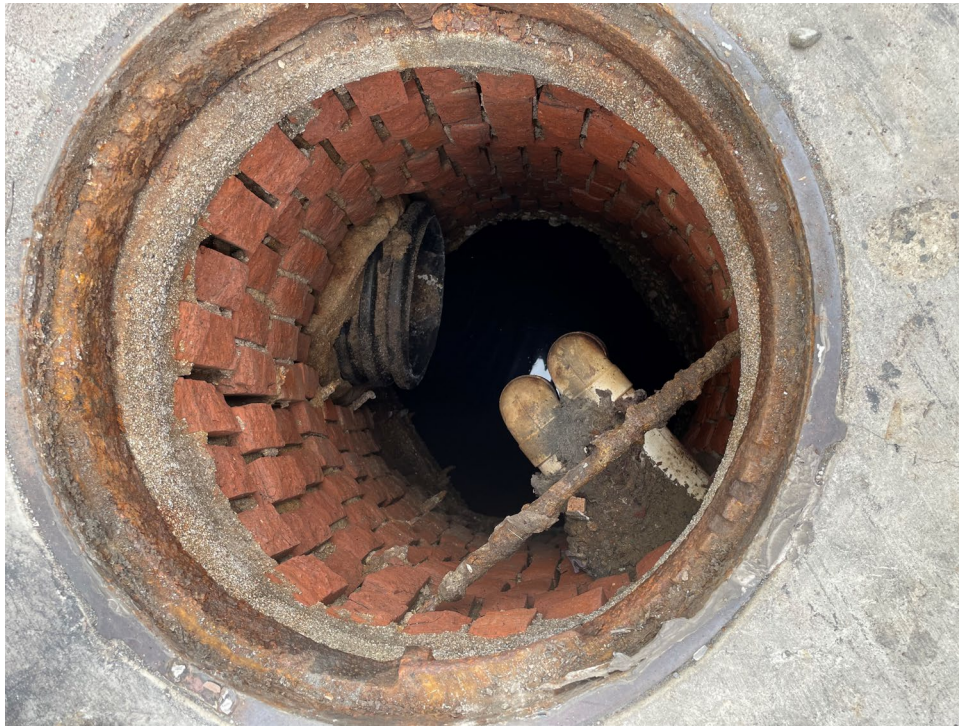
Figure 1: May 3, 2022, photo of MH B0005.

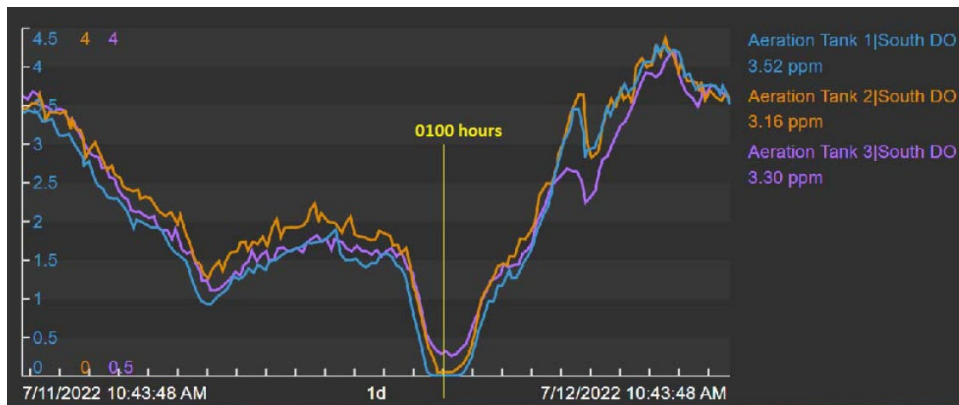
Figure 3: OSI-PI graph of Whittier Narrows WRP operational data for the 24-hour period from approximately 1045 hours on 7-11-22 to 1045 hours on 7-12-22.

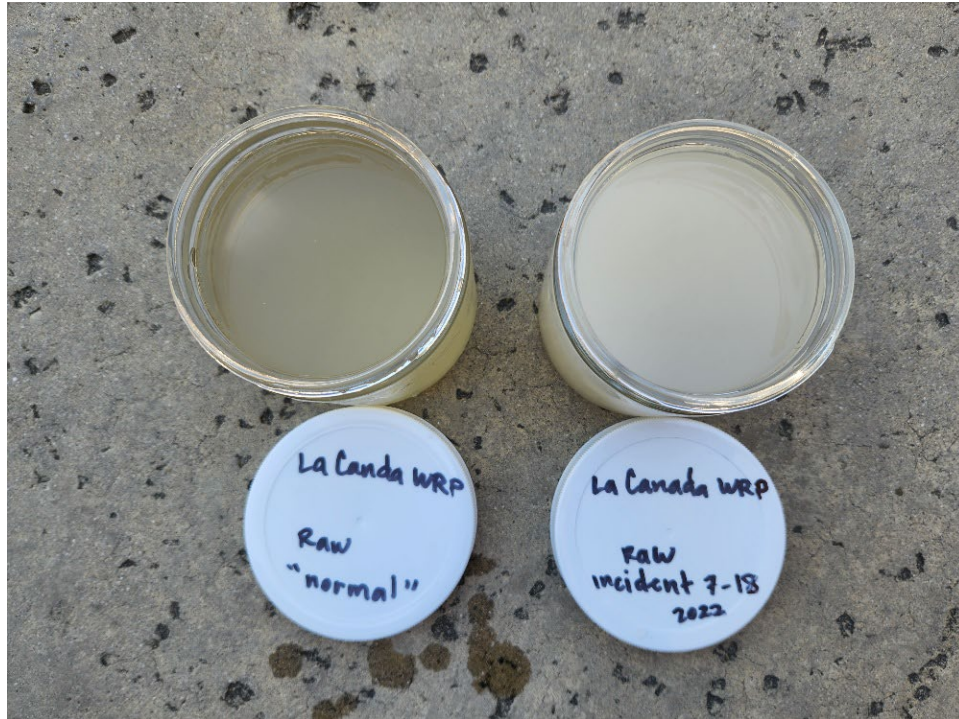
Figure 4: Photo showing a color comparison of “normal” plant influent at the La Cañada WRP vs. that seen when the white color was entering the WRP on 7-18-22.
