2022 ANNUAL REPORT

INDUSTRIAL WASTE PRETREATMENT PROGRAM

LOS ANGELES COUNTY SANITATION DISTRICTS

APPENDIX H
INDUSTRIAL WASTE REPORTS ON INCIDENTS

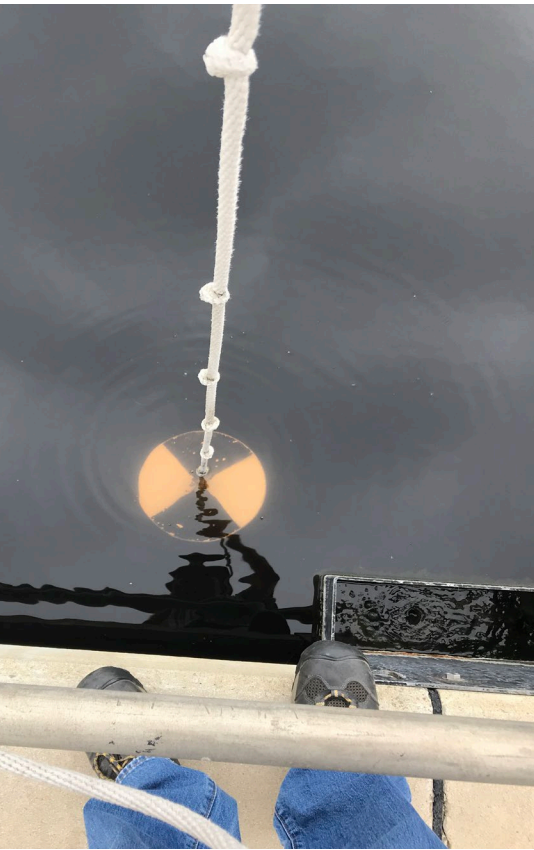
Figure 5: Secchi disk indicating the light red/tea tint in the secondary effluent at Los Coyotes WRP at 1015 hours on July 24,2022.

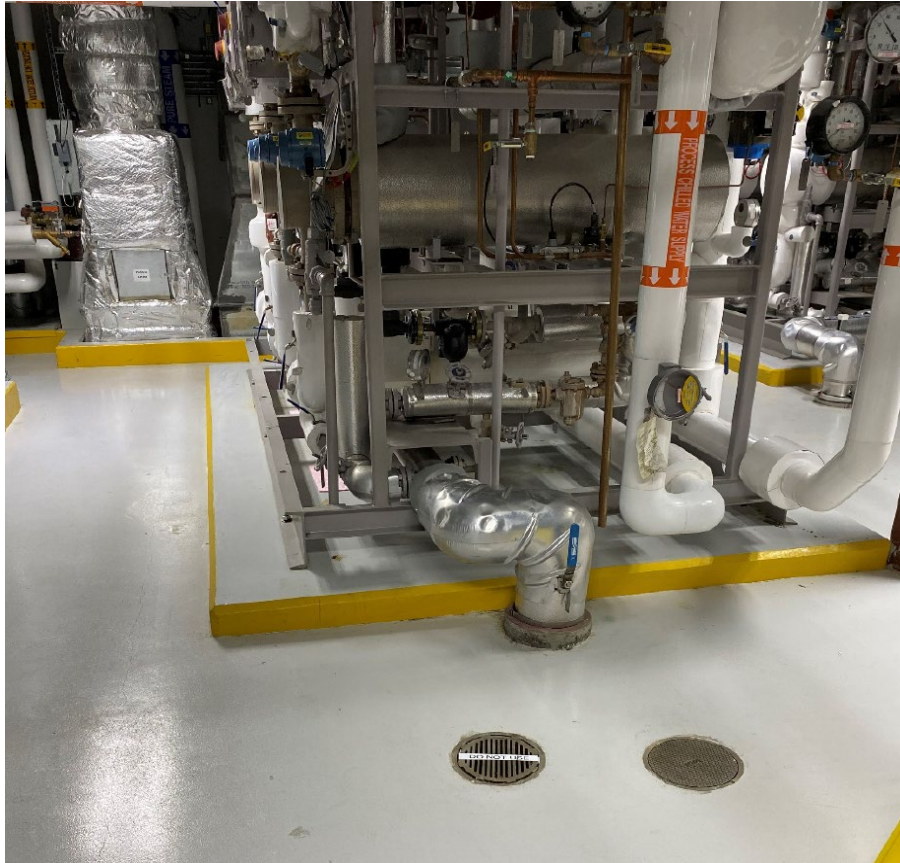
Figure 6: 7-26-22 photo of the heat exchanger and adjacent floor drain at Gilead Sciences.

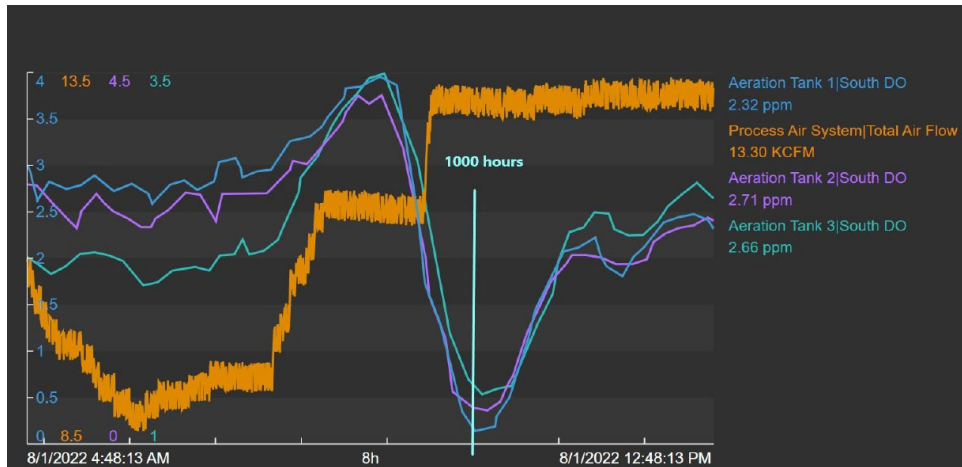
Figure 1: WNWRP aeration tank dissolved oxygen levels and process air addition rates on August 1, 2022, for the 8-hours period between 0448 hours and 1248 hours. Note the steep drop in D.O. concentration that started just before 0900 hours.

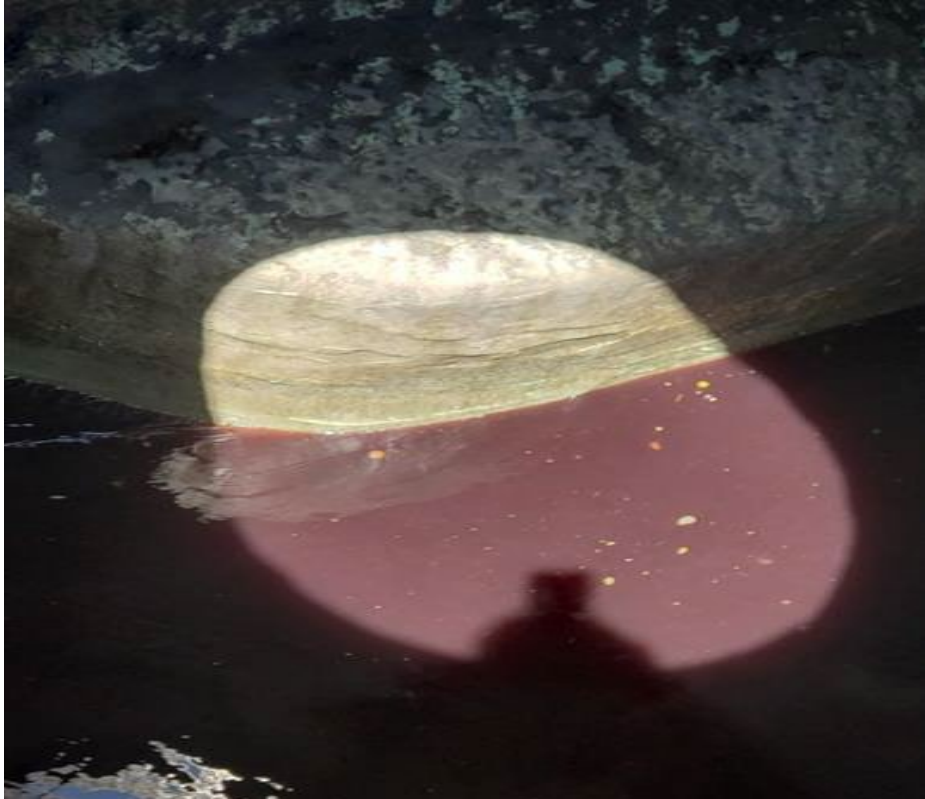
Figure 2: Burgundy-colored wastewater in MH F 0255 on August 2, 2022.

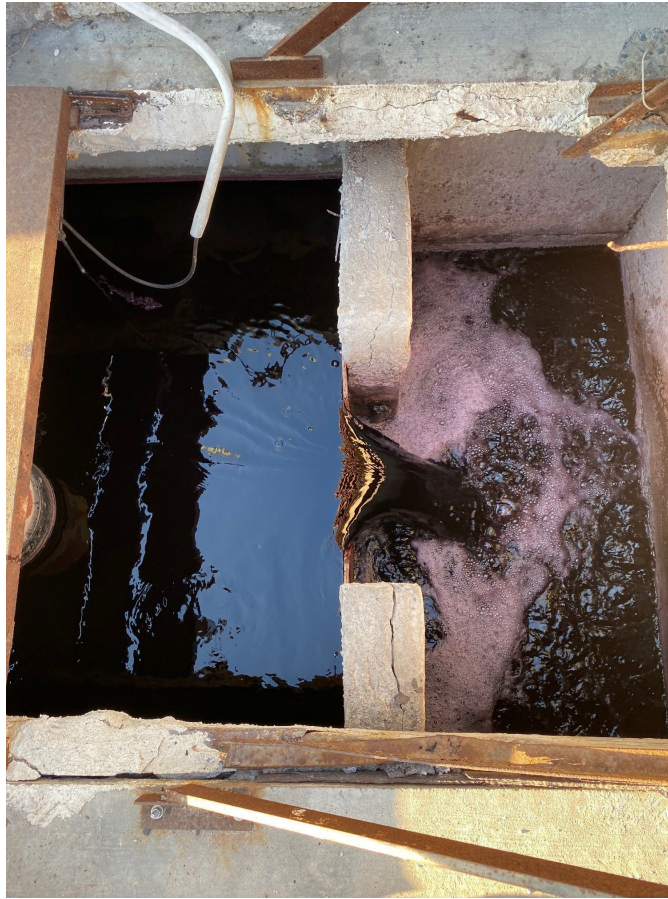
**Figure 3: Burgundy colored wastewater being discharged
By Super Dyeing LLC on August 2, 2022.**

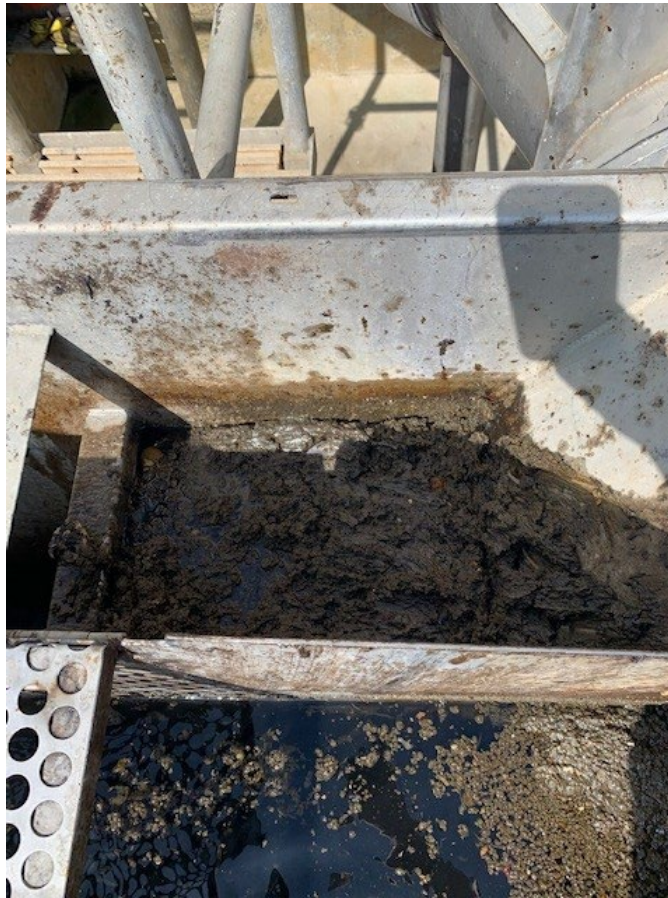
**Figure 5: JWPCP North Screw Compacter 2 on August 26, 2022.
Note the unusual gritty consistency of the material.**

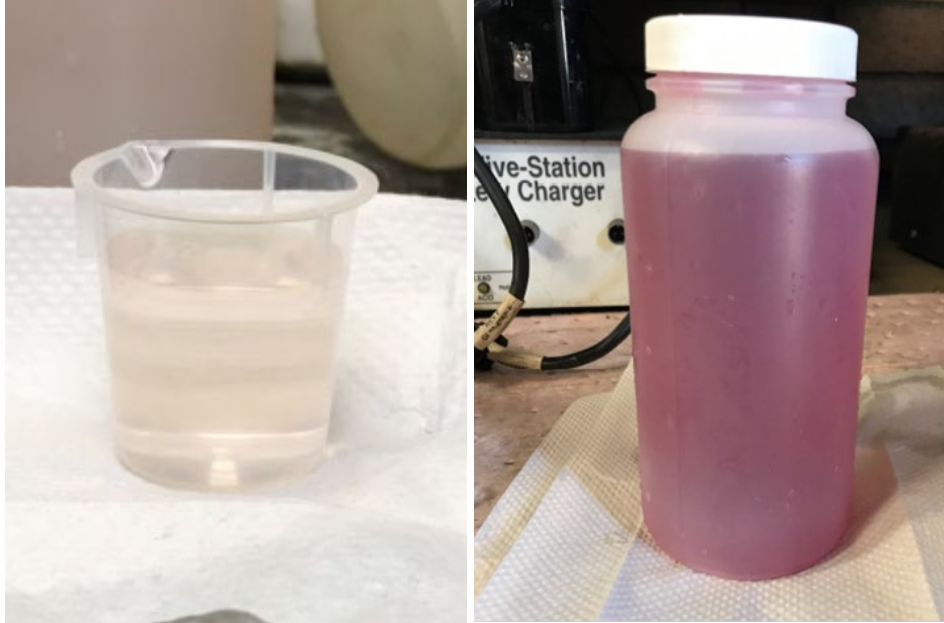
Figures 1 and 2: Sample on the left is that taken from the primary channel at SJC West WRP at 1000 hours on September 14, 2022, and that on the right is a sample of wastewater taken from the batch treatment tank at Danco Anodizing on September 14, 2022, at 1030 hours. Note the light red tint in the WRP sample and the similar, but much darker color in the Danco sample.

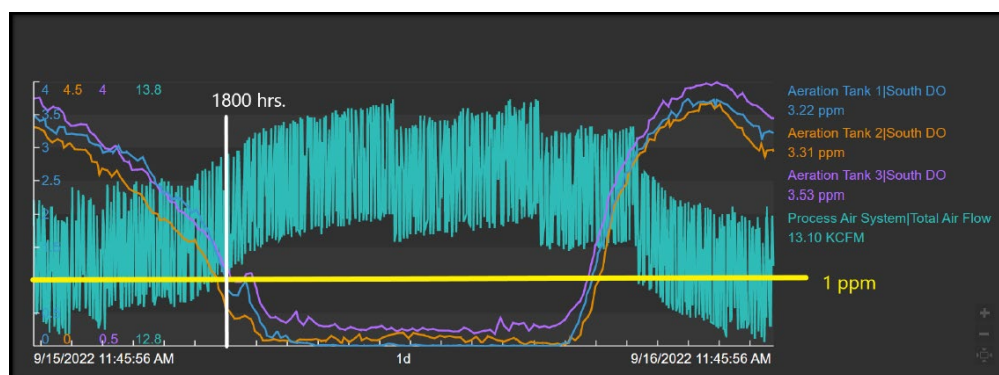
Figure 3: WNWWRP aeration tank dissolved oxygen levels and process air addition rates for the 24-hour period between 1145 hours on September 15, and September 16.

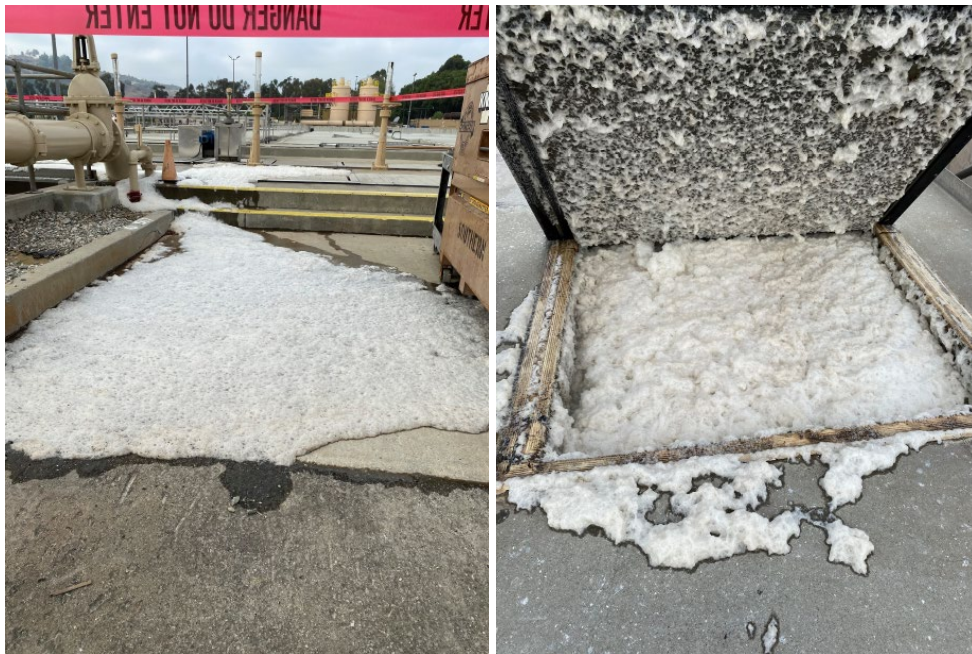
Figures 4 and 5: White foam at the San Jose Creek East WRP at 0830 hours on September 30, 2022.

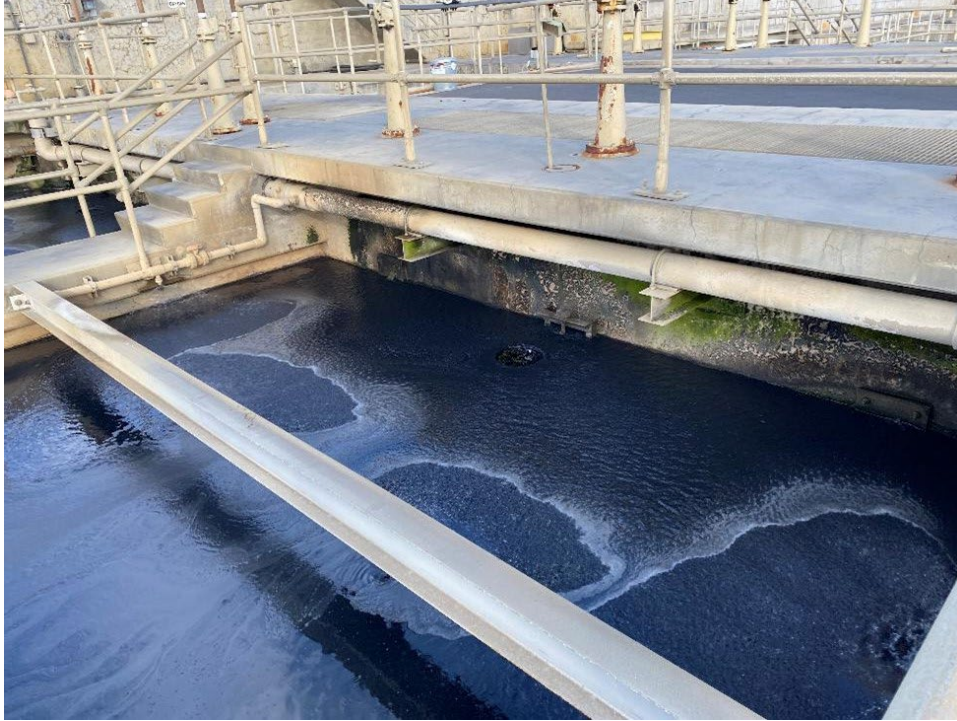
Figure 1: Unusual clarifier skimmings at JWPCP secondary tanks on October 20, at 0800 hours that appear to contain a petroleum sheen.

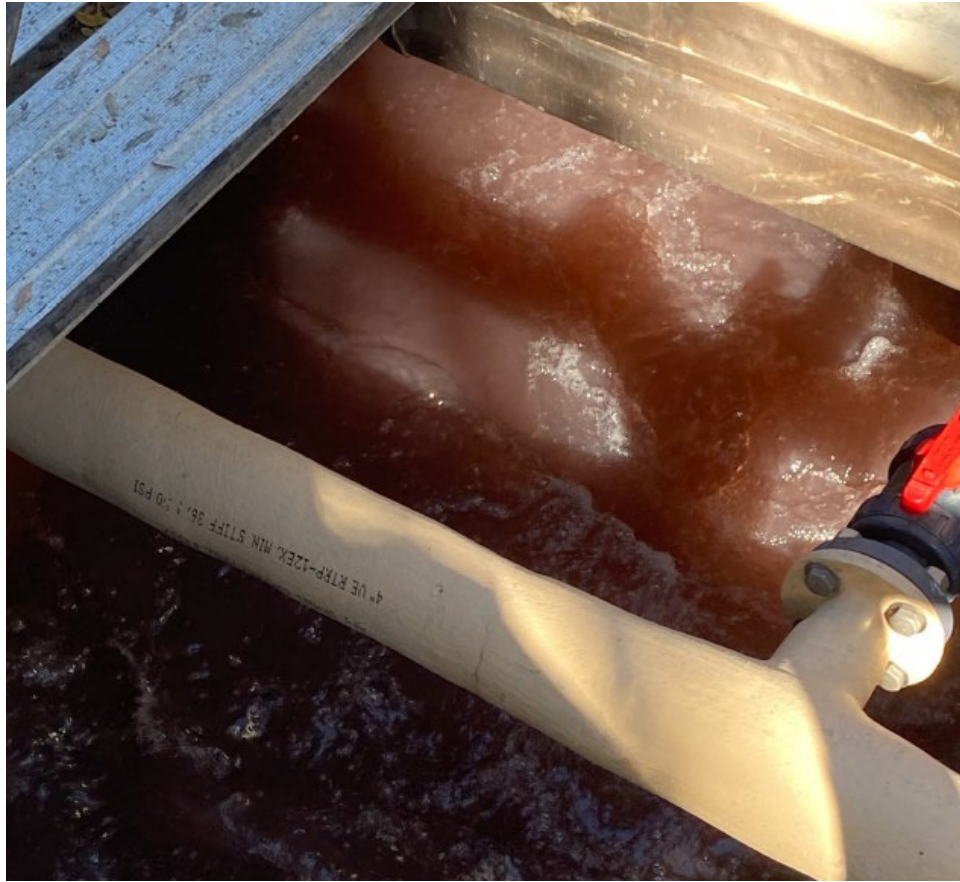
Figure 2: Red color in the primary effluent channel at LCWRP at 1010 hours on October 25, 2022.

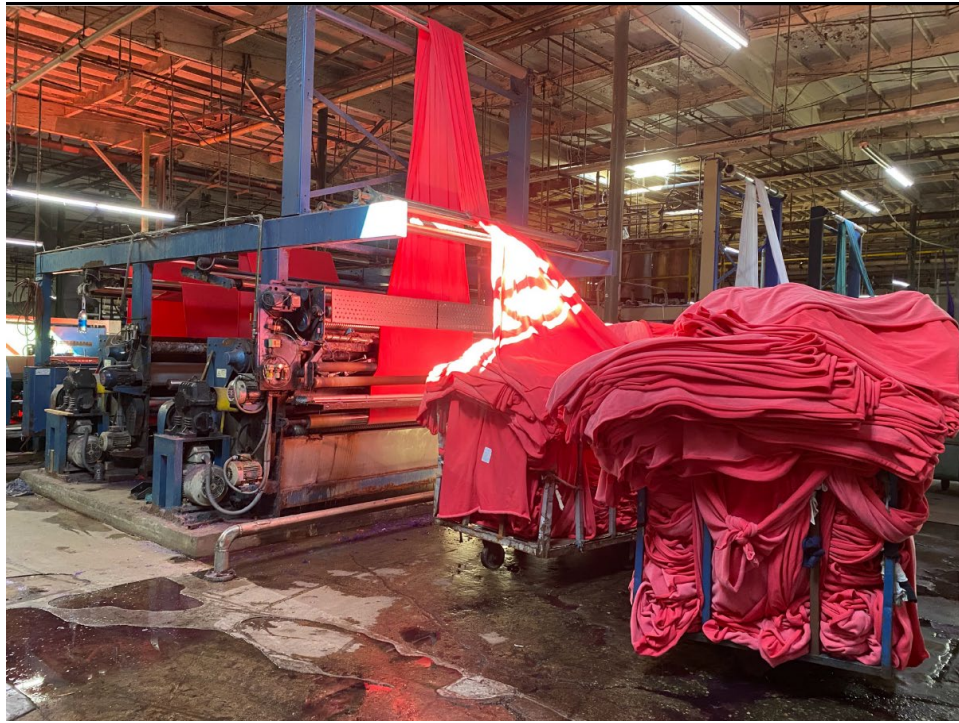
Figure 3: Photo taken on October 25, 2022, at Tri-Star Dyeing and Finishing showing some of the red fabric being dyed/processed that day.

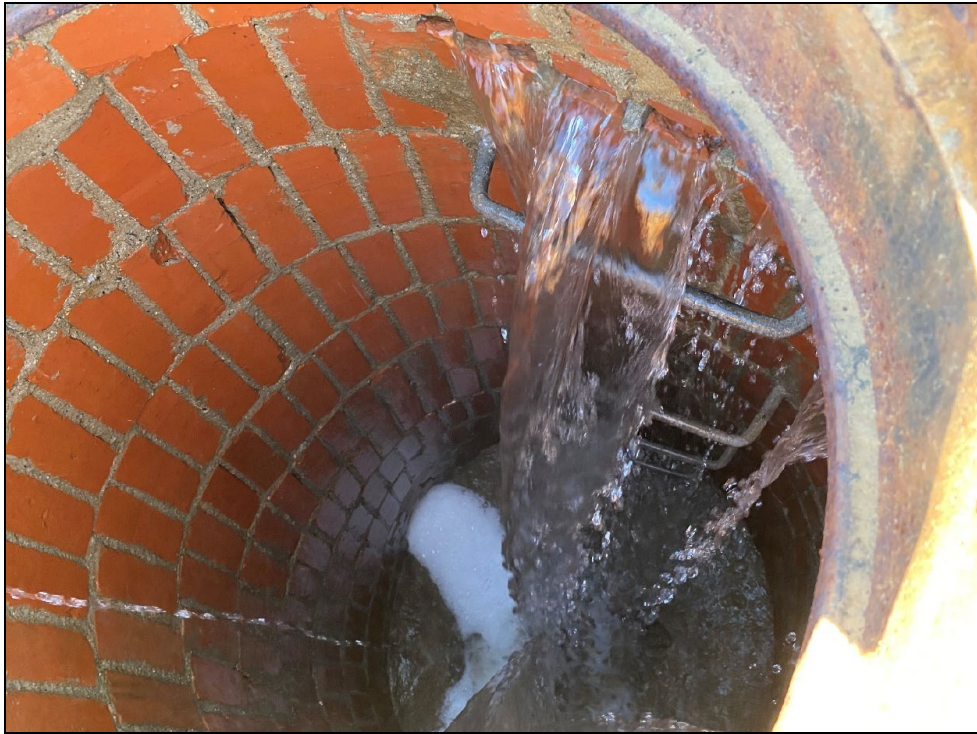
Figure 1: Photo taken on December 20, 2022, at 0900 hours showing the active infiltration of the firewater from the ruptured underground firewater line into a sewer system manhole on the Plant 42 property.

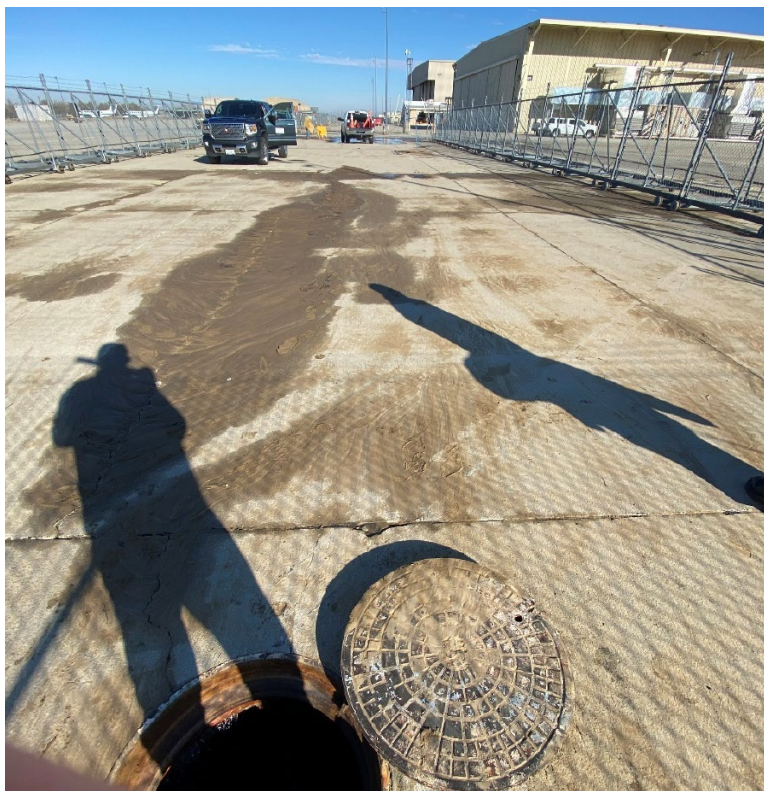
Figure 2: December 20,2022 0900 hours photo showing the location of the of the local line manhole shown in Figure 1. Note the adjacent taxiway as well the sand and soil blown to the surface by the erupting water coming up through cracks and joints in the concrete surfaces.
