2016 ANNUAL REPORT

INDUSTRIAL WASTE PRETREATMENT PROGRAM

COUNTY SANITATION DISTRICTS OF LOS ANGELES COUNTY

APPENDIX H
INDUSTRIAL WASTE REPORTS ON INCIDENTS

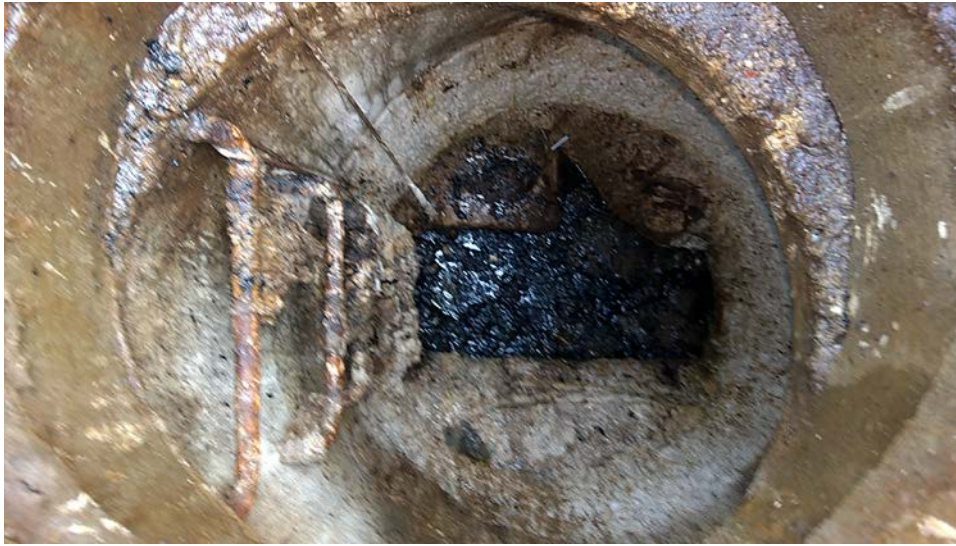
Figure 1: 1-6-16 Florence Avenue Trunk MH 1081 photo of the 2" thick layer of black oily material in the sewer channel.

An investigation, led by Senior I.W. Inspectors Andy Woods and Kent McIntosh, as well as area I.W. Inspector Jason Finn, with the participation of I.W. Inspectors Sanjay Patel and Steve Lajkowitz, traced the material found at MH 1081 approximately three-quarters of a mile upstream to an oil field production facility operated by Breitburn Operating, L.P. This facility produces oil from wells using standard and fracking extraction techniques. Oil and brine produced from the wells is separated on-site, with the brine discharged to the sanitary sewer under permit with the Districts. The investigation determined the facility had discharged the tarry material found in the downstream trunk sewer due to an overflow of their air floatation "Wemco" treatment system tank into a surge tank that flows to the sewer. A sample of material floating on top of the Wemco tank was taken and compared to a sample of tarry material removed from the Florence Avenue trunk. GCMS analysis indicated the samples were a close match. Breitburn was issued a Notice of Violation for causing the incident. Breitburn representatives stated they will increase their diligence in operating and maintaining their treatment system to prevent a similar discharge from recurring.

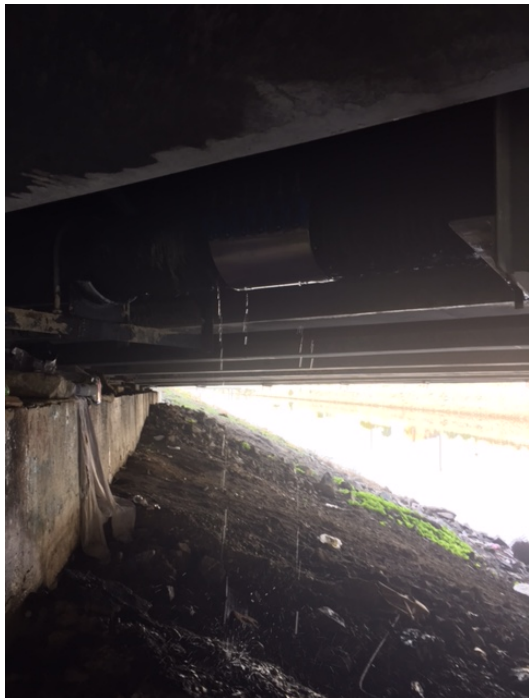
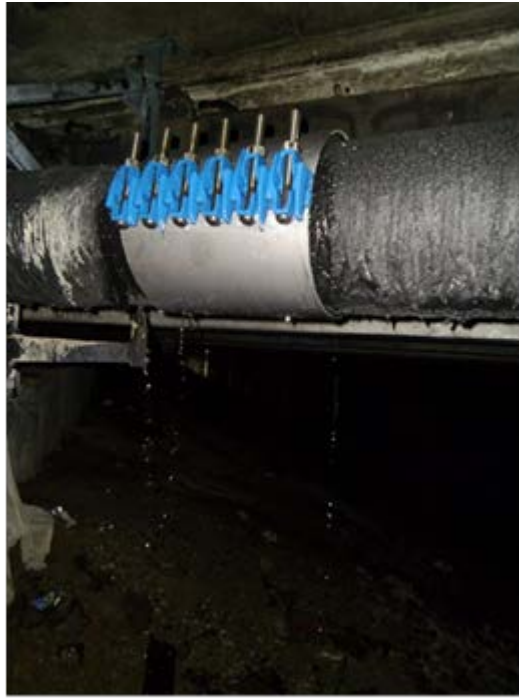
Figures 2 and 3: 1-14-16 temporary repair sleeve installed on the damaged 14" brine line.

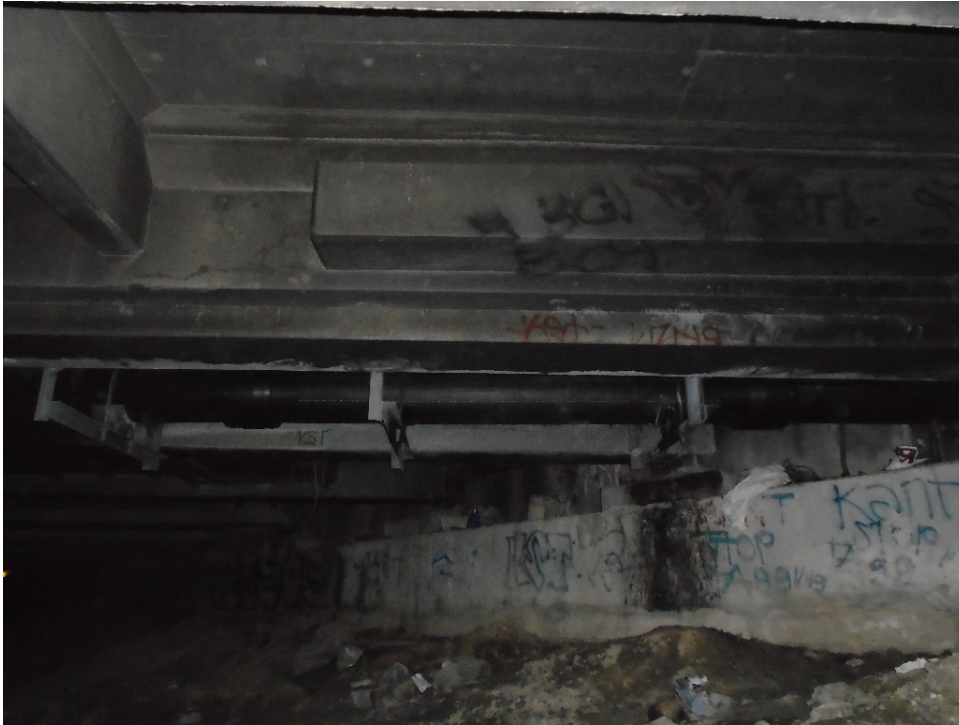
Figure 7: The 14" WBMWD brine line following completion of repairs.

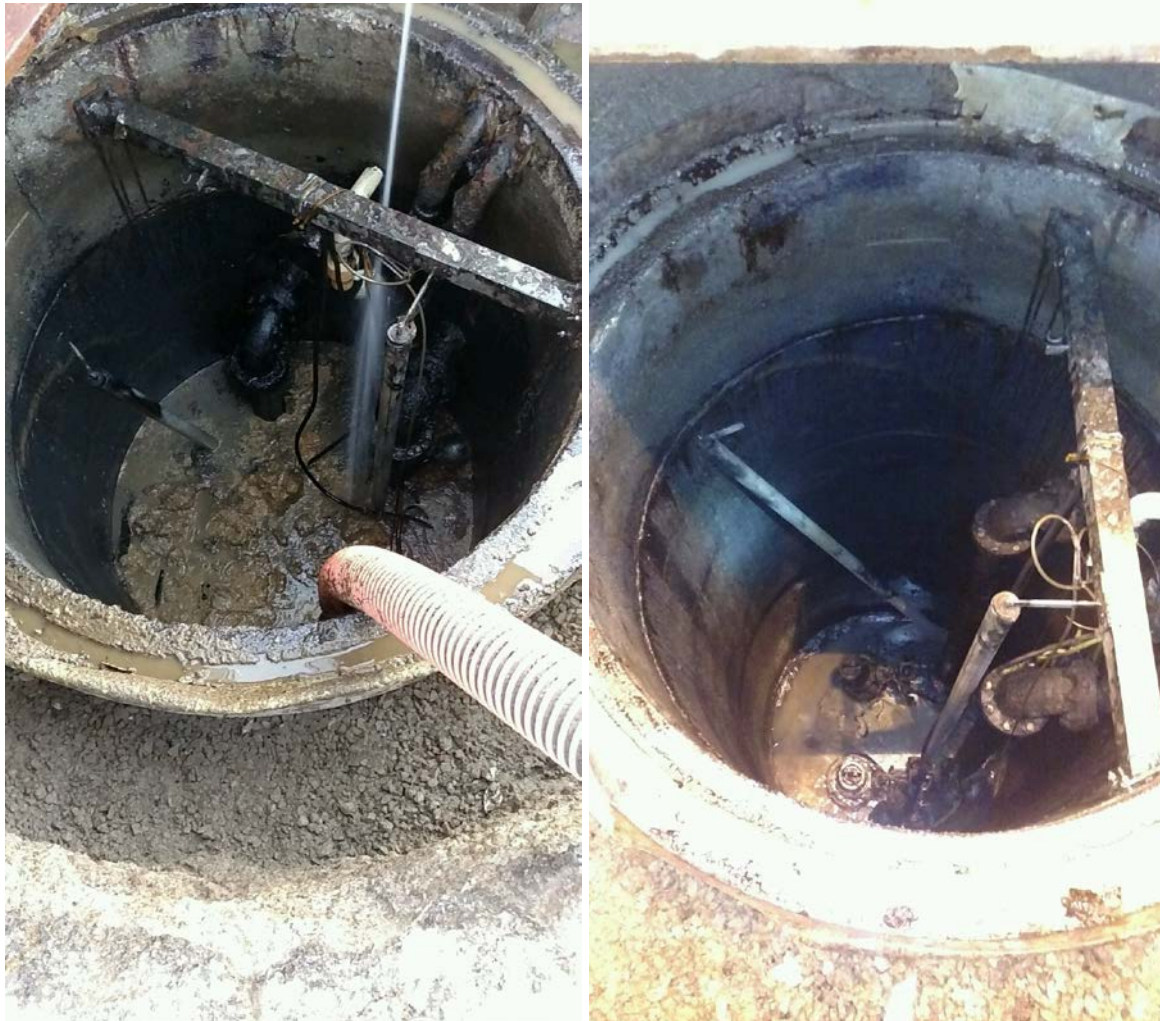
Patel inspected the Hanjin facility on 1-15-16 at 1345 hours. The inspection confirmed that Ocean Blue Environmental had been on-site earlier that same day servicing a small sewage lift station outside one of their buildings (see photos below) that had been completely full of accumulated heavy sanitary waste solids. According to the contact at Hanjin, Ocean Blue used pressure water and a fire hose to break up heavy sanitary solids that had accumulated in the lift station so that they could be vacuumed from the wet well. The contact stated no industrial waste flows into the lift station. Inspection of the wet well did not find any evidence to contradict this claim. The contact further stated the heavy accumulation of solids had caused the lift station pumps to fail. The contact indicated the lift station had not been opened for almost 15 years prior to that day as they had not had any issues with it previously. There are two other lift stations at the site. The Hanjin contact said those will now be considered for preventative maintenance operations to avoid similar failures.

Figures 8 and 9: These photos were supplied by Ocean Blue Environmental to area I.W. Inspector Sanjay Patel to document the heavy solids they encountered when servicing the small sewage pumping station wet well at the Hanjin Terminal in Long Beach on 1-15-16.

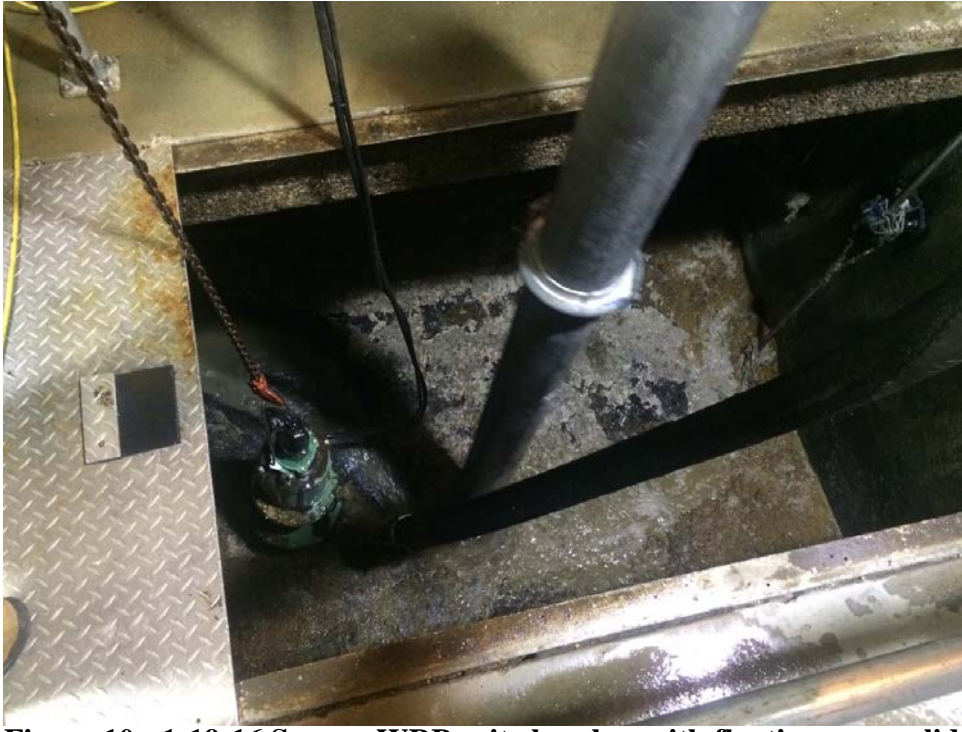
Figure 10: 1-19-16 Saugus WRP grit chamber with floating grey solids.

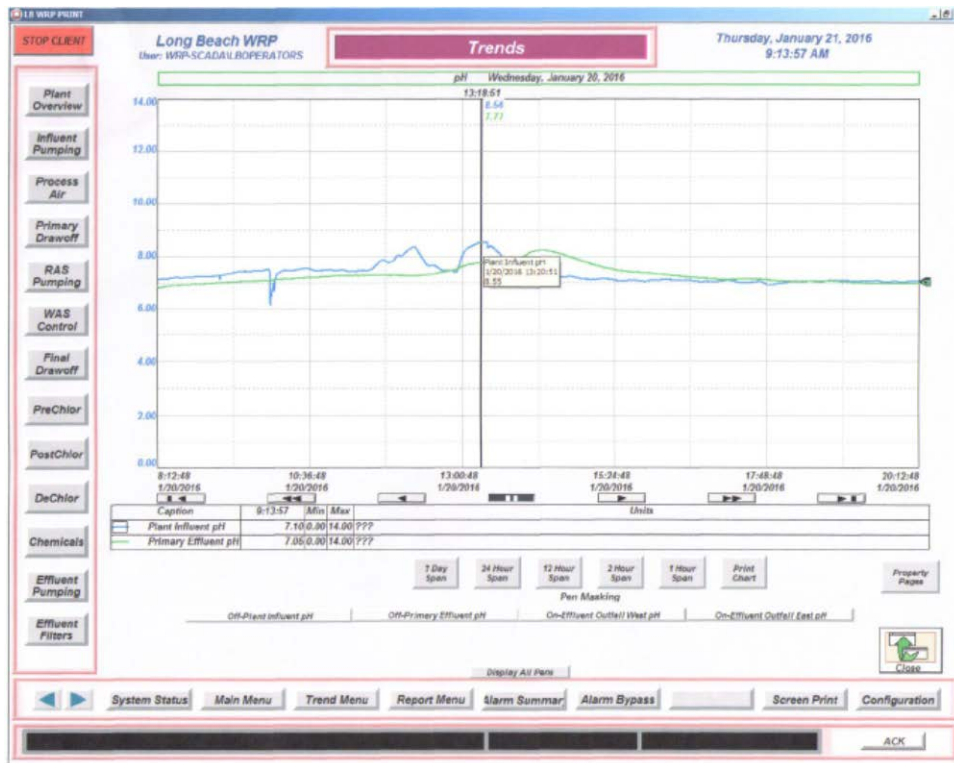
Figure 11: LBWRP influent pH trend chart on 1-20-16 from 0812 hours to 2012 hours.

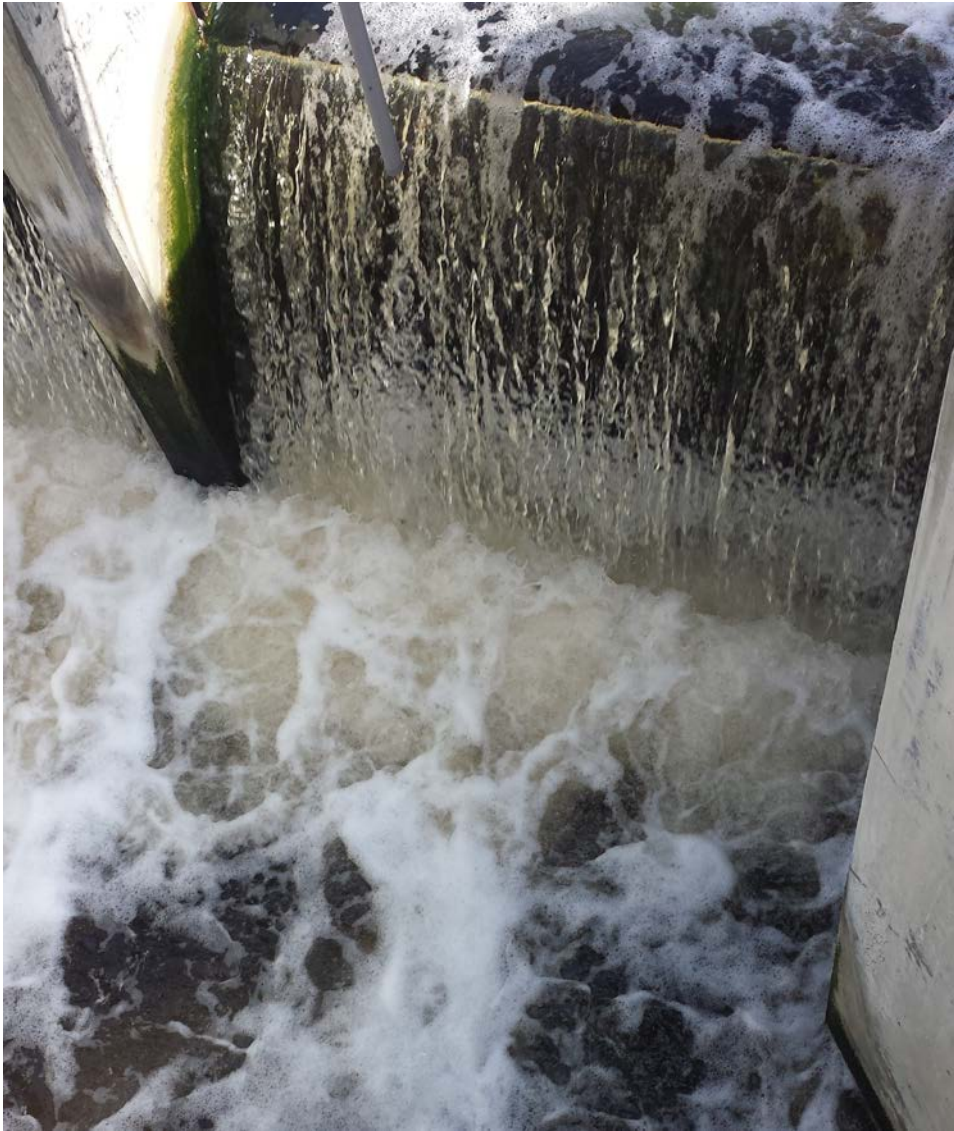
At 1535 hours Night Team Senior IW Inspector Kent McIntosh spoke with swing-shift TPO II Rudy Fernandez at LCWRP. Although there was still some color in the effluent, it was diminishing and was completely gone by 1630 hours. No NPDES violations occurred due to the color.

Figure 2: Los Coyotes final effluent on 2-18-16 at 1117 hours. Note slight brown tint in the forebay waters.

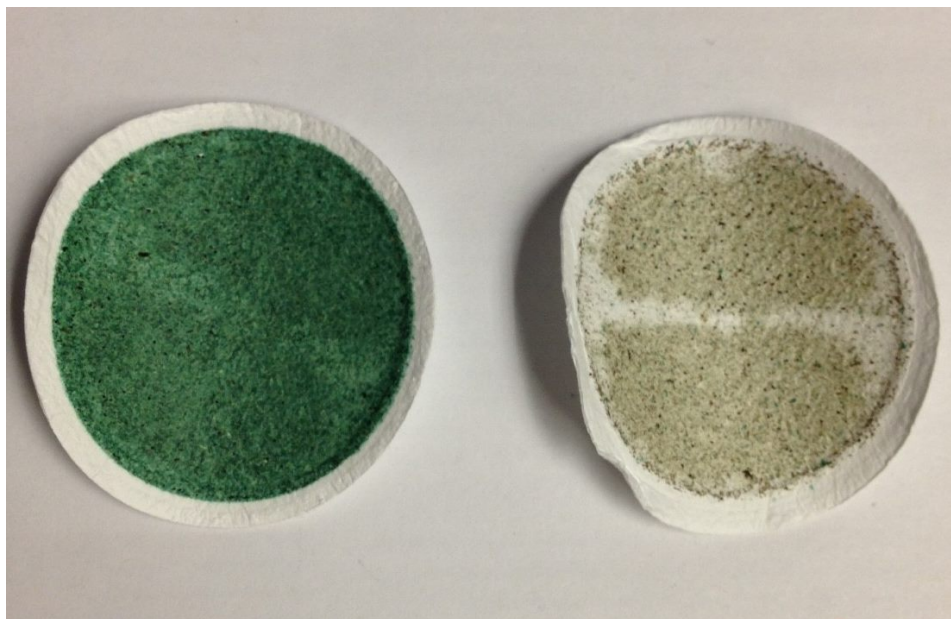
Figure 1: 0.45 μ membrane filters with blue-green colored particulates noted on 3-13-16 (left) and from a previous secondary effluent sample when the blue-green color was absent (right).

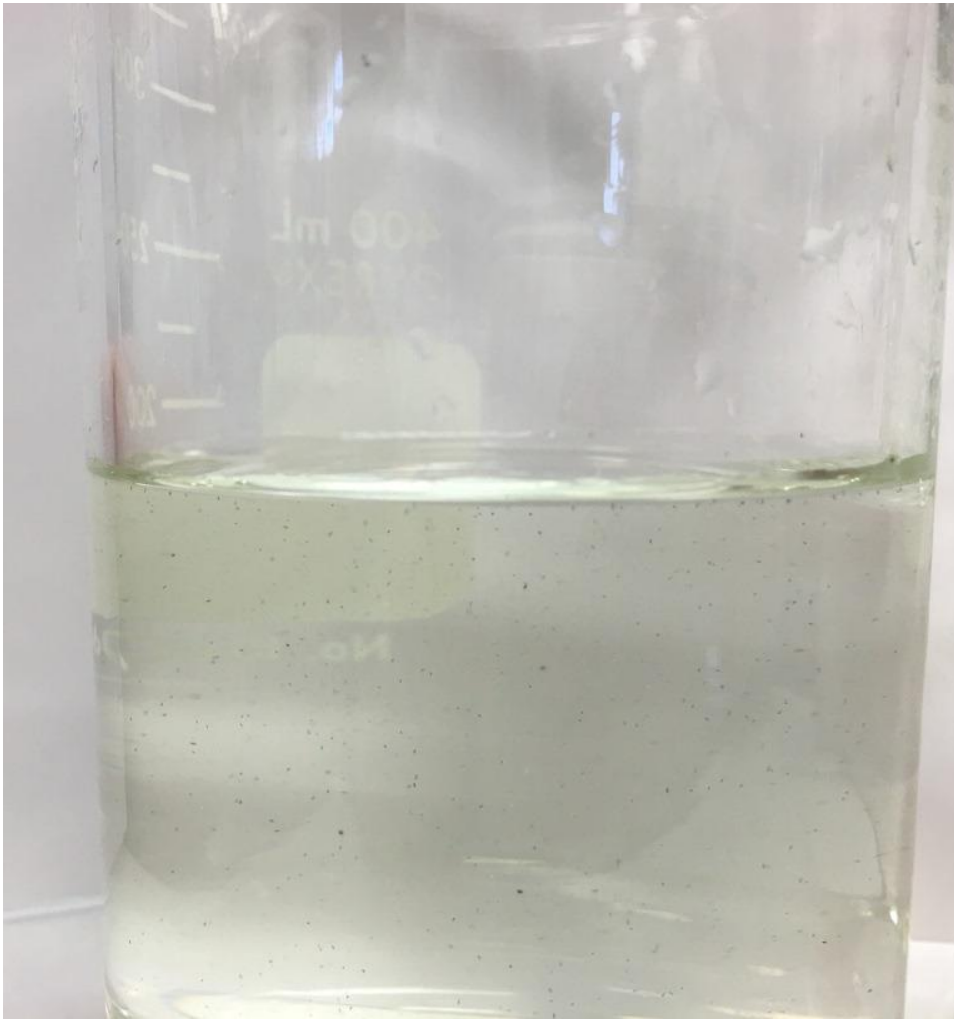
Figure 2: 3-16-16 WNWRP secondary effluent with blue green particulates present.

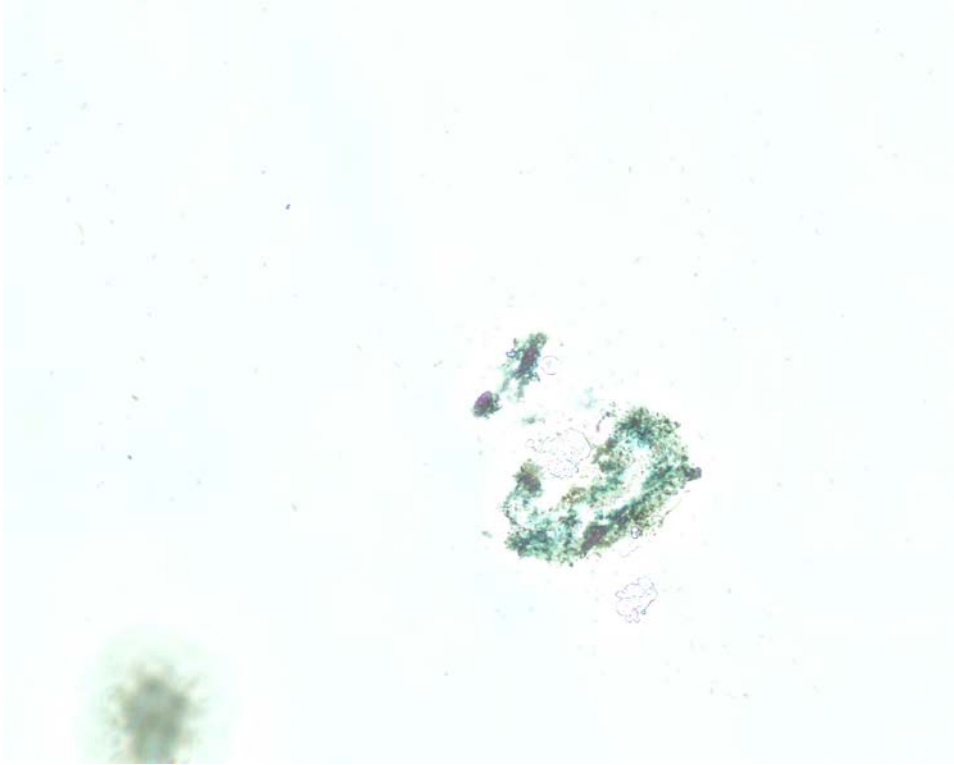
Figure 3: 20X microscope image of blue-green material in secondary effluent.

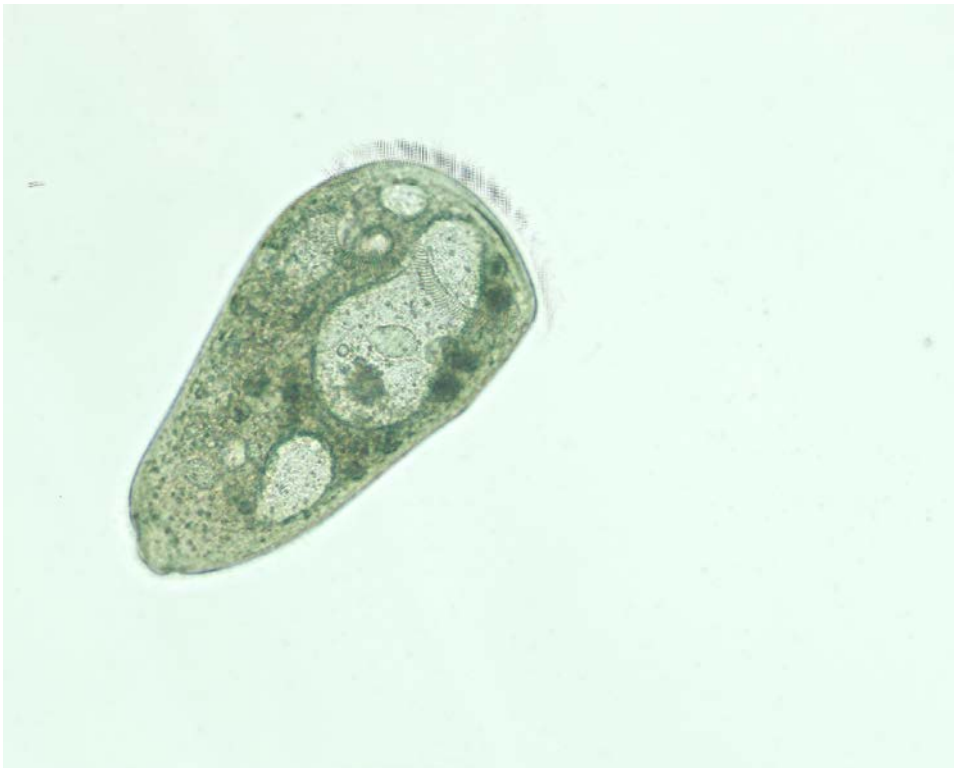
Figure 4: 200X microscopic of a ciliated protozoan from the WNWRP secondary effluent exhibiting a blue-green color.

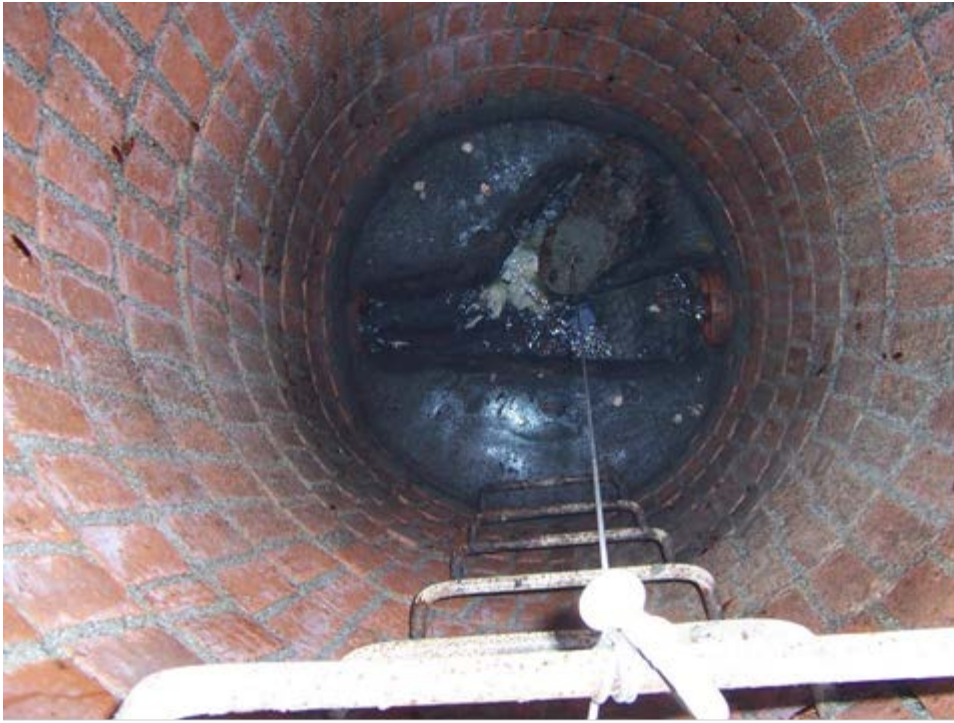
Figure 6: Gas trap valve on the SGVFO sewer line (entering from the 1:00 o'clock position) found wired open on 3-17-16.

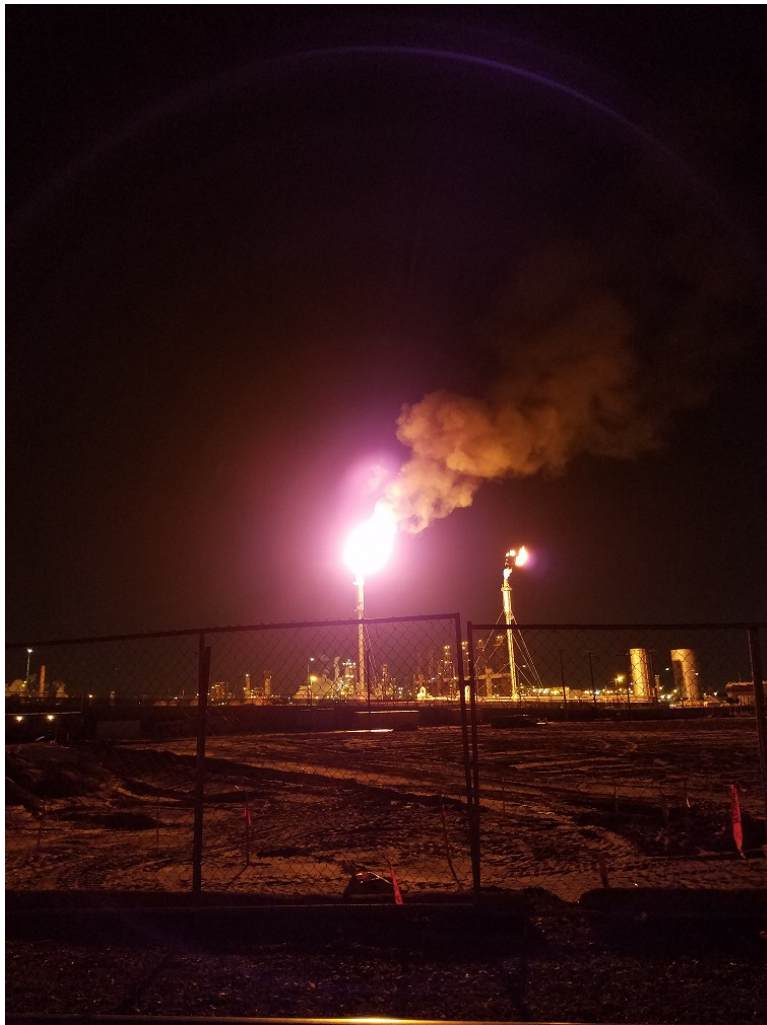
Figure 7: Huge flare at the ExxonMobil Torrance oil refinery at 1930 hours on 3-16-16.

Night team IW Inspector Kristopher McGinnis went to the refinery on the evening of 3-16-16 to investigate Barnum's report. He arrived on-site at 2000 hours. He was told a power outage had occurred at the refinery at 1720 hours due to a Mylar balloon contacting nearby power lines. Per refinery operators, after a two second power "bump," all refinery systems had failed. When the power was restored shortly thereafter, some systems automatically came back on-line, but most systems linked to pumps did not, thus causing large amounts of oil, gas, and partially refined product to be automatically diverted to the flaring system, causing the huge flame noted by Barnum (see Figure 7 above). At the time of McGinnis' inspection, the refinery was still in the process of manually activating and bringing on-line all required systems. Fortunately, the power outage did not affect the industrial wastewater pretreatment systems adversely and no off-spec wastewater discharges occurred at either the Van Ness outfall (IW#516) or the Del Amo outfall (IW#1148). McGinnis did issue a verbal warning for the Del Amo outfall because the company had failed to manually test and record hourly pH readings when the pH recorder had failed for two hours after the power outage. According to the flow log, there had been discharge to the sewer until 2008 hours. At the Van Ness outfall, the pH recorder was also non-functional for about two and a half hours after the power failure, but operators had taken and recorded hourly pH readings as required. There was no adverse impact to the downstream treatment plant, JWPCP, from this incident. A follow-up inspection the next morning by IW Inspectors Tingting Wei and Shawn Cleaver found normal refinery operations had resumed.

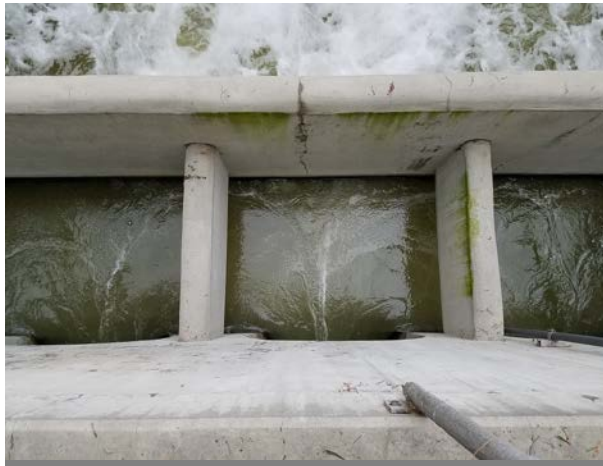
Figure 1: April 8, 2016, 6:38 p.m. photo of LCWRP forebay (top) and final effluent channel (bottom). Note the foam in the forebay but its near absence in the channel.

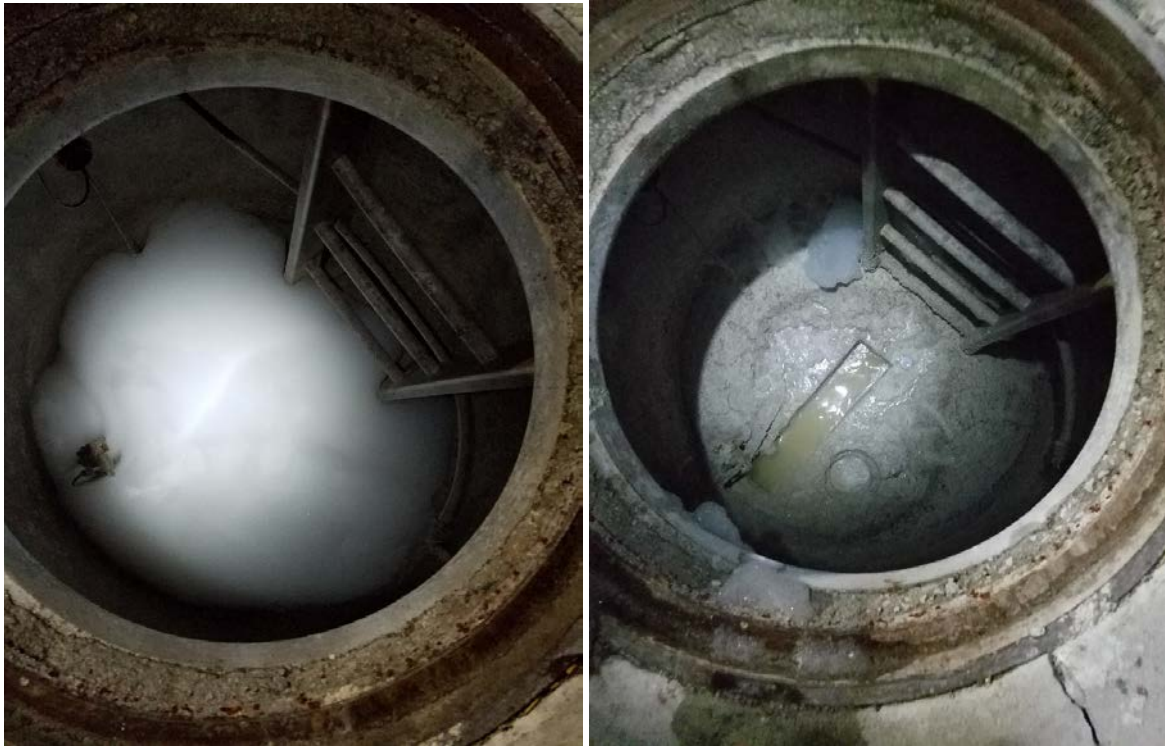
Figures 3 & 4: G & K Services legal sample point. Left photo shows $\approx 2'$ of foam in the sample point vault at 8:15 p.m. on April 8, 2016. Right photo taken 20 minutes later shows the vault after defoamant was added.

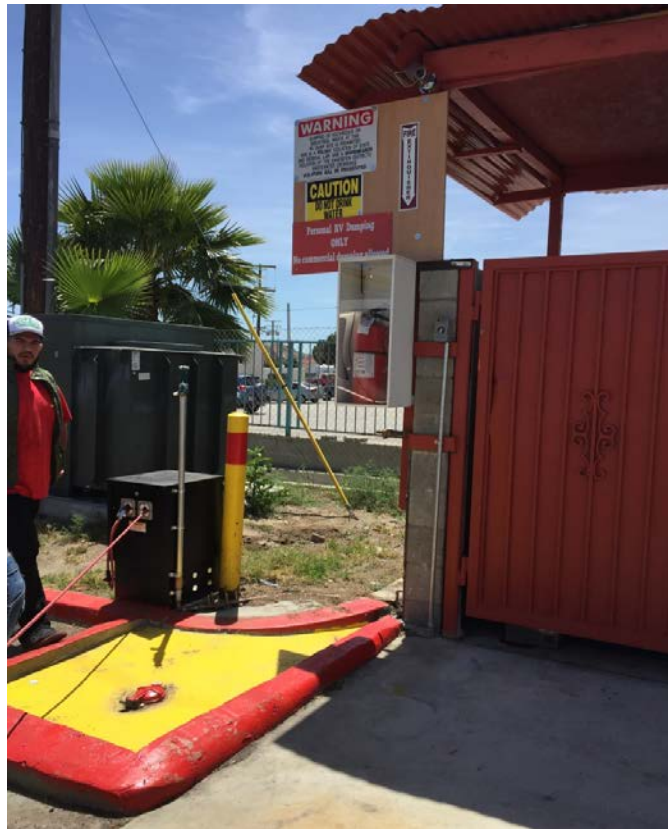
Figure 9: RV Disposal Station at the Castaic Truck Stop following completion of corrections on May 3, 2016.

included installing a backflow prevention device, hose, containment berm, Districts' warning sign, and drain cap lock. Follow-up inspection on May 3, 2016 verified all deficiencies were corrected properly. The facility owner said he's in the process of attempting to get all required permits and approvals necessary to manufacture the DEF solution on-site, until then the facility has ceased all DEF manufacturing operations. No referrals to other agencies will be made at this time.

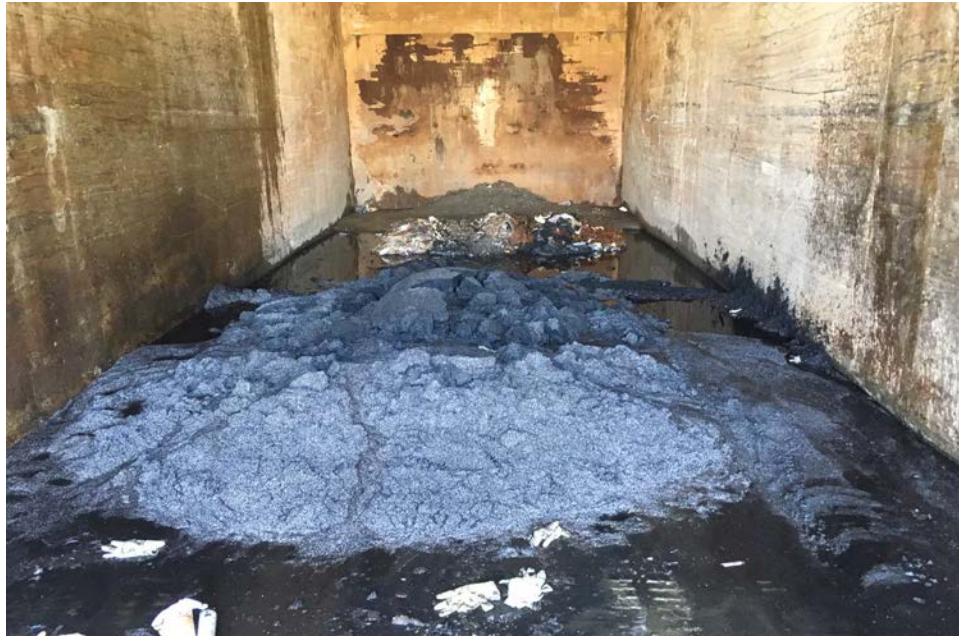
Figure 12: Sand removed from the local sewer by DPW and brought to JWPCP for disposal.

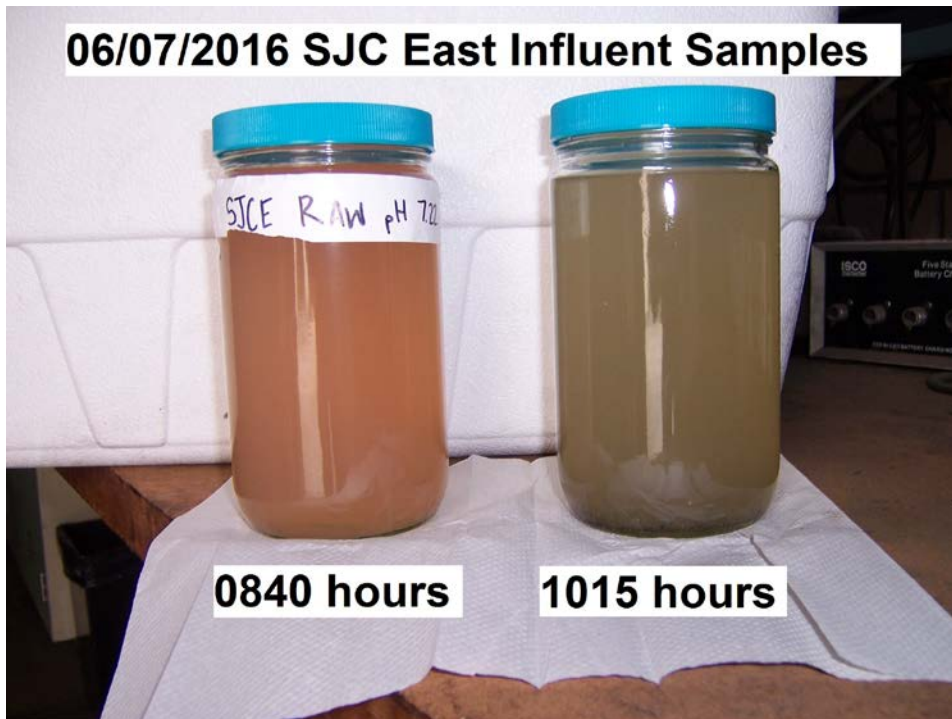
Figure 1: San Jose Creek East WRP 6-7-16 raw influent samples comparing the red color noted by WRP operators at 0840 hours and “normally” colored influent at 1015 hours.

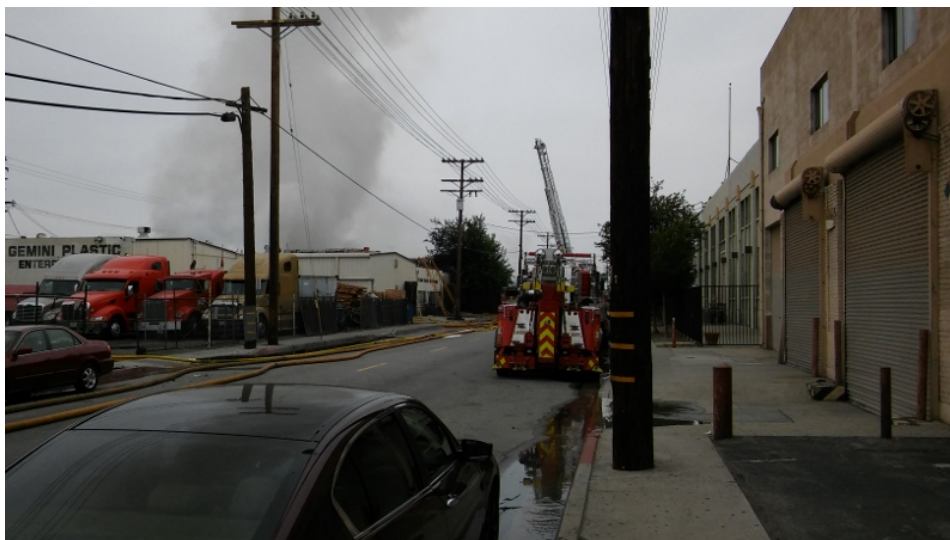
Figure 4: Initial View of the 6-14-16 fire at Panda International Trading Company in Maywood at 0930 hours on 6-14-16.

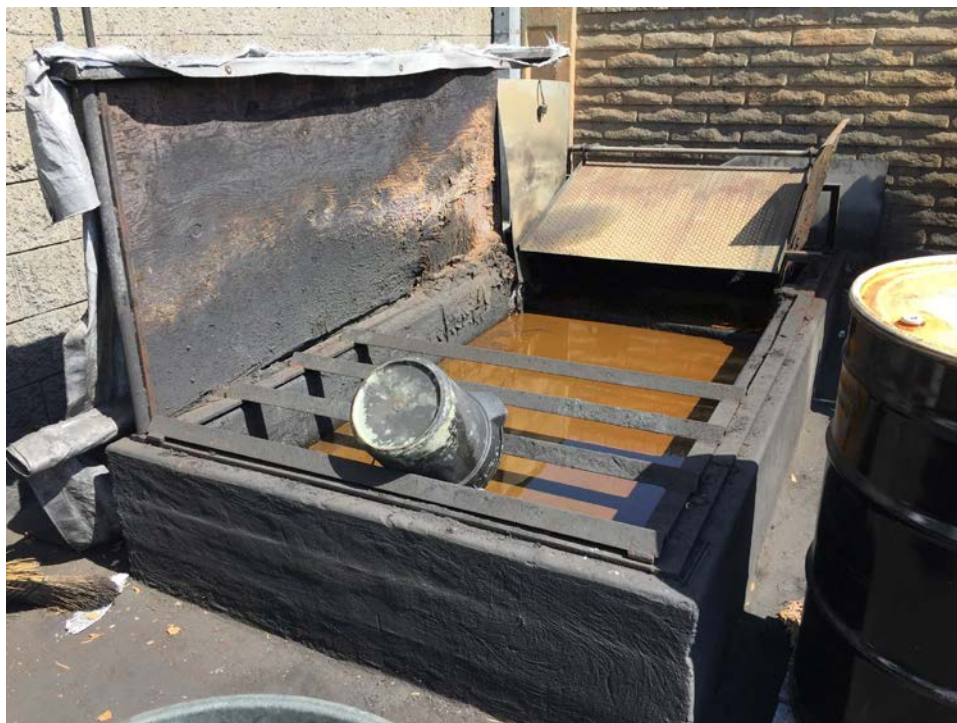
Figure 8: Waste water-based coolant evaporation pit at Carbro Corp.

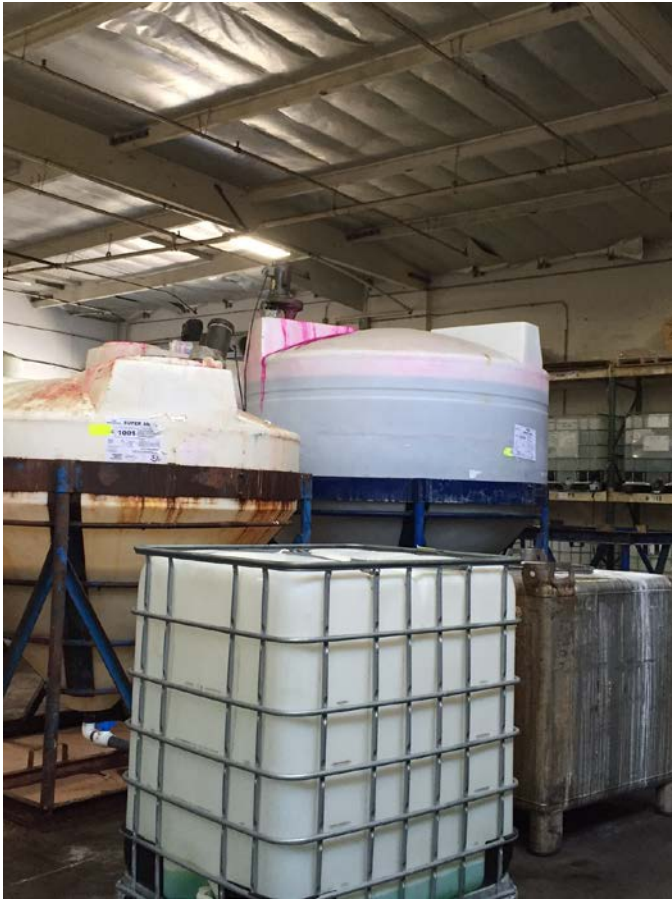
Figure 10: Approximate 1500-gallon cone-bottomed poly tank in the back of the photo nearly full of pink colored solution. Note staining present on the top of the tank.

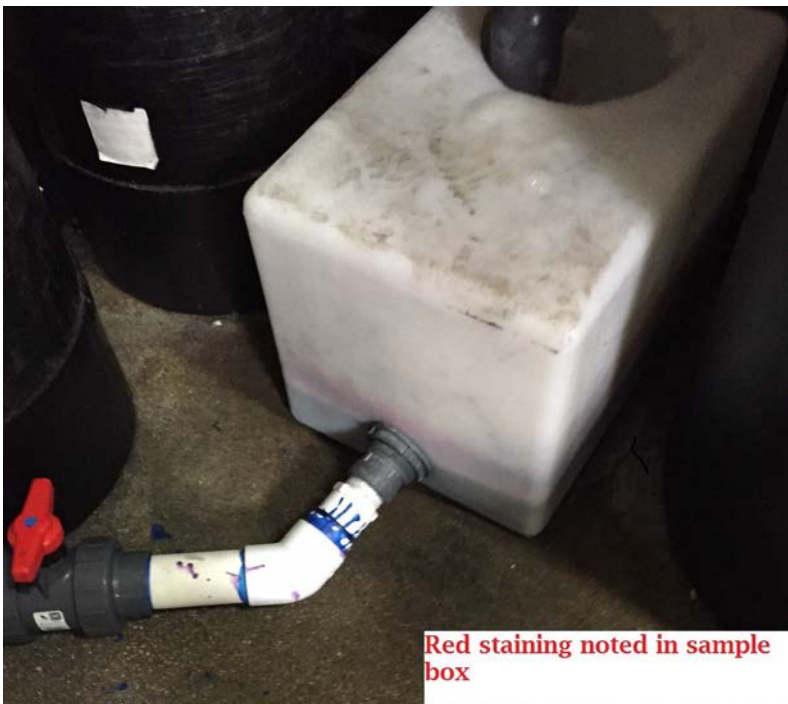
Red staining noted in sample box

Figure 11: Pink staining present in the OCCS sample box on 6-16-16.

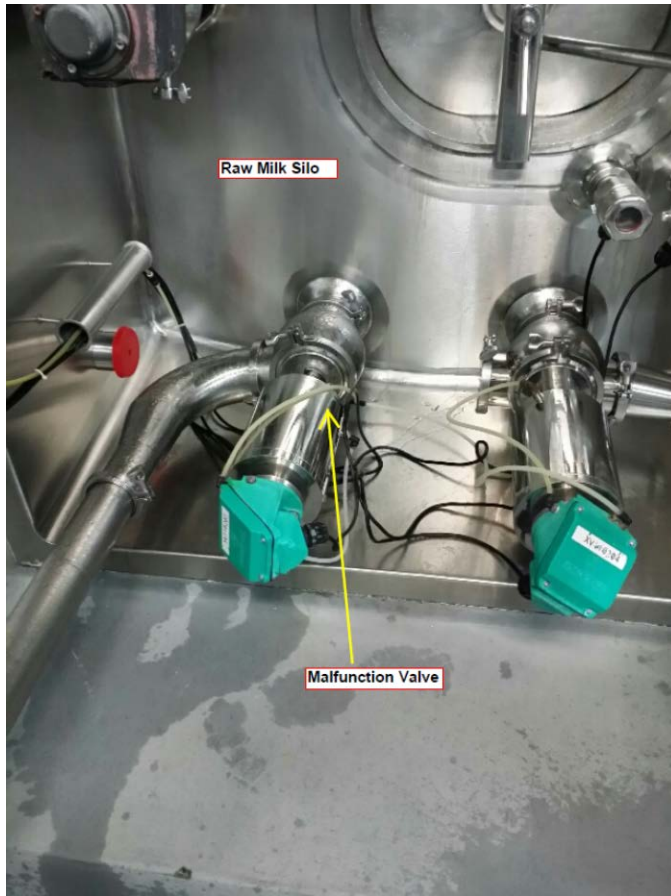
Figure 2: Base of the 50,000-gallon stainless steel raw milk silo and the tank's pneumatically controlled bottom inlet valve that failed, causing about 17,000 gallons of its contents to drain into nearby floor drains that flowed directly to the sewer.

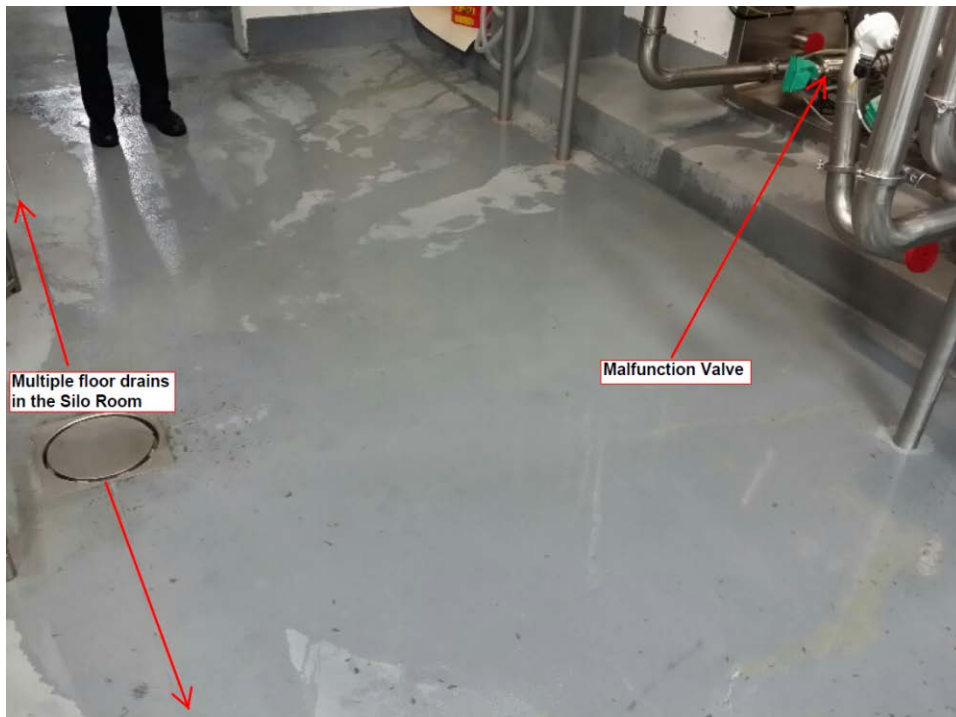
Figure 3: 7-12-16 photo showing the close proximity of the valve that failed to the nearest sewer floor drain.

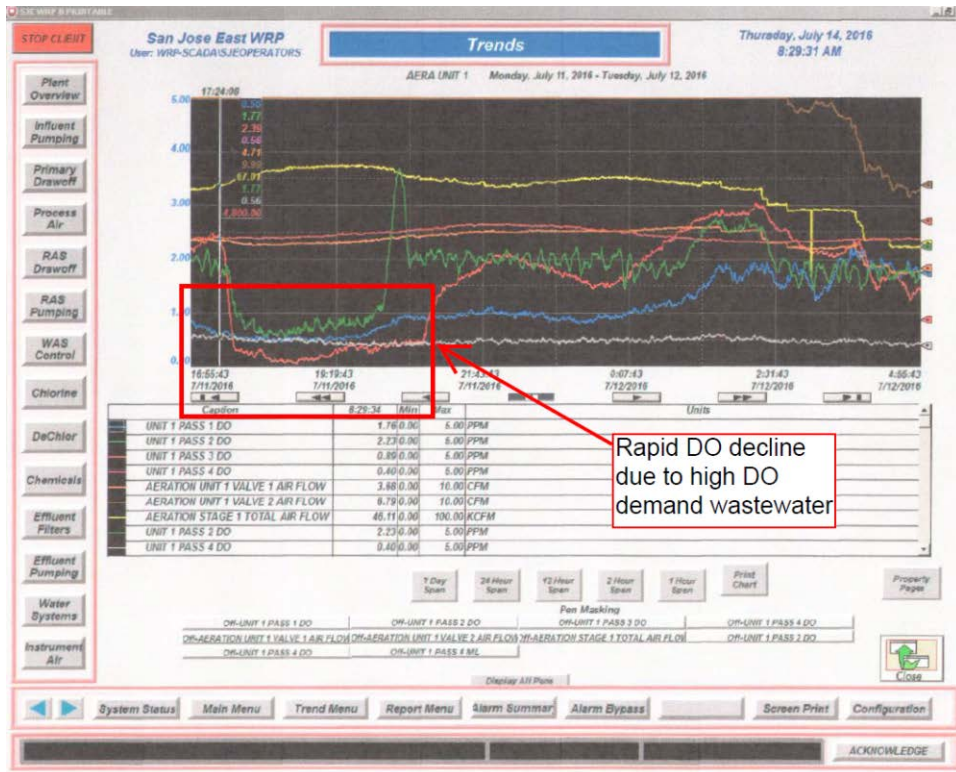
Figure 4: Operations computer control screen shot from SJC-East WRP showing how dissolved oxygen levels rapidly bottomed out at 1655 hours on 7-11-16 once the high strength milk spilled at Los Altos Foods passed through primary tanks into the secondary aeration tanks.

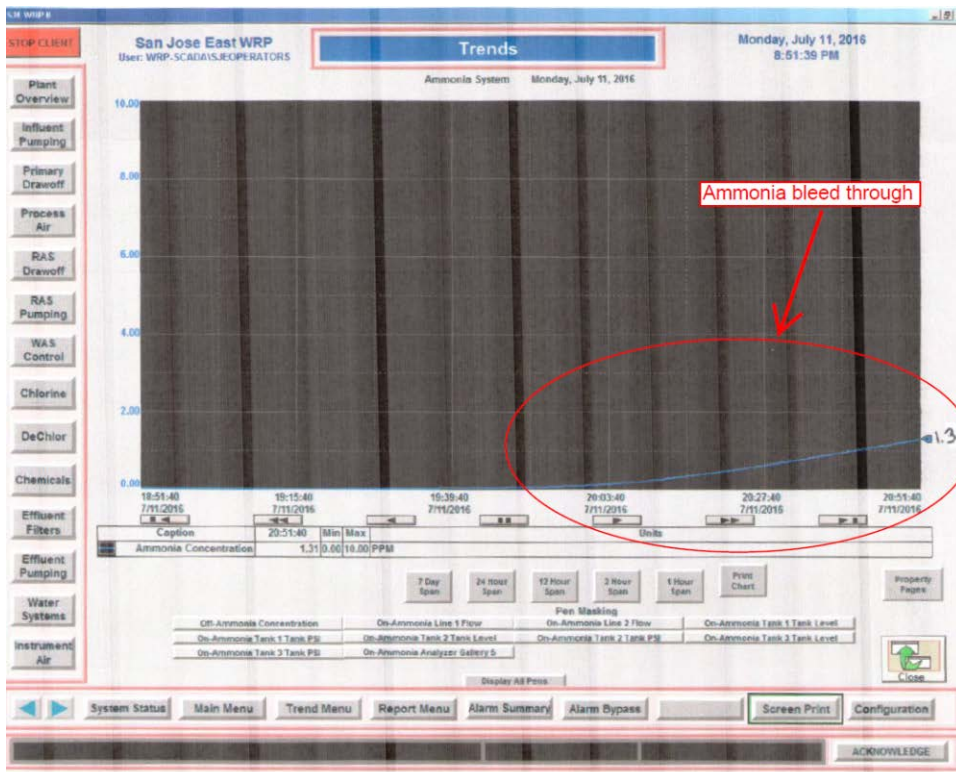
Figure 5: Operations computer control screen shot from SJC-East WRP showing ammonia concentrations increasing as the WRP became overwhelmed by 2000 hours due to the high strength milk spill.

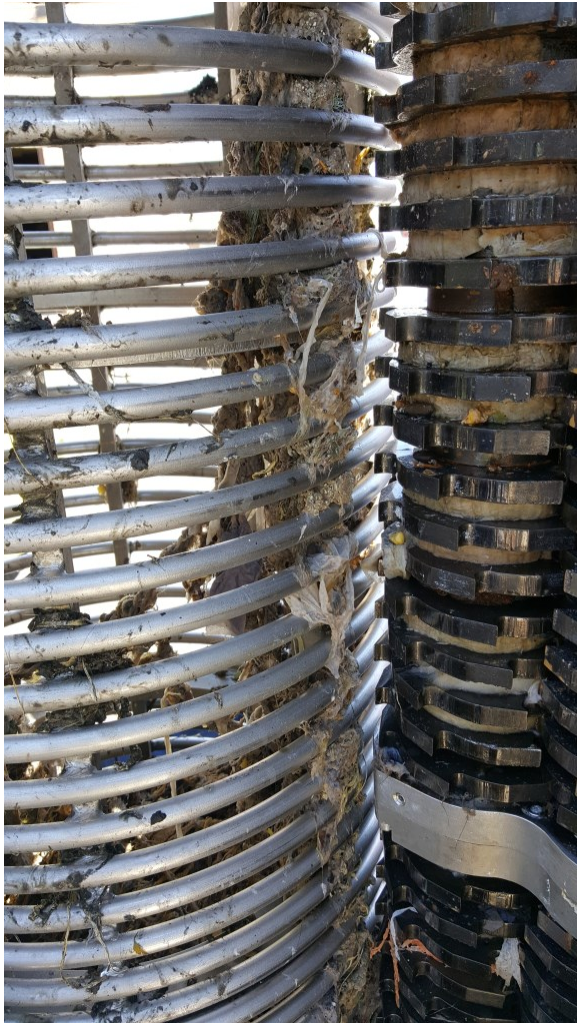
Figure 2: 8-1-16 photo of Saugus WRP Channel Monster with remnants of the “rubber band like” materials present.

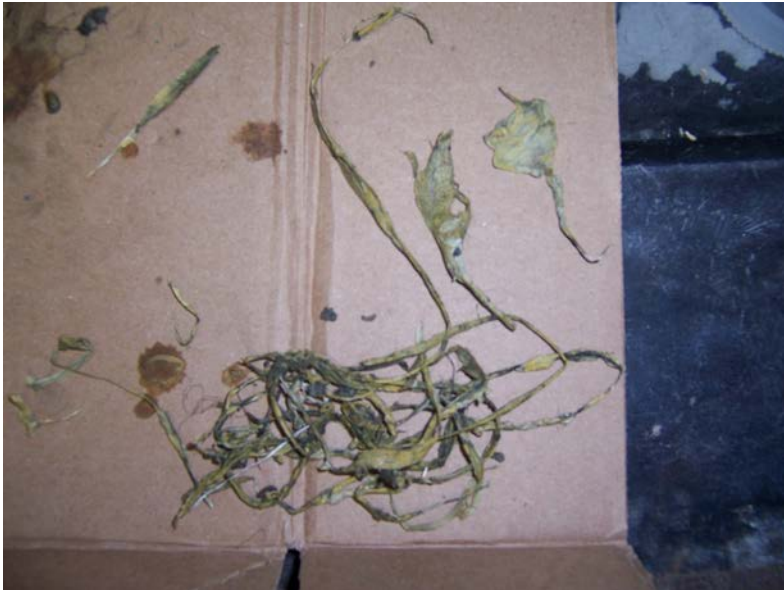
Figure 3: Photo of the materials reported to be elastic or rubber bands. Note the materials are in fact not elastic and can be “unrolled” to reveal their true identity as the remnants of flushable wipes.

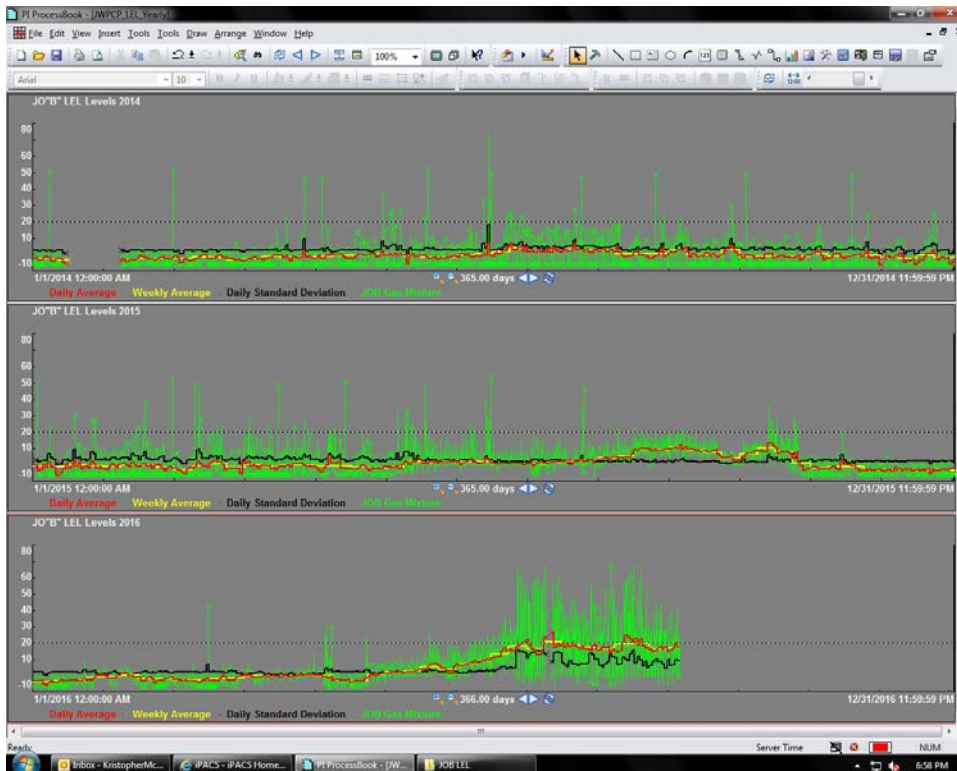
Figure 7: JWPCP J.O. ‘B’ headworks annual LEL trends. Note the uncharacteristically high LEL readings observed beginning on July 11, 2016.
