2016 ANNUAL REPORT

INDUSTRIAL WASTE PRETREATMENT PROGRAM

COUNTY SANITATION DISTRICTS OF LOS ANGELES COUNTY

APPENDIX H
INDUSTRIAL WASTE REPORTS ON INCIDENTS

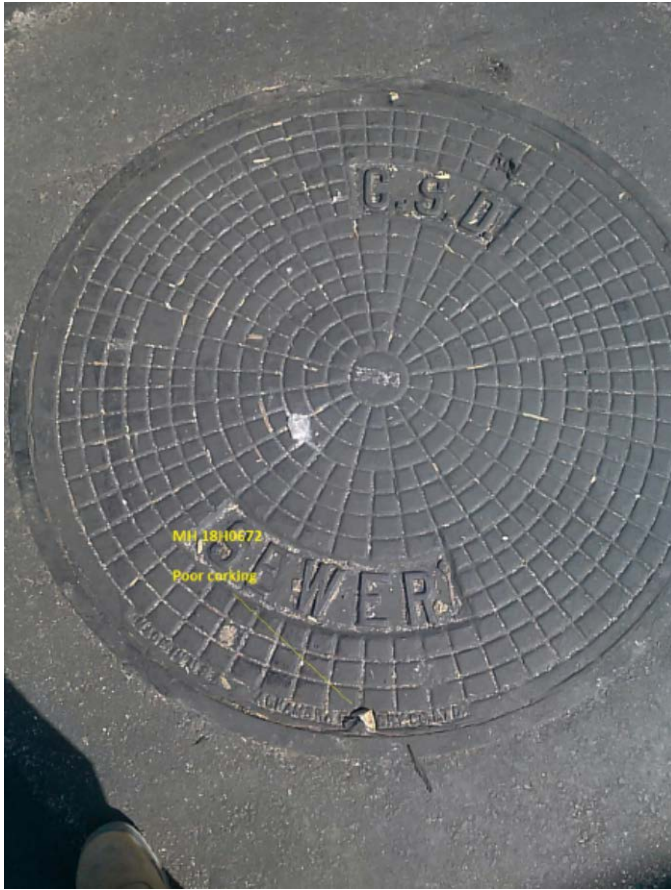
Figure 3: MH 18H0672 on 9-1-16, note partially displaced and torn cork in one of the pick holes.

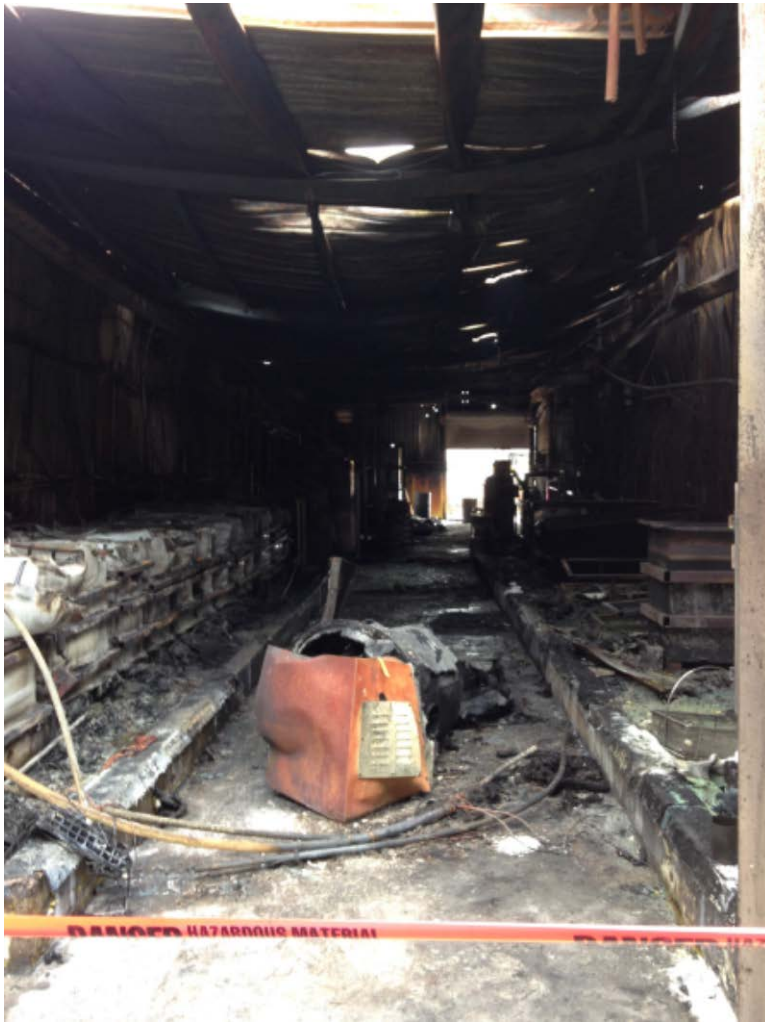
Figure 4: Photo showing the fire damaged metal processing area at Bodycote Thermal Processing on 9-4-16. Note the partially melted open-top white poly plating tanks on the left.

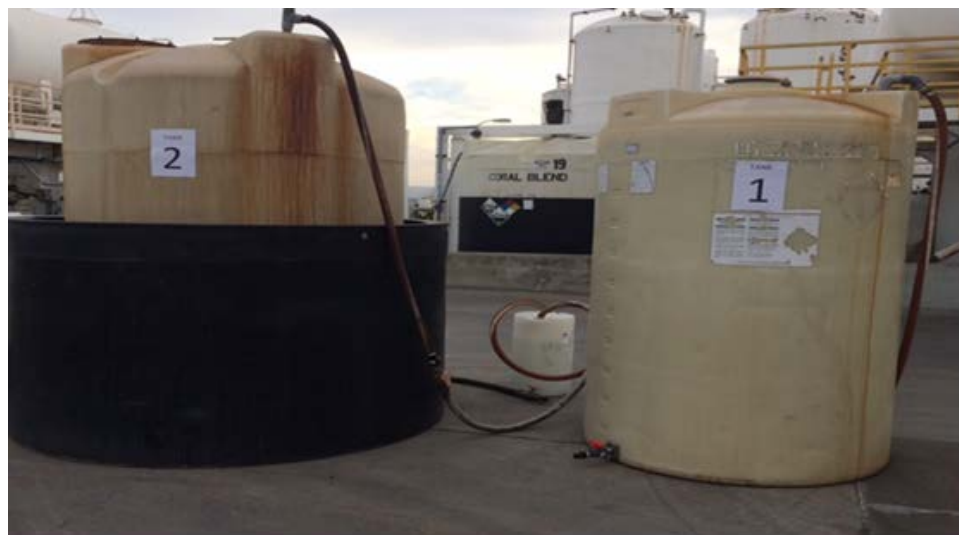
Figure 1: 11-22-16 photo from Eugene Boudreau showing the two tanks containing the spilled acid and spill containment area wash down water.

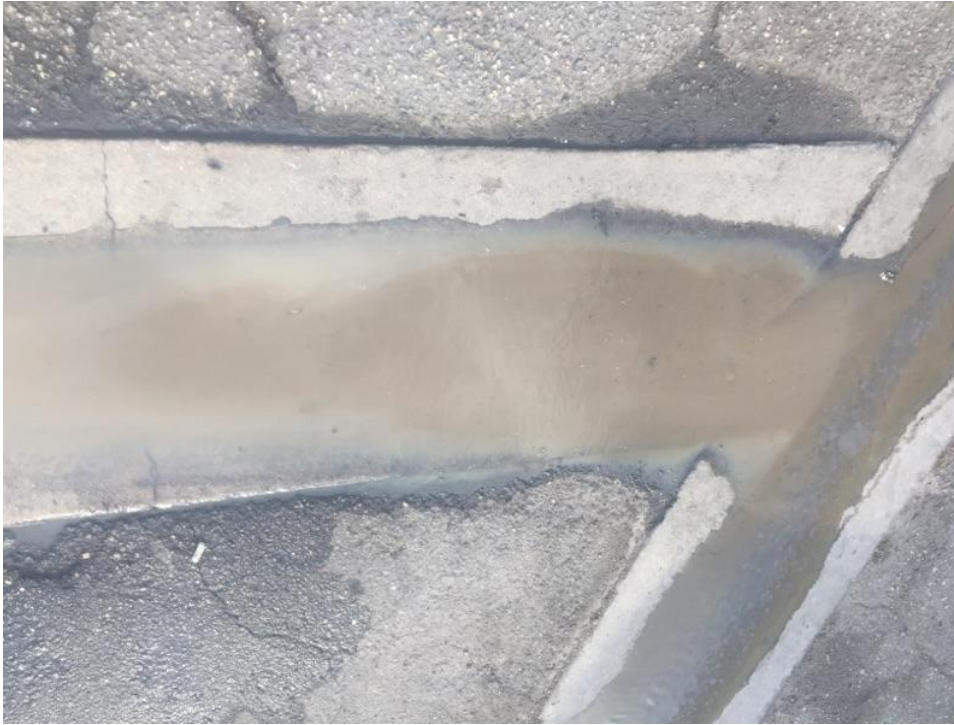
Figure 2: Photo of the contaminated water in a driveway swale sent to Boyd by the anonymous complainant. Note the color matches that expected of water contaminated with emulsified grease.

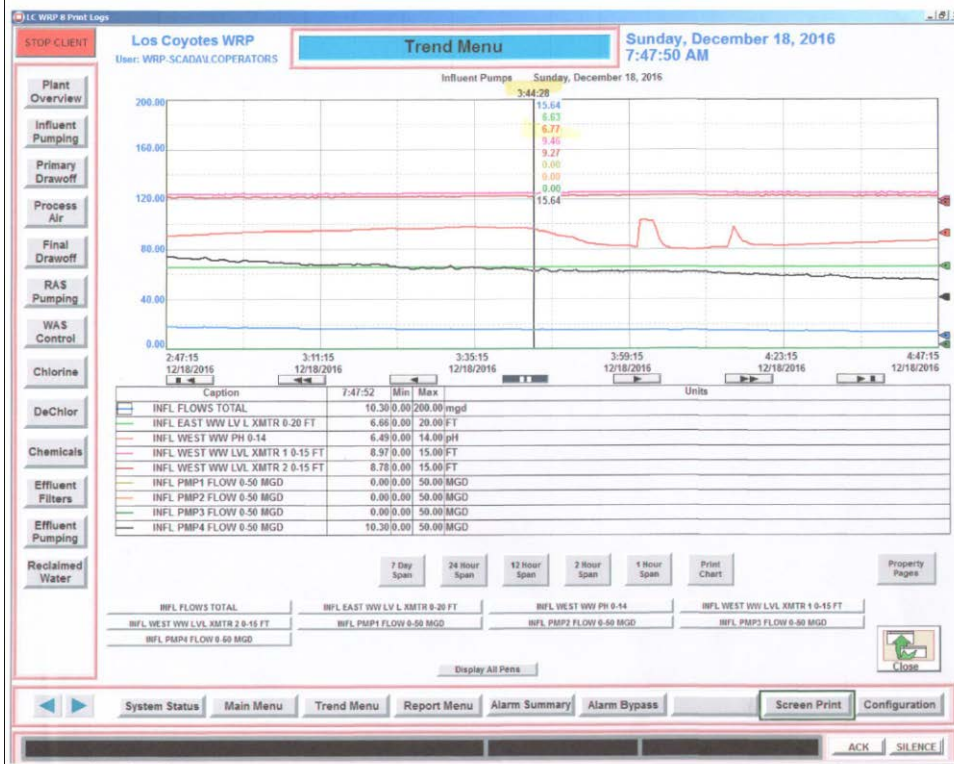
Figure 4: LCWRP screen shot indicating the influent trend pH (red line) during the early morning hours of Sunday, 12-18-16. The data indicates the normal pH trend was first disrupted at 0345 hours. The normal pH trend was regained by 0500 hours.

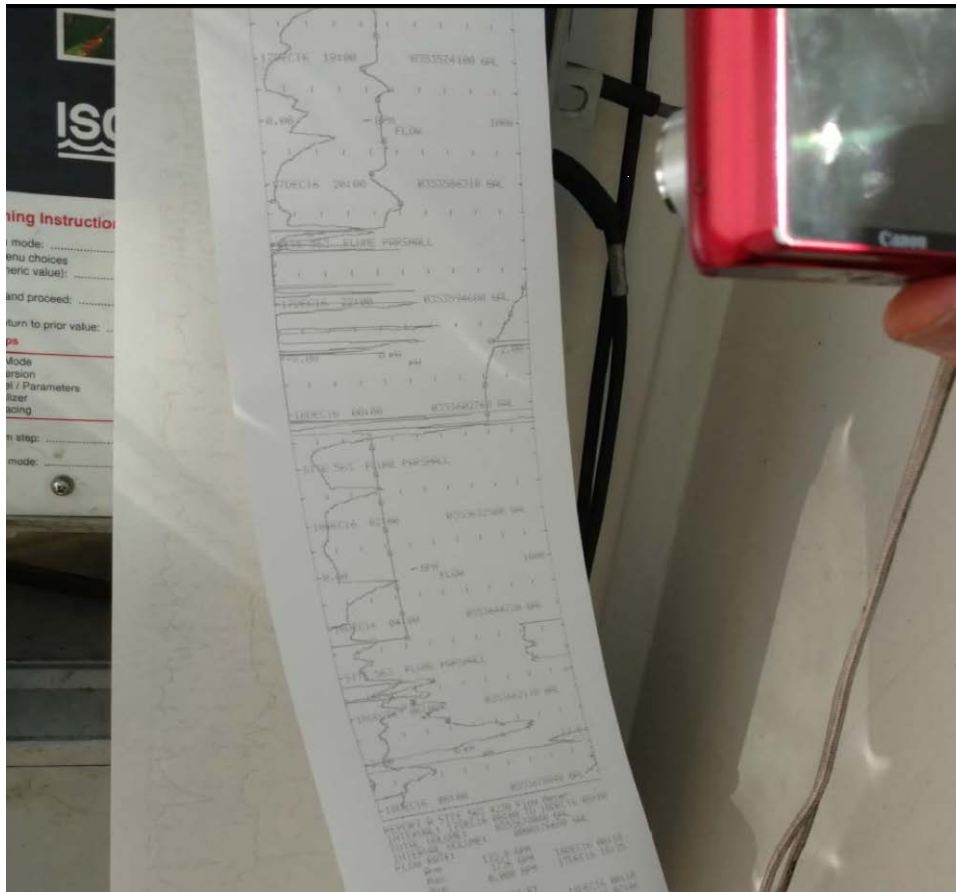
Figure 5: BCI Coca-Cola flow/pH chart recording on 12-17-16 indicating unusually erratic flows and low/high pH discharges between 8:15 p.m. and midnight.
