**2015 ANNUAL REPORT**

INDUSTRIAL WASTE PRETREATMENT PROGRAM

COUNTY SANITATION DISTRICTS OF LOS ANGELES COUNTY

**APPENDIX H**  
INDUSTRIAL WASTE REPORTS ON INCIDENTS

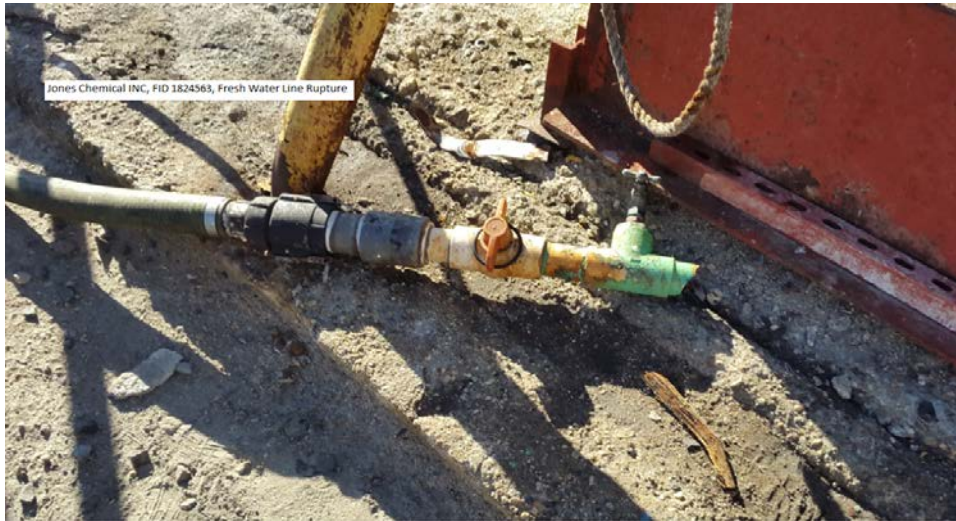
**Figure 6: Broken potable water line. Note the valves which were quickly closed to limit the spill volume.**

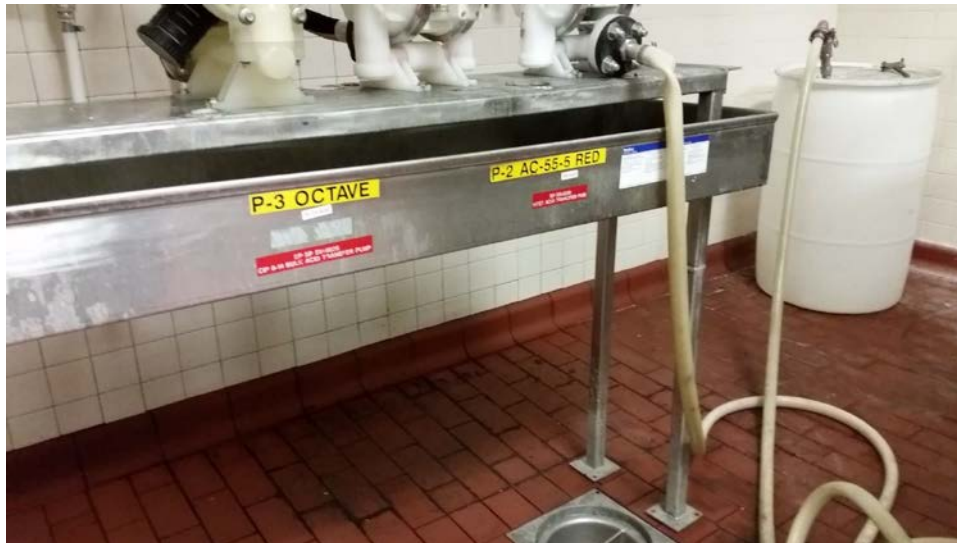
On Sunday, 2-15-15 at 0715 hours, Long Beach Main Pump Plant Operator Anthony Gould notified Senior I.W. Inspector Bill Barnum that he had just received a call from Environmental Engineer Dexter Deane of General Mills in Carson self-reporting multiple low pH discharges that past night and morning that were caused by a ruptured acid hose line in their clean-in-place (CIP) system.

**Figure 1: CIP system pump room at General Mills on 2-15-15. Note the diaphragm pumps above and the open floor drain directly beneath where the spilled acid entered the facility's industrial wastewater collection system.**

Follow-up inspections by area I.W. Inspector Shawn Cleaver found that facility managers had implemented level sensor improvements to the acid delivery system to prevent a repeat of the incident. The flexible hoses attached to pumps will be replaced by hard plumbed lines. Additionally, Cleaver will recommend the facility be subject to the Districts' Slug Discharge Control and Spill Containment program. A verbal warning was issued, as is generally the case for self-reported violations, to the company for the hose line equipment violation that caused the spill and the low pH discharge.

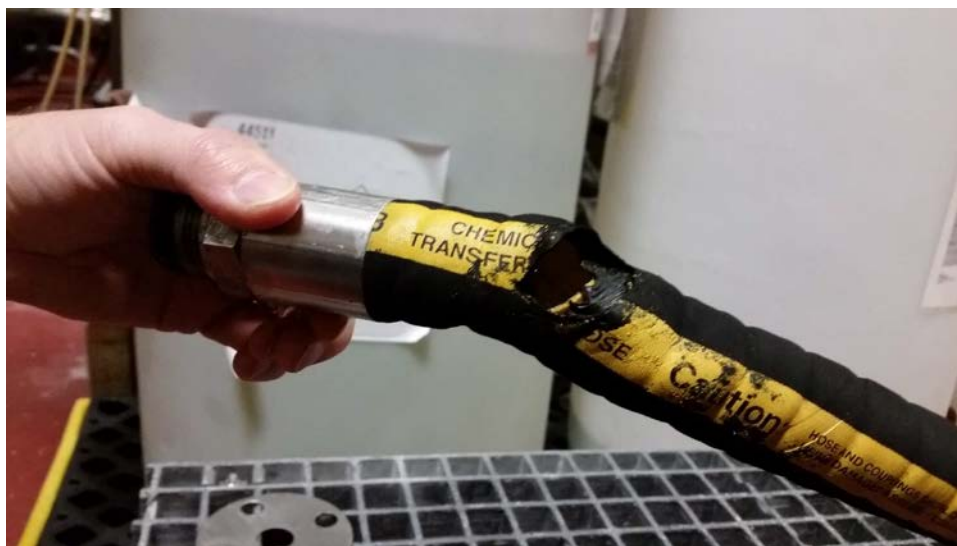
**Figure 2: Ruptured acidic sanitizer solution flexible hose line at General Mills on 2-15-15.**

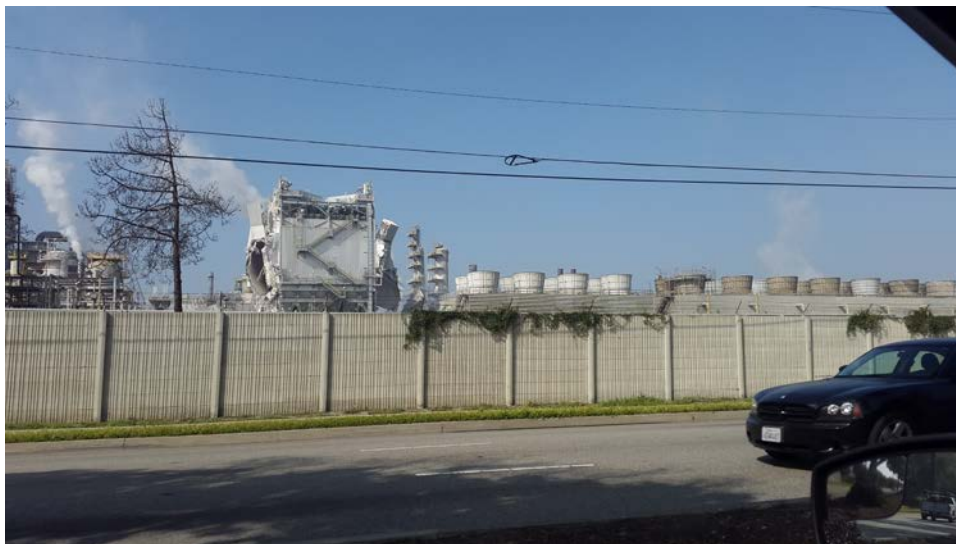
**Figure 4: Inspector street view photo looking west from Crenshaw Boulevard at the ESP unit on 2-18-15. Note the walls of the unit have been bowed and blown outward by the force of the explosion in the unit.**

Barnum and Placencia arrived onsite at the refinery at 0930 hours on 2-18-15. It was determined the refinery had experienced an explosion at the electrostatic precipitator unit which caused damage to some surrounding units such as the pretreater and fluid catalytic cracking unit. There was no lingering fire after the flash explosion and flammable gases from the surrounded units were purged to the south flare station. Leaks from the damaged units were contained with suppression firewater which was accumulating in spill containment areas on-site. Inspections of the downstream sewer lines and offsite monitoring stations determined that there was no impact to the collection system or JWPCP since the refinery was able to shut off flow and initiate firewater impound procedures. Inspectors followed up with the refinery to determine proper disposition of the impounded firewater, and although the refinery was subsequently issued a written notice of violation for failing to properly notify the Districts during one of the discharges of treated firewater, there were no negative impacts to the collection system or JWPCP since the refinery was able to properly treat the discharge and meet all applicable discharge limits as verified by follow-up sampling activity conducted by the I.W. inspection staff.

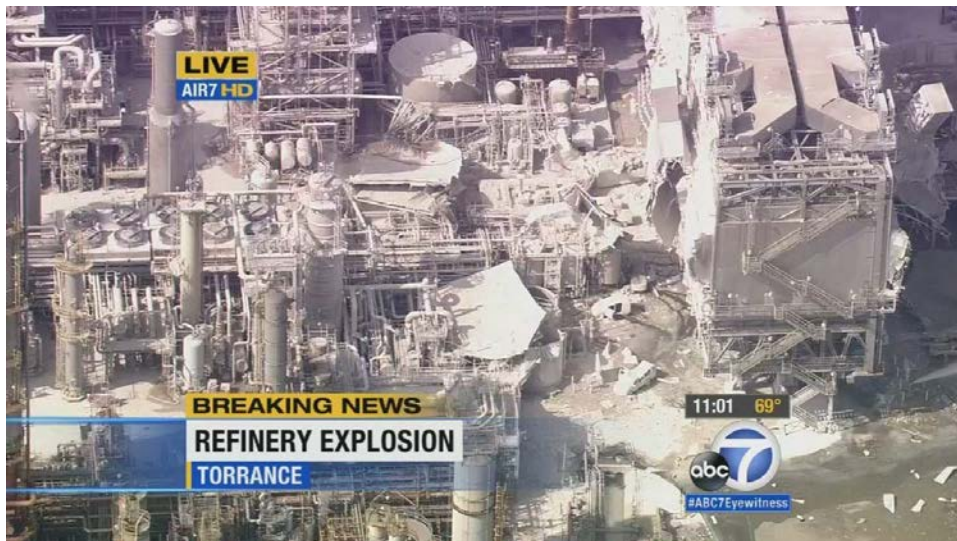
**Figure 5: KABC News helicopter picture of the damaged ESP unit and surrounding area covered in debris.**

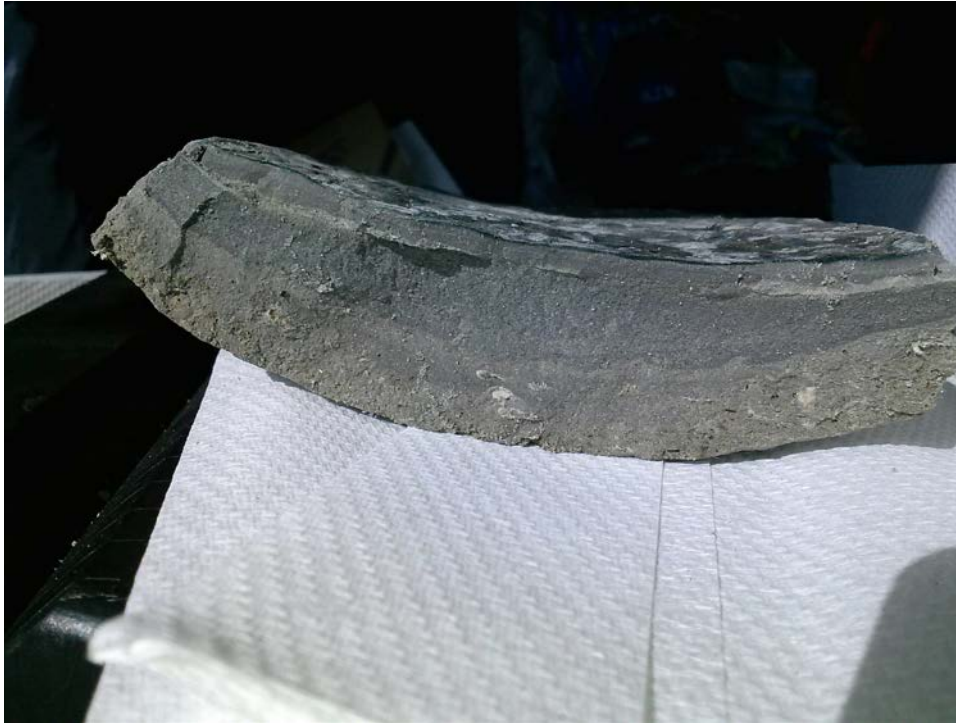
**Figure 8: Layered concrete removed from Long Beach local sewer line by hydroblasting operations by National Plant Services on 2-15-15.**

Area I.W. Inspector Sanjay Patel followed-up with City of Long Beach Code Enforcement Officer Keith Wardlow on 2-23-15 and 2-24-15. According to Wardlow, the concrete found in the local sewer line came from concrete washout slurry periodically overflowing a pit with an old sewer connected drain at the LBMPP construction site. These overflows occurred over a period of several months and went unnoticed by site workers. Further investigation by Patel and Sanchez, which included contacting City of Long Beach Sewer Maintenance Supervisor Ed Mendoza, revealed that LBMPP prime contractor Prado Construction was responsible for the discharges and had contracted NPS to hydroblast the impacted local line and removes the concrete debris. Patel and Sanchez met with Steve Mueller from Prado Construction. Mr. Mueller explained exactly how the concrete slurry that got into the sewer had periodically overflowed from an excavation pit over a nine-month period, eventually impacting the local sewer line for about 1200' downstream. It was noted that at no time were any Districts' trunk sewers or downstream collection system lines or treatment plant operations affected by this incident.

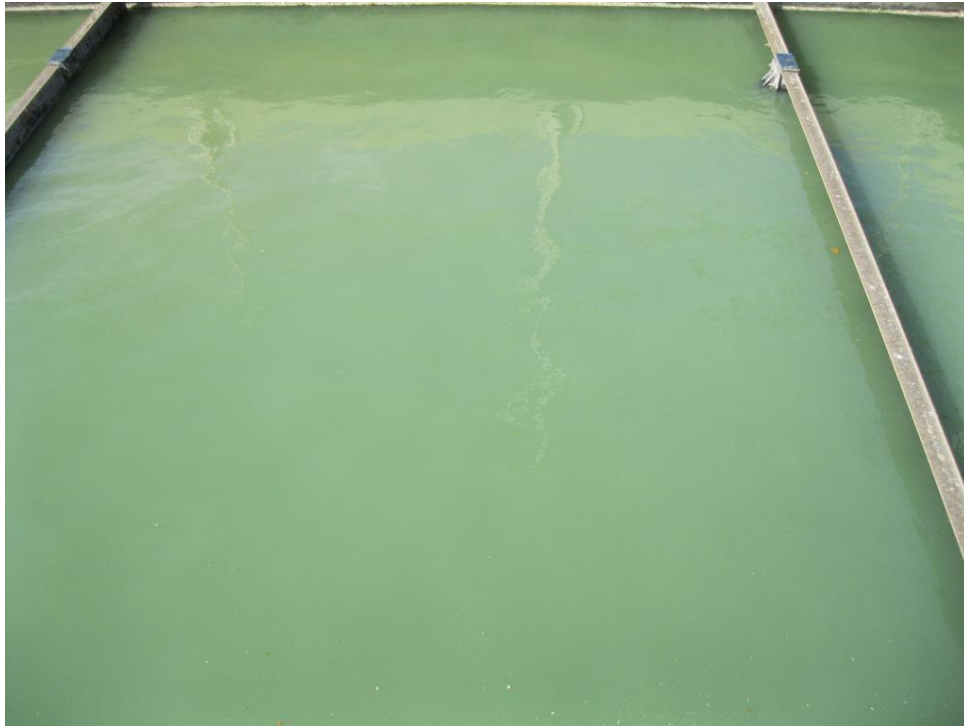
1-2 hours since the color was not yet in the secondary tanks. Operators took two 1.0 L samples of the green colored primary tank wastewater for possible analysis. The green colored wastewater had no unusual odors. The colored material did not adversely affect treatment plant operations indicating it may be a non-toxic fluorescein dye. No violation(s) of waste discharge requirements resulted from this incident.

**Figure 9: Green color in a Lancaster WRP primary tank on 2-27-15.**

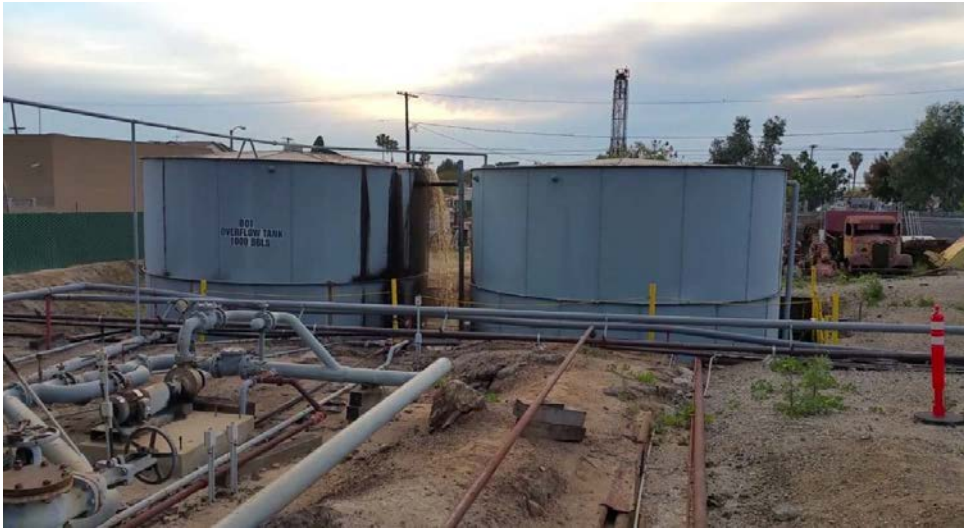
**Figure 1: Photo taken at 1830 hours on 3-17-15 of the ongoing spill of oily wastewater from the “001 OVERFLOW TANK” at the Oil Operators facility in Signal Hill.**

Further follow-up was conducted on 3-18-15 by Senior I.W. Inspector Andy Woods. The company claimed an internal investigation determined the tank overflow was caused by a chemical vendor that had visited the site on 3-17-15 at approximately 1800 hours. The vendor closed a surge tank effluent valve to temporarily isolate and check an unused injection port. After finishing this work, the vendor forgot to re-open the effluent valve. Rising water in the surge tank then overflowed into the first overflow tank where a high-water sensor subsequently failed due to oily-scum buildup impeding the sensor's signal. The first overflow tank then began surcharging through a roof port into the containment area below because the pipe between the two overflow tanks has a smaller diameter than the influent pipe. Shortly thereafter, Inspector McIntosh fortuitously discovered the overflowing tank. McIntosh was able to notify the company of the situation before the containment area filled, thus preventing a possible overflow of the wastewater into the adjacent storm drain system. None of the spilled wastewater and cleanup water was discharged to the sewer. The incident didn't impact Districts' sewer lines or downstream treatment plant operations. The high level tank sensor that had failed on 3-17-15 was cleaned, tested, and found to be working properly on 3-18-15. The containment area high level alarm was also tested and found to be working properly.

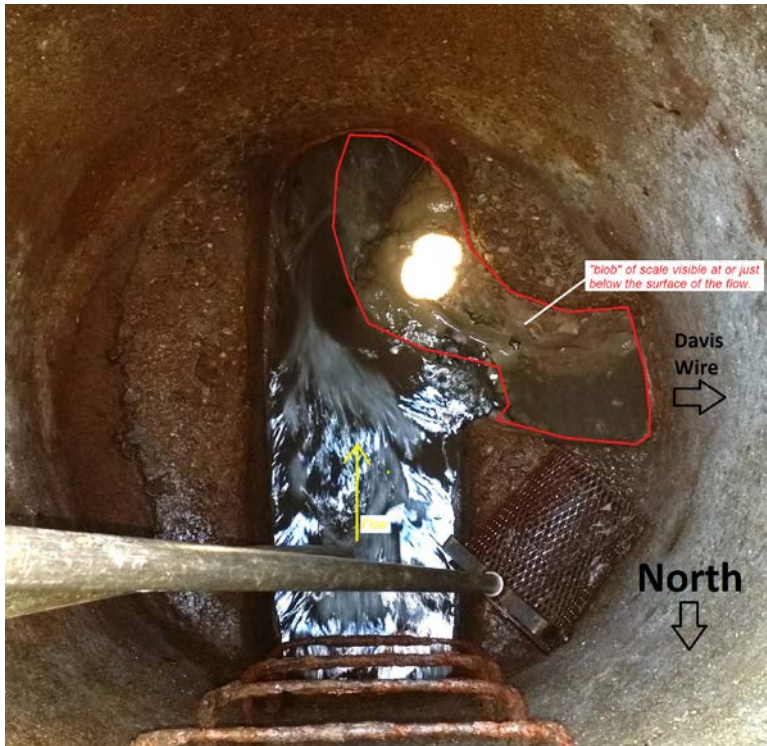
**Figure 7: White or grey scale in MH 22 1214A on 4-13-15.**

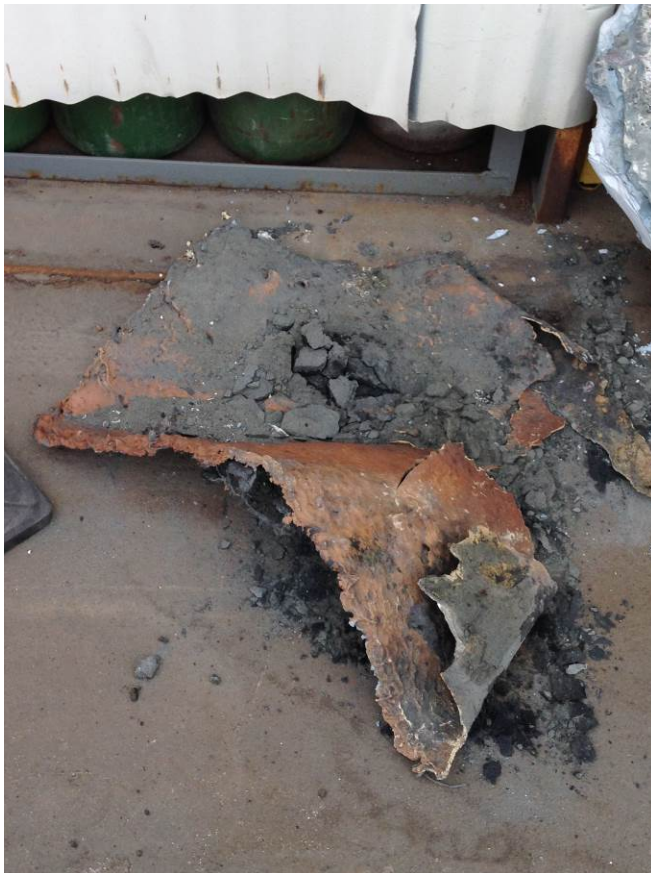
**Figure 12: Photo of liner material, epoxy resin and dark solids removed from Manhole 03 0427 on the Water Street trunk on 4-16-15. Note the orange color of the liner that matches that in Figure 11 above.**

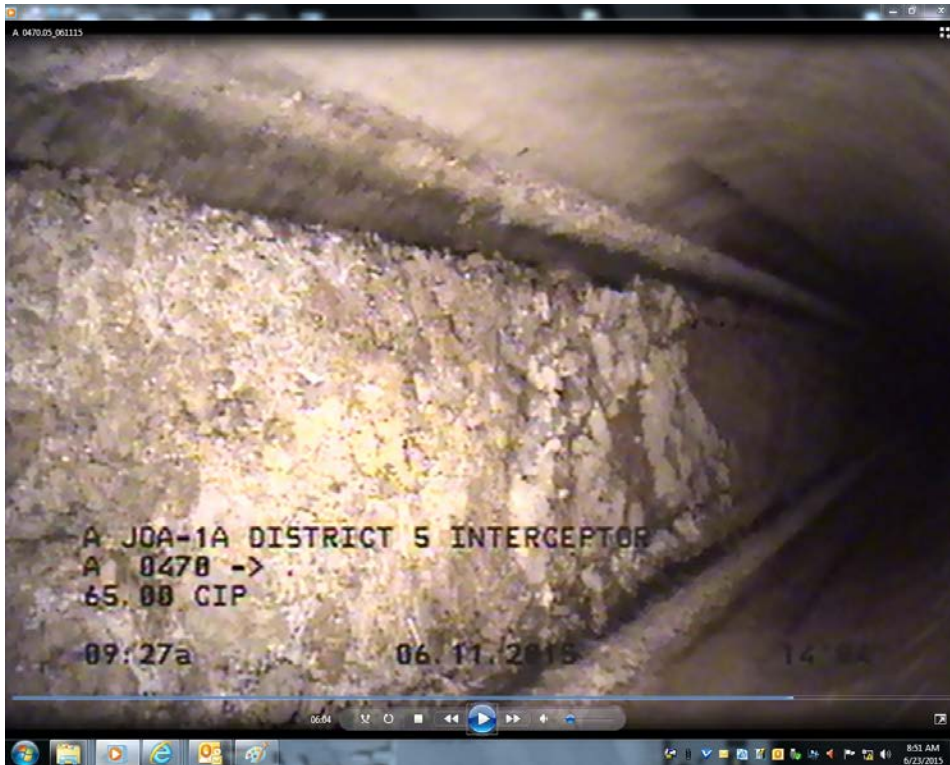
**Figure 6: CCTV video screen grab photo of the FOG CCTV sewer crews encountered at MH 08A0470 on 6-11-15.**

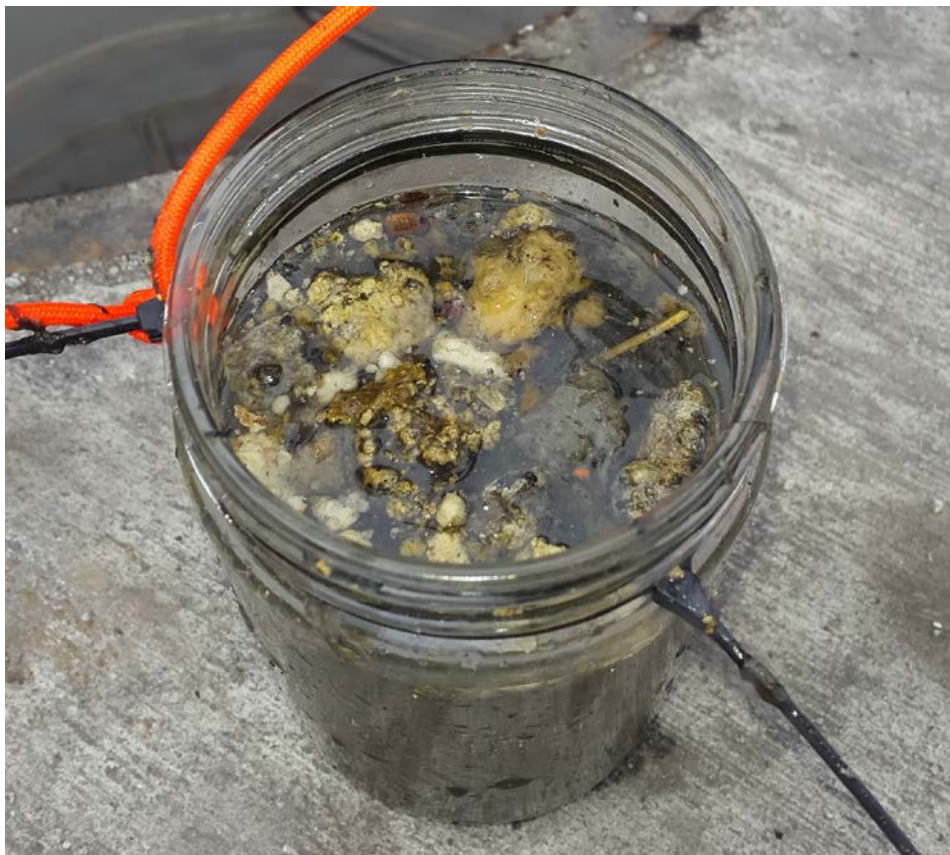
**Figure 7: Sample of the FOG removed from MH 08A0470 on 6-12-15.**

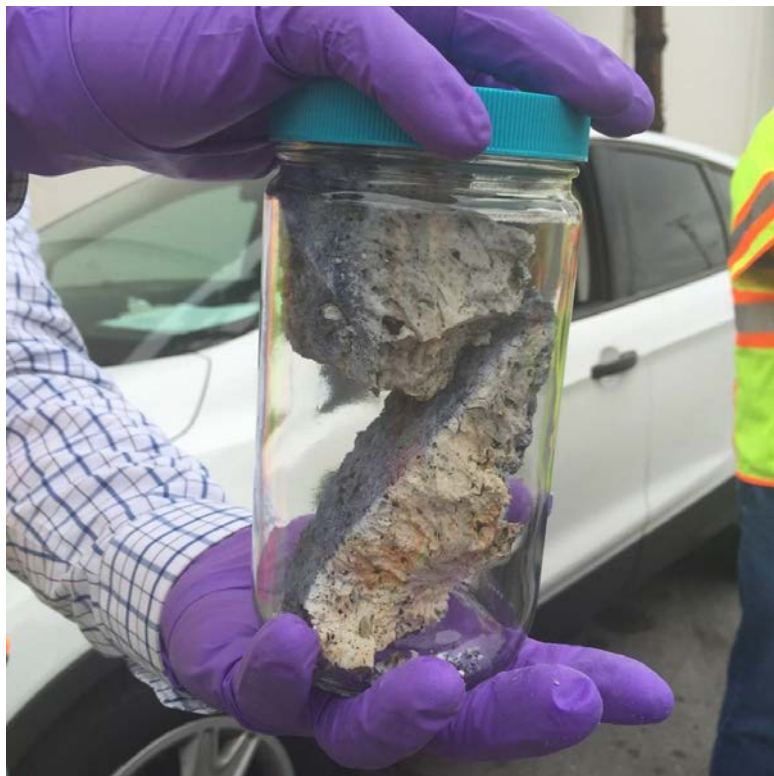
**Figure 2: Solids removed from the Phoebe Avenue trunk in La Mirada on 7-21-15. The solid material was broken up by hydrojetting and removed as the chunks pictured.**

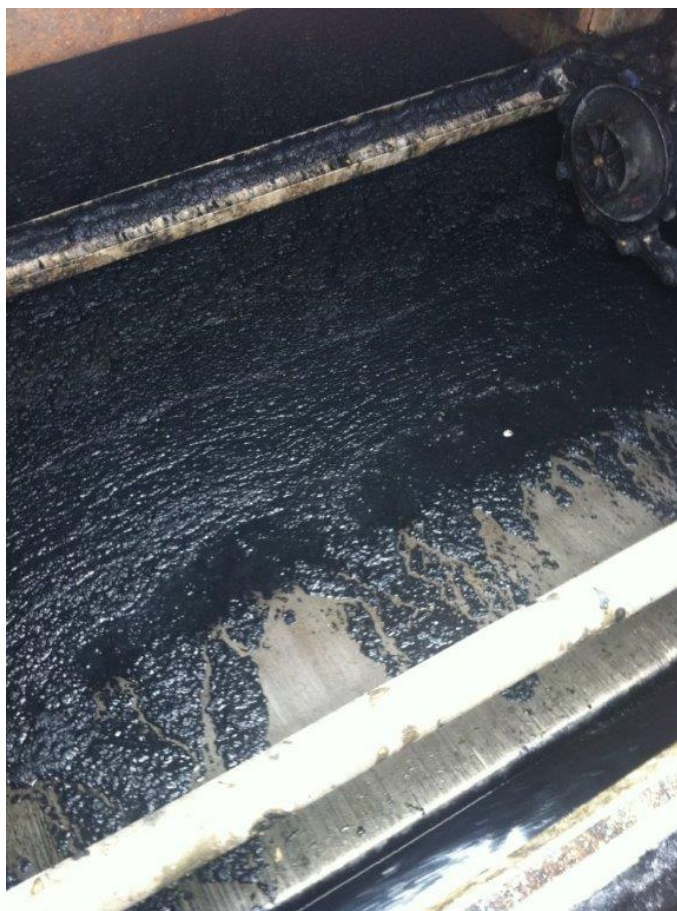
**Figure 5: E-3 south battery primary skimmer black solids observed on 7-30-15. Note how the solids appear essentially visually identical to that of a black oily material.**

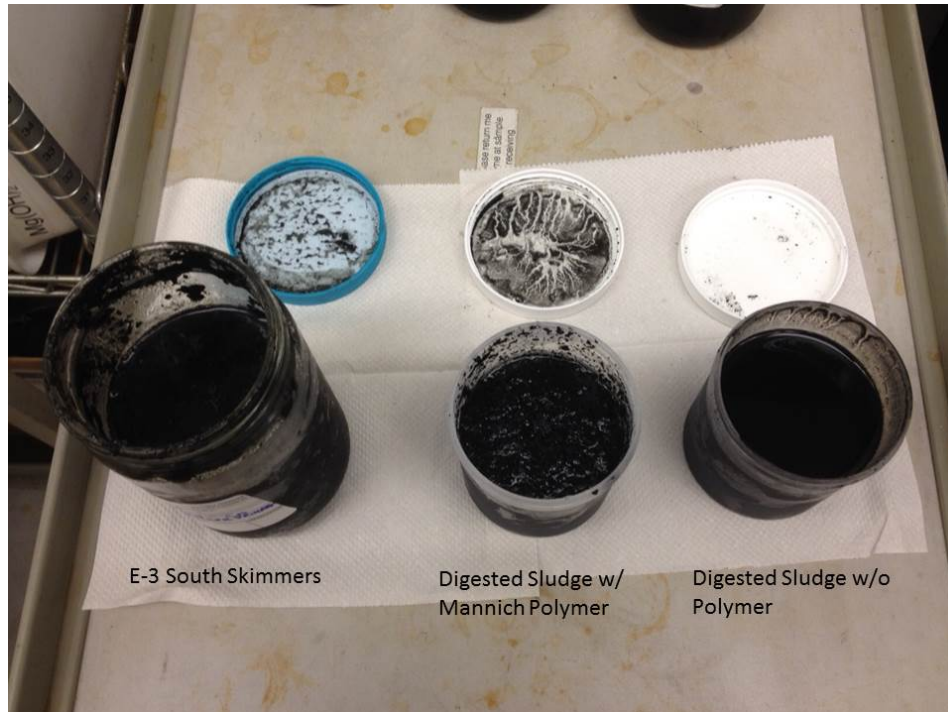
**Figure 6: Comparison of the black solids removed from the JWPCP skimmers on 7-27-15 with digested sludge containing Mannich polymer that was taken from the JWPCP Solids Processing Unit.**

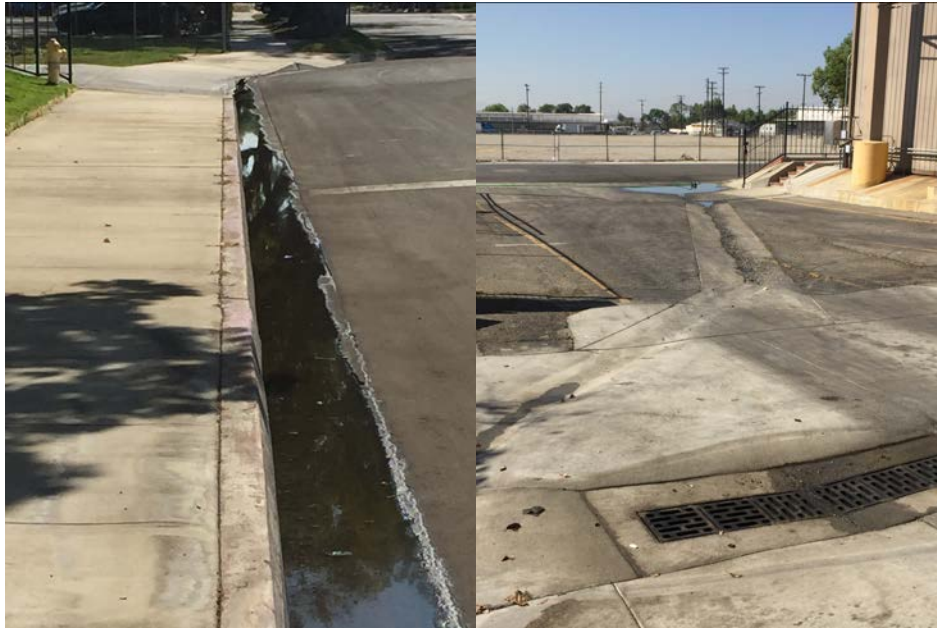
**Figures 4 and 5: Spilled process wastewater noted at Partners Alliance Cold Storage on 8-27-15.**

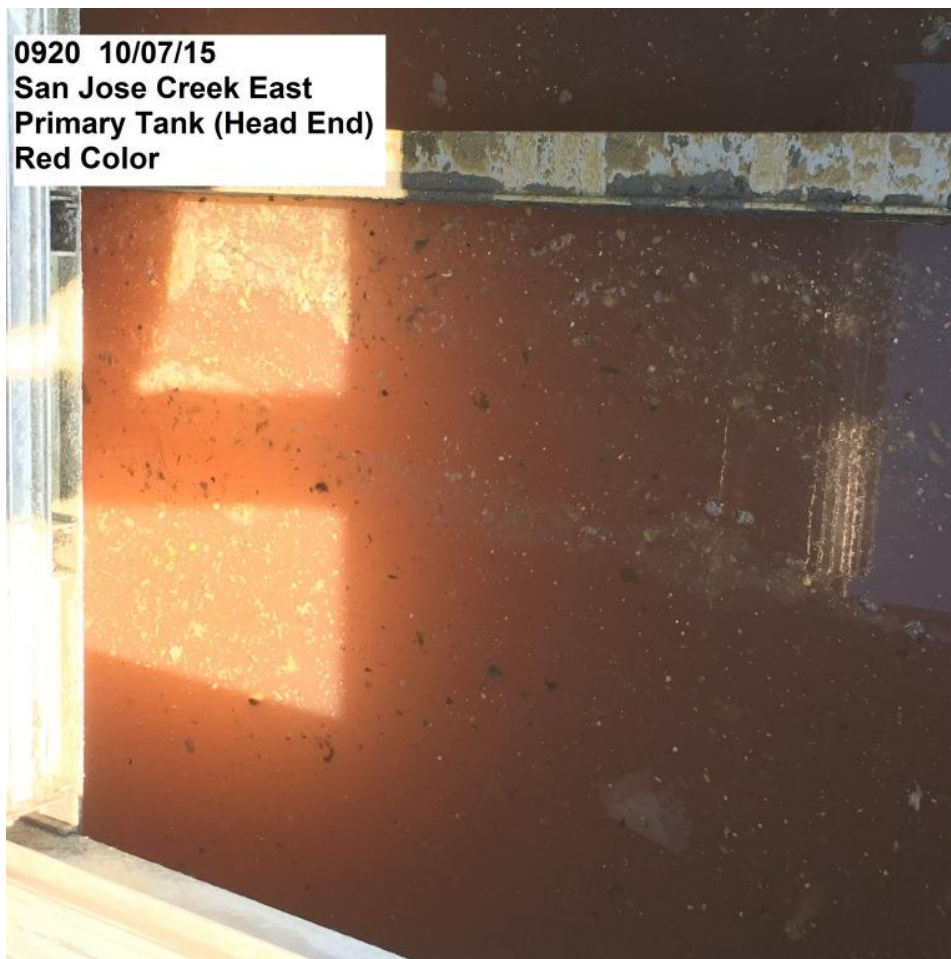
**Figure 9: Red color in San Jose Creek East WRP Primary tanks on 10-7-15.**

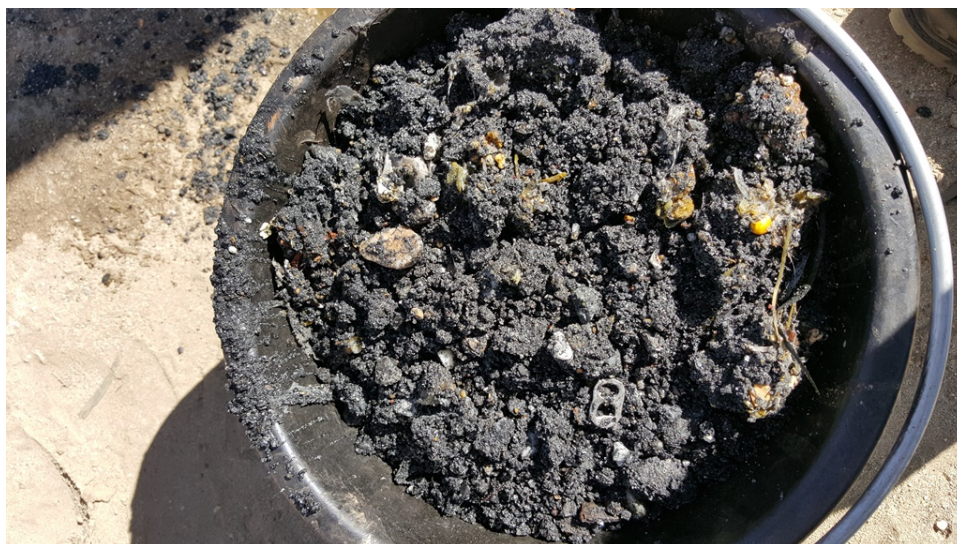
**Figure 3: Sand and grit removed from MH B0237 on 11-13-15. Note that these particular cleanings did not have much grease present.**

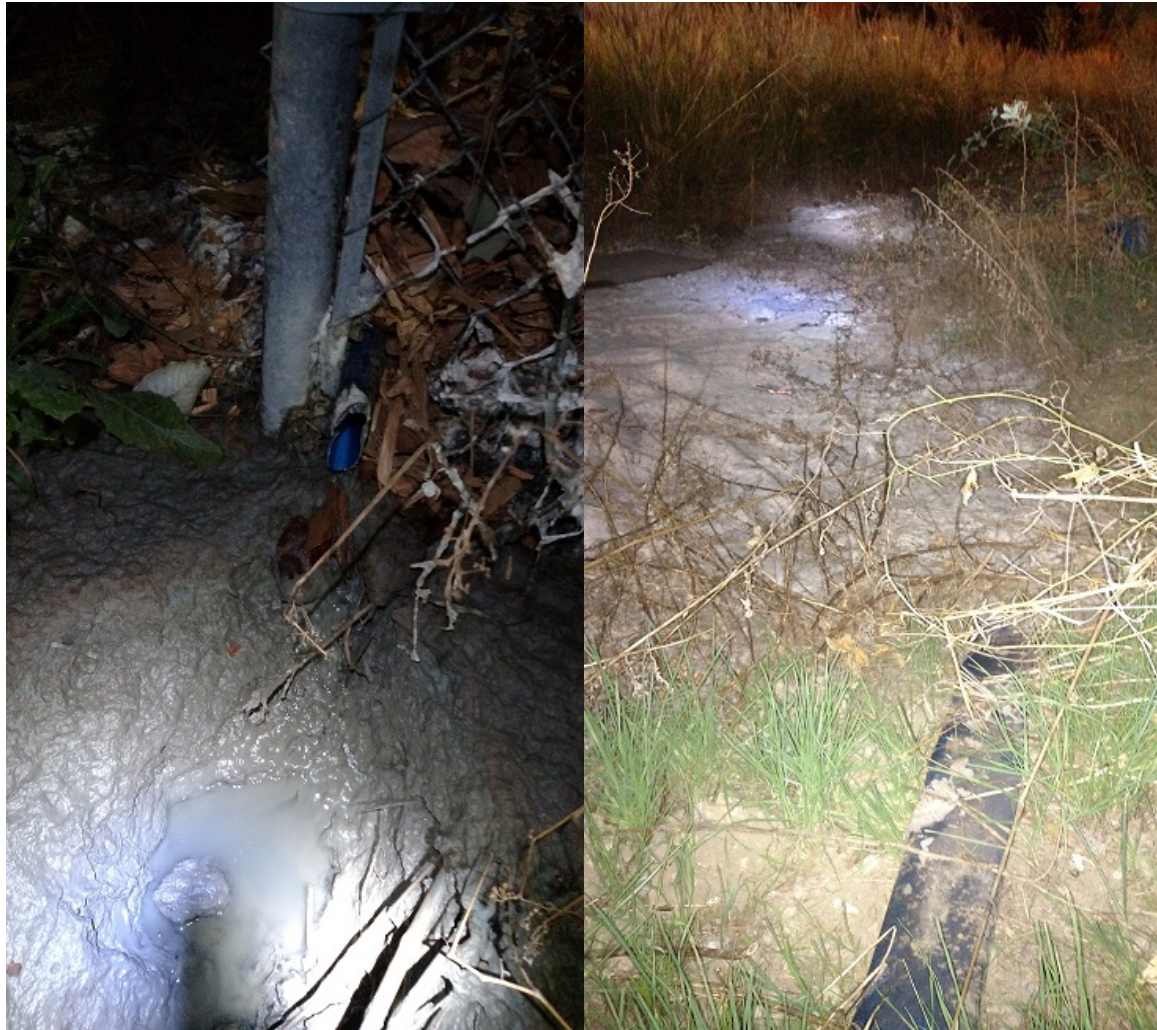
**Figures 4 and 5: Wet paper pulp waste discharged into an open area north of 2725 E. El Presidio Street in Carson, CA. Note black flex hose used to convey the waste in Figure 5.**

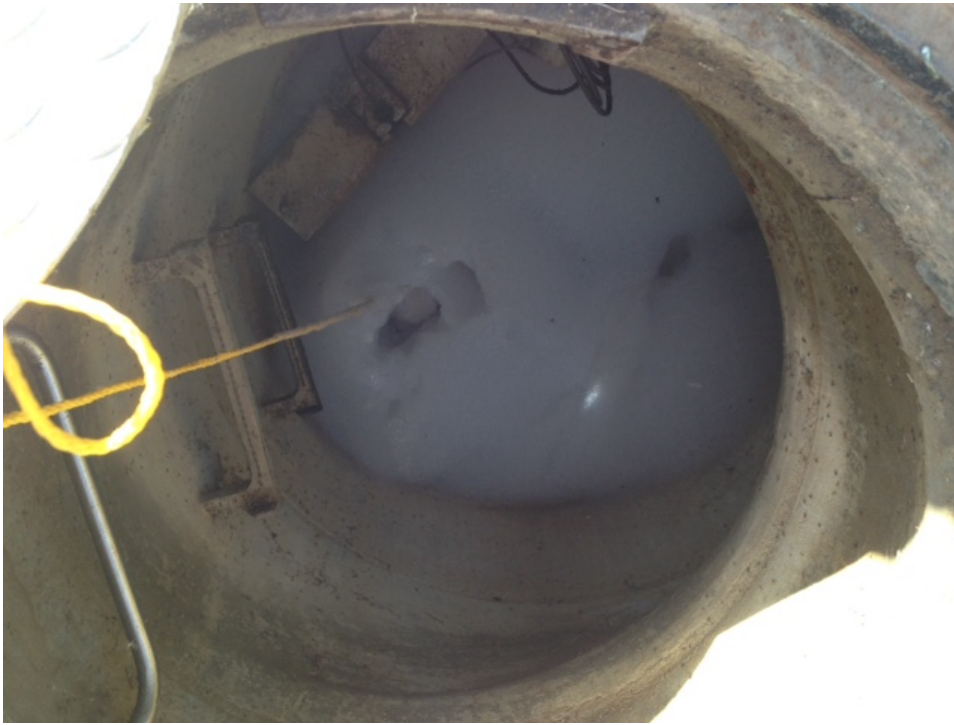
**Figure 9: Several feet of white foam noted above the industrial wastewater monitoring flume at Northrup Grumman Site 3 permit location #14934 at 1230 hours on 11-17-15.**

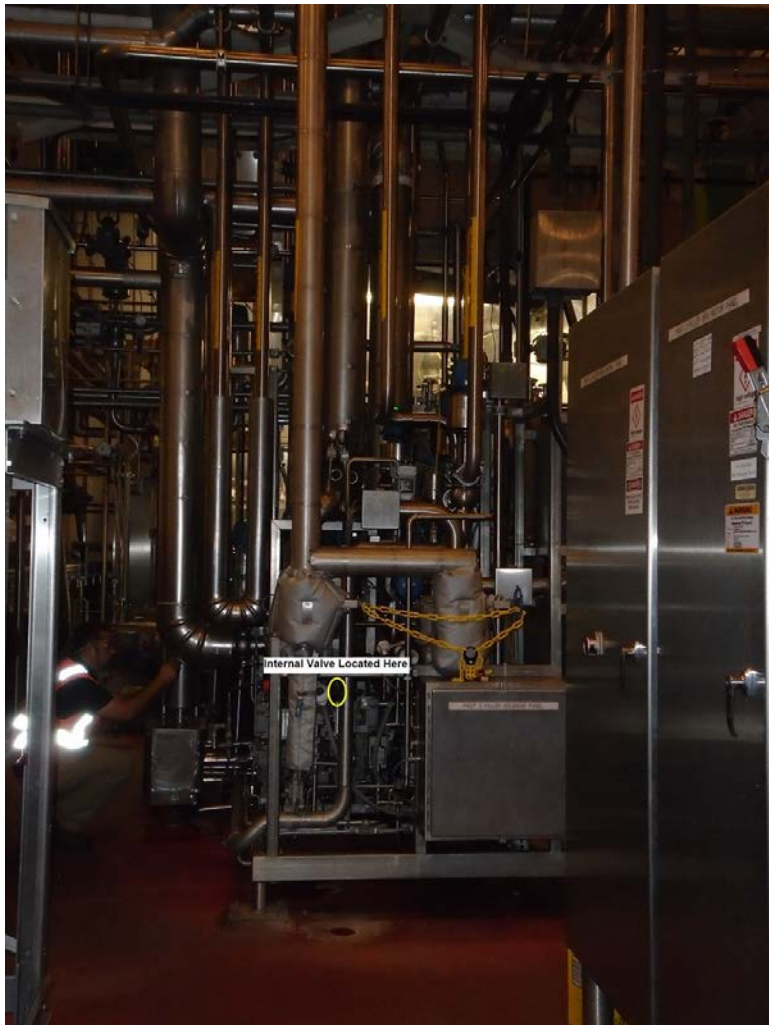
**Figure 1: Tropicana filling line #2 filler bowl manifold. Note the location of the internal valve that failed and the floor drain immediately beneath that received the leaking juice.**

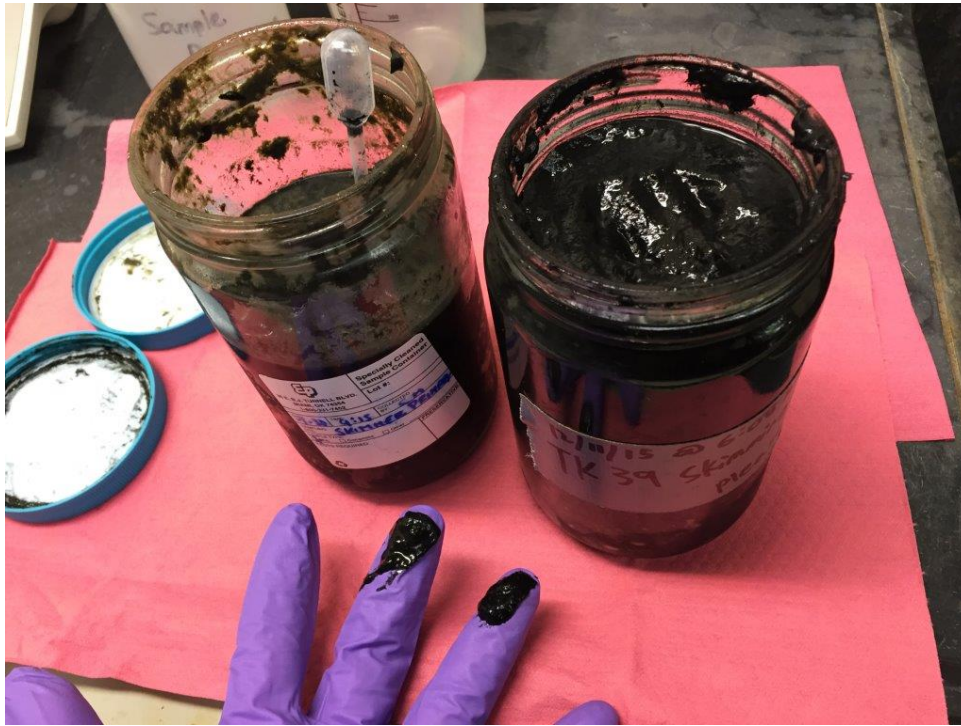
**Figure 3: Visual comparison of 7-30-15 and 12-11-15 samples of JWPCP primary skimmings solids both reported as having a black “oily” appearance. Note their similarity.**

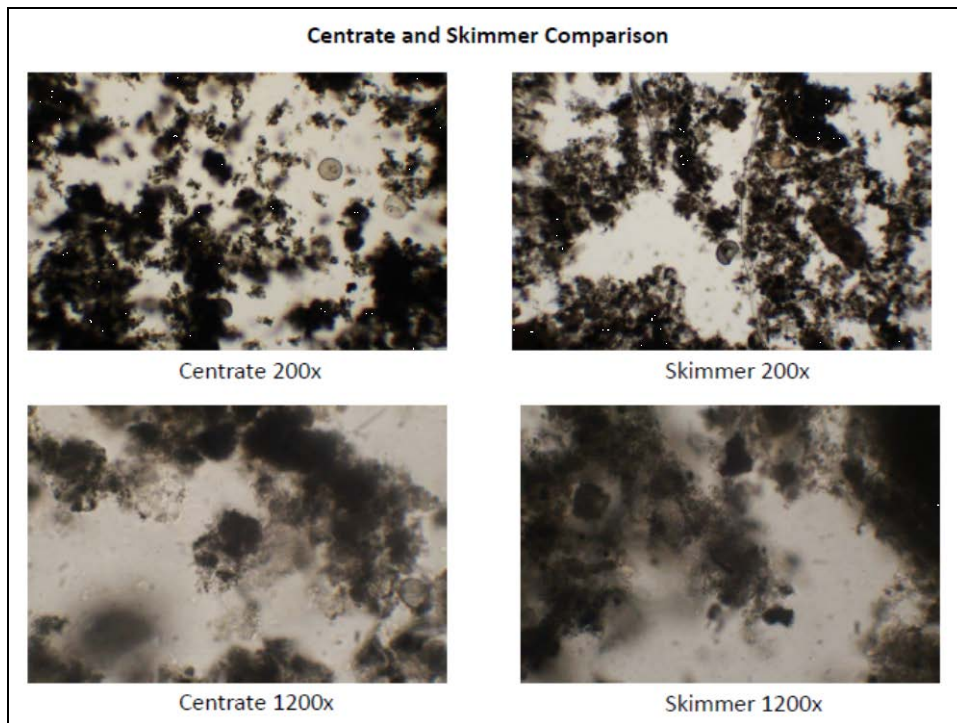
**Figure 4: Microscopic comparison of the JWPCP solids processing unit thickened centrate taken on 12-11-15 with primary skimmings with the black “oily” appearance taken that same day. Note: their essentially identical appearance.**

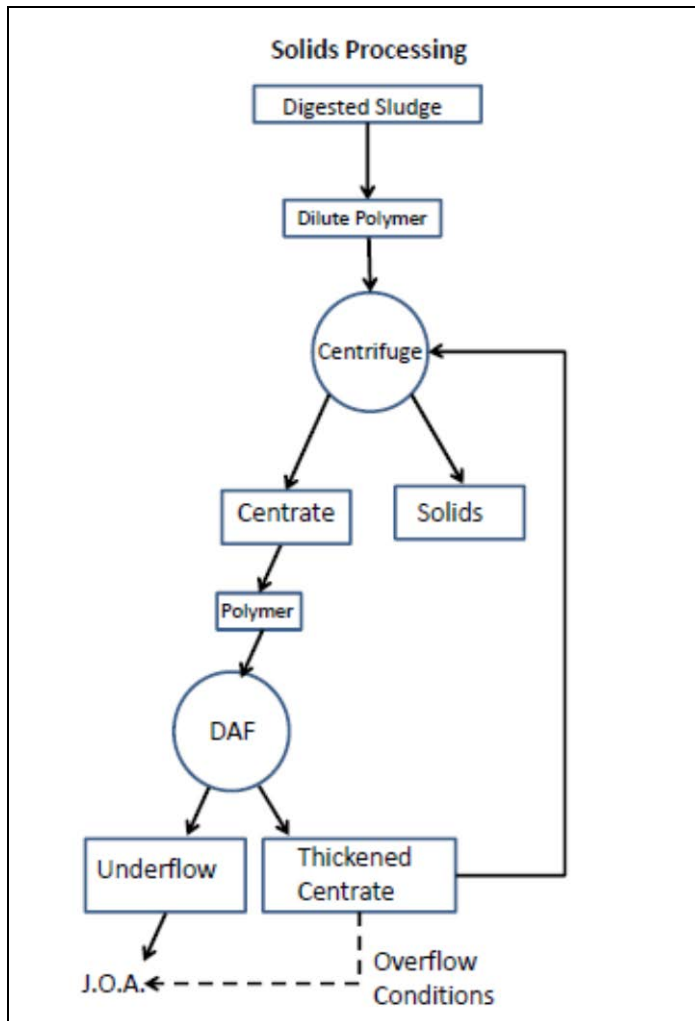
**Figure 5: Diagram showing how JWPCP Solids Processing Unit thickened centrate solids can overflow and reach the JWPCP J.O. 'A' headworks.**
