2014 ANNUAL REPORT

INDUSTRIAL WASTE PRETREATMENT PROGRAM

COUNTY SANITATION DISTRICTS OF LOS ANGELES COUNTY

APPENDIX H
INDUSTRIAL WASTE REPORTS ON INCIDENTS

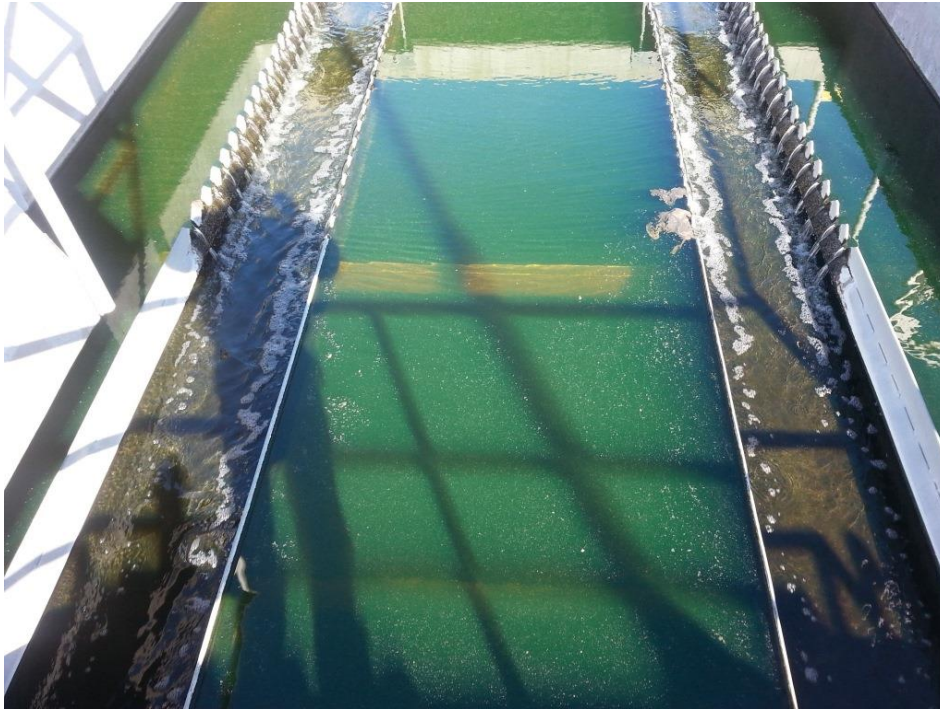
Figure 1: Fluorescent green colored water in the secondary settling tanks at the Saugus WRP on 1-17-14.

Inspections conducted by I.W. Inspectors Peter Carlstrom and James McCurdy at suspect source facilities upstream of the Saugus WRP failed to identify a source. Initially thought to be caused by a fluorescein dye, contact was made to local sewer agencies inquiring about possible pipe tracing activity, but none were reported. Lab analysis of the WRP sample failed to conclusively show the color was in fact fluorescein. No evidence was found of any possible colored discharges at the Saugus liquid waste disposal station. An internet search found a possible manufacturer of fluorescein dyes used for medical purposes located upstream of the WRP. Such a manufacturer was the source for a very similar series of green color incidents at the Whittier Narrows WRP in 2008. However a site inspection at the facility confirmed that it does not discharge any industrial waste. No reports of color at the Saugus WRP have been received since the 1-17-14 incident. The incident did not result in an NPDES violation. I.W. Inspectors will continue to be vigilant for possible sources.

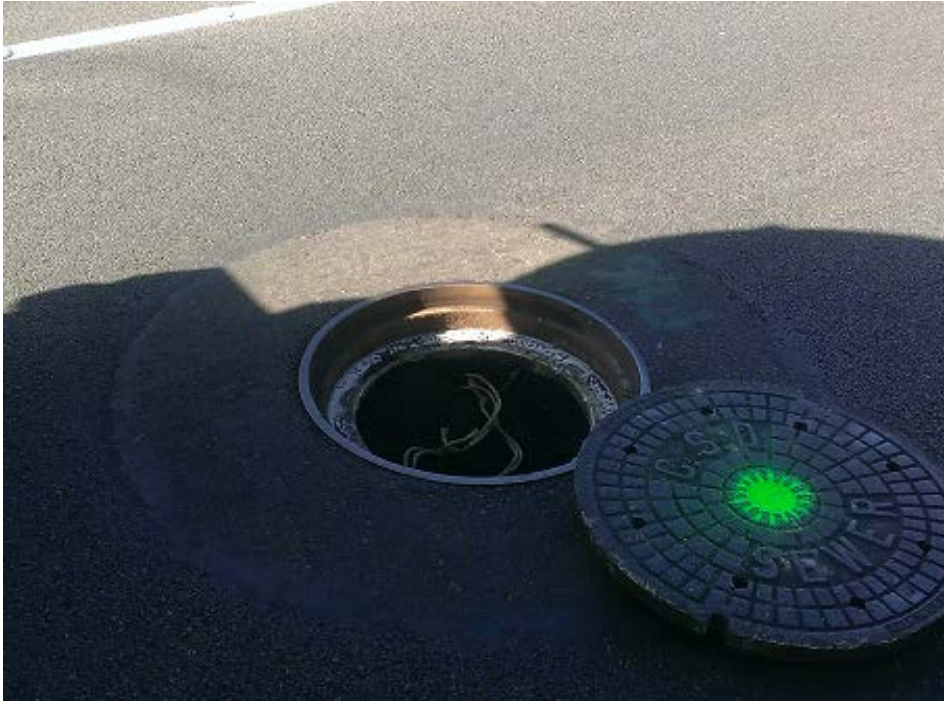
Figure 2: MH 02 F 0086 on the J.O. ‘F’-unit 4 trunk in Norwalk where the unusual smoking effect was observed.

Sanchez found that the manhole in question was the only one where sealant was applied, with the smoking effect not observed at any of the other 5 or 6 manholes the crew had worked on that day. After requesting that the crew replicate their actions, Sanchez observed that the manhole’s chimney was quite moist all the way from the top to the bottom and that as air wafted over the rim, small amounts of water vapor could be seen condensing around the manhole’s ring. When applied, the caulking material appeared to generate its own “vapor,” but this effect could be attributed entirely to the water vapor condensing around the rim. No unusual odors were present and no discoloration of the sewage was evident. Measurements for explosivity indicated only background levels. After reviewing the field findings, it was determined that the “smoke” was water vapor escaping the manhole’s chimney and condensing at the rim. This became more evident as the fresh granular activated carbon (GAC) was placed into the basket canister at which time the “smoke” ceased totally. There is no evidence that the unusual water vapor visual effect was associated with any industrial sources or that it had any deleterious effects.

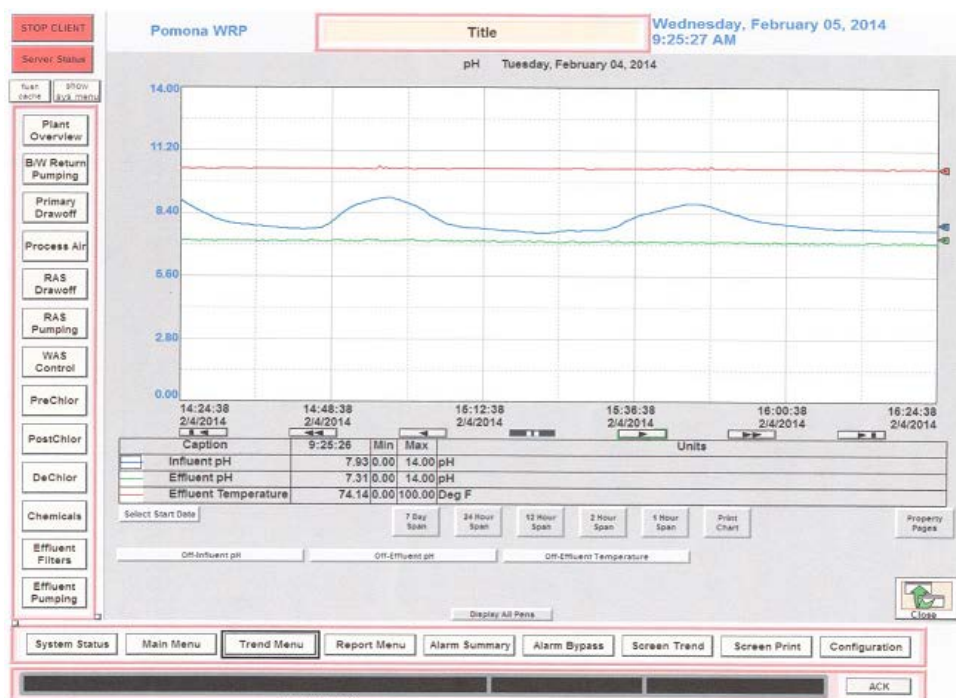
Figure 1: Influent pH screen grab chart from the Pomona WRP on 2-4-14. The blue line indicates the two high pH periods.

Inspection of possible industrial facilities, as well as investigating sewer maintenance activity upstream of the Pomona WRP, failed to identify an incident source. Initial indications including the timing, recording chart patterns, and visual characteristics of the wastewater led I.W. investigators to believe that the elevated pH was caused by upstream sewer crown spray work. Investigators confirmed that the crown spray contractor was indeed performing work on sewers in the Pomona area on the day of the event, but the work was done on a sewer (the Chino Basin Wastewater Line) that bypasses the Pomona WRP. A cross connection located near the treatment plant that could possibly allow wastewater from the Chino Basin Line to infiltrate the Pomona WRP was identified, but the connection design does not allow any infiltration. To

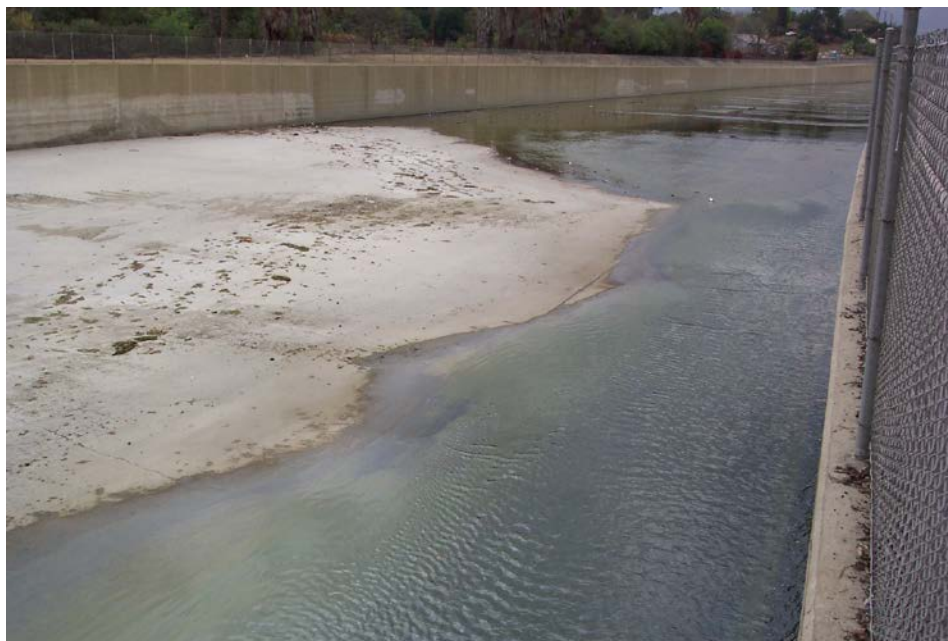
Figure 3: 2-6-14 oily sheen on San Jose Creek at location noted on Figure 2.

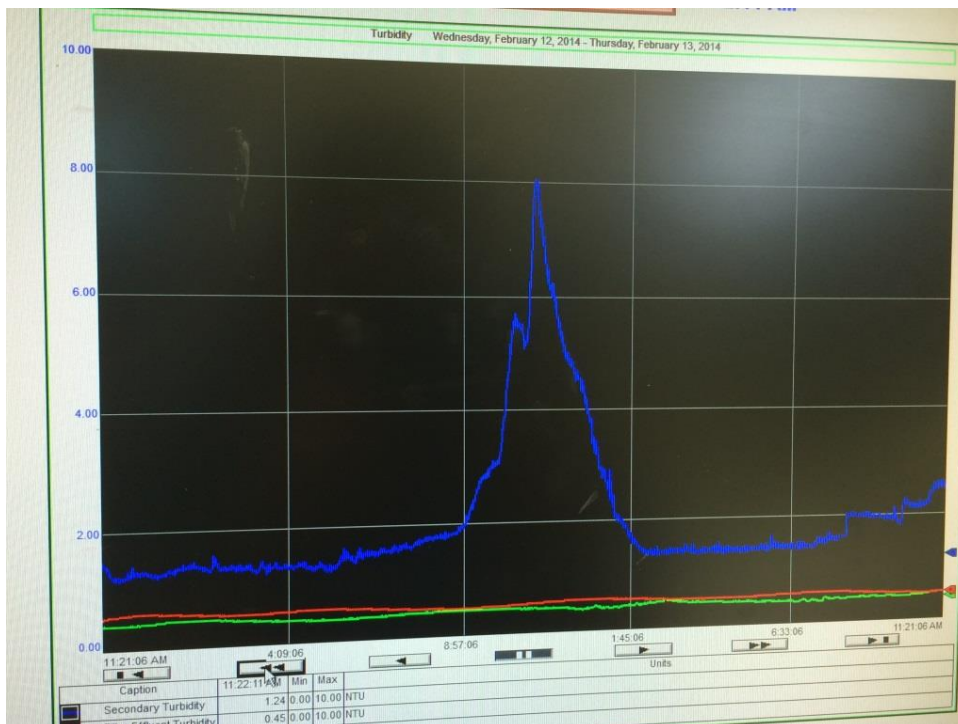
Figure 4: Screen grab photo of the Lancaster WRP control room computer showing the high secondary turbidity spike on 2-12-14. This spike is typical of the spikes being noted.

Investigation by area I.W. Inspector James McCurdy found no source(s) for the incident. Inspections at the two most likely potential sources, the Lancaster State Prison and the Lancaster liquid waste disposal station (LWDS) found no evidence of any discharges which could be

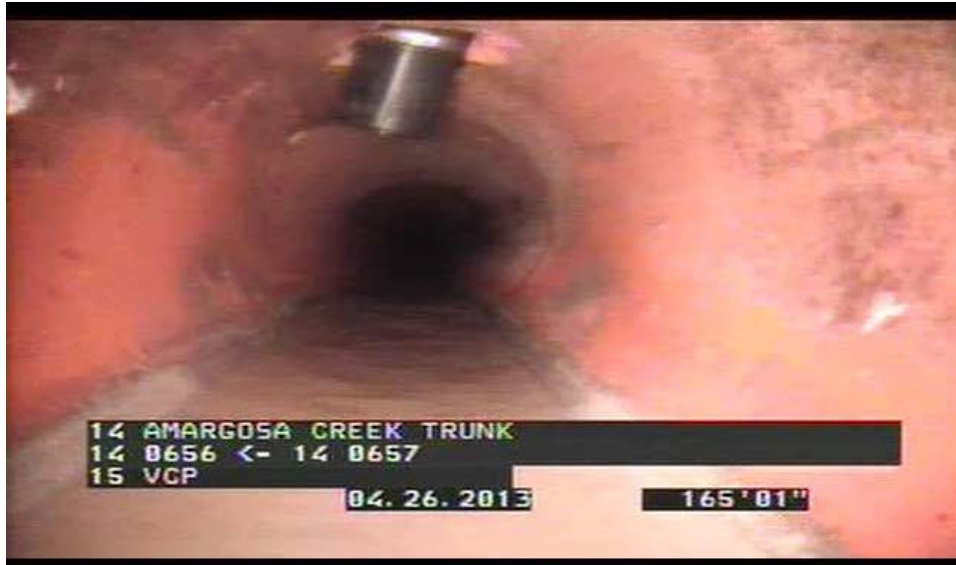
Figure 5: 4-26-13 CCTV screen grab showing the illegal 4" line connection on the 15" Amargosa Creek trunk sewer in Lancaster.

Investigation by area I.W. Inspector James McCurdy determined the connection was indeed made illegally and had been made to accommodate the discharge of sanitary wastewater from a bathroom located inside a modular office trailer at the site of Bunge's Storage at 510 West Ave L in Lancaster. It is planned to issue a notice of violation to the owner of the storage yard on 3-4-14 for violating Section 302 of the Sanitation Districts' *Wastewater Ordinance*, which prohibits making a direct connection of a sewer line 6" or smaller to a Sanitation Districts' trunk without first obtaining a permit from the Sanitation Districts. Following issuance of the notice of violation, the owner will be required to correct the situation as appropriate. This will likely include removal of the illegal connection, repair to the trunk line, and his payment for the costs incurred by the Sanitation Districts in completing this work. The Sanitation Districts may also levy a fine for the violation.

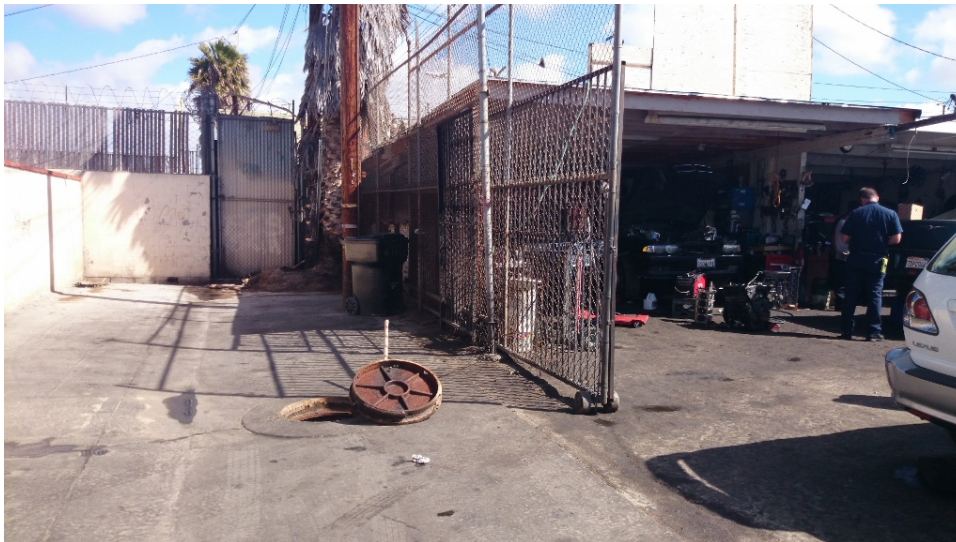
on-site. However, the inspection did not find any direct evidence that used oil or other waste materials were being dumped into a nearby sewer manhole. It was noted that some used oil was dumped onto the root structure of a nearby palm tree. Fire Department and Inglewood code enforcement officers wrote both companies multiple citations for violations noted. City code enforcement officers will follow-up on these violations.

Figure 1: Photo taken on 4-1-14 showing local line sewer manhole located in the alley behind 10101 Hawthorne Blvd in Inglewood. Note the palm tree directly behind the manhole where some waste used oil was noted that had appeared to have been dumped onto the tree roots.

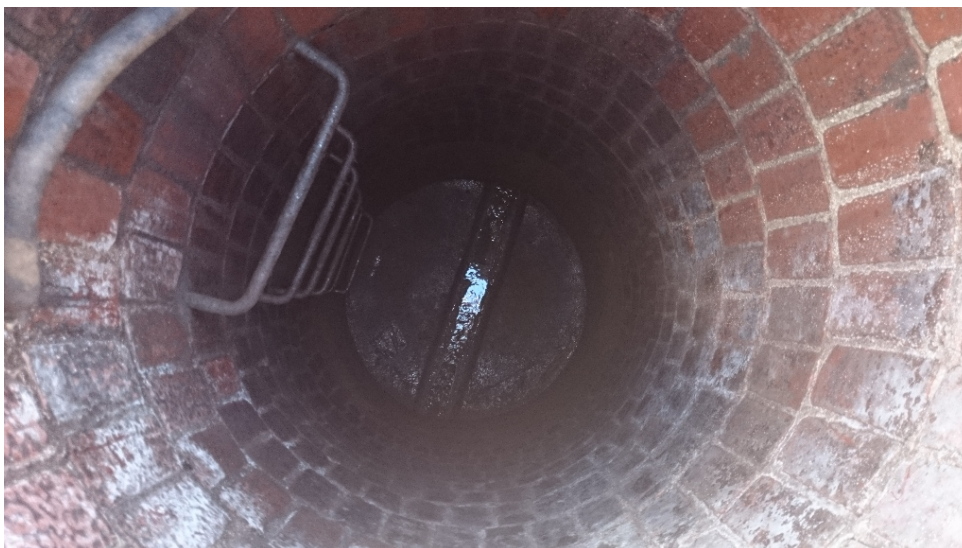
Figure 2: View into local sewer line manhole shown in Figure 1. Note the lack of oil or oily residue that would be expected if the manhole were being regularly used to dispose of waste oil.

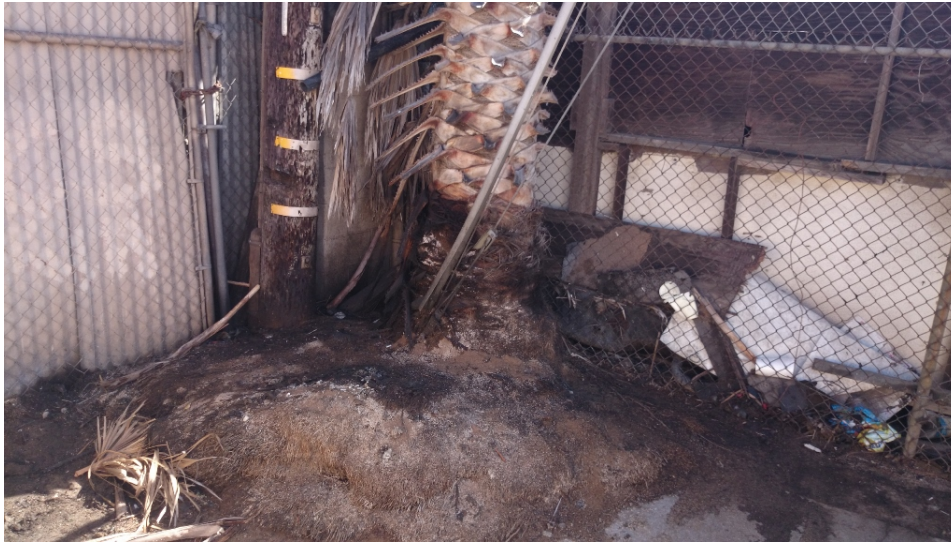
Figure 3: Oily residual from suspected illicit disposal of used oil on palm tree roots.

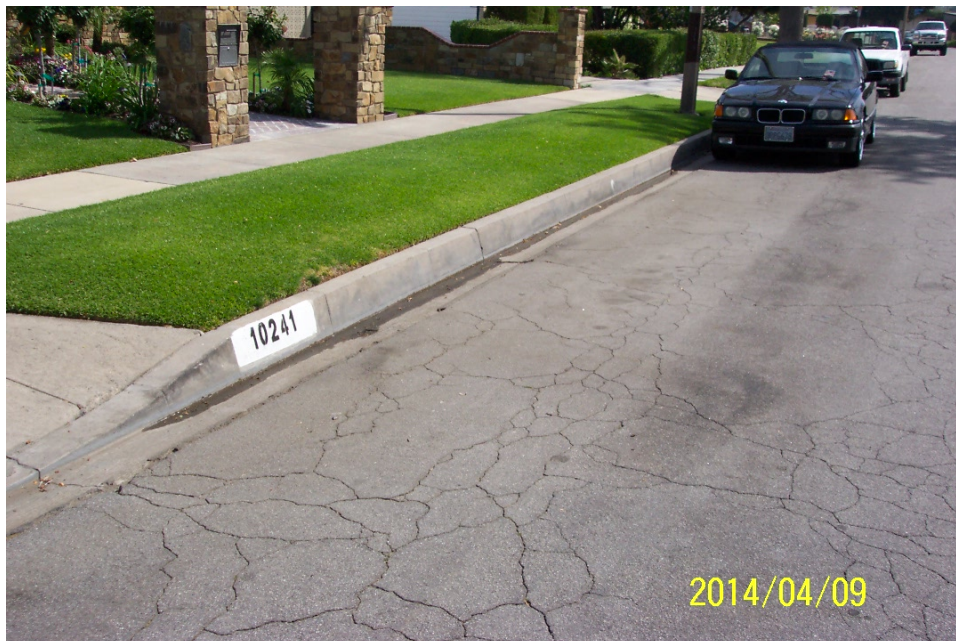
Senior I.W. Inspector Juan Sanchez went to the location reported on 4-9-14. He observed no evidence of the illicit storm drain dumping activities alleged. There was no visible staining, oil residue, odors or any other indication of the reported "chemical laden waste" being dumped (see photograph below). Sanchez deferred to local code enforcement for further inspection activities inside the yard or within the residence.

Figure 1: 4-9-14 photo of the street gutter in front of the residence located at 10241 Parkinson Ave in the City of Whittier where illicit dumping activities into the storm drain were alleged. Note the lack of any evidence for such activities.

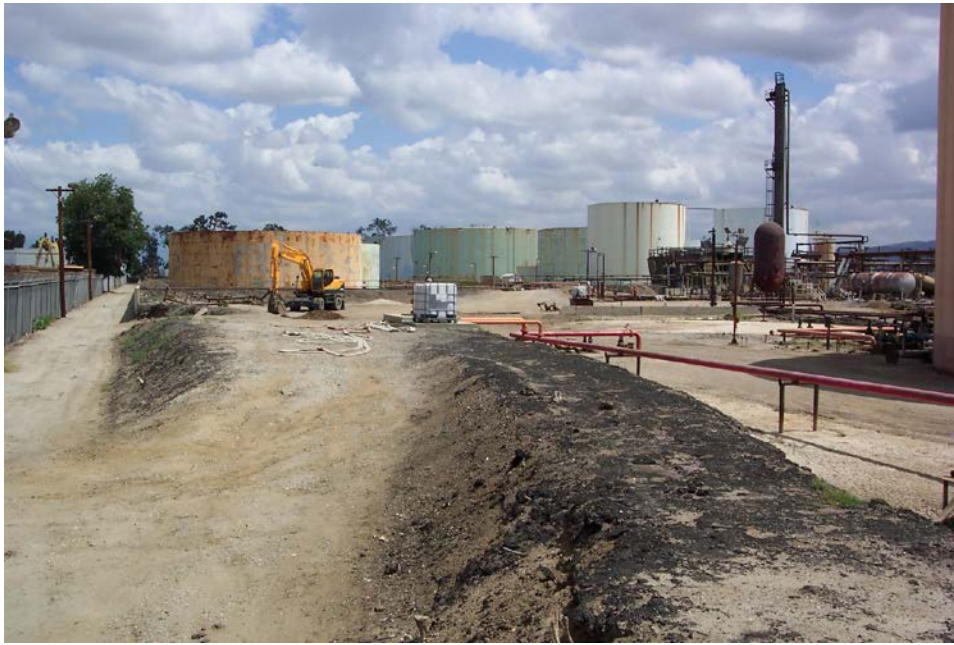
Figure 3: Large, old refinery tanks at the Ridgeline facility which are in the process of being emptied and demolished.

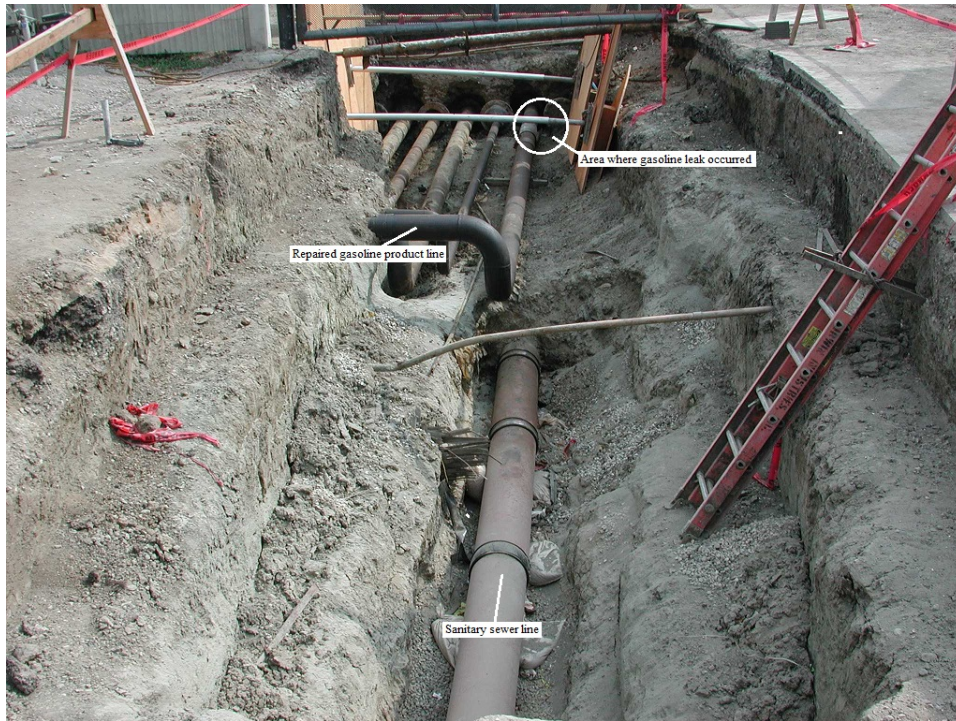
Figure 3: 2002 photo of the excavation where a gasoline product line leak was repaired to prevent gasoline seeping into an adjacent domestic sewer line causing significant periods of elevated explosivity in both the ExxonMobil sewer line and the downstream J.O.' D' trunk sewer.

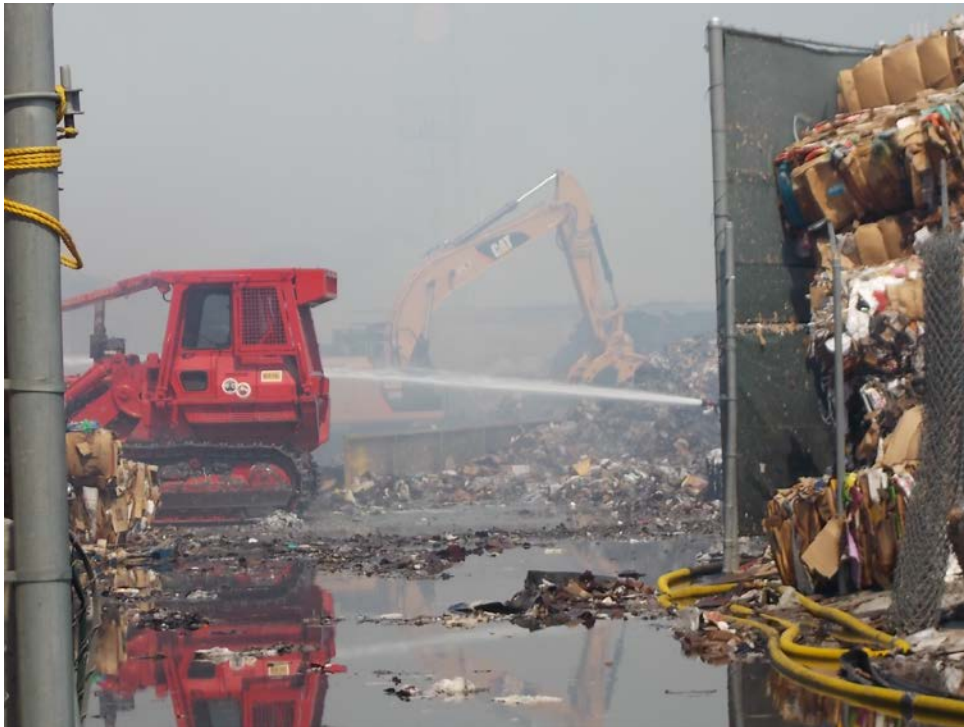
Figure 5: Fire Department heavy equipment working on 5-30-14 to expose and extinguish burning materials in tightly packed waste paper bales at the Pan Pacific Fiber facility. Note the large amount of firewater runoff being generated by this effort.

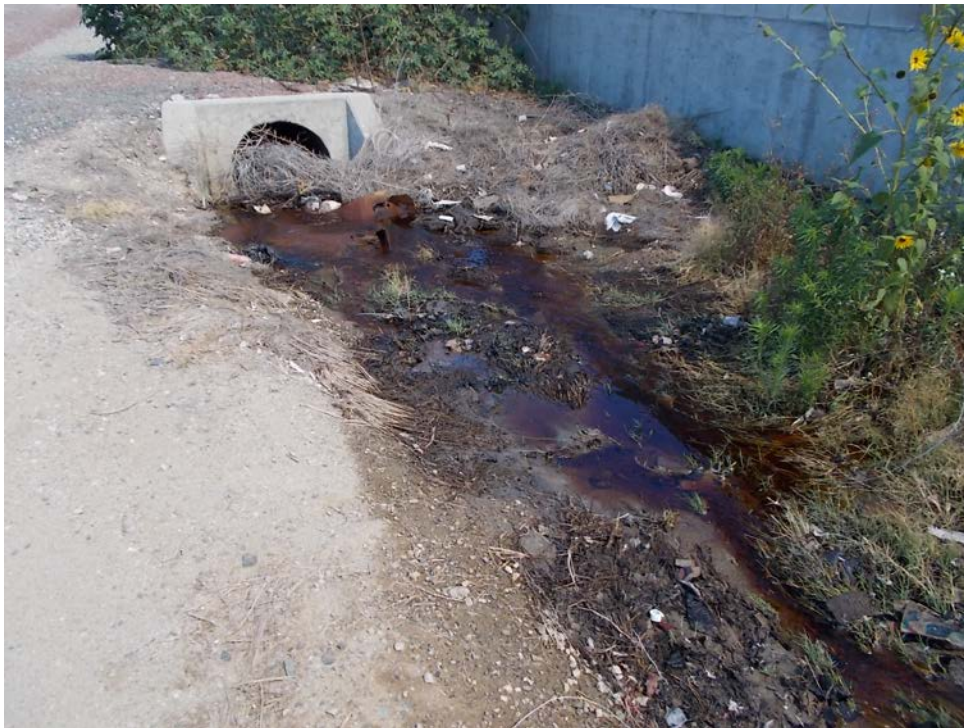
Figure 6: Storm water runoff channel downstream from the Pan Pacific Fiber facility on 5-30-14. Note the red brown color water due to the fire at the facility.

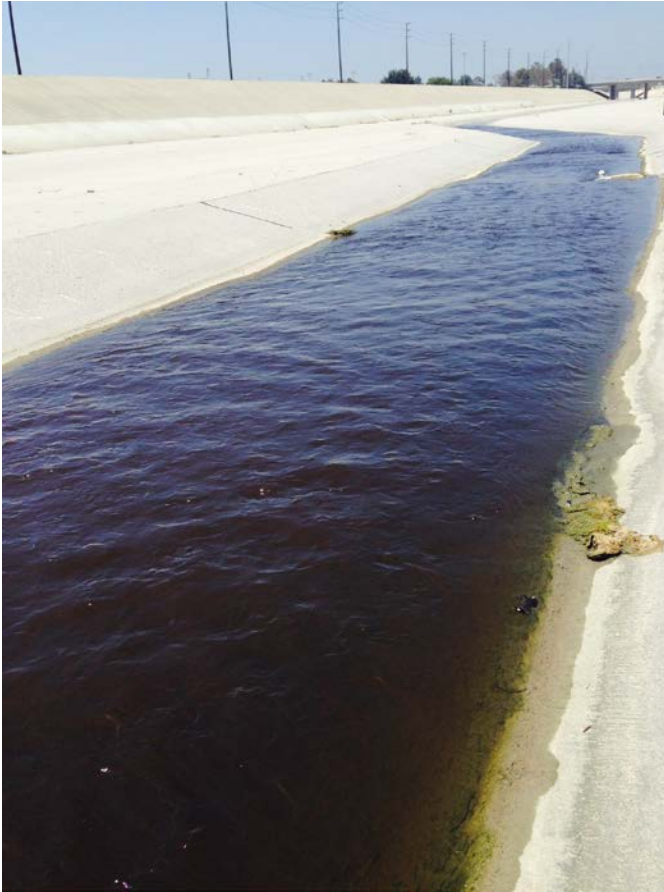
Figure 7: 5-30-14 photo of Coyote Creek looking south about a 0.8 mile upstream of the Long Beach WRP's outfall into the creek. Note the dark color of the water in the creek.

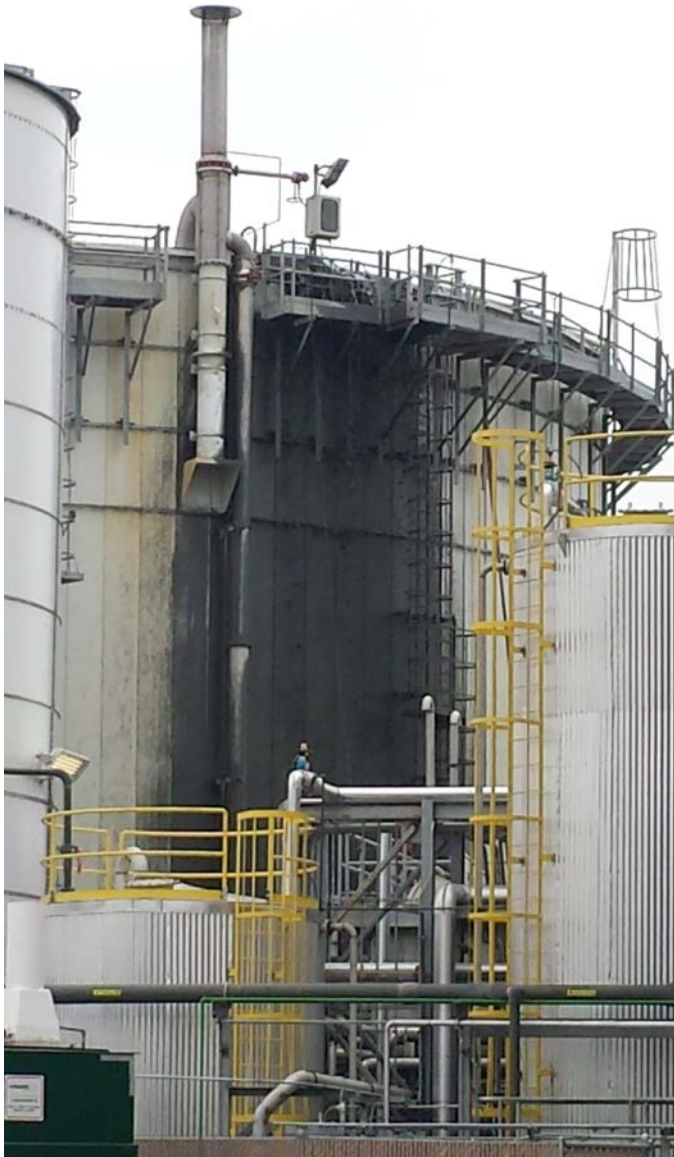
Figure 1: 2 MGD digester tank at the Ralphs' facility in Compton. Note dark staining on the side of the tank where foam from the tank has overflowed.

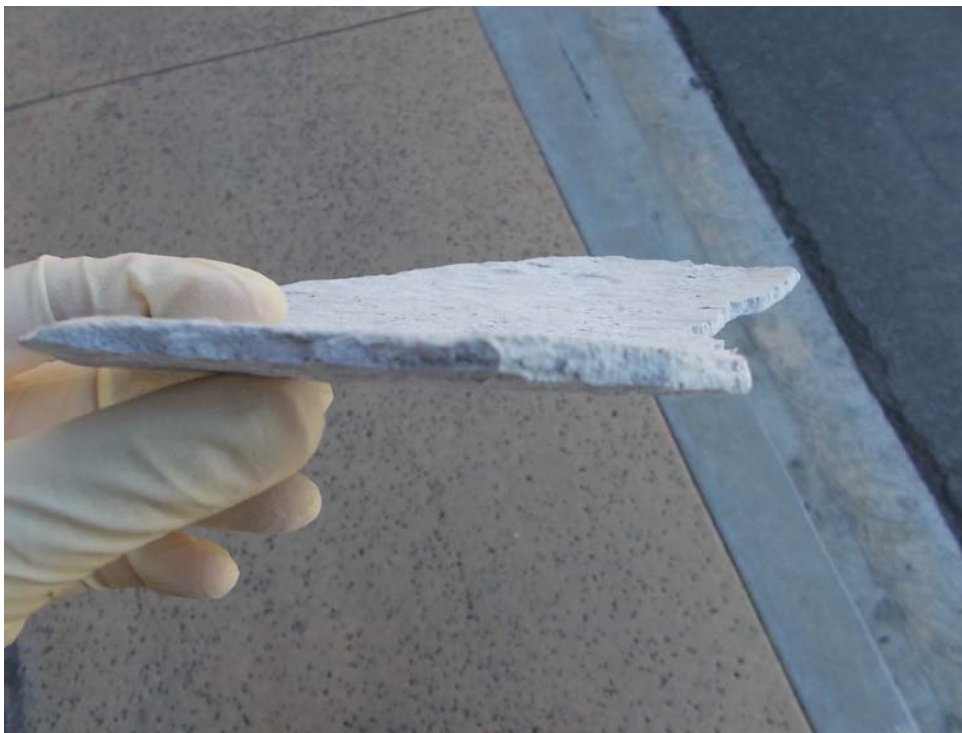
Figure 4: Sample of the scale like material found at MH 29 in the Puente Trunk on 7-21-14.

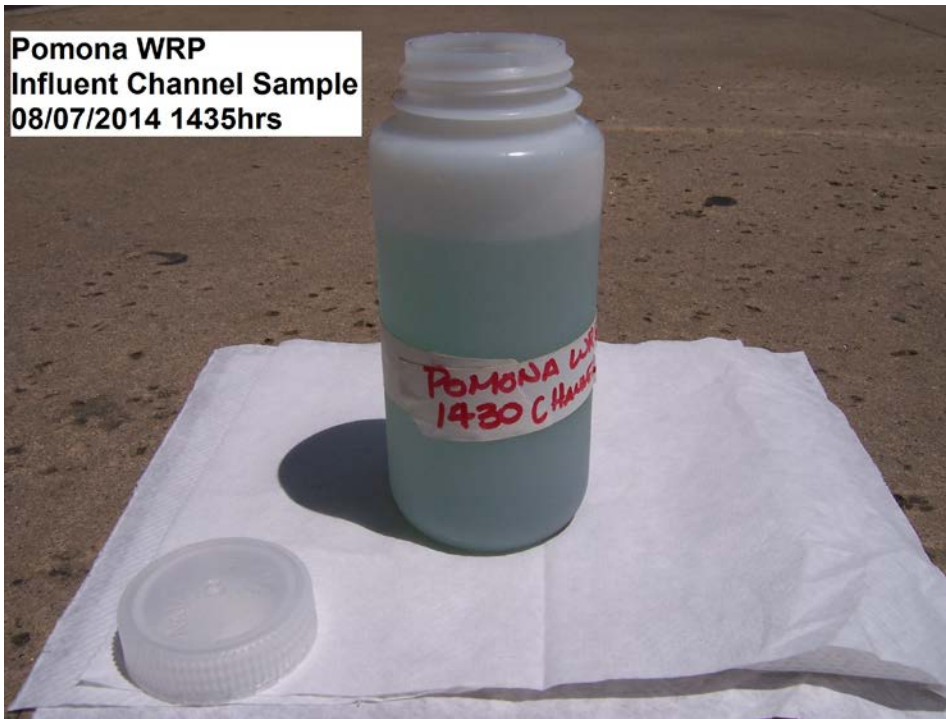
Figure 1: Pomona WRP raw influent sample taken at 1430 hours on 8-7-14. Note the light blue color of the sample.

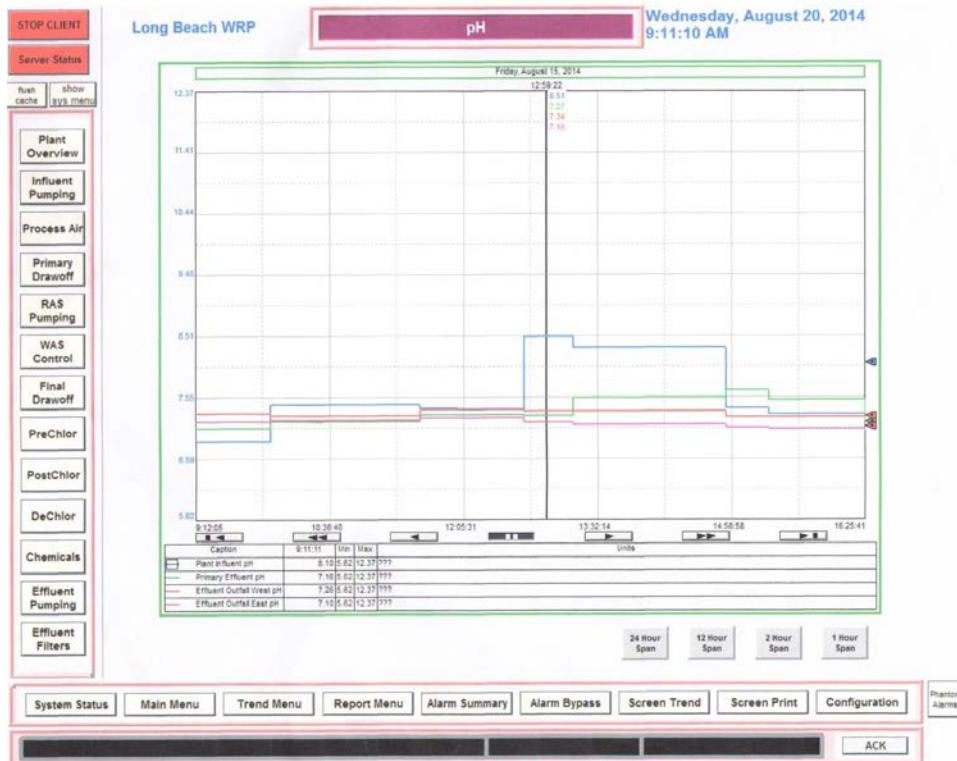
Figure 3: Control screen grab from the Long Beach WRP showing the influent pH trend (blue line) on 8-15-14. Note the elevated pH began about 1230 hours, lasted about 2.5 hours and peaked at 8.5.

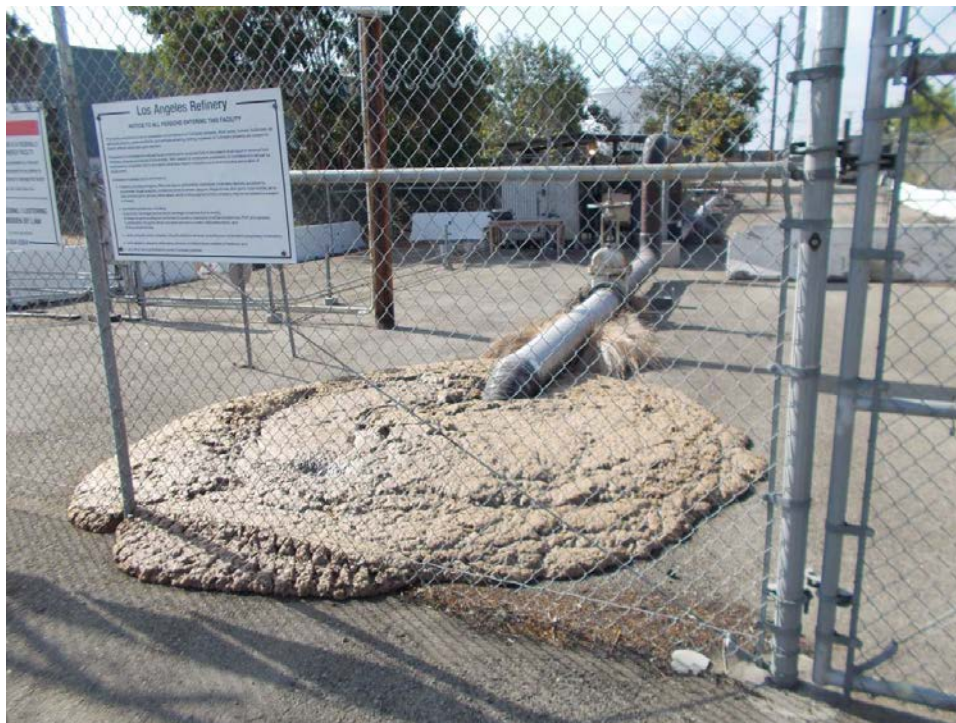
Figure 1: Thick brown foam overflowing the industrial wastewater discharge manhole at the Phillips 66 oil refinery at 0930 hours on 9-3-14.

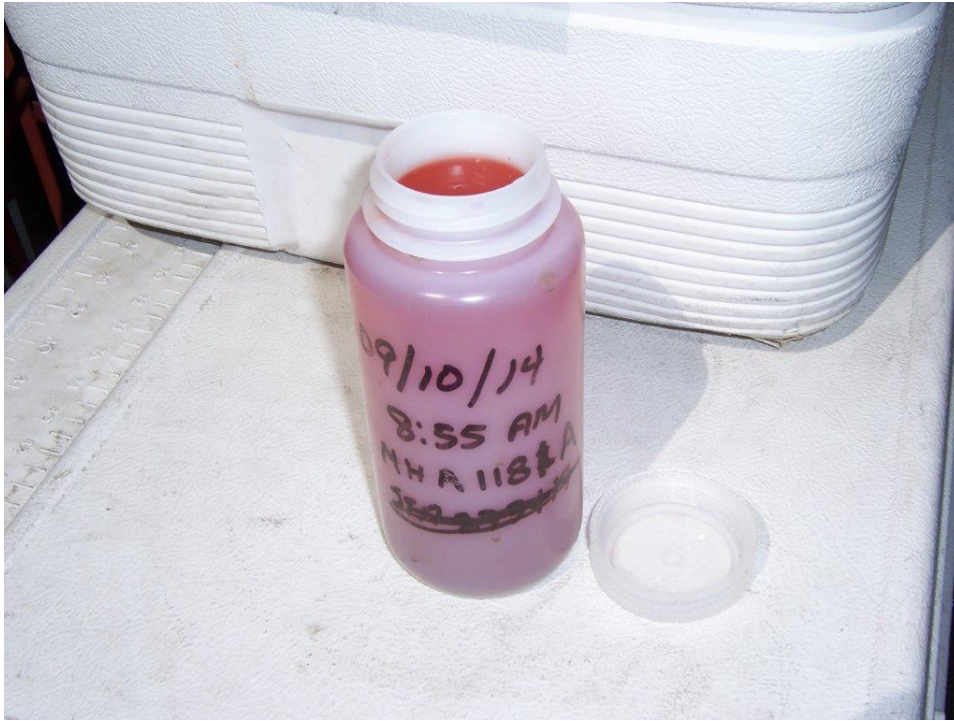
Figure 3: Sample of red-colored wastewater taken at Manhole 02 A 1181 at 0855 hours on 9-10-14.

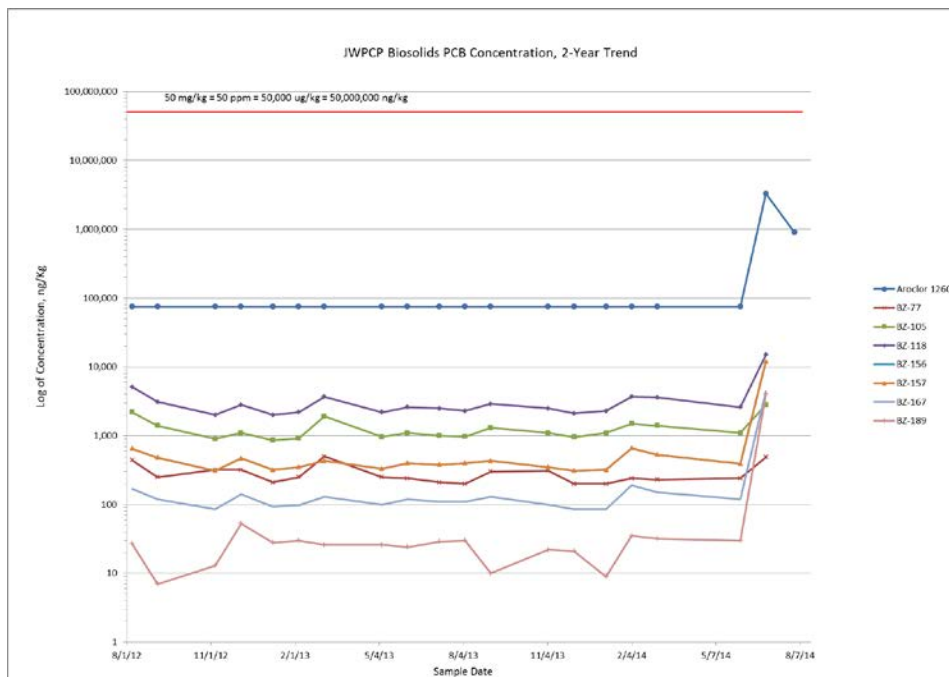
Figure 4: PCB sample data for JWPCP biosolids 8/2012-8/2014. The August 2014 result is preliminary. Note that non-detect results are represented as half the detection limit. Note also that the data is plotted here logarithmically and the limit of 50 ppm is represented by the top red plot line.

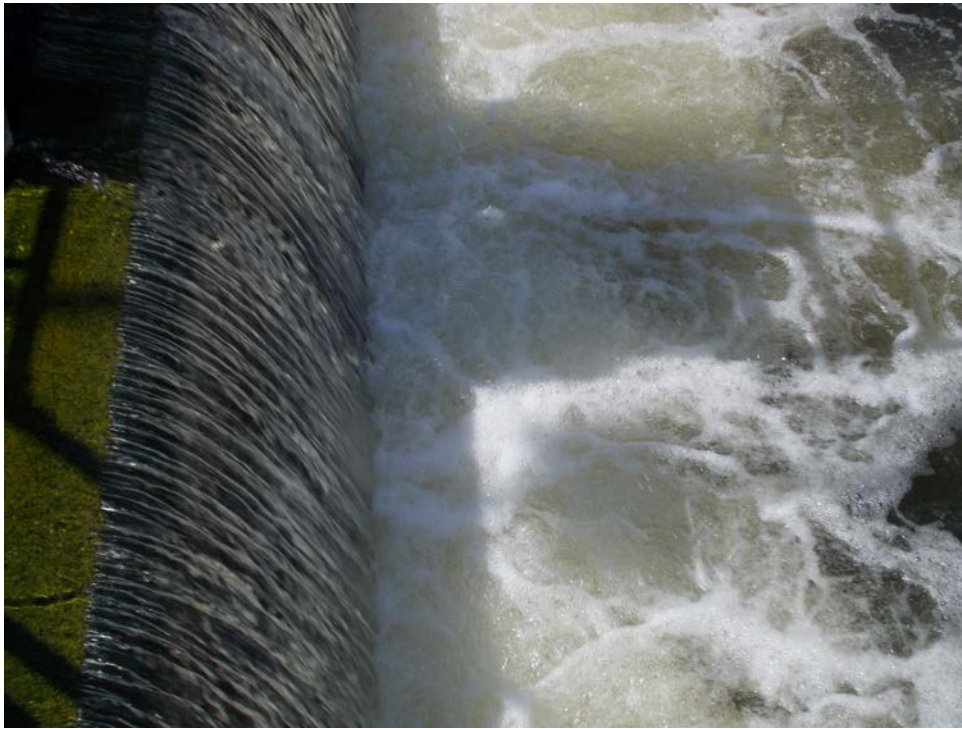
Figure 4: LCWRP outfall photo taken at 1230 hours on 10-9-14. No color present.

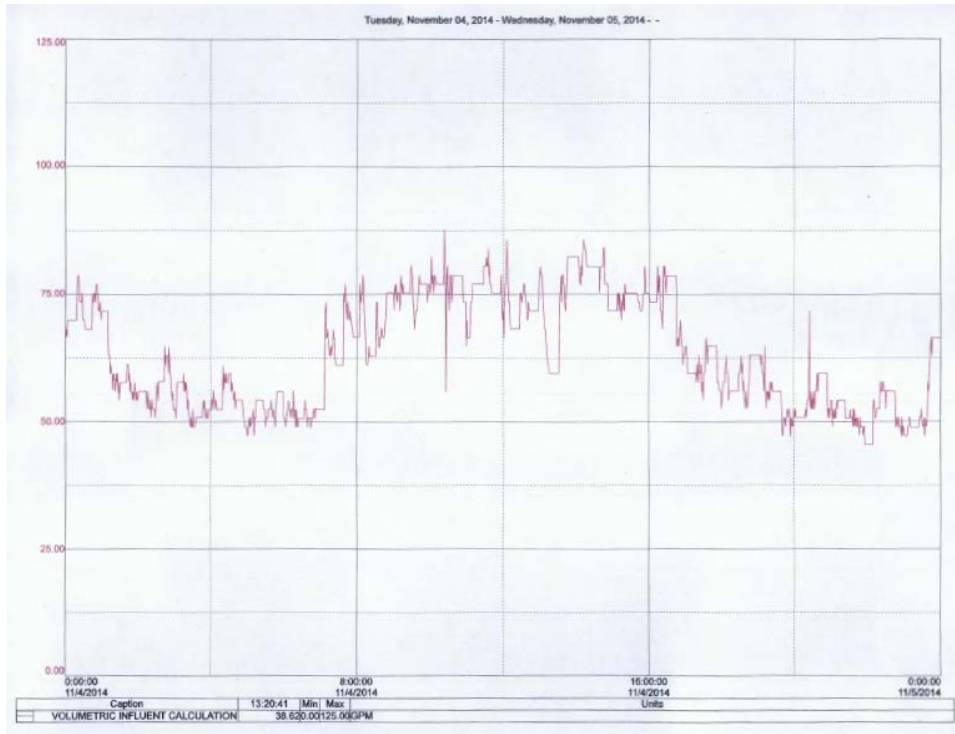
Figure 1: Pomona PP#4 flow chart for Tuesday, 11-4-14. Note that the flow is ranging from 50-75 gpm during the 24-hour period.

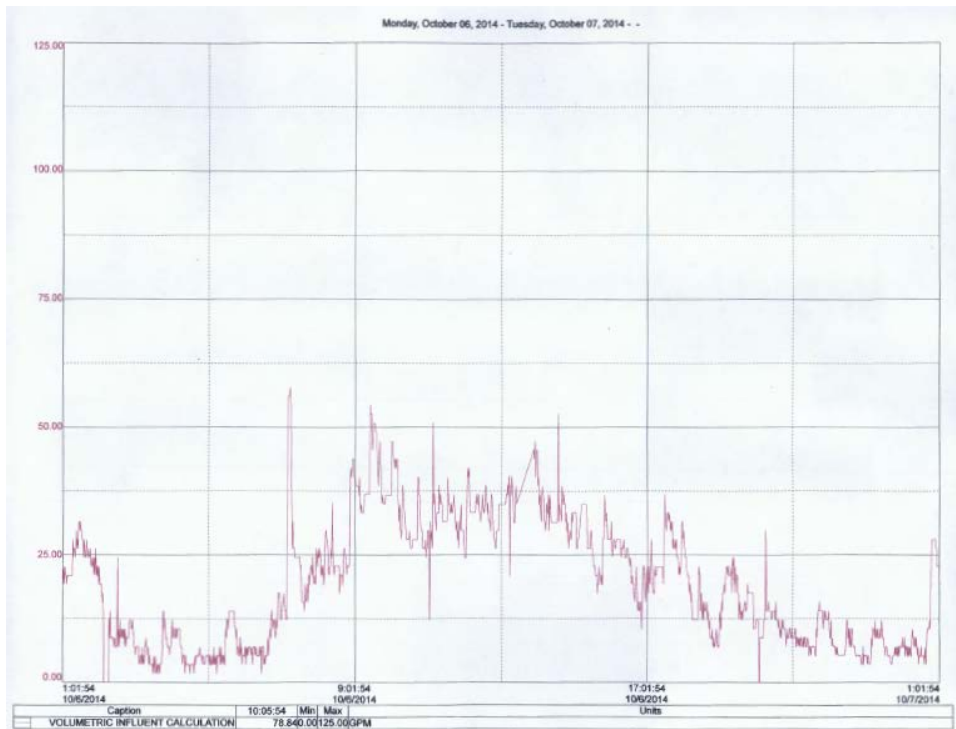
Figure 2: Pomona PP No.4 flow chart for Monday, 10-6-14. Note that the flow is ranging from just above zero to 40 gpm during the 24-hour period.

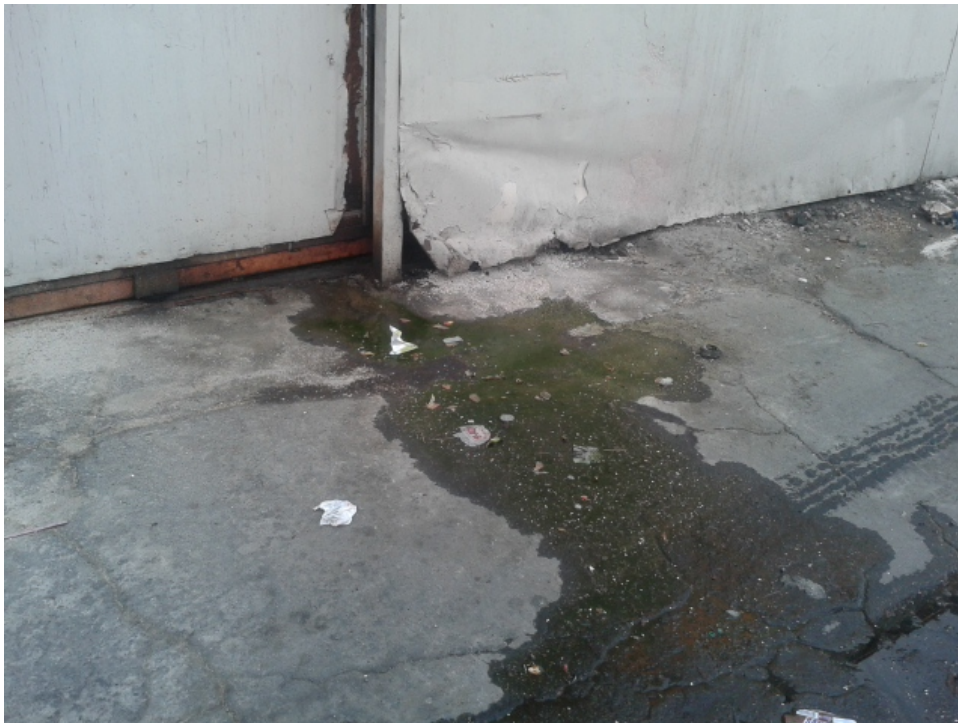
Figure 1: Tipster photo email attachment claiming to be of antifreeze solution being discharged into an alley at Manny's General Auto Repair in Compton on 11-17-14.

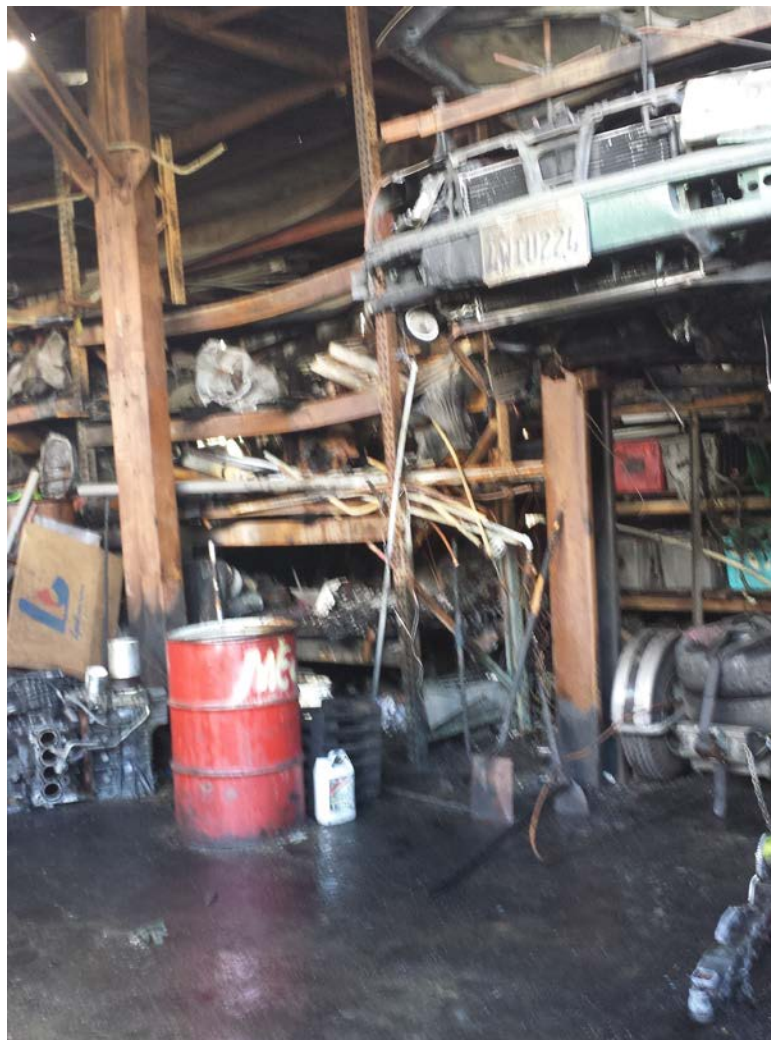
Figure 2: Photo taken on 12-4-14 showing interior of Manny's General Auto Repair shop. Note apparent fire damage.

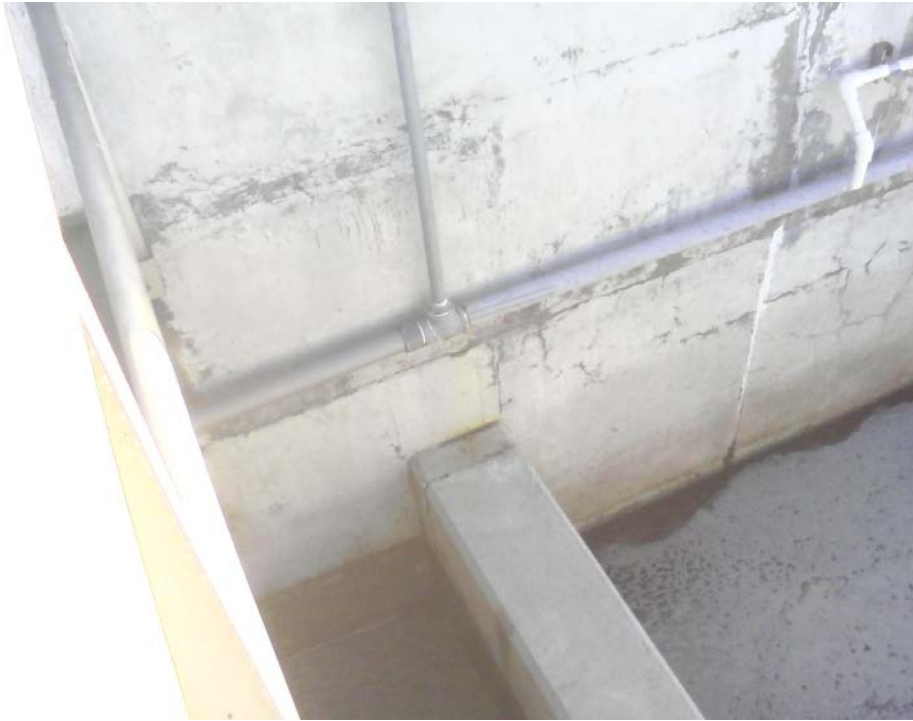
Figure 3: 12-4-14 photo of pink colored staining on a filter tank wall at Whittier Narrows WRP.

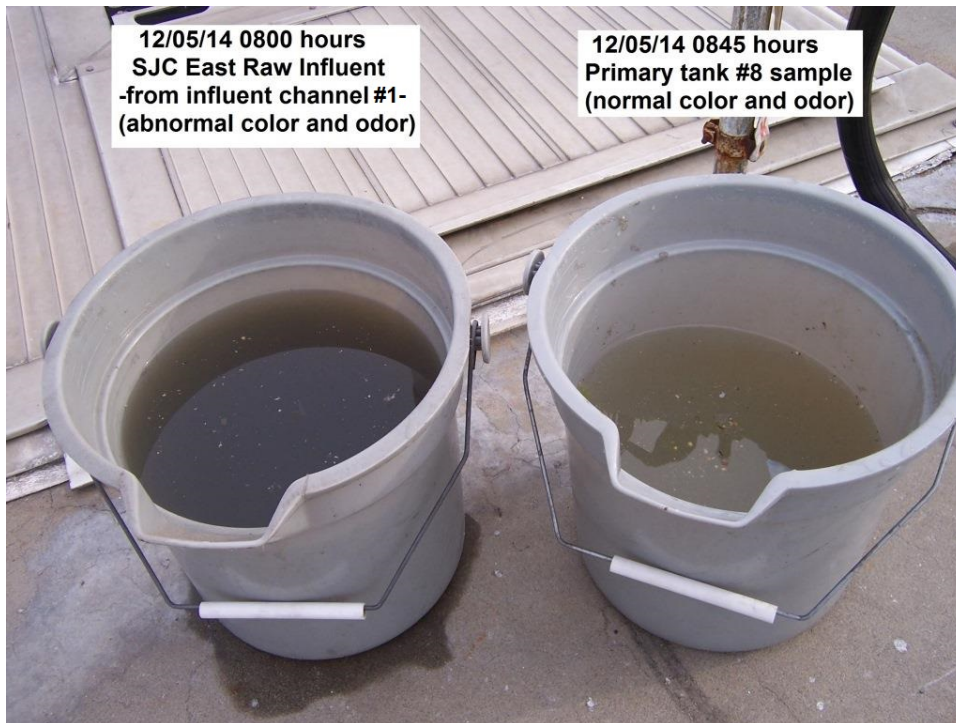
Figure 5: Photo of samples taken at SJC-East WRP on 12-5-14 to compare the unusual dark colored raw influent to normal colored sewage.

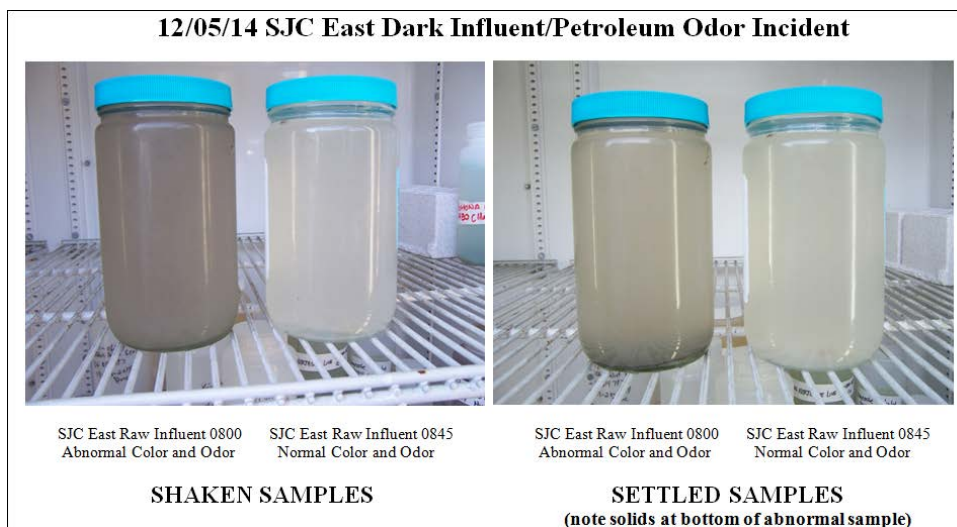
Figure 7: Photos of WRP raw influent samples taken on 12-5-14 to compare the unusual dark colored sample to normal raw influent.
