2014 ANNUAL REPORT

INDUSTRIAL WASTE PRETREATMENT PROGRAM

COUNTY SANITATION DISTRICTS OF LOS ANGELES COUNTY

APPENDIX H
INDUSTRIAL WASTE REPORTS ON INCIDENTS

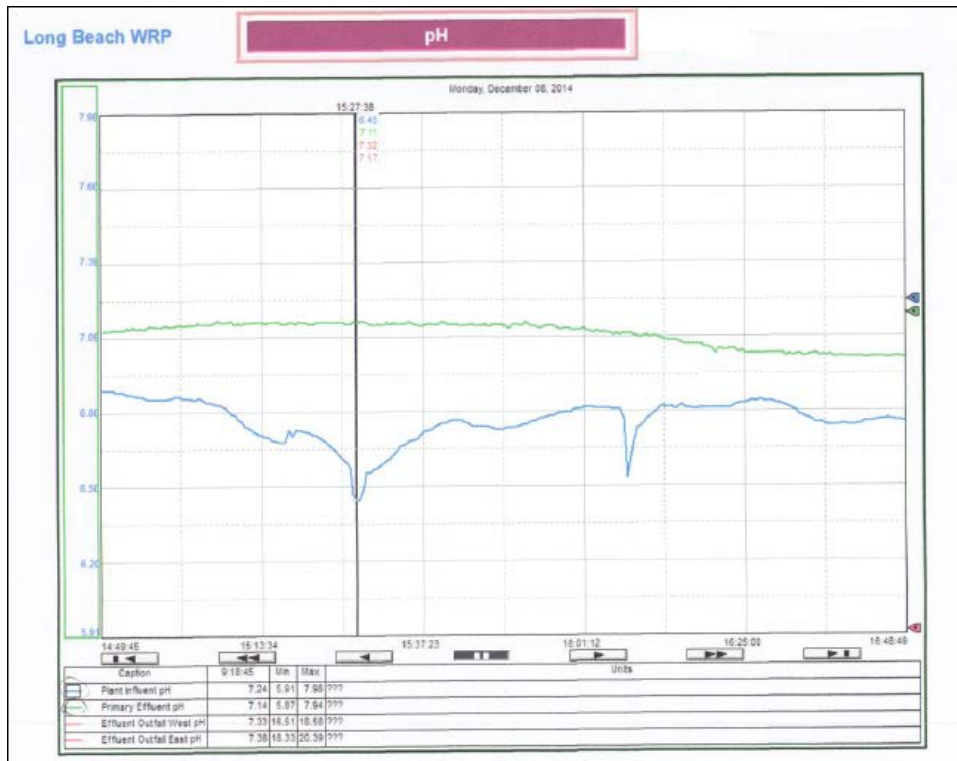
Figure 8: Long Beach WRP influent pH trend data (blue line) for Monday, 12-8-14 between 1448 and 1648 hours. The data indicate WRP influent pH reached a low point of 6.45 at 1527 hours.

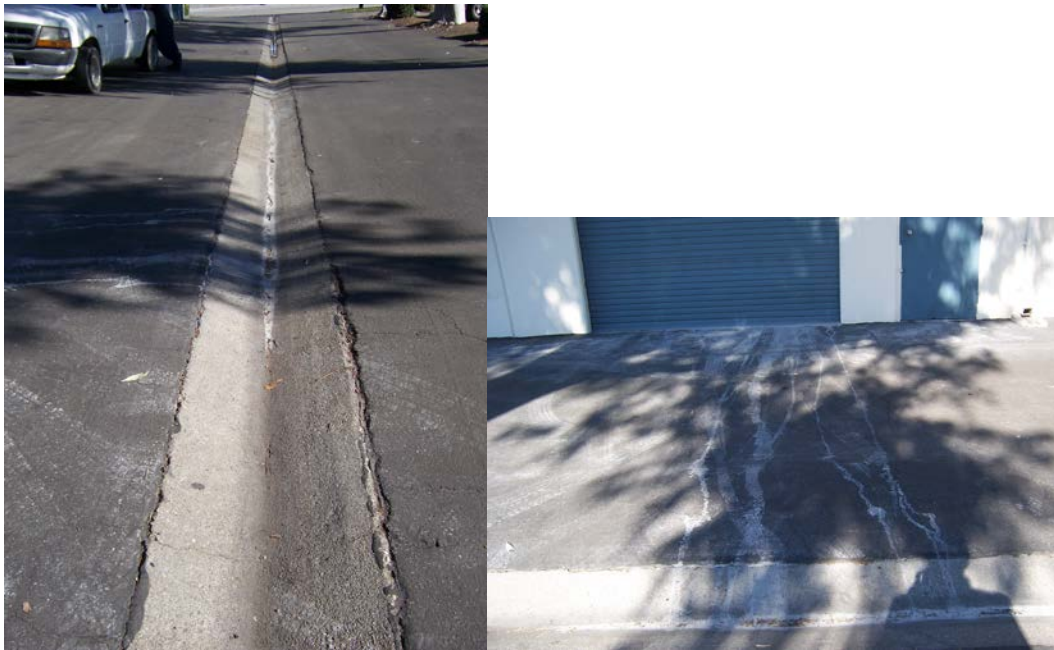
Figures 9 and 10: 12-22-14 photos of staining on pavement outside the auto body repair shop located at 3201 N. Alameda St. Suite F in Compton.

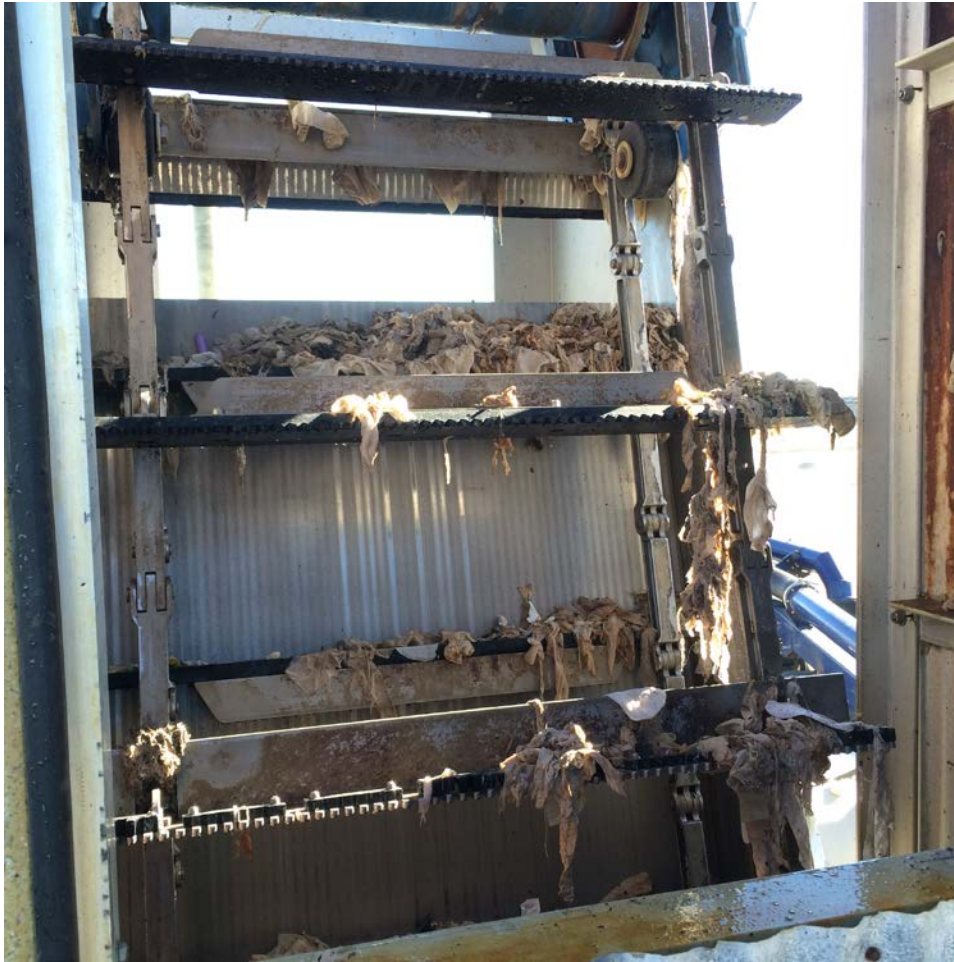
Figure 11: Excessive ragging on the flex rake screen at Lancaster WRP on 12-29-14.

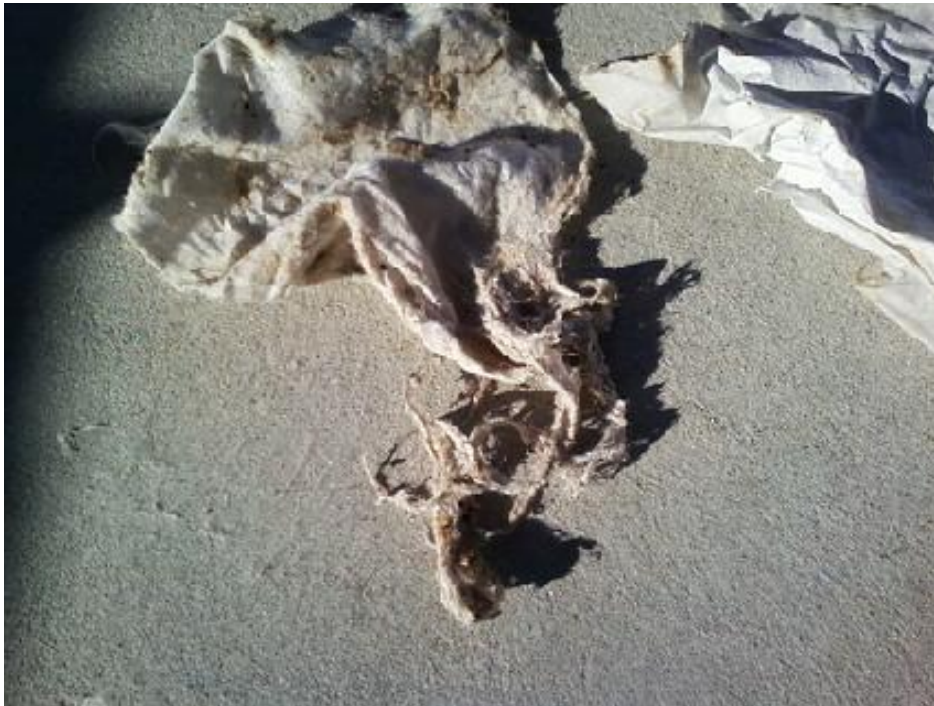
Figure 12: 12-29-14 photo of plastic-based disposable wipe removed from the flex rake screening system at Lancaster WRP. Note how similar the wipe appears to cloth when encountered at this location.
