Audit of Sanitary Sewer Overflow (SSO) in the City of Carson

Los Angeles County Sanitation Districts

4 May 2022

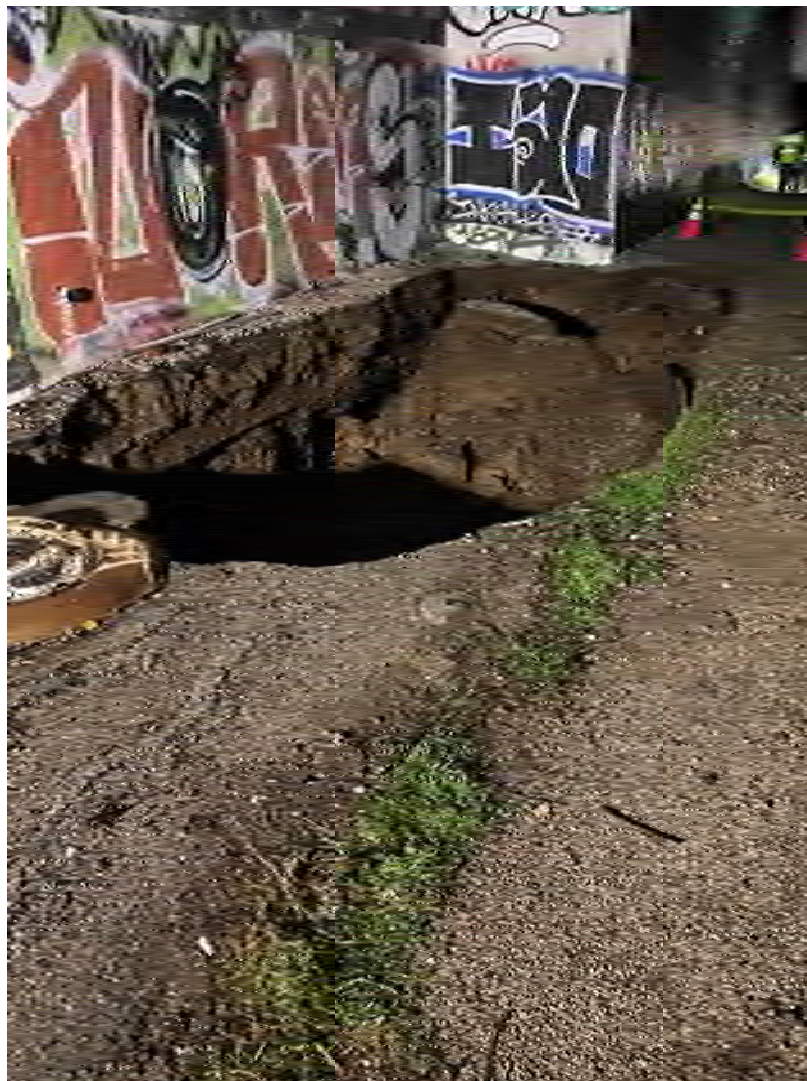
Photo 3-5 Location of the Pipe and Manhole After the Failure

On January 14, 2022, GHD interviewed a Construction Management Section (CMS) staff member to gain an understanding of the collapse and restoration operations. Of note from this discussion was that the downstream manhole (476) appears to have collapsed on itself (the manhole cover was in about the same horizontal position but located several feet underground). This is illustrated in **Photo 3-4** (before the failure), **Photo 3-5** (after the failure), and **Photo 3-6** (during excavation). No manhole shafting was observed during excavation operations.

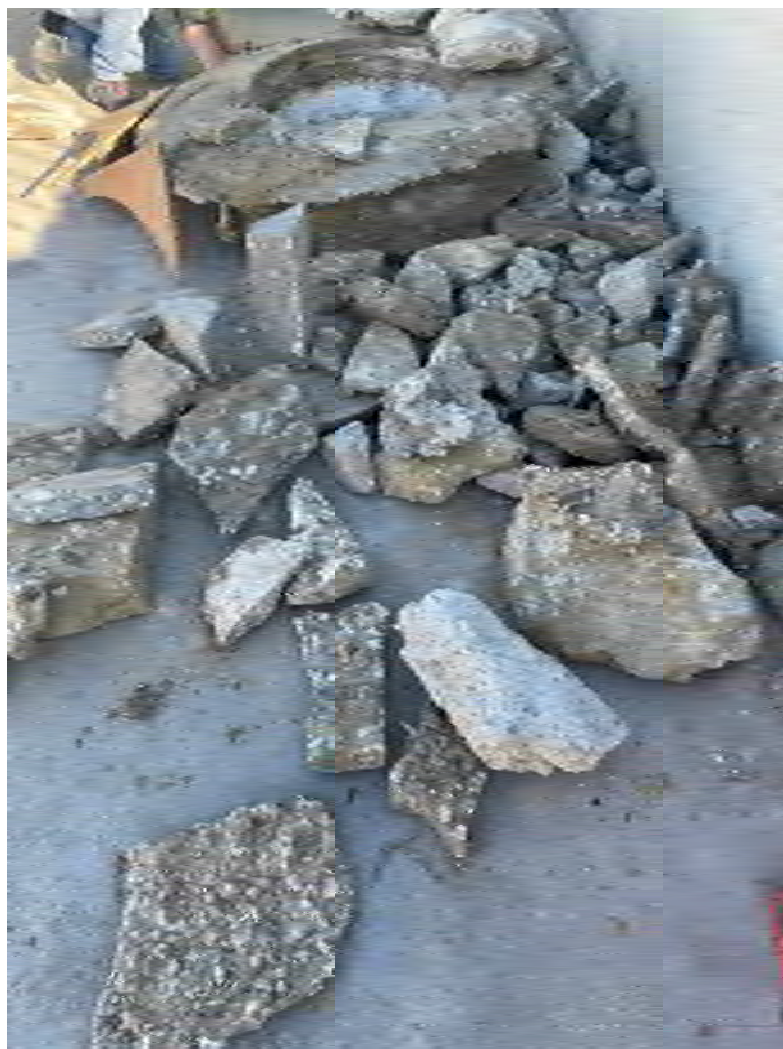
Photo 3-8 Pile of Debris from Collapse Site

Various concrete debris pieces from the collapse site were transported to the Compton Yard for storage. On January 24, 2022, GHD visited the Compton Field Office to view the debris. The pile of debris is shown in **Photo 3-8**. Some pieces easy to identify included the top of the manhole/collar and several broken pieces of pipe. The origination of the remainder of the concrete debris is unclear but none appeared to be manhole shafting or bricks. It seems possible that some of the concrete debris could have been in the original backfill when the sewer was constructed.

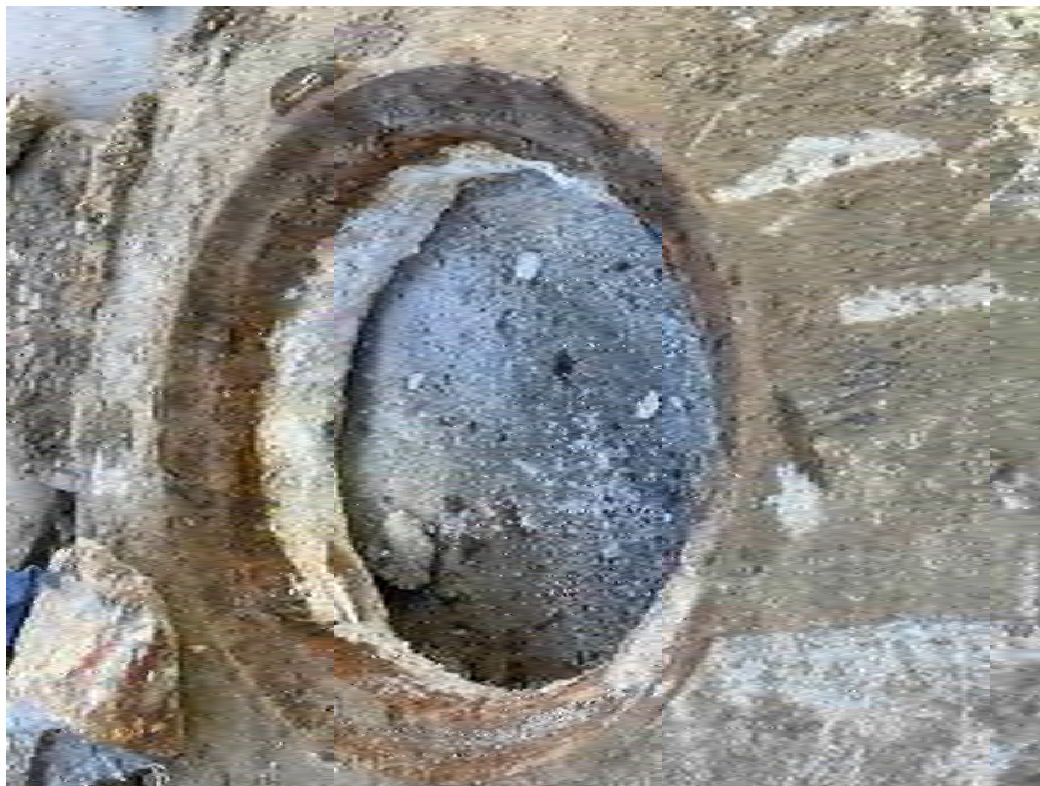
Photo 3-12 Manhole Ring and Cover Debris

As shown in **Photo 3-12**, the manhole ring and cover along with the cast in place collar were included in the debris. The concrete and grout located below the ring and cover was highly friable, indicating that it has been weakened by corrosive gasses often found in sanitary sewers.

There was no apparent material from the manhole shafting, brick or precast among the debris collected and transported to the Compton Yard. This could indicate that the material broke into very small sections and washed downstream.

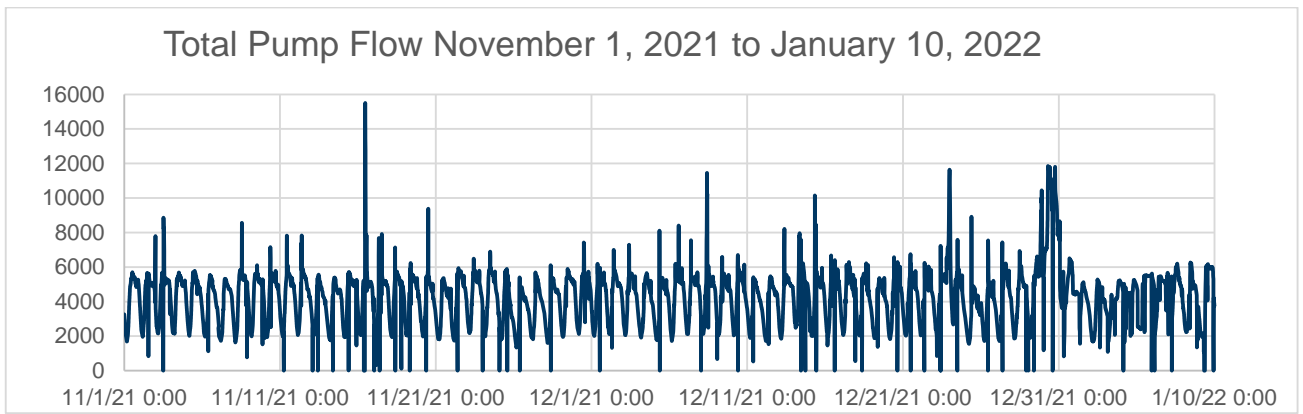
Figure 3-2 MSPP Discharge from November 1, 2021 to January 10, 2022

Figure 3-2 shows the discharge from the Main Street Pumping Plant from November 1, 2021 through January 10, 2022. This graph shows the typical daily peak discharge is 6,000 to 7,000 gallons per minute (gpm). In fact, during peak dry weather, flow is consistently at or slightly below 6,000 gpm. The spikes in flow above 6,000 gpm are typically due to pumping down the wet well for daily cleaning. During storm events, the peak discharge increases to approximately 12,000 gpm. One data point on the graph shows a peak of approximately 15,550 gpm on November 16, 2021, at 11:15 AM. This was not associated with a storm; rather, it appears pump station operations caused this flow for a short period of time, approximately 15 minutes. Figure 3-3 shows discharge on and around December 30, 2021, the day of the failure, the peak discharge was approximately 11,856 gpm at 7:30 AM. The average discharge for the morning hours of December 30, 2021, once the storm started, was approximately 11,300 gpm.

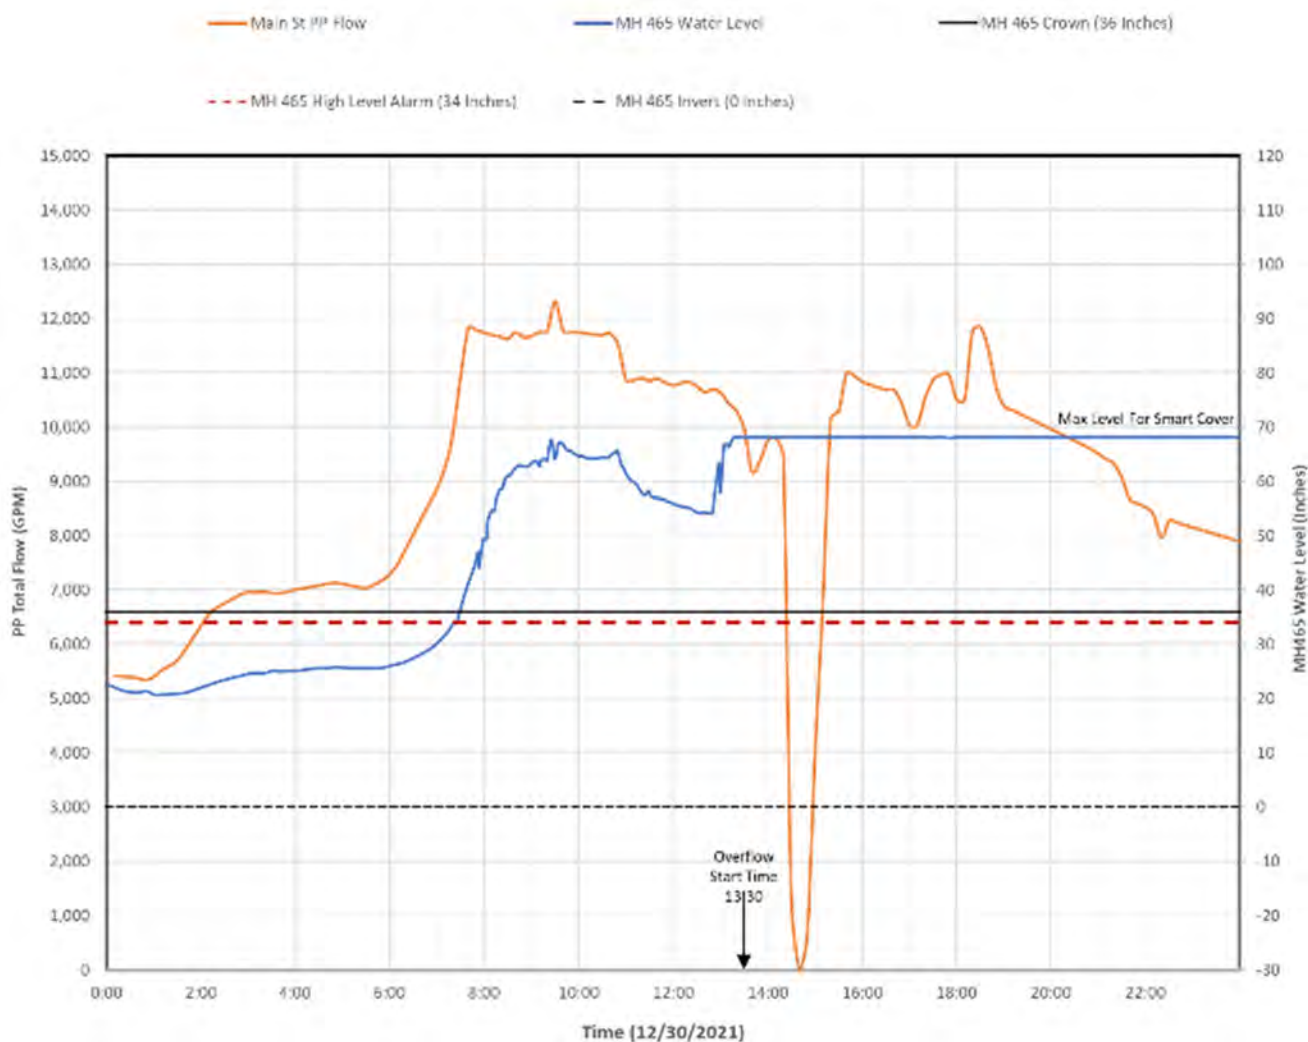
Figure 3-5 Pump Flow and Smart Cover Data Combined

The Main Street Pumping Plant discharge information and Smart Cover information were then combined in a single graph for December 30, 2021 (refer to **Figure 3-5**). It should be clarified that manhole 465 is not part of the 216th St Replacement Trunk. It is part of a smaller (36-inch diameter) sewer upstream of the failed sewer, which was 48-inch diameter (there is a second 30-inch sewer parallel to the sewer for MH 465). Therefore, the amount of surcharge at MH 465 is not necessarily indicative of the amount of surcharge at the failure location. This graph shows that the manhole 465 water level (blue line on the graph) generally follows the Main Street PP discharge (orange line on the graph) until about 13:17. The MSPP flow line also shows that the pump plant was shut down for a short period of time after the SSO was discovered as the cause of the SSO was being investigated. **Figure 3-5** also shows that the pipe was surcharged from about 07:30 onward as the water level (blue line on the graph) is above the crown of pipe (solid black line on the graph) by as much as 2.5 feet and was likely even higher, as this is the highest level the Smart Cover can detect. The maximum level would be approximately the same elevation as the rims of manholes 721 and 719 on 212th Street (the SSO location).

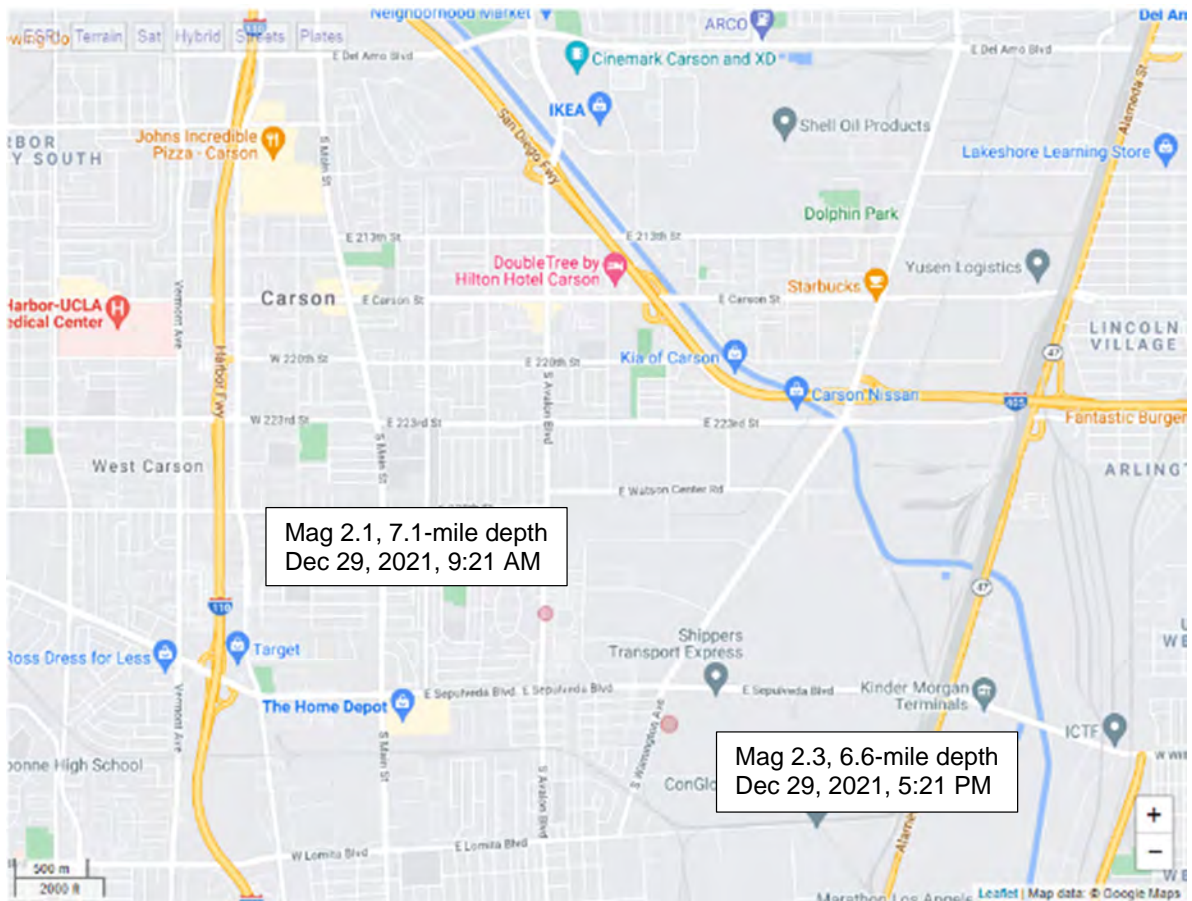
Figure 3-7 Carson Area Earthquakes

As seen in **Figure 3-7**, two earthquakes (magnitude 2.1 and 2.3) occurred in the Carson area on December 29, 2021. The epicenter of both earthquakes was more than 2 miles from the failure site. It is not believed that these seismic events were major contributors to the failure.
