**2023 ANNUAL REPORT**

INDUSTRIAL WASTE PRETREATMENT PROGRAM

LOS ANGELES COUNTY SANITATION DISTRICTS

**APPENDIX H**  
INDUSTRIAL WASTE REPORTS ON INCIDENTS

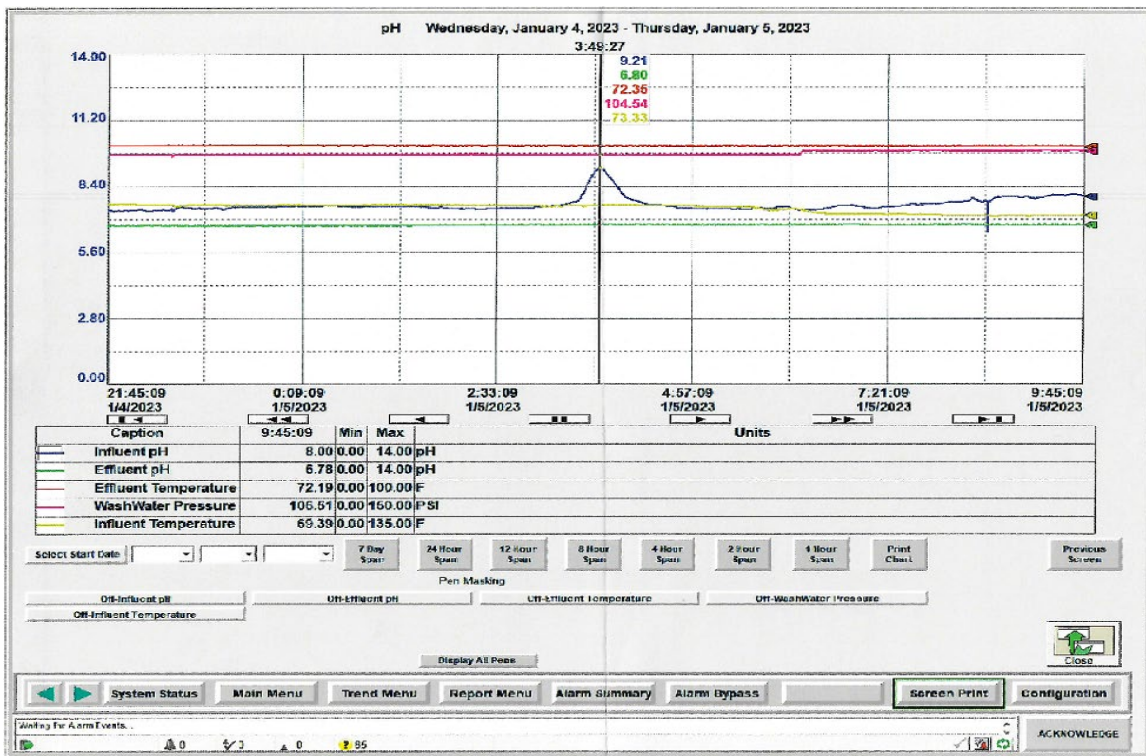
**Figure 1: Pomona WRP pH Trend**

On Thursday, January 5, 2023, at 0554 hours, Pomona WRP operators called the IW Section and reported that the WRP had experienced an approximate 30-minute period of high pH influent earlier that morning. Operators stated that at 0334 hours the influent pH began rising until it peaked at 9.2, then returned to normal by 0407 hours. At the time of the incident, an operator was onsite and collected a sample of the high pH influent from influent channel #1. He described the sample as white-colored with orange foam on top and had no unusual odor. Beyond the high pH, the suspect material did not adversely affect any treatment processes. The operator was unsure which influent line the material entered on (north or south), but "guessed" it most likely came in on the south line.

Investigating IW Inspectors obtained the WRP sample and verified the pH values. Caustic dosing and crown spraying schedules did not coincide with the incident. Inspectors described the sample as appearing much like past high pH organic waste influent. The investigation of upstream companies found Ling's to be the source of high pH wastewater impacting Pomona WRP. Ling's is a food manufacturer that uses caustic cleaners during their overnight sanitation operations. A verbal warning was issued to the company for adversely impacting the plant. IW staff is currently revising the company's IW permit, and IW inspectors have requested pH monitoring equipment and a possible upper pH limit.

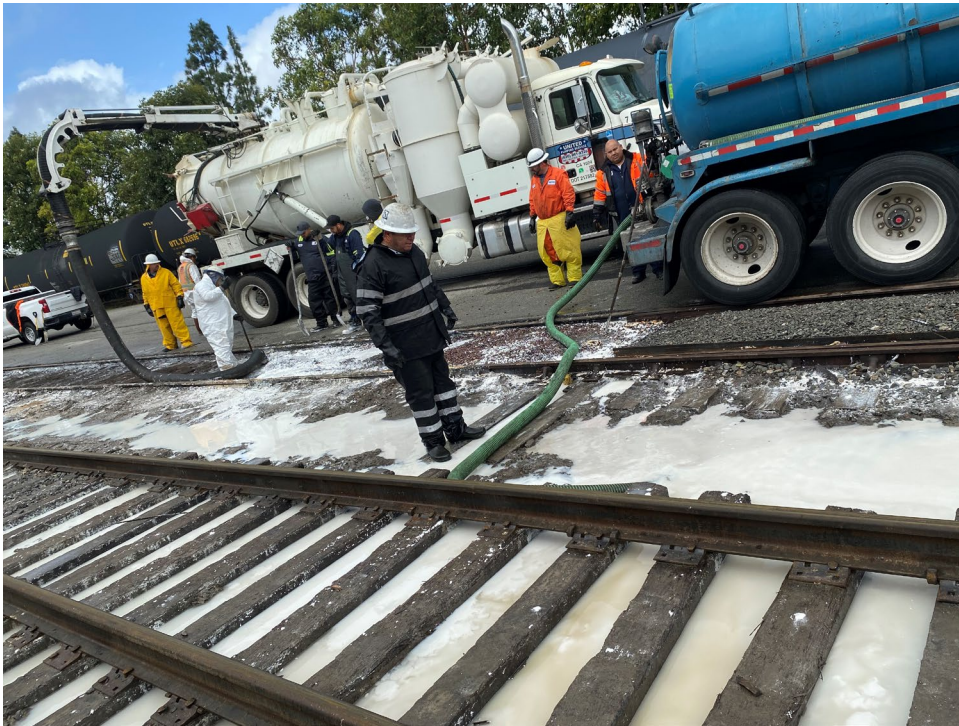
On Thursday, January 05, 2023, at 1010 hours, the Los Angeles County Fire Department's Health and Hazardous Materials Unit called the Industrial Waste Section and reported that they were onsite at a large spill of white latex paint, just north of the intersection of 61<sup>st</sup> Street and Eastern Avenue in the city of Commerce. At the time of the call, Southern California was experiencing a considerable amount of rain from the previous 8 to 10

**Figure 2: White Latex Paint Spill Clean Up**

The PRP is Ventura Transfer Company, located in the city of Commerce adjacent to a BNSF rail spur. LACoFD and Ventura Transfer staff surmised the likely cause of the spill was an unhoused person crawling under the railcar and opening the belly cap releasing the material. The company hired United Pumping Service to haul the spilled material to a tanker truck washing facility owned by Ventura Transfer Company in Carson, Ca, which has a current Industrial Waste Permit (FID #1389703, IW #3720). Ventura Transfer requested a one-time discharge allowance for the spilled material to be discharged through their Carson industrial waste pretreatment system and outfall.

After careful consideration and inspection visits, the Carson Ventura Transfer facility (# 3720) was granted approval for discharge of the stored spill material (25,000 gallons, white latex, rainwater) to the sewer at the Carson facility (IW #3720). Conditions of approval include the slow release of the material at no more than 5 gpm over an extended period, likely several weeks, to avoid having any negative impacts on the downstream operations at the Davidson City PP and JWPCP. The Company began discharge of the spill material according to the one-discharge conditions, and IW staff are closely monitoring the company regarding compliance. There have been no reported negative impacts to the Davidson City PP or JWPCP.

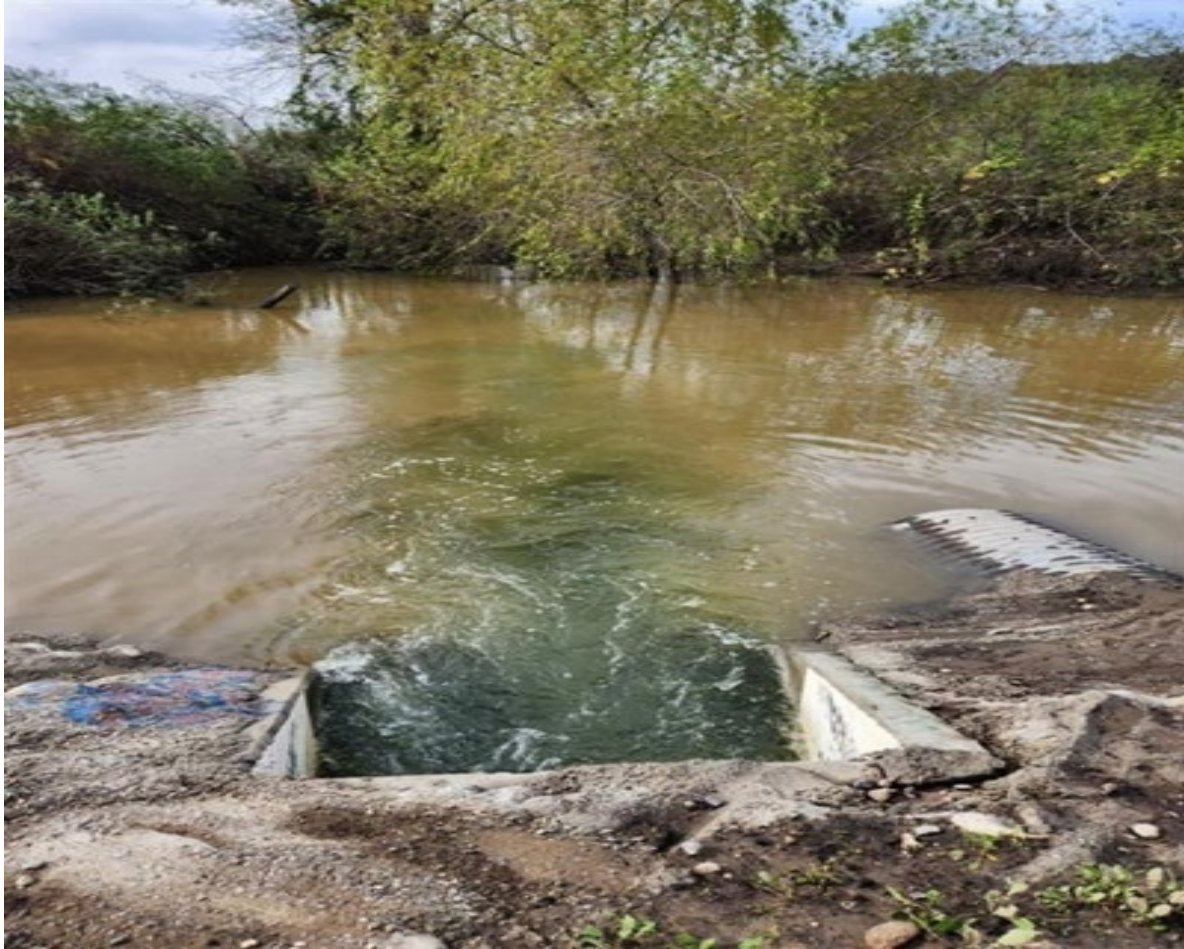
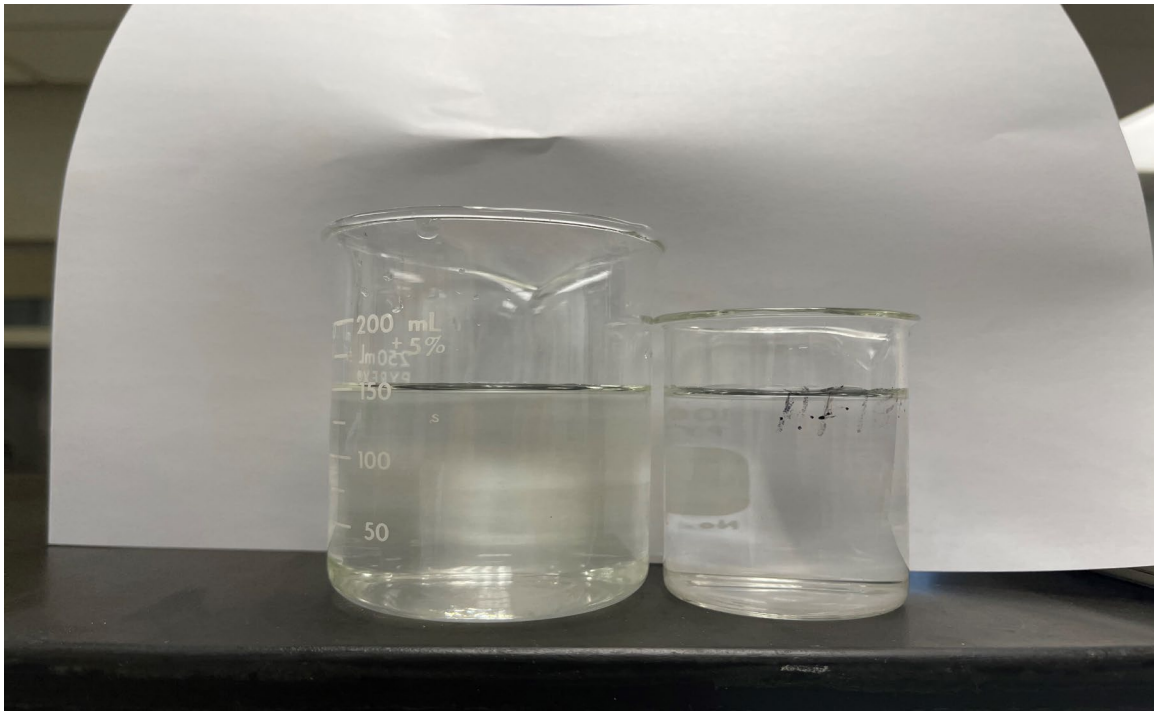
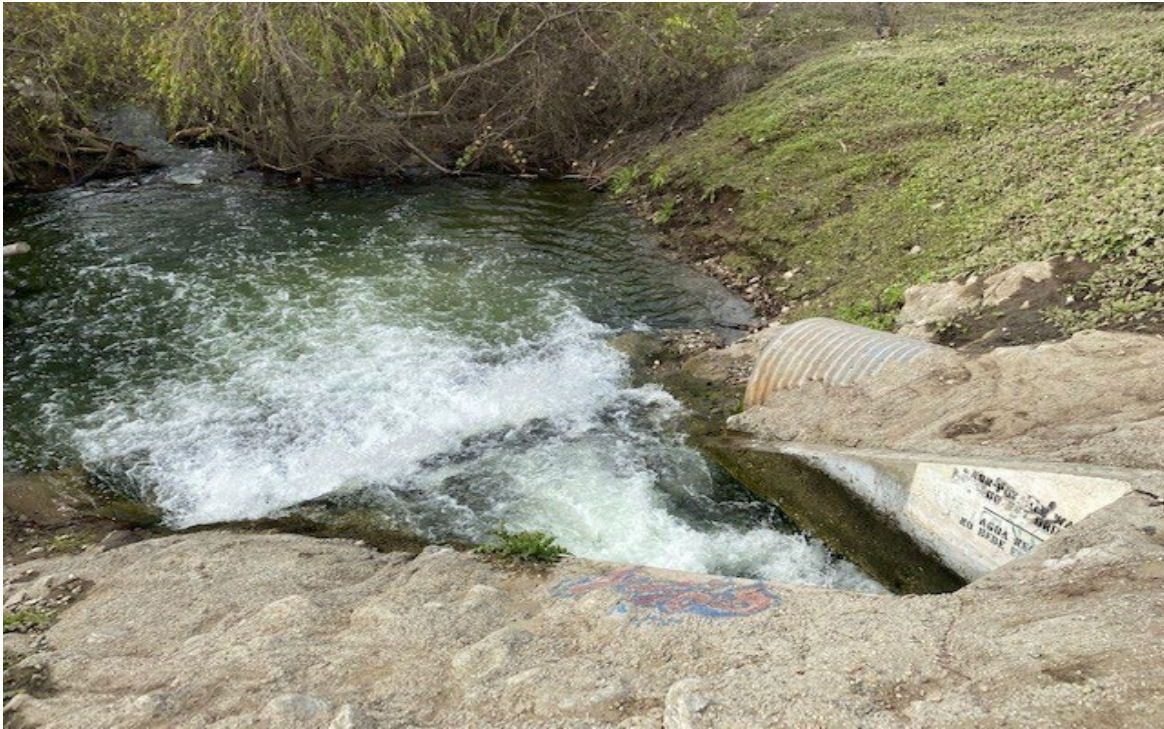
**Figure 3: WN-004 Discharge to Receiving Waters on Jan. 13, 2023**

**Figure 4: WN-004 Effluent (left) Comparison to Distilled Water (right)**

**Figure 5: WN-004 Discharge to Receiving Waters on Jan. 13, 2023**

During the bypass event on January 10, 2023, there was a moderate amount of rainfall (0.83 in) in the vicinity of the WRP that likely contributed higher stormwater flows to the receiving waters. Investigating IW staff found no green color or evidence of green color in the immediate receiving waters or at WN-004 outfall. IW Inspectors found the WRP effluent clear and the receiving waters muddy. WRP operators reported no green color in any process waters within the timeline of this investigation. Moreover, operators reported some flooding issues at the WRP during the recent heavy rains.

United Site Services is the predominant source of green color entering WNWRP. United Site Services discharges chemical toilet wastes daily beginning at 2000 hours and continues until all operating service trucks are empty. Further, they use deodorant/blue-green color tablets in the portable toilets that they service. Although there was no direct evidence that the company's effluent caused the green color incident at WNWRP, the company was warned that the improper use of their color deodorizing tablet has historically been a source of color problems at the WRP. There have been no additional color incidents reported by the Operations Staff at WNWRP since the initial report of color. IW inspectors will continue to monitor WNWRP and United Site Services.

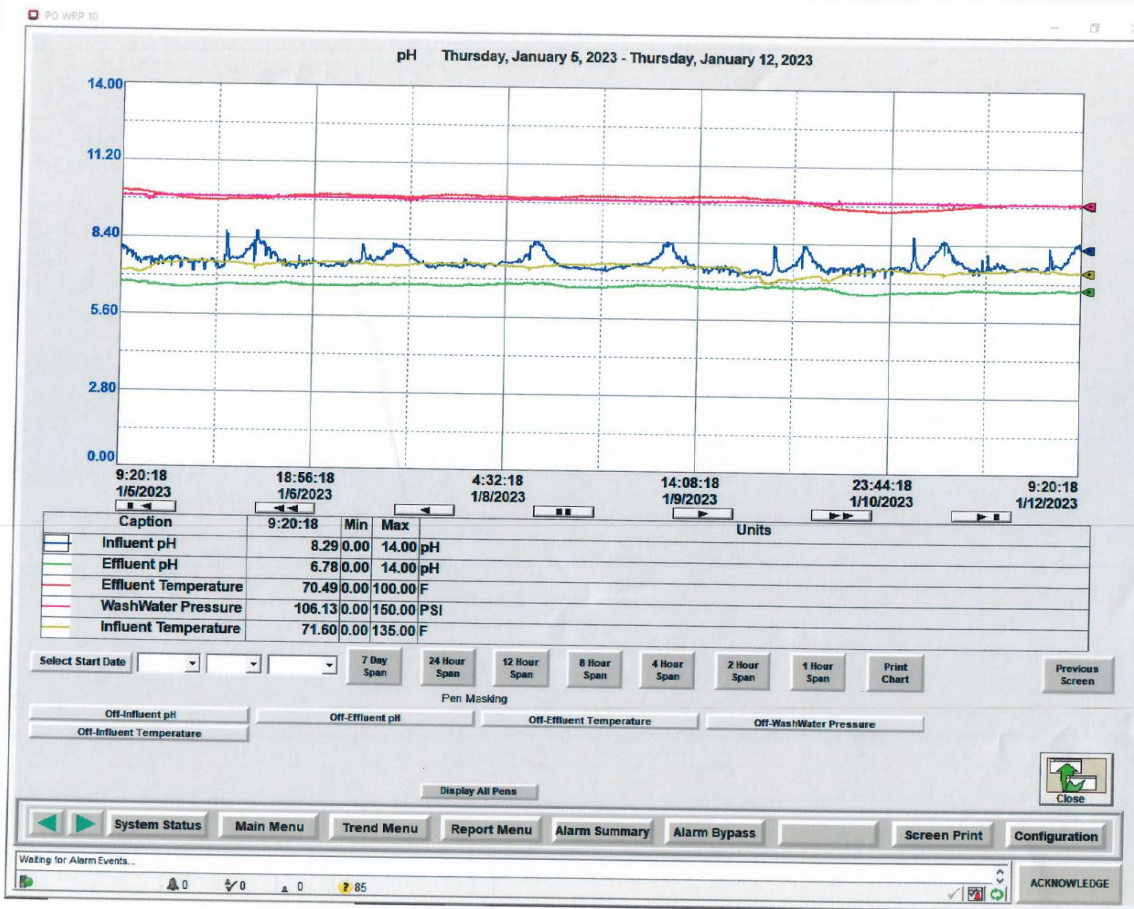
On Thursday, January 12, 2023, at 0856 hours, Pomona WRP operations staff called Supervising IW Inspector John Boyd and reported that the WRP had experienced a moderate increase in influent pH rising to 8.4-8.5 at the time of the call. An operator stated that the influent pH began rising at about 0600 hours that morning but had NOT tripped the influent pH alarm, which is set at 9. Additionally, the operator mentioned that the secondary aeration tank dissolved oxygen levels were decreasing and suspected the D.O. conditions may be related to the elevated pH. A similar rise in influent pH occurred the previous day, but it had not been reported to IW Section staff. A sample of the elevated pH raw influent was taken during the incident by operation staff.

Figure 6: Pomona WRP pH Trend on Jan. 13, 2023

IW Inspectors investigated ten upstream facilities having risk factors aligned with the reported incident. The investigation found no likely source. The WRP pH and D.O. levels did not reach alarm levels, and WRP operations and processes return to normal. IW Inspectors will continue to monitor upstream dischargers and the WRP.

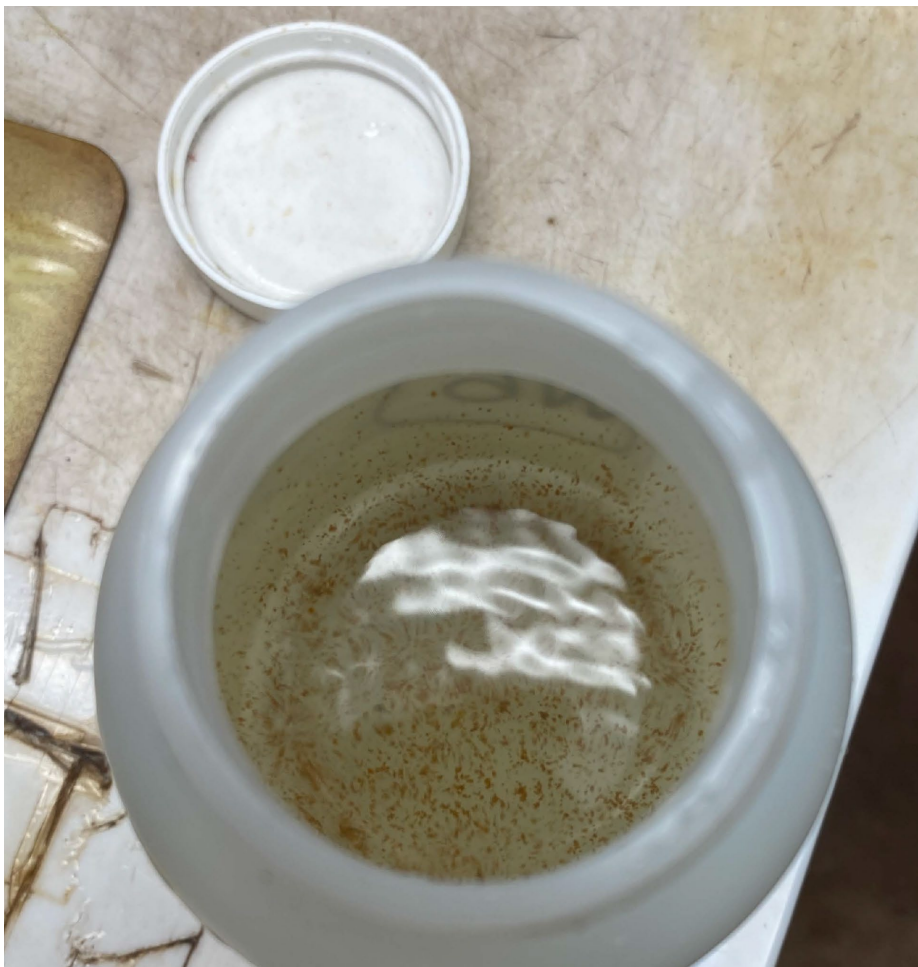
On Tuesday, February 7, 2023, at 1510 hours, David Thaete of Phibro-Tech, (FID: 1892464, Permit: 21498) reported to Supervising Industrial Waste Inspector Stephen Sealy that the company had made an error interpreting lab data and had accidentally discharged approximately 7,000 gallons of treated wastewater that measured 47 mg/l copper. The facility's any time copper limit is 3.38 mg/l. The company also notified the Department of Toxic Substances Control (DTSC) to self-report the discharge of hazardous waste from their situs. Area Industrial Waste Inspector David Joh was notified and assigned to follow up with the company to determine the cause, the current disposition of the off-spec material, and how the company plans to eliminate the risk of such releases in the future.

**Figure 2: Retain Sample showing solids containing copper at 47mg/l from discharge batch 676**

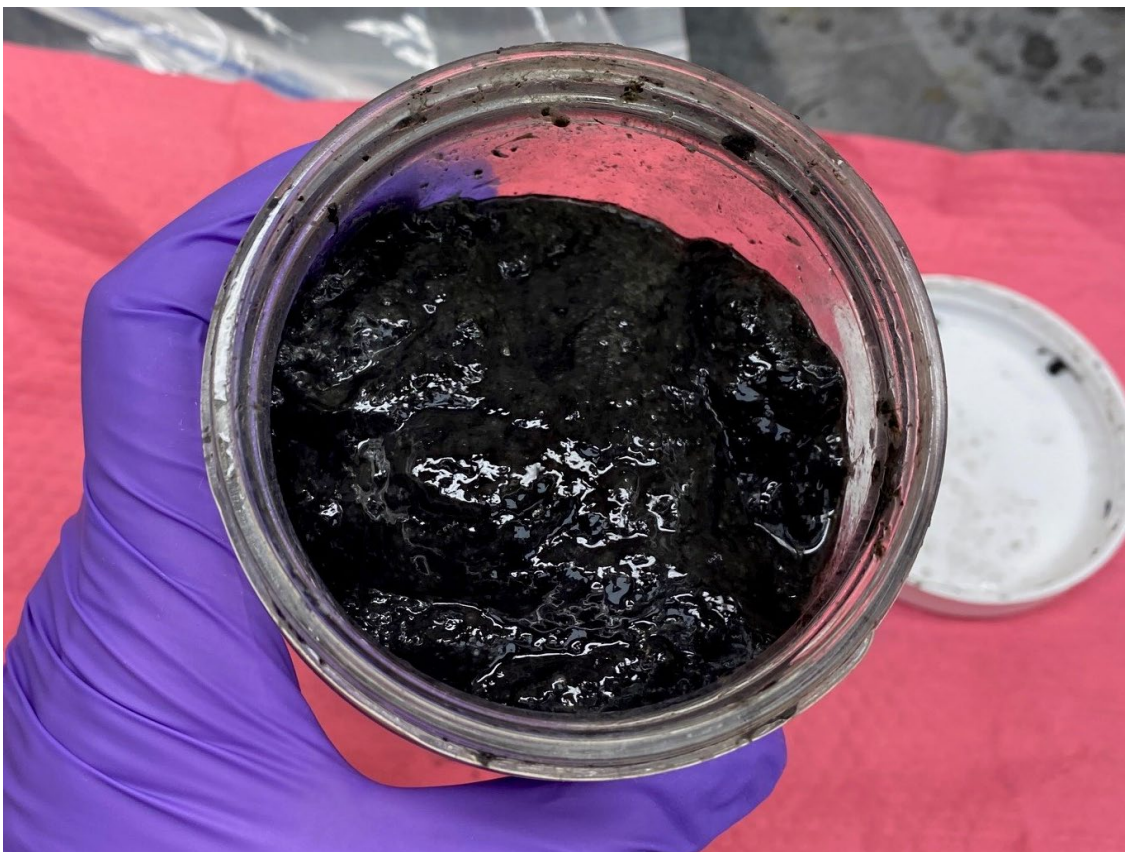
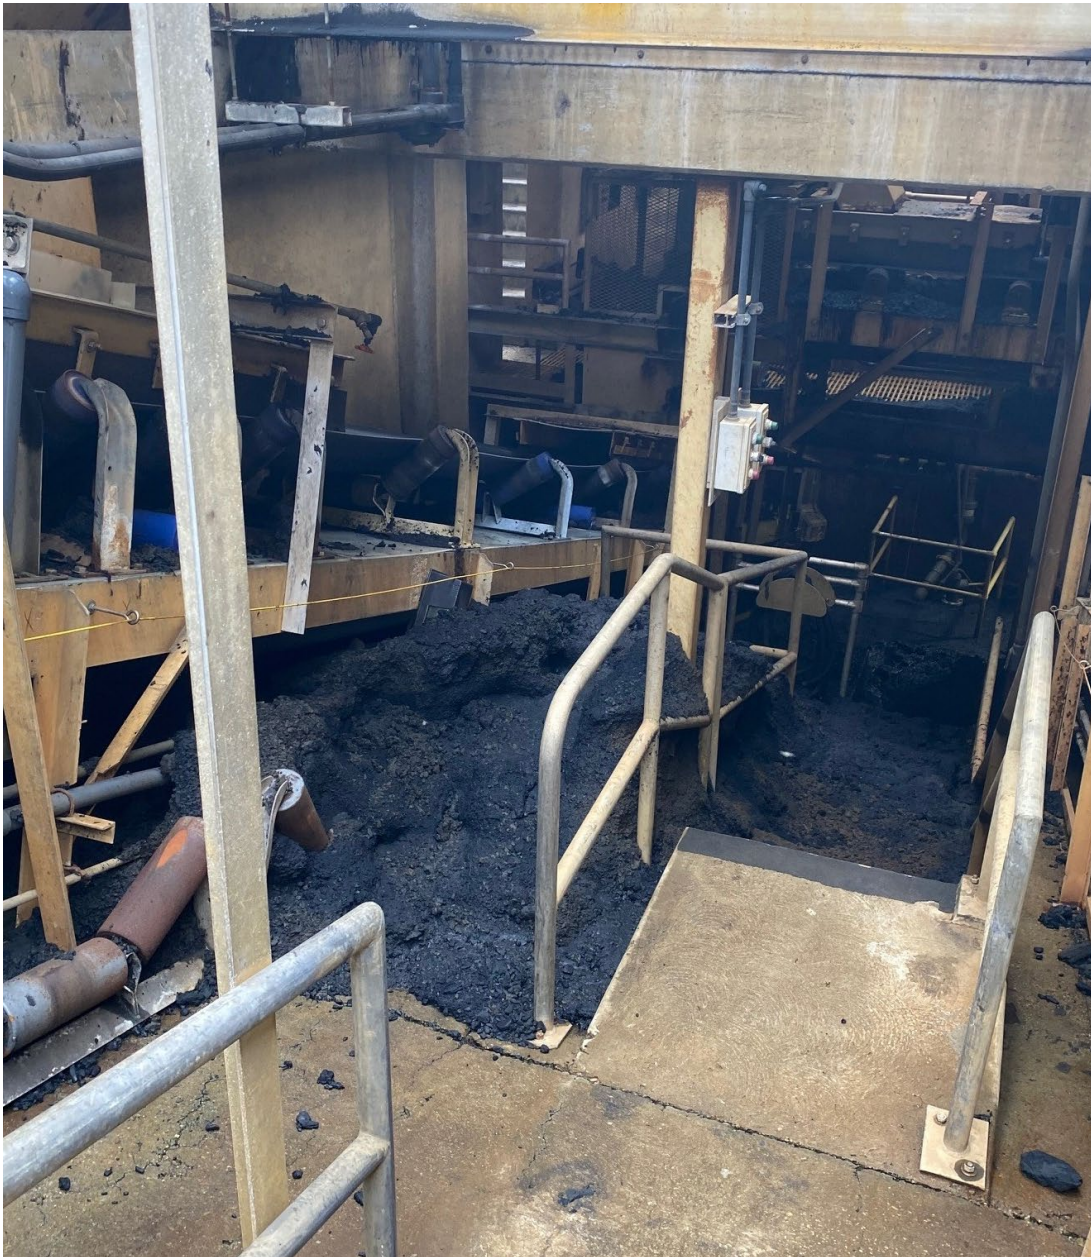
J.O. "B" headworks impacting the primary tanks in E3 battery and skimming trough. Wei then notified Supervising IWI Bill Barnum at 0955 hours and initiated an investigation.

**Figure 3: Gelatinous Solids from inlet works**

**Figure 4: Excess biosolids in conveyor/sump**

Senior IWI Tingting Wei began the investigation verifying the solids were entering the plant at J.O. “A” and J.O. “B” inlet sewers and noted the material was in the primary tanks causing issues with the level sensors. The material was sampled and had similar properties to the black gelatinous solids found during previous black solids incidents at the JWPCP headworks. The material was similar to those past incidents in which the black solids had a “polymer” feel and no oily component. IWI Wei inquired if there were any solids processing problems, polymer leaks or equipment failures in Solids Processing. The investigation found that a belt conveyor in Solids Processing had broken and the solids from that conveyor area needed to be removed to allow for repair. The solids were washed to the headworks through the diversion structure that is currently open to both J.O. “A” and J.O. “B”. and therefore, returned to the inlet works. Due to the information found during the preliminary part of the investigation, no industrial inspections were conducted as it is not likely an industrial discharger is responsible for this upset event.

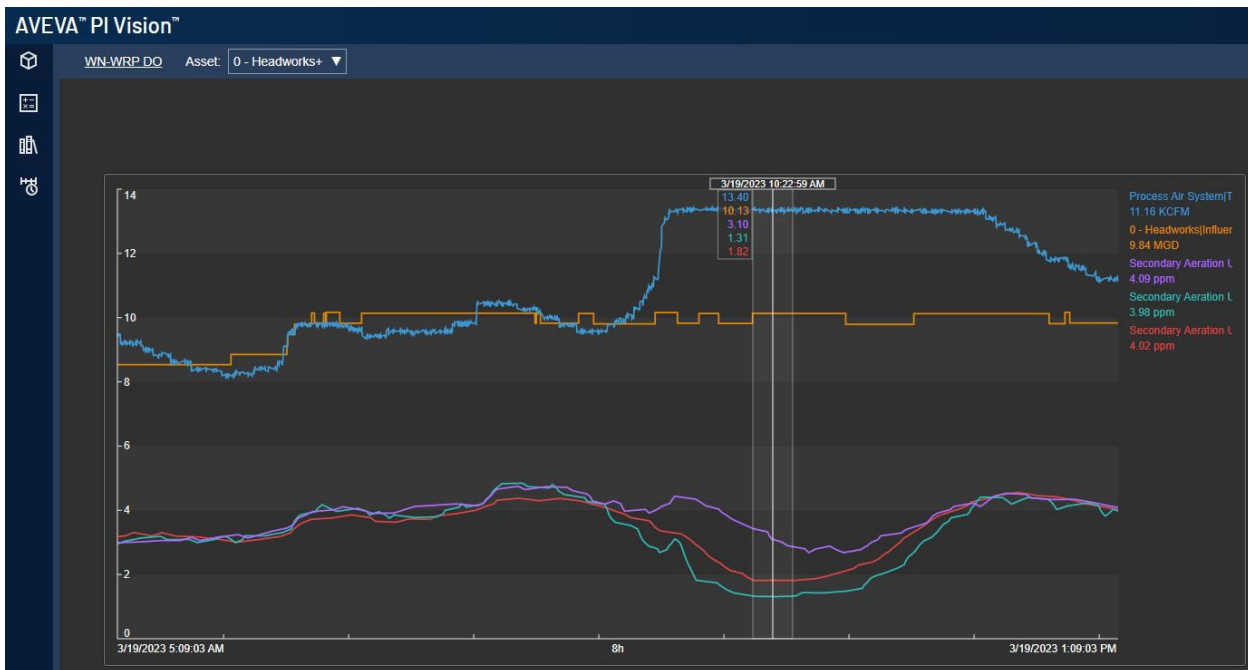
On Monday, March 20, 2023, at 0903 hours Whittier Narrows WRP Operators reported to the Industrial Waste Inspection Staff that the treatment plant had experienced a low dissolved oxygen concentration event in the aeration tanks the preceding day, Sunday, March 19, 2023. The incident began at 0930 hours when the D.O. concentrations began declining to a minimum D.O. point of 1.30 mg/l at 1030 hours the same day. Treatment plant operators responded by reducing the incoming headworks flow while increasing the process air flow (see Figure 1). This action reversed the negative trend and restored normal D.O. levels in the aeration units. There were no other adverse operational effects reported. The incident lasted approximately 2 hours.

**Figure 1. WNWRP Process Air, Headworks Flow & Aeration Units D.O.**

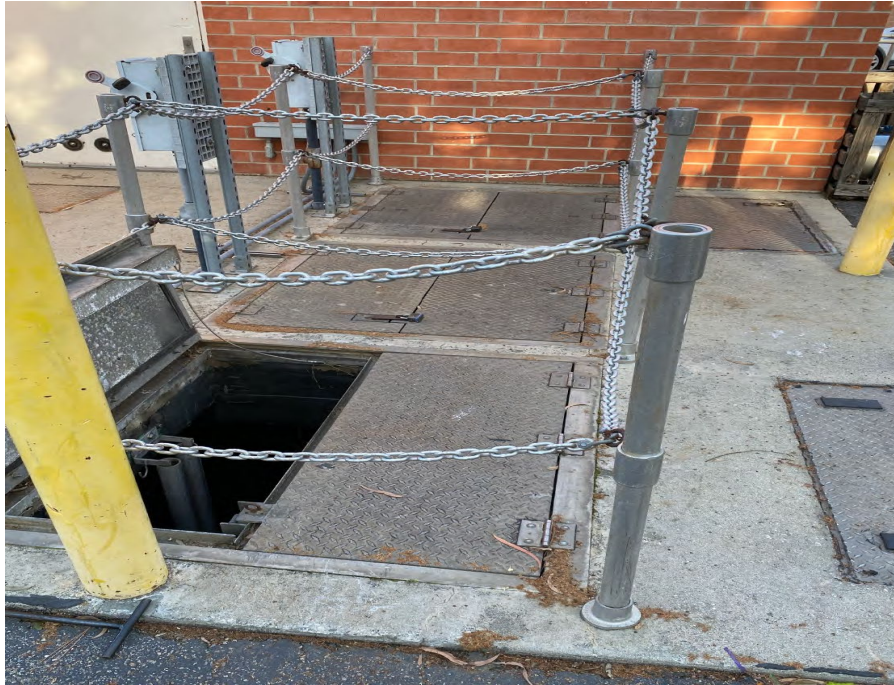
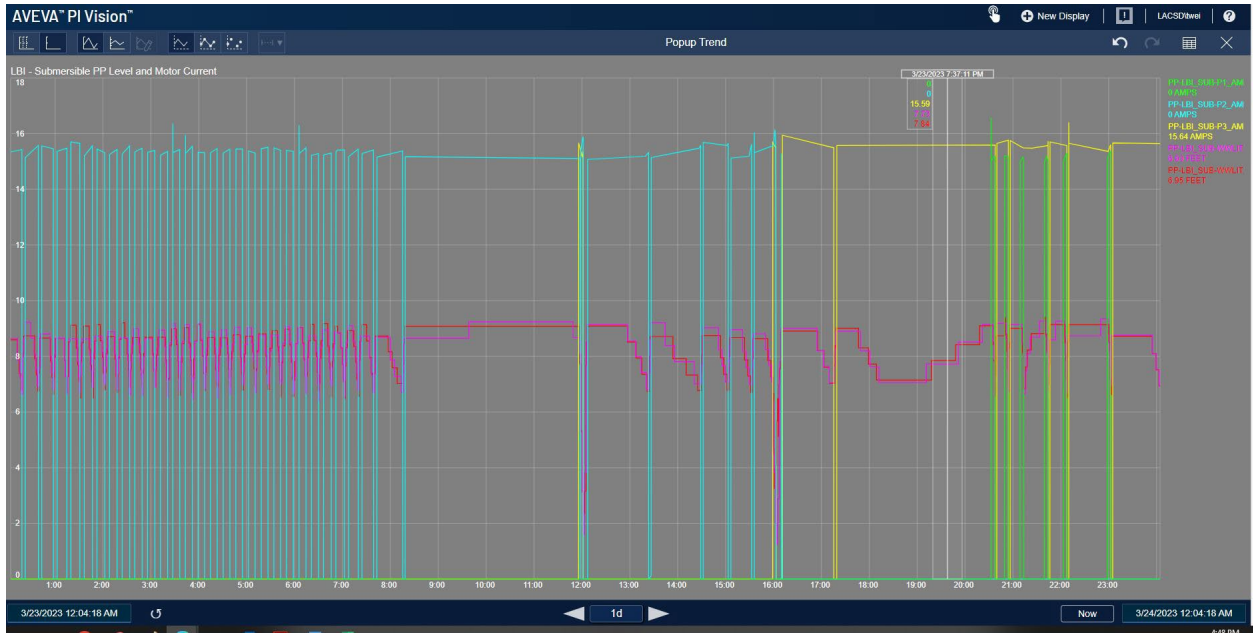
On Thursday, March 23, 2023, at 1445 hours, Industrial Waste Inspection staff received a call from Pumping Plant Operations reporting that the Long Beach Interceptor Pumping Plant at the submersible side was experiencing elevated flows to the extent that pumps were operating up to 2 hours to draw down wet wells that normally take 8 minutes. Pumping plant staff mentioned the problem began at the beginning of a series of heavy rain events the previous week. Pumping Plant Operations identified that higher influent flows coincided with rain events but requested IW staff to investigate whether any industrial sources were contributing to the problem.

**Figure 2. Submersible Side of Long Beach Interceptor Pump Plant**

**Figure 3. Submersible Pump Plant Level and Motor Current – 03-23-2023**

IW Inspectors investigated the report and determined there were no contributory industrial sources to the elevated flows at the pumping plant. IW Inspectors found tributary industrial dischargers in compliance for rainwater diversion systems and peak discharge flow rates. Nevertheless, IW Inspectors noted some evidence of water infiltration into the influent sewer lines, which likely occurred during the recent storms. IW Inspectors will continue to investigate any potential rainwater intrusion from nearby facilities, including California State University Long Beach.

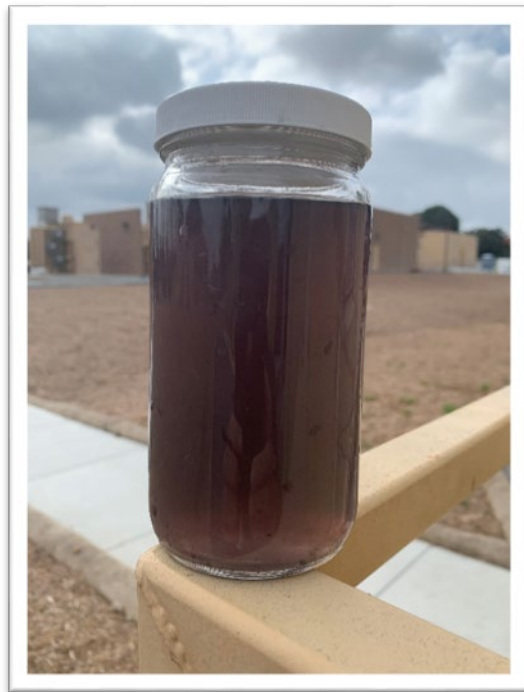
On Tuesday, April 25, 2023, at 0900 hours, Los Coyotes WRP Operations called the Industrial Waste Section to report purple-colored wastewater at the influent pH box. Industrial Waste Inspectors met with plant operations, confirmed the color, and collected a grab sample of the purple influent. Operations reported no other treatment plant anomalies to IW Staff. Further, Operations mentioned that the color seemed minor and unlikely to impact treatment operations. Industrial Waste Inspectors found no evidence of color in the influent sewer lines to LCWRP. Investigative inspections of the two largest industrial sources of color, Tri-Star Dyeing & Finishing and Shaw Diversified Services, found no samples of purple-color wastewater from either facility. Nevertheless, Inspectors observed Tri-Star Dyeing & Finishing had a sizable amount of finished purple fabric stored on the production floor. Tri-Star Dyeing & Finishing is a prime suspect and historically has discharged adverse color to LCWRP. There were no further adverse color or operational impacts to LCWRP.

**Figure 1. Raw Influent Sample**

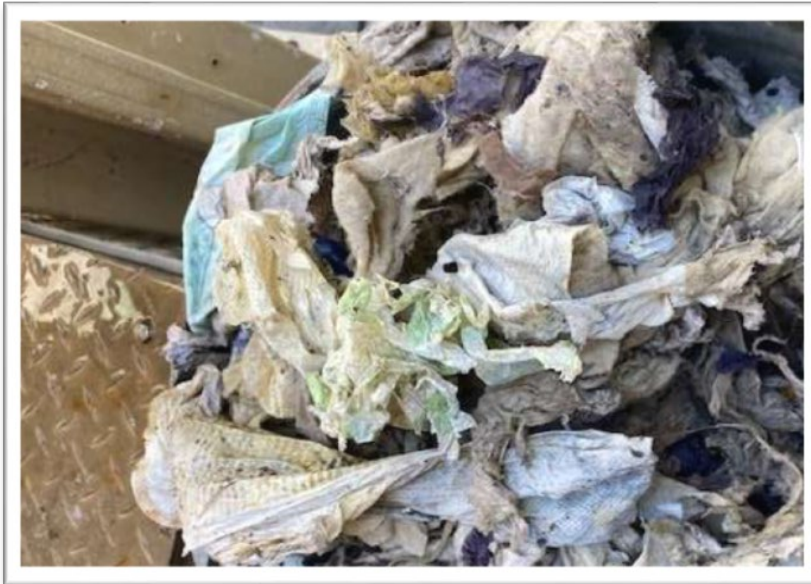
On Friday, April 28, 2023, at 0915 hours, Saugus WRP Operations called the Industrial Waste Section to report excessive ragging at the influent grinder the previous day, Thursday, April 27, 2023. Saugus WRP Operators stated that the grinder overload alarm signaled at 1230 hours and again at 1435 hours on April 27. Both alarms were cleared by de-ragging the influent pumps. After a second grinder failure alarm, Operations applied back up comminutor #2, which overloaded at start up from a collection of rags blocking the teeth. Once these rags were cleared, the plant operated normally and without any further incident.

Industrial Waste Inspectors visited the plant and observed sample rags retained from the incident. The rags appeared to be an assortment of “flushable” wipes and disposable cleaning rags often observed in the influent. An investigation found no upstream industrial source of the wipes. Nevertheless, a review of the Saugus Liquid Waste Disposal Station records indicated the station received 15 loads on the day of the incident and 17 loads the day prior, many of which were from concerts and outdoor events. Since the incident, Operations reported normal treatment plant conditions and no excessive ragging. The plant is now operating the influent grinder and comminutor, which serves to mitigate the rags.

**Figure 3. Sample of Influent Rags**

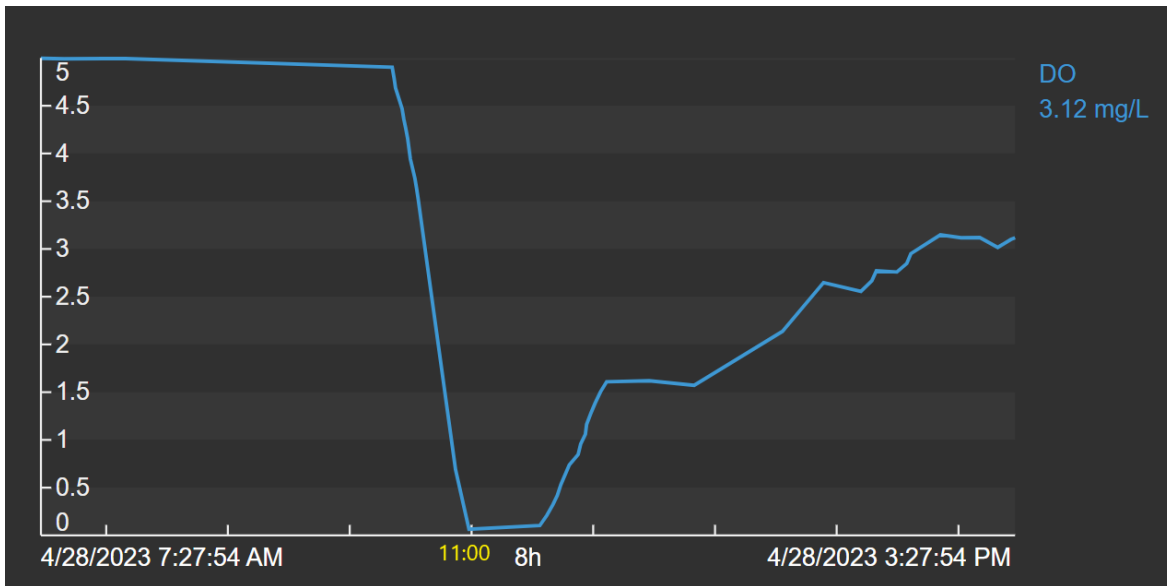
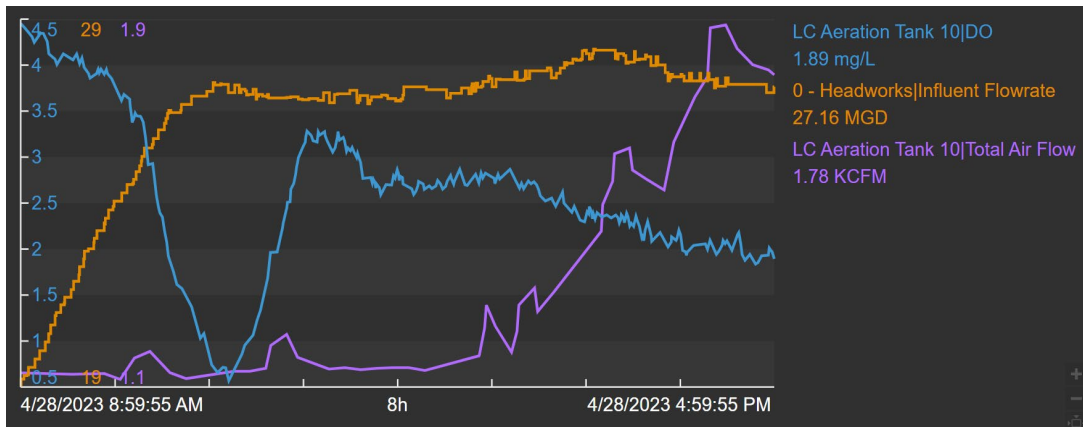
On Wednesday, May 03, 2023, at 0955 hours, Los Coyotes WRP operators notified IW Inspection staff of an ongoing issue with low dissolved oxygen (D.O.) and high secondary-effluent COD. The principal incident occurred on April 28, 2023, at approximately 1030 hours when secondary D.O. dropped sharply to near 0 mg/l for about 30 minutes (see Fig 1.) In addition, on April 28, 2023, secondary-effluent COD results were 62 mg/l, instead of an average 30 mg/l. There were no reported odors, colors or other indicators associated with this event. LCWRP Operators continued to observe fluctuating D.O. values that compelled Operations to notify IW Inspection on May 03, 2023.

**Figure 4. Dissolved Oxygen on 04/28/2023 LC Aeration Tank (PI Vision)**

Figure 5. Dissolved Oxygen, WRP Flow, & Air Flow – 04/28/2023 (PI Vision)

IW Inspectors investigated 10 significant COD dischargers tributary to LCWRP. None were identified as the source of COD loading on LCWRP during the incident timeframe. All companies were in permit compliance except Bumble Bee Foods, LLC (FID 2067191, IW#016412). Bumble Bee Foods was issued a Notice of Violation (NOV) for a flow rate exceedance. Despite the NOV, there was no evidence of any high COD strength wastewater discharged from this facility in relation to the incident. It should be noted that Shasta Beverages, Inc (FID: 2037456, IW#015351) has historically adversely impacted LCWRP with high strength COD discharges. Shasta was inspected twice during this investigation. Although no direct evidence was discovered, Shasta will remain a company of interest and will be subject to follow up inspections. IW Inspectors continue to monitor this situation closely.

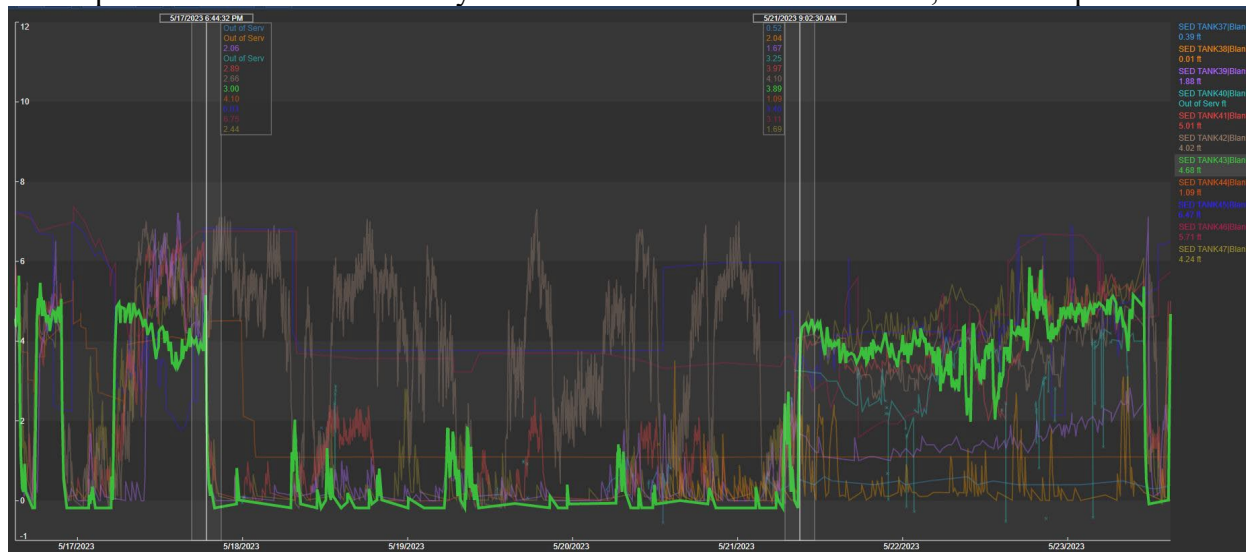
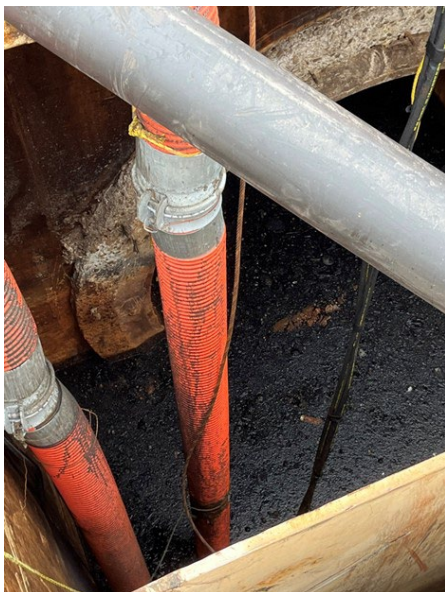
On Tuesday, May 23, 2023, Supervising IWI Andrew Woods received a call from Primary Operations at JWPCP regarding loaded skimmings in the sedimentation tanks. During a follow-up call with JWPCP Operations at 1550 hours, Senior IWI Tingting Wei was informed that Operations again noticed the loaded skimmings in tank 37-55 (Unit 7&8). The sludge blanket level sensors were zeroed out from 1124 hours to 1443 hours. Operations did not observe any unusual materials in the JO. B inlet, so no samples were collected.

Figure 8. Sludge blanket level trend 5/16-5/23

Figure 6. Diversion at stoplog shows heavy amount so floating solids

Industrial users with the potential to impact JWPCP were inspected for potential solids or polymer loading. No users were found to contribute or cause the solids loading in JWPCP E3 South Primary Sedimentation Tanks. Inspection staff will remain vigilant and continue to look for industrial sources that may have contributed to the plant upset. Notable upstream maintenance activities include the J.O. -B Unit 1A relining project. A stoplog has been placed at MH B 0926 and 3 large mobile pumps are being used to drain the sewer section. On May 20, 2023, night inspection, 2 out of the 3 pumps were on, drawing down to the bottom of the line. Contractor’s comments as well as IW Inspection staff visual observation on Monday, May 22, 2023, (when the lines not being drawn down to the very bottom, only 1 pump was running) this suggest the line is heavily impacted with solids.

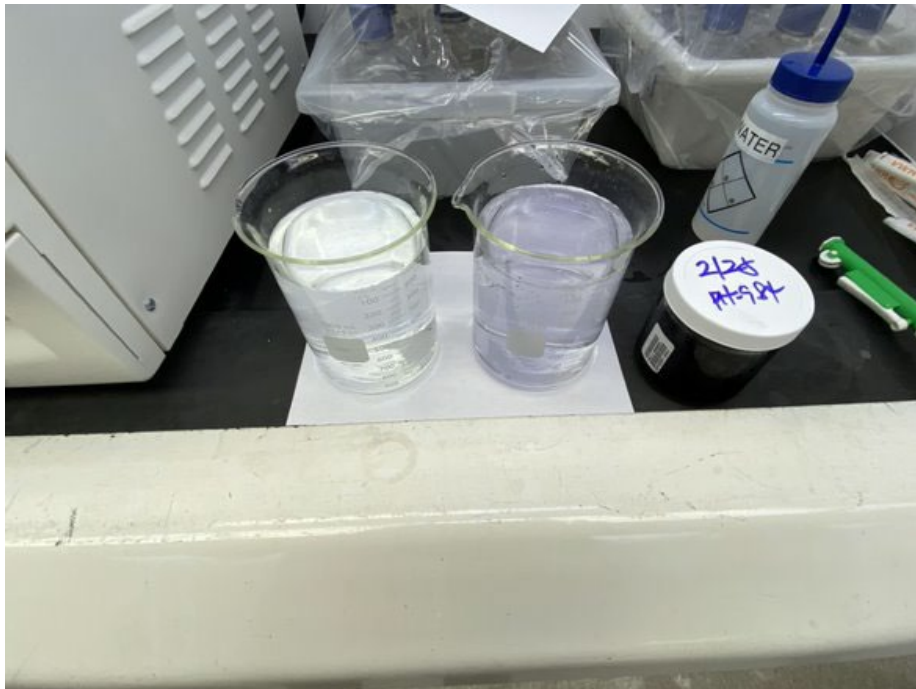
Investigative inspections at the two largest industrial sources of color, Tri-Star Dyeing & Finishing and Shaw Diversified Services, found no wastewater samples indicative of tea-color wastewater from either facility. Nevertheless, Inspectors observed Tri-Star Dyeing & Finishing had a substantial amount of dyed fabric stored on the production floor indicating a robust production schedule. Moreover, finished dyed fabrics were in colors that could generate tea-colored wastewater. Although no “tea-colored” effluent was observed during the inspection, an effluent color dilution test result led to the issuance of a Notice-of-Violation for failing to comply with the permit-required effluent qualitative color test. Tri-Star Dyeing & Finishing is a prime suspect and historically has been a source of adverse color to LCWRP. There were no further adverse color or operational impacts to LCWRP.

**Figure 9. Failed Qualitative Color Test**

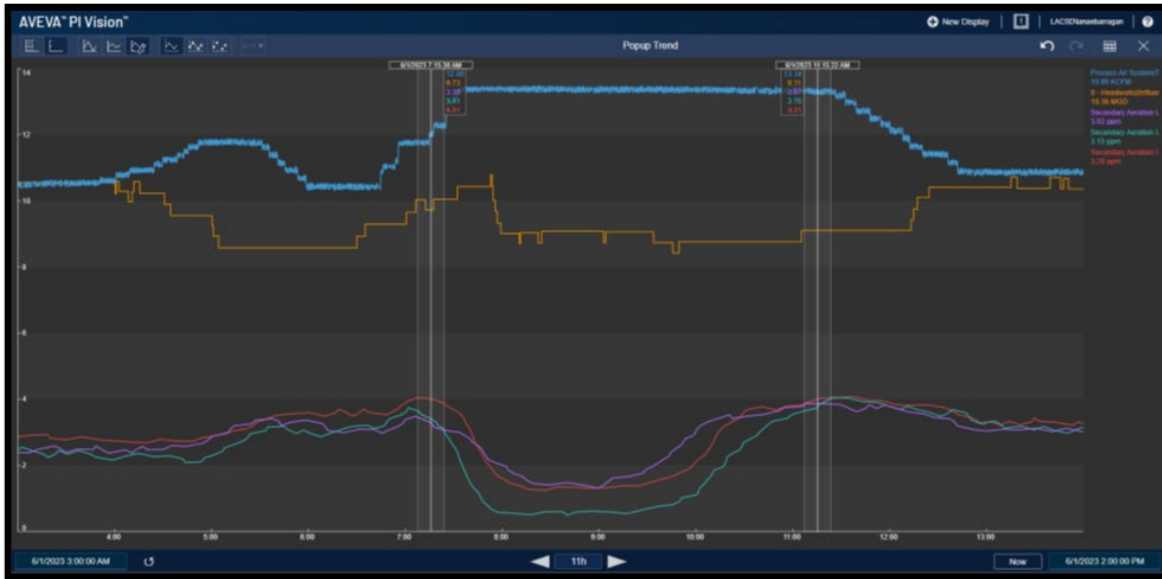
On Thursday, June 01, 2023, at 0809 hours, Whittier Narrows WRP Operations called the Industrial Waste Section to report low dissolved-oxygen (DO) concentrations in the secondary aeration units. The DO levels declined to 0.50 mg/L (*Figure 1*). WRP Operations further described a previous low DO incident occurring on May 14, 2023, which found aeration process DO levels declining to 0.40 mg/L. Both incidents occurred in the morning between 0800 and 1100 hours. In both cases, WRP Operations responded by reducing the incoming headworks flow while increasing the process air. This action reversed the negative trend and restored normal D.O. levels in the aeration units. IW Inspectors received Raw and Primary Effluent grab samples taken by plant operations during the incident. There were no other adverse operational effects reported.

Figure 10. WNWRP Process Air, Headworks Flow & Aeration Units D.O.

Industrial Waste Inspectors performed several inspections at major tributary dischargers having an elevated risk for Chemical Oxygen Demand (COD) to WNWRP. No clear industrial source was identified during the investigation. Furthermore, inspections at lesser dischargers found wastewater operations in compliance and having normal production practices. WNWRP COD grab sample results did not demonstrate elevated levels of Chemical Oxygen Demand in either the influent or primary effluent locations. Nevertheless, IW Inspectors will continue to monitor tributary dischargers and work with Operations staff to resolve this.

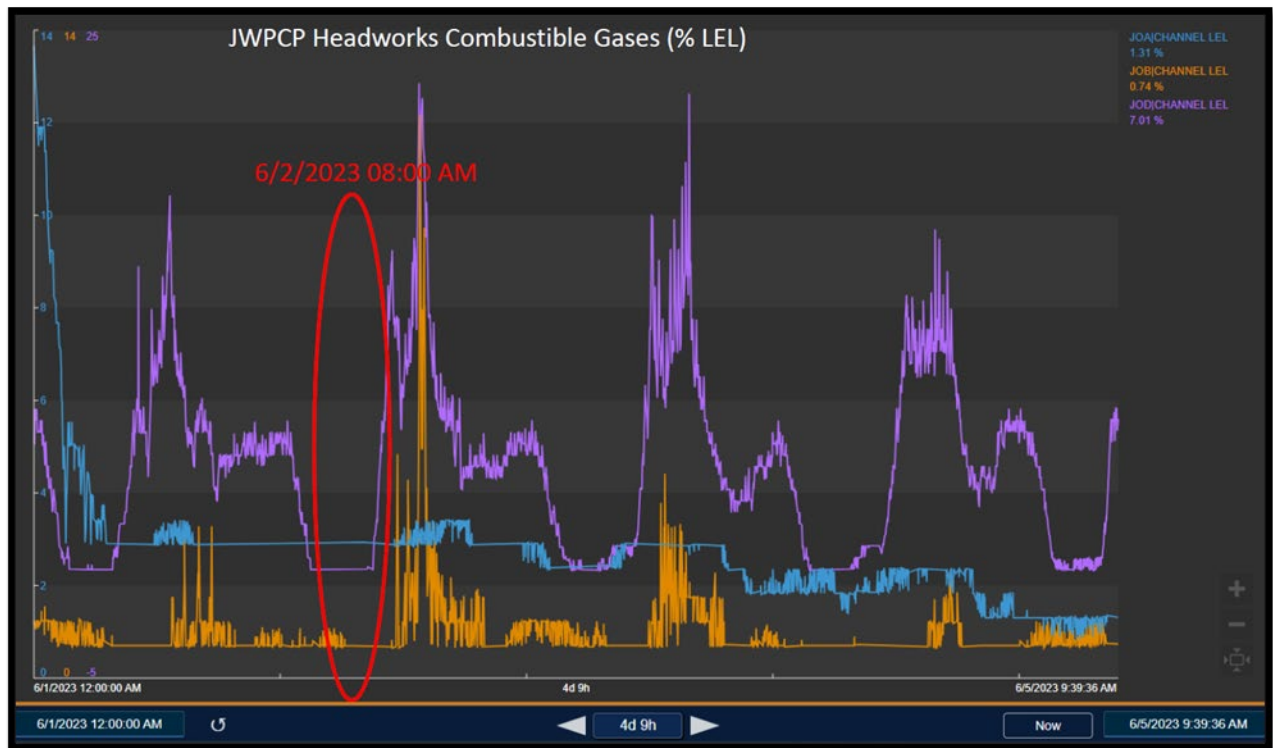
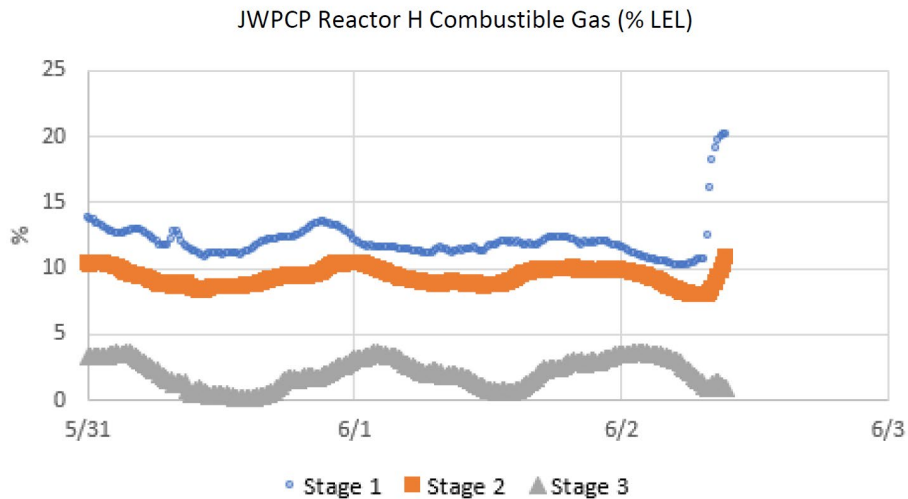
On Friday, June 2, 2023, at 0948 hours, the IW Section received an email from Wastewater Research reporting elevated combustible gas at JWPCP in Stage 1 Secondary Reactor "H." Combustible gas is measured by the lower explosive limit (LEL), which peaked at 20% (LEL) in Stage 1 Secondary Reactor "H." Research Staff did not observe similar LEL trends in Reactors B, C, D, E, F, G, or H. Reactors A and B were not in service. No other treatment plant anomalies were reported.

Figure 11. JWPCP Headworks Combustible Gases (%LEL) showed no combustible material entering the plant before the Reactor H incident.

Figure 12. JWPCP Reactor H Combustible Gas (%LEL)
