**2023 ANNUAL REPORT**

INDUSTRIAL WASTE PRETREATMENT PROGRAM

LOS ANGELES COUNTY SANITATION DISTRICTS

**APPENDIX H**  
INDUSTRIAL WASTE REPORTS ON INCIDENTS

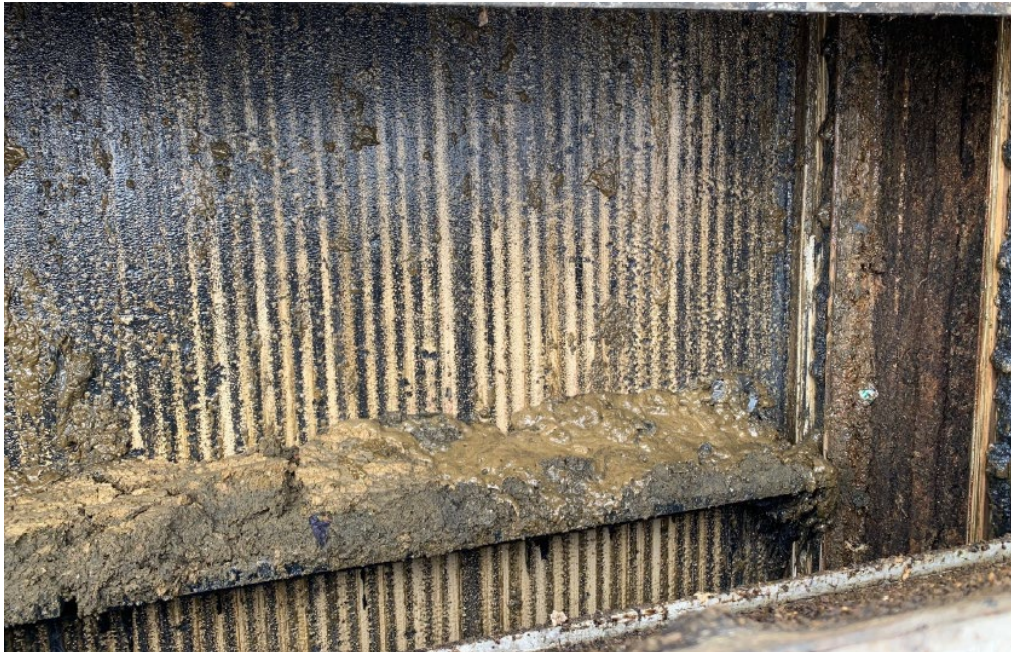
An internal investigation upstream of J.O. "A" inlet at the JWPCP found that a non-routine deep cleaning of a concentrated-polymer storage tank (Tank 1) took place on June 6, 2023. The bulk of the polymer was vacuumed and stored in a solids-dewatering pit for future disposal. Some rinse water from the "cleaned tank" was drained to a sump plumbed to J.O."A", which may have introduced residual concentrated polymer into the JWPCP J.O."A" inlet. This event, in combination with 14 truckloads of food waste slurry received at the Carson liquid waste disposal station between 0600 and 1200 hours on June 6, 2023, may have led to some E-1 and E-2 skimming issues and the inability of the lab to obtain samples through the thickened floating mat at the J.O. "A" inlet.

Figure 13. Heavy grease/solids impacting JWPCP J.O."A" bar screens.

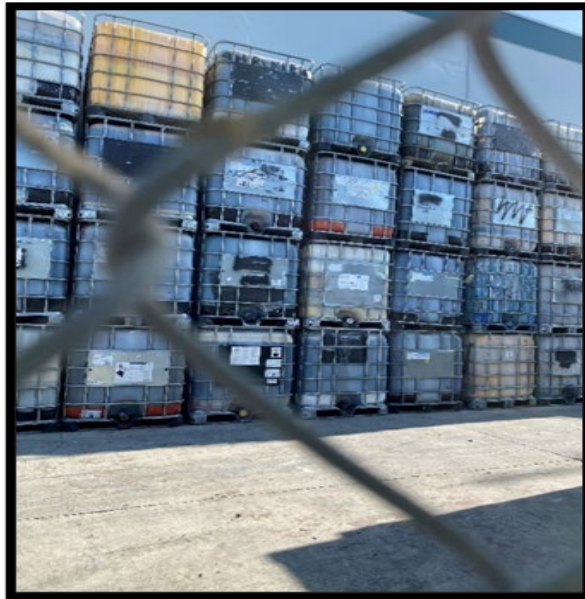
IW Inspectors conducted inspections at 13 companies having zinc, copper, chromium, and aluminum risks to SJCWRP-East. Of the 13 facilities inspected, two companies were identified as parties of concern: Acrylatex Corporation in Azusa and Stabile Plating located in Covina. Acrylatex Corp. is a paint recycling facility that has the potential to generate wastewater having elevated levels of zinc. The company was found to have more than 300 Intermediate Bulk Containers (IBCs) (*approximately 100,000 gallons*) of reclaim-paint wastewater stored at the facility. Moreover, company records indicated that the company discharged more than 20,000 gallons of wastewater during the time frame of the toxicity event. Stored wastewater samples were taken for laboratory analysis, results are pending.

The second company, Stabile Plating, is an aluminum anodizing facility tributary to SJCWRP-E. Wastewater samples taken at Stabile Plating revealed exceedances for chrome and copper. Although there are no discharge limits for aluminum, the sample result found 1140 mg/l of aluminum. IW Inspectors issued a notice-of-violation to Stabile Plating for chrome and copper phase 1 limit violations. The investigation will remain active pending further sample results, and inspectors will continue to monitor metal-bearing wastewater dischargers upstream of SJCWRP-E.

Figure 14. Acrylatex Wastewater IBC Totes

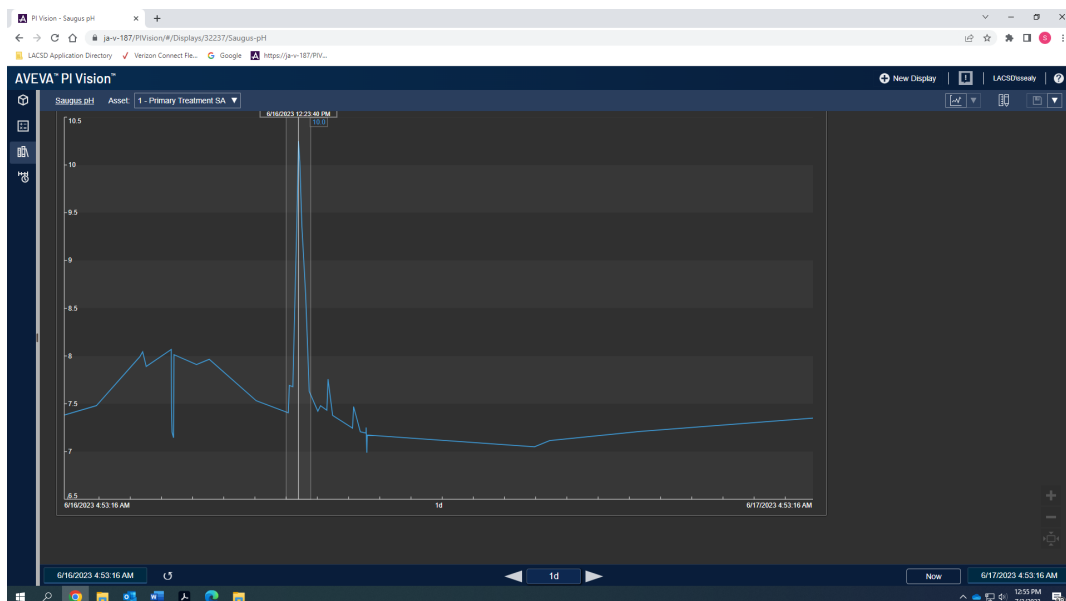
Additionally, Operations noted two brief, overnight increases in primary effluent ammonia concentrations. The first anomaly happened on Sunday, June 11, 2023, at 2000 hours, and the second occurred on Thursday, June 15, 2023, at 2100 hours. Ammonia concentrations reached 47 ppm and 45 ppm respectively, whereas normal is about 39 ppm during evenings. Both spikes in pH and ammonia had no adverse impacts on operations or treatment plant effluent.

Figure 15. Saugus WRP pH Trend June 16, 2023

IW Inspectors investigated 5 permitted facilities having WRP risks for elevated pH and/or ammonia at Saugus WRP. Suspected sources include the Saugus WRP liquid waste disposal station, a chemical manufacturer, a drinking water treatment plant, and rubbish waste bin washing facility. No evidence was found linking these facilities with the high pH or elevated ammonia incident. Furthermore, a review of the sewer maintenance schedule showed no crown spraying or caustic dosing upstream of the plant. This event had no negative impact on SAWRP operations. Operator's influent grab sample from June 16, 2023, was submitted for 7 metals analysis; results are pending. Follow up inspections at tributary industrial users will be performed to ensure continued compliance with permit requirements.

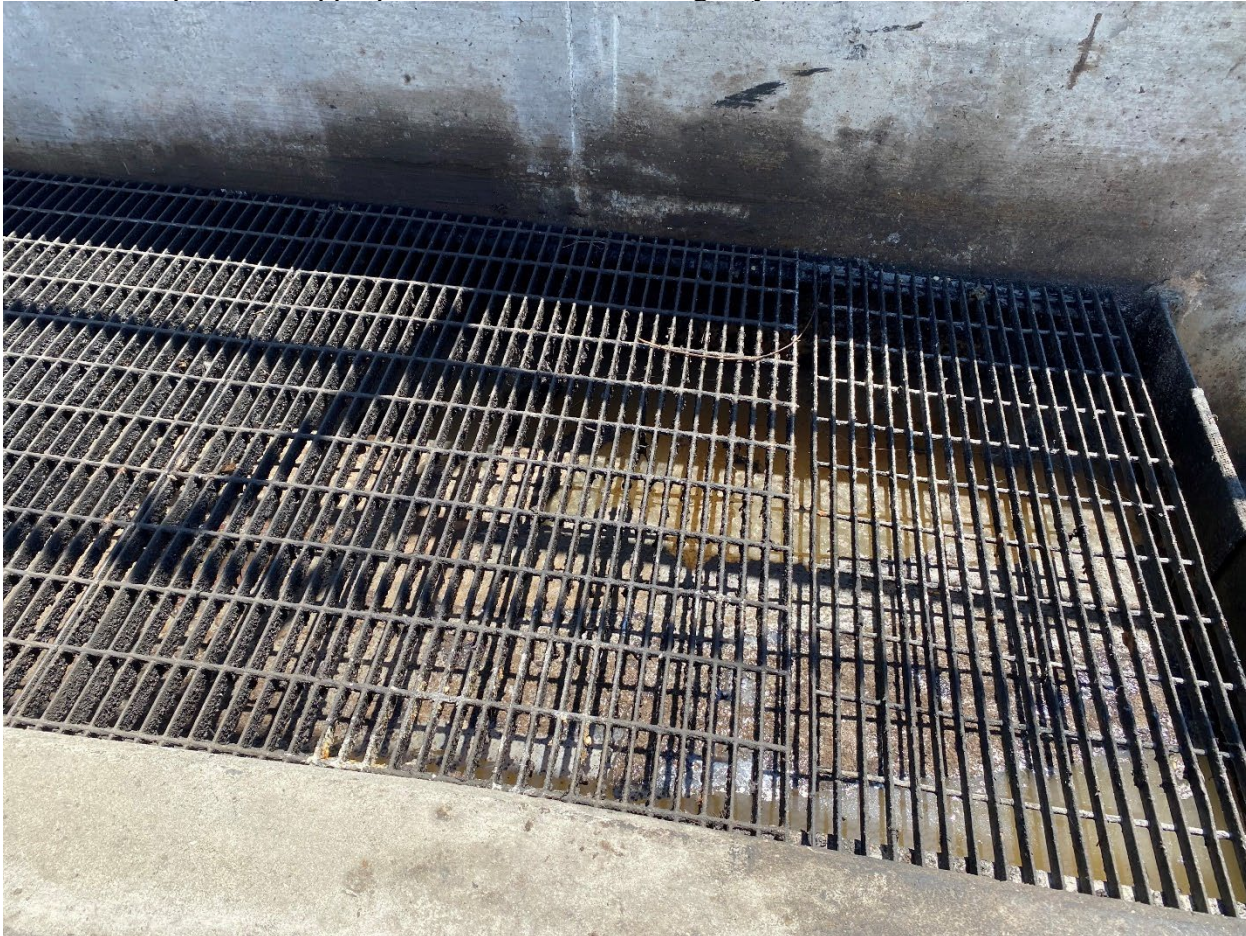
On Saturday, June 24, 2023, at 1421 hours Charles Nicholson of Frito Lay (FID 2014095) emailed the IW Inspection Staff reporting a spill of oily cornmeal waste on June 23, 2023, at 1840 hours. According to the contact, a level sensor that energizes a treatment system pump failed causing a cornmeal-waste storage tank to overflow into a nearby drain, which is plumbed to a stormwater trench (figure 9). On Monday June 26, 2023, IW Inspectors responded with IEUA Inspectors to investigate the impact of the

spill. Inspectors and facility staff were unable to determine the specific volume of cornmeal wastewater that overflowed into the stormwater trench (*Figure 9*). Nevertheless, the company was required to record an estimated spill volume and final disposition of the spill in their permit required spill log. This spill did not affect the IEUA or CSD sewer systems, and therefore no further actions by our agency was required. IEUA personnel referred the spill to the appropriate local stormwater agency.

**Figure 17. Trench Prior to Storm Drain**

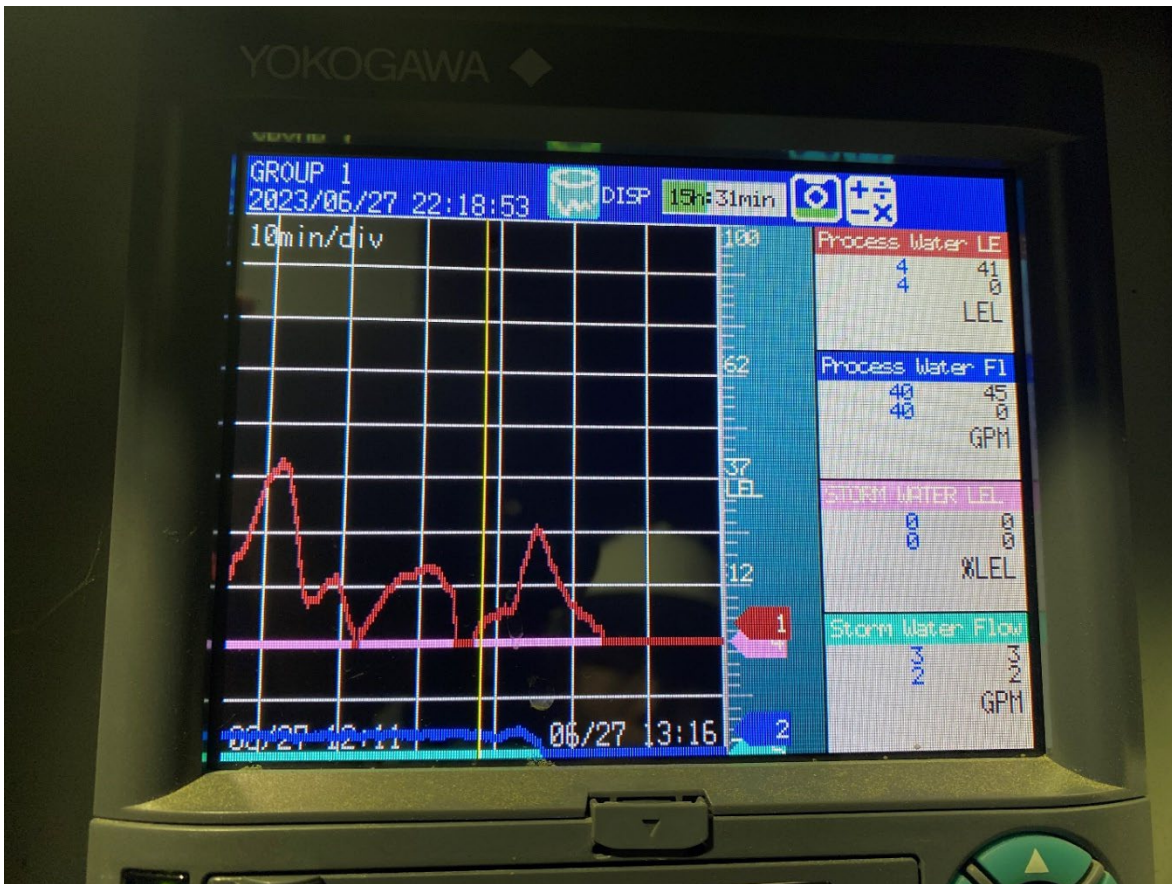
On Tuesday June 27, 2023, at 1846 hours, Equilon Enterprises, LLC dba Shell Oil Products (FID 2024720, IW 014939) notified the Industrial Waste Section that the facility's combustible gas monitoring system (CGMS) had exceeded the upper-level alarm lower explosive limit of 20%. The facility was discharging at the time of the alarm but ceased discharge upon knowledge of the event. A facility representative admitted that there may have been multiple instances earlier in the week where the lower explosive limit (LEL) exceeded 20%. The fire department was notified as part of the CGMS policy requirement.

Figure 18. Equilon Enterprise LLC dba Shell Oil Products monitoring equipment. Trend indicates LEL exceedance prior to wastewater impoundment and notification. Trend timespan is June 27, 2023, 133-1243 hour.

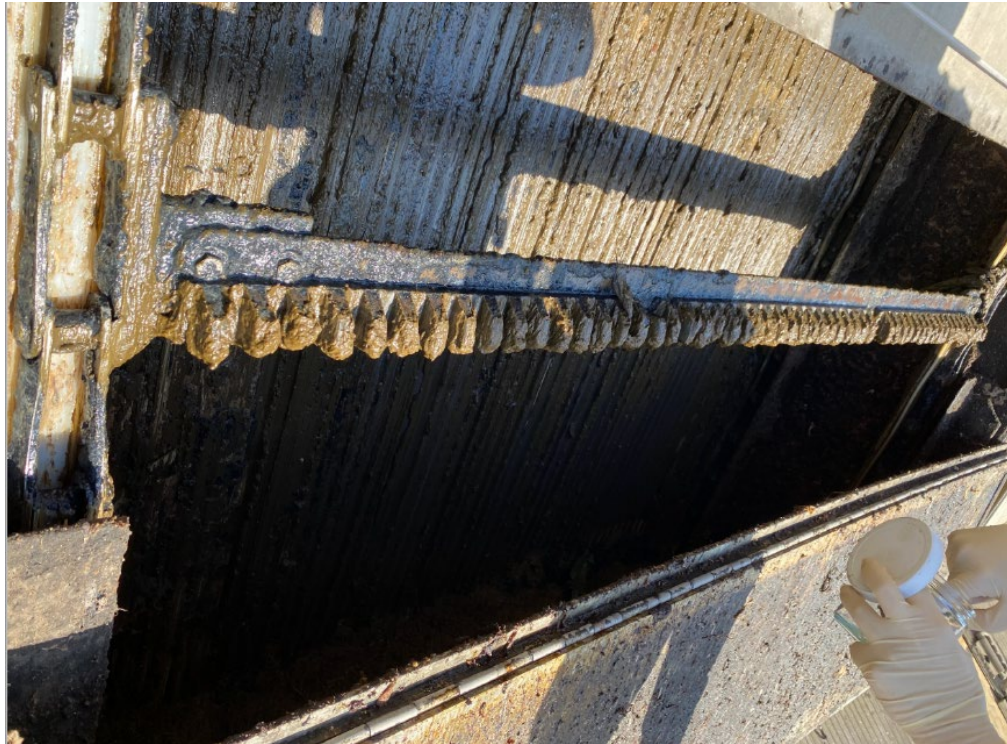
Figure 19. Food waste collected on the J.O. "A" inlet bar rakes.

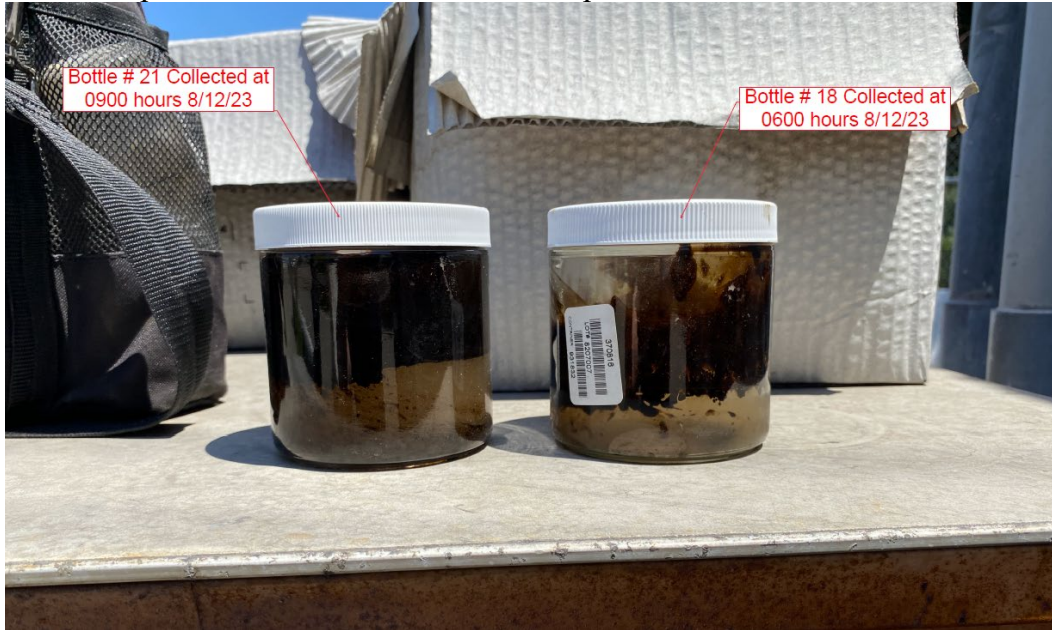
**Figure 3. Oily samples collected from the Phillips 66 Refinery's effluent sampler on August 12, 2023.**

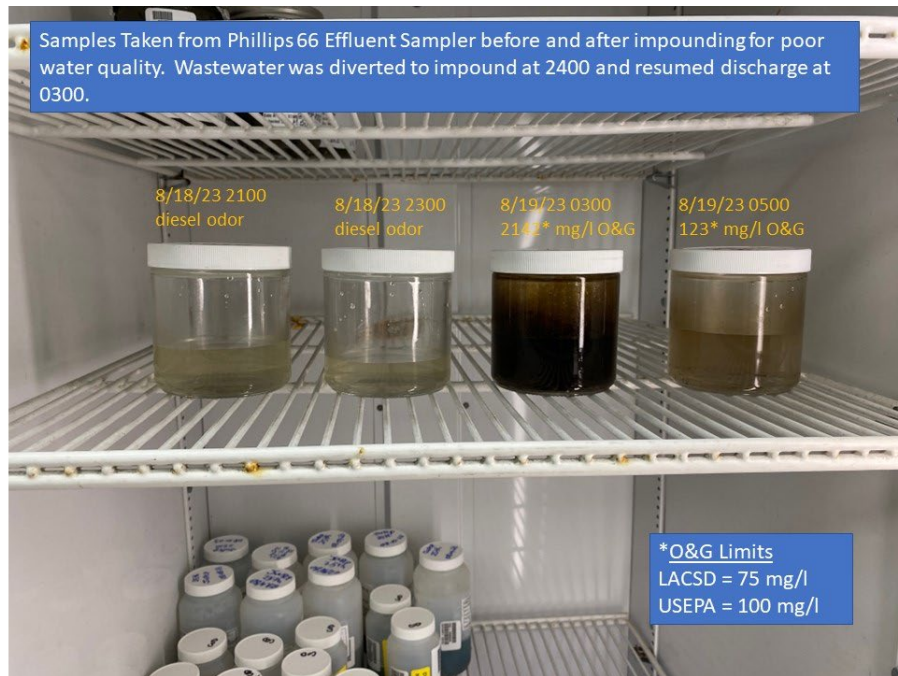
Figure 5. Samples Taken from Phillips 66 Effluent Sampler August 19, 2023.

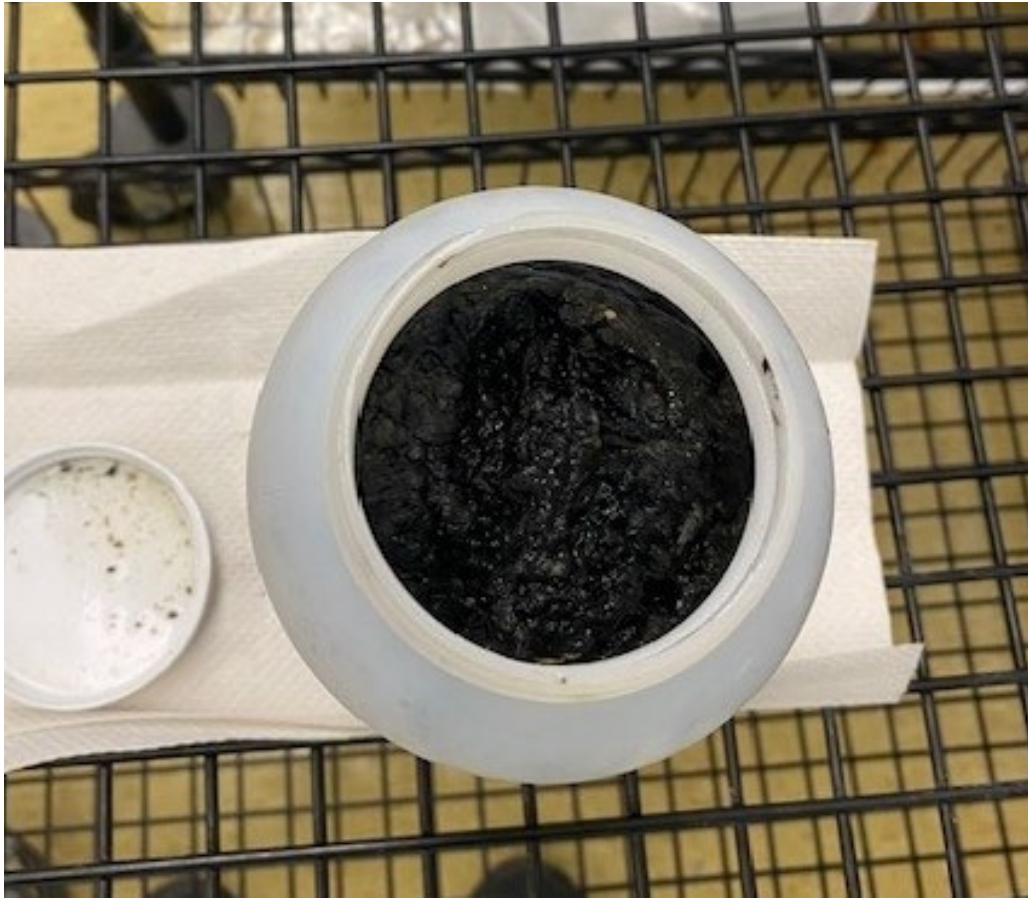
**Figure 5. Gelatinous solids from the J.O.'A' Inlet to the headworks**

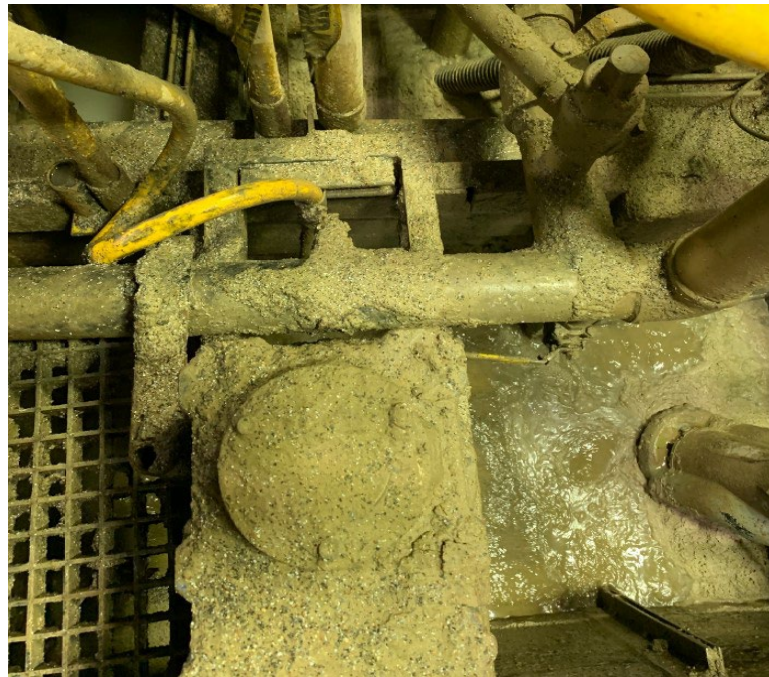
**Figure 4. Sand in the collection pit at Owens Corning.**

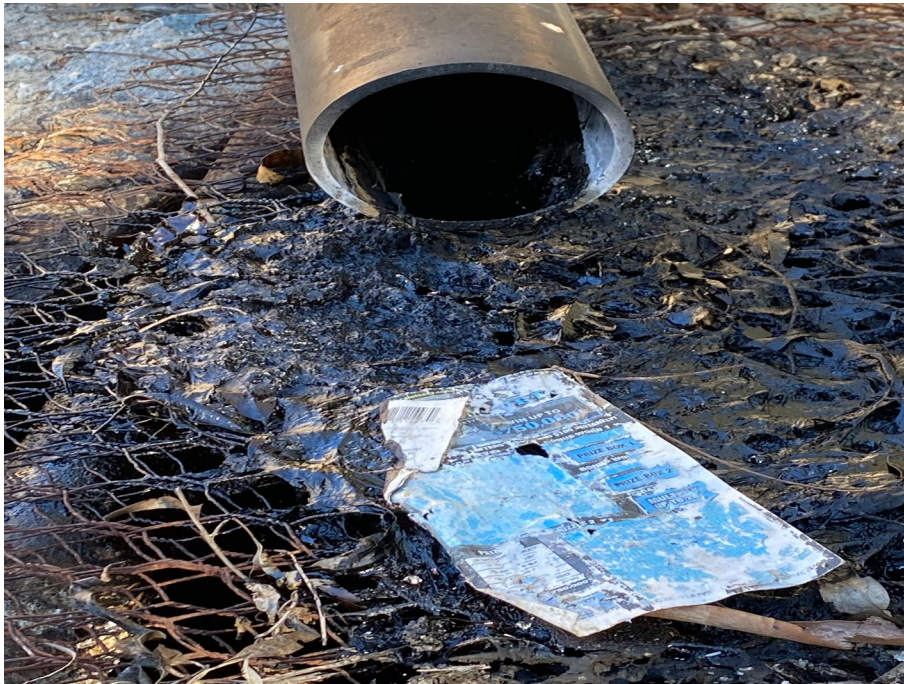
**Figure 1. Oil at Pacific Palms Legal Sample Point.**

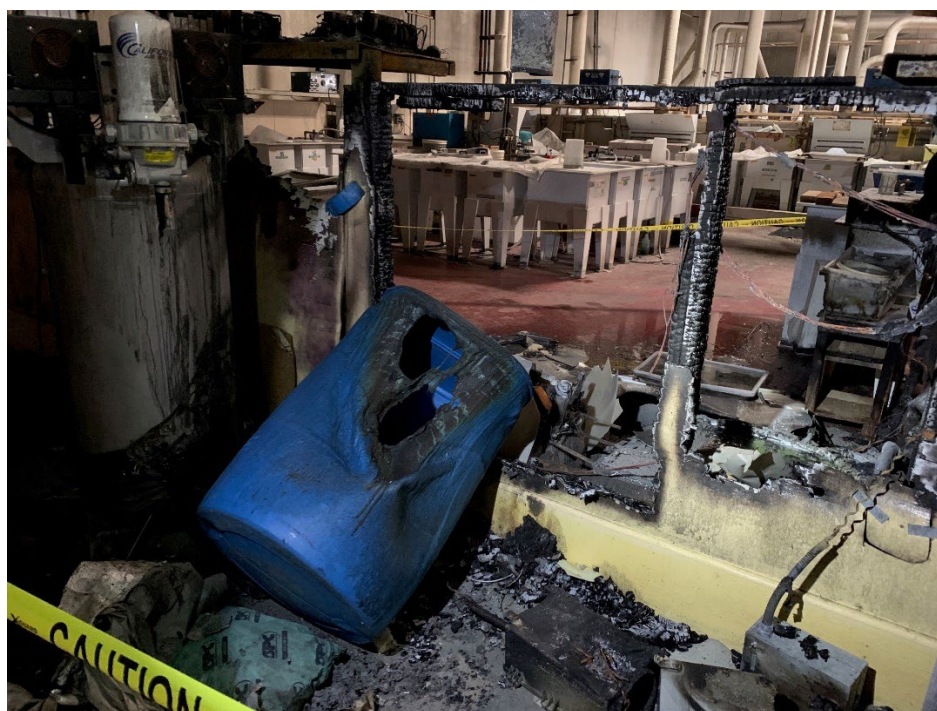
Figure 1. Fire-damaged gold plating line.
