# ANNUAL REPORT, 2023

## WHITE POINT OUTFALL SYSTEM INSPECTION

**LOS ANGELES COUNTY  
SANITATION DISTRICTS**

**A.K. Warren Water Resource Facility  
White Point Outfall System Inspection Annual Report, 2023  
Order No. R4-2023-0181, NPDES No. CA0053813, CI-1758**

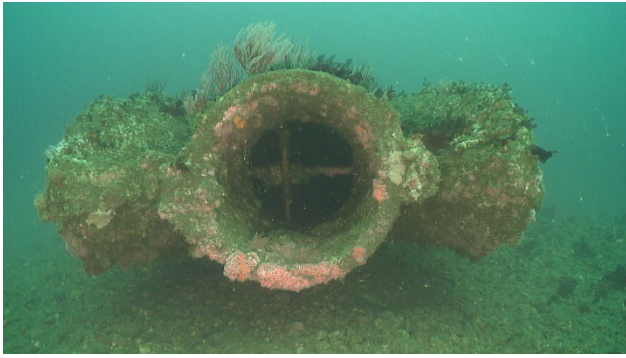
**Figure 18: The tri-jet end structure of the 60-inch outfall with detached support girder.**

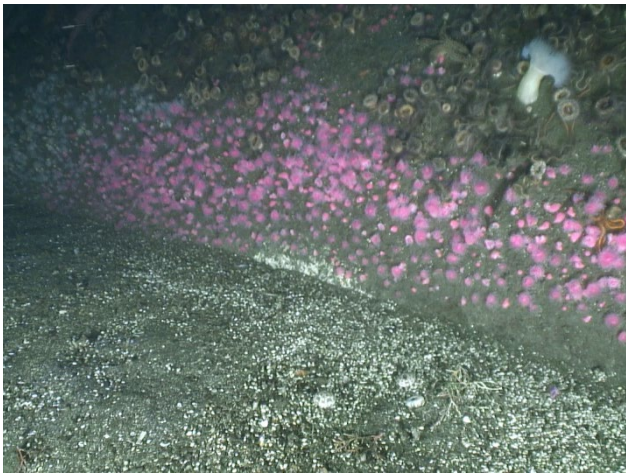
**Figure 22: A buried port with no flow, 10<sup>th</sup> from the terminus, on the north side of the 120-inch outfall.**

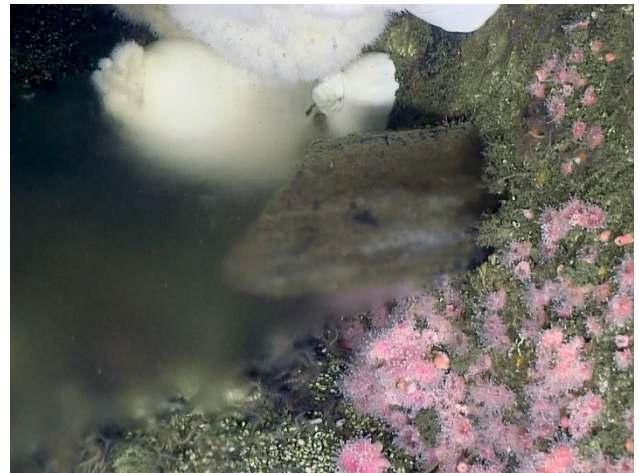
**Figure 25: A partially blocked port, 8<sup>th</sup> from the terminus, on the south side of the 120-inch outfall.**

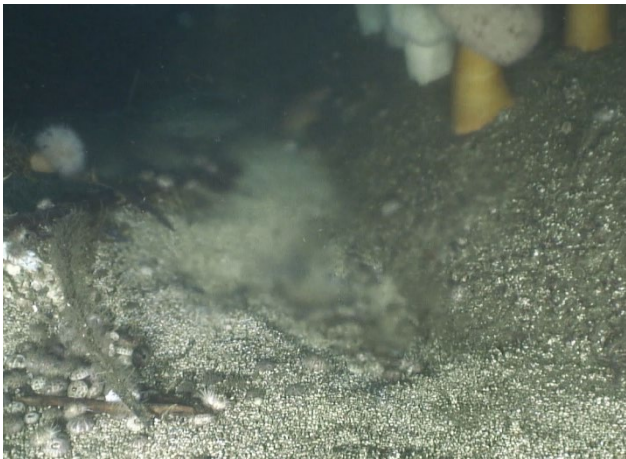
**Figure 23: A buried port with reduced flow (weeping), 15<sup>th</sup> from the terminus, on the north side of the 120-inch outfall.**

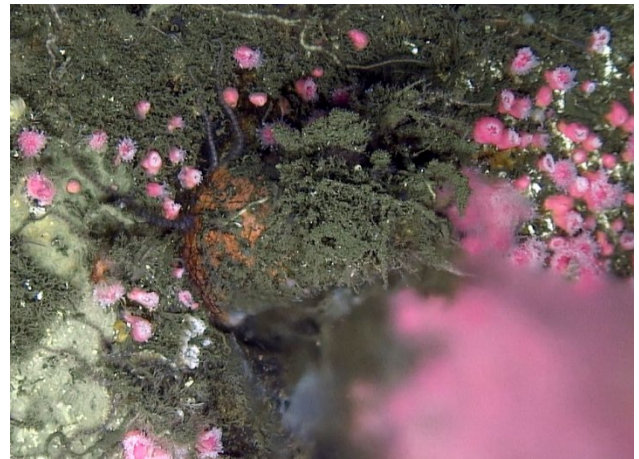
**Figure 26: A partially blocked port with reduced flow, 11<sup>th</sup> from the terminus, on the south side of the 120-inch outfall.**

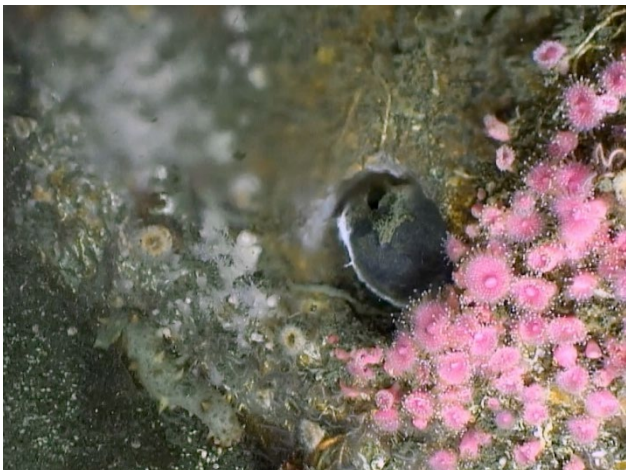
**Figure 24: An internally blocked port with reduced flow, 7<sup>th</sup> from the terminus, on the south side of the 120-inch outfall.**

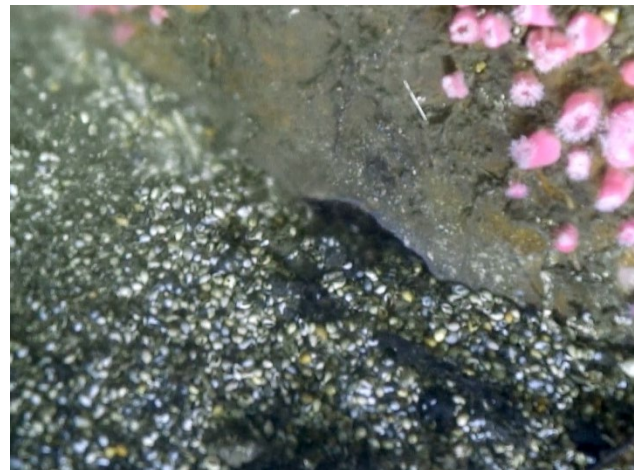
**Figure 27: A partially buried port with reduced flow, 12<sup>th</sup> from the terminus, on the south side of the 120-inch outfall.**

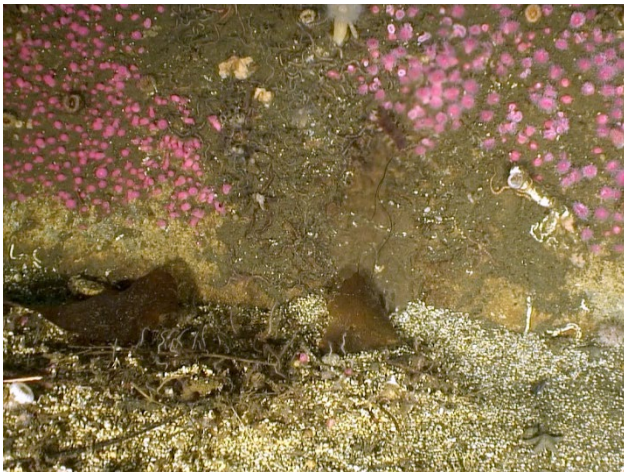
**Figure 28: A buried port with reduced flow (weeping), 13<sup>th</sup> from the terminus, on the south side of the 120-inch outfall.**

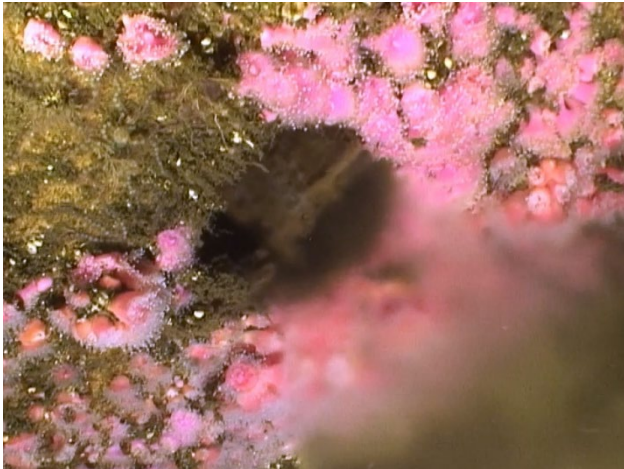
**Figure 29: A partially blocked port, 20<sup>th</sup> from the terminus, on the south side of the 120-inch outfall.**

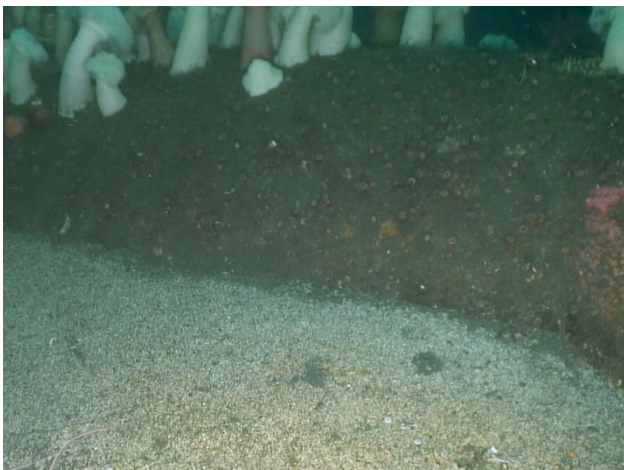
**Figure 30: A buried port with no flow, 21<sup>st</sup> from the terminus, on the south side of the 120-inch outfall.**

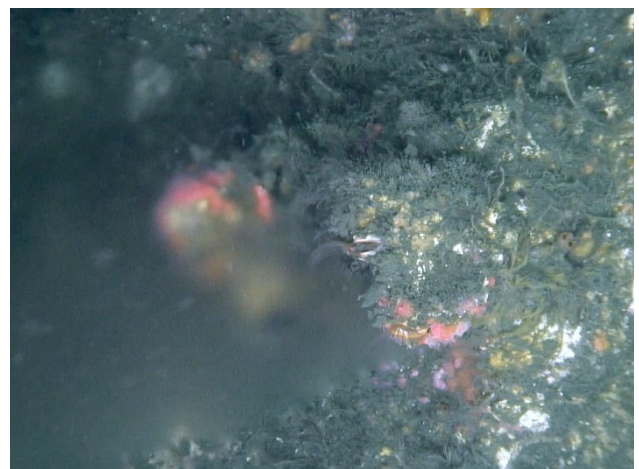
**Figure 32: Barnacle collar formed around a port on the 120-inch outfall. Effluent flow does not appear to be altered by these collars.**

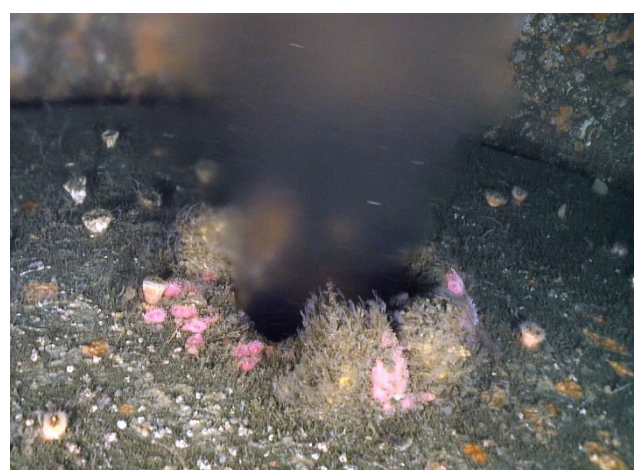
**Figure 33: Vertical port encrusted with barnacles and other fouling animals on the 120-inch outfall.**

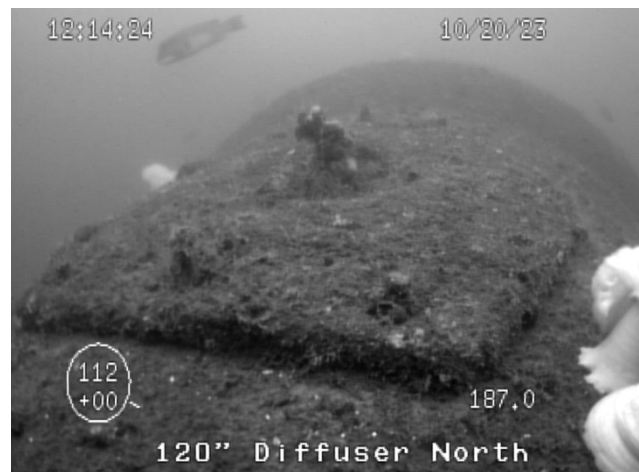
**Figure 35: Detached anode on the 120-inch outfall.**

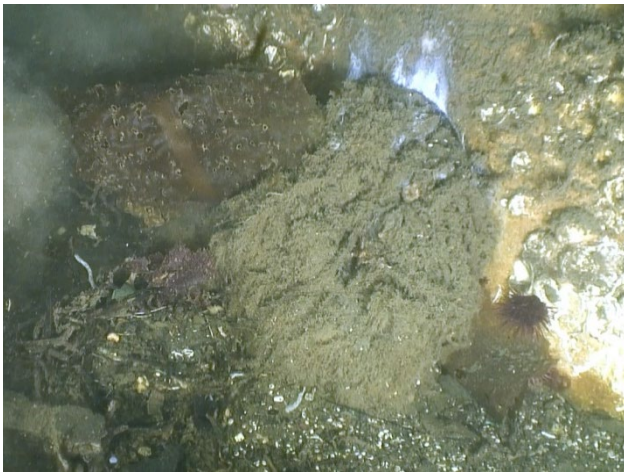
Diffuser Leg and Side	Port Number	Figure Number	Description
East Leg North Side	3	37	partially blocked (internal obstruction), substantially reduced flow

**Figure 37: A partially blocked port with substantially reduced flow, 3<sup>rd</sup> from the terminus, on the north side of the east diffuser leg of the 90-inch outfall.**

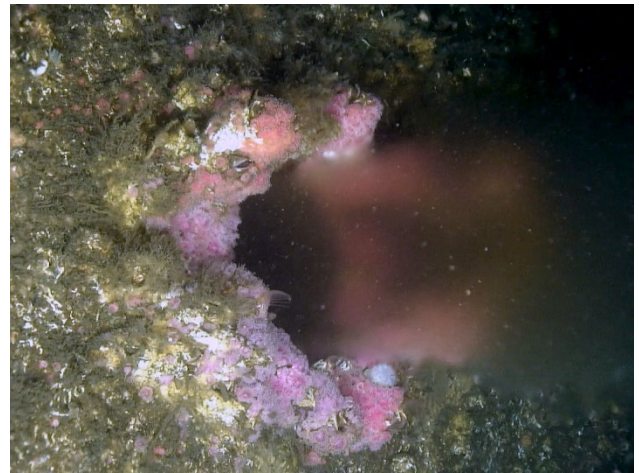
**Figure 40: Barnacle collar formed around a port on the 90-inch outfall.**

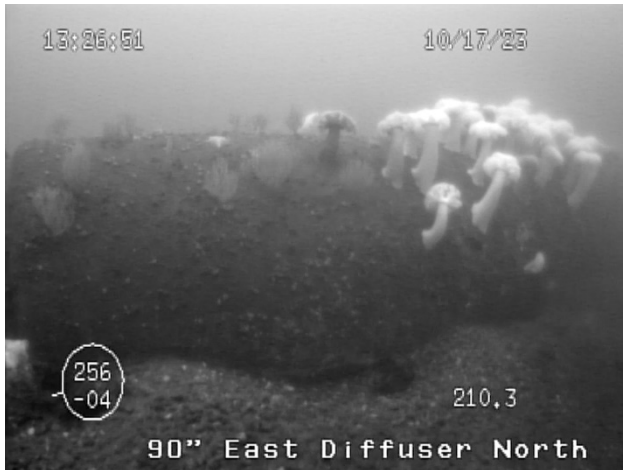
**Figure 41: Area of partial undercutting, 2<sup>nd</sup> pipe section from the terminus, on the north side of the east diffuser leg of the 90-inch outfall.**

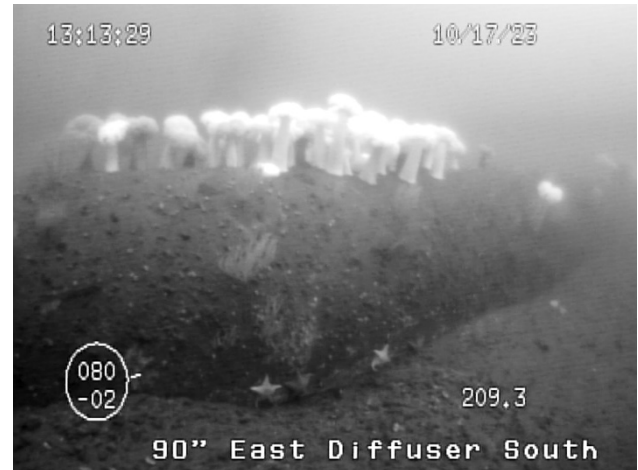
**Figure 42: Area of partial undercutting, 2<sup>nd</sup> pipe section from the terminus, on the south side of the east diffuser leg of the 90-inch outfall.**

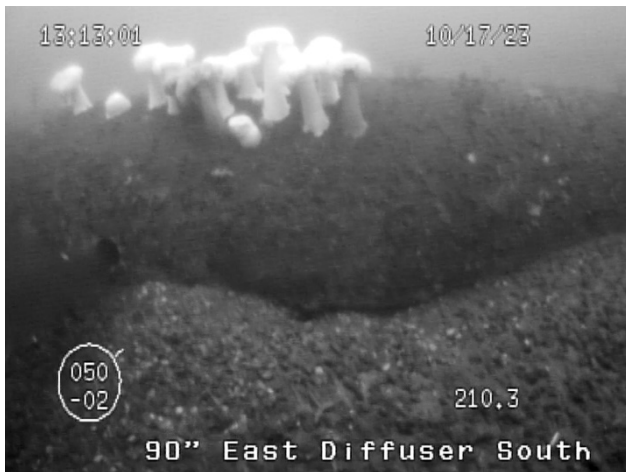
**Figure 43: Area of partial undercutting, 3<sup>rd</sup> pipe section from the terminus, on the south side of the east diffuser leg of the 90-inch outfall.**

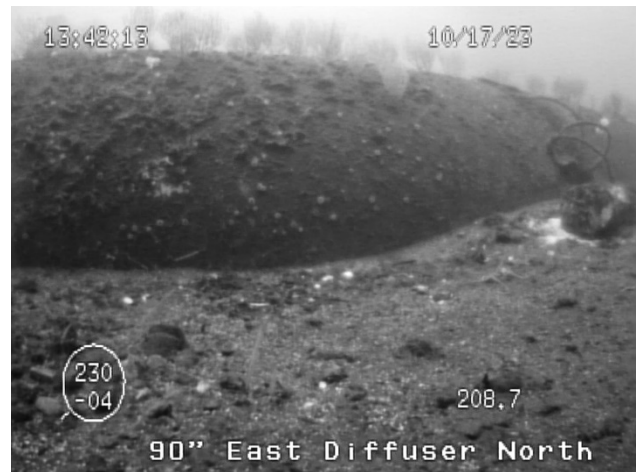
**Figure 46: Area of partial undercutting, 10<sup>th</sup> pipe section from the terminus, on the north side of the east diffuser leg of the 90-inch outfall.**

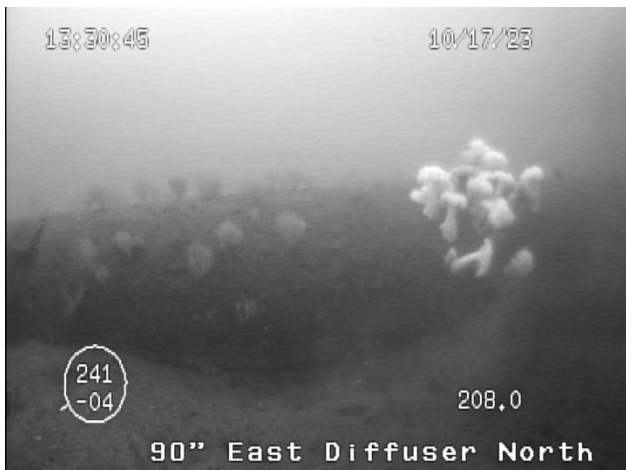
**Figure 44: Area of partial undercutting, 4<sup>th</sup> pipe section from the terminus, on the north side of the east diffuser leg of the 90-inch outfall.**

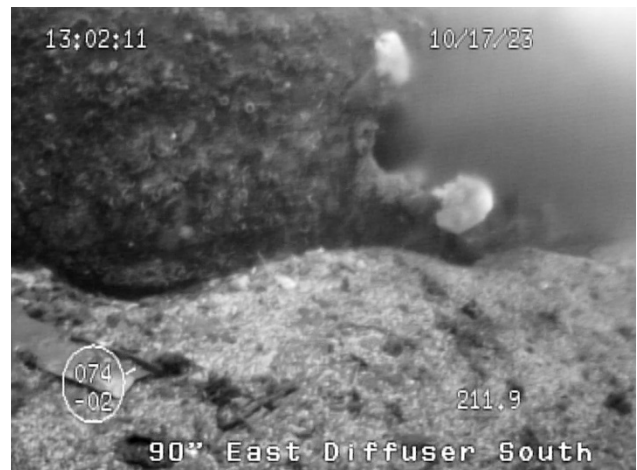
**Figure 47: Area of partial undercutting, 11<sup>th</sup> pipe section from the terminus, on the south side of the east diffuser leg of the 90-inch outfall.**

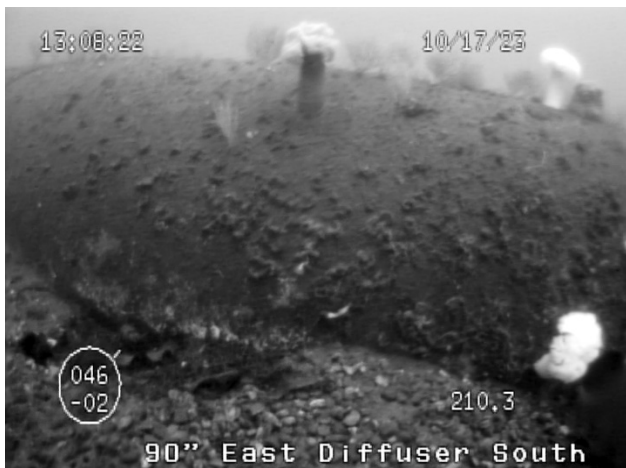
**Figure 45: Area of partial undercutting, 5<sup>th</sup> pipe section from the terminus, on the south side of the east diffuser leg of the 90-inch outfall.**

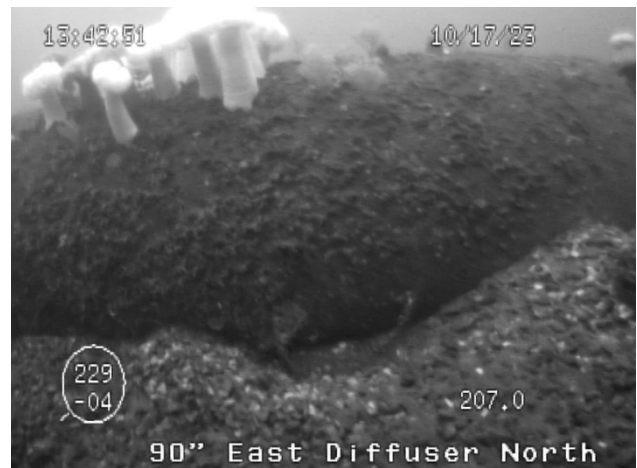
**Figure 48: Area of partial undercutting, 12<sup>th</sup> pipe section from the terminus, on the north side of the east diffuser leg of the 90-inch outfall.**

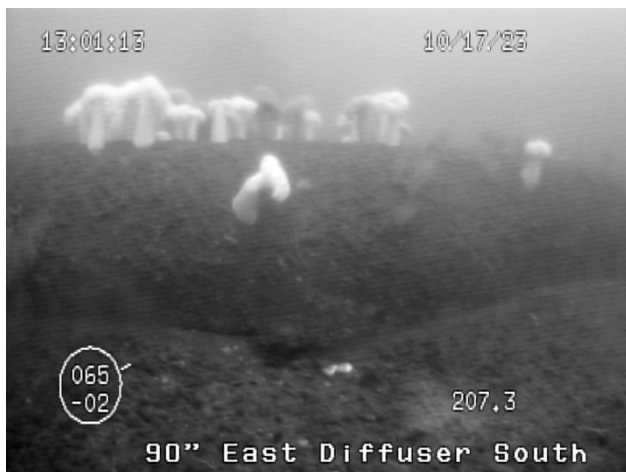
**Figure 49: Area of partial undercutting, 12<sup>th</sup> pipe section from the terminus, on the south side of the east diffuser leg of the 90-inch outfall.**

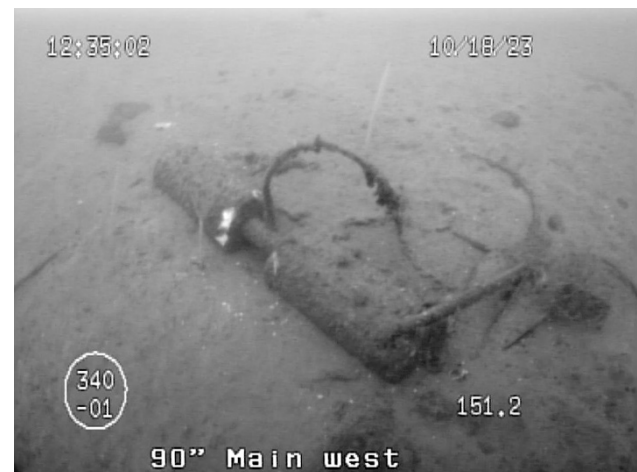
in 168 feet of water. A boat anchor was observed several feet from the outfall entangled with an anode that was previously reported as missing (**Figure 50**).

**Figure 50: An anode that was previous reported missing entangled with a boat anchor several feet off of the 90-inch outfall.**

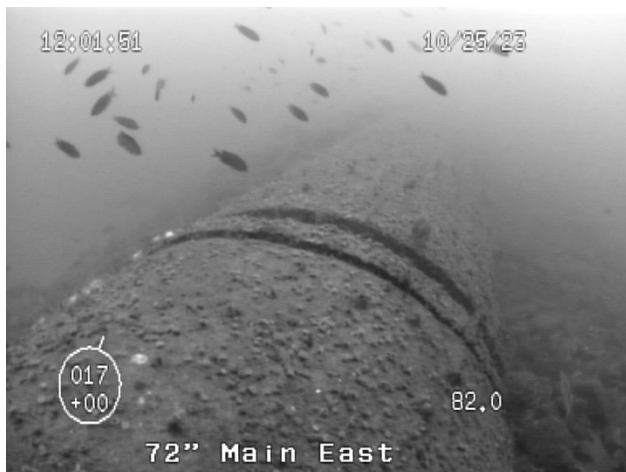
The raised and flush manhole covers appeared to be in good condition with no evidence of corrosion. There are two pipe sections located in 105 feet of water that have two flush manhole covers per pipe section. Most of the joints appeared to be in good condition. Cracking within the joint collars was observed in 30 joints (Figure 54, Appendix D).

**Figure 54: Cracked joint collar on the 72-inch outfall.**

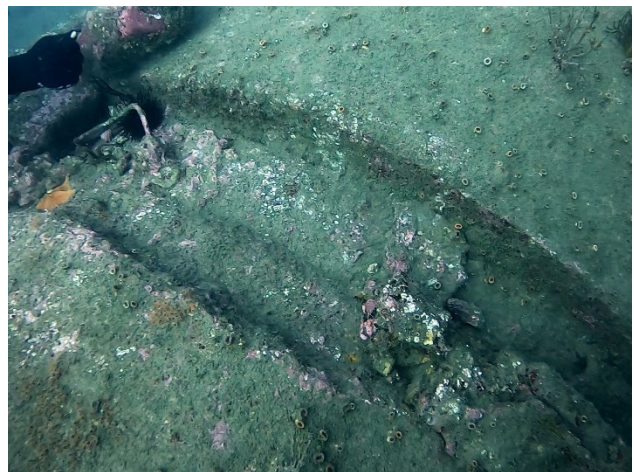
Deterioration of the joint collar, where portions of the concrete collar has spalled away from the joint, was observed in 33 joints (**Figure 55**, Appendix D). The deterioration of the concrete collars does not appear to affect the structural or functional integrity of the joint. All the encapsulated joints appear to be in good condition (**Figure 56**). Of the 214 cast iron joints and 10 cast iron manhole covers, ranging in water depth from 161 to 48 feet, that were outfitted with aluminum anodes in 2015, 54 joints and 7 manhole covers were observed having detached cable connections (Appendix D). Ten detachments from joints and one detachment from a manhole cover were new observations for this survey. Four manhole covers not listed in Appendix C were observed as not having anodes installed, located on two consecutive pipe sections between MH-72-009 and MH-72-010. Several pieces of anode cable debris and rope were seen at various locations on the outfall and within the ballast rock. A fishing pole was observed adjacent to the east diffuser leg terminus. Two moderately sized tires, which have been encountered in previous surveys, were again located within the ballast rock in 108 feet of water.

**Figure 55: Deteriorating joint collar on the 72-inch outfall.**

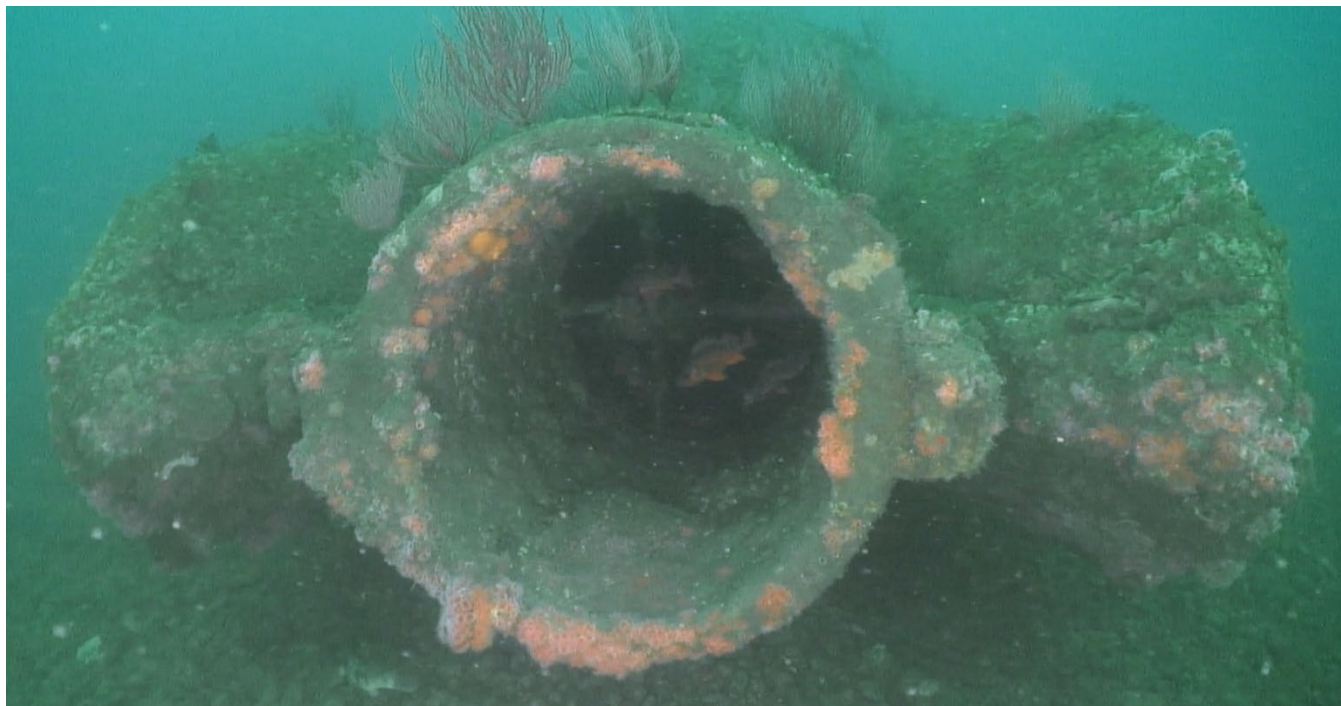
The tri-jet end structure appears to be structurally sound even though the support girder has been detached since 2015 (**Figure 57**). The stainless steel crossbar installed inside the middle jet in 2001 to prevent diver access was observed intact. The steel plate on the west jet shows signs of corrosion, though the steel plate is still intact (**Figure 58**). The steel plate covering the east jet has partially corroded away, creating an opening in the end structure that is still too small for diver access (**Figure 59**).

**Figure 57: Tri-jet end structure of the 60-inch outfall showing the stainless steel crossbar within the middle jet. Little to no ballast material remains supporting the structure.**

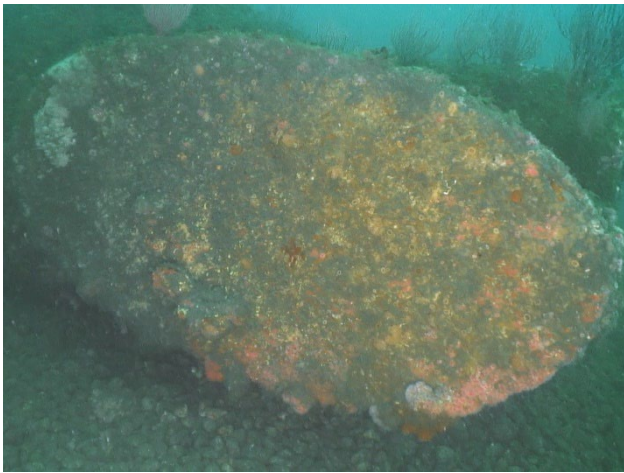
**Figure 58: Signs of corrosion on the steel plate covering the west jet of the tri-jet end structure on the 60-inch outfall.**

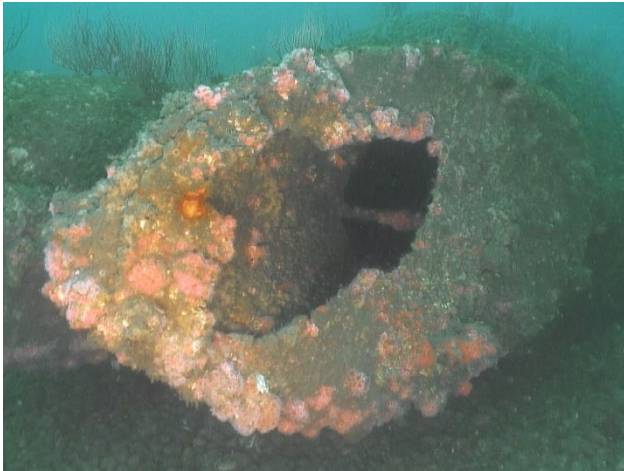
**Figure 59: Partially corroded steel plate covering the east jet of the tri-jet end structure on the 60-inch outfall.**

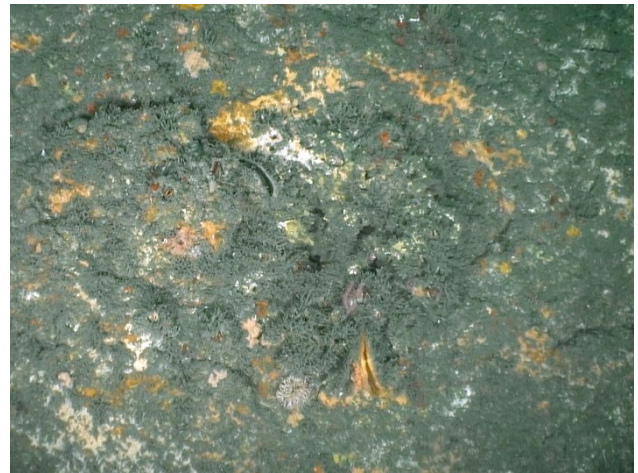
All 42 ports on the main barrel were inspected and none had internal obstructions. All of the ports had various sized barnacle collars, with several of the ports appearing to be entirely encrusted. Without continuous effluent flow out of the ports, as seen in the 120- and 90-inch outfalls, the barnacle collars can develop over the ports causing differing degrees of external blockage (**Figure 60**). The shallowest ports were observed in 98 feet of water.

**Figure 60: Barnacle collar formed around and over a port on the 60-inch outfall.**

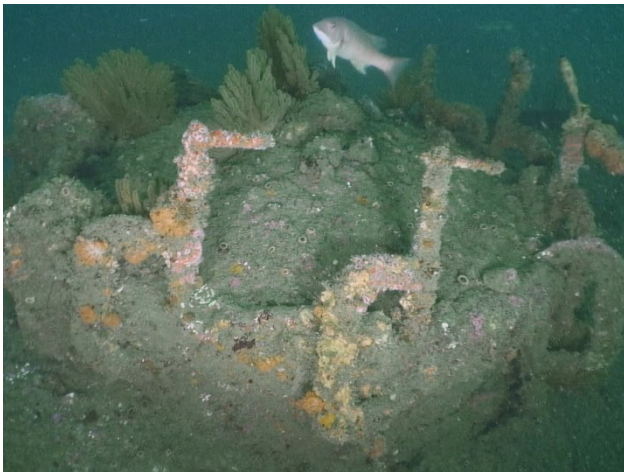
The raised manhole covers appeared to be in functional condition with no evidence of corrosion. The inner most raised manhole cover, located in a water depth of 66 feet and fitted with six C-clamps in late 2015 (LACSD 2016), was inspected to ensure all clamps were secure (**Figure 62**). Divers conducted dives to this manhole on 20 January 2023 and 14 June 2023 and insured that the installed C-clamps were still secured. Additional dives on the manhole throughout the year will continue until new permanent clamps can be made and installed.

**Figure 62: Six C-clamps were installed onto the inner most raised manhole in late 2015 on the 60-inch outfall.**

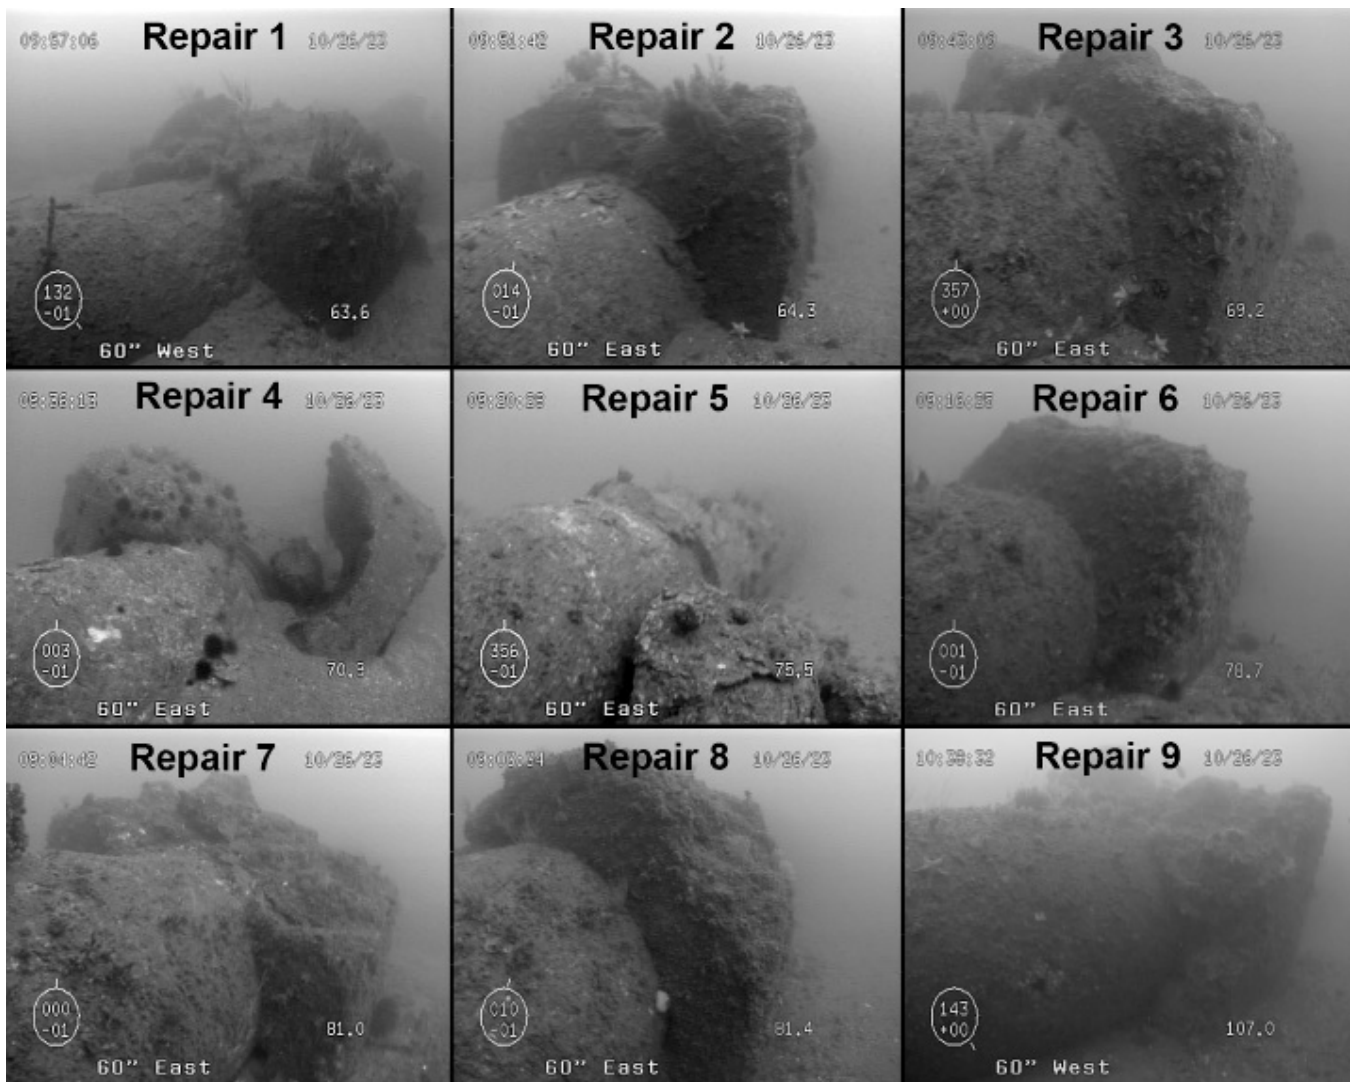
Although heavily corroded, the thick cast iron joints appear structurally intact and hydraulically tight. The joints with block repairs are in various stages of deterioration (**Figure 63**). The fifth inner most block repair exhibited considerable deterioration since the 2022 outfall inspection, with nearly the entire repair breaking apart from the joint (**Figure 64**). Though deteriorating, the underlying joints appeared to be in a similar or slightly better condition than the other joints on this outfall.

**Figure 63: All the block repairs on the 60-inch outfall. The numbering starts at the most inshore repair.**

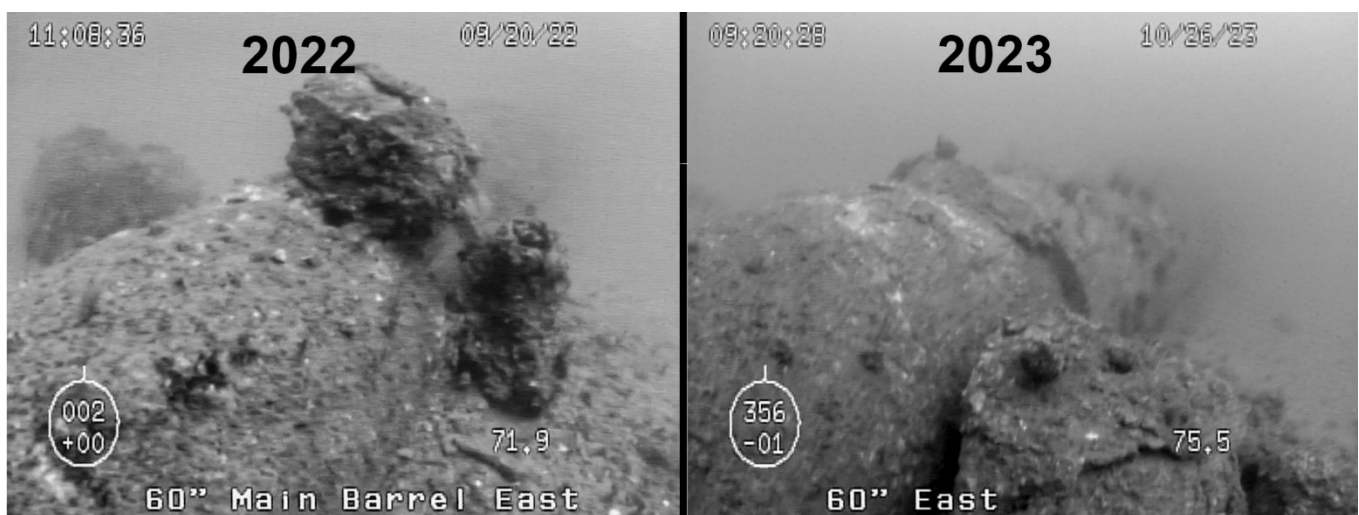
**Figure 64: A comparison of the 5<sup>th</sup> inner most block repair between the 2022 outfall inspection and the 2023 outfall inspection, showing extensive deterioration.**

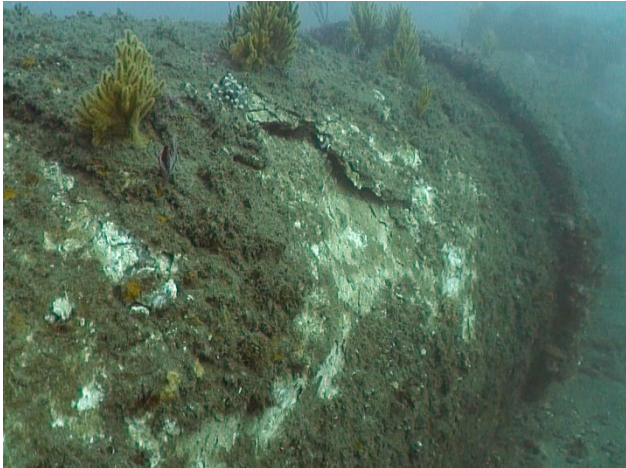
Concrete spalls were frequently encountered along the length of the outfall, many of which extended deep enough to expose the steel rebar (**Figure 65**). Much of the exterior concrete is brittle and could be easily removed or dislodged, although the underlying concrete is hard. The most severe spalling was observed near the joints.

**Figure 65: Area of spalling on the 60-inch outfall.**
