2019 ANNUAL REPORT

INDUSTRIAL WASTE PRETREATMENT PROGRAM

LOS ANGELES COUNTY SANITATION DISTRICTS

APPENDIX H
INDUSTRIAL WASTE REPORTS ON INCIDENTS

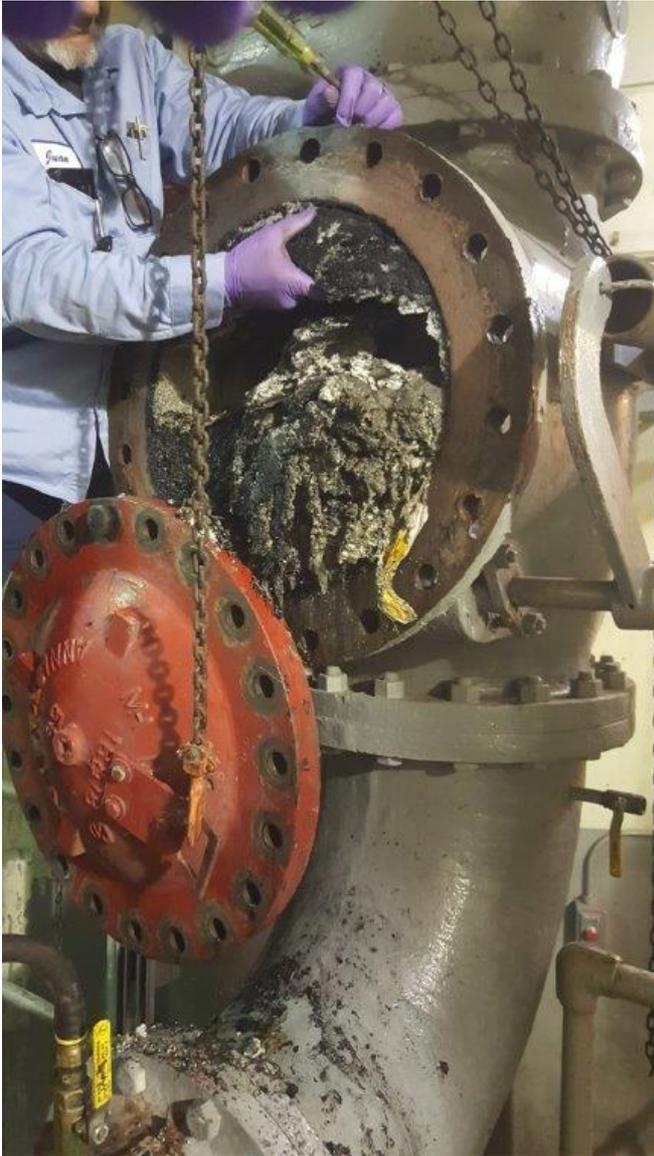
On Thursday, 1-3-19 at 0800 hours, Jeff Masters, Districts' Supervisor of Pumping Plant Operations and Maintenance called Supervising IW Inspector John Boyd and reported that his maintenance technicians were again seeing heavy greasing at the Coyote Creek Pumping Plant in Cerritos while conducting their annual maintenance duties at the plant. Specifically, they are observing grease in the check valves. This condition was also noted during similar maintenance operations about a year earlier on December 12, 2017.

Team 2 Senior IW Inspector Jim Percy, as well as fellow Team 2 Inspectors James McCurdy and Jason Finn met with operators on-site at the pumping plant at 1000 hours on 1-3-19, and again on Monday, 1-7-19 at 0930 hours. A layer of accumulated grease was observed in the pump housings. Heavy greasing was also observed in the adjacent check valves (see Figure 1 below). The grease appears to be cooking grease as opposed to any petroleum-related material. Inspections of upstream industrial wastewater dischargers conducted over the previous year as a result of the December 2017 report have not identified any source(s) for this grease; however it's suspected that at least some of the grease may be coming from a relatively nearby large restaurant, Clearman's North Woods Inn, which discharges directly into the District's 18" Valley View trunk. This trunk feeds wastewater to the Coyote Creek Pumping Plant. The restaurant is located about 1.2 miles upstream of the pumping plant (see Figure 2 below). Inspection of the restaurant on 1-14-19 found that the restaurant lacks any grease control equipment such as under-sink grease traps or a grease interceptor. IW Inspectors are working with the Los Angeles County Department of Public Works and City of La Mirada code enforcement officials to require grease control equipment be installed by the restaurant. IW Inspectors will also continue to be vigilant for other potential grease sources located upstream of the pumping plant.

Figure 1: 1-7-19 Photo of heavy greasing in one of the check valves at the Coyote Creek Pumping Plant.

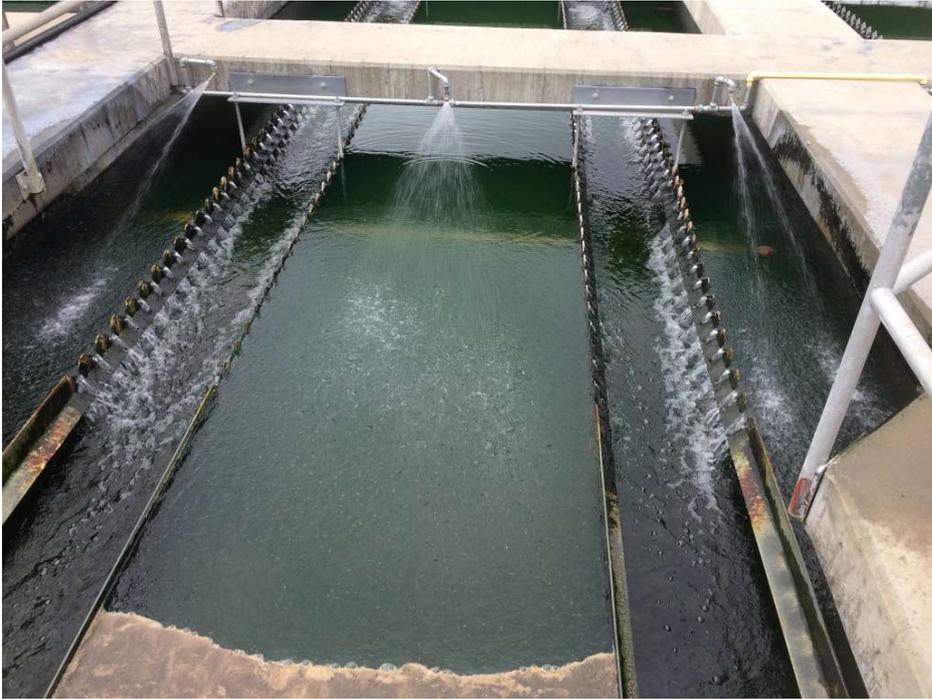
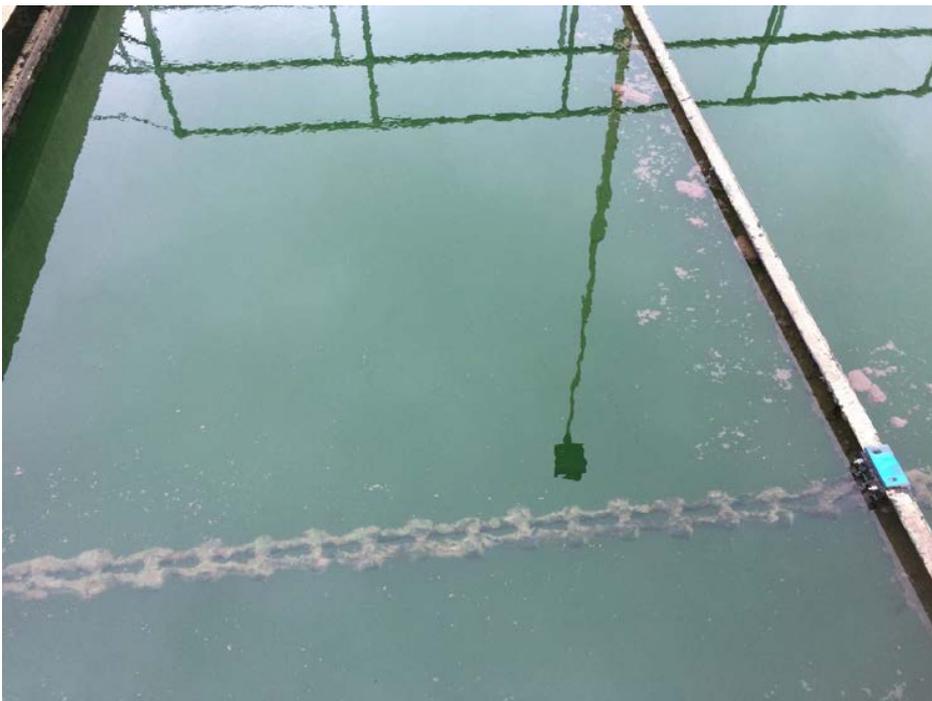
On Thursday, 1-17-19 at 1500 hours, Supervising TPO Ron Foster of the Saugus WRP called Supervising IW Inspector John Boyd and reported that WRP operators had just noted that the water in the secondary clarifiers was an unusual "emerald" green color at 1440 hours. There were no unusual odor or treatment issues associated with the color, nor were the secondary aeration tank dissolved oxygen concentrations outside their normal levels. Foster said the operators took two samples of the material for IW Inspectors and he had also taken some pictures, which he sent to Boyd (see Figures 4 and 5 below).

Figure 4: Picture taken at about 1450 hours on Thursday, 1-17-19 of the green color in the Saugus WRP Secondary Clarifier tanks. Operators described the color as emerald green.

Figure 5: Picture taken at about 1450 hours on Thursday, 1-17-19 of the green color in the Saugus WRP Secondary Clarifier tanks. Operators described the color as emerald green.

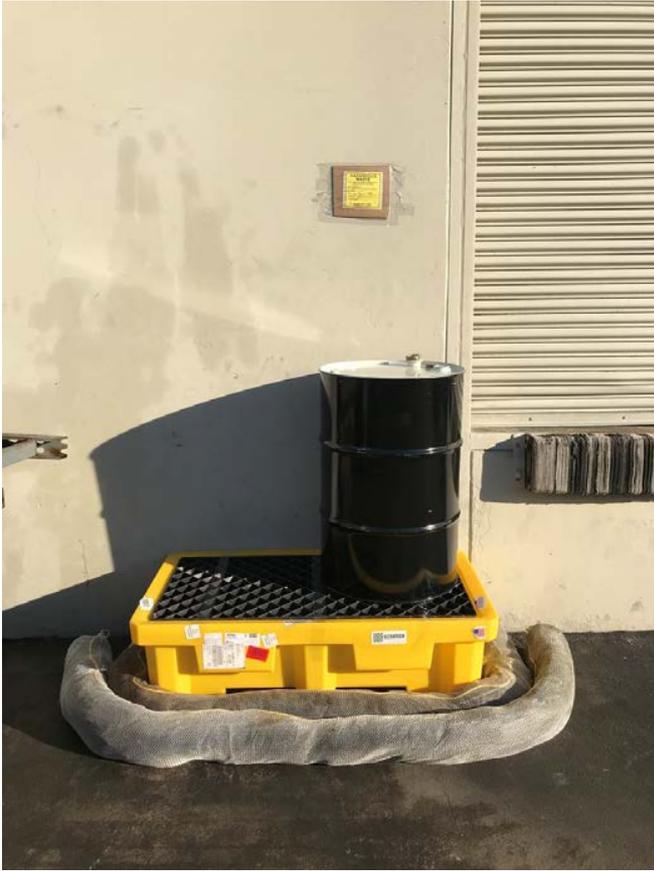
Figure 6: 2-4-19 GN photo showing the company's new containment pallet that was purchased and installed to prevent any spill(s) reaching the stormdrain.

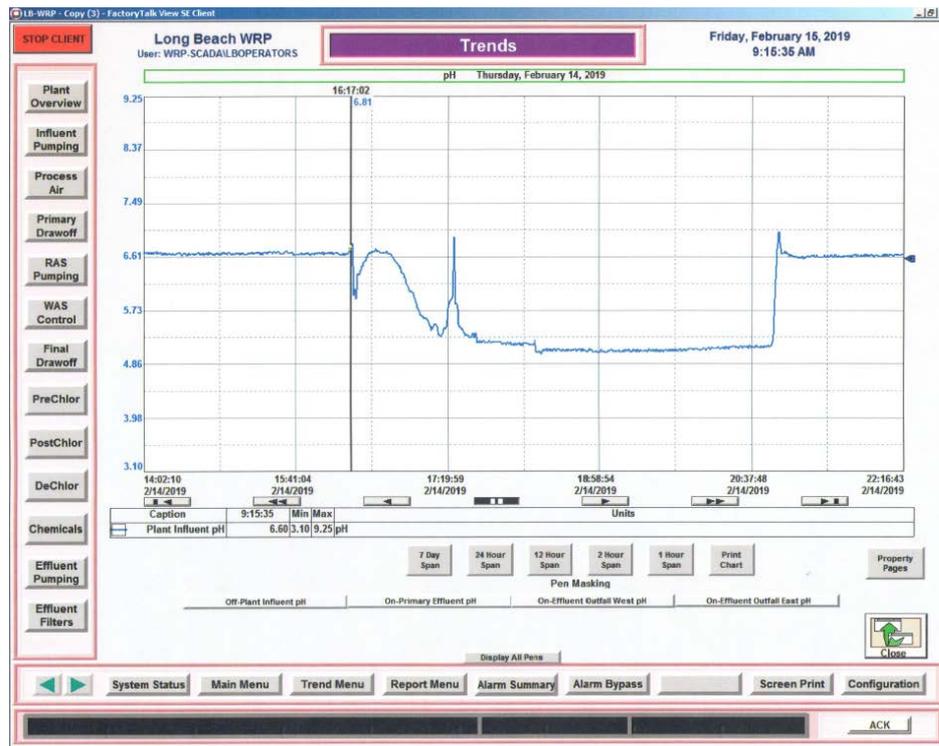
normal-range pH reading of 6.61. Since its unknown how long the ragging blocked the path of free flow across the meter probe it's unclear how long the low pH influent actually persisted.

Figure 1: LBWRP influent pH data for Thursday, 3-14-19. Note the drop in pH for approximately 4 hours late in the afternoon that day.

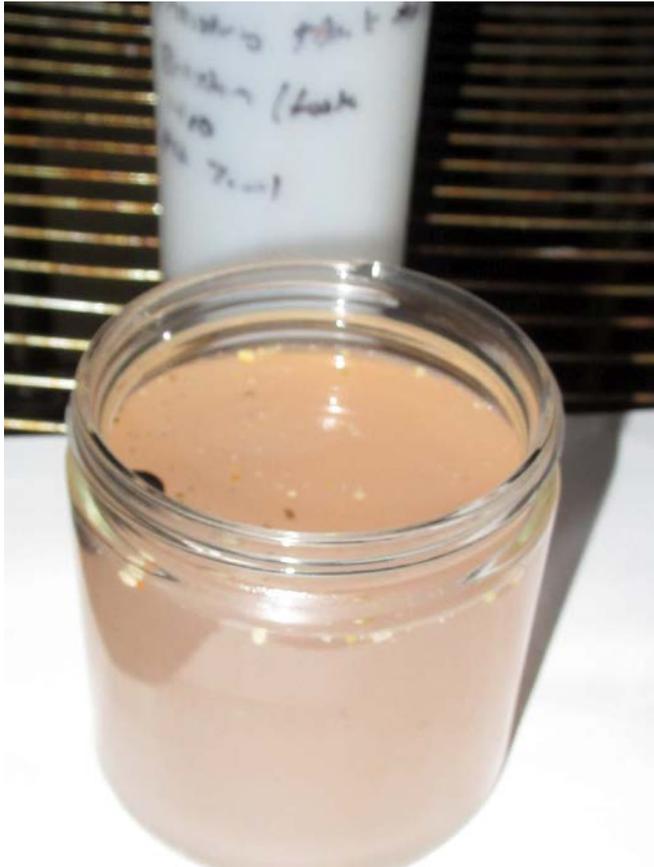
On Thursday, 2-21-19 at 1600 hours, Pomona WRP TPO II Benson Braxton called Supervising IW Inspector John Boyd and reported that at 1400 hours he had noticed "reddish-pinkish" colored wastewater in the WRP's primary tanks. He noted that by the time of his call the color was no longer entering the treatment plant. The colored wastewater was already passing into the plant's secondary tanks, though there were yet to be any noticeable effects on secondary aeration tank dissolved oxygen levels and the plant influent pH had been steady throughout the day in the normal 7.0-7.2 range. There were also no unusual odors associated with the colored influent. Braxton said he took several samples of the primary wastewater that contained the color (see Figure 4). Braxton stated the WRP was not diverting flow, but he was remaining vigilant to dissolved oxygen levels in the secondary tanks should the colored material prove to be high strength.

Figure 4: Sample of Pomona WRP primary tank wastewater taken on 2-21-19. Note the red color.

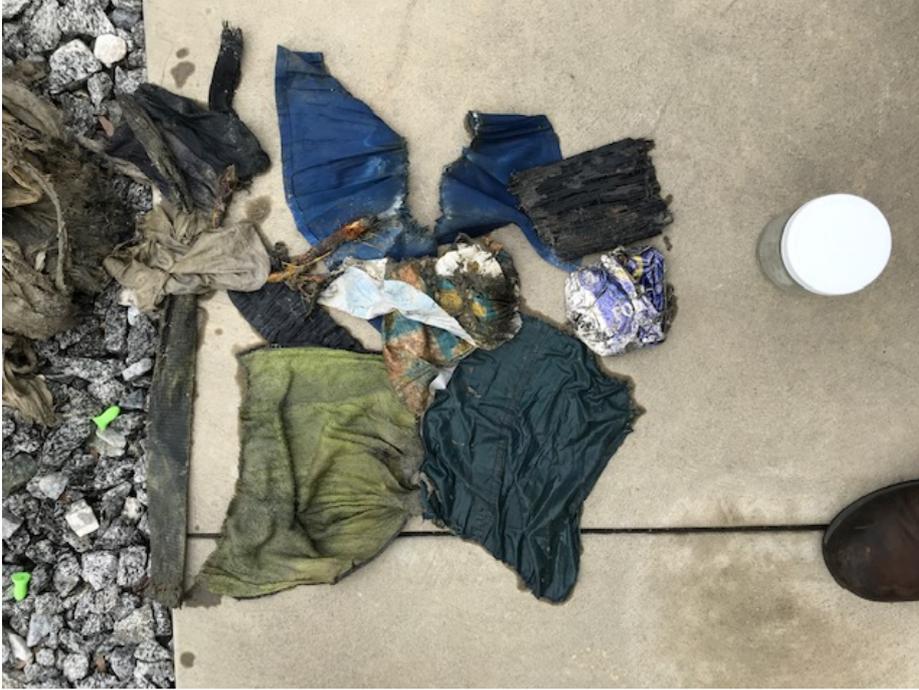
Figure 6: Various Rags removed from Whittier Narrows WRP influent pumps. Note that some of the rags are clearly clothing items.

Investigation of the rags at Whittier Narrows WRP found various types of garments such as ladies, men's and children's underwear, socks and miscellaneous scraps of other clothing articles, wood, pine needles, cordura strap, belt and beer can (see Figure 6). That said, the bulk of the rags were in fact the now ubiquitous non-woven wipes. Sealy speculated that it seemed likely there was an open sewer manhole somewhere or one that is being used to dump garbage and then re-closed. He surveyed the area upstream, examining trunk sewer line manholes on the J.O. 'B' and J.O. 'H' lines looking for evidence of manholes being used for this purpose. While he noted many homeless people living proximal to such manholes in the Whittier Narrows Park area as far north as Garvey Avenue, he didn't find any manholes that appeared to be ajar or regularly opened. Sealy spoke with WNWRP Supervising TPO Carlos Alfaro and requested he track the types of materials he's seeing when doing the monthly pump service, as it will help to identify repeatable materials if there are any. Alfaro agreed to this and said he'll call Sealy if he finds anything of interest or that could be of help in terms of this investigation, which will be reopened depending on future findings.

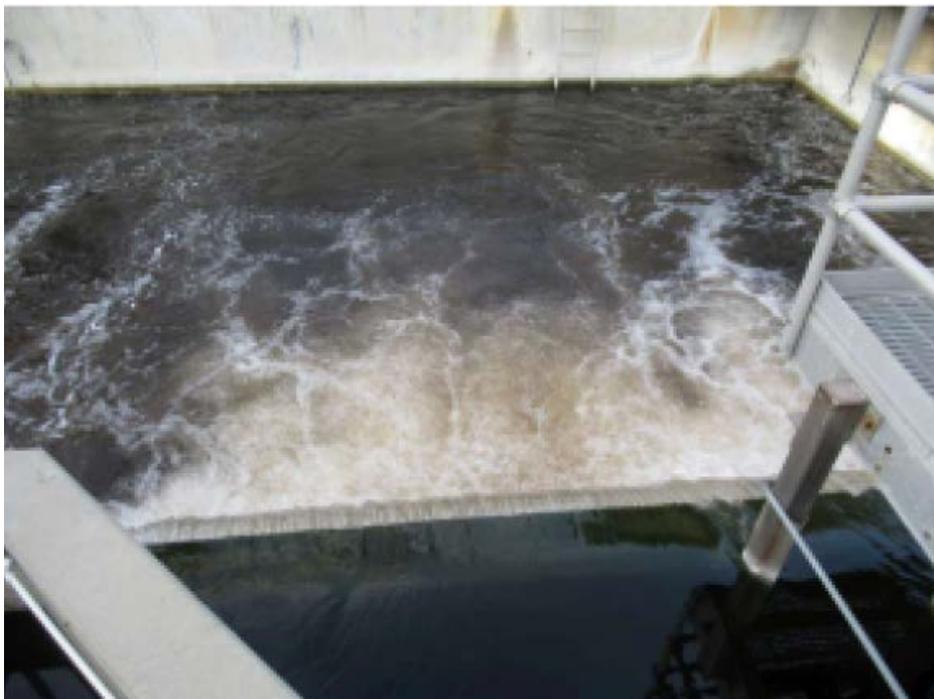
On Sunday, 3-3-19 at 1630 hours, Los Coyotes WRP TPO II Rudy Fernandez telephoned Senior IW Inspector Kent McIntosh and reported brown color in the final effluent and filters. McIntosh responded immediately, arriving at the WRP at 1705 hours, where he met with Fernandez and TPO I Araceli Chambers. McIntosh and Chambers confirmed the presence of the color in the effluent forebay (see Figure 1). At 1655 hours operators collected two 1.0 liter samples of the slightly colored final effluent. McIntosh noticed a slight brownish color in the samples.

Figure 1: 4-3-19 final effluent forebay picture at 1711 hours of the brown-colored effluent at Los Coyotes WRP.

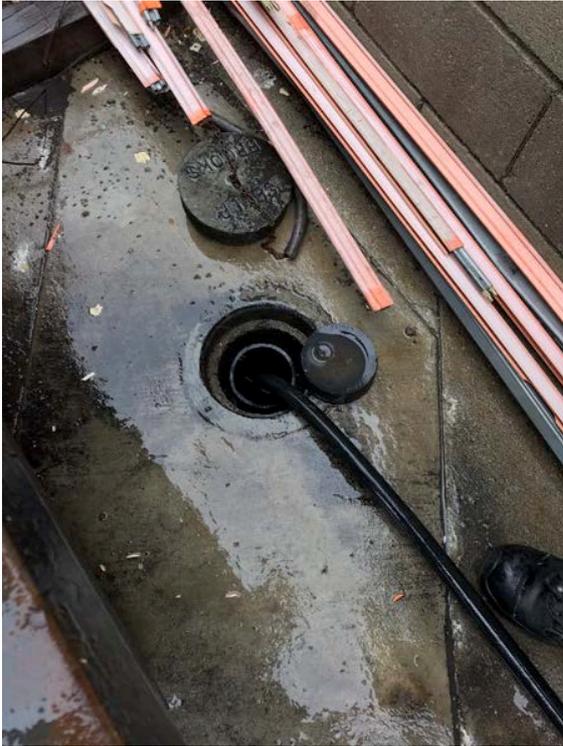
Figure 4: Photo taken by L.A. County Fire Department Health/Hazmat Inspector Eric Bald of the sewer line cleanout at Sterling Machinery Exchange.

Area IW Inspector Kent Hanks conducted the investigation into this referral, inspecting the facility on 3-11-19. Sterling Machinery Exchange is an industrial machine dealer. They buy, sell and broker industrial machines such as CNC (Computer Numerical Control) machines. The company does not have an industrial wastewater discharge permit, nor do they need one as there was no evidence found that they generate or sewer any industrial wastewater. The site consists of a sales room, several repair shops for paint touchups and light repairs, and storage buildings. Some machines are stored in an outdoor area without cover. The contact claimed they do not dispose of any fluids from the machines.

In the outdoor storage area, the pavement slopes towards a central blind sump. The contact stated that under normal conditions, the blind sump does capture rainwater during storms, but that this subsequently evaporates. However, because of this winter's unusual heavy rains, the sump had overflowed, causing excessive pooling/flooding in the yard. To relieve the flooding, the company installed a small pump in the sump and directed the pump discharge flow into a nearby sewer line cleanout along the building's west wall. Hanks informed him that storm water is not allowed to be discharged to the sewer without a permit, and that the cap to the cleanout should stay in place at all times unless the sewer line needs to be maintained or cleaned. The contact stated that going forward they would not discharge any storm water to the sewer, instead directing it to the street storm drain or allowing it to evaporate in place.

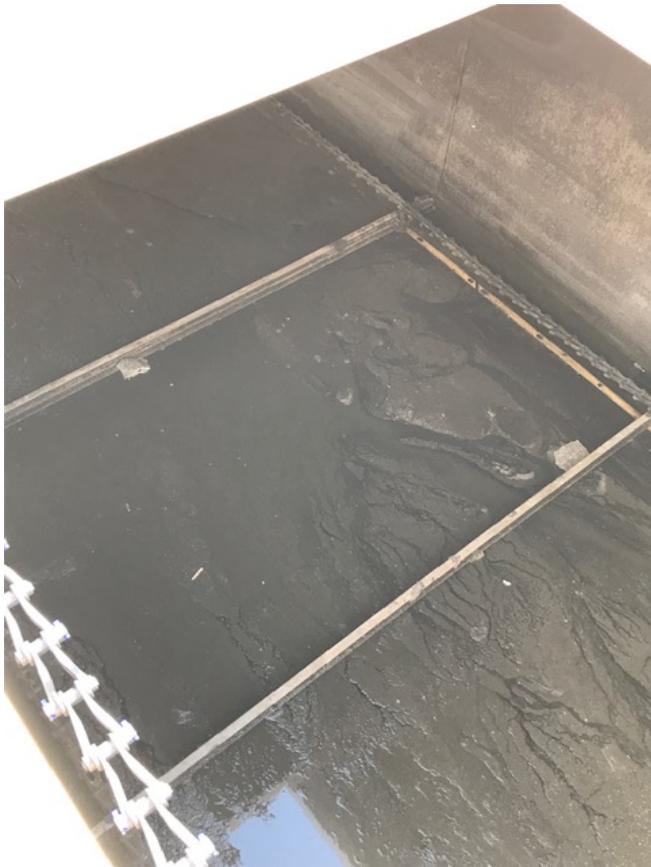
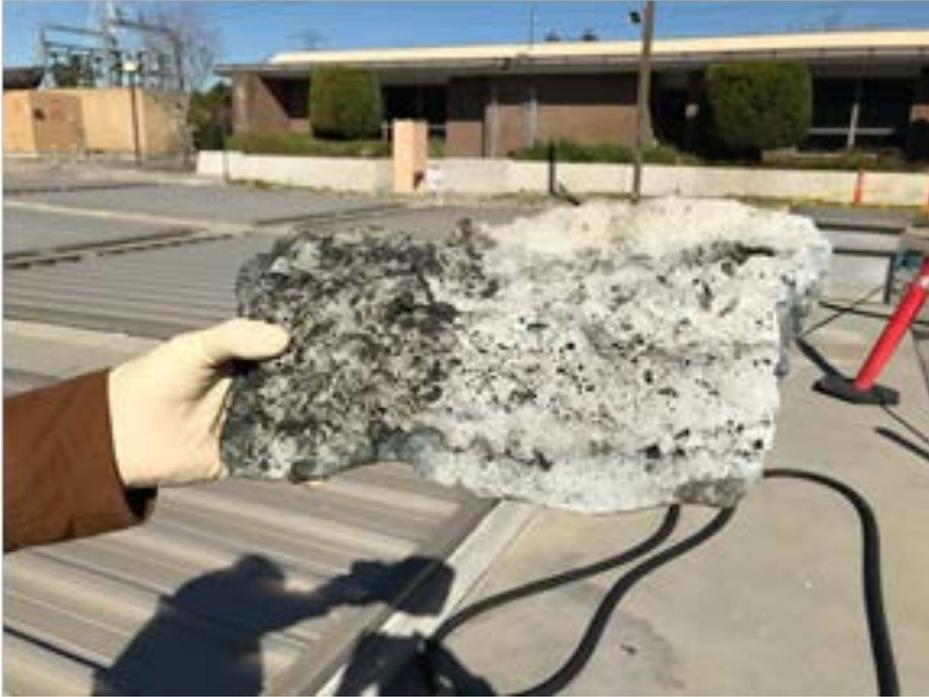
Figure 6: San Jose Creek West WRP primary treatment tank with 2 chunks of the resin material visible floating on the surface.

Figure 7: One of the chunks of resin material after its removal from the San Jose Creek West WRP's primary tank.

Sealy and Carlstrom investigated this report and determined that the resin chunks found in the SJC West WRP influent channels, pumps wells, etc. appear to be from the recent cured-in-place pipe (CIPP) sewer line relining projects along the SJC Interceptor trunk line that is upstream of the WRP. The resin chunks were shown to Districts' field engineering staff and they will pursue further action to determine cause(s) for its appearance at the WRP. No further actions are planned by the Industrial Waste Section staff on this incident at this time.

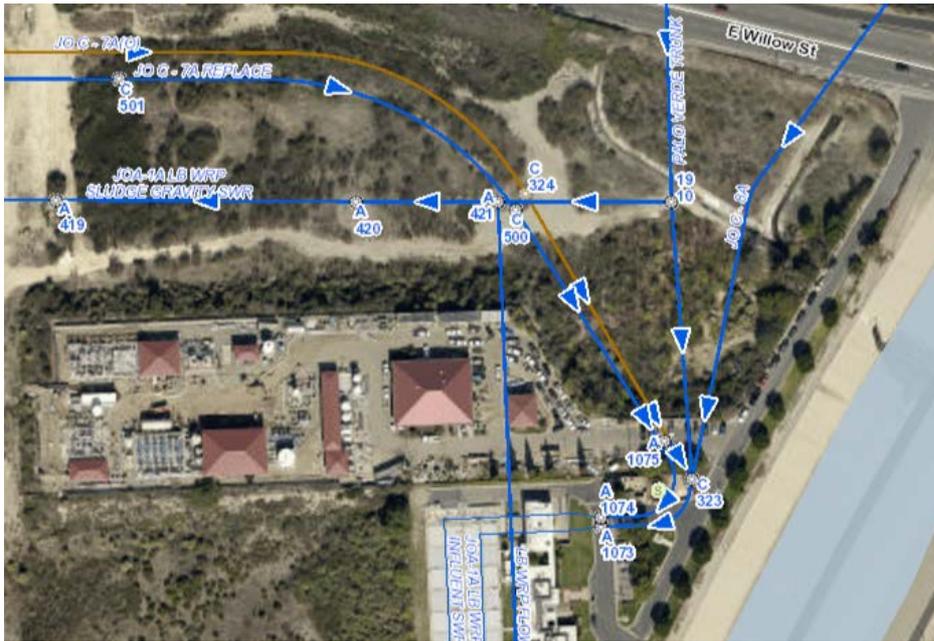
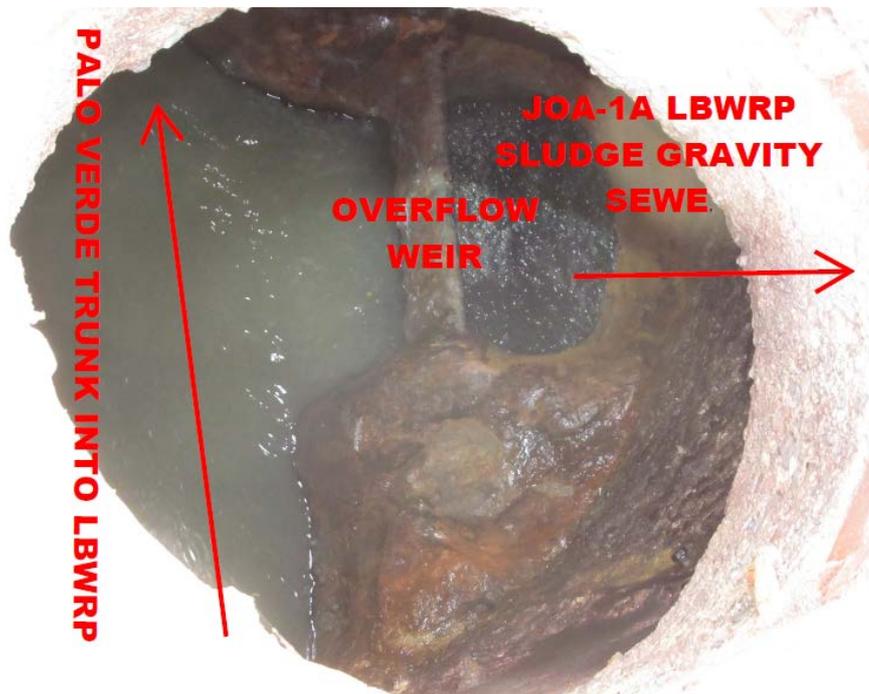
This incident was ultimately determined by Team 2 IW Inspectors to have been likely caused by an overflow of the WRP's sludge waste line, which contains high concentrations of ferric chloride used in the treatment process, making its way back into the WRP's influent via the Palo Verde trunk sewer at MH 19 0010 (see Figures 8 and 9 below). Ultimately, the incident did not detrimentally impact WRP operations.

Figure 8: GIS screenshot that shows the Long Beach WRP and upstream lines. Note that the despite the flow direction for the line between MH A421 and MH 19 0010 indicating an east to west flow, IW inspectors verified that flow can and does occasionally flow the other direction causing waste sludge laden wastewater to re-enter the WRP.

Figure 9: 1620 hours 4-4-19 annotated photo of the interior of MH 19 0010 showing how, at high flow rates, wastewater in the waste sludgeline, can overflow the weir and flow back into the 24" Palo Verde trunk sewer, which then flows back to the WRP.

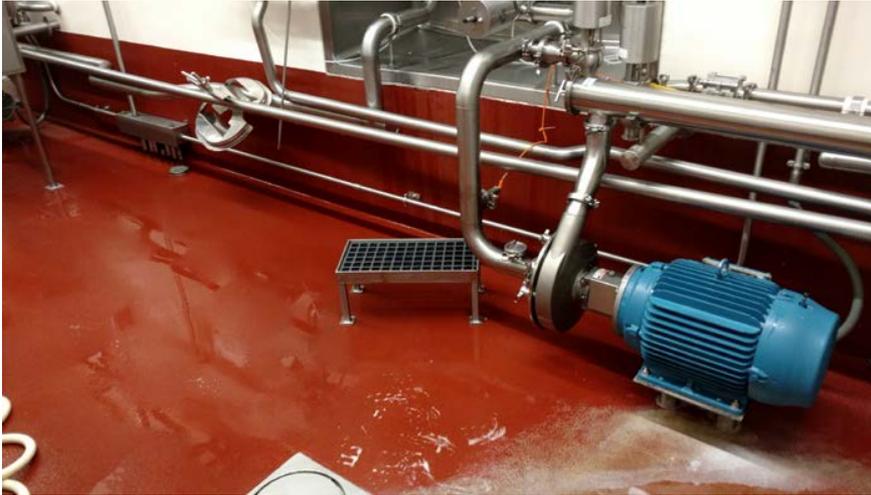
Figure 10: Location of the pipe flange failure in the milk silo room at the Ninth Street Dairy that caused the spill.

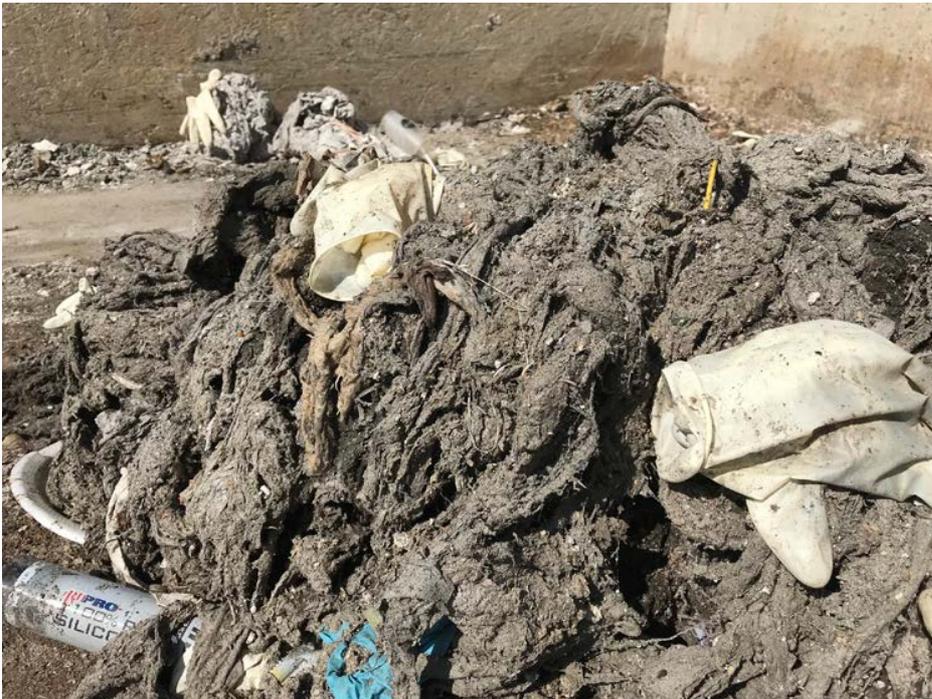
Figure 3: Rags removed from MH H469 in April 2019.

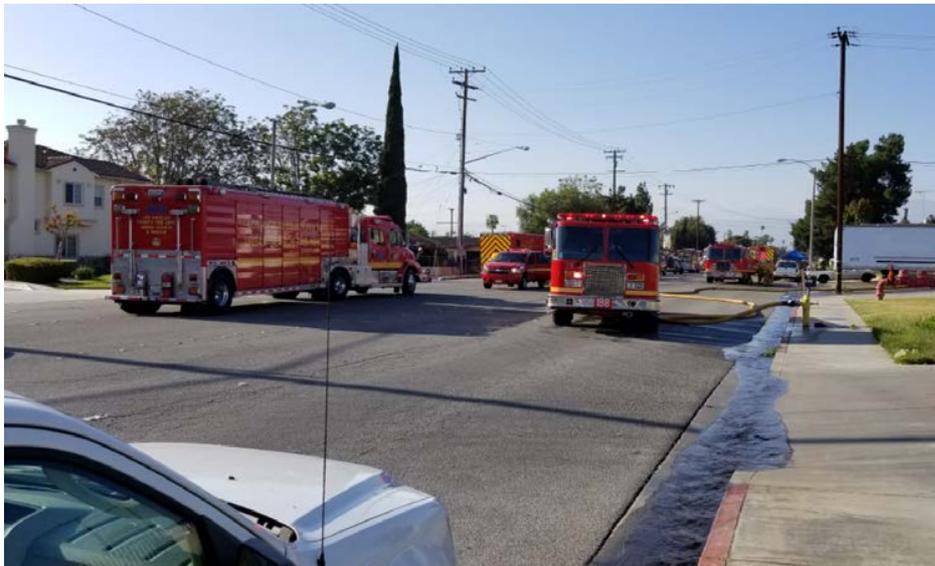
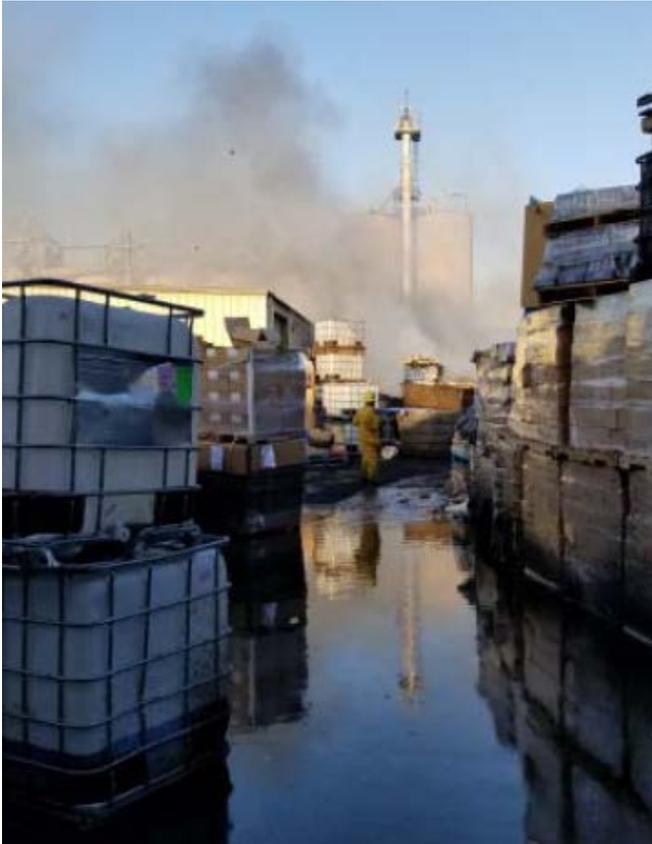
Figure 2: 5-3-19 photo of fire trucks on-site at Master Recycling Center. Note the ongoing flow of firewater from the site going to the storm drain.

Figure 3: 5-3-19 photo of the ongoing fire. Note the firefighter and rising smoke. Also note the copious amounts of ponded water from fighting the fire.

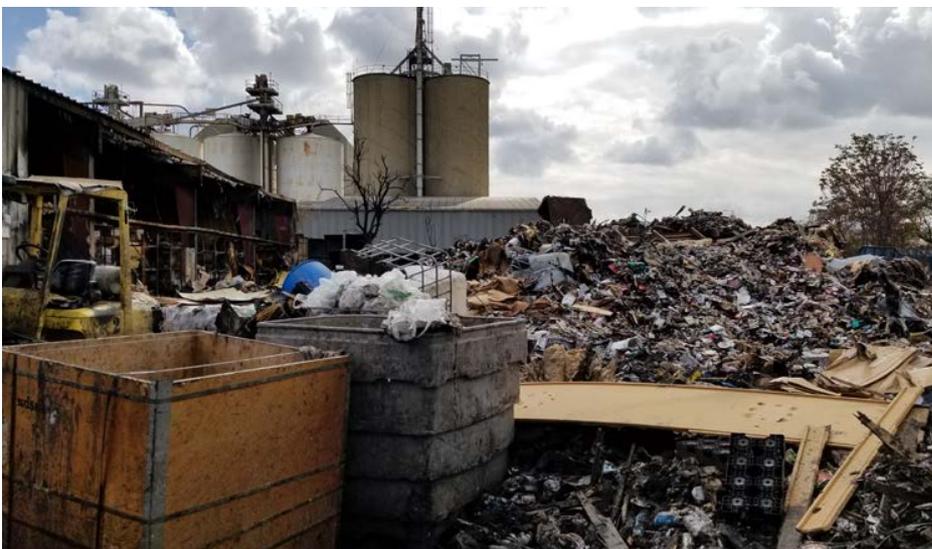
Figure 4: 5-7-19 photo of the fire aftermath at Master Recycling Center.

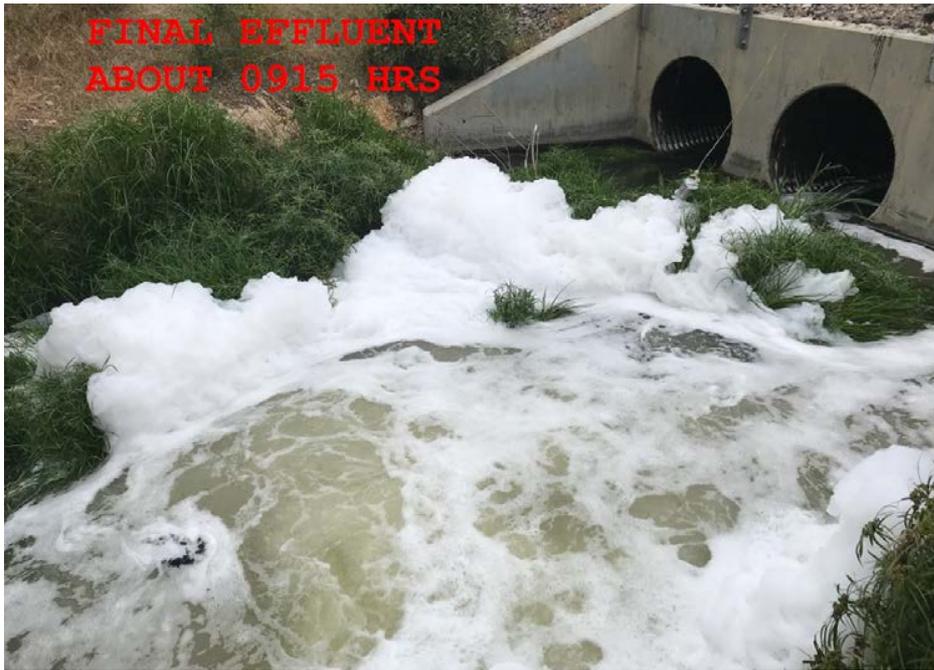
Figure 5: White foam at the Pomona WRP effluent discharge point into San Jose Creek at 0915 hours on 5-23-19.

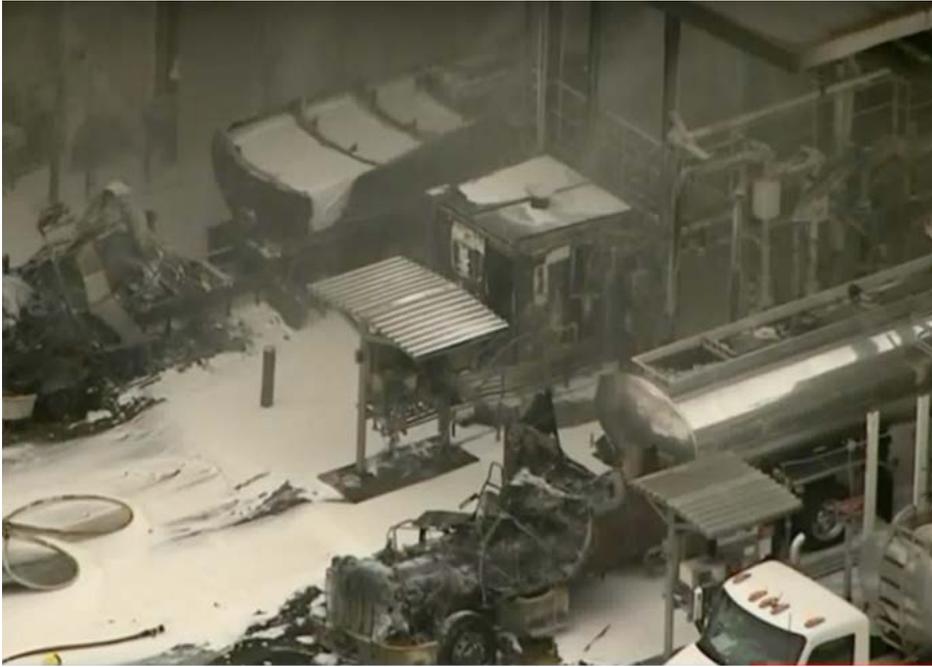
Figure 2: Close-up photo of the loading dock area and destroyed tanker trucks after the fire had been extinguished on 6-3-19.

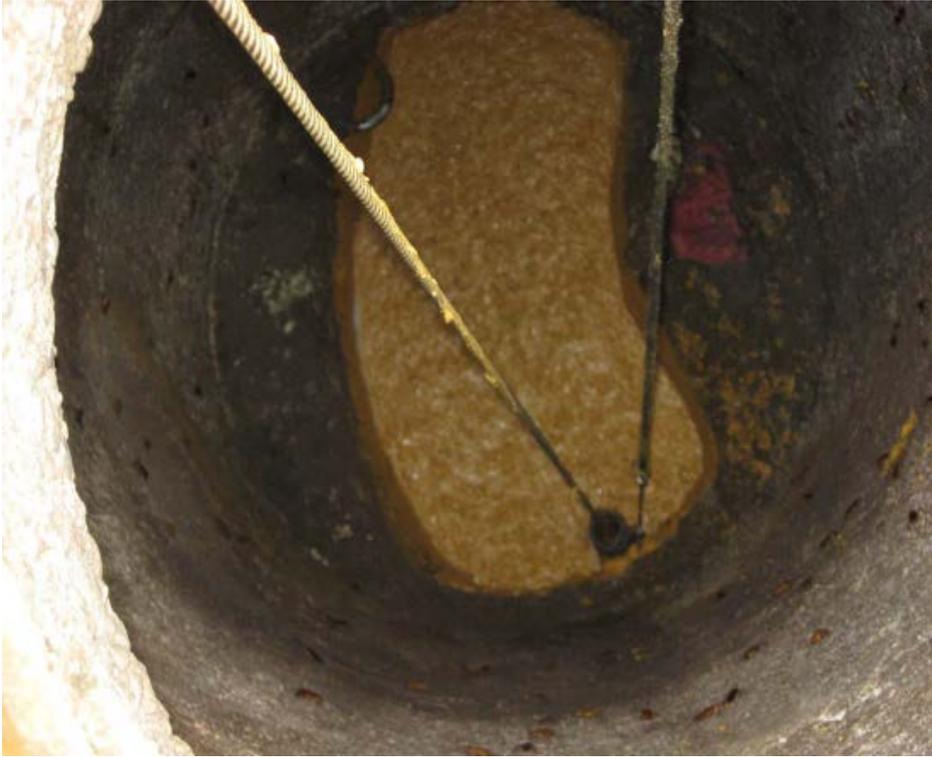
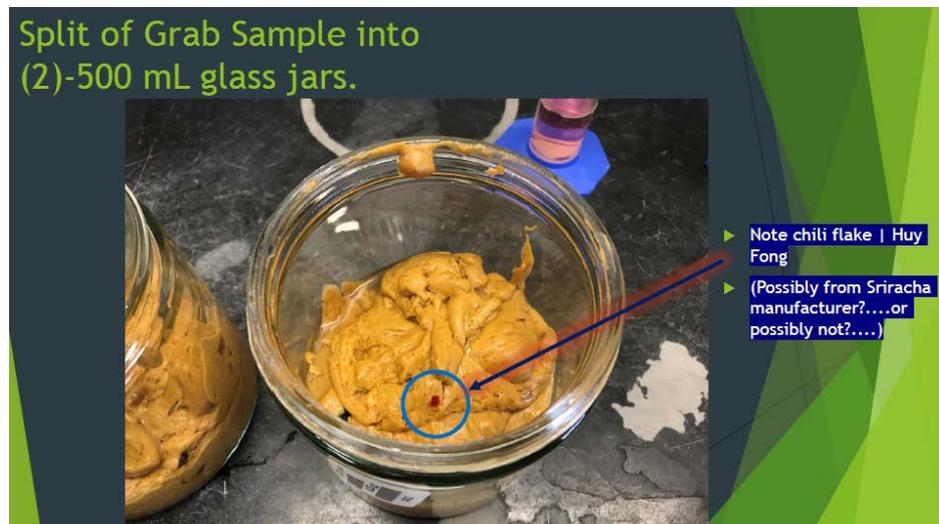
Figure 1: Photo of the grease in MH 22 1037 on 8-23-19.

Figure 2: Sample of the unusual yellow-orange colored thick grease type material removed from MH 22 1037. Note its highly viscous nature and “ropy” texture.

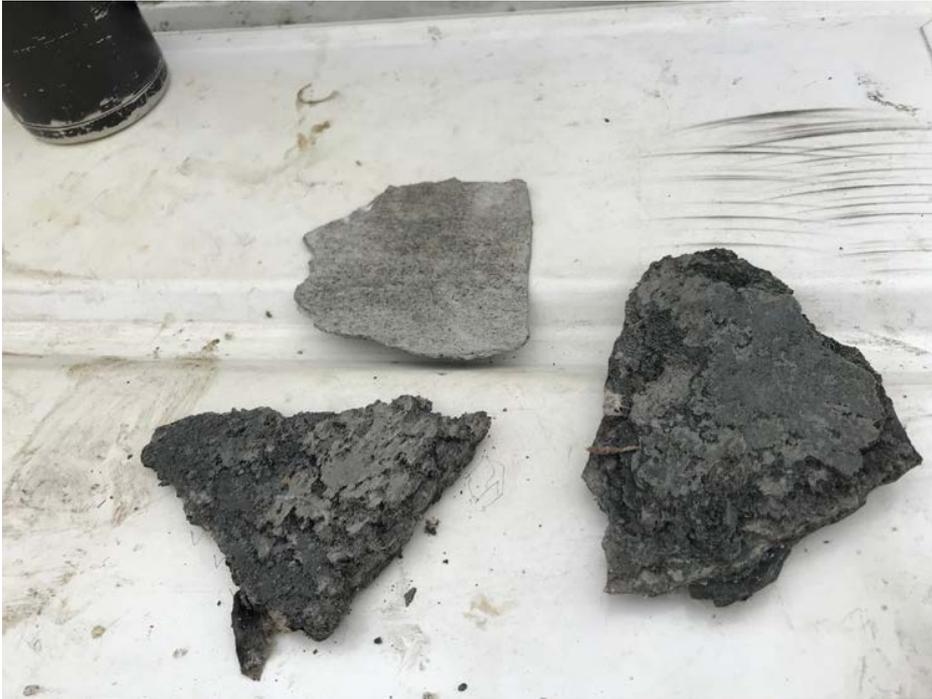
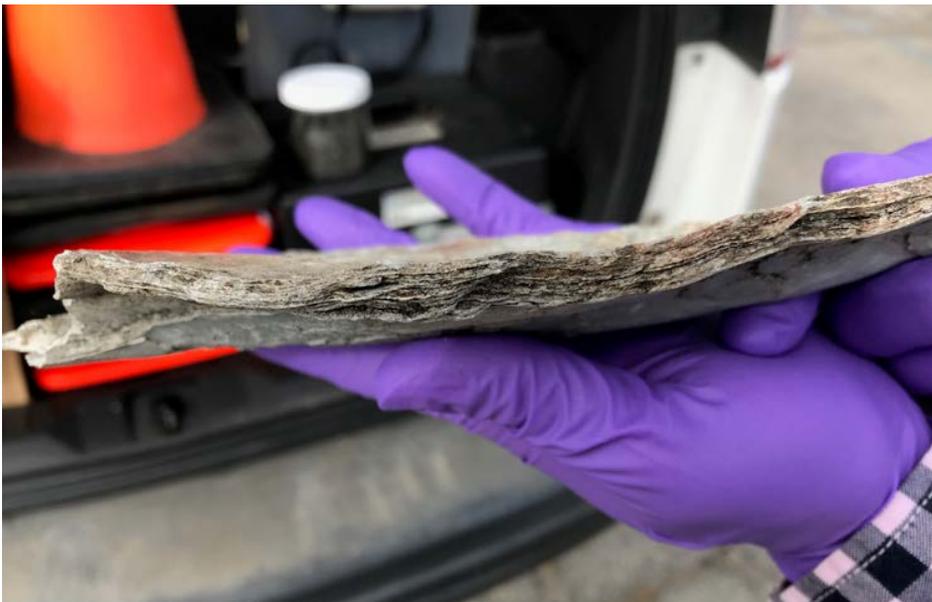
Figure 2: Pieces of the scale retrieved from the sewer.

Figure 3: Side view of the scale.
