2020 ANNUAL REPORT

INDUSTRIAL WASTE PRETREATMENT PROGRAM

LOS ANGELES COUNTY SANITATION DISTRICTS

APPENDIX H
INDUSTRIAL WASTE REPORTS ON INCIDENTS

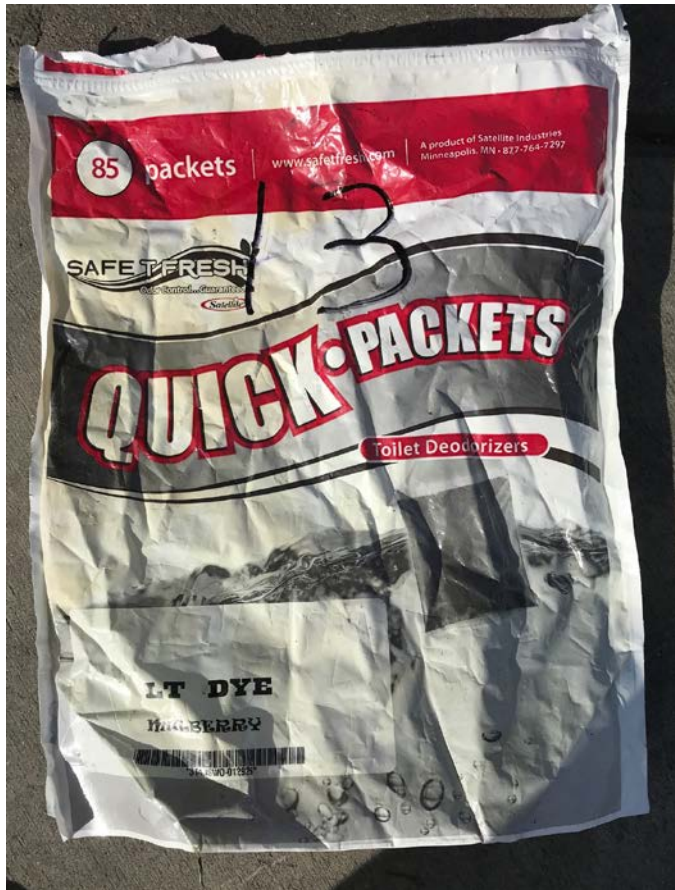
vibrant dye. Neunsinger verified that the company is still using the less vibrantly colored packets, but it appears that as a result of the Tournament of Roses Parade and football game in early January they were discharging a much larger number of toilets than usual and doing so in a period when overall flows into J.O.'B' were lower than usual, thus explaining why the color was noticed at the WRP. Neunsinger noted that the blue color influent to WNWRP did not cause any operational problems at the WRP and no color was noticeable in the secondary effluent, although a slight blue color was noticeable in the primary effluent samples (buckets 1&2) on 1-4-2020. Ultimately, there was no color noted in the final effluent on 1-4-2020 and no NPDES violation or other operational issues resulted from the color. United Site Services was not cited for the discharge.

Figure 1: United Site Services Satellite dye-deodorizer packet.

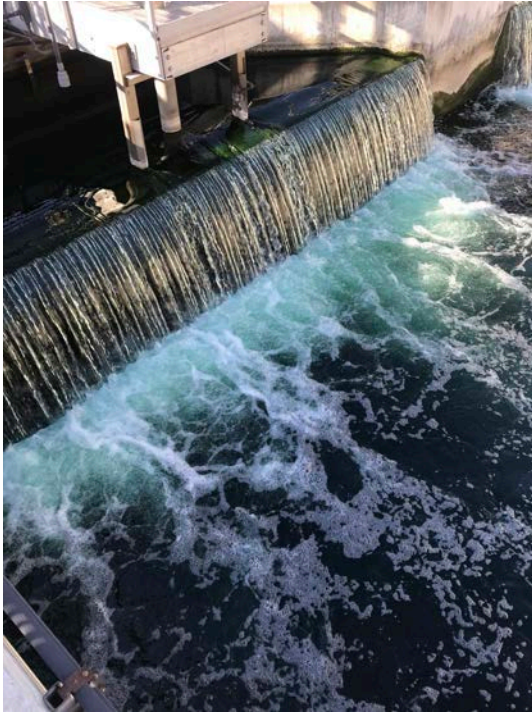
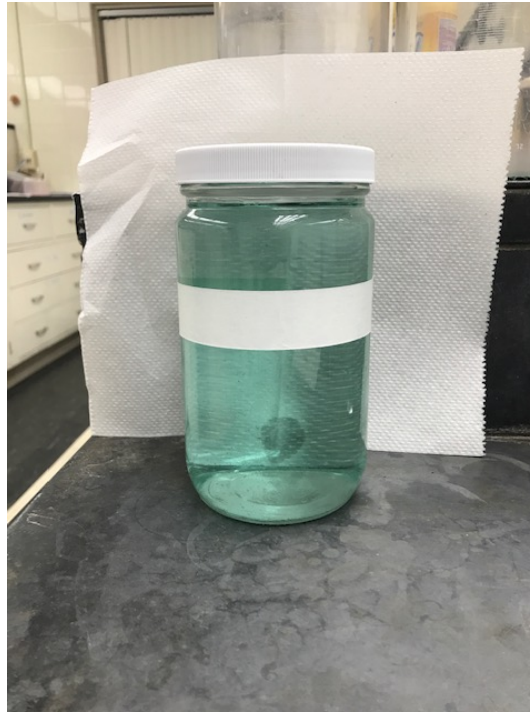
On Tuesday, 2-25-2020 at 0740 hours, Los Coyotes WRP TPO II Mike Nelson notified Supervising IW Inspector David Sanchez that plant operators had just observed a green color in the plant's secondary & final effluents. Nelson stated TPOs would collect samples of secondary and final effluent. Three days later, on Friday, 2-28-2020 at 0130 hours, TPO II Tom Jauregui came to the LCWRP IW inspector's trailer and reported to Night Team inspectors that he had just noted blue color in the secondary effluent as he was investigating an issue with the turbidity meter. Both incidents resulted in NPDES effluent color violations. A third and final color incident in this series of incidents at the LCWRP was reported later on 2-28-2020 when observation of primary effluent samples indicated olive-green colored wastewater came into the treatment plant sometime around noon that day.

Figures 3 & 4: On the left: Los Coyotes WRP forebay at 0800 hours on 2-25-2020. On the right: Sample of LC WRP secondary effluent on 2-28-2020 at 0130 hours Note the distinct blue-green color present in each.

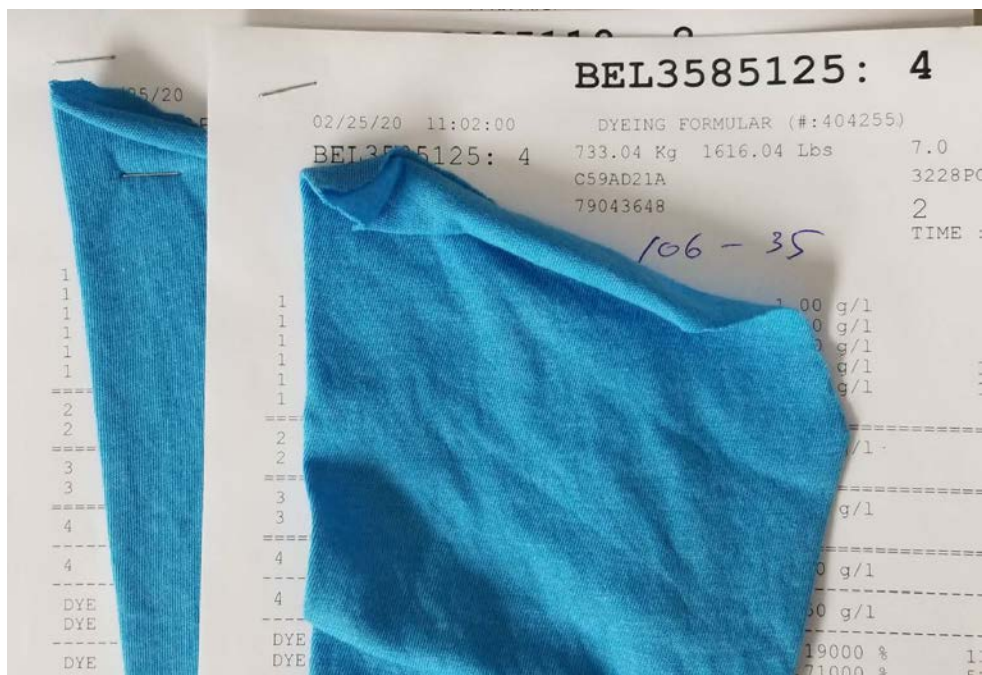
Figure 5: Teal colored dyed fabric swatches from Tri-Star Dyeing & Finishing. Note the time/date stamp on the swatch sample production log sheet is 1102 hours on 2-25-2020.

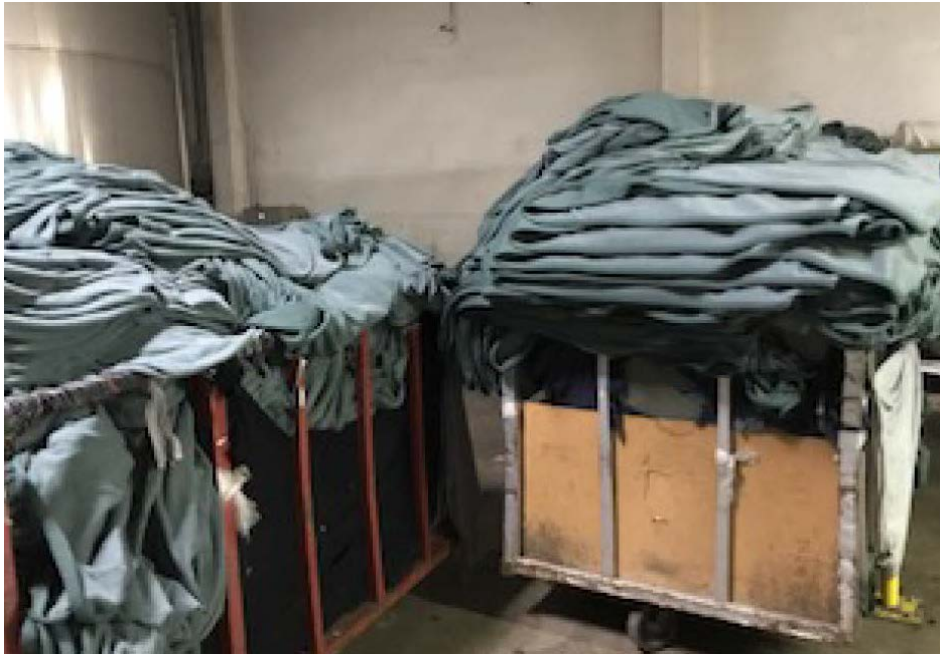
Figure 6: Bins of green colored dyed fabric seen at Tri-Star Dyeing & Finishing on 2-26-2020 at 2100 hours by Jose Ruiz and Supervising IW Inspector Steve Sealy.

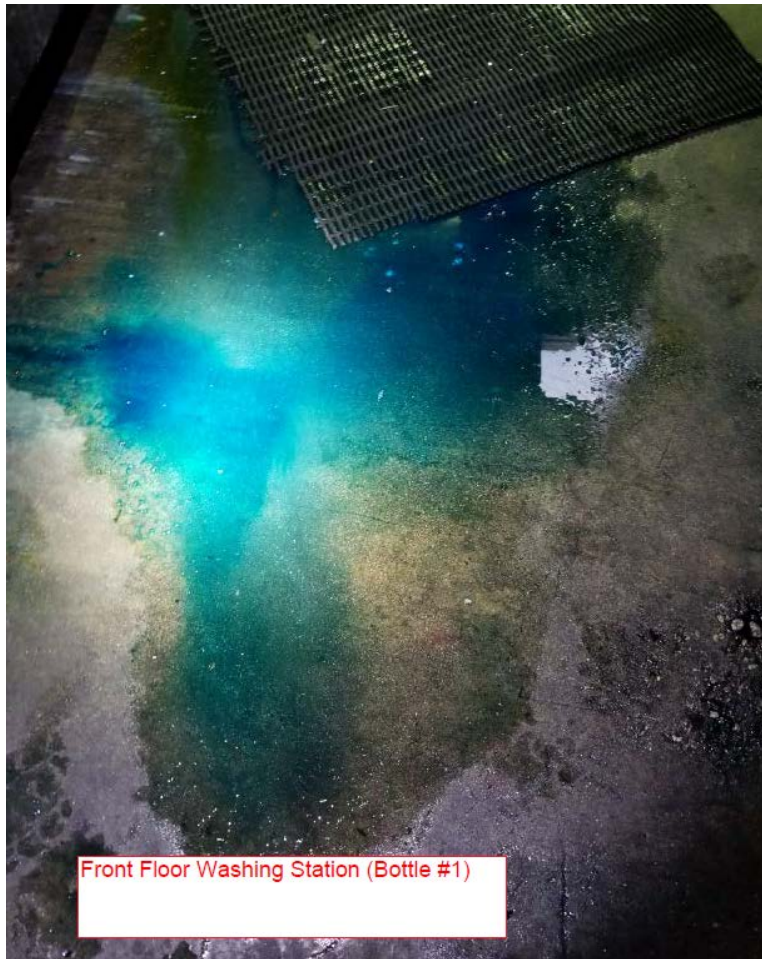
IW inspectors also inspected many other possible, but less likely sources for the color. One of these inspections was conducted at L.A. Supply Company at 1720 hours on 3-6-2020 by Inspector Ruiz and Senior IW Inspector Jim Percy. This company supplies chemicals and dyes used by the textile manufacturing industry. The facility had previously been determined by IW inspectors to be permit exempt as they did not compound chemicals on-site or discharge industrial wastewater containing these chemicals and dyes. Managers claimed they were simply a “box in, box out” operation. However, the inspection on 3-6-2020 revealed the company discharged some highly colored dye residual as part of operations previously unknown to IW Inspectors, namely the cleaning of totes and drums returned from their customers. According to UV-vis absorption spectra analysis, samples of the dye present in wastewater found puddled on-site at one location (see Figure 7) matched that the dye present in the samples from the LCWRP a week earlier. However, while admitting they had washed some totes and drums, company managers insisted the amount of wastewater and dye discharged was “very small.” Inspectors lacked corroborating evidence to support the issuance of a notice of violation for causing the incidents at the LCWRP.

Figure 7: Puddled blue-green dye containing wastewater found adjacent to a drain at L.A. Supply Company during an inspection on 3-6-2020.

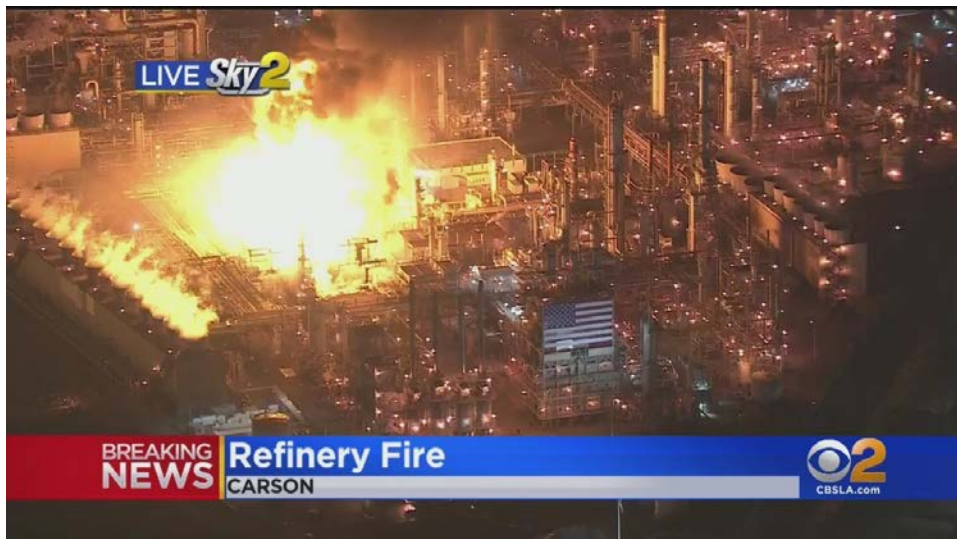
Figure 8: Local television news coverage helicopter photo of the Tesoro Carson oil refinery fire taken at about 2300 hours on 2-25-2020.

Per Pengphol's company contact, the fire broke out at 2250 hours on 2-25-2020 at a compressor at the hydrocracker unit located at the north side of the facility. The cause of the fire remains under investigation. Firefighting foam was used to control and extinguish the fire. The contact estimated 1,834,000 gallons of firewater was generated from fighting the fire. This firewater is being held in Tank 20 on-site.

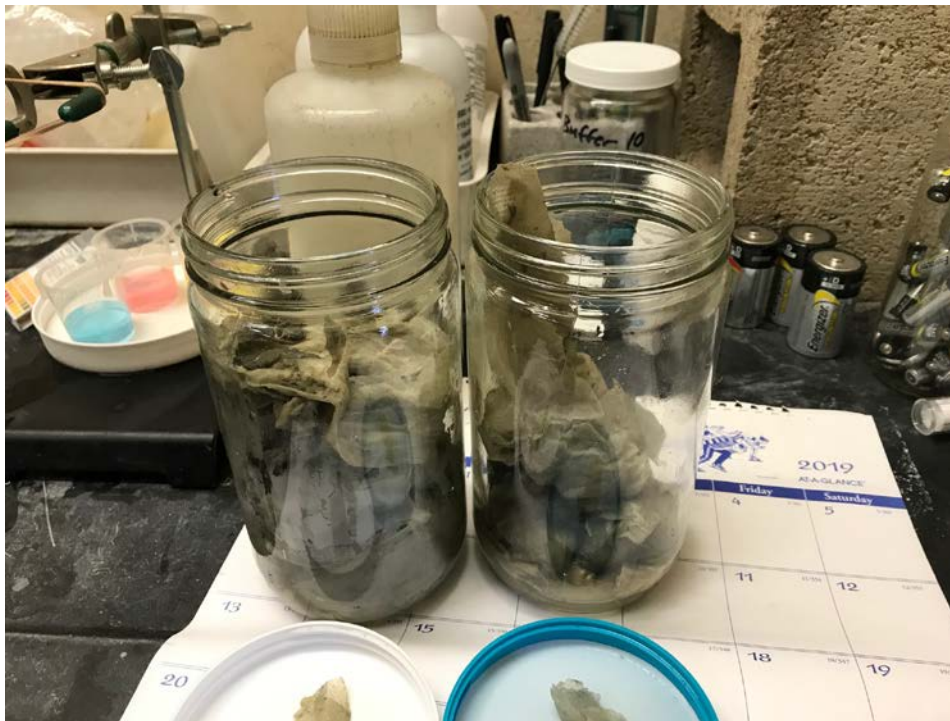
Team 4 Senior IW Inspector Greg Neunsinger and IW Inspector Ken Hanks met with San Gabriel Valley Sewer Maintenance Crew members Frank Peralez and Louis Olvera, at MH 02 2128 and observed the accumulation of rags/wipes. Neunsinger and Hanks identified the rags as sanitary wipes and not shredded cloth, clothing, or shop rags (see Figure 1). This manhole is located where the Garfield Avenue trunk and the Garfield Avenue Relief trunk sewers split.

Figure 1: Photos of the “rags” identified as non-woven wipes removed from the sewer at MH 2 2128 on 3-9-2020.

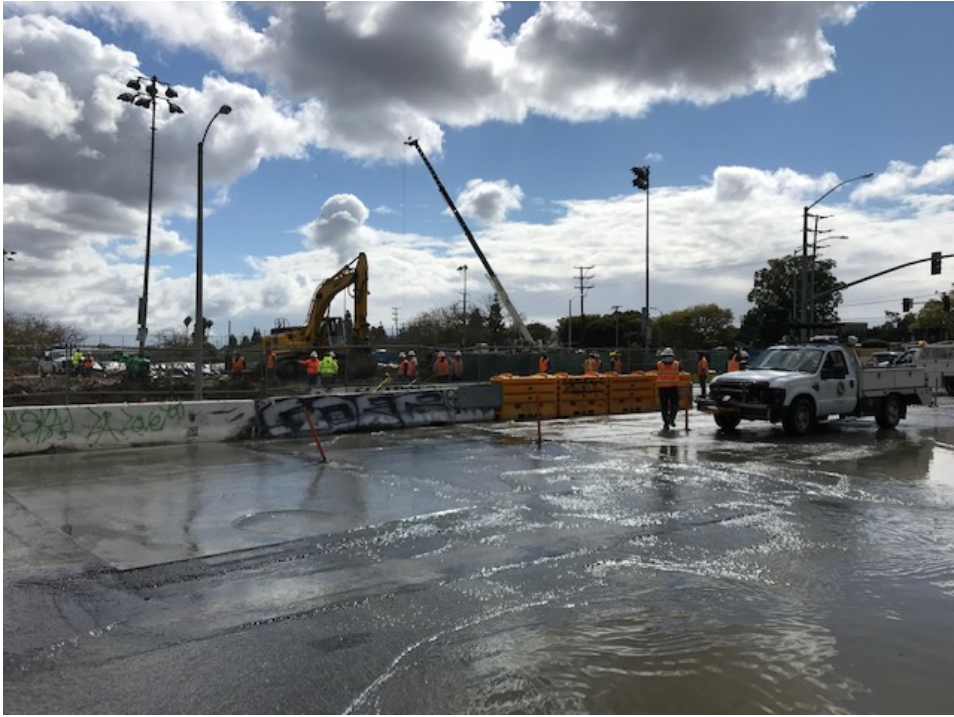
Figure 3: Street flooding on Figueroa Street at 0930 hours on 3-19-2020.

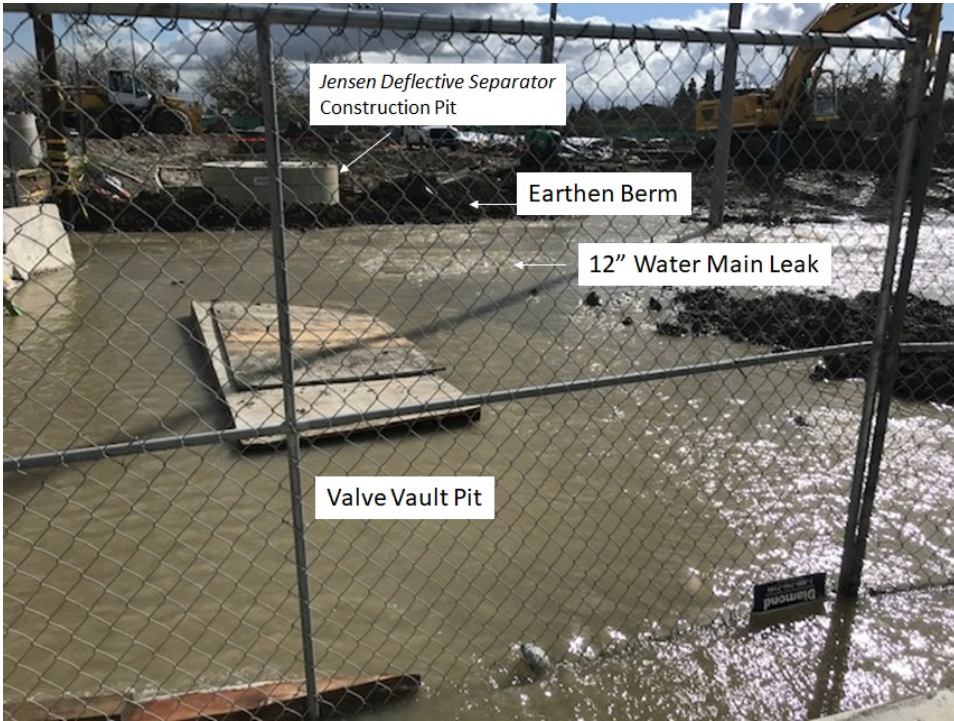
Figure 4: Annotated 3-19-2020 photo of the area where the flooding is coming from due to a broken water main.

On Thursday, 3-19-2020 at approximately 0915 hours, a contractor performing work on the Carson Stormwater and Runoff Capture Project adjacent to the City of Carson's Carriage Crest Park ruptured a 12" water main operated by California Water Service while operating an excavator near the pipeline. The water inundated a construction pit associated with the ongoing project located in the middle of Figueroa Street as well as the intersection of Figueroa and Sepulveda Blvd. (see Figures 3-6 above). This water main serves the JWPCP, as well as several businesses along Sepulveda Blvd. including the Target and Home Depot stores. Water service was restored to the JWPCP within an hour and a half by isolating the break at a valve located at a loop in the water main. It was expected that some of the local businesses would be disrupted for at least 12 hours thereafter since they were connected within the area serviced by isolation valve. To keep the water from further inundating the Carriage Crest construction site an earthen containment dike was built between the construction site and the broken water main. It appeared the containment was effective, and the other Carriage Crest construction pits were dry. Barnum required Project Manager Andres Acosta to notify Supervising Inspector John Boyd if anything changed and/or they needed to dewater the construction pit using their permitted industrial

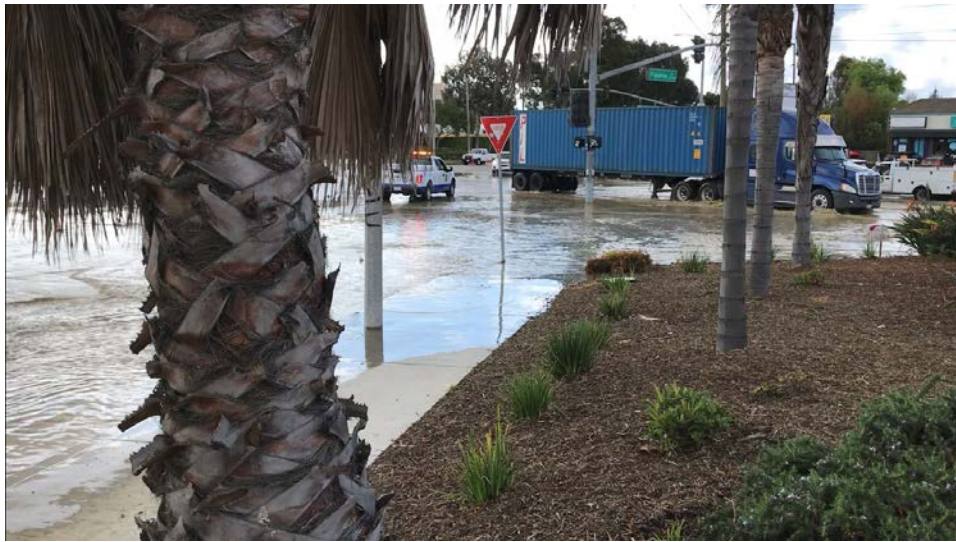
Figure 5: 3-19-2020 flooding in the intersection of Figueroa Street and Sepulveda Blvd.

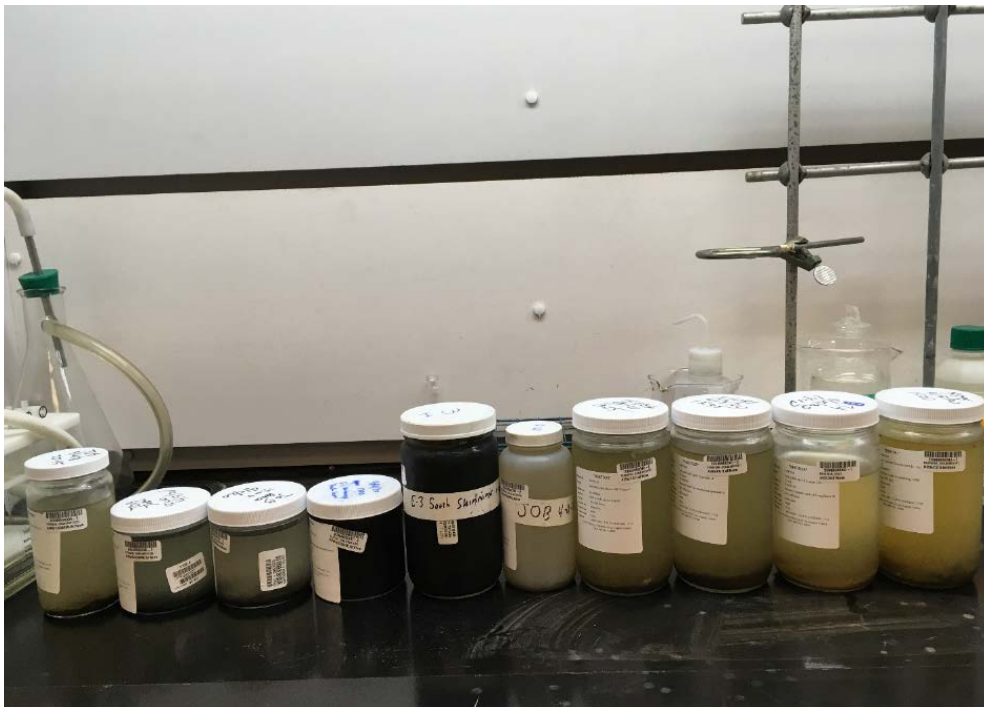
Figure 2: Samples submitted for GCMS and FTIR analysis as part of the JWPCP black solids investigation.

Sample analyses of the floating material taken from the JWPCP skimmers indicated it contained hexadecenoic acid and oleic acid methyl ester. Both compounds are food grade greases commonly found in animal and vegetable food products and waste commonly generated by dairy plants, animal fat rendering facilities, and food manufactures. Additionally, a hair in one sample was identified as a horse hair. Inspectors suspected the source could be a grease rendering operation or possibly a biodiesel manufacturing operation. Inspections at these types of facilities, as well as at large food manufacturing operations, oil refineries, tanker truck washing operations, and examination of Liquid Waste Disposal Station load manifests failed reveal a likely source for this incident. Inspectors continue to be vigilant to a source for this incident.

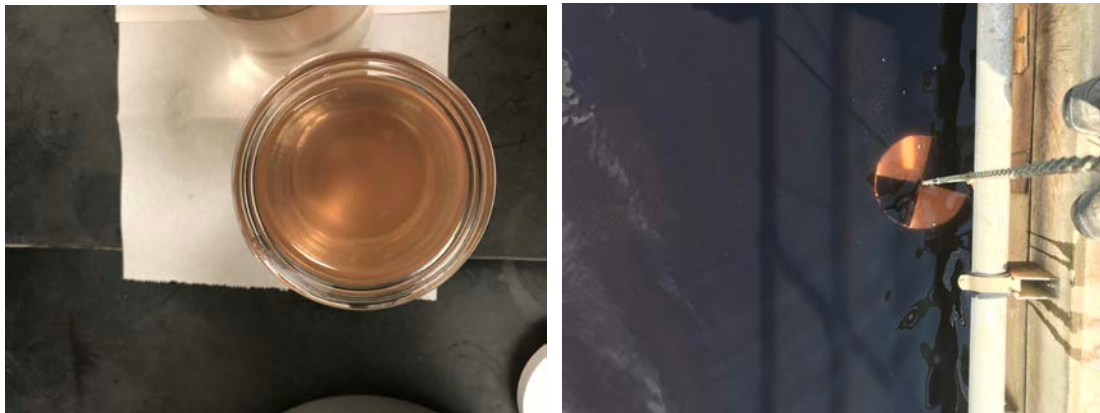
On Wednesday, 4-8-2020 at 0657 hours, JWPCP TPO II Porfy Ochoa reported to Team 3 Senior IW Inspector Bill Barnum that the plant was seeing a pink color in the final effluent. These observations of color at the JWPCP, in some cases pink, in others more purple, continued to occur periodically for the next week.

Figures 3 and 4: Pictures of a JWPCP filtered grit chamber grab sample taken at 2000 hours on 4-8-2020 and JWPCP clarifier "D" earlier that same afternoon.

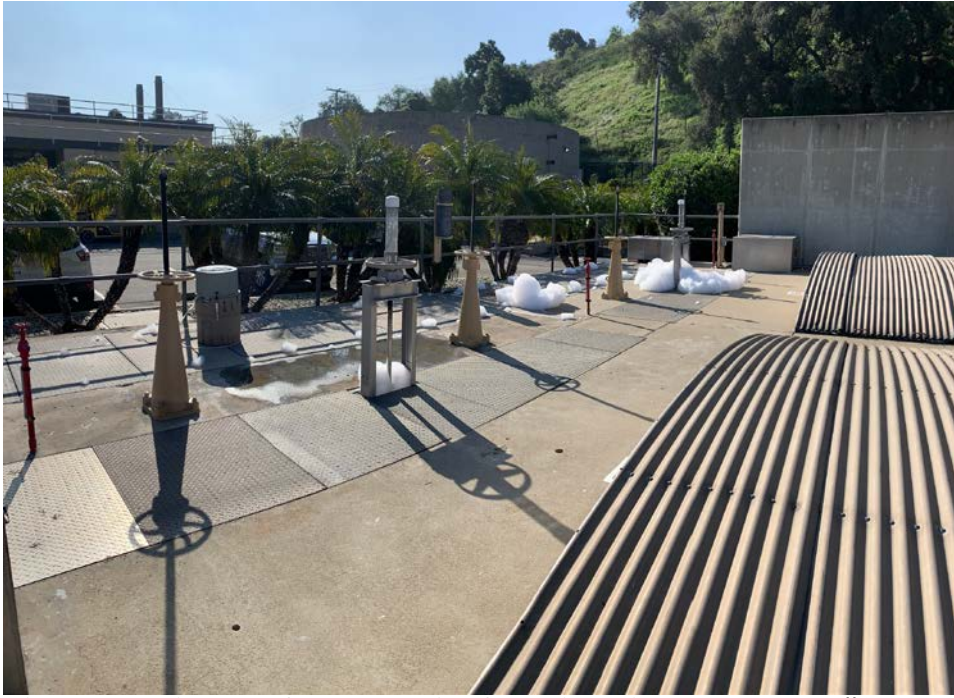
Figure 6: Picture of heavy white foam in primary channel #1 at the Pomona WRP at 0900 hours on 4-14-2020.

North Teams' Supervising IW Inspector Andy Woods coordinated the investigation. Unfortunately, the investigation did not result in identifying a source of the foam. Inspectors found no foam in the sewers upstream of the WRP and were thus unable to trace it to a source. Inspections were conducted at all known permitted industrial wastewater sources for foaming material in the south line's upstream area, but nothing unusual was noted except for the fact that the flows from one large industrial laundry, 9W Halo Western, had increased by about 50% due to the ongoing COVID-19 pandemic. However, this facility's wastewater was observed to be low-foaming and the facility is not suspected of being the source for the WRP incident. Note that the historical source for previous foam incidents at the Pomona WRP, Master Recycling Center, is no longer in business in Pomona, having left the site in September 2019 and moved to Rancho Cucamonga. Inspectors checked the local sewer line manhole downstream of this facility, and went to the site, but saw no evidence of any foam or ongoing/recent discharge or activity at the site. No NPDES violation resulted from this incident.

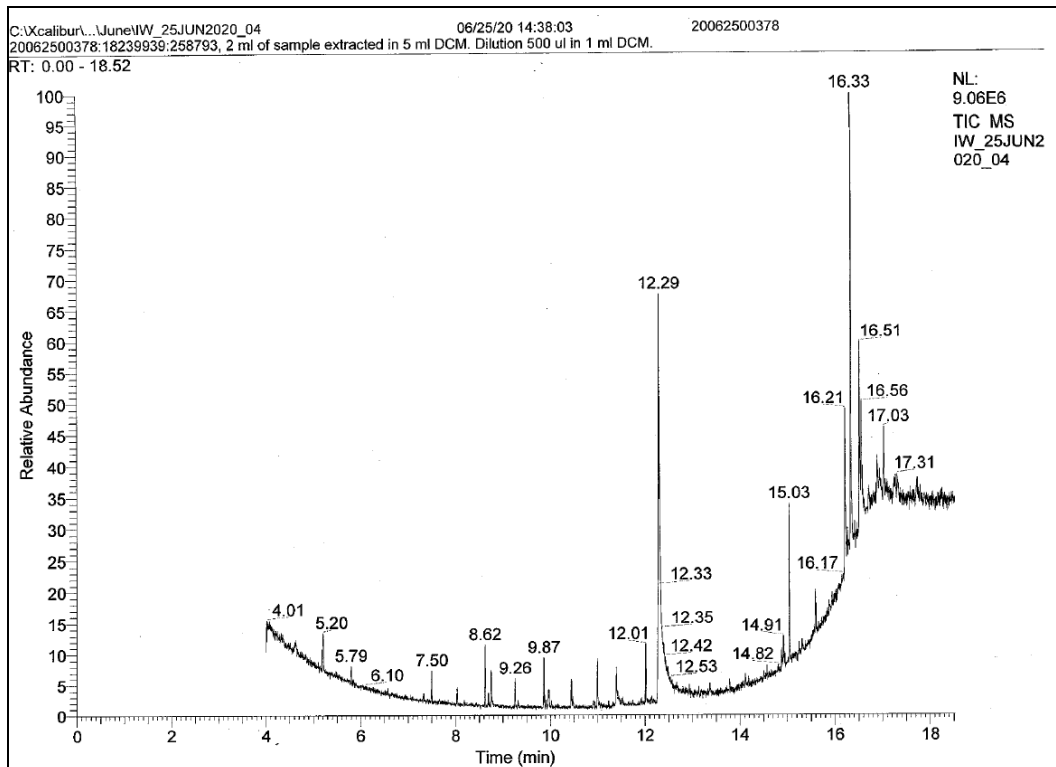
Figure 3: Laboratory chromatogram (GCMS) analysis of the skimmer sludge. Peaks on the graph indicate fatty acids common in food products.

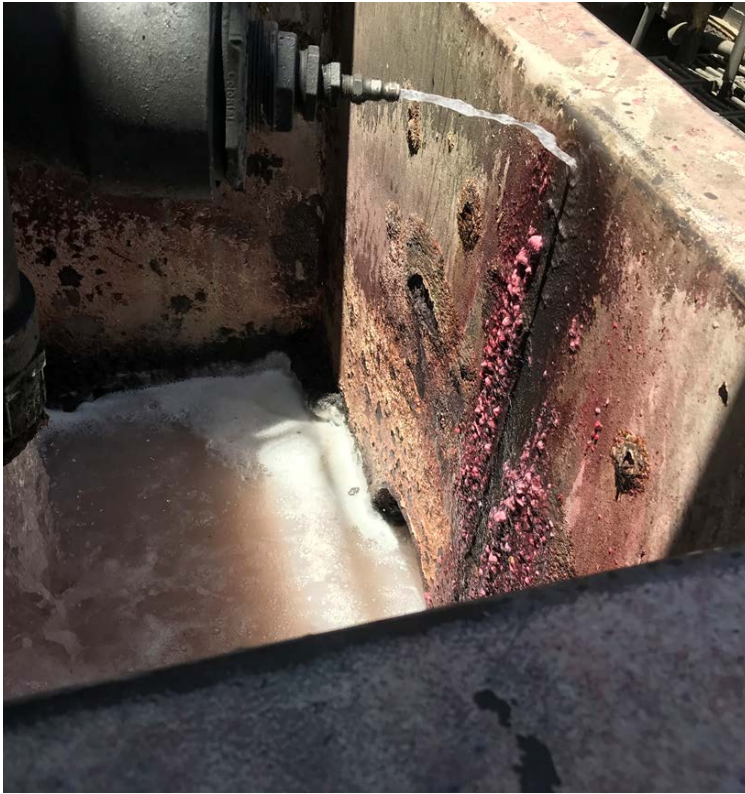
On Tuesday, 6-30-2020 at 0932 hours, the Lancaster WRP notified the IW Section that at 0900 hours they had noted pink colored influent (See Figure 4). A sample of the influent with the color was taken at 0930 hours. There was no unusual odor or other conditions associated with the color. The influent pH was noted to be a normal 7.45 at 0930 hours. Operators also stated they had checked the Lancaster WRP LWDS and found that no loads had been received there on 6-30-2020 that could be attributed to a dump station load.

Figure 4: Primary grit chamber tank at Lancaster WRP on 6-30-2020. Note the pink color.

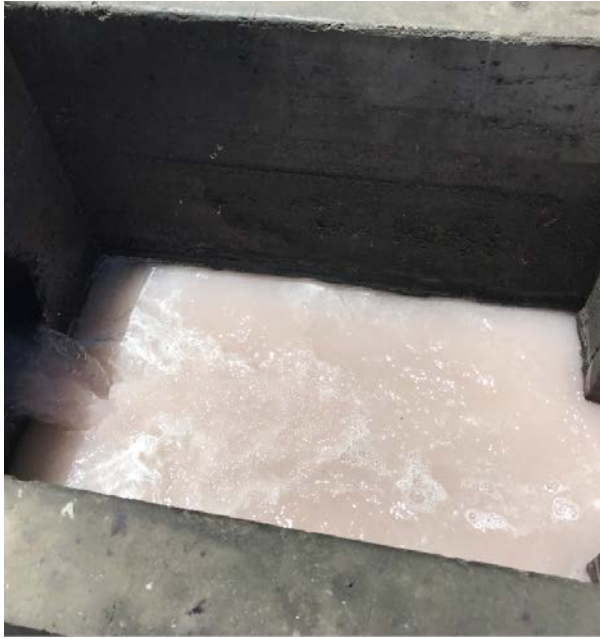
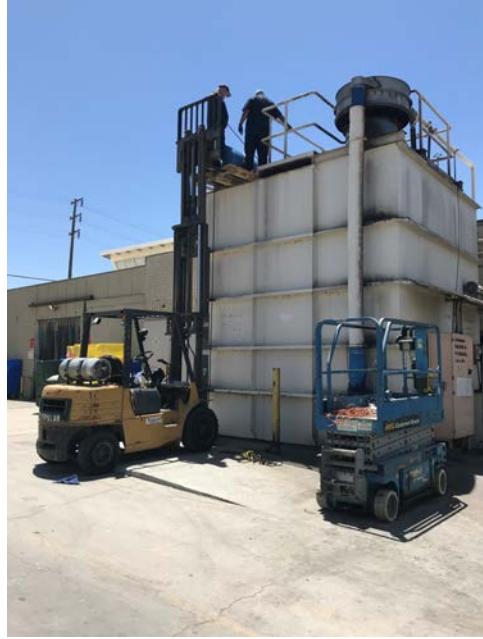
Figures 5 and 6: Pink colored wastewater in the flume at Mission Linen Supply and the company personnel manually adding bleach into the facility's above-ground flow equalization tank to remove the color prior to discharge.

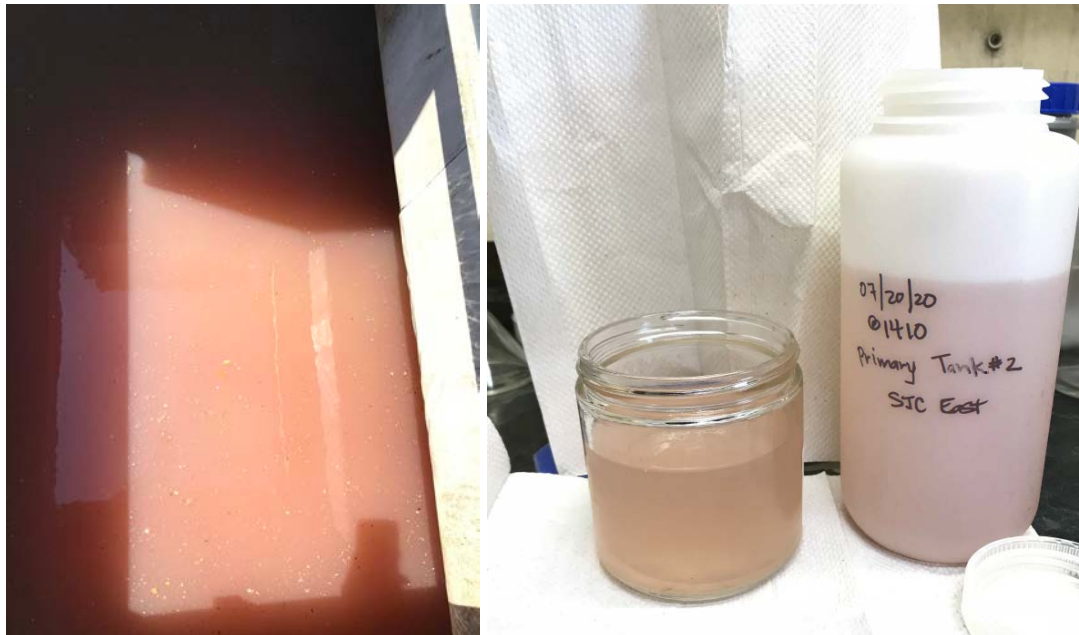
On Monday, July 20, 2020 at 1408 hours, operators at the San Jose Creek East WRP reported to Industrial Waste (IW) inspection staff that during normal rounds at 1400 hours operators had noticed red color in primary tanks 2 and 3. Operators collected samples of the colored primary effluent wastewater (See Figures 1 and 2). Influent pH and odors were normal. At the time of the notification call, there had been no impact on secondary treatment operations as the color had not yet reached secondary tanks.

Figures 1 and 2: 7-20-2020 1410 hours SJC-East WRP Primary Tank #2 and a grab sample taken from the tank.

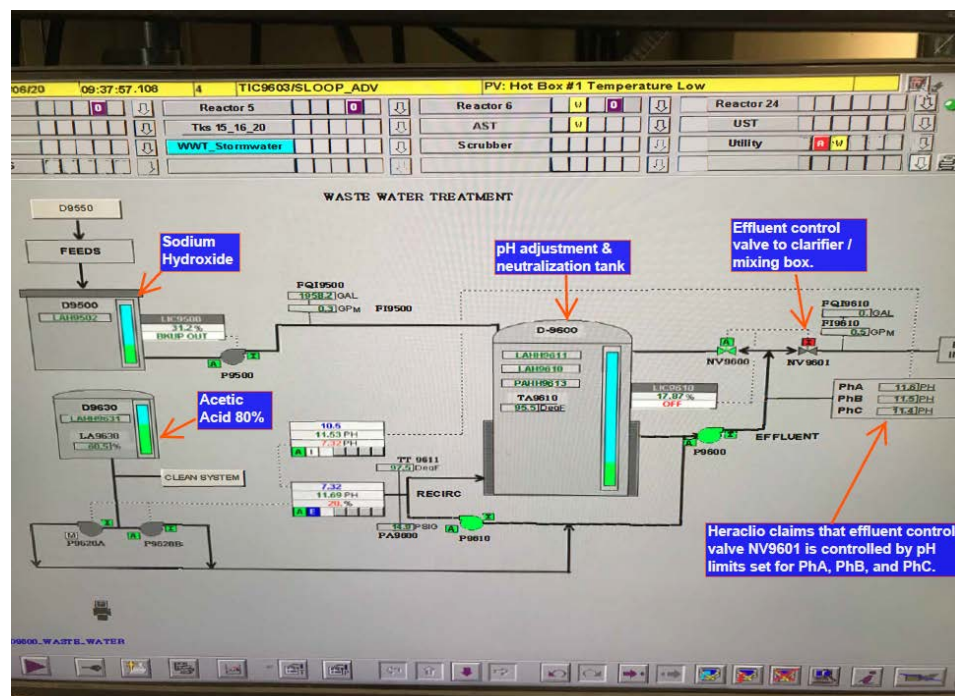
A follow-up investigation by the area IW inspector found that an actuator valve malfunction caused the release of a small volume of the Ancamine product to the industrial wastewater pH neutralization tank. The malfunction went unnoticed for 45 minutes resulting in the discharge to the neutralization tank and 20 minutes of discharge to the clarifier of mixed wastewater and product. The company ceased the discharge as soon as they realized what had occurred and pumped out the contents of the clarifier and neutralization tank (approximately 16,000 gallons) for disposal off-site as hazardous waste. It is unknown how much product was discharged, but it appears to have been minimal and it had no known impact on the downstream collection system sewers or the treatment plant (JWPCP). Research into the cycloaliphatic amine compound that comprises the Ancamine 2074 product indicates it has non-toxic characteristics. The company was cited for failure to notify the Sanitation Districts of the event and discharge of unpermitted material.

Figure 1: Industrial wastewater pretreatment system control panel at Evonik Corp indicating the pretreatment process.

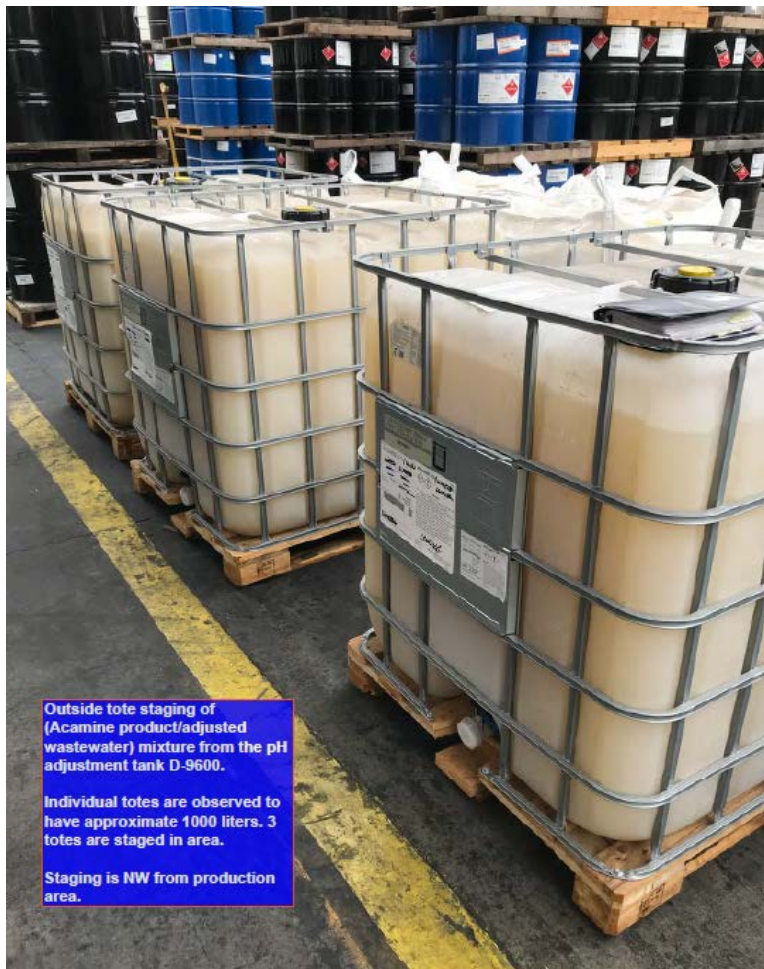
Figure 2: Totes of wastewater removed from the clarifier and pH neutralization tank following the 10-6-2020 spill.

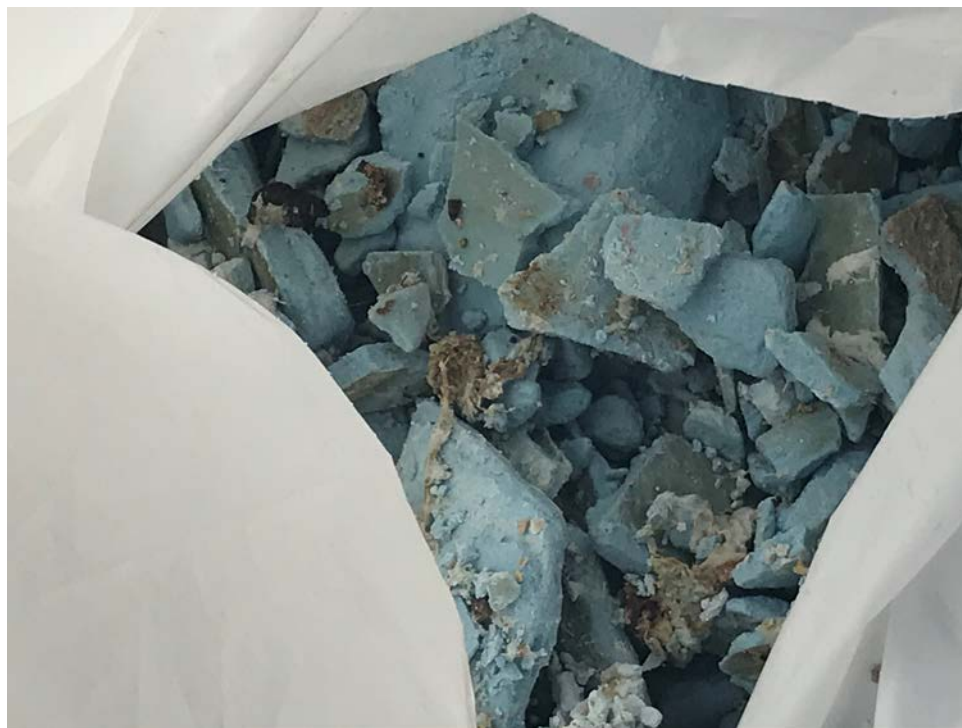
Figure 3: Sample of the blue solids removed from the sewer by City of Lancaster sewer maintenance crews.

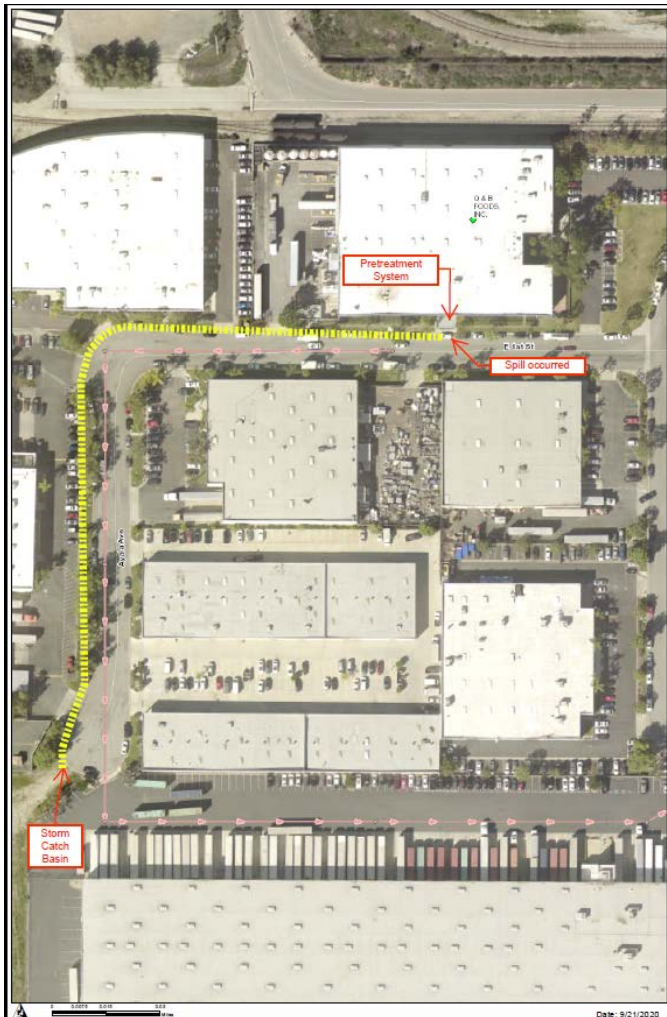
The IW inspection staff investigated the spill report and determined that about 300 gallons of industrial wastewater overflowed the facility's pH neutralization vault, flowing into the downstream storm drain system, see Figure 1. The overflow occurred as a result of a blockage in the line immediately downstream of the vault. A sewer cleaning contractor hydrojetted the line, clearing the blockage. The 1,500 gallons of spilled wastewater and wastewater generated from cleaning up the spill was hauled off-site for proper disposal. The incident had no adverse impact on the downstream sewer system or Districts' treatment plant, the San Jose Creek East WRP.

Figure 1: Spill location and the route the spilled wastewater took to the storm drain system.

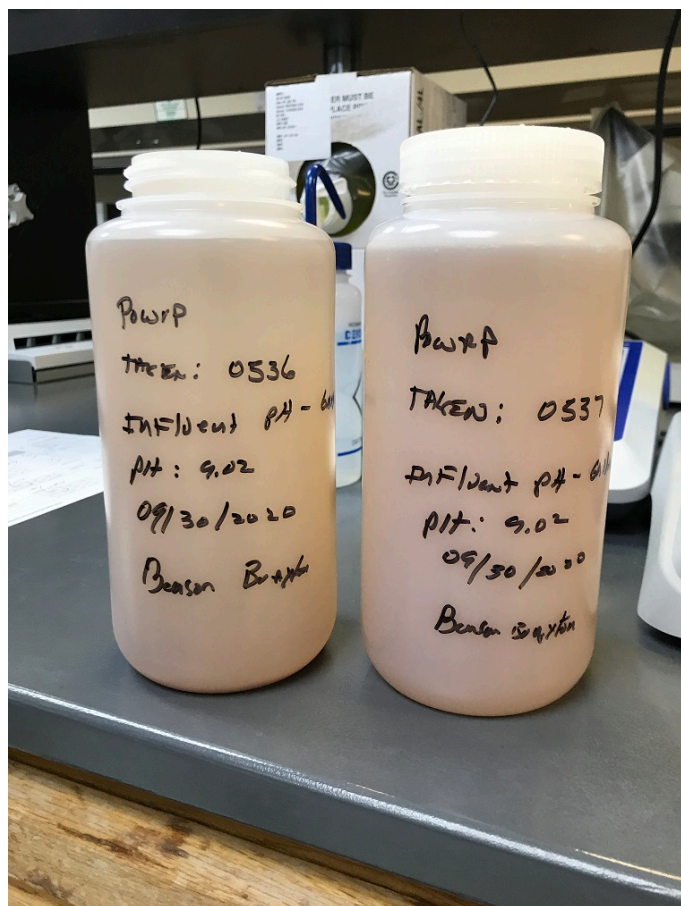
On Wednesday, 9-30-2020 at 0652 hours, the Pomona WRP TPO II notified the IW Section that at 0530 hours there had been a high pH influent alarm at the WRP (alarm level is pH=8.5). When operators responded to the alarm, they also observed red color in the WRP influent. The pH trend began rising above the normal background level of 7.0 at 0516 hours, peaked at 9.0 at 0535 hours, and then returned to normal by 0600 hours. Two samples were taken of the red colored, high pH, influent at 0536 hours and 0537 hours for analysis.

Figure 2: Pomona WRP influent samples taken on 9-30-2020.

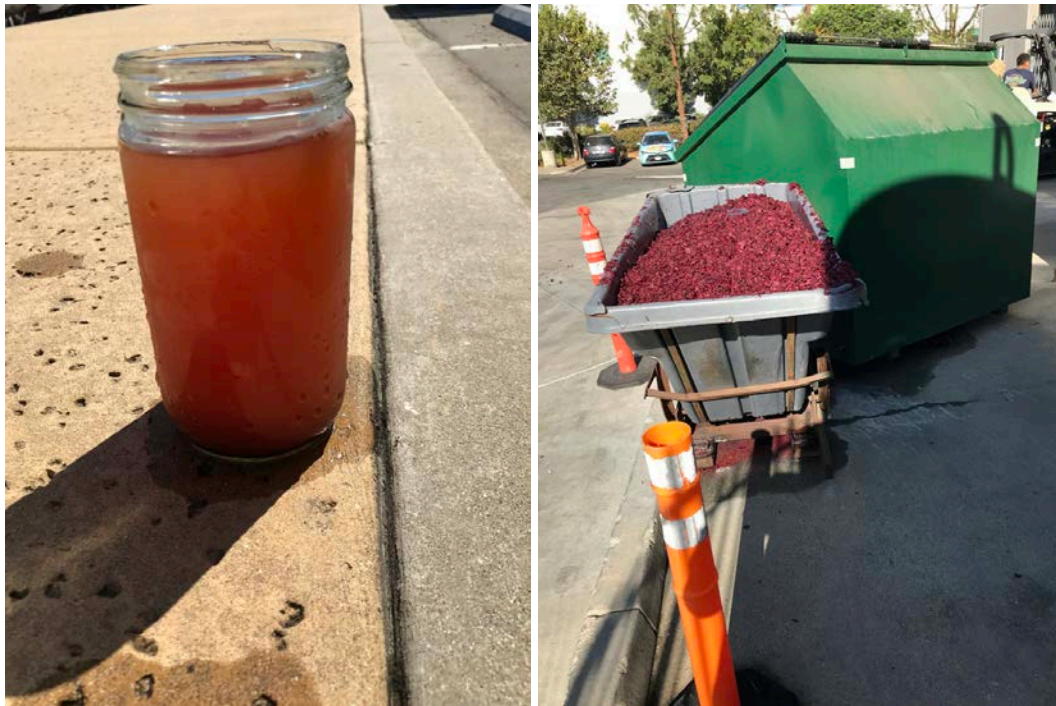
IW inspectors investigated five upstream industrial facilities in an effort to identify the source of red color and high pH that was observed in Pomona WRP raw influent on 9-30-2020. It was determined that Juicy Whip Inc. in La Verne (IW Permit#16648), a beverage manufacturer, had both red colored and high pH wastewater at the legal sample point and was the source of the incident. The facility has a permitted annual average discharge of 8,100 GPD. The inspection at Juicy Whip noted that company had processed Jamaica, a red beverage, which uses Hibiscus flowers for color and flavor, at 0300 hours on 9-30-2020. The inspector also identified a malfunctioning controller/monitoring probe that was overdosing caustic into the pH neutralization system, thus accounting for both the high pH and highly colored nature of the wastewater discharged. Sample analyses and comparison of the WRP samples and a sample taken from Juicy Whip indicated a match (see Figure 5). Notices of Violation were issued to Juicy Whip for the malfunctioning and out-of-calibration pH neutralization and monitoring system, as well as for causing the elevated influent pH and excessive color at the WRP. Juicy Whip will modify their production schedule to reduce the discharge of highly colored wastewater during early morning hours when the WRP is most susceptible being impacted by highly colored influent. No NPDES violations or adverse effects on treatment plant operations occurred as a result of this incident.

Figures 3 and 4: Sample of the wastewater discharge at Juicy Whip on 9-30-2020 (on the left) and Hibiscus flower waste.

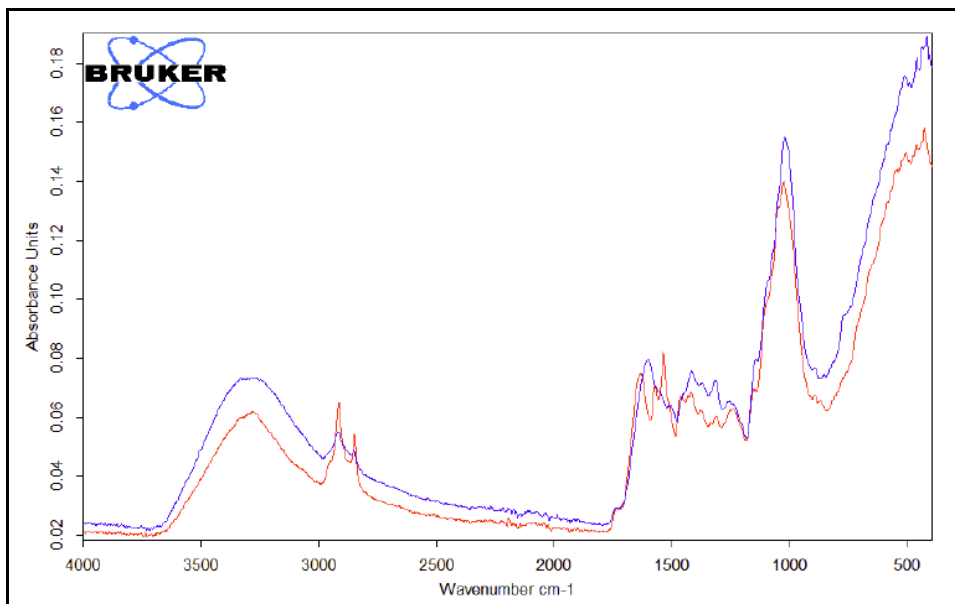
Figure 5: FT-IR spectra results comparing the colored solid extracts from the WRP (red) sample and sample from Juicy Whip (purple).

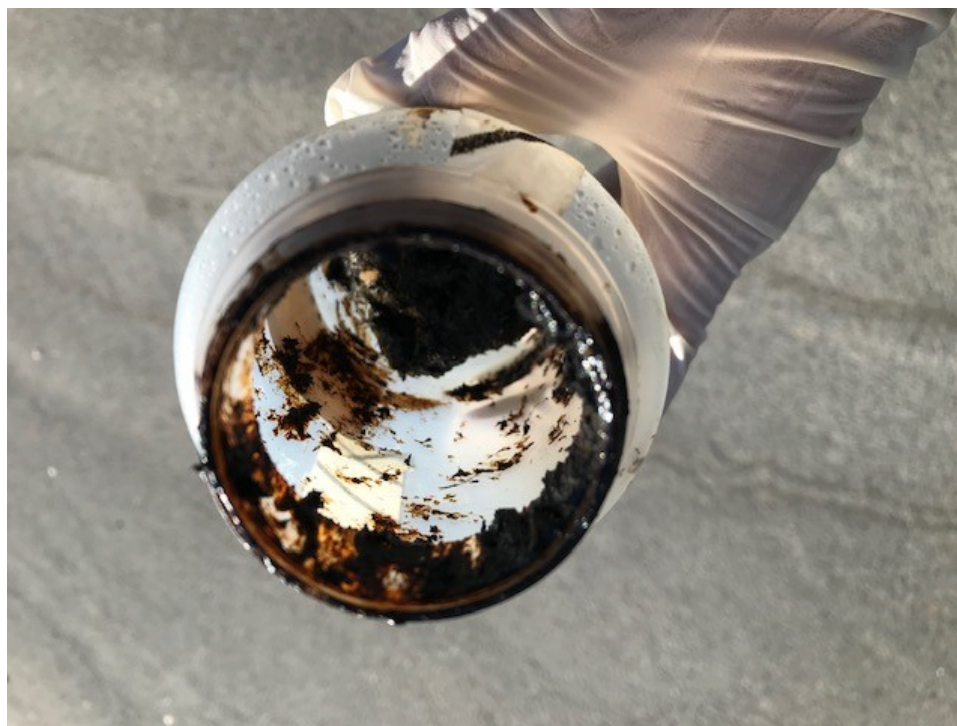
On Thursday, 10-15-2020 at 1510 hours, the San Gabriel Valley Field Office (SGVFO) called the IW Section and reported that a sewer maintenance crew had encountered black oily material in a siphon structure on the 30” diameter North Plant Outfall Relief trunk in Whittier earlier that afternoon. The location of the siphon structure is essentially the intersection of Mulberry Drive and Painter Avenue (Manhole (MH) 18 0640-MH 18 0639). The SGVFO also stated that just prior to seeing the oil at that siphon, the crew had cleaned another siphon only two reaches upstream (MH 18 0643-MH 18 0642) and found no oil there.

Figure 1: Oily material recovered from the siphon structure on 10-15-2020.

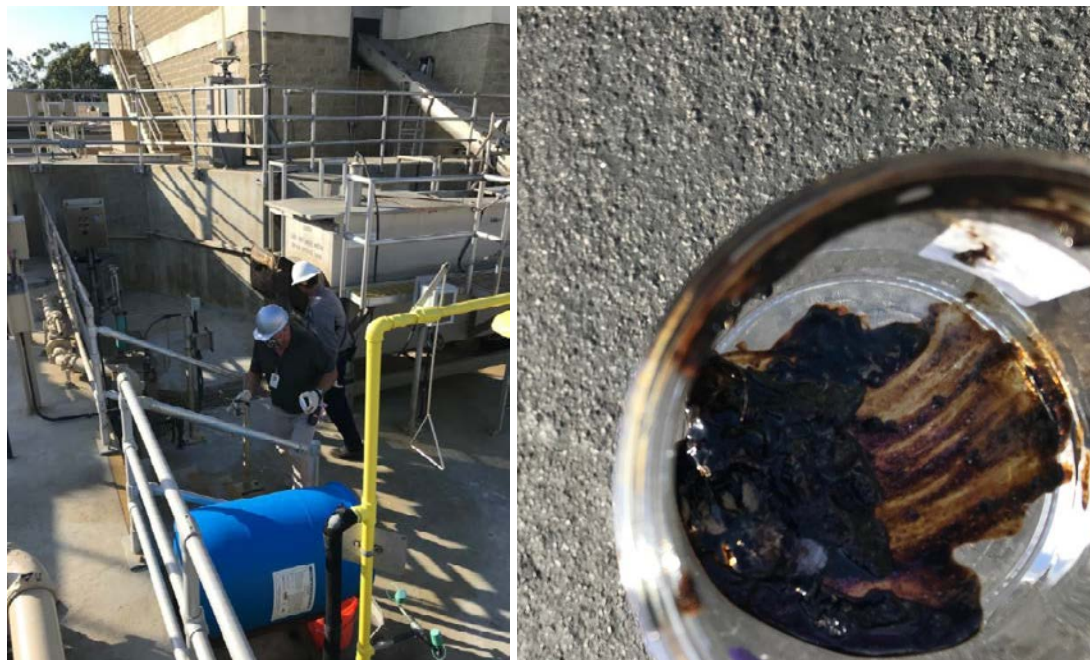
On Tuesday, 11-24-2020 at 1338 hours, Treatment Plant Operators at the JWPCP notified IW Inspectors of a gasoline/kerosene odor present in primary treatment gallery. Operators also reported that the primary treatment skimmings appeared oily. Operators were advised by IW inspectors to grab a sample of the oily material if possible. Operators took a sample from Inlet Works 1 & 2.

Figures 1 and 2: IW Inspectors taking petroleum oil samples from the influent screenings compactor at JWPCP on 11-24-2020.

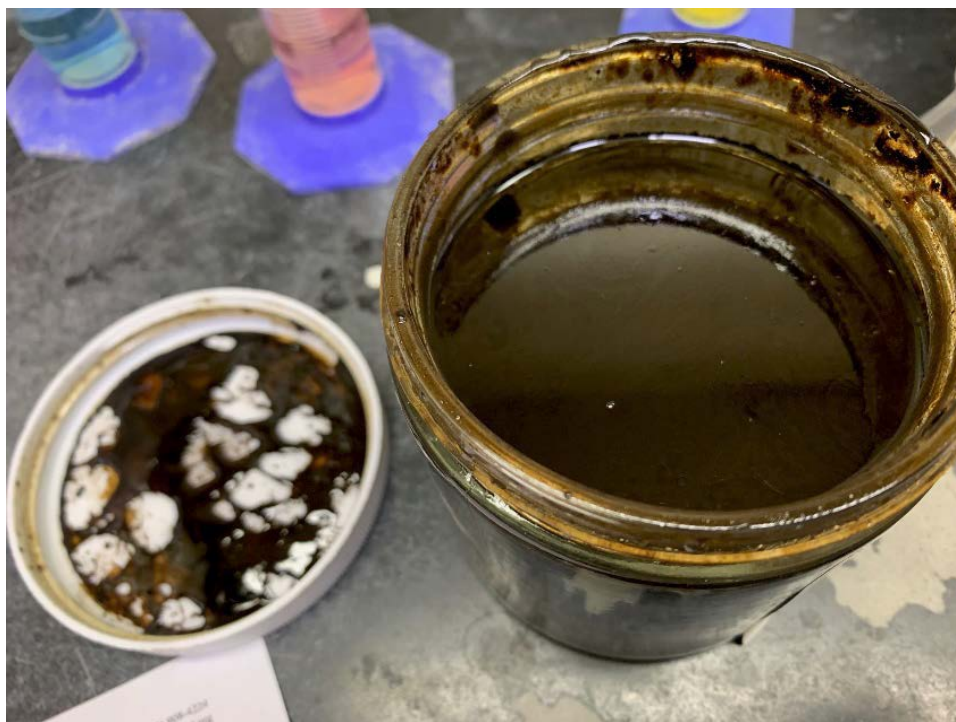
Figure 3: Sample collected from the discrete ISCO sampler at the Phillips 66 oil refinery's legal sample point on 11-24-2020. The sample characteristics were consistent with the oil found at JWPCP and subsequent GCMS analysis confirmed the match.
