2020 ANNUAL REPORT

INDUSTRIAL WASTE PRETREATMENT PROGRAM

LOS ANGELES COUNTY SANITATION DISTRICTS

APPENDIX H
INDUSTRIAL WASTE REPORTS ON INCIDENTS

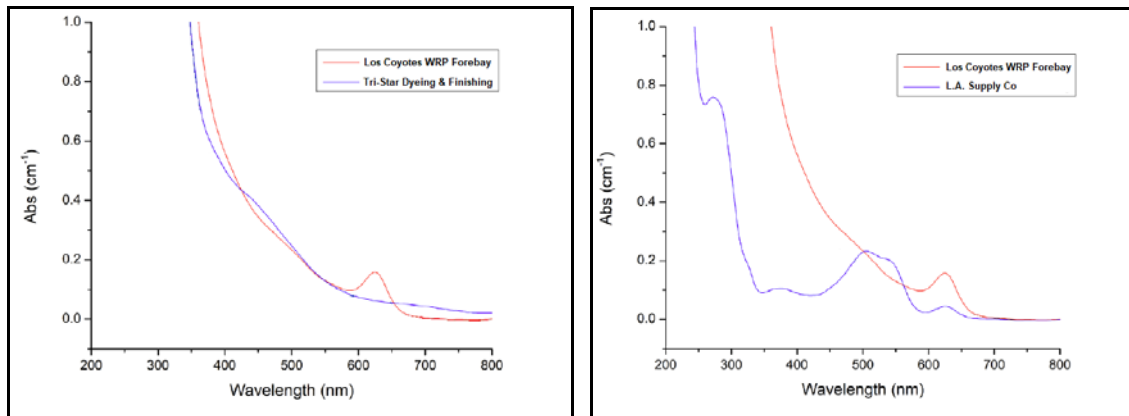
Figures 1 and 2: UV scan color analysis showing how samples from Tri-Star Dyeing & Finishing and L.A. Supply Co. compared to the sample from the Los Coyotes WRP.

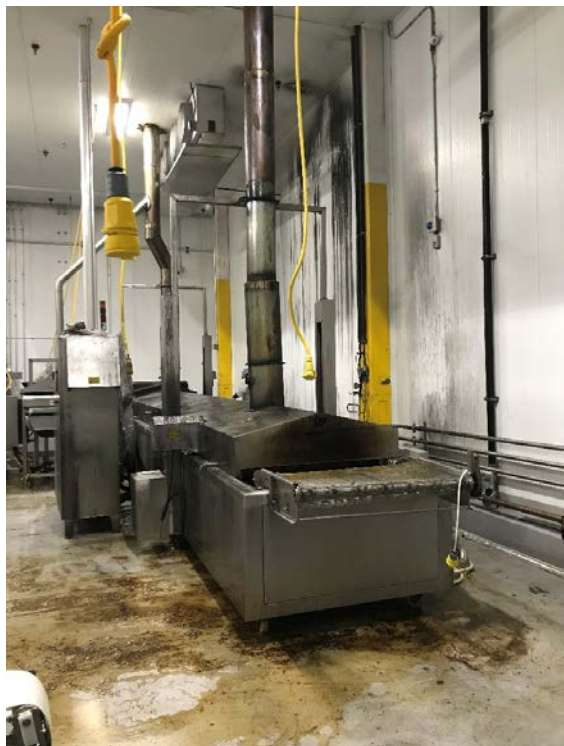
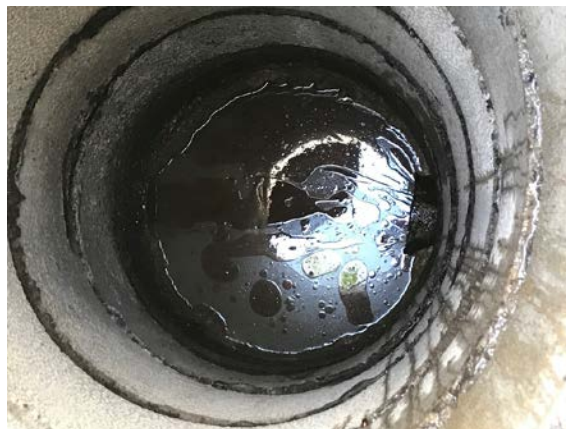
Figures 3 and 4: 12-17-2020 photos showing the stuffed chicken fryer that caught fire and oil residual floating on the top of the wastewater in the industrial wastewater sampling box at Signature Fresh. Note also the oil on the floor next to the fryer.
