**2021 ANNUAL REPORT**

INDUSTRIAL WASTE PRETREATMENT PROGRAM

LOS ANGELES COUNTY SANITATION DISTRICTS

**APPENDIX H**  
INDUSTRIAL WASTE REPORTS ON INCIDENTS

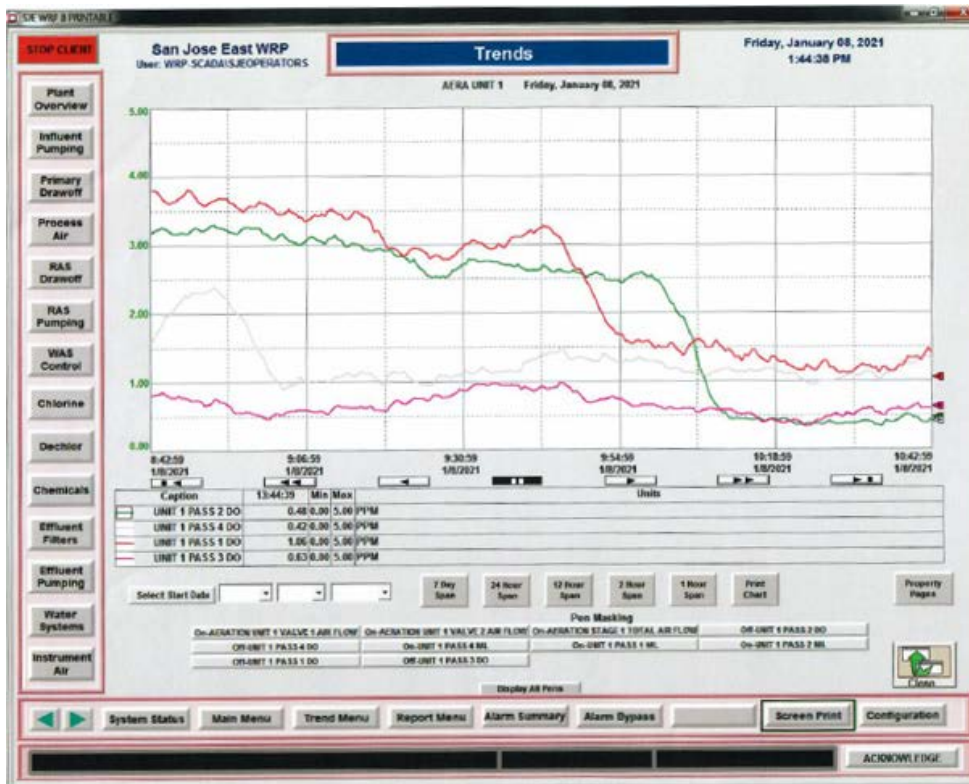
**Figure 1: San Jose Creek East WRP dissolved oxygen trend data showing the D.O. drops in the aeration tanks on 1-8-2021 at about 0945 hours.**

Both day and night shift IW Inspectors responded to this incident report. Calculations based on WRP trend data (See Figure 1) indicated the high strength wastewater that caused the incident entered the WRP at about 0800 hours. It had no other observed unusual characteristics such as unusual odors, colors, or the presence of grease observed in the WRP by operators. Also, the influent pH trend data was normal, though it was missing for the period of 0700-0750 hours that day due to maintenance activity. A total of 17 possible industrial sources for high strength industrial wastewater were inspected by IW staff on Friday, 1-8-2021 and Monday, 1-11-2021, but none was identified as the primary cause/source of the incident. Inspections at two of these facilities did indicate some unusual activity, but neither seemed a likely main cause for the incident: One was at a manufacturer of mayonnaise and food dressings that had conducted regular quarterly sewer line cleaning in the early morning hours of 1-8-2021 that could have dislodged some high strength solids to the sewer. The other was a meat processing facility where grease moderately coating their industrial wastewater discharge

The impact of the high strength wastewater on the WRP was significant but did not ultimately result in any violations of any effluent limits or guidelines. WRP operators were able to treat the high strength waste by increasing oxygen supplied to the aeration tanks by turning up the blowers. WRP trend data indicated that plant operations eventually returned to normal, but not until 2300 hours on 1-8-2021. IW Inspectors continue to be vigilant to possible sources for this incident.

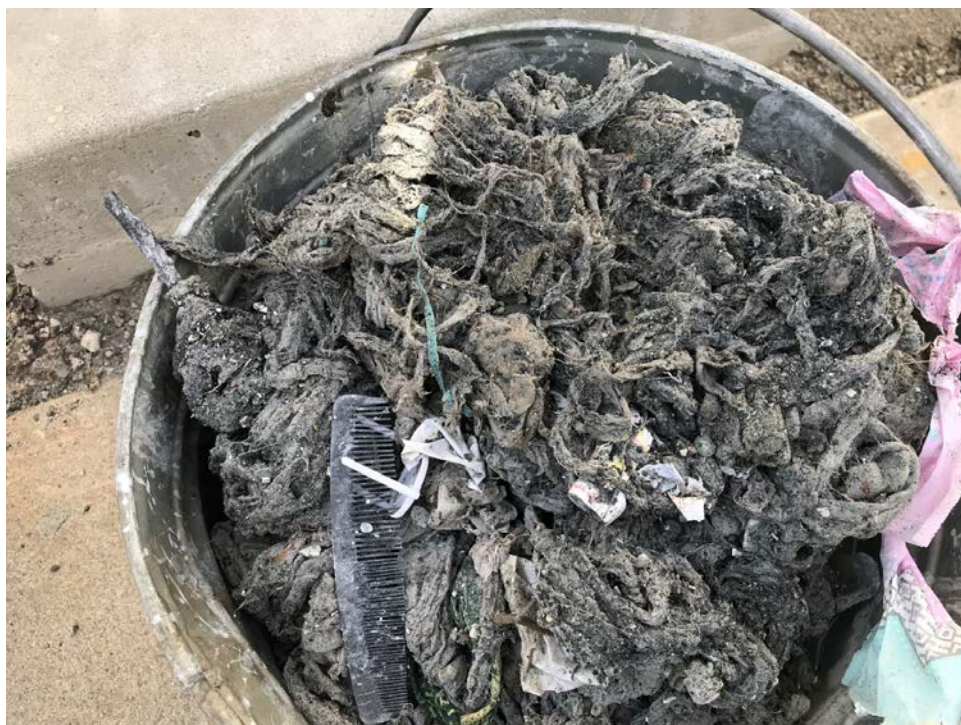
**Figure 2: "Rags" removed from the J.O. 'E' Unit 3 trunk sewer line in a bucket at the Compton field office on 1-19-2021.**

IW Inspectors responded to the report of ragging in the J.O. 'E' Unit 3 trunk sewer line on the same day it was reported. They examined the rags removed from the sewer at the Compton field office and determined that the rags were non-woven plastic wipes now used by large segments of society (see Figure 2). Inspectors did also inspect two possible industrial sources of cloth rags located upstream of the sewer line in question, a textile dyehouse and an industrial laundry, but found no evidence that either was discharging any cloth type rags. It was also noted that this section of trunk sewer was last cleaned in June 2008, with October 2017 CCTV video possibly indicating that a buildup of likely wipes and grease was present. No further investigation or action on this incident by the IW Inspection staff is anticipated.

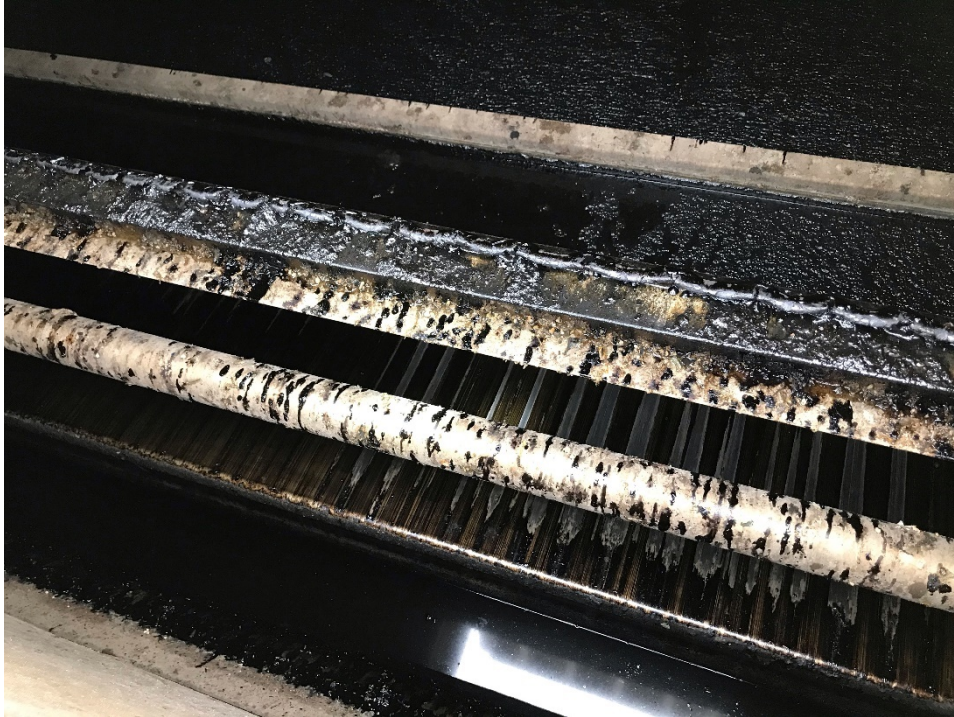
**Figure 2: Black oil globules on the JWPCP E1 skimmings trough on the morning of 2-9-2021.**

Investigating IW Inspectors determined that the oily material which caused the paint thinner/kerosene odor and oily sheen came in through the J.O. 'A' headworks by noting oil globules in the E-1 skimmings trough (see Figure 2). It was subsequently determined that the Phillips 66 Carson oil refinery (IW#21079) was the source of this material. This large facility has a permitted annual average discharge of 2,823,000 GPD. The discharge of excessive amounts of oil by the refinery was caused by an upset to the refinery's pretreatment system. This incident matched the 11-24-2020 upset at the refinery which also caused a similar impact at the JWPCP. GC-MS analysis of samples from the JWPCP headworks and the Phillips 66 Carson refinery matched and confirmed the refinery as the source of the diesel range hydrocarbons at JWPCP. IW Inspectors estimate that 5,200 gallons (3,700 pounds or 120 barrels) of total oil and grease were discharged to the sewer by the refinery between 1800 hours and 2400 hours on Monday, 2-8-2021.

On 3-2-2021 the Phillips 66 Carson Refinery was issued a Notice of Violation (NOV) for causing the 2-9-2021 incident and failing to notify the Districts of their pretreatment system upset that resulted in excessive quantities of restricted waste (oil) to be discharged to the sewer. Refinery managers acknowledged responsibility for the incident and claimed that they are working on altering their notification procedures so that immediate notification is made in the future to the Districts when they become aware that an out-of-spec discharge has occurred. The incident had no known negative impact on treatment plant operations or effluent quality at the JWPCP.

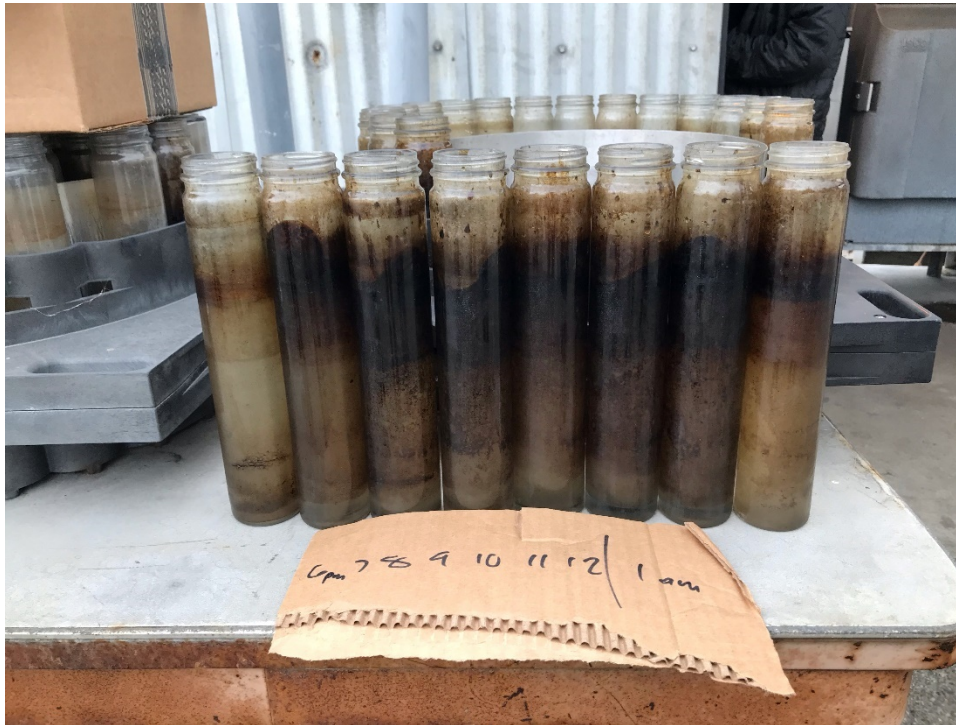
**Figure 3: Hourly glass sample bottles at the Phillips 66 Carson oil refinery indicating excessive amounts of oily material were discharged to the sewer between 1800 and 2400 hours on 2-8-2021. Note clean sample bottles in the left rear of the photos as compared to the bottles in the foreground that contain high concentrations of black oil.**

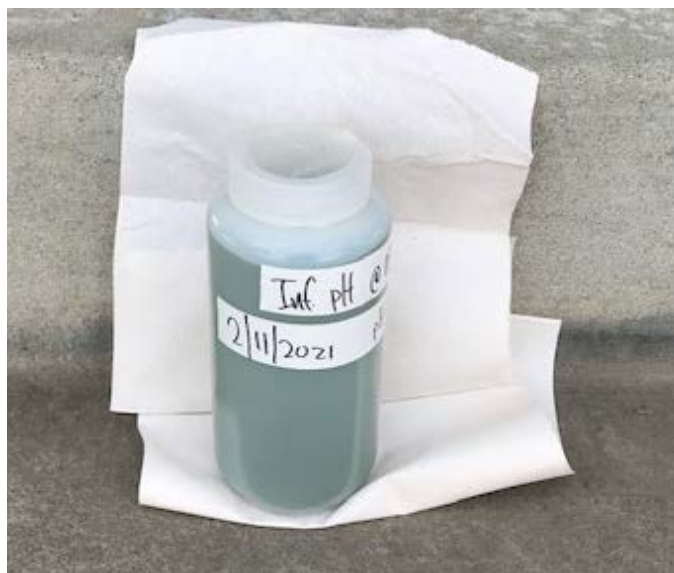
**Figure 4: 2-11-2021 sample of the green colored raw influent at WNWRP.**

IW Inspectors quickly identified the source of the green color in both incidents as being Vanguard Design Inc., (IW#22004), a garment washing and dyeing facility about a mile upstream of the WRP that has a permitted annual average discharge of 22,000 GPD. Visual analyses, as well as laboratory IR scan test results, confirmed the color at the WRP and the dye used by the Vanguard Design matched in both incidents. Historically, the Vanguard Design facility has done mostly stonewashing operations which produce wastewater with a less intense color, but during the ongoing COVID-19 pandemic they have shifted their business to more garment dyeing due to the economic downturn caused by the pandemic. This is now causing color incidents at the WRP. On 2-26-2021 Vanguard Design Inc., was issued a NOV for causing both incidents and IW Inspectors are working with company managers to improve their color removal pretreatment operations in order to prevent future similar incidents at the WRP. Company managers acknowledge the problem and seem cooperative thus far to trying to solve the issue. A compliance meeting with Districts' Enforcement managers and company managers has been scheduled for 3-16-2021 at 1400 hours.

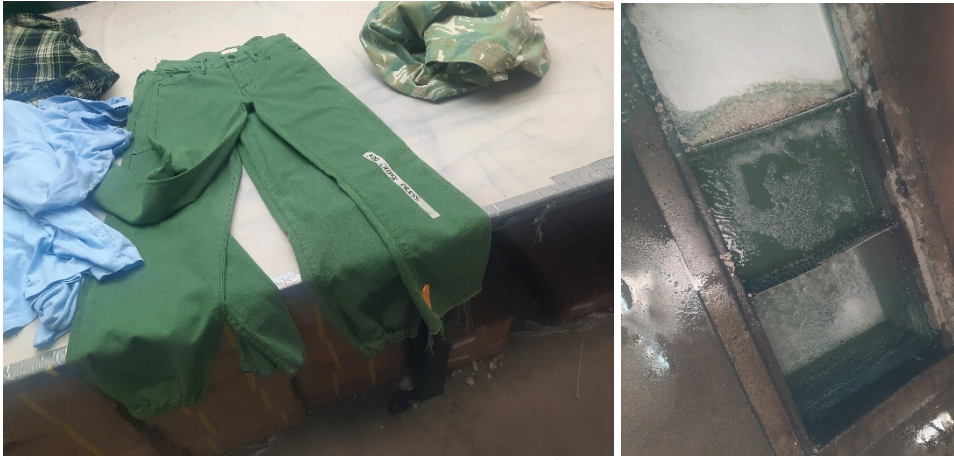
**Figure 5 and 6: 2-11-2021 photos of green pants being dyed at Vanguard Designs Inc., as well as the green-colored wastewater in the drains at the facility. Note the close match in visual appearance to that of the wastewater noted at WNWRP in Figure 4 above.**

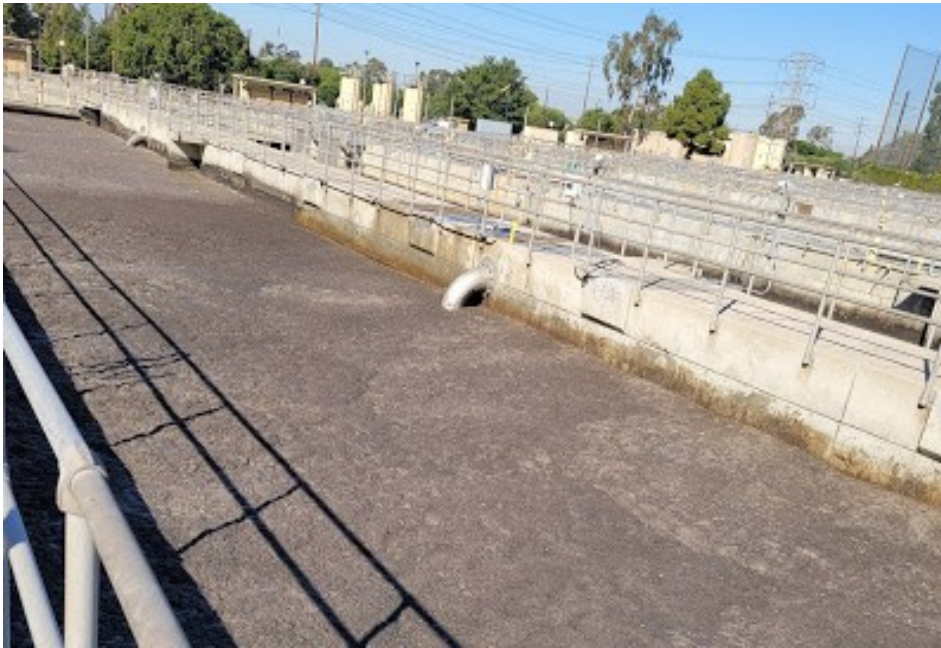
**Figure 7: 2-18-2021 excessive foam in aeration tank at LCWRP at 0730 hours.**

IW Inspectors responded immediately to the report of the foam. Microscopic examination of the foam by laboratory personnel revealed it to be composed of filamentous Nocardia bacteria, indicating the foam is biological in nature. Nocardia foaming can be caused by high levels of fats, oils and greases, and/or high sludge age conditions. It's also believed that different types of surfactants (soaps) can result in the formation of Nocardia forms. Typical industrial wastewater caused excessive foam in a WRP usually appears as billowy white, not as the thick brown Nocardia foam as seen in Figures 6 and 7 above. IW Inspectors conducted inspections at 16 possible industrial sources for foam causing materials but did not identify a likely source. It remains unclear if the moderate high pH influent spikes noted on 2-18-2021 are related to the foam incident. No NPDES violations resulted from the incident and no foam was observed in plant effluent. The sample results for the MBAS and NID analyses requested for the WRP primary and secondary effluent samples taken remain unavailable as of 3-4-2021. IW Inspectors remain vigilant as to any possible industrial sources for the incident.

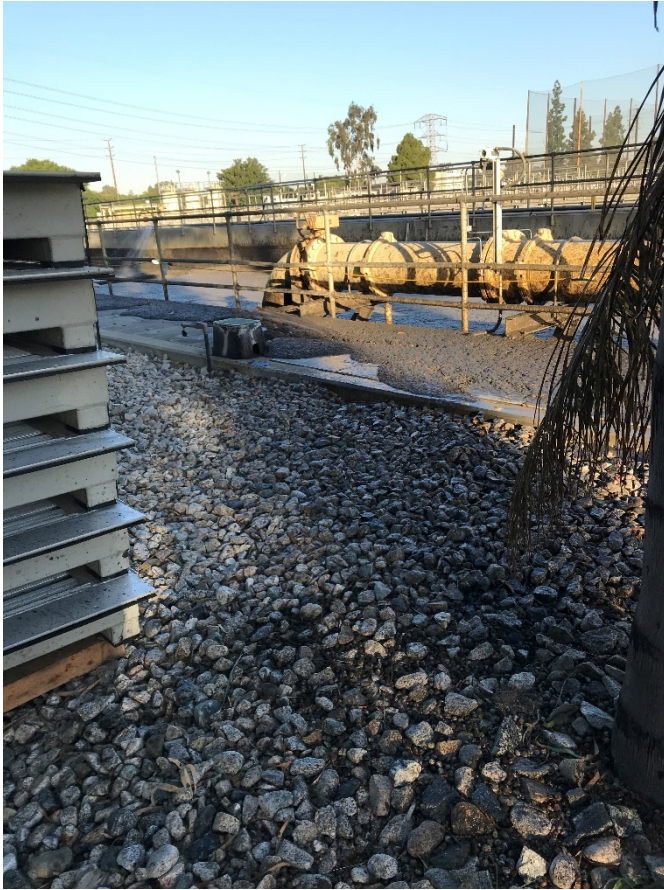
**Figure 8: 2-18-2021 excessive foam in aeration tank at LCWRP at 0730 hours. Note that the foam got deep enough to overflow onto the walkway above the tank.**

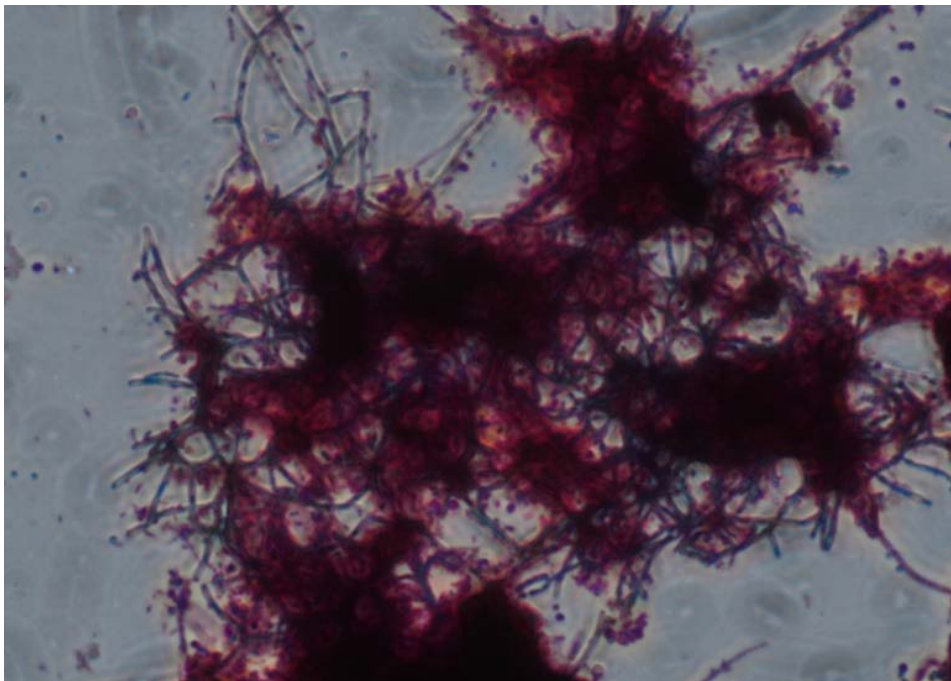
**Figure 9: Microscopic photo of the Nocardia filaments in the foam from the LCWRP on 2-18-2021.**

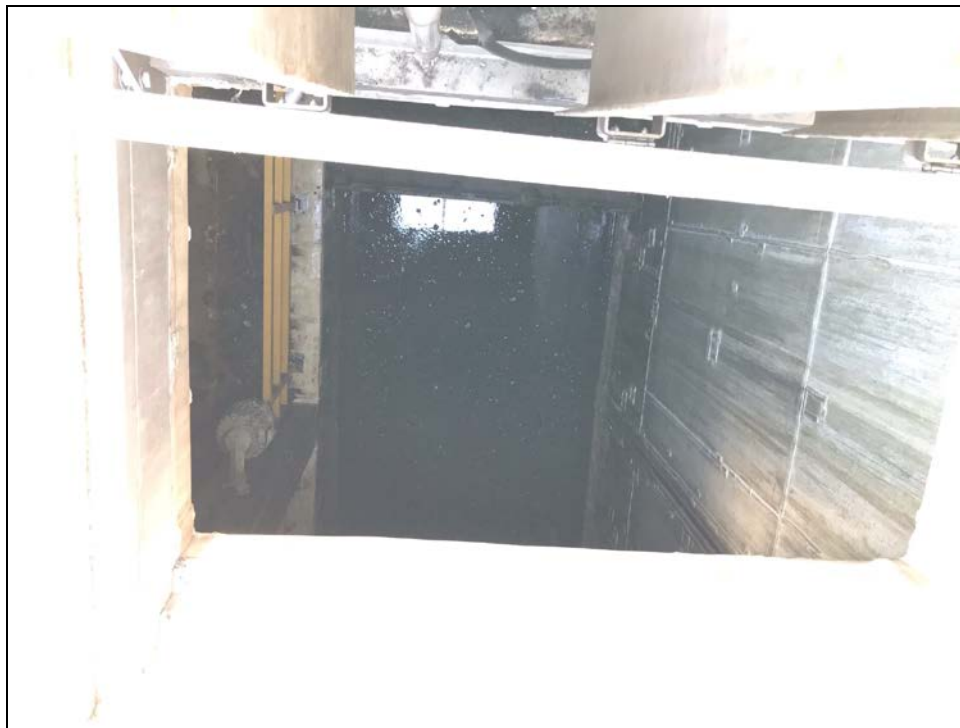
**Figure 1: Floating oil in the wet well at the Long Beach Main Pumping Plant on 3-9-2021.**

IW Inspectors responded immediately, arriving on-site at the LBMPP at 1130 hours on 3-9-2021. After observing the oil in the wet well (see Figure 1 above) they attempted to see if it could be traced in the sewer upstream to a source, but no oil was visible in samples taken from manholes just upstream of the pumping plant. Inspectors then inspected likely sources for the oil, including the large Ultramar oil refinery in Wilmington, as well as numerous oil production field leases which have industrial wastewater discharge permits, but found nothing out of the ordinary. The influent area to the LBMPP is quite large, including most of Long Beach, Lakewood, and Signal Hill.

Testing of the wet well sample indicated it was a near 50/50 mixture of petroleum oil and animal/vegetable oil. This mix indicates it was highly unlikely to have come from a single source and likely represents fat, oil, and grease discharged into the sewer by industrial, commercial, and residential sources. It was noted that prior to the construction of the “new” Long Beach Main Pumping Plant recently, operators had little opportunity to observe the quality of the waste in the wet well and it may be that such a layer of floating oil was not uncommon, but unobserved by operators. However, with the new plant allowing such observations, the oil can now be seen more easily. Lastly, discussions with operators indicated the oil was observed when they were in the process of drawing down the wet well to draw down the level in J.O ‘C’ trunk line so CCTV inspection could be performed. It is possible that in drawing down the sewer, oils that had built up in the sewer upstream of the pumping plant were released and ultimately collected in the wet well. Inspectors remain diligent in looking for potential sources and are checking in with the LBMPP for updates on the condition of the wet well.

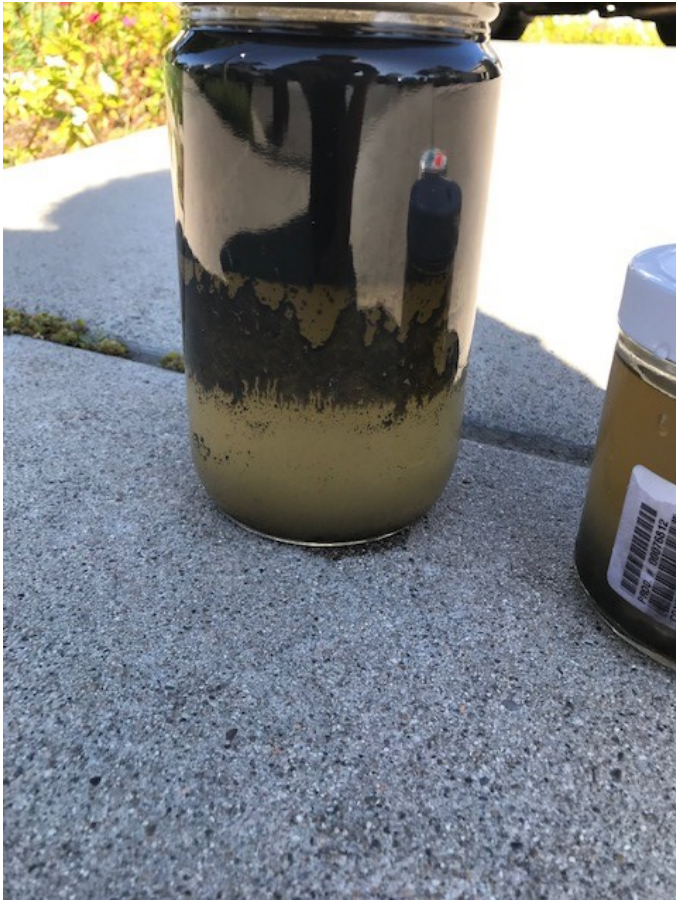
**Figure 2: Sample of the oil taken from the LBMPP wet well on 3-9-2021.**

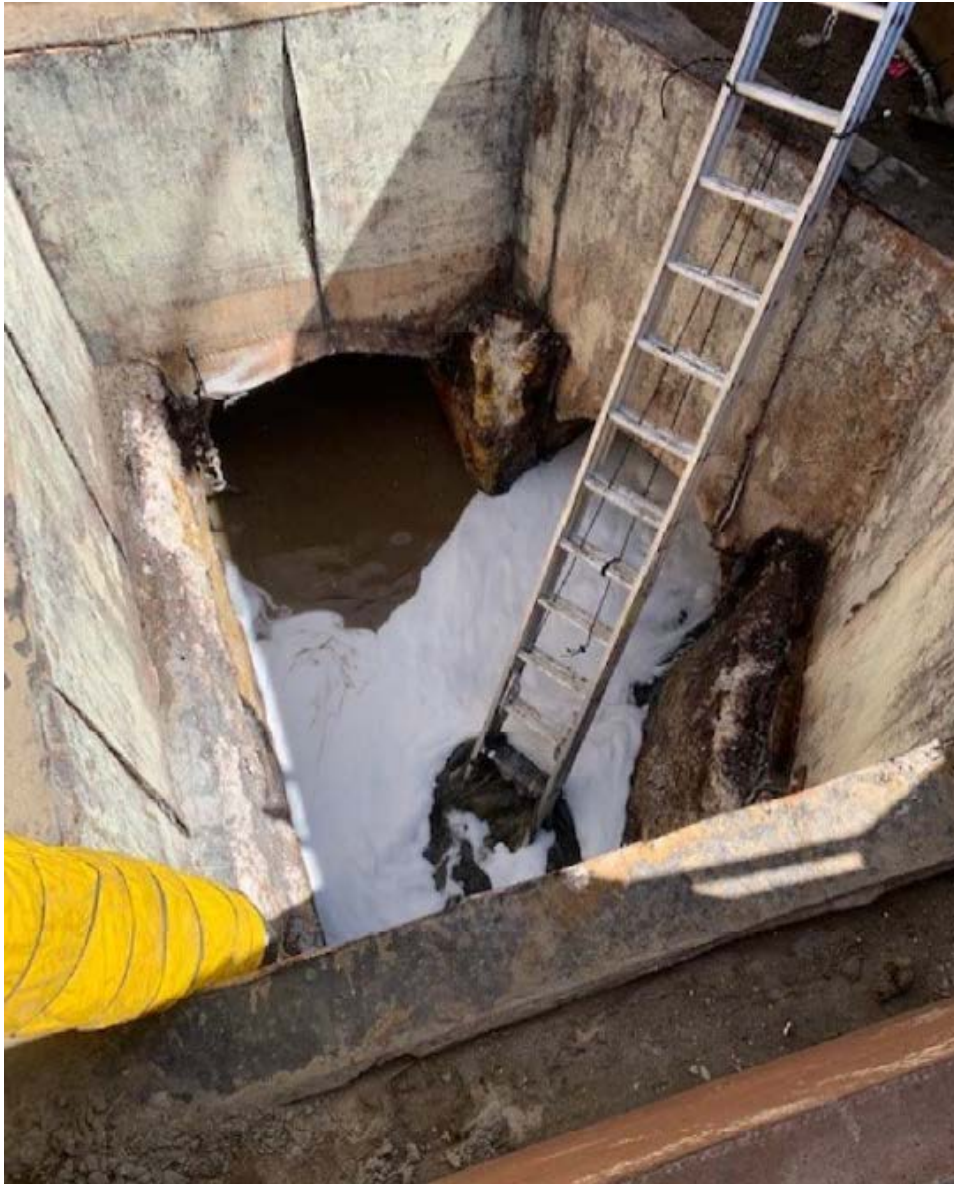
**Figure 3: Looking into the vault that is MH 18 A575 on 3-17-2021. Note the white foam and the yellow air blower hose used to control the presence of sulfide gas.**

The investigation by IW Inspectors determined that the source of the white foam was multiple (4) 5,000-gallon loads of shampoo laden wastewater from the Bocchi Laboratories Inc. shampoo manufacturing facility located in Santa Clarita that were hauled and dumped at the Pomona Liquid Waste Disposal Station as is allowed under the permit issued by the Districts. This waste is not allowed to be discharged to the sewer at the manufacturer's location due to concerns the downstream Valencia WRP would be adversely affected by the foam caused when the wastewater reached the aeration tanks at the WRP. Instead the loads are directed to the Pomona LWDS and discharged there so that the waste flows to the JWPCP where the potential to cause foaming is much less due to dilution from the large flow volume treated there.

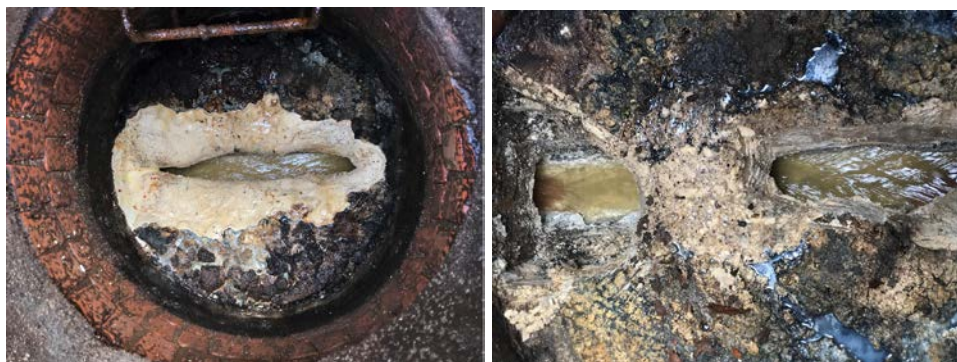
**Figures 7 and 8: 3-23-2021 local sewer line manhole grease in Azusa.**

IW Inspectors quickly determined the source of the grease to be a large meat processing and cooking operation upstream of MH 914A, S & S Foods LLC. This facility cooks ground beef used in fast food restaurant tacos and hamburger beef patties. The facility has an industrial wastewater permit (IW#16449) and a permitted annual average discharge of 75,000 GPD. S & S managers admitted they were the cause of the grease, saying that they had been having issues with running and properly maintaining their pretreatment system during the ongoing COVID-19 pandemic. This system is supposed to remove grease from their wastewater discharge. Company managers voluntarily agreed to hire an outside contractor to clean the local line sewer and this was accomplished without incident on Tuesday, 3-30-2021, under the observation and guidance of both City and Districts' sewer maintenance personnel (Figures 10 and 11). A verbal warning was issued to the company for causing the greasing and managers said they will be more diligent in operating their grease removal pretreatment system.

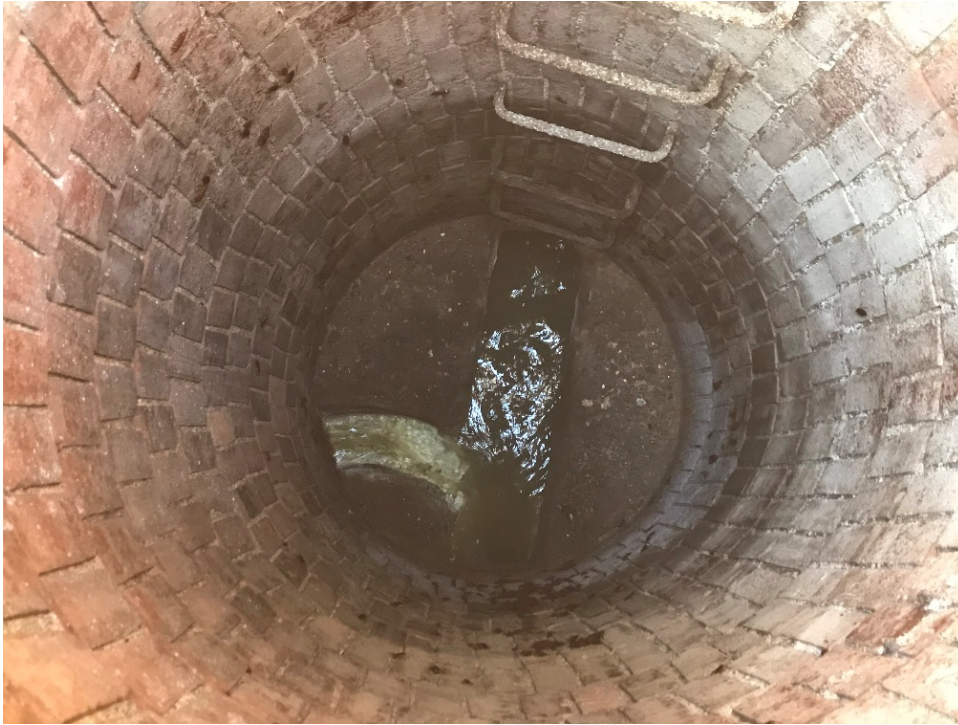
**Figure 9: 3-23-2021 MH 22 0914A; where the local line shown above joins the Districts' 15" diameter Coney trunk sewer. Note the grease in the local sewer line and lack of such in the Districts' line. The Coney trunk was cleaned at this location on 2-24-2021.**

Districts sewer maintenance also reported that during Districts cleaning of the sewer reach between MH 22 914A and MH 22 914 on 2-24-2021 they noted “heavy grease,” though not enough to warrant notification of IW inspection staff. Districts and City staff will monitor this situation more closely in the coming months.

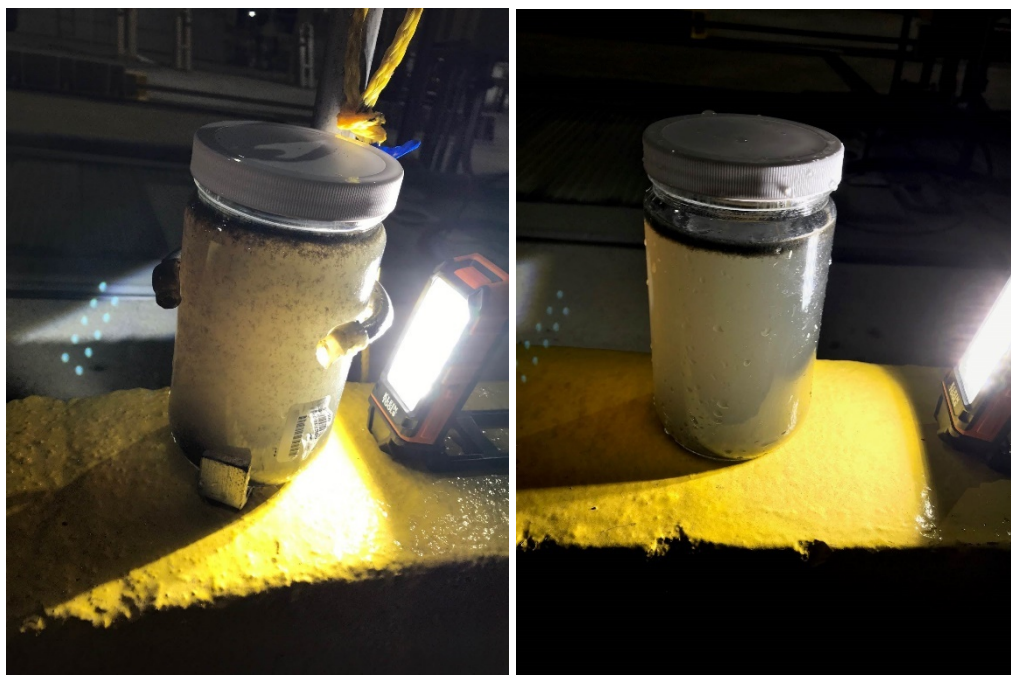
**Figures 1 and 2: Samples of JWPCP raw influent taken on 4-14-2021 at 0100 hours. Note the appearance of the samples immediately upon collection (left) and then after 1 minute of settling (right). Note how readily the material floats due to the presence of cationic polymer.**

IW Inspectors on both night and day shifts investigated this incident. Although some similar appearing material was spotted at one industrial discharger, Qualawash Holdings LLC in South Gate, a tanker truck washing facility that also washes totes and containers used to haul bulk chemicals, GC/MS analysis of the suspect waste determined it was not the same material reported at JWPCP. Furthermore, numerous inspections at other industrial facilities influent to the J.O. ‘B’ trunk line that feeds the E-3 South Skimmer tanks found no likely sources for the incident.

Eventually, IW Inspectors determined that the most likely cause of the incident was the upstream Districts’ San Jose Creek East and Los Coyotes Water Reclamation Plants taking secondary aeration unit tanks out of service and discharging the solids from those tanks to the JWPCP. The SJC-East WRP took 2 units out of service and washed the solids to the waste line on 4-12-2021 – 4-13-2021. Then on 4-14-2021, the LC WRP removed a unit from service and

In summary, it appears the mostly likely cause of the recent events of floatable solids entering JWPCP via J.O. 'B' was from upstream WRP discharge of secondary solids to the sewer. It is not anticipated that any further investigation of the floatable solids found at JWPCP from 4-13-2021 to 4-14-2021 will be needed, but inspection staff remain vigilant and will respond if further complaints of floating solids are noted by operations staff.

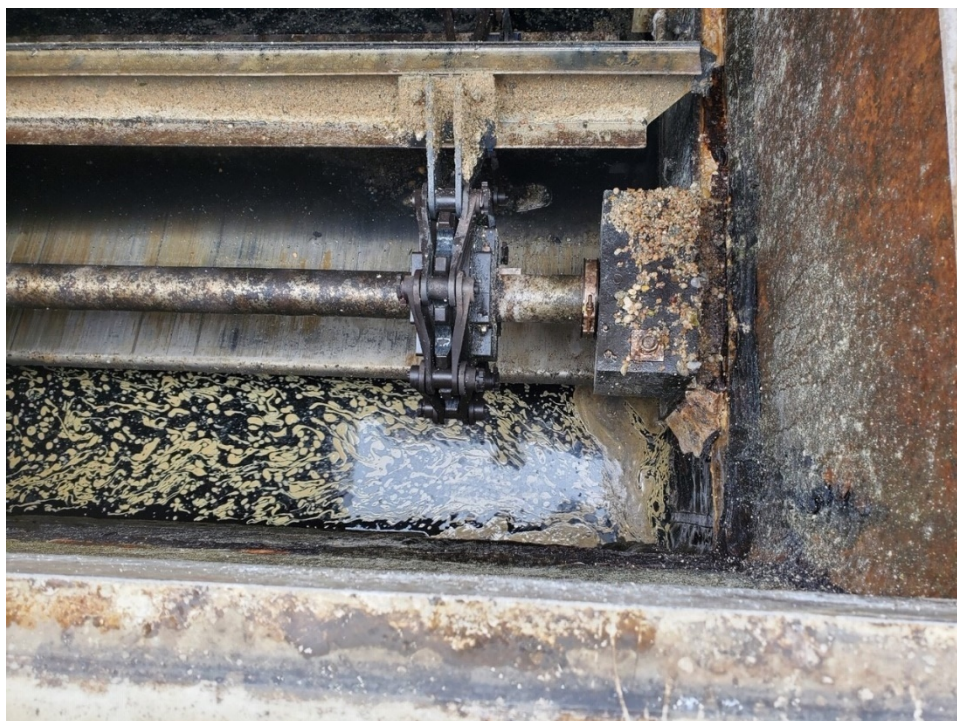
**Figure 3: Oily material in JWPCP North Skimmer trough on 4-14-2021 at 1300 hours.**

IW Inspectors investigated the report on 4-14-2021 and 4-15-2021. They found that the oil was not a petroleum-based oil material. Instead, the globules observed above in Figure 3 were food-based grease probably liberated by JWPCP operators doing routine steam cleaning of the E-3 influent line on the morning of 4-14-2021. Checks of plant influent found no similar oily material was entering the JWPCP during the afternoon of 4-14-2021 and inspections at possible upstream industrial sources did not reveal a likely source.

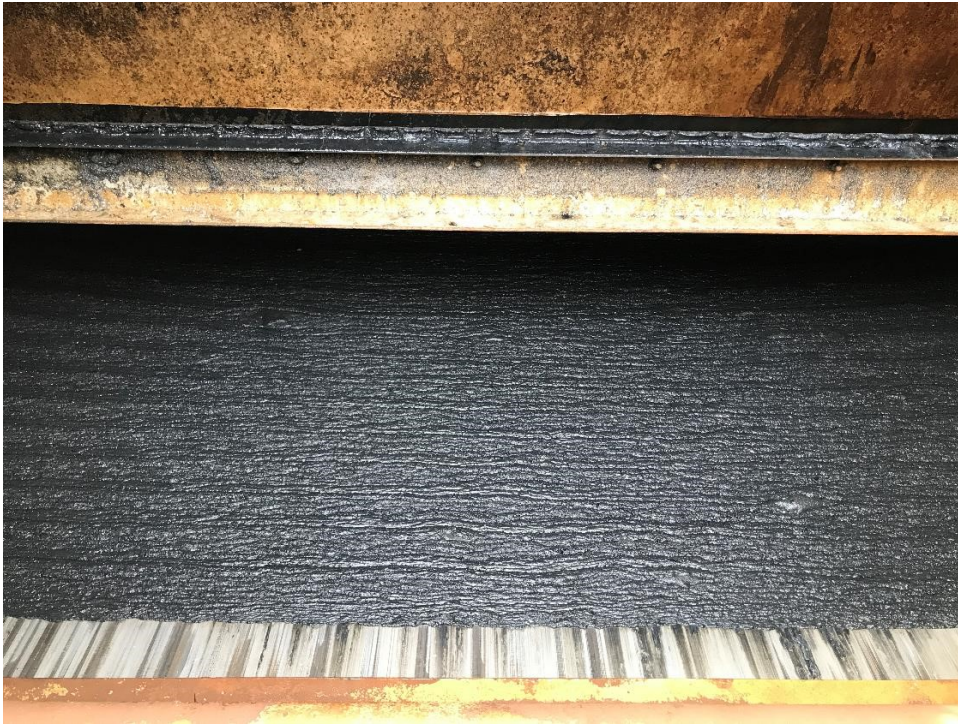
**Figure 4: 4-25-2021 floating black oily solids in the skimming trough of the E-1 battery of sedimentation tanks at JWPCP.**

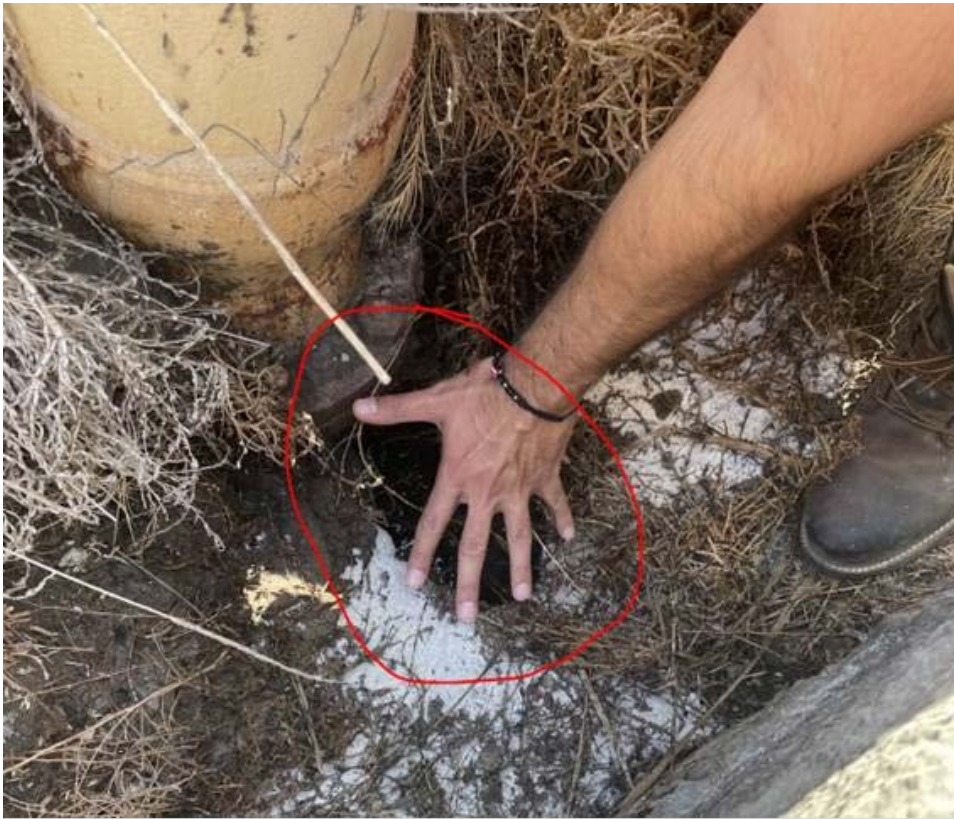
**Figure 11: 6" wide hole in the ground next to Synergy's discharge line and MH 03 0556 on 8-13-2021. MH 0556 cover structure at lower right.**

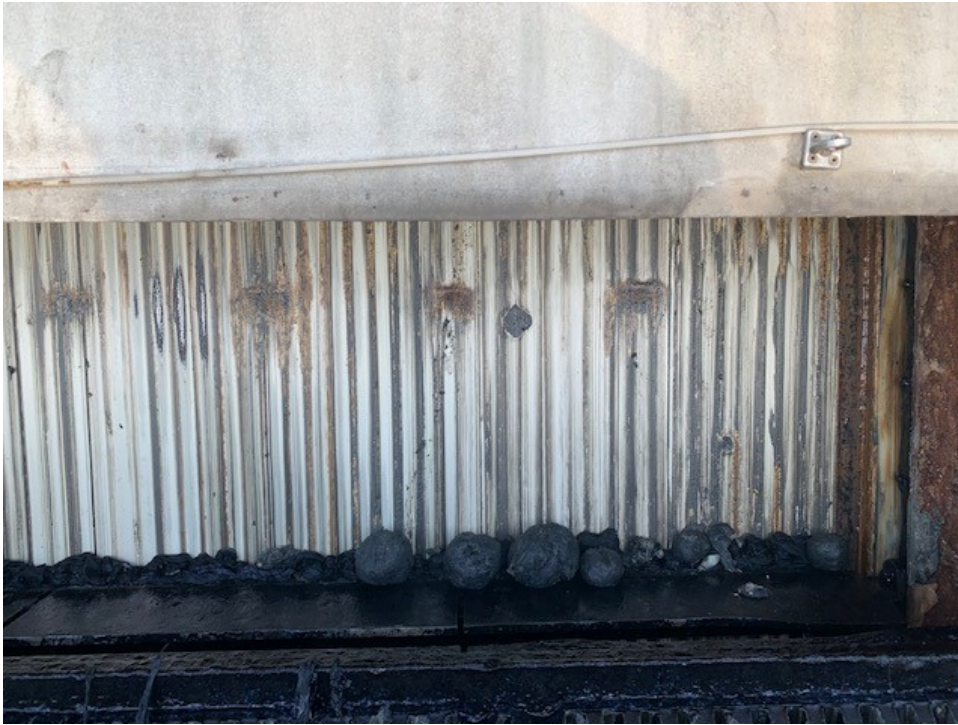
**Figure 1: Bar screen #1 at JWPCP on 9-8-2021 with the observed greasy material, including grey grease balls about the size of grapefruits.**

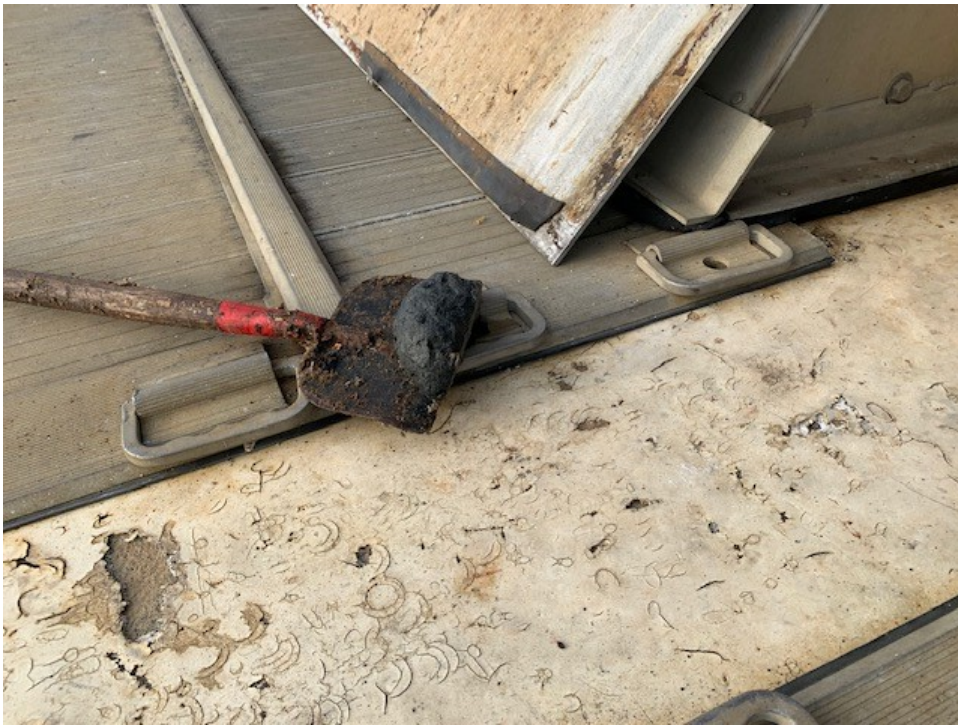
**Figure 2: 9-8-2021 photo of a large grease ball at the JWPCP headworks bar screens. Note hoe for scale.**

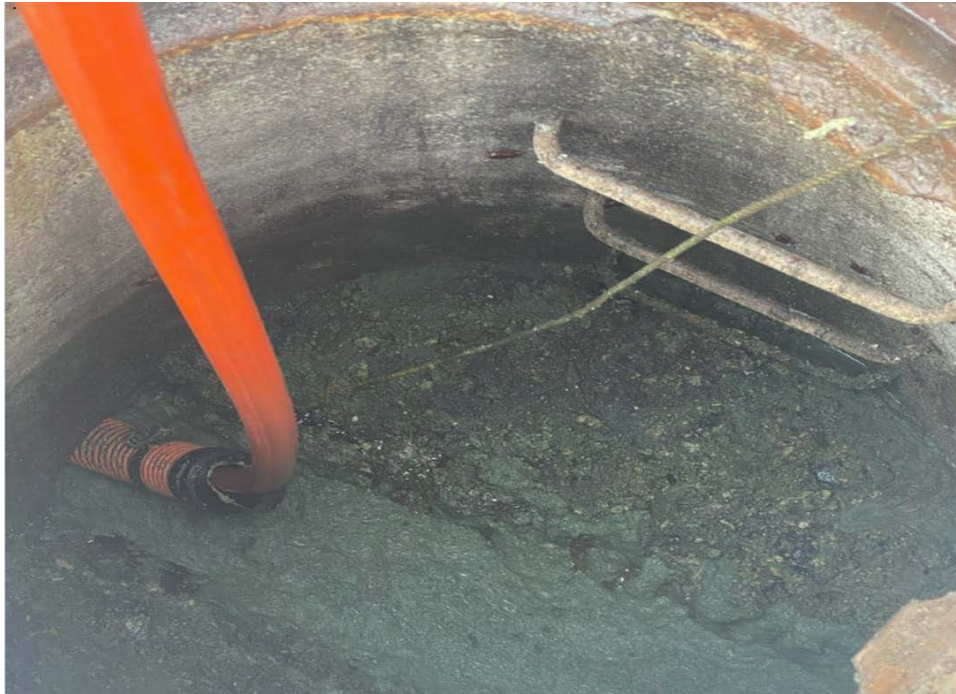
**Figure 6: City of Pomona sewer maintenance staff photo showing excessive grease in a city sewer line at approximately 1047 E. 3rd Street. Note that the line channel is completely full of grease.**

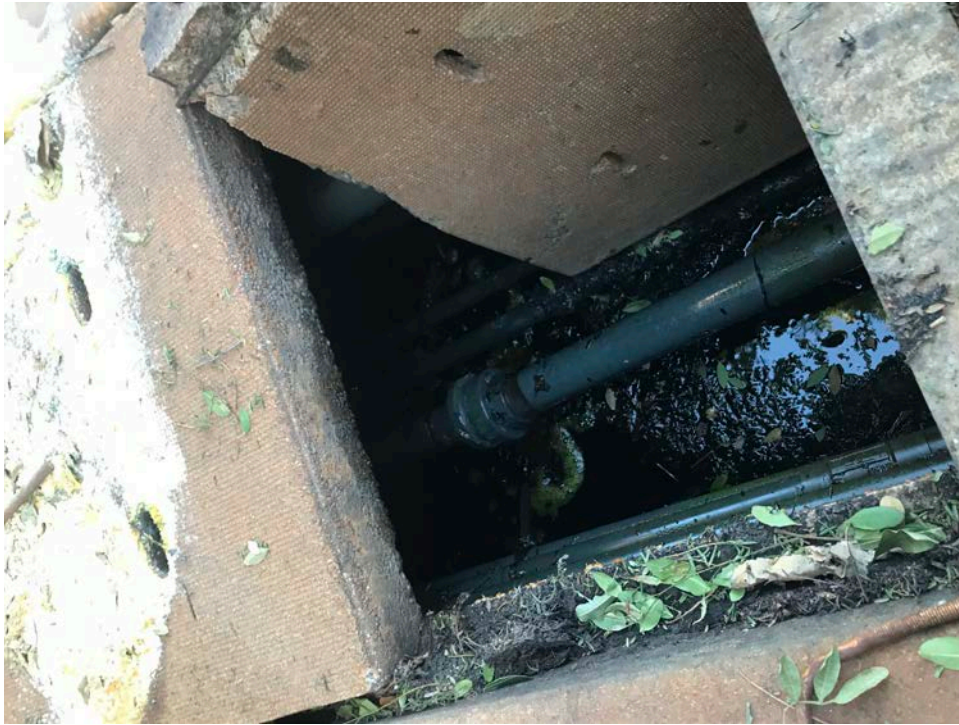
**Figure 9: 10-13-2021 picture of the separated connection on the ferrous chloride line that was causing the chemical to leak into the influent sewer line at the Long Beach WRP, causing the orange and green colors noted at the WRP.**

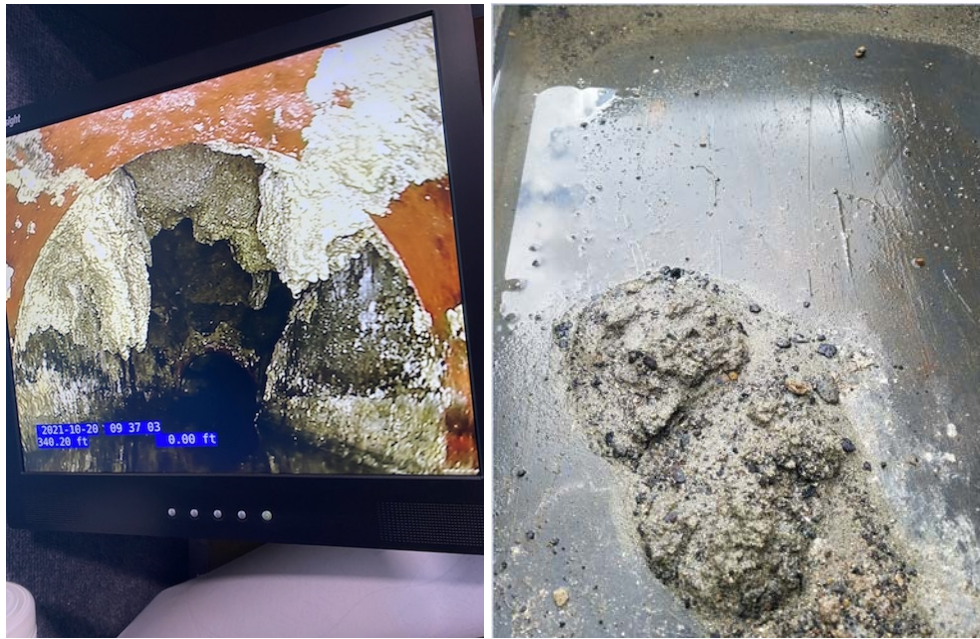
**Figures 10 and 11: 10-20-2021 Pomona city sewer maintenance CCTV and photo of the FOG and debris removed from the local line at approximately 4200 Valley Boulevard.**

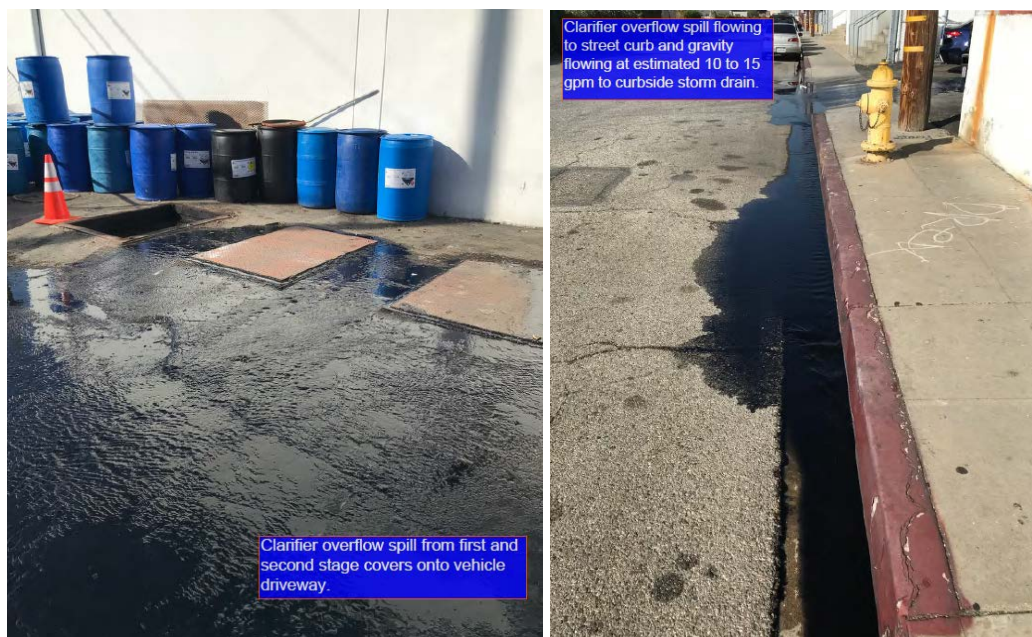
**Figures 1 and 2: 11-3-2021, 1015 hours photos of the ongoing overflowing industrial wastewater clarifier into the street gutter, i.e., storm drain, at the Stantex Inc. facility in Vernon.**

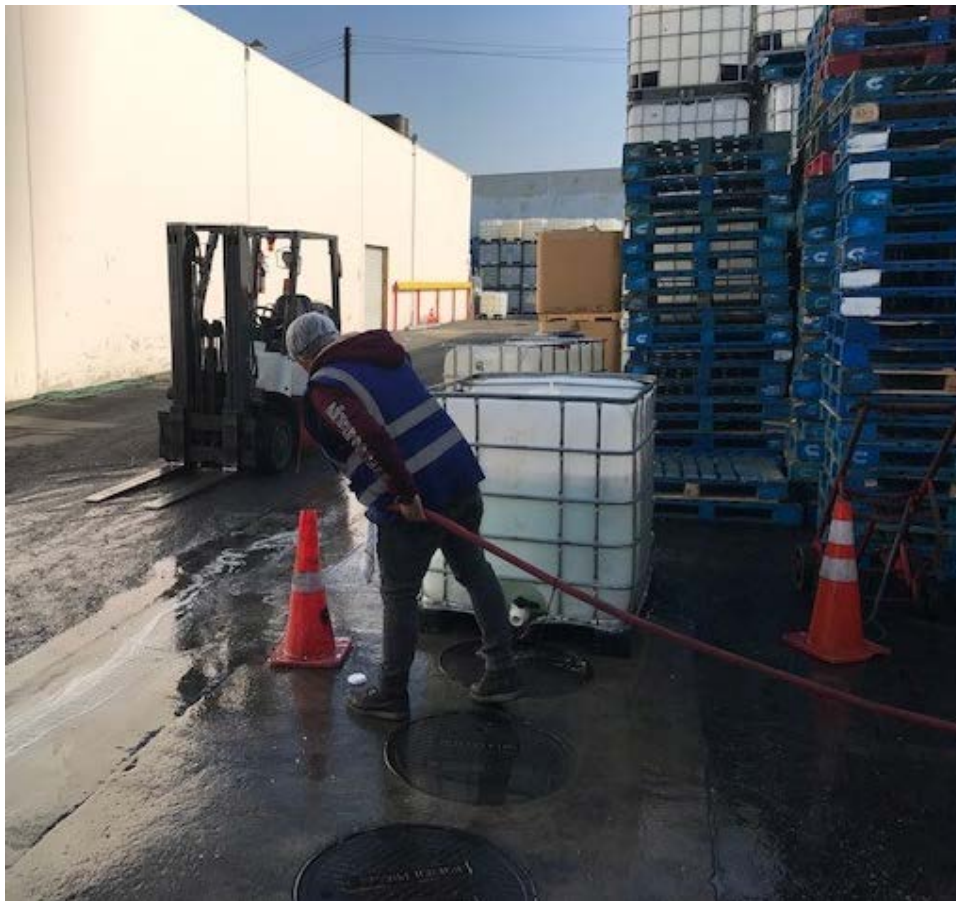
**Figure 1: Photo taken by IWMC on 12-8-2021 documenting the improper washing of storage totes in the alley outside of Vanitas Manufacturers Inc. in Carson.**
