**Audit Report for December 30, 2021**  
**Sewer Collapse and Wastewater Spill in the City of Carson**

4 May 2022

On December 30, 2021, the Districts' 216th Street Relocation Trunk Sewer experienced a critical failure in the City of Carson causing a Sanitary Sewer Overflow (SSO) event that impacted local residents on 212<sup>th</sup> Street and caused closure of some local beaches.

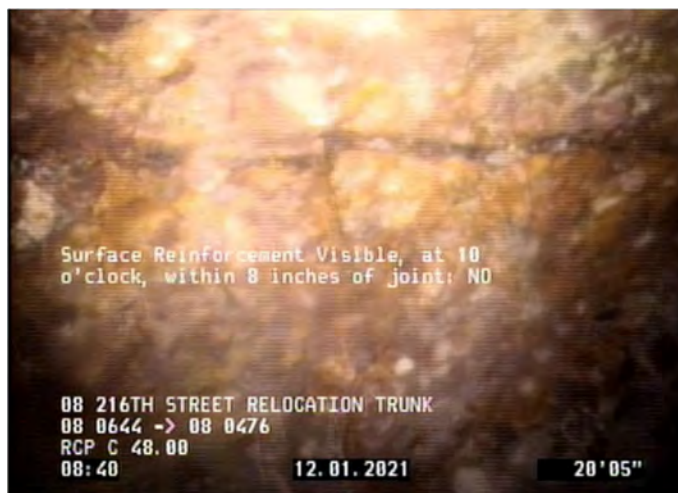
Photo 3-1 CCTV Inspection Photograph 1

The progression of deterioration is not as expected for several of the defect categories. For example, Surface Reinforcement Visible (SRV) is noted at 2 feet in January 2016; not noted in October 2016 or October 2017; but noted again in October 2018. This can likely be attributed to the quality and limitations of the CCTV videos. Additionally, it is possible that some SRV defects may have been rust stains on the concrete and not true reinforcement, but the quality of the video makes this distinction difficult. Moreover, the CCTV notes mention SRV less in later inspections. After the 2018 inspection, SRV is only mentioned one time at a location not previously noted. As an example, **Photo 3-1** below notes a short segment of SRV at 20'-5". It is difficult to determine if this is a rust stain or actual corroded reinforcement.

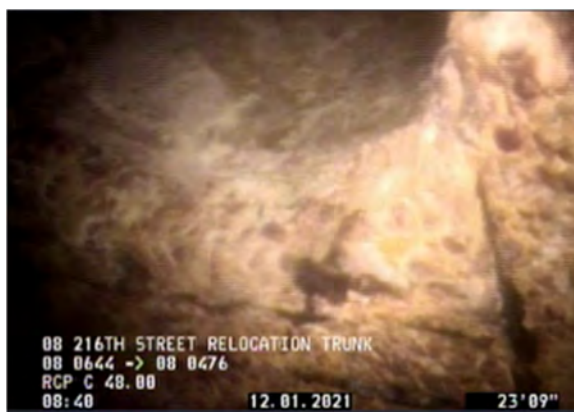
Photo 3-2 CCTV Inspection Photograph 2

Specific inspections, CCTV or physical entry, of the manhole were not performed. However, at the end of a CCTV run, the camera pans up to show the inside of the ending manhole. **Photo 3-2** and **Photo 3-3** show screenshots from the December 2021 inspection showing significant corrosion including visible aggregate, discolored walls, and exposed reinforcement in manhole 476.

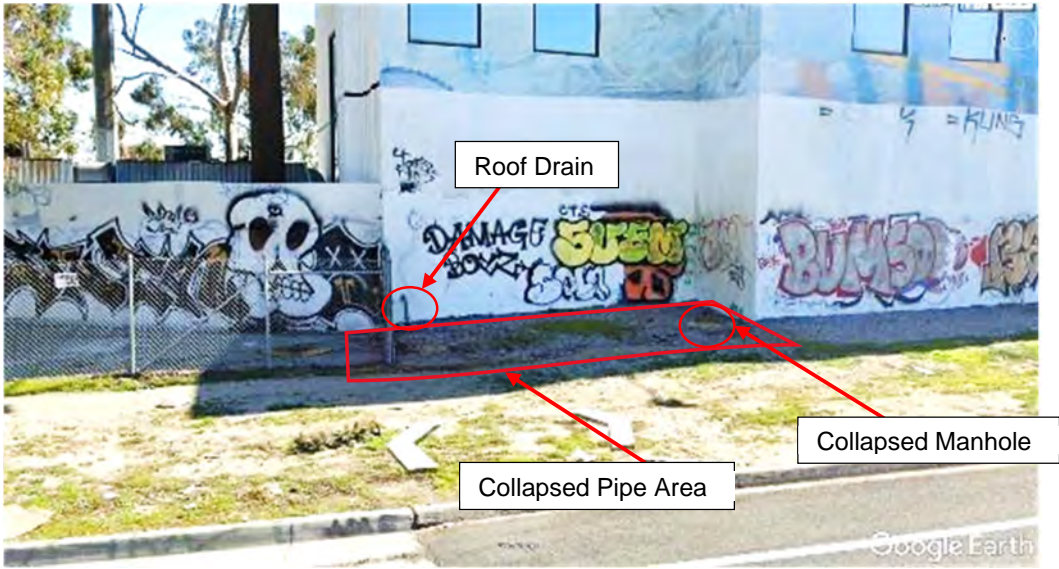
*Photo 3-4 Location of the Pipe and Manhole Before the Failure*

Also noteworthy in **Photo 3-4**, is that there appears to be a roof drain at the building corner which could have added even more rainwater to the area above the collapse.

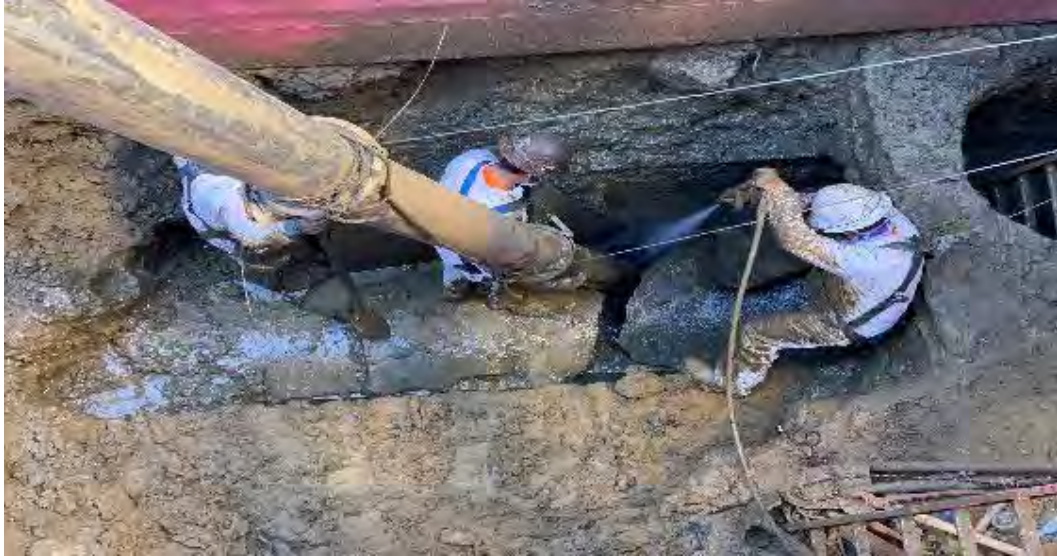
*Photo 3-7 Pipe Condition When First Exposed*

Once excavated, the CMS staff observed the pipe condition and noted that the entire crown of the pipe was collapsed, the walls were as thin as approximately 1-inch, and minimal reinforcement was observed. **Photo 3-7** shows the pipe condition when first exposed.

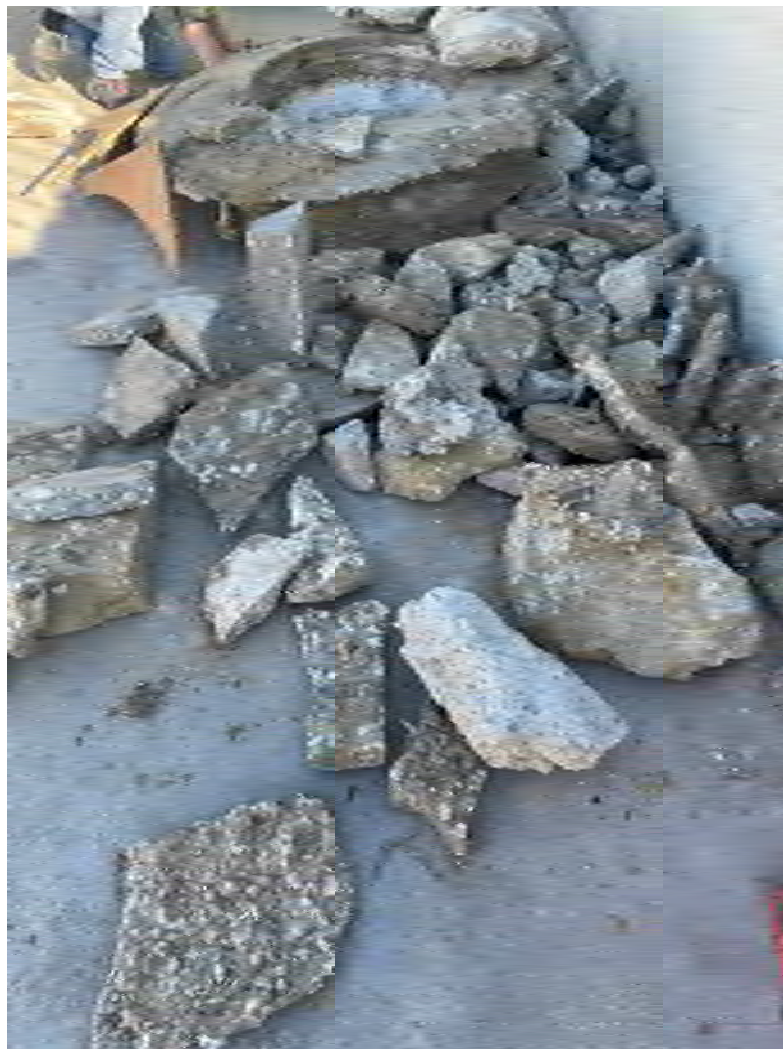
*Photo 3-8 Pile of Debris from Collapse Site*

Various concrete debris pieces from the collapse site were transported to the Compton Yard for storage. On January 24, 2022, GHD visited the Compton Field Office to view the debris. The pile of debris is shown in **Photo 3-8**. Some pieces easy to identify included the top of the manhole/collar and several broken pieces of pipe. The origination of the remainder of the concrete debris is unclear but none appeared to be manhole shafting or bricks. It seems possible that some of the concrete debris could have been in the original backfill when the sewer was constructed.

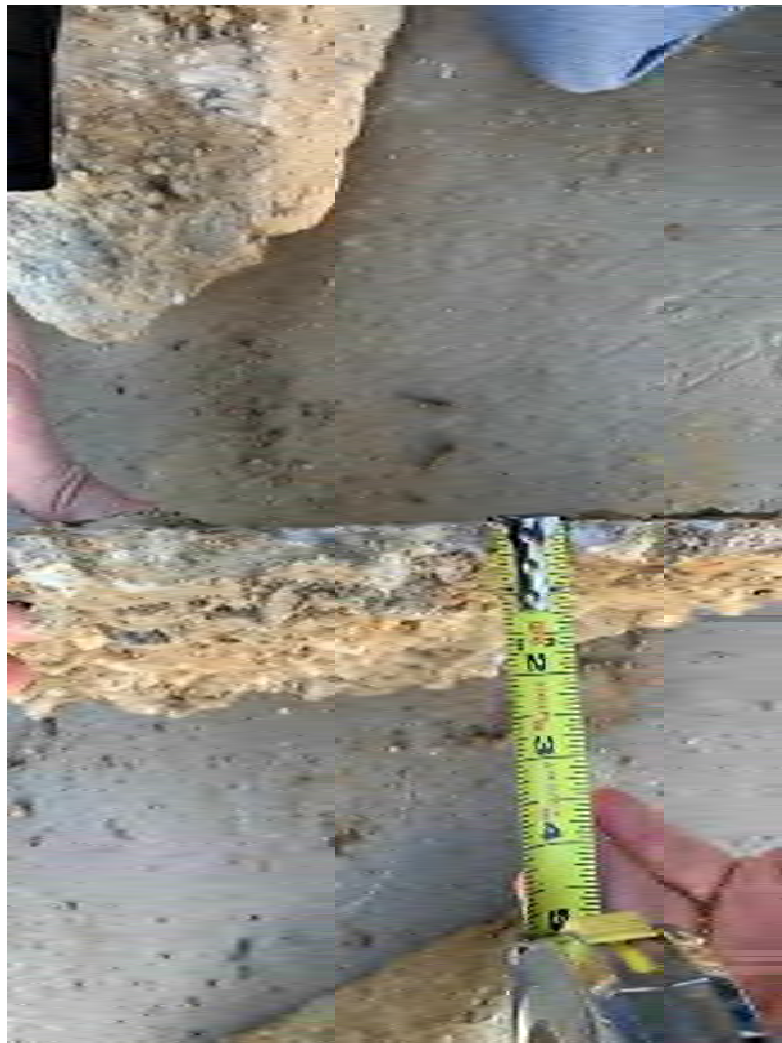
*Photo 3-9 Corroded Pipe Section*

**Photo 3-9** shows a corroded pipe segment that has a wall thickness of under 1-inch. During the repair phase of the project, the CM group drilled a hole in the collapsed pipe below the spring line and measured a thickness of 3.5 inches, leading to a theory that the pipe walls were originally 3.5 inches thick. In an attempt to determine if the concrete debris could have been from the pipe or manhole shafting, two plywood templates were cut with radii of 27.5 inches for a 48-inch pipe with 3.5-inch thick walls and 21.5 inches for a 36" shafting with 3.5-inch walls (refer to **Photo 3-10** ). No definitive determination of the outside wall diameter was established with the templates. Currently, 48-inch RCP typically has 5 to 6-inch-thick walls depending upon the design and manufacturer. None of the pipe pieces at the Compton Yard were found to have embedded reinforcement or rust stains from reinforcement. Later, core samples were taken from below the spring line of the existing 48-inch pipe installed under the same construction contract as the collapsed section and the thickness was measured to be 4.5-inches thick and reinforcement was observed in the samples (refer to **Photo 3-11**). This indicates that the collapsed pipe likely had 4.5-inch thick walls.

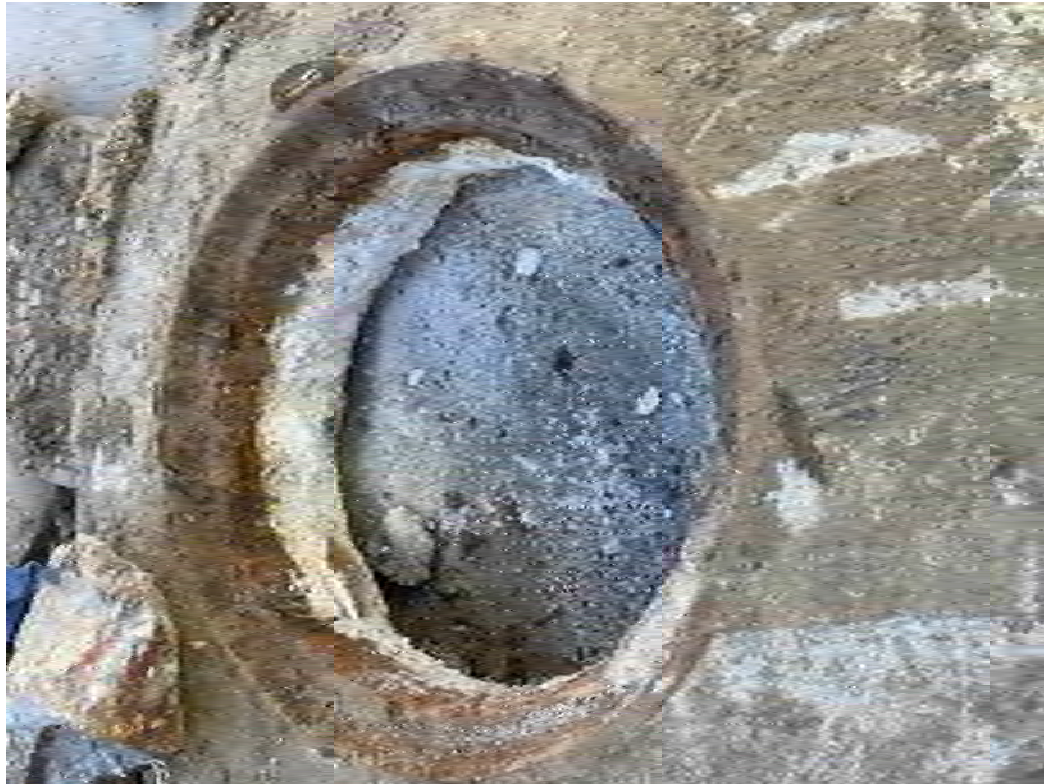
*Photo 3-12 Manhole Ring and Cover Debris*

As shown in **Photo 3-12**, the manhole ring and cover along with the cast in place collar were included in the debris. The concrete and grout located below the ring and cover was highly friable, indicating that it has been weakened by corrosive gasses often found in sanitary sewers.

There was no apparent material from the manhole shafting, brick or precast among the debris collected and transported to the Compton Yard. This could indicate that the material broke into very small sections and washed downstream.

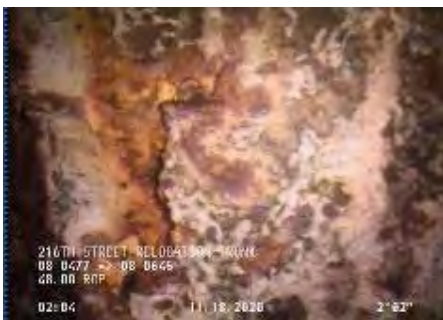
*Photo 6-1 216<sup>th</sup> Street CCTV View*

**Photo 6-1** and **Photo 6-2** show a comparison of a close-up CCTV view from a recent inspection of the Districts' 216<sup>th</sup> Street Relocation Trunk and an image from a vendor's HD video.
