2018 ANNUAL REPORT

INDUSTRIAL WASTE PRETREATMENT PROGRAM

COUNTY SANITATION DISTRICTS OF LOS ANGELES COUNTY

APPENDIX H
INDUSTRIAL WASTE REPORTS ON INCIDENTS

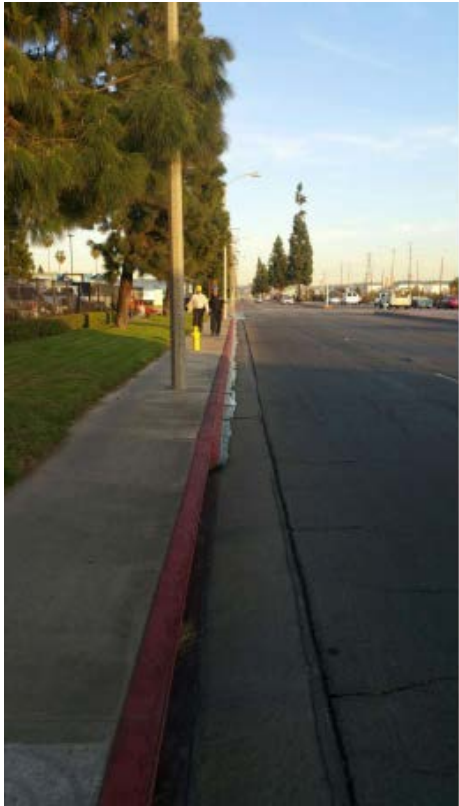
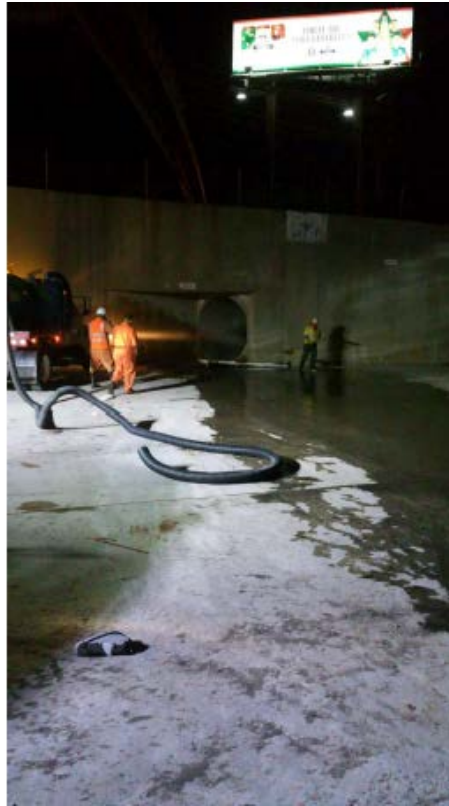
Figures 3 and 4: 1-24-18 wastewater spill in the gutter of Valley Boulevard in the City of Industry (left) and spill cleanup operations in Thompson Creek (right).

Night Team Senior IW Inspector Kent McIntosh responded to the report, arriving on-site at the Alta Dena facility at 1630 hours on 1-24-18. He discovered that the volume of the spill was almost certainly much larger than had been reported, estimating it was up to several thousand gallons. He noted an outside contractor, United Stormwater Inc., was on-site conducting cleanup operations of the storm drains and creek downstream of the Alta Dena facility that were impacted by the spill. The spill was caused by a sewer line collapse and resulting line blockage inside the facility which caused wastewater containing milk residual to

The Alta Dena facility is a fluid milk processing plant that is about 75 years old. Over the years it has expanded and modernized and yet retains much of the original plumbing infrastructure. At least partly as a result, this is the second incident of a significant surface spill caused by plumbing issues reported in just over a year.

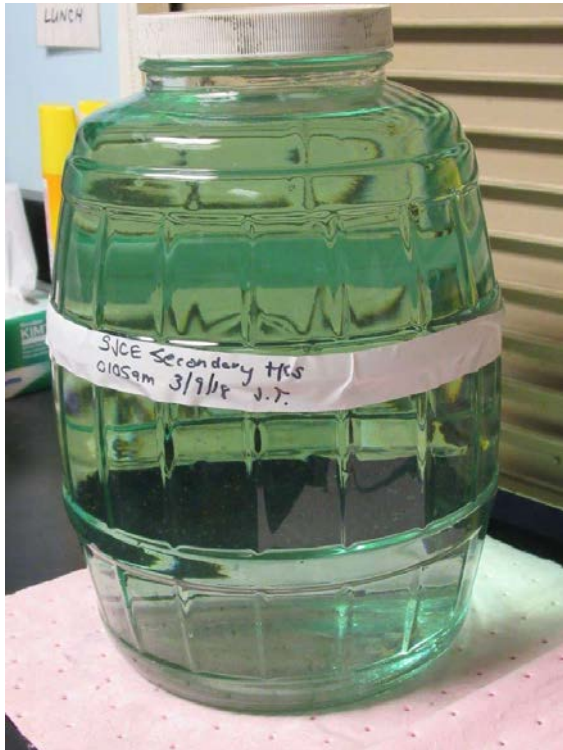
Figure 2: SJC-West WRP sample taken from a secondary clarifier at 0105 hours on 3-9-18.

The subsequent investigation by both day and night team IW Inspectors did not result in a source being identified for the color despite 23 potential source industrial facilities being inspected. The fact that the color was no longer present in the influent when Woods was on-site made tracing the color upstream to a source, or even limiting the area from where the color came, impossible. Examination of primary effluent bottle samples by IW Inspector Tanna Pekin indicated the green-colored wastewater entered the WRP between 2200 hours and midnight on 3-8-18. HPLC analysis of the sample taken by the operators revealed that the green-colored dye that caused the color was a close match to non-toxic food grade dye (see Figure 3), thus explaining its lack of negative impact on WRP operational parameters.

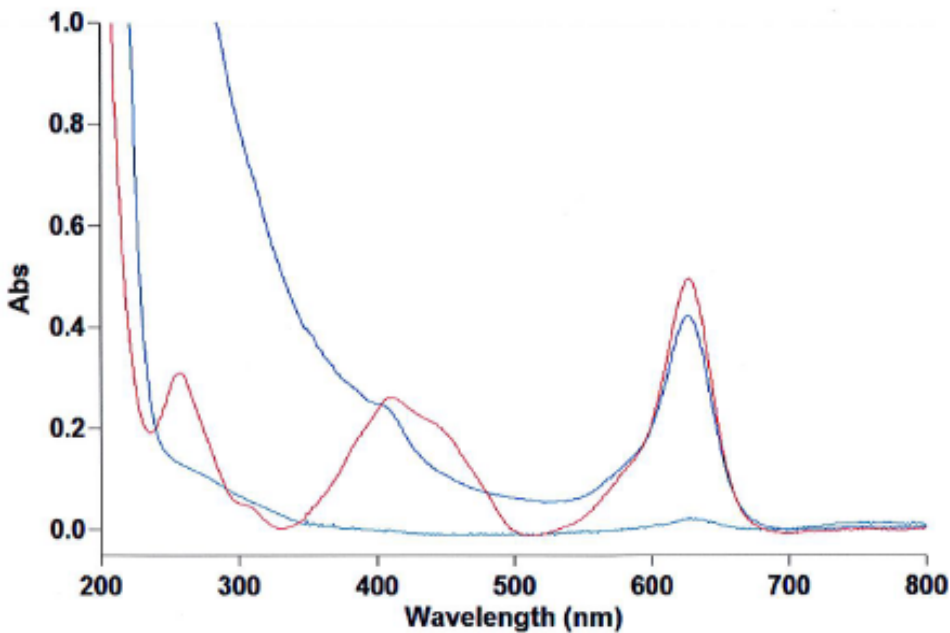
Figure 3: HPLC test results that indicate the extracted green dye from the treatment plant sample (dark blue line) match green food dye (red line).

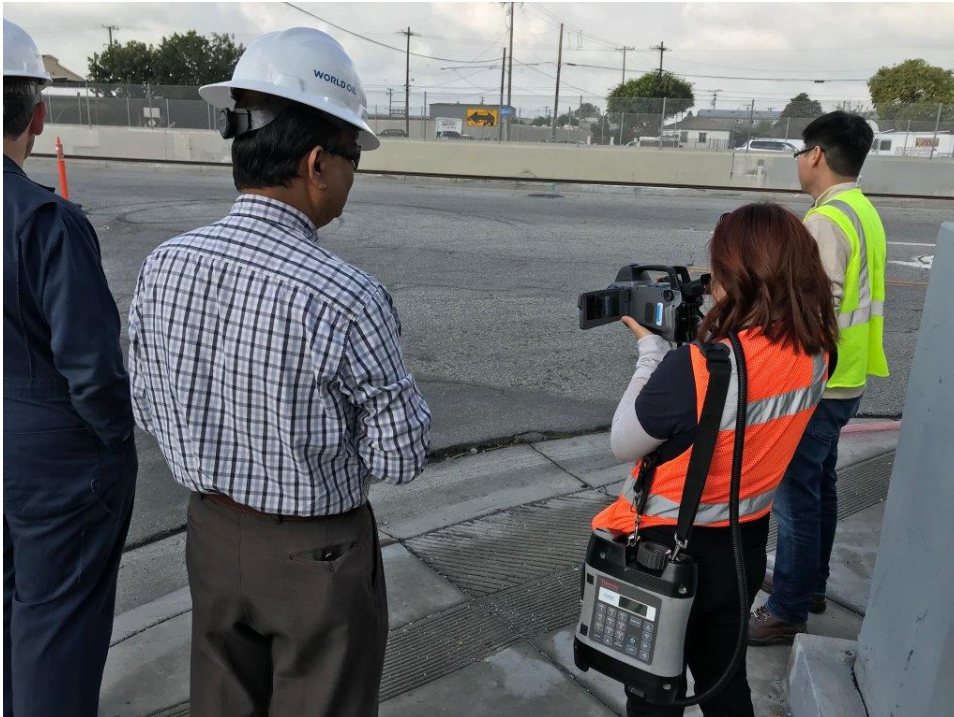
Figure 9: 3-24-18 SCAQMD Inspector Pham using a FLIR camera to detect the presence of headspaces gases emanating from MH 01 1463.

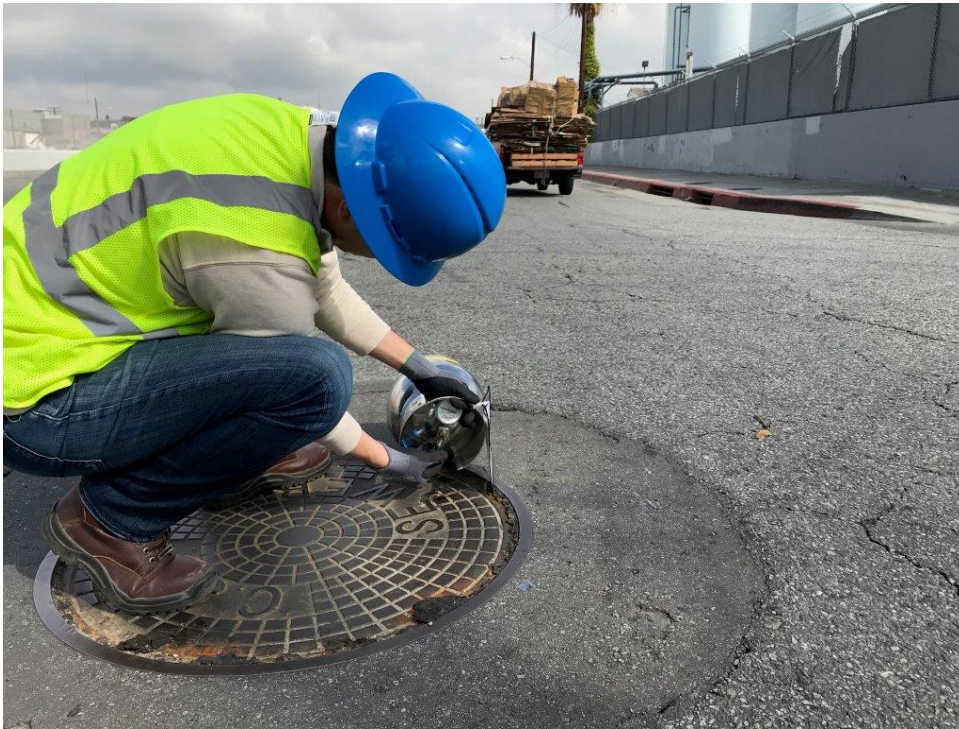
Figure 10: 3-24-18 SCAQMD Inspector using a stainless steel canister to collect a sample of the headspace gas emanating from MH 01 1463.

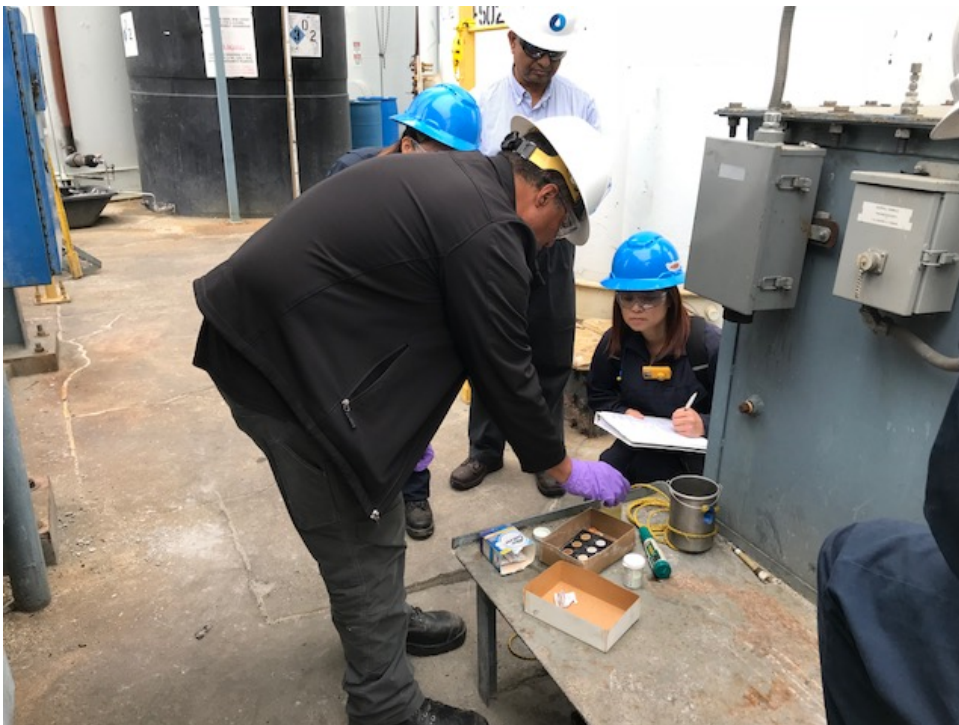
Figure 11: IW Inspector Shawn Cleaver conducting a field hydrogen sulfide test at Demenno Kerdoon while being closely observed by SCAQMD inspectors on 4-5-18.

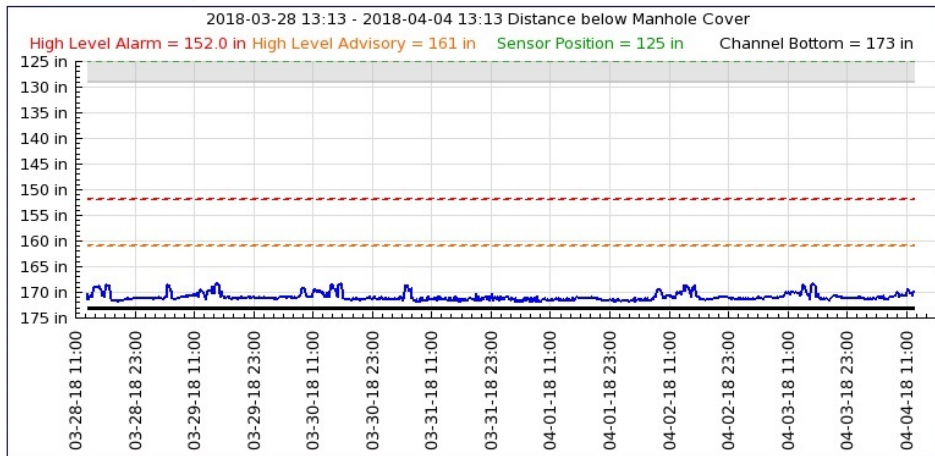
On 4-2-18 Area IW Inspector Kristopher McGinnis spoke with Balas to obtain more information on the maintenance schedule of the JO 'H' Unit 2 trunk line and to confirm that the smart cover placed on MH H 0250 was still in place and functioning. Balas stated that the trunk line is on annual cleaning schedule while the downstream siphon is cleaned semi-annually with the most recent cleaning performed in September of 2017. The smart cover located at MH H 0250 is still in place and functioning properly. The device was set to alarm when less than 160" of clearance was detected. After the cleaning that occurred on Saturday, 3-31-18 the device had been reading approximately 170" of clearance (See Figure 3).

Figure 3: MH H 0250 Smart cover data chart.

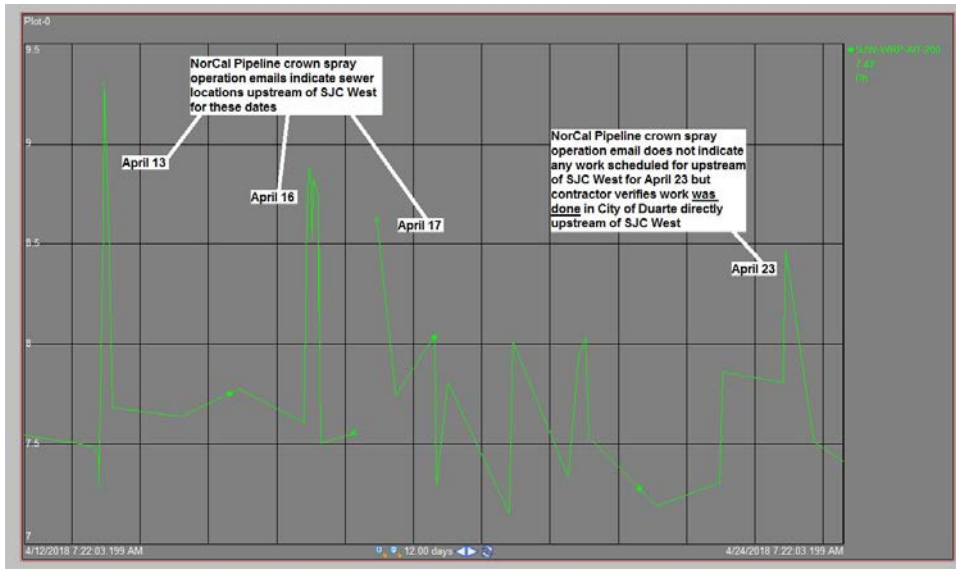
Lee subsequently directly contacted sewer crown spray contractor NorCal Pipeline and it was quickly determined the high pH event at the treatment plant was in fact caused by the routine application of crown spray on a portion of the Duarte Trunk in the city of Duarte. The information regarding the crown spray work done on 4-23-18 was not included in the daily

Figure 7: Annotated SJC-West WRP influent pH chart for the period from 4/12/18-4/24/18. The annotation documents that the high pH incident of 4-23-18 was due to crown spray activity upstream of the treatment plant despite the crown spray notification email not indicating such.

notification email thus causing the confusion and investigation. This issue will be discussed with the contractor so similar events will not happen in the future.

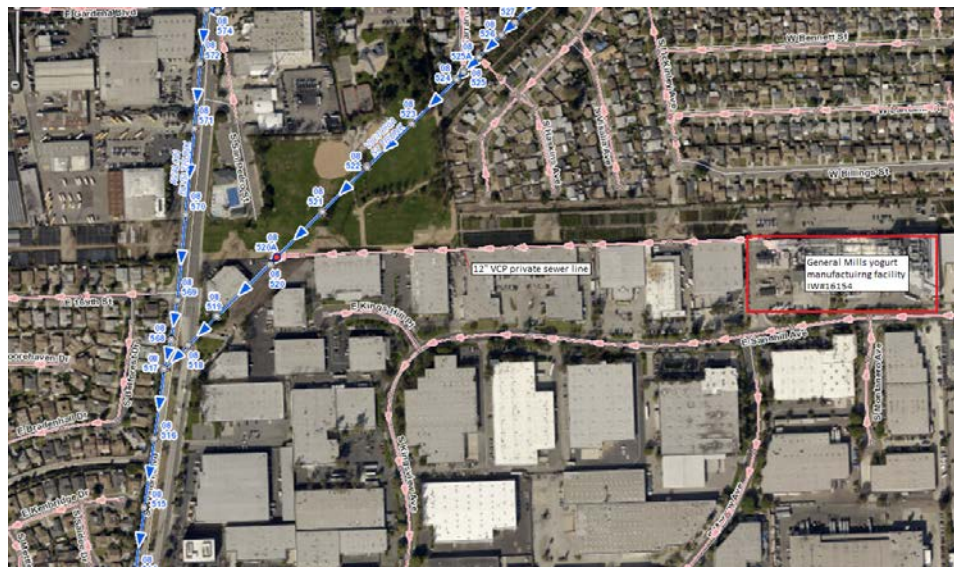
Sanchez, as well as Area IW Inspector Nattapong Pengphol and Team 3 Senior IW Inspector Bill Barnum, all investigated the report. They determined that the etching damage present in the manhole was wholly due to periodic discharges from the nearby upstream General Mills yogurt factory (previously known as Yoplait). The industrial wastewater flow from the General Mills facility flows to, and directly connects to, MH 08 0520 via an 12" diameter private sewer line (see Figure 10). The only flow in that private line is that from the General Mills facility. Inspections at the facility revealed that the company currently has frequent issues with discharging industrial wastewater which exceeds their lower limit. Their permit requires the facility to have and maintain a wastewater pH neutralization system, as well as an industrial

wastewater pH meter/recorder. The past two years of pH monitoring records were acquired from the company and reviewed by Pengphol. His review found frequent exceedances indicating near daily pH violations of both the Districts' local limit of 6.0 and the Federal limit of 5.0. The exceedances are caused by the wastewater pretreatment system failing to neutralize acidic wastewater generated by the use of a clean-in-place ("CIP") system used to flush out and sanitize production manufacturing and packaging equipment. The CIP system uses both highly acid and alkaline solutions. It was also noted that the high biological oxygen demand (BOD) nature of their industrial wastewater combined with the presence of bacteria used in the yogurt making process lends itself to unusually fast biodegradation which can also result in the discharge having a low pH.

Figure 10: LACSD GIS diagram showing the General Mills facility in Carson and its private industrial wastewater sewer line that connects to the Districts' 12" Victoria Street Trunk sewer at MH 08 0520A.

The facility is in the process of evaluating the shortcomings of their existing industrial wastewater pretreatment system with the goal of improving its ability to properly neutralize the acidic wastewaters prior to discharge. Pengphol is monitoring this effort closely and has given the facility a deadline of June 29, 2018 to resolve pH issue. Note also that Pivovaroff was able to coordinate the repair the relatively minor etching damage at MH 08 0520A. The etched portion of the Districts' trunk line, which was only a few feet long, was repaired within a one-hour time period using wet-patch cement on 5-3-18. Due to the relatively quick work necessary to fix the damage, cost recovery for this effort is not anticipated. Note that the 12" private line is unlikely to have suffered any corrosion damage due to the fact that it is a vitreous clay pipe (VCP) not subject to acidic corrosion damage.

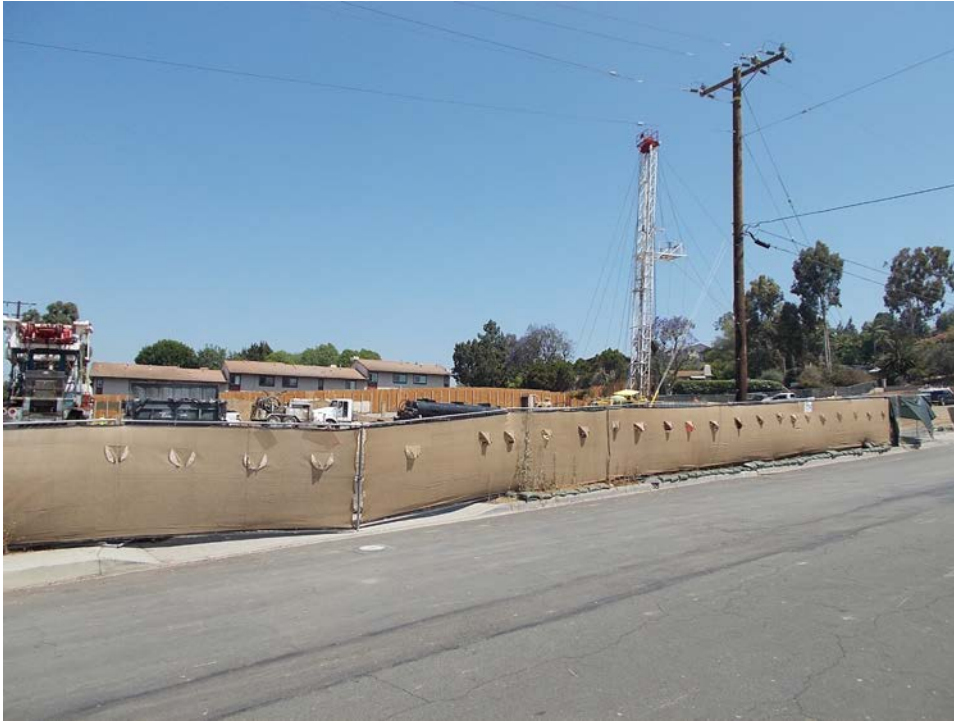
Further investigation by Supervising IW Inspector David Sanchez and Area IW Inspector Jason Finn on 5-9-18 and 5-10-18 respectively found that the residence is located adjacent to an ongoing project being conducted by a land developer's contractor, Rival Well Services, Inc., to abandon three old oil wells at the site. Both bentonite drilling mud and brine that contains oil residual are on-site, but the contractor claims none of these materials are or will be sewered, and no evidence of such was found. Neither Finn nor Sanchez noticed a sulfide or sewer like odor while on-site. Finn will continue to periodically visit the resident location in the hope of being present when the odor is present, thus allowing him to apply his expertise to determine its source.

Figure 2: Photo of the oil well abandonment construction site looking north from Davidson Drive. The home where the sewer/sulfide odor was reported is located beyond the far fence line visible in the photo.

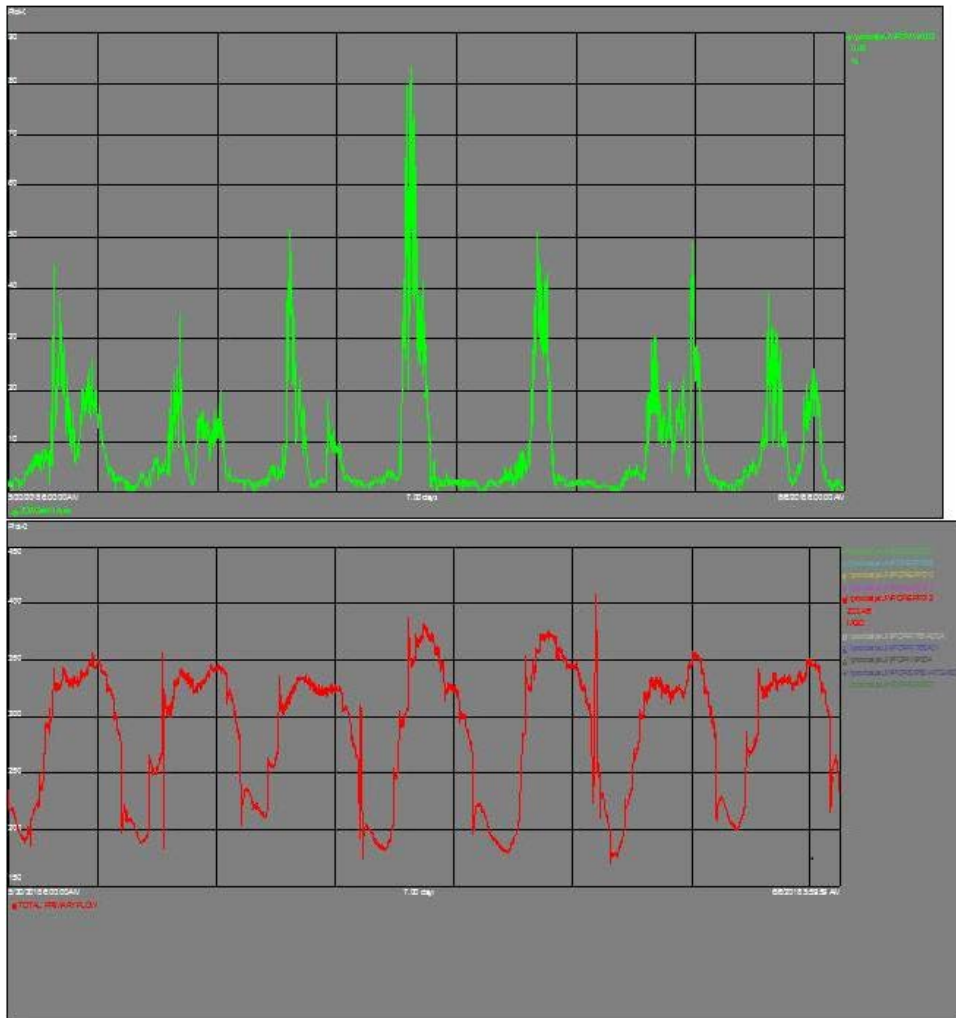
Figure 6: JWPCP J.O. ‘B’ headworks LEL (top chart with green trend line) and flow (bottom chart with red trend line) trends for May 23 - 29, 2018. Note that there is rough correlation between the diurnal high flow periods and increased explosivity concentration.

In his discussions with JWPCP Operators on May 26, Barnum was informed that they had been noting periods of unusually high explosivity (LEL) in the J.O. ‘B’ headworks headspace since May 21. Barnum recalled that field measurements that Team 3 IW Inspectors have made over the last several months at the JWPCP J.O. ‘B’ headworks headspaces using a portable photo ionization detector (P.I.D.) that was purchased by the IW Section earlier this year had detected no significant volatile organic compounds. He also noted that a gas sample collected from the headspace on May 6th resulted in a finding of 1.49% methane by volume of air which is equivalent to 29.8% LEL when the fixed combustible gas sensor was measuring 30% LEL. This data is a strong indicator that the source of the explosivity in the headspace is essentially solely due to methane generated by the decomposition of raw sewage in the Districts’ collection system, not from an industrial source such as one of the large upstream petroleum refineries. It is well established that the lower reaches of the J.O. ‘B’ sewer just upstream of the JWPCP is typically high in such “biogenic” methane but it remains unclear why the headworks’ LEL sensor/meter has been measuring high levels since May 21, but not before. Barnum believes there may be a causal relationship between high influent flowrates, i.e., diminished headspace, in the headworks headspace and increased explosivity readings there (see Figure 6 above), but the exact nature of that relationship has yet been determined.

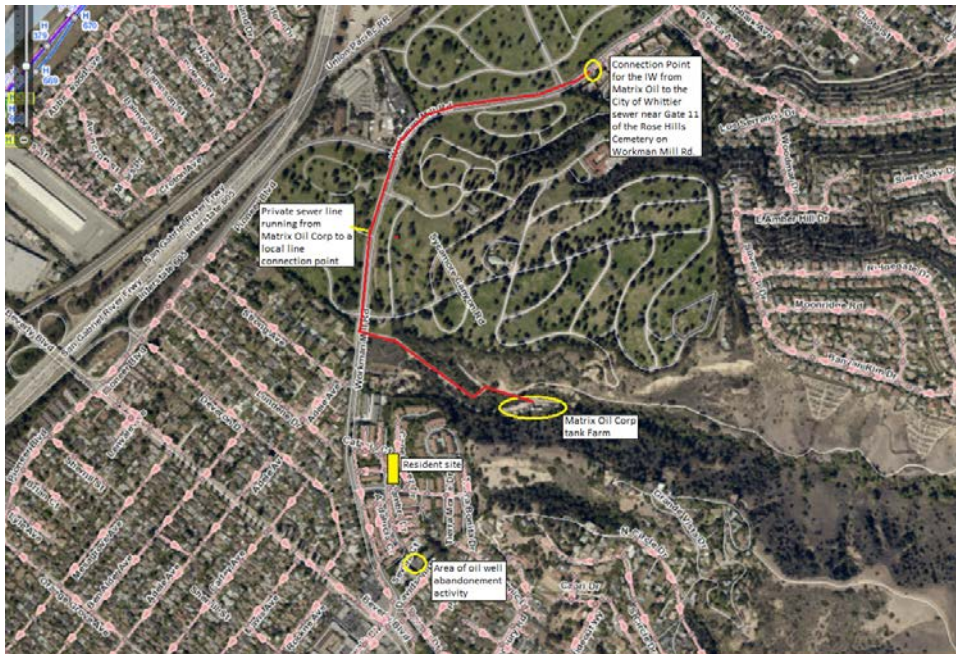
Figure 1: Annotated GIS diagram showing the location of the residence where the odor complaint and the locations of the oil abandonment project, Matrix Oil Corp., and sewer lines pertinent to the odor report.

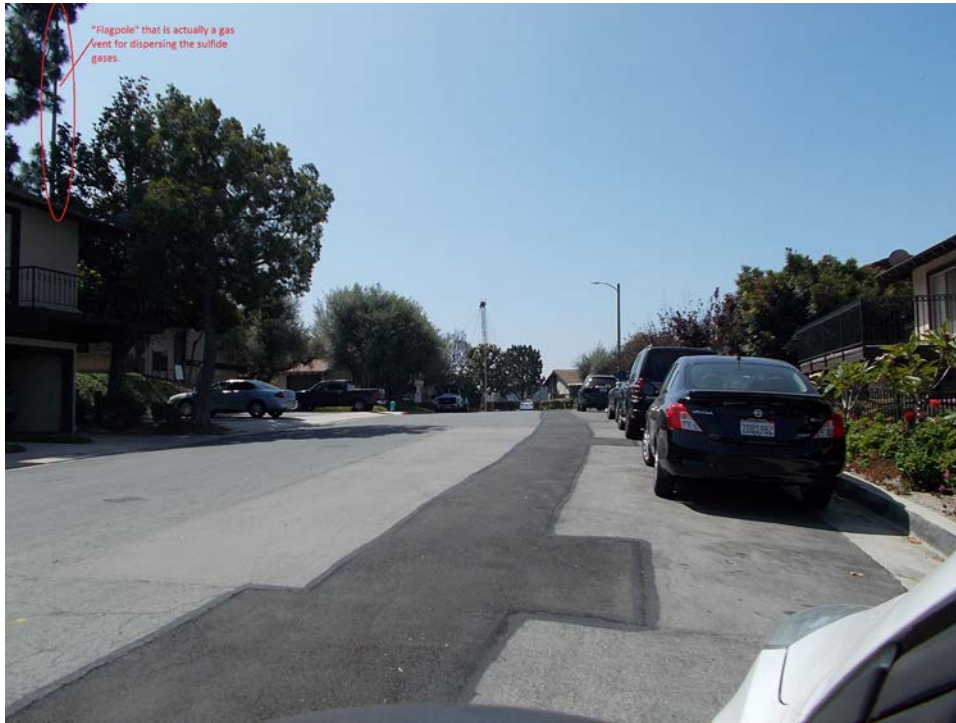
The next day, 6-27-18, Finn spoke with Mr. Kyle Cason, Assistant Director of Public Works with the City of Whittier about his findings. Cason stated that the City is well aware of the “sewer” odors in this neighborhood and explained that the odors have been determined to be due to escaping sulfide gases trapped in the geologic formation strata beneath the area. Whether or not this condition is related to historic petroleum exploration/production activities in the area is unclear. Per Cason, the Homeowner’s Association (HOA) that the complainant’s residence belongs to has long had a responsibility to own, operate, and maintain a system of in-ground pipes to collect the gas, as well as vent pipes disguised as flag poles, to vent the gas above the roof line of the homes. Cason stated that the HOA has admitted that the vent pipe nearest to the residence in question is not currently working (see Figure 3). He further stated that it’s the responsibility of the HOA to make the necessary repairs to vent the gases properly. Finn concluded that this incident is not a sewer-related odor issue and thus no further action will be taken at this time by Districts’ staff.

Figure 3: Photo taken on 6-26-18 by Finn of the flagpole/gas vent pipe that is nearest the residence of the odor complainant.

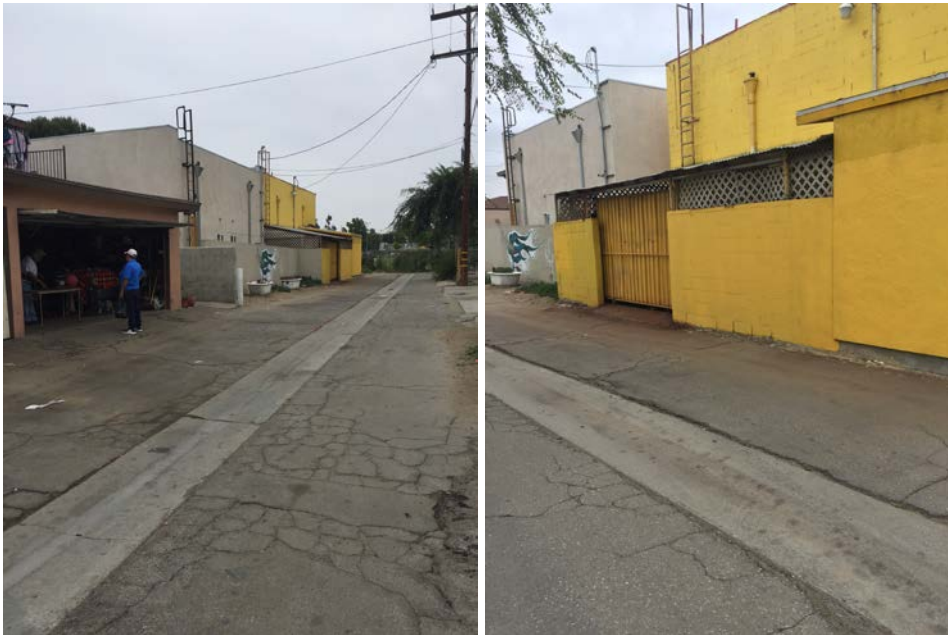
Cleaver responded to the reported location at 1310 hours on Tuesday, 6-5-18. His inspections of the business the tipster referenced, as well as several other businesses in the immediate area, revealed no evidence that chemicals or other illicit materials were being dumped into the alley or the local sewer line that runs in the alley. However, discussions with local residents did indicate that people from the small apartment building complex adjacent to the alley (see Figures 4-6 below) have been repairing autos in the alley resulting in used motor oil and engine coolant being improperly discarded/left in the alley. Cleaver concluded that Amigo's Auto Parts was not responsible for dumping chemicals in the alley and that the problem reported was due to auto repair and motor oil being dumped and/or left in the alley by area residents. This type of illegal disposal of automotive wastes generally does not fall under the Districts’ regulatory jurisdiction. It is a matter for local code enforcement to address. As such, no further action was taken on this report by the IW inspection staff.

Figures 4 and 5: View north from the apartment complex of the alley that runs up to Amigo's Auto Parts #3 (left) and the rear area of the of the business itself (yellow building). Note the lack of evidence of dumping activity.

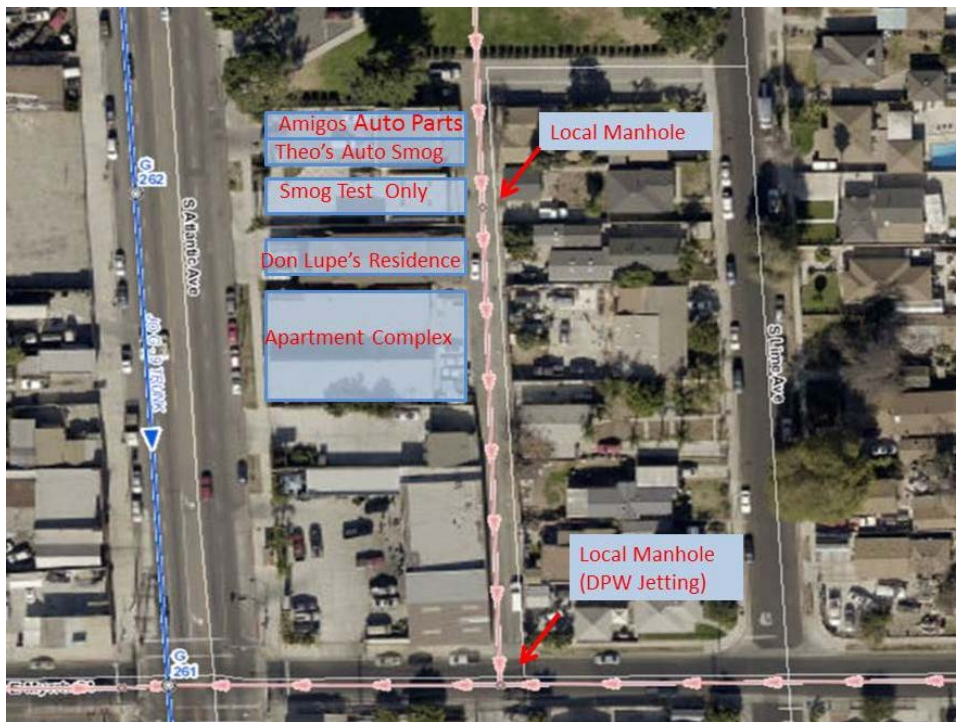
Figure 6: Annotated GIS diagram showing the businesses, apartment complex, and the local sewer running in the alley.

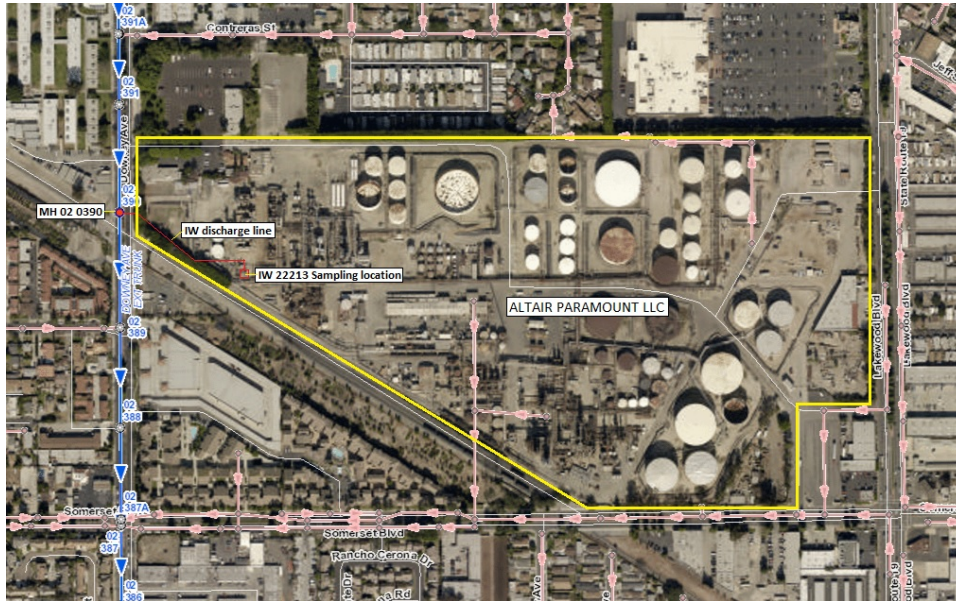
constriction remained. She further stated she was now concerned that the Districts' sewer line that they connect directly to (the 15" VCP Downey Avenue Extension trunk) might be partially blocked. She wanted to know if she should advise her contractor to try to clean the Districts' trunk line too. Boyd advised her not to do that and then contacted Night Team Supervising IW Inspector Andy Woods and asked him to go to the site as soon as possible to evaluate the situation. Boyd then also called the Long Beach Main Pumping Plant Alarm Center and spoke with Operator Randy Bones, advising him the situation such that if necessary, he could call out a sewer maintenance crew to clear the trunk line depending on Woods' findings. Note that the refinery's industrial wastewater discharge line connects to the trunk at or very close to Manhole (MH) 02 0390 (see Figure 7 below).

Figure 7: Annotated GIS diagram showing the relationship of the refinery, its industrial wastewater discharge line, and where it connects to the Districts' 15" Downey Ave Extension trunk sewer just north of MH 02 0390.

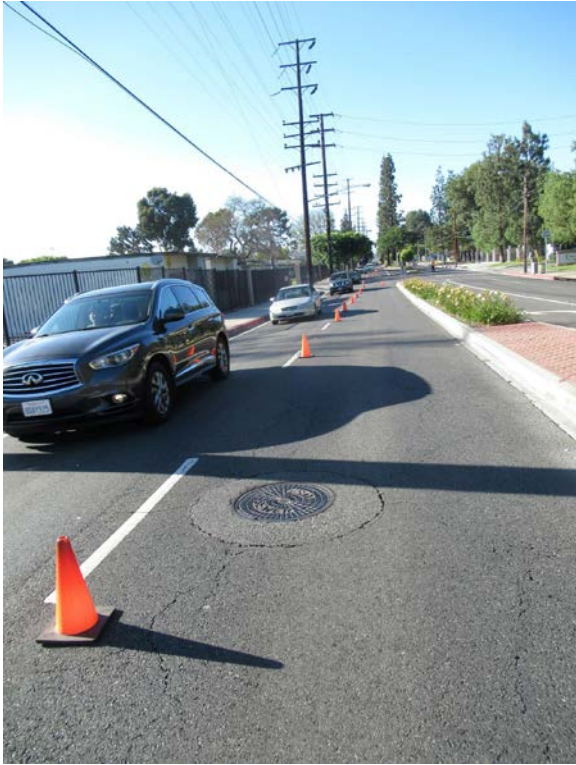
Woods and Night Team Senior Inspector Kent McIntosh responded immediately location. Upon arrival they checked the trunk sewer at MH 02 0390 and determined that the line was flowing freely and appeared clear of any obstruction(s). Woods' subsequent questioning of Gleeson and company operators revealed that the final section of their private lateral line had not been able to be cleaned or visually checked due to the length of the line. This information collectively indicated that the partial obstruction causing the reduction in flowrate at the company was in the final section of the company's lateral. Gleeson stated it was their intent to continue to discharge at the limited flowrate available, impounding additional wastewater being generated into tankage on-site, and getting another contractor on-site with better equipment as soon as possible to try again to clear the line.

**Figure 8: 6-13-18, 1756 hours
MH 02 0390 on the 15" Downey Ave.
Extension Trunk. Note traffic diversion
set up by Woods and McIntosh to check
the line.**

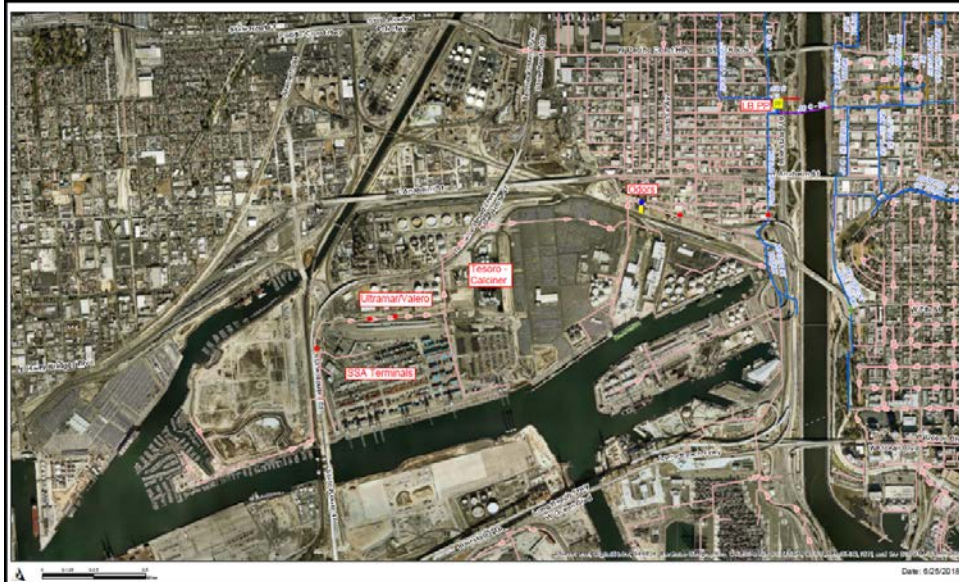
wastewater discharged by the Ultramar Valero oil refinery which is located about 1.5 miles upstream (see Figures 11 and 12). The flow from the refinery discharges into a City of Los Angeles' maintained local line on Pier A Way and then flows the City's Henry Ford Pumping Plant before the line transitions to being maintained by the City of Long Beach. Ultimately, the flow goes past the Oceanwide Repair facility on West 9th Street before joining the Districts' sewer system at the Pico Ave trunk at MH 03 0426.

Figure 11: Annotated GIS diagram showing the relationship of the location where the odor was reported to the upstream Ultramar/Valero oil refinery outfall.

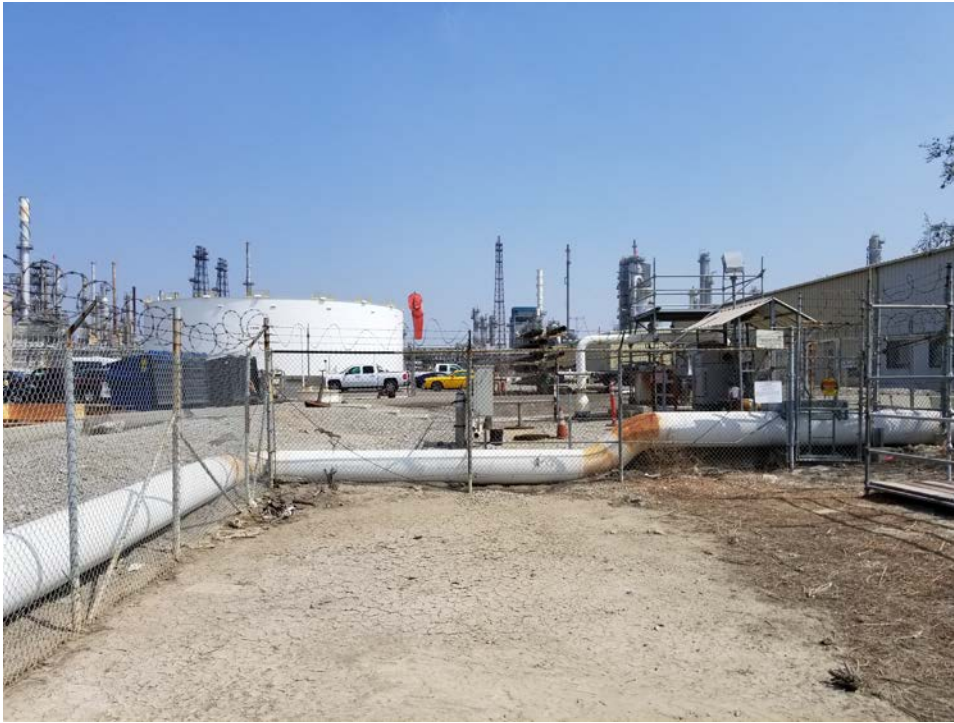
Figure 12: Picture looking north showing the Ultramar/Valero oil refinery industrial wastewater outfall and monitoring area in Wilmington.

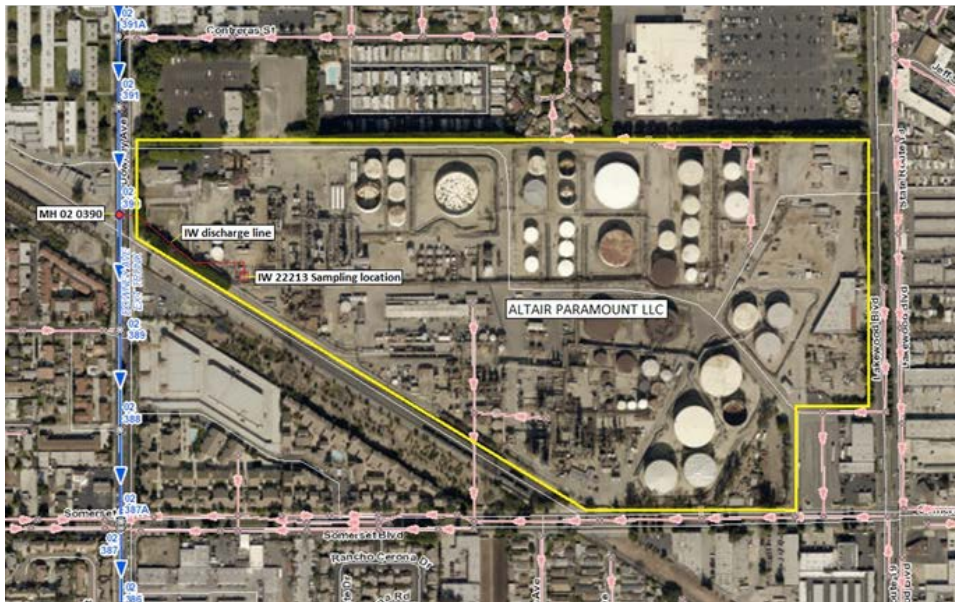
Figure 1: Annotated GIS diagram showing the relationship of the refinery, their industrial wastewater discharge line, and where it connects to the Districts' 15" Downey Ave Extension trunk sewer just north of Manhole (MH) 02 0390.

The problem was determined to be caused by excessive scaling in the company's 8" diameter private lateral line that connects to the Districts' 15" Downey Avenue Extension trunk sewer just north of MH 02 0390. The scale likely built up over decades. The initial attempts to clear the scale in late June were unsuccessful, but a more concerted second attempt was made on 7-17-18. Area IW Inspector Tingting Wei reports that this second attempt was successful, with the company now able to resume their normal discharges to the sewer. The Districts' sewer line CCTV crew examined the Downey Avenue Extension trunk and found it was undamaged and unobstructed either before or after the line scale cleaning was completed.

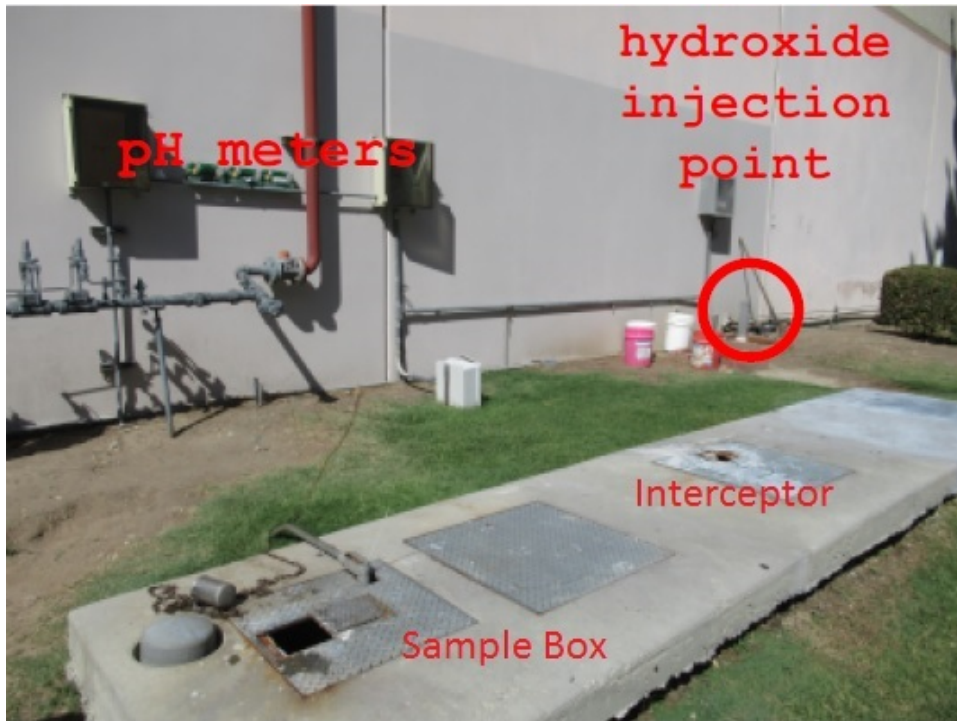
Senior IW Inspector Kent McIntosh arrived at the Langer Juice facility at 1535 hours on 7-24-18. He met with Production Manager Adolfo Resendez, Vice President David Langer, and Ms. Kaur. Kaur restated that they had had “a mishap in our blend room that caused some cranberry cocktail juice base to drain to the sewer and the wastewater discharge pH to drop below 6.0.” Shae added “we are correcting this by adding caustic and lots of gallons of water to be within specs on the waste water pH.” She originally reported a spill was 150 gallons, but later told McIntosh that the volume was about 350 gallons and that the pH of the material was 2.4. She explained that earlier in the day Southern California Edison had requested that the company “curtail” its electricity usage due to high power demand (the high temperature in the City of Industry that day was 102°F), so the facility ceased normal production. Instead, they decided to only mix and blend concentrates for shipment to other producers. During this work, an employee accidentally left a drain valve open on one of the large blending tanks while he was pumping the cranberry juice concentrate. The concentrate drained into a grated floor trough in the blend room and was subsequently pumped to the industrial wastewater pretreatment system, where the low pH overwhelmed the automatic pH neutralization function of the system and then was discharged to the sewer through the IW sample box. The pH meter/recorder at the sample box alarmed when the low pH wastewater began to discharge to the sewer and the company’s subsequent response to the alarm was to immediately and directly add highly alkaline 50-percent sodium hydroxide solution into the interceptor located just upstream of the sample box, as well as to add city water directly into the sample box to dilute the flow. This approach did result in raising the pH of the wastewater in the interceptor and sample box to an acceptable level. McIntosh’s review of the facility’s effluent pH data indicated that at about noon, the pH dropped from 9.8 to below 6.0 (as low as, very briefly, pH 2.3). However, by 1400 hours, the pH recovered and remained above 6.0. Thereafter, the company resumed some normal production. McIntosh issued a verbal warning for discharge of low pH wastewater.

Figure 3: Photo of the outfall and monitoring area at the Langer Juice Company facility in the City of Industry.

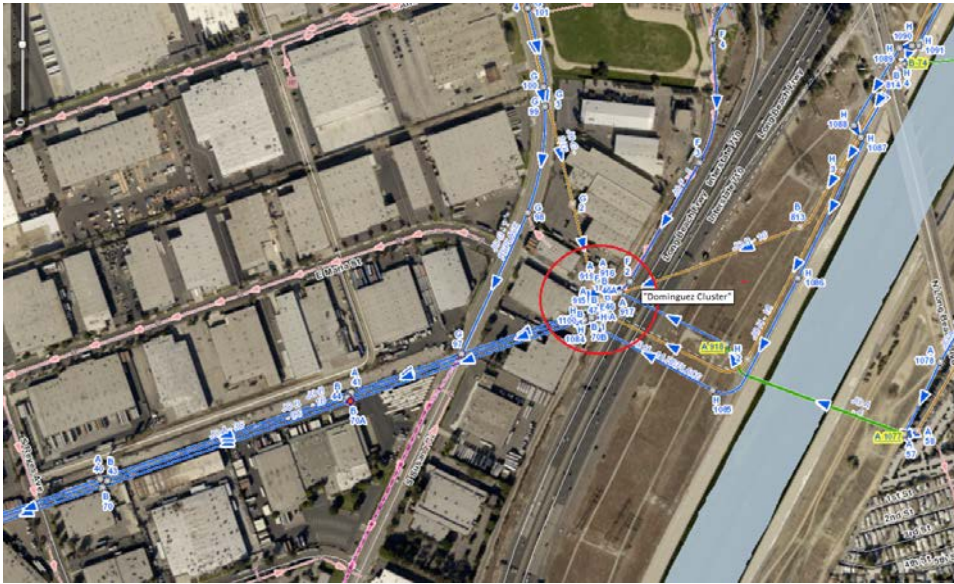
On Monday, 8-20-18 at 1022 hours, CFO Supervising Technician Albert Steele sent an email to Supervising IW Inspector John Boyd reporting that one of his technicians had monitored an LEL of 44% at 0845 hours that same day in the headspace of MH 08 0070A on the 72" diameter J.O. 'B' unit 1B sewer in Compton that is located just downstream of the Dominguez Cluster.

Figure 1: GIS Map Figure showing the location of MH B70A downstream of the Dominguez Cluster in Compton.

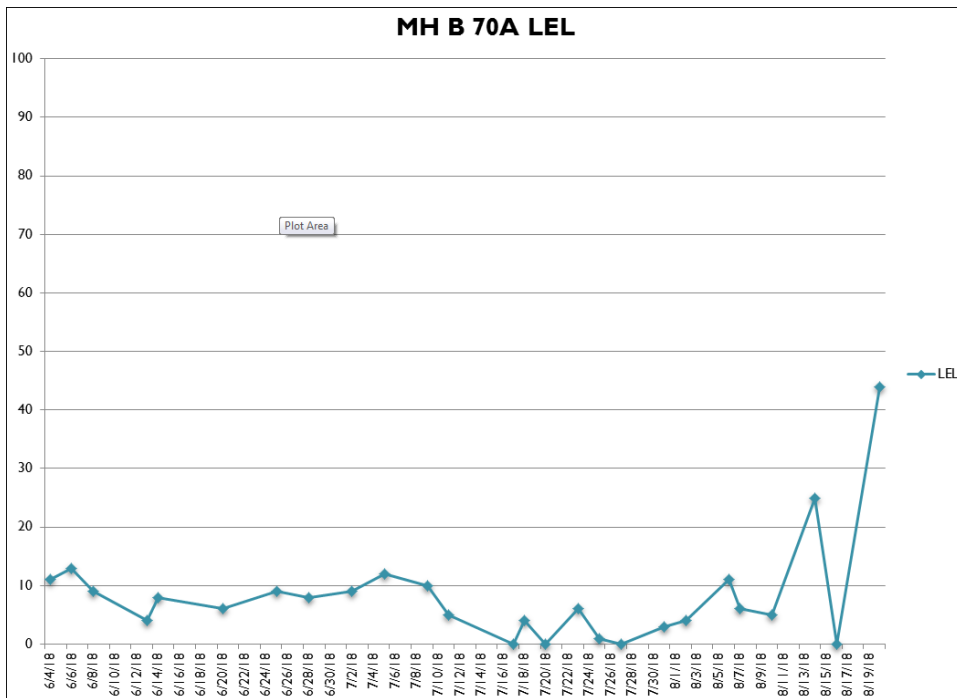
Upon being notified of the elevated LEL report at MH B70A, Team 3 Senior IW Inspector Bill Barnum commented that that level did seem high to him, but he and Boyd agreed that it would be useful if Steele could provide any other recent LEL data for the manhole so that the 8-20-18 data could be put into context. Boyd contacted Steele about this. Steele responded shortly thereafter with the CFO data for the manhole from 6-4-18 to 8-16-18 which indicated that 44% was higher than normal (see Figure 2 below).

Figure 2: MH B70A headspace explosivity data 6/4/18-8/16/18

Inspectors Barnum and Pengphol responded to MH B70A shortly after receiving the elevated LEL report, arriving on-site at 1105 hours on 8-20-18. The highest LEL they measured with their two explosimeters was 10%, which was about normal for this reach of sewer (see Figure 2 above). Inspection of further upstream manholes also indicated no elevated explosivity levels. No source for this incident was identified. It was noted that the Districts' downstream

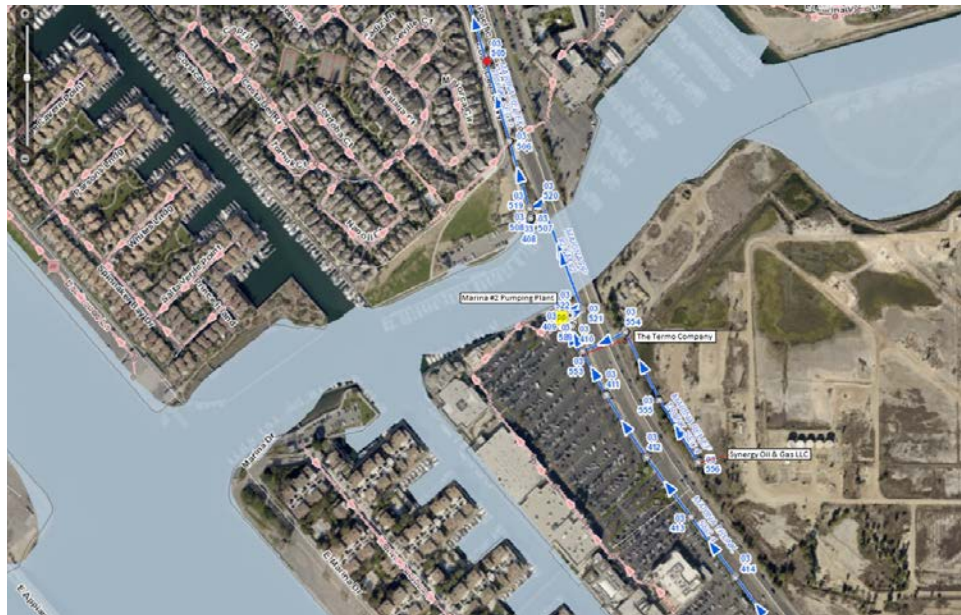
On Tuesday, 8-21-18 at 1225 hours, CFO Supervising Technician Albert Steele sent an email to Supervising IW Inspector John Boyd reporting that one of his technicians had monitored an LEL of 100% at 1018 hours that same day in the headspace of MH 03 0505 on the 18" diameter Marina Relief trunk section 3 in Long Beach. The information was forwarded to South Teams' Supervising IW Inspector David Sanchez at 1332 hours.

Figure 3: GIS map showing the area around the upstream of MH 03 0505, including the Marina #2 Pumping Plant and Section 4 of the Marina trunk sewer.

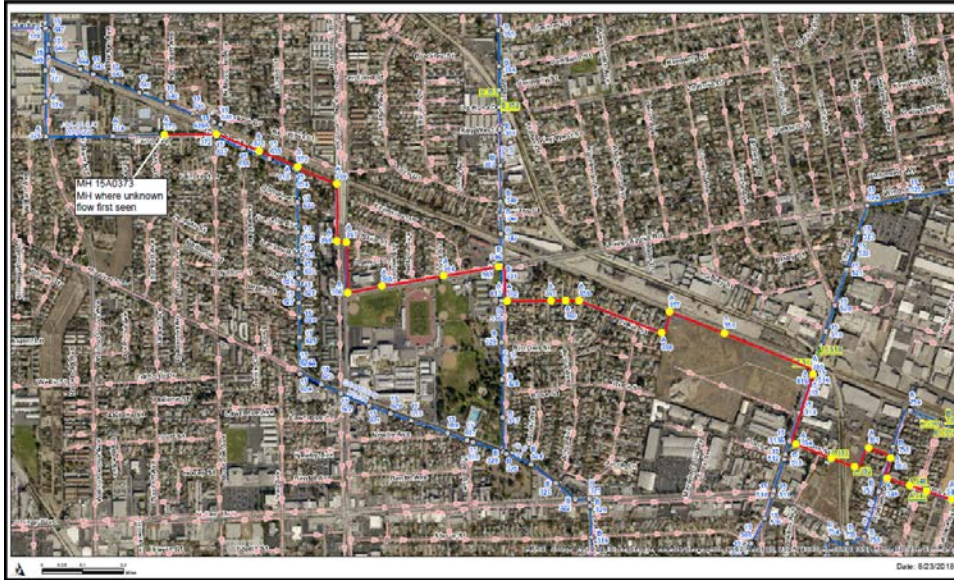
On Wednesday, 8-22-18, IW Supervising Engineer Bill Cheyne received an email and phone call from Districts' Engineering Associate Jubilant Ako of the San Gabriel Field Office. Ako requested the IW Section's assistance in investigating the source of a flow from an unknown source seen in an isolated portion of the SJCWRP Interceptor Trunk in the City of Rosemead. Ako stated that as part of an ongoing sewer sliplining construction project, flow had been diverted around the length of trunk from MH 15A0399 to MH 15A0357. After diverting, workers reported still seeing some unexpected flow in the line starting at MH 15A0373 and gradually increasing in volume to MH 15A0357. A records search done at the JAO public counter found no documentation of any connection permits to the trunk in this area. Senior Inspector Steve Sealy was notified and started an investigation by meeting on-site with Districts' Construction Inspector Cedric Elias.

Figure 4: GIS map showing the SJCWRP Interceptor (red) and the location of MH 15A0373 where the flow from an unknown source was reported.

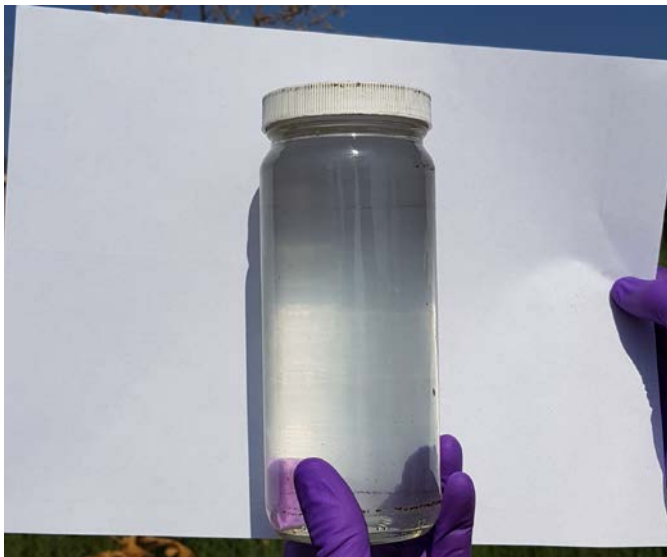
Figure 5: 8-22-18 sample of wastewater taken from MH 15A0356 on the SJCWRP Interceptor trunk. Note the clarity and lack of any color in the sample.

IW Inspectors, including Sealy, Greg Neunsinger, Kristopher McGinnis, and Nguyen Dang conducted the investigation into this report. Inspections were conducted at 5 possible industrial sources for the flow seen at MH 15A0357. None of these facilities had any evidence of illicit discharges or direct connections to the trunk sewer. Additionally, several locations along the trunk line were inspected at MH 15A0356, MH 15A0362, MH 15A0373, and MH 15A0383 where the flow was observed. A follow-up conversation with Steve Klopka, a Districts' construction inspector overseeing the sliplining process being performed by SAK, a 3rd part contractor, found that the times of the active sliplining construction activity correlated with the times when the unknown flow was being observed in the downstream sewer. A sample of the flow taken at MH 15A356 by the IW inspectors found its appearance (clear and colorless) and odor (none) matched what be expected of the water generated during the sliplining process. IW inspectors concluded that the source of this flow was the wastewater being generated from the sliplining project.
