2018 ANNUAL REPORT

INDUSTRIAL WASTE PRETREATMENT PROGRAM

COUNTY SANITATION DISTRICTS OF LOS ANGELES COUNTY

APPENDIX H
INDUSTRIAL WASTE REPORTS ON INCIDENTS

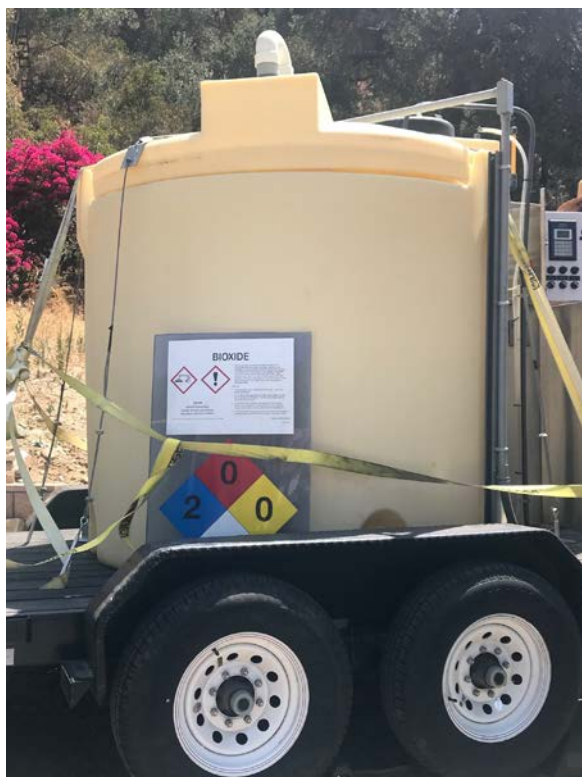
Area IW Inspector Anie Kellzi, with the assistance of Senior IW Inspector Steve Sealy, investigated this report. Inspections conducted on 8-24-18 and 8-28-18 confirmed the presence of a 750-gallon capacity poly tank full of “Bioxide” chemical (calcium nitrate solution) at the lift station. However, discussion with representatives of the La Verne Fire Department and the chemical supplier, Evoqua, revealed that its use was never initiated. The tank of Bioxide solution was subsequently removed from the site. The lift station pumps sewage up to a connection to the local sewer at 6633 Canterwood Way. This practice appears to be the cause of the strong odors on Canterwood due to the sewage becoming septic in the lift station. Strong odors were present during the inspections on 24th and 28th. The development company has now

Figure 7: 8-24-18 photo of the 750-gallon poly tank of "Bioxide" solution at the Meritage Homes' development sewer lift station.

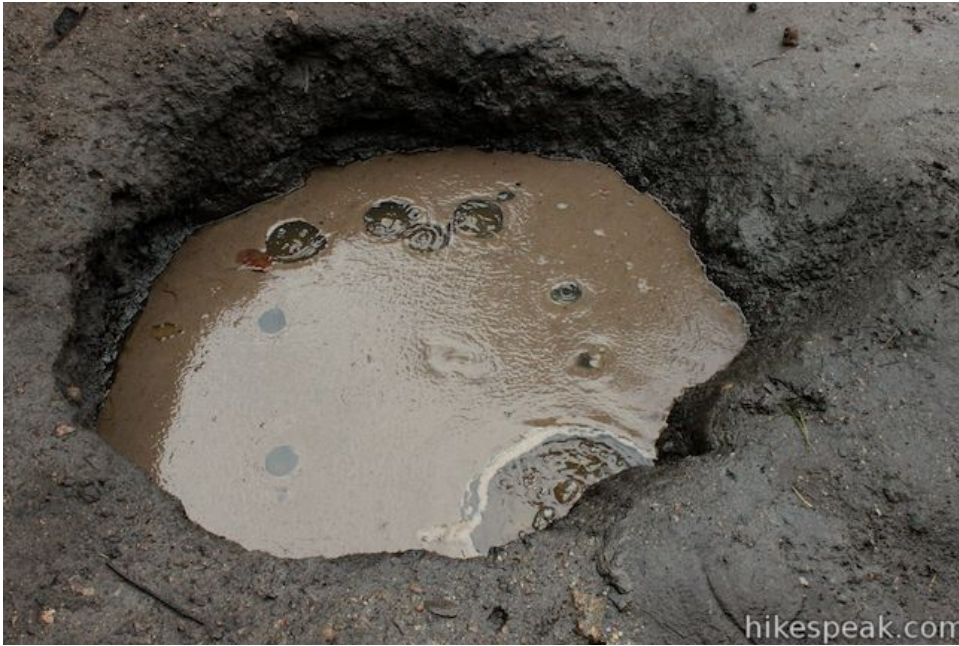
Pekin arrived at the WRP at 0935 hours on 11-19-18. She picked up the oil sample collected by operators and later submitted it for laboratory analysis. Inspections at the limited number of potential known IW sources located upstream of the WRP revealed no likely sources, and as noted above, the oil did not come in through the LWDS. It was noted that the oil had a very similar appearance as local oil produced from the local "Placerita Canyon" oil field that is located to the east and south of the WRP (see Figure 3 below). Boyd suspects that the oil may be from one of the local oil field operators cleaning out a brine tank or rainwater holding pond. These oil field operators normally do not discharge their brine water to the sanitary sewer, reinjecting into the field instead. Also, none of these operators in the Santa Clarita area has a sewer discharge permit for any wastewater they generate. Inspectors are attempting to acquire a sample of the local field oil to see if it can be matched to what came into the WRP. If a match is found, then inspectors will intensify their search for a source. As of 12-14-18 testing and characterization of the oil received at the WRP was currently in progress. Ultimately, the oil received at the WRP on 11-19-18 was of a limited volume, estimated at less than a barrel, i.e., 42 gallons, and had no adverse impacts on WRP operations or effluent quality.

Figure 3: Photo from a Google search that indicated this is Placerita Canyon Oil Field oil at a natural seep located within Placerita Canyon State Park about 6 miles from the Saugus WRP. Note that the appearance of the oil is essentially a visual match for the oil that that came into the WRP on 11-19-18.

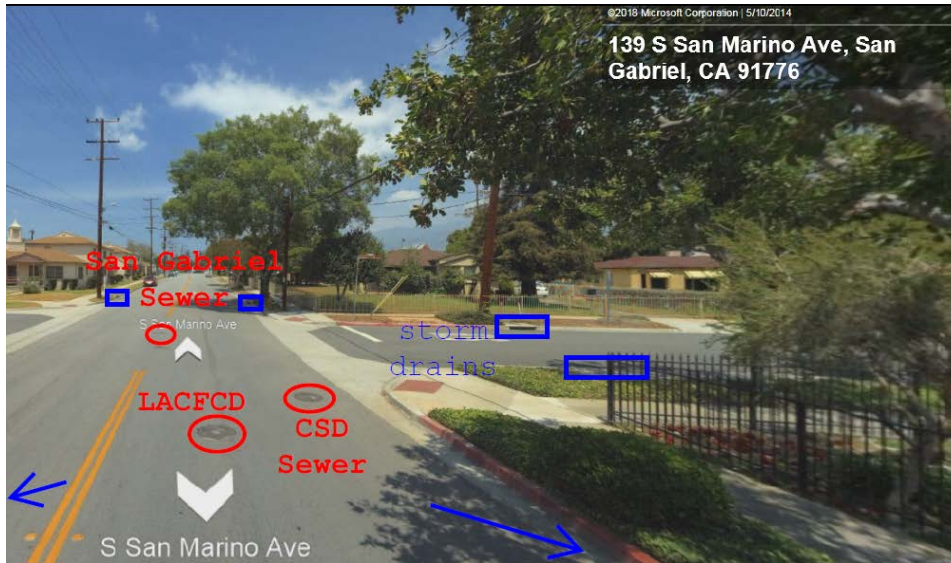
Figure 2: Annotated photo of the area where the sewer odor was reported on 12-14-18.
