2017 ANNUAL REPORT

INDUSTRIAL WASTE PRETREATMENT PROGRAM

COUNTY SANITATION DISTRICTS OF LOS ANGELES COUNTY

APPENDIX H
INDUSTRIAL WASTE REPORTS ON INCIDENTS

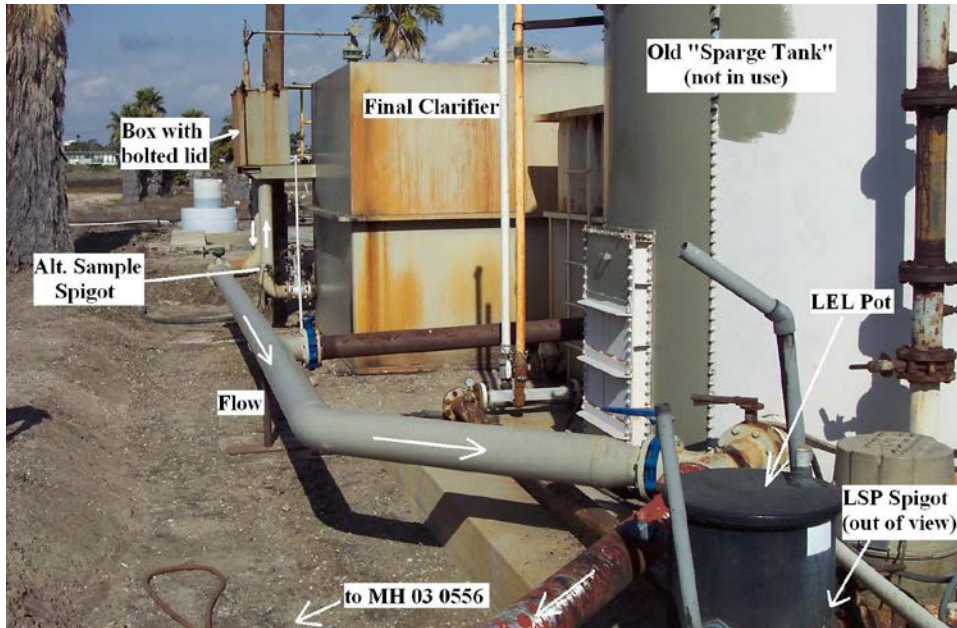
The investigation of this report, which was led by Senior IW Inspector Andy Woods under the Supervision of Supervising IW Inspector David Sanchez, and which ultimately involved a half dozen other IW inspectors, found that the lone source of the high explosivity condition in the sewer was methane being discharged into the sewer from the Synergy oil and natural gas production field located immediately upstream of the manhole headspaces where the explosivity was reported (see Figure 1). There have been lingering questions over the past decade plus as to whether or not the mats of algae material found in this line, which grow in and coat the line due to the warm, humid conditions there, have contributed to, or even been the primary source, of the high explosivity conditions periodically noted there. However, close examination of recent sewer headspace gas data following the successful cleaning of the line by a Districts' sewer maintenance crew later in mid-January indicated the algae was not the source of the explosive condition. Rather, it was wholly attributable to Synergy and the degree to which they remove, or fail to remove, methane gas entrained in the brine which they discharge to the sewer. IW inspectors will be closely monitoring Synergy and enforcing the "letter of the law" in

Figure 2: The industrial wastewater (brine) pretreatment system and legal sampling point (LSP) at Synergy Oil & Gas, LLC.

terms of how Synergy operates their pretreatment system and explosivity monitoring equipment in order to permanently address this long standing issue. Synergy was issued a written notice of violation for causing this incident on 1-6-17.

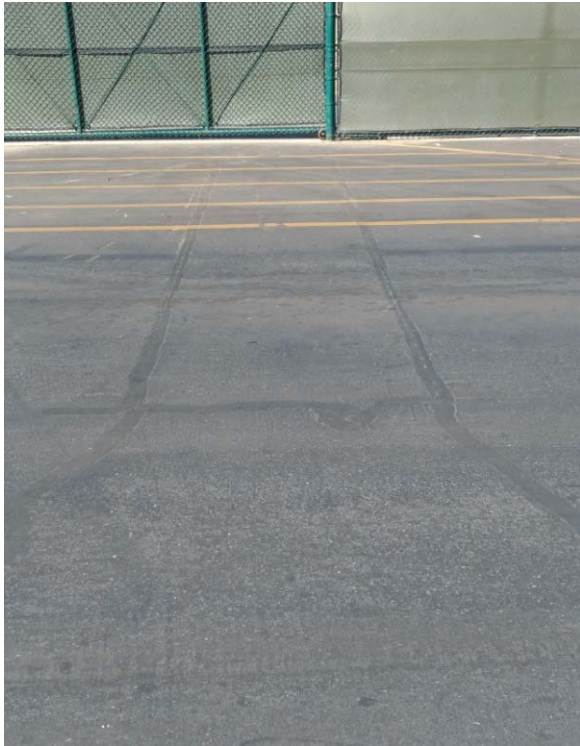
Figure 3: Concrete cut-out showing the location of the illicit line at the college.

Area Inspector James McCurdy was notified and responded. His investigation and review of Districts' direct connection permits confirmed that the illicit connection was not permitted by the Districts. Tracing of a visible cutout in the concrete above the illicit line quickly revealed that the line was coming from an outside washpad pad area drain (with 2-stage clarifier) adjacent to the baseball field at Cerritos College. Interviews with the college's Facility Manager, Mr. Shannon Kaveney, indicated that several years prior the college had used an outside

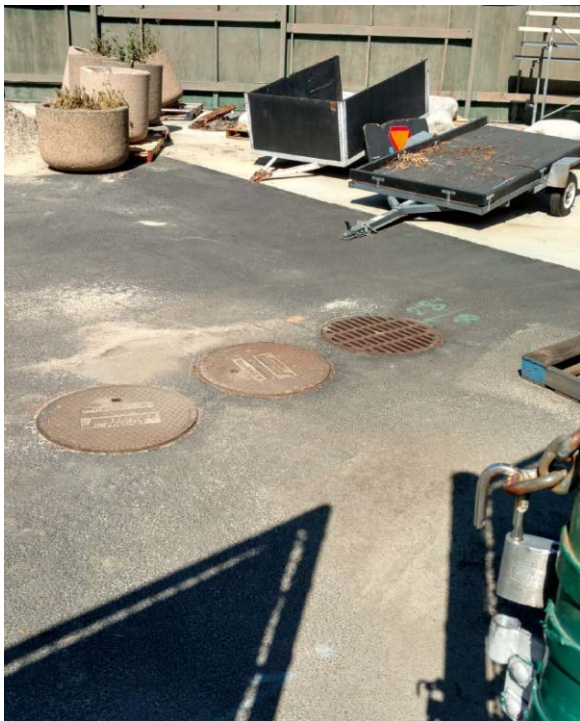
Figure 4: Drain and 2-stage clarifier next to the Cerritos College Baseball field that was illicitly connected to the J.O. 'F' Unit 3C Trunk in Cerritos.

contractor to construct the washpad with the intent that vehicles would be washed there. The washpad though has not been used for that purpose, instead functioning as an equipment storage area due to the subsequent construction a different washpad when a new facility building was constructed. Mr. Kaveney didn't dispute that the connection was made illegally, but stated it predated both his and the current Facility Director's employment at the College. McCurdy issued a written Notice of Violation to the College for the violation. Kaveney agreed to immediately seal the connection and eventually properly abandon the drain and clarifier. A follow-up inspection conducted by McCurdy on 4-25-17 revealed that the illicit drain and clarifier had been sealed and abandoned in place, effectively closing the issue.

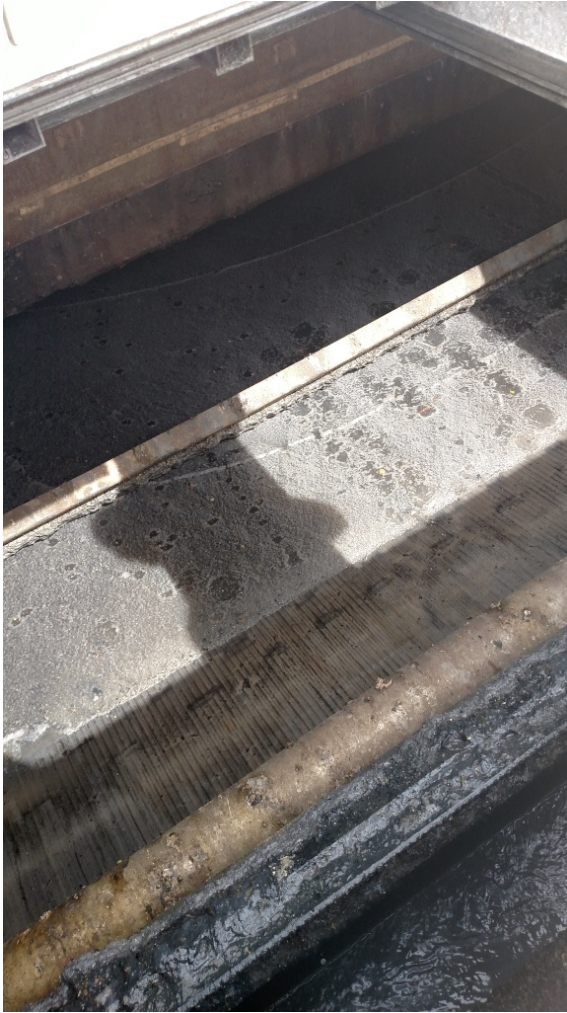
On Wednesday, 3-22-17 at 1330 hours, Valencia WRP Supervising TPO Matt Linn notified the IW Section that operators performing routine plant rounds noticed dense grey bubbles/foam collecting on the surface of the water along the launderers at the tail end of the primary tanks. He indicated that some foam periodically appears in this area of the primary tanks but never in this amount. Linn could not speculate what the foam was (whether it was grease or soap etc.) and said that analysts in the treatment plant lab attempted to use a centrifuge to separate the foam from the water but could not. Linn stated that this portion of the primary tank surface is skimmed and sent to the digesters weekly. He also wanted to report that recent routine lab analysis of the digester volatile organics has been steadily increasing over the past month and wondered if this foamy material could be the cause.

Figure 7: Unusual bubbles/foam on the primary tanks at Valencia WRP on 3-22 17.

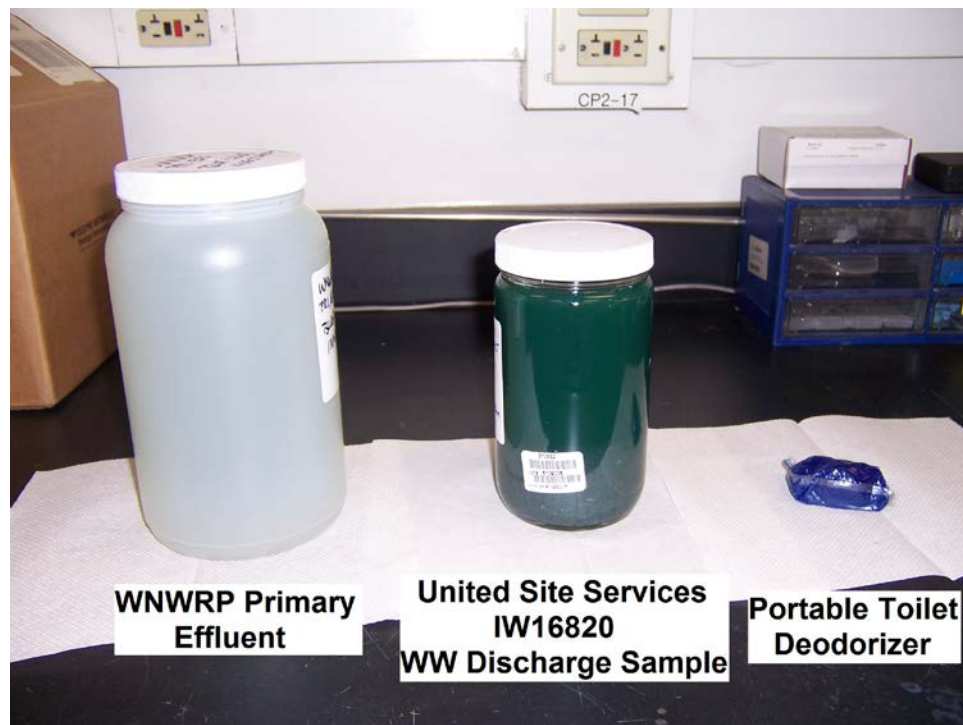
Investigation by Percy, as well as Area IW Inspector Greg Neunsinger, revealed that the color was coming from United Site Services in El Monte. The facility discharges portable toilet waste into the sewer nightly at their facility under permit with the Districts. The discharge is typically deeply blue colored due to the use of a blue dye present in a fragrance deodorizer product put into the water that is pumped into each portable toilet prior to its placement at a customer site. Sample analysis comparing the color seen at the WRP with those from United Site Services verified a match (see Figures 1-3 below).

Figure 1: Samples of WNWRP primary effluent containing a slight green color, United Site Services wastewater, and the packet of blue-colored deodorizer product added to each portable toilet.

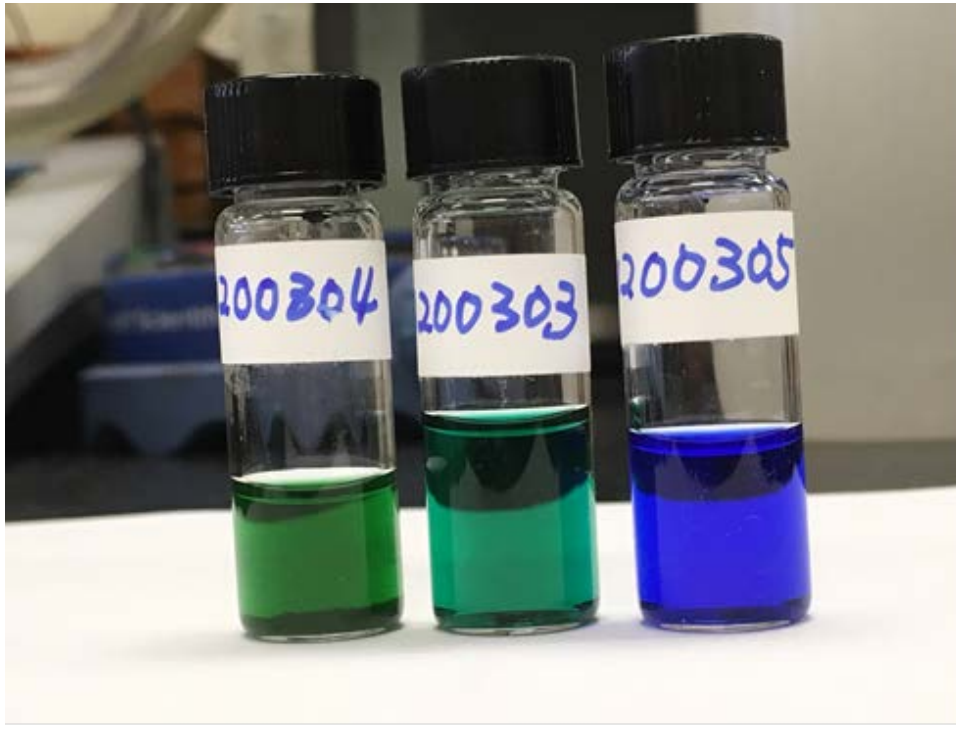
Figure 2: SPE methanol eluents from two samples 17051200304, 17051200303, and the methanol solution of sample 17051200305.

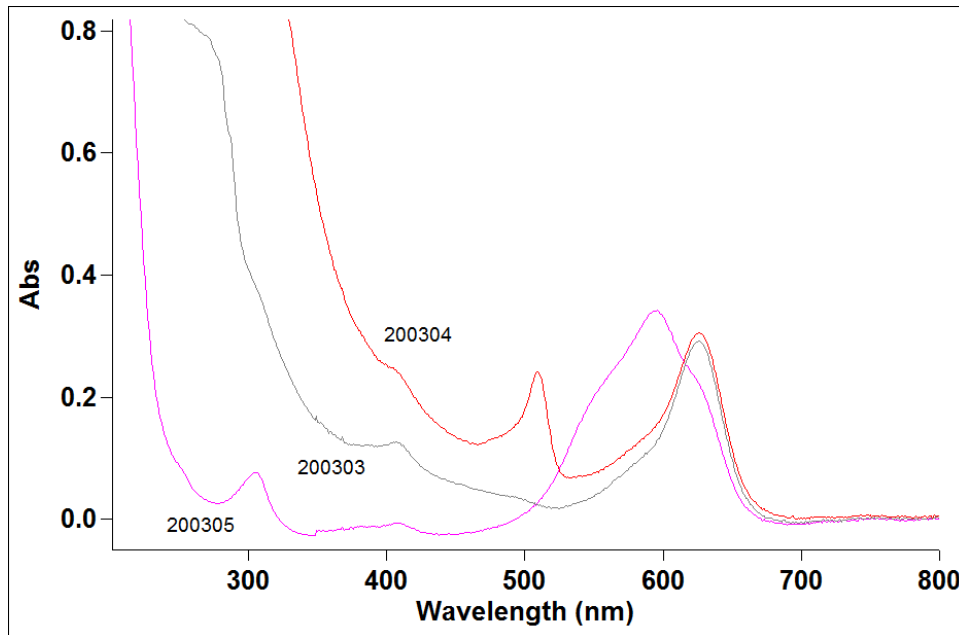
Figure 3: UV spectra of SPE methanol eluents from samples 17051200304, 17051200303 and methanol solution of sample 17051200305. The Spectra indicate a match between the wastewater sample from United Site Services (17051200303) and the primary effluent sample from Whittier Narrows WRP (17051200304)

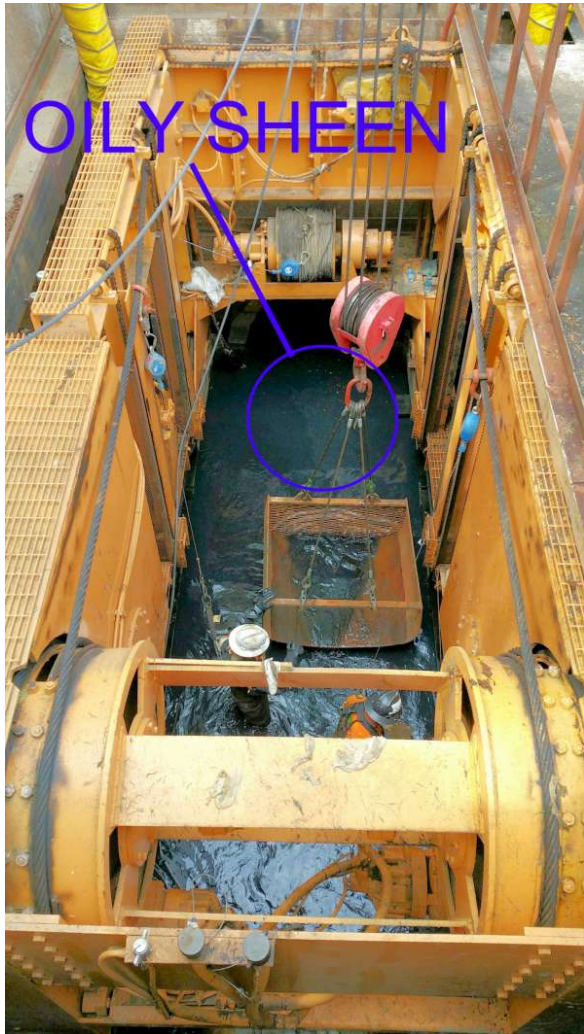
On Wednesday, 6-7-17 at 1200 hours, Districts' Industrial Waste Section Secretary Sandra O'Karma received a telephone call from Districts' Supervising Engineer James Andraska of the Carson Field Office. Andraska reported that a Districts' sewer construction contractor working on a large trunk sewer relining project had just observed an oily sheen on the surface of the J.O. 'A' Unit 6 trunk sewer at 63rd Street and De Forest Avenue in Long Beach. Andraska said that workers had collected a sample of the material that was available for pick-up by IW Inspectors. Coordinating Inspector Jason Finn received the information from O'Karma and notified area Senior IW Inspector Andy Woods of the report at 1203 hours. During the following week, two more reports, one on 6-8-17 and one on 6-14-17, of the same oily material being seen at the same location were made to the IW Section by Districts' Construction Inspector Jose Mendoza.

Figure 2: Sewer rehabilitation access point near MH 03A0063.

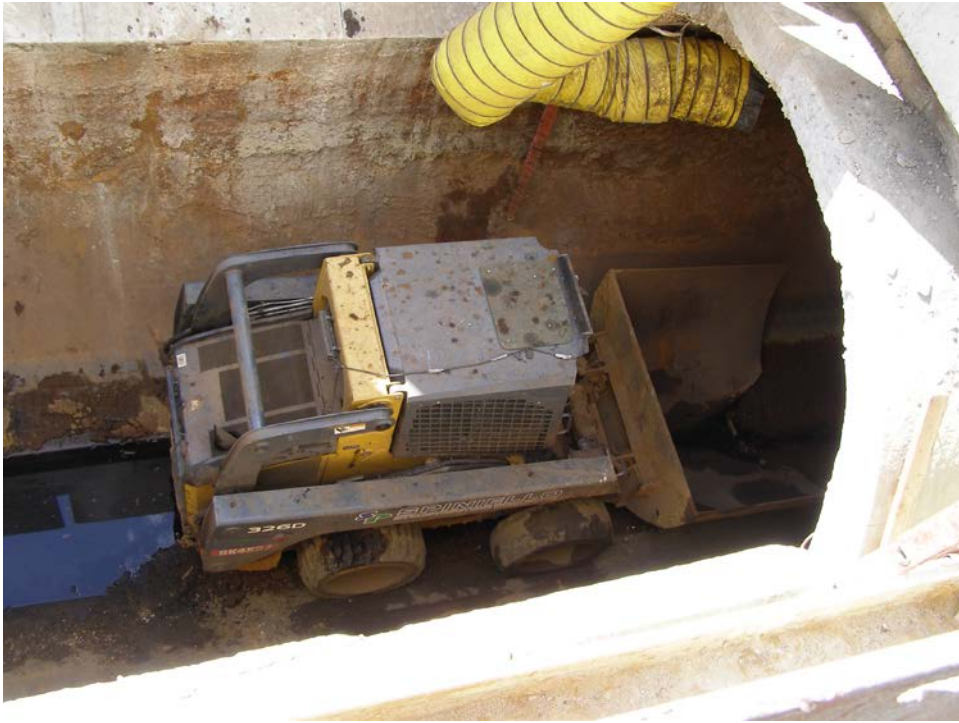
Figure 7: Bobcat excavator in the 144" J.O. 'B' Unit 1A trunk sewer at the rehabilitation project access point in between MHs B14 and B15.

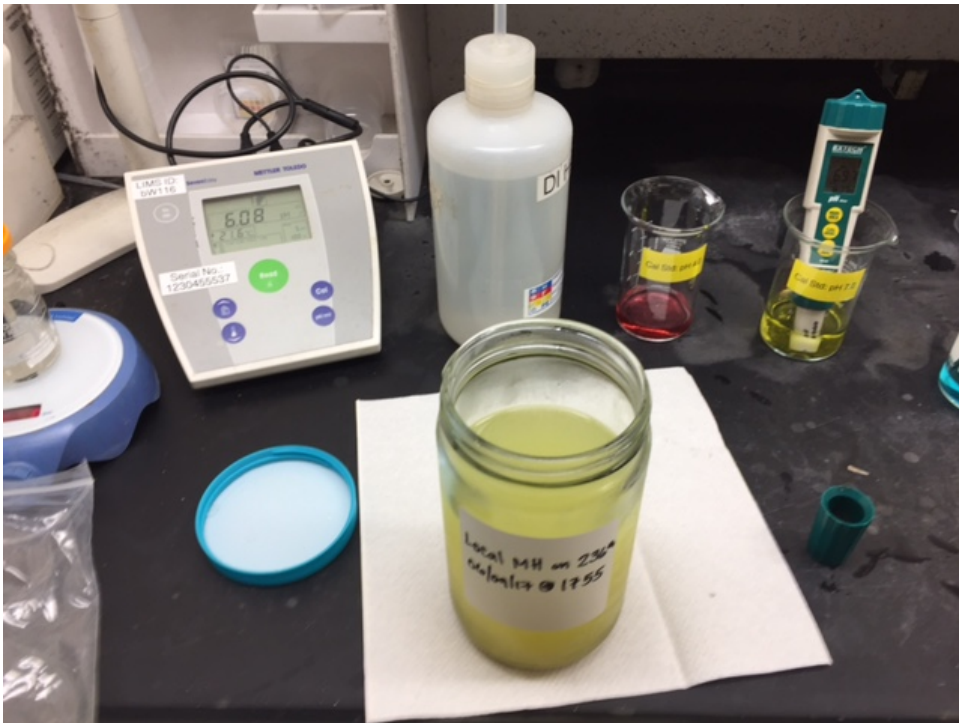
Figure 8: Sample of yellow colored wastewater taken at 1755 hours on 6-9-17 from the local line sewer MH on 236th Street in Carson.

Barnum’s investigation quickly determined that the yellow liquid observed earlier had entered the 144” trunk sewer from a 15” local sewer line connection where East 236th Street meets Wilmington Avenue. The source of the yellow colored waste with a solvent odor was subsequently successfully traced by Day and Night Team Inspectors, led by Senior Inspectors Bill Barnum and Kent McIntosh respectively, to BNX Shipping, a logistics company dealing in imported dry goods. On Monday, 6-12-17 an inspection at BNX Shipping found evidence the company had recently washed paint rollers that were used to paint yellow safety lines on the warehouse floor with Behr Premium 1 Part Epoxy Concrete & Garage Floor Paint – Unmellow Yellow. The warehouse manager of BNX Shipping was warned not to discharge oil-based paint or solvents into the sewer and issued a verbal warning. There have been no reported incidents of noxious fumes or yellow colored sewage since the incident. The worker exposed to the solvent fumes reported no lasting effects from his exposure and no further action is anticipated.

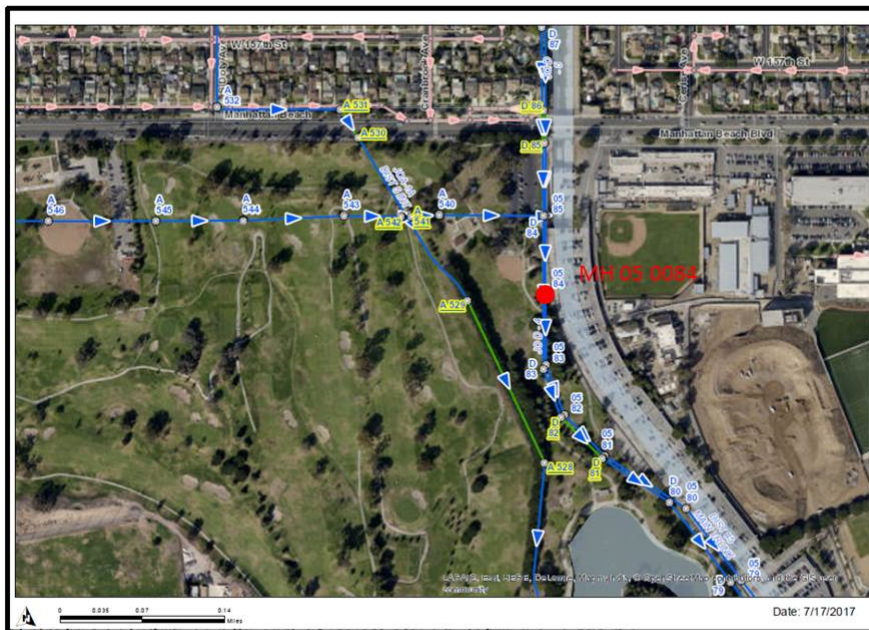
On Friday, 7-14-17 at 1000 hours, Supervising Engineering Technician Ron Rivers of the Compton Field Office telephoned Senior Inspector Bill Barnum and reported that his crew had discovered an illegal connection into Manhole (MH) 05 0084 of the 42" District 5 Main Trunk in Alondra Park in Lawndale. Rivers stated that the manhole cover had been opened, slid aside, and two wash basins had been set up with plumbing connected into the manhole through a wooden cover mounted flush with the manhole rim. According to Rivers his crew was on-site to retrieve data from a flow meter installed in the manhole when they observed the connection but were unable to access their equipment.

Figure 1: Map showing the location of MH 05 0084 on the District 5 trunk sewer manhole being used for illicit dumping activity in Alondra Park in Lawndale.

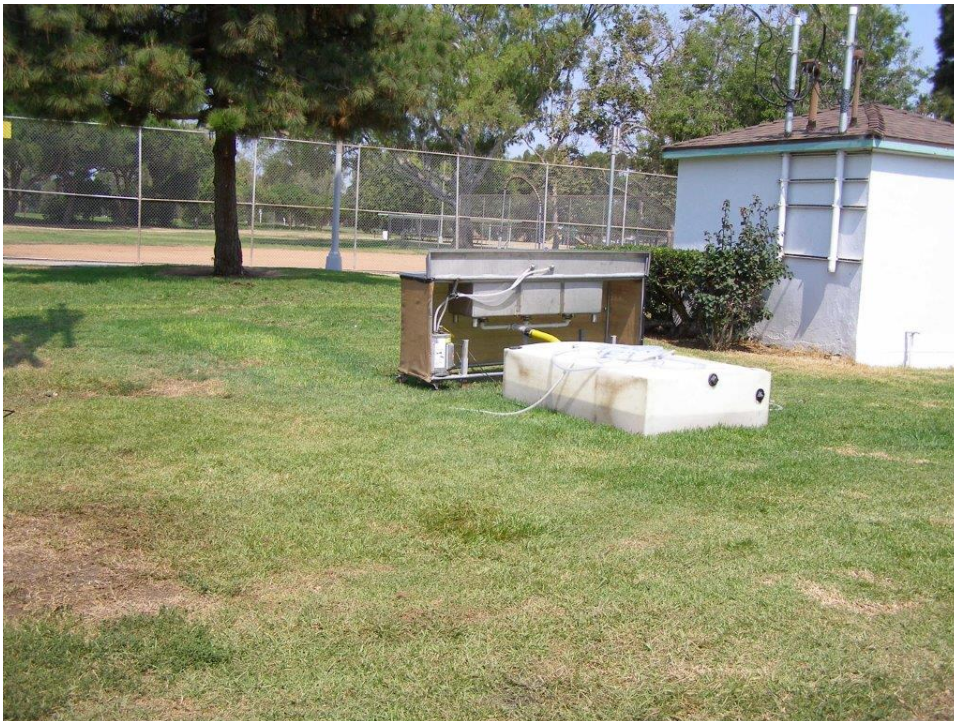
Senior IW Inspector Bill Barnum investigated this report. He arrived on-site at MH 05 0084 at 1020 hours on 7-14-17, finding the two stainless steel commercial style wash sinks temporarily set-up as dishwashing stations as reported by Rivers (see Figure 2 above). The sinks were set up as part of an annual weekend Hawaiian Festival held in the park. The President of the Hawaiian Inter-Club Council of Southern California, Mr. Lono Kollars, claimed the wash station installation had been used on the Districts' manhole for years and with the knowledge of the County Department of Parks and Recreation. Barnum noted the event is operated under permit from the County. Barnum informed Mr. Kollars that the equipment would need to be removed from the manhole immediately since it was in violation of the Wastewater Ordinance, which prohibits any such unauthorized use of the Districts' sewerage system under Section 216. Mr. Kollars immediately had his crew remove the piping from the manhole. Barnum inspected the Districts' flow monitoring equipment in the manhole which appeared intact and undisturbed, replaced the manhole cover and sealed the manhole with corks and silicon caulking (see Figure 3). Ultimately the event organizers contracted with a private waste hauler to set up a collection tank for each wash station and then hauled the wastewater offsite for proper disposal (see Figure 4).

Figure 4: 7-17-17 post event photo of a wash station with the plastic collection tank about 1/3 full of wash water awaiting servicing and removal.

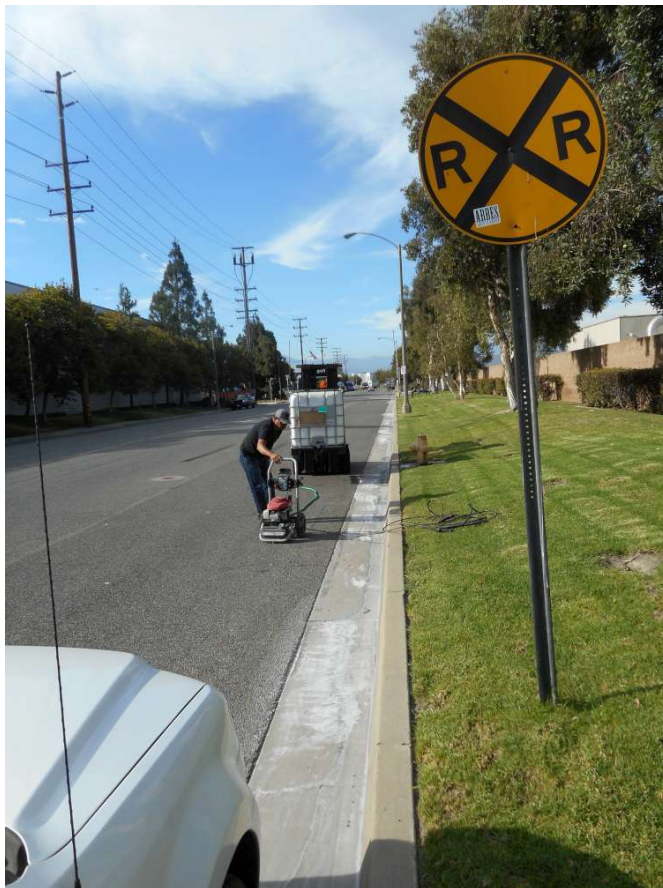
Joh and Night Team Senior IW Inspector Kent McIntosh arrived on-site at 1605 hours that same day. They observed the final stages of the cleanup of the salt laden wastewater that got into the storm drain (see Figure 5 below). The spill was caused by a sewer backup that occurred when a sewer cleaning contractor was performing maintenance on the company's industrial wastewater discharge line. The contractor was jetting the line when a blockage caused by diatomaceous earth solids in the line occurred, causing 300 gallons of water to overflow out of an open cleanout into the adjacent street gutter. The spilled water was collected and the street pressure washed to remove all the residual salts. The company contact called Districts' IW Section Engineer David Sonboli and obtained permission to put the approximate 500 gallons wastewater from the event into their industrial waste pretreatment system for disposal. The water was subsequently treated and discharged without incident. The event was recorded as required in their spill log. There were no known negative impacts to the Districts' sewers or downstream treatment plant operations from this incident.

Figure 5: Contractor preparing to pressure wash the street gutter to remove residual salts on 7-27-17 at 1605 hours.

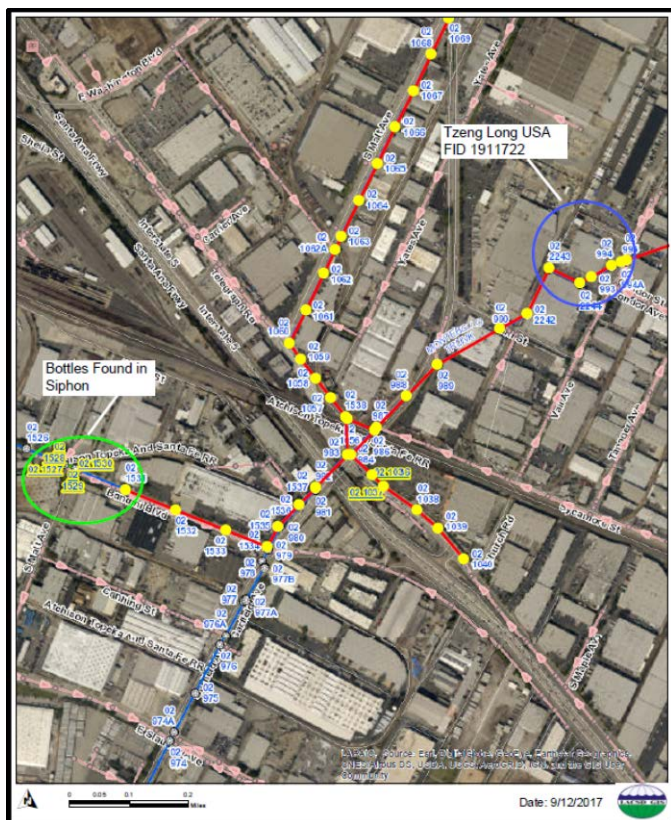
On Tuesday, 9-12-17 at 1020 hours, Supervisor of Sewer Maintenance Bill Balas of the San Gabriel Field Office telephoned Supervising IW Inspector John Boyd and reported that one of his Lead Maintenance and Construction Workers, Bruce Gomez, was encountering "tons" of plastic bottles (see Figure 2 below) at manhole (MH) 02 1530 on the 24" Montebello Relief trunk (sections 1 & 2). This manhole is the upstream manhole on a double barrel siphon structure located at the intersection of Bandini Boulevard and Malt Avenue in the City of Commerce. Balas said it's unclear if the bottles are still coming down the line. The bottles are building up on the upstream side of the siphon. North teams Supervising IW Inspector Dave Lee was notified of the report.

Figure 2: GIS map indicating location where the plastic bottles were initially encountered by a Districts' sewer maintenance crew and the source of the bottles, Tzeng Long USA.

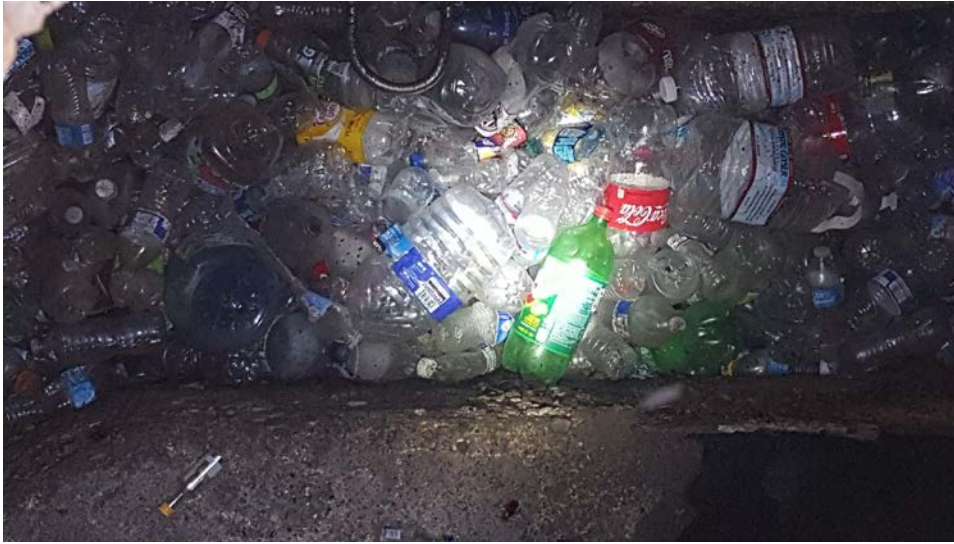
Senior IW Inspector Steve Sealy investigated the report. He arrived on-site at MH 02 1530 at 1045 hours on 9-12-17 and met with Bruce Gomez and observed the bottles in MH 1530 (see Figure 3). Being aware that there was a large plastic bottle recycling operation, Tzeng Long USA, located not far upstream of MH 1530, Sealy immediately proceeded there to see if that could be the source of the bottles found in the sewer. Upon arrival at the Tzeng Long USA facility Sealy noticed that Districts' MH 02 0994 was located very close to large piles of plastic bottles (see Figure 5) and displayed evidence of being frequently subjected to hard hits from front end loaders used by the company to collect and move around the piles of plastic bottles (see Figure 7). The company manager, Mr. Alan Ho, initially denied that the bottles

Figure 3: Plastic bottles in the Montebello Relief trunk sewer at MH 02 1530 on 9-12-17.

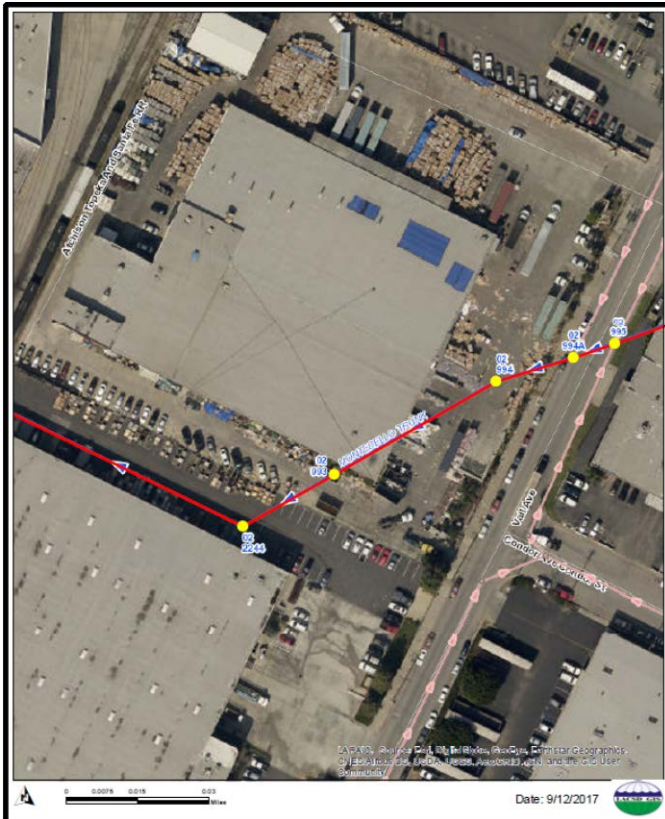
Figure 4: GIS close up of Tzeng Long USA property indicating the location of MH 02 0994.

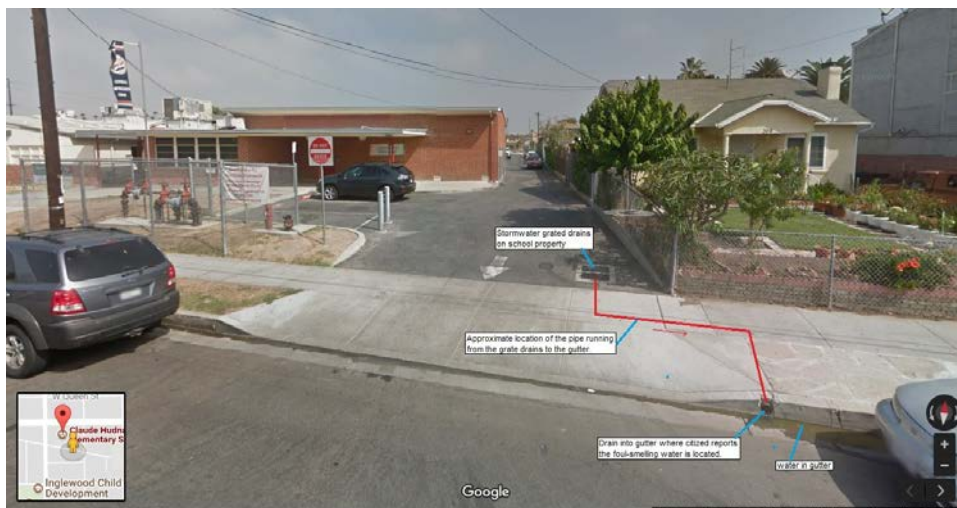
Figure 9: Google Maps “Streetview” annotated picture indicating the area on Olive Street about which the odor complaint was filed.

either time. On both occasions he observed small puddles of clear water with a neutral pH of 7 standing in the street gutter (see Figure 9 above). The water had no detectable odor. He noted that the 4" diameter pipe that likely conveyed the now standing water to the gutter appears to be connected to a series of storm drain catch basins along the west side of the school. There was no evidence of any illicit discharge of odorous or inappropriate wastes to the school's storm drain system or the street gutter. There was no evidence that this situation involves or is negatively impacting the Districts' sewer system or downstream operations. No further action by the IW inspection staff is anticipated. Barnum's findings were given to Cheyne to pass back up the chain of command.

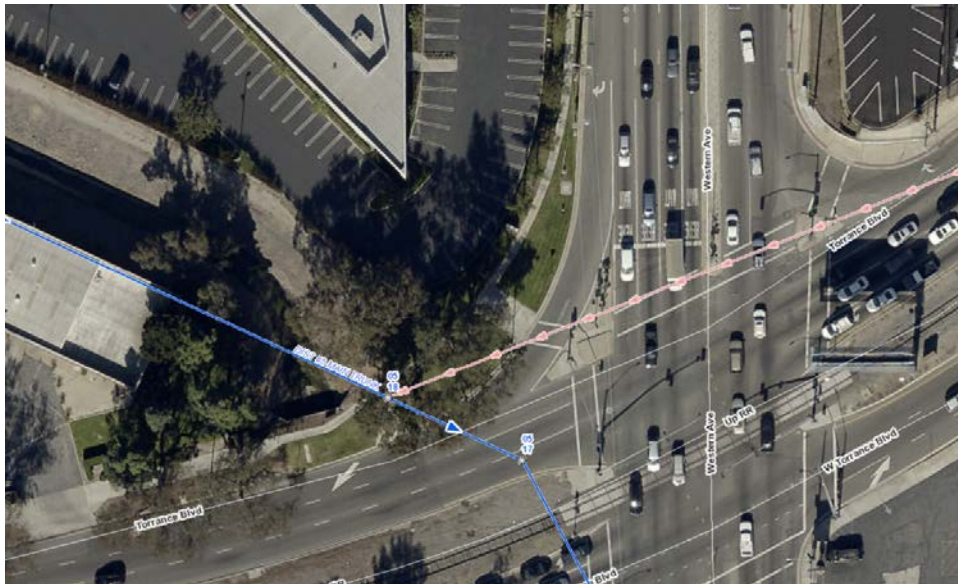
On Friday, 10-13-17 at 1010 hours, Industrial Waste Manager Dave Snyder forwarded Supervising Inspector John Boyd an email string containing correspondence from Andrew M. Taylor, Senior Environmental Manager with the Environmental Health, and Safety Department of the AT&T Corporation and Frank Caponi, Manager of Districts' Air Quality Engineering Section. The string contained information claiming that an AT&T manhole/vault at the intersection of Torrance Boulevard and Western Avenue in Torrance was impacted with raw sewage. The information was forwarded to Supervising IW Inspector David Sanchez for follow-up.

Figure 1: GIS screenshot showing the sewer lines in the area where the flooded AT&T vault was reported in Torrance.

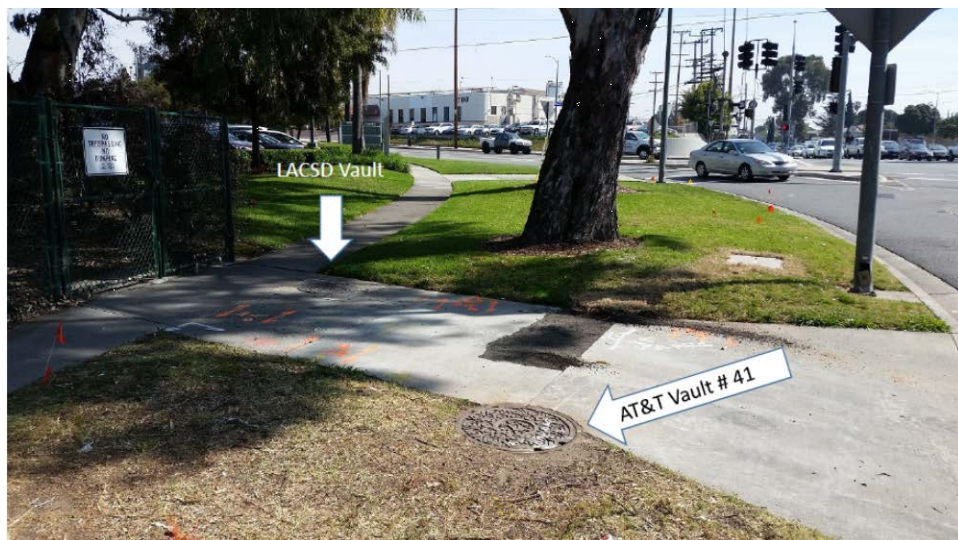
Figure 2: AT&T photo showing the AT&T vault that was reported to contain sewage, and the adjacent "LACSD Vault" (actually Manhole 05 0018 on the 48" District 5 Main Trunk).

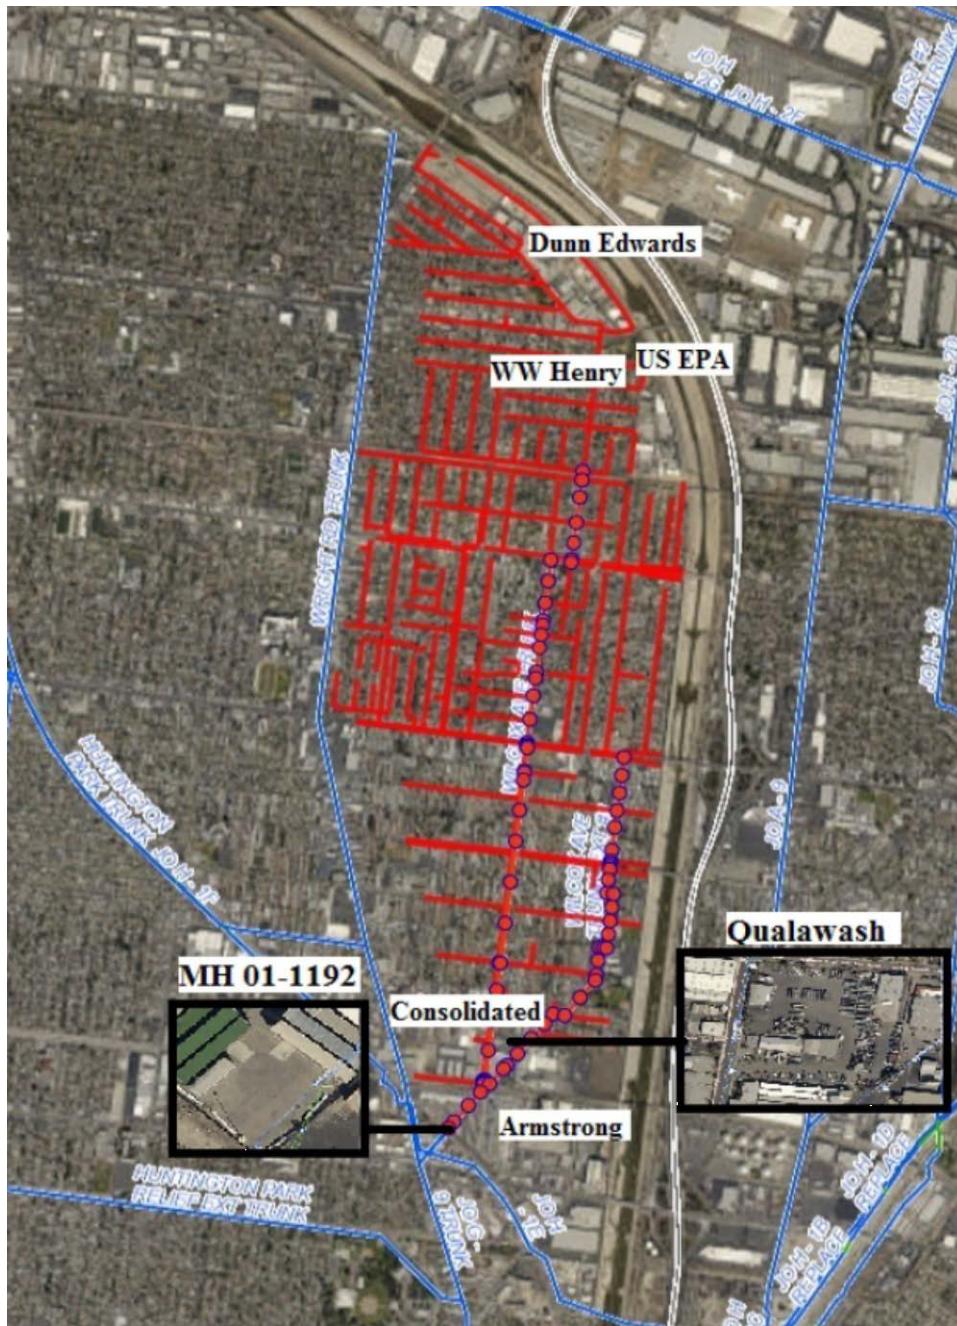
On Tuesday, 11-7-17 at 1303 hours, Supervising Engineer Bill Cheyne received an email from Rick Pearce, Supervisor of Sewer Maintenance at the Compton Field Office. Pearce reported an unusual petroleum/resin odor at MH 01 1192 on the Wilcox Avenue Relief Trunk in the City of South Gate (see Figure 2 below). Cheyne forwarded the email to Coordinating Inspector (CI) James McCurdy, who then notified Senior IW Inspector Peter Carlstrom and Area IW Inspector Ken Hanks via phone. Pearce stated during a subsequent phone conversation with CI McCurdy at 1400 hours that the sewer crews regularly access this manhole to remove ragging material and that the odor has gotten progressively worse. Sewer crews last accessed the manhole on 11-6-17 at approximately 0930 hours, according to Pearce.

Figure 2: GIS map with annotations indicating the location of the trunk sewer line manhole (MH) 01 1192 where the petroleum/resin odor was detected by a sewer maintenance crew on 11-7-17, as well as multiple upstream industrial wastewater dischargers inspected as part of the investigation.

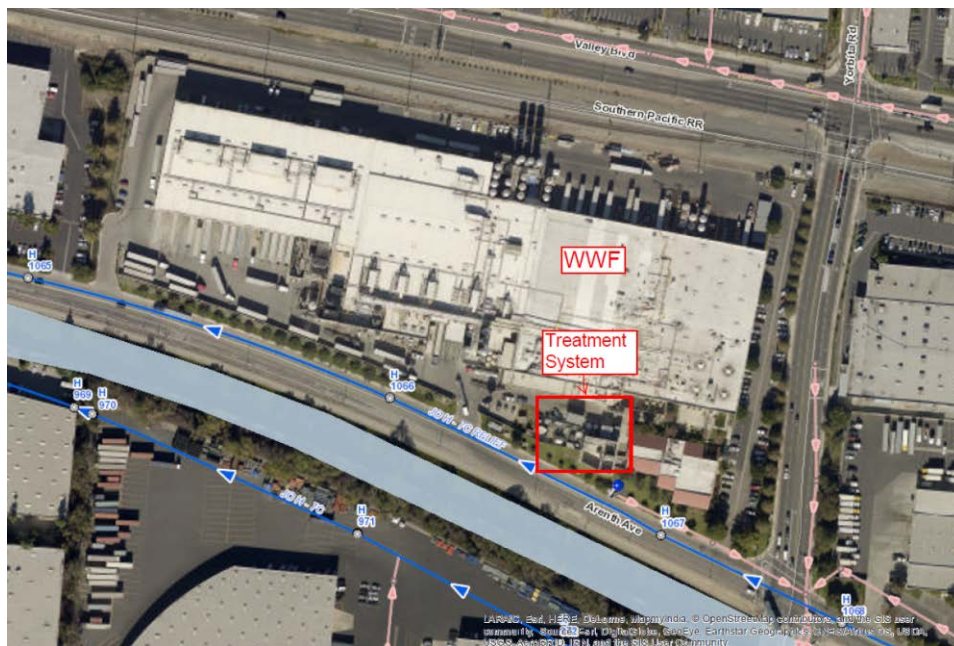
Figure 4: GIS screen shot showing the location of the White Wave Foods plant, treatment system, and sewer connection location where the facility discharges their industrial wastewater into the local sewer line. Note that the facility does not connect directly to the J.O. 'H' Unit 7C trunk sewer that runs by the facility. Instead the discharge goes into the local sewer line shown just to the south pretreatment area.

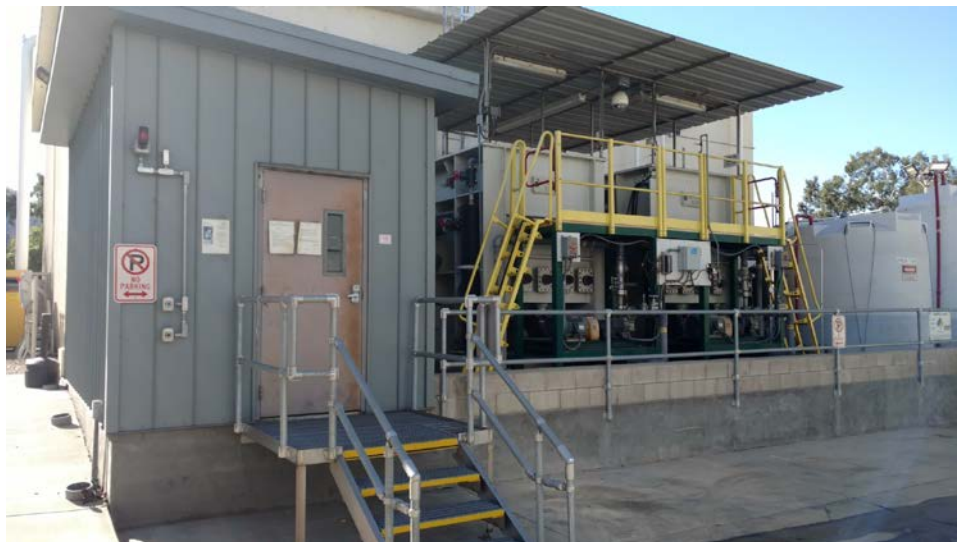
Figure 5: The pretreatment system (on the right) and its control room (grey building on the left) at White Wave Foods.

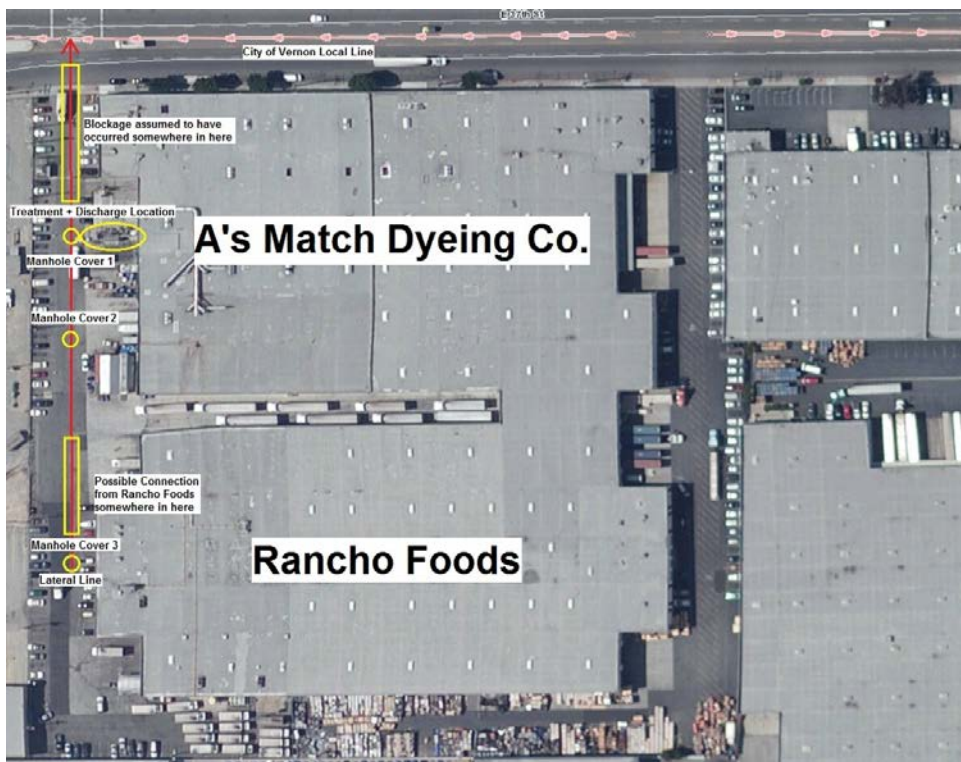
Figure 1: Area map showing the locations where Rancho Foods and A's Match Dyeing Company connect to the lateral sewer line.

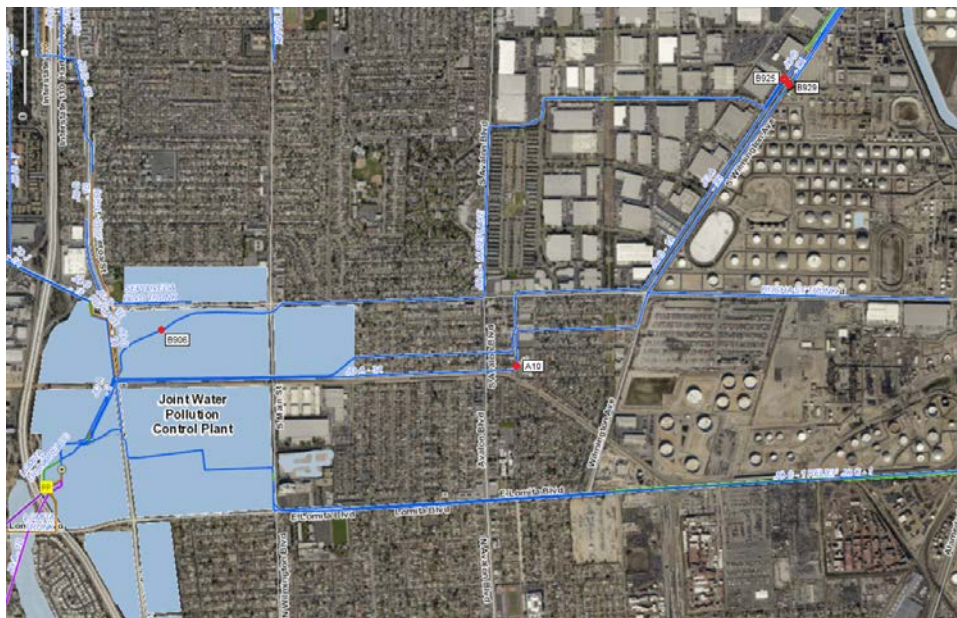
The following day on Wednesday, 12-13-17 at 1328 hours, CFO Supervising Engineering Technician Albert Steele sent an email to Supervising IW Inspector John Boyd reporting that two more high elevated manhole headspace explosivity conditions just upstream of the JWPCP had been noted by one his technicians; specifically, MHs A10 (77% LEL at 1310 hours) and B906 (100% LEL at 1320 hours). MH A10 is located on the 114" diameter J.O. 'A'-Unit 3A trunk sewer just under a mile upstream of the JWPCP while MH B906 is located on the J.O. 'B'-1A Replacement Box trunk sewer (10' W X 12' H) on the grounds of the JWPCP just north of the solids processing area. Steele reported that the flow rates at both manholes appeared normal, but there was a strong sulfide odor present at MH B906. However, he was unaware that there were any reports of elevated LEL at the JWPCP headworks. He also said he was unaware of the high LEL in MHs B929 and B925 that had been reported the

Figure 7: GIS Map showing the location of the 4 manholes reported with elevated headspace explosivity on 12-12-17 and 12-13-17.

McIntosh investigated the report of 12-12-17. He inspected both of the large oil refineries located upstream of the two manholes as well as two tanker truck wash facilities, finding nothing unusual at these facilities. Barnum responded to the 12-13-17 report from Steele, inspecting the two manholes himself within two hours of the original reports. Barnum verified that the explosivity in the MH B906 headspace was still elevated at >100% LEL but MH A10 was significantly lower at 34% LEL. He detected a strong sulfide odor at MH B906 but no odor was detected at MH A10. Barnum spoke with TPO II Mario Gomez at the JWPCP Primary Operations Control Room who stated that combustible gas levels at both the J.O. 'A' and J.O. 'B' inlets to the headworks had been normal for the previous two days and there had been no indication of any elevated explosive conditions in the secondary reactors. Previous high LEL investigations conducted over the previous 5+ years by IW Inspectors at these manholes have indicated that biogenic methane can be found in high concentrations in the headspaces of these sewers and is the cause of the elevated explosivity periodically noted there by sewer maintenance personnel. Samples collected from the headspaces of these manholes during previous investigations consistently confirmed that biogenic methane is the source of occasional elevated explosivity in these sewers. The inspection staff concluded that no further investigation was warranted given the lack of evidence indicating any industrial sources were causing the elevated readings.

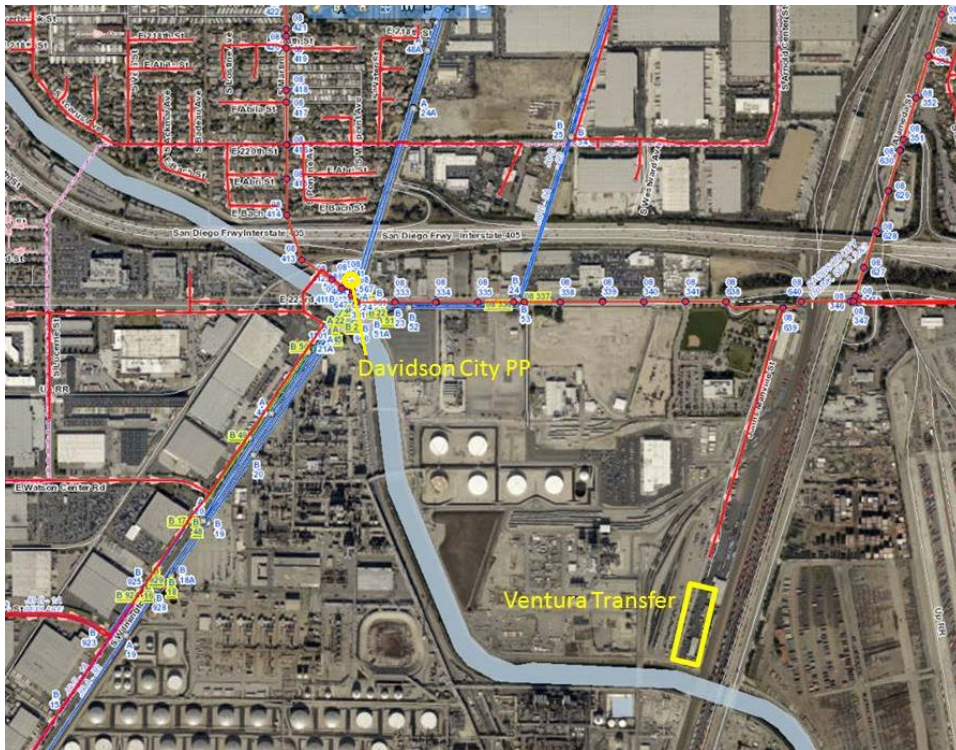
Barnum, working with Area IW Inspector Nat Pengphol, traced the odor detected on 12-28-18 by Pivovarovoff to the area outside the gate leading into the Ventura Transfer Company at 1020 hours. However, although the odor was present in the street in front of the facility it was not present in the wastewater being discharged from the facility into the sewer at that time. Examination of tanker washing ticket information revealed that Ventura Transfer operators were currently washing an intermodal container which had recently contained dicyclopentadiene. A half-full 320-gallon tote tank was found that appeared to contain the steam condensate waste generated from prewashing the container. The material in the tote had the same odor as the pump plant odor. According to the site contact, the material in the tote was to be comingled with other hazardous wastes for off-site disposal and would not, nor had been, discharged into the sewer. Pengphol and Barnum felt it was very likely this incident was caused by some of the dicyclopentadiene being discharged into the sewer by the company, but sufficient evidence to support the issuance of a violation notice to the company was not found.

Figure 8: GIS Diagram showing the proximity of the Ventura Transfer Company to the Davidson City Pumping Plant.

There are many chemicals and compounds that could potentially be present in the industrial wastewater generated by Ventura Transfer Company due to the nature of their business. Team 3 IW Inspectors, under the leadership and guidance of Supervising IW Inspector David Sanchez, are currently undertaking a sampling study of the wastes and wastewaters generated at Ventura Transfer Company. In addition more frequent inspections are being conducted at the facility to more effectively regulate the company and to help prevent these types of incidents from occurring again.
