2022 ANNUAL REPORT

INDUSTRIAL WASTE PRETREATMENT PROGRAM

LOS ANGELES COUNTY SANITATION DISTRICTS

APPENDIX H
INDUSTRIAL WASTE REPORTS ON INCIDENTS

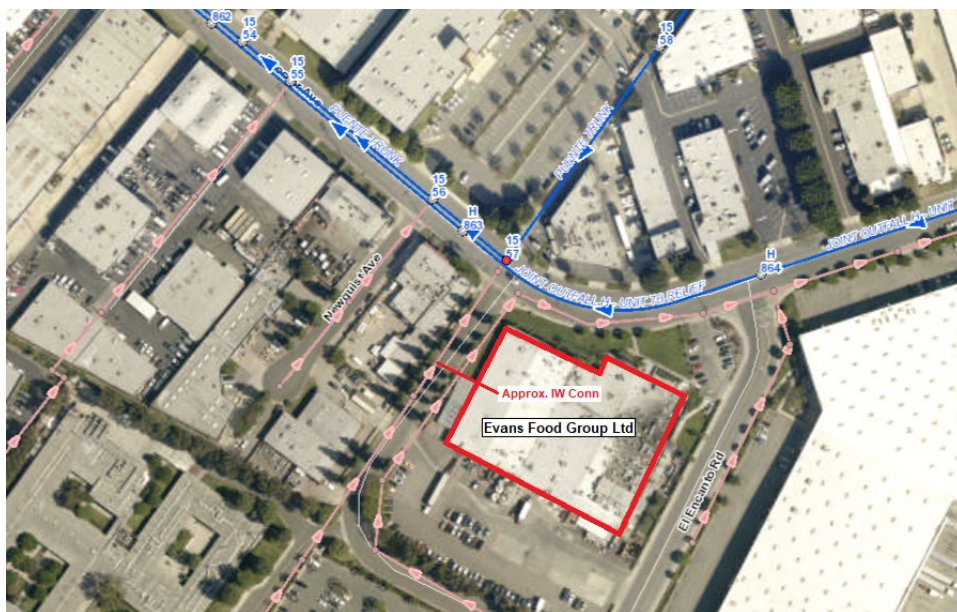
On Tuesday, 1-11-2022, the San Gabriel Valley Field Office notified the IW Inspection staff that one of their sewer maintenance crews had encountered a partial grease blockage between Manholes (MH) 15 0057 and MH 15 0056 in the 10” diameter Puente Trunk in the City of Industry (see Figure 1 below) on Saturday, 1-8-2022, during routine cleaning activities. The crew jetted the line and it seemed to resolve the issue. However, once the line was cleared, the crew observed grease entering MH 15 0057 from a southern local line. A sample of the grease material was collected (see Figure 4). This section of the Puente Trunk is cleaned annually, and it was stated that this was the first time the crew had noted excessive grease at this location.

Figure 1: Annotated GIS diagram showing the location of the excessive grease observed in the Districts' Puente Trunk sewer at MH 15 0057 and the location of the source of the grease nearby, Evans Food Group, LTD.

Both day and night shift Industrial Waste Inspectors investigated the report. It was determined that the source of the grease was Evans Food Group, Ltd., aka Gayton Foods, a large manufacturer of chicharrones (fried pork skins/rinds) that was discharging excessive amounts of grease, generally during after-hours clean-up operations. The Evans facility holds IW permit #22180 and has a permitted flowrate 16,000 gpd. The facility was found to have an inadequate pretreatment system to remove the grease from their industrial wastewater discharge.

A Notice of Violation (NOV) was issued to the facility on 1-26-2022 for causing excessive greasing in the downstream sewers and a requirement was issued to cease the discharge of the excessive grease immediately. Additionally, after contacting the local sewer agency (the Los Angeles County Department of Public Works Sewer Maintenance District, aka the LACDPW SMD), the local sewer line was hydrojetted by the SMD to remove residual grease. A compliance meeting with Sanitation Districts' enforcement managers and Evans Food Group facility representatives may be scheduled to address these issues.

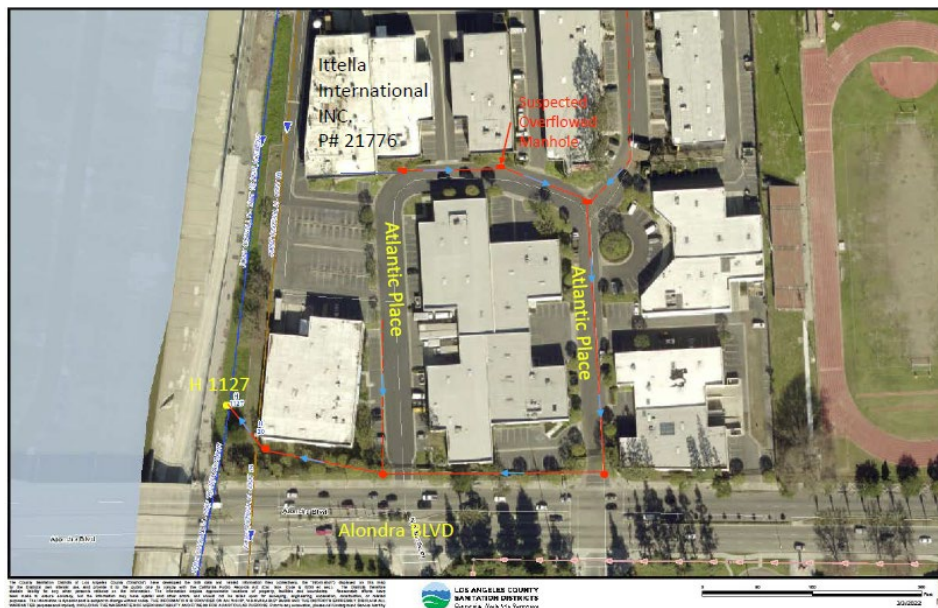
After the above, LACSD IW inspectors were contacted on 3-2-22 by the Los Angeles County Department of Public Works (LADPW) Source Control Division and a joint LACSD-LADPW investigation of the sewer system configuration upstream of the 3-1-22 SSO was conducted. It was determined that the sewer lines upstream of the estimated 30,000-gallon SSO were part of relatively extensive private line system, owned and operated by a business park landlord. The business park includes about 20 tenants and the private sewer system joins directly to the downstream J.O. 'H' Unit 1B trunk sewer at manhole H1127 (see Figure 1). The landlord was ultimately held responsible for the SSO and required to properly maintain the lines moving forward. The exact cause of the overflow was not determined as City of Paramount crews successfully jetted the line on 3-1-22, clearing and washing away the blockage causing material. It is thought most likely that a buildup of sanitary debris caused the SSO.

Figure 1: Geographic Information System based annotated diagram of the private sewer line system (red lines) in the City of Paramount where an SSO occurred on 3-1-22.

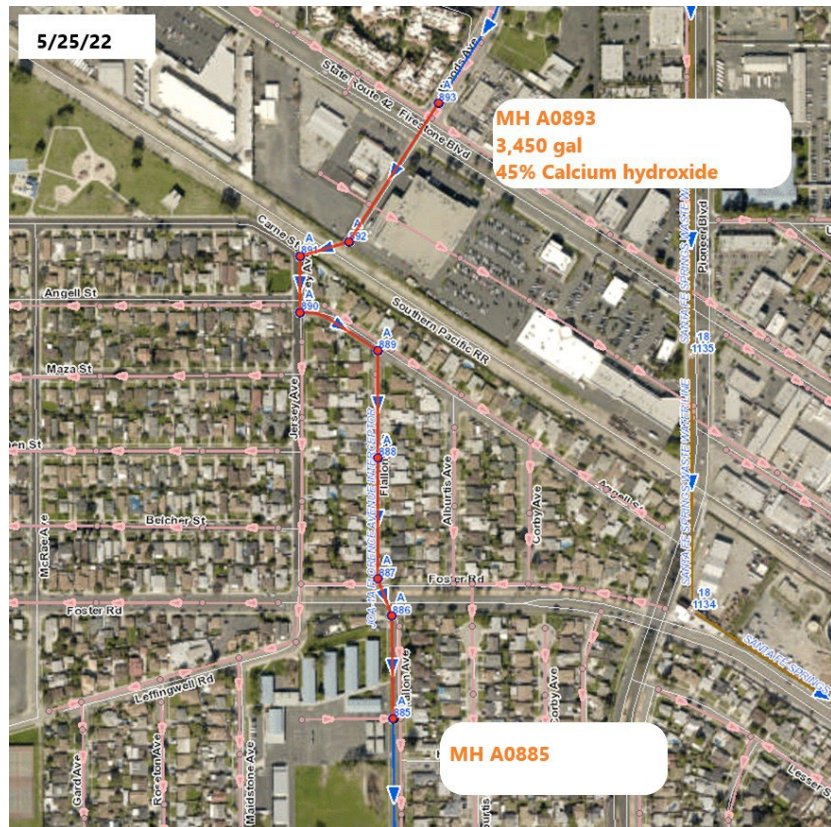
On Wednesday, May 25, 2022 at 1050 hours, Districts' sewer maintenance reported to the IW Section the presence of milky-colored wastewater with a "chemical" odor in the Florence Avenue Interceptor Trunk at manhole 18 A 0885 in Norwalk.

Figure 5: Annotated GIS map indicating the location of the observed milky-white colored wastewater with a chemical odor at MH 18 A 0885 and the location where calcium hydroxide solution is added at MH 18 A 0893 on a weekly basis to treat the J.O. ‘F’ trunk sewer line.

A review of the daily caustic dosing schedule by IW inspectors found that every Wednesday 3,450 gallons of 45% calcium hydroxide solution is dumped into manhole 18 A 0893 to treat the J.O. ‘F’ Trunk sewer via the Florence Avenue Interceptor Trunk. This is about a half mile directly upstream of manhole 18 A 0885 and was determined to be the source of the milky-white wastewater with a chemical odor that sewer maintenance crew reported. This information was conveyed to the Supervisor of the sewer maintenance crew and no further action was taken.

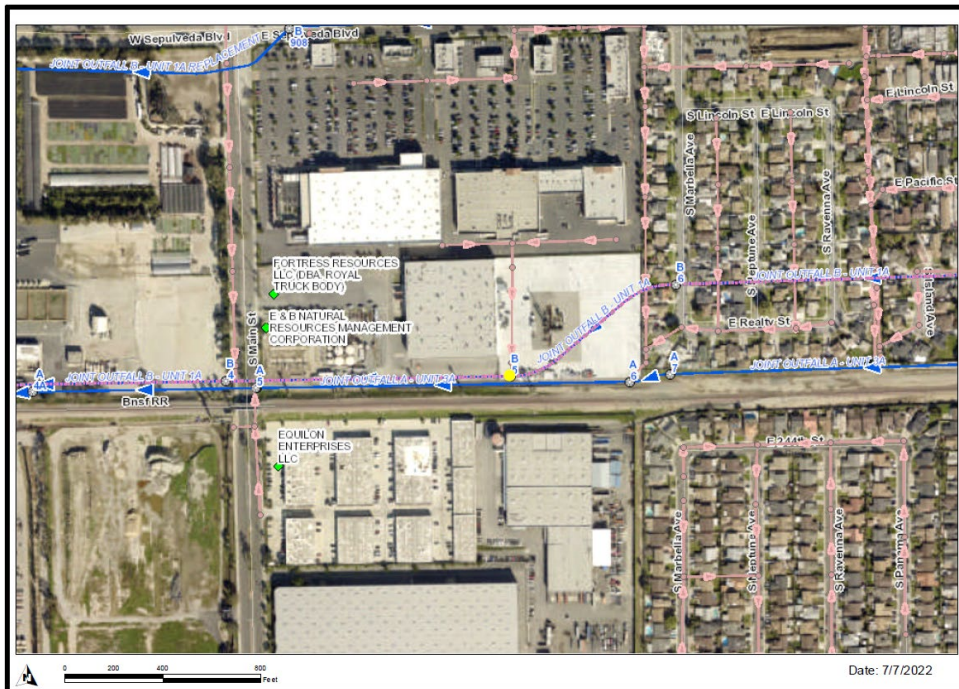
Figure 2: GIS map showing the location of MH B0005 and nearby permitted industrial wastewater dischargers.

IW inspectors investigated the lines but were unable to determine the origin of the lines or any history of their purpose. Dye testing of nearby buildings and facilities indicated no flows from those facilities went into any of the 3 lines in question. All three lines will be cut and capped by the Districts' construction crews as part of the ongoing rehabilitation project of the J.O. 'B' trunk line.

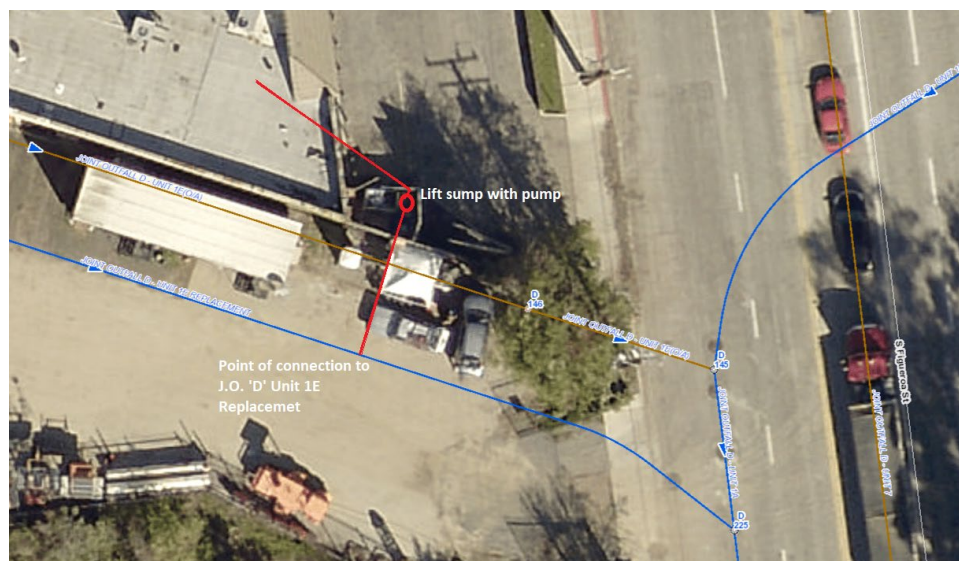
On August 9, 2022, investigating IW inspectors determined that the manhole where the possibly illicit discharge was occurring is not owned by the Districts, but instead is a private small sewage lift station that feeds into the adjacent Districts J.O. 'D' Unit 1E Relief Trunk sewer line about 75' upstream of MH D 0225 (See Figure 4). The lift station belongs to the plaza/strip mall property owner on the southwest corner of Figueroa Street and Sepulveda Boulevard. The lift station pump failed causing a back-up of sanitary sewage into the night club's restroom, which the plumber was hired to address. There was no evidence found of an illicit discharge; visual observation of wastewater in the lift station access manhole did not show that the wastewater there had any suspicious characteristics. The plaza, of which the nightclub is part, suffers from frequent plumbing back-ups due to failures of the lift-station pump. Further investigation by the IW inspection staff on August 10, 2022, determined that the lift station was again not operating properly, resulting in a small sanitary sewer overflow (SSO) from the lift station which was cleaned by a Districts' sewer maintenance crew. The plaza owner was notified of the lift station failure and repairs were made the following weekend. The lift station pump failed again on August 15, 2022, and another small SSO occurred. City of Carson Code Enforcement is now the lead agency on this situation, and they have been utilizing the Los Angeles County Department of Public Works as the primary responder for these further SSOs. The plaza owner is now aware that it is his responsibility to clean up the overflows on his property and to properly maintain the lift station.

Figure 4: Diagram showing the private lateral sewer line that flows from the strip mall/plaza to J.O. 'D' Unit 1E via a private sewer lift station.
