2016 ANNUAL REPORT

INDUSTRIAL WASTE PRETREATMENT PROGRAM

COUNTY SANITATION DISTRICTS OF LOS ANGELES COUNTY

APPENDIX H
INDUSTRIAL WASTE REPORTS ON INCIDENTS

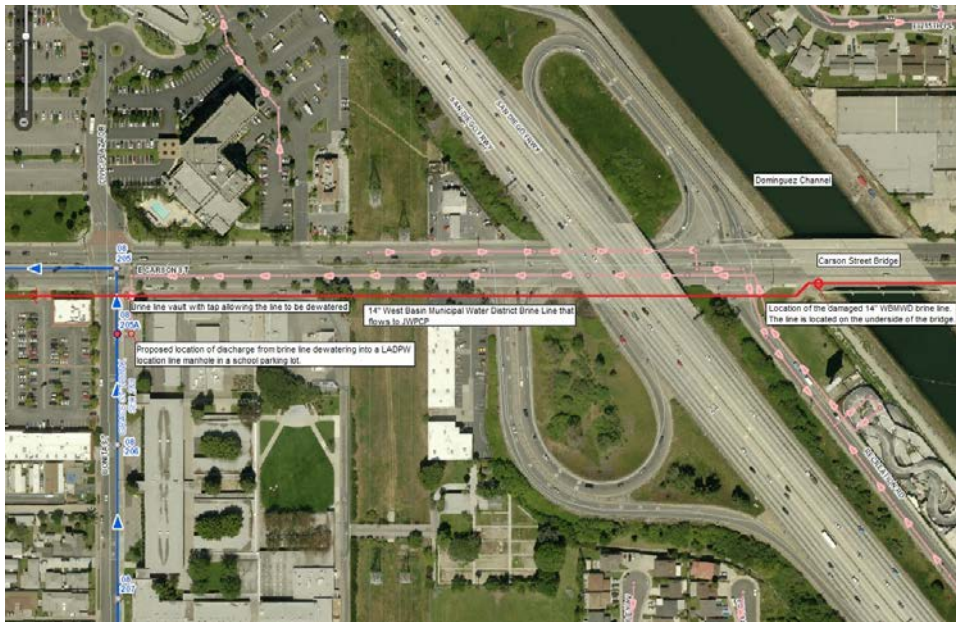
Figure 4: Diagram indicating the location of the damaged brine line and its proximity to the Grace Street trunk in Carson.

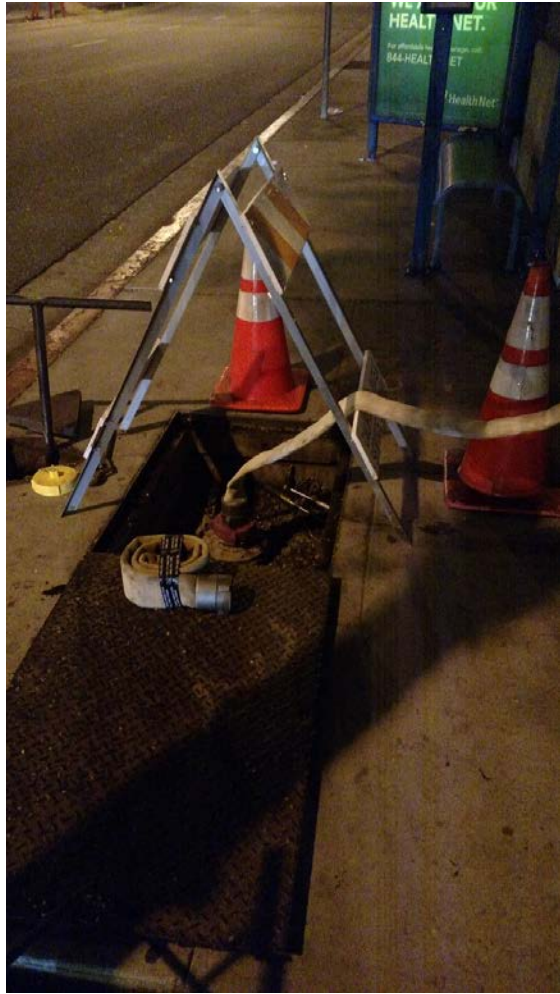
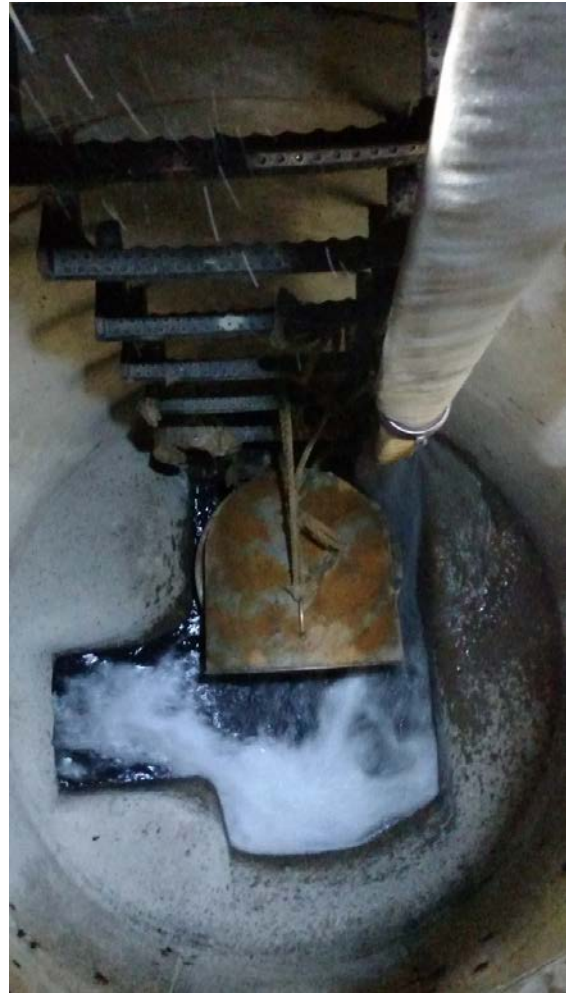
Figures 5 and 6: “Blow off” connection where a 3” diameter firehose is being used to tap into the water in the underground brine line and the same firehose line as it discharges into the local discharge line manhole. Note the absence of any surcharging.

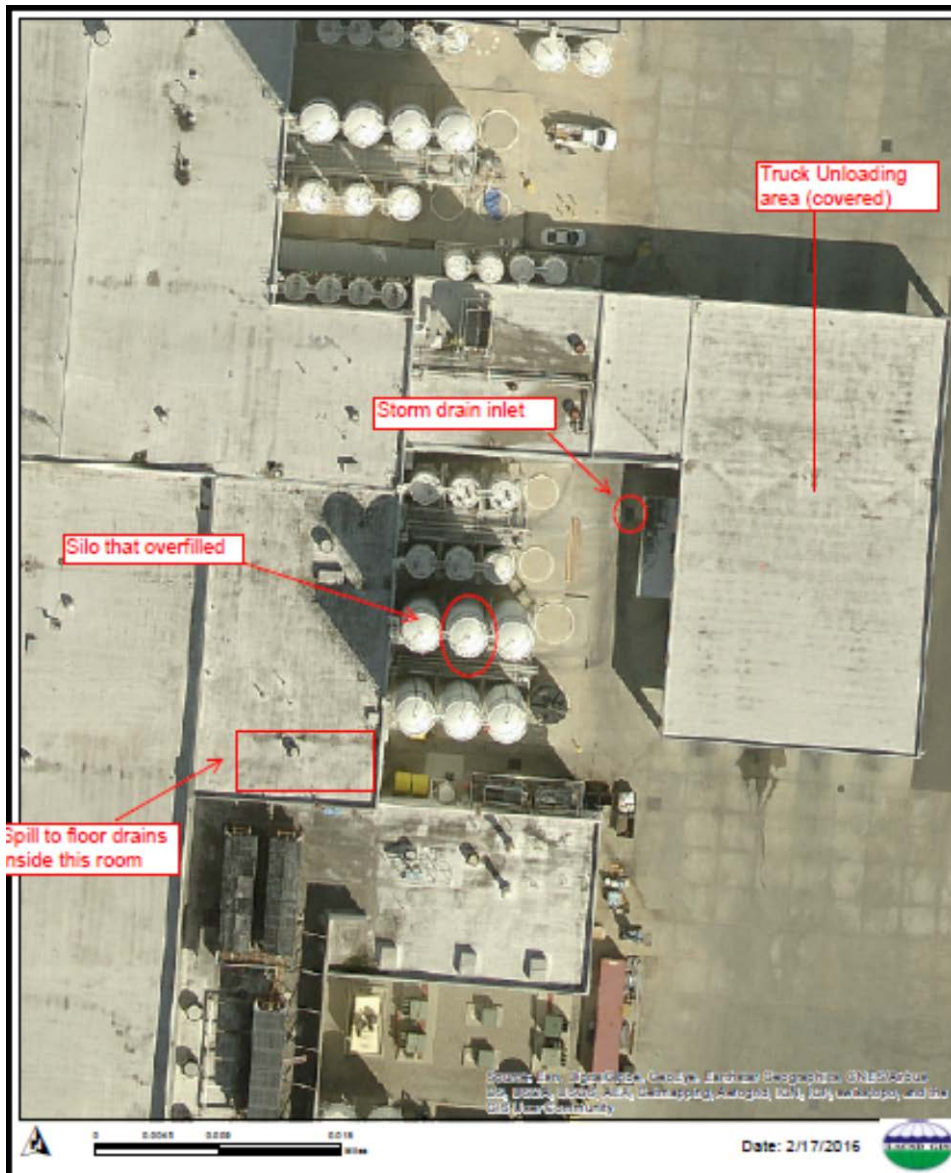
Figure 1: GIS diagram indicating location of the milk spill at the Alta-Dena Certified Dairy on 2-14-16.

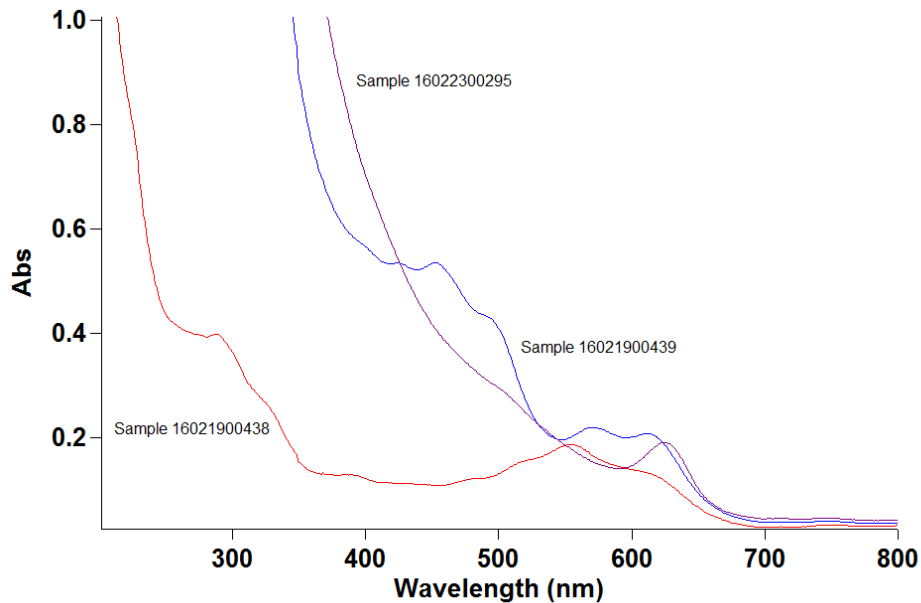
Figure 3: HPLC sample results comparing LCWRP final effluent forebay color extract sample (sample 16022300295) to samples taken at Tri-Star Dyeing and Finishing (sample 16021900438) and Shaw Diversified Services (sample 16021900439). Districts' laboratory analysts determined there was no definitive match in these results.

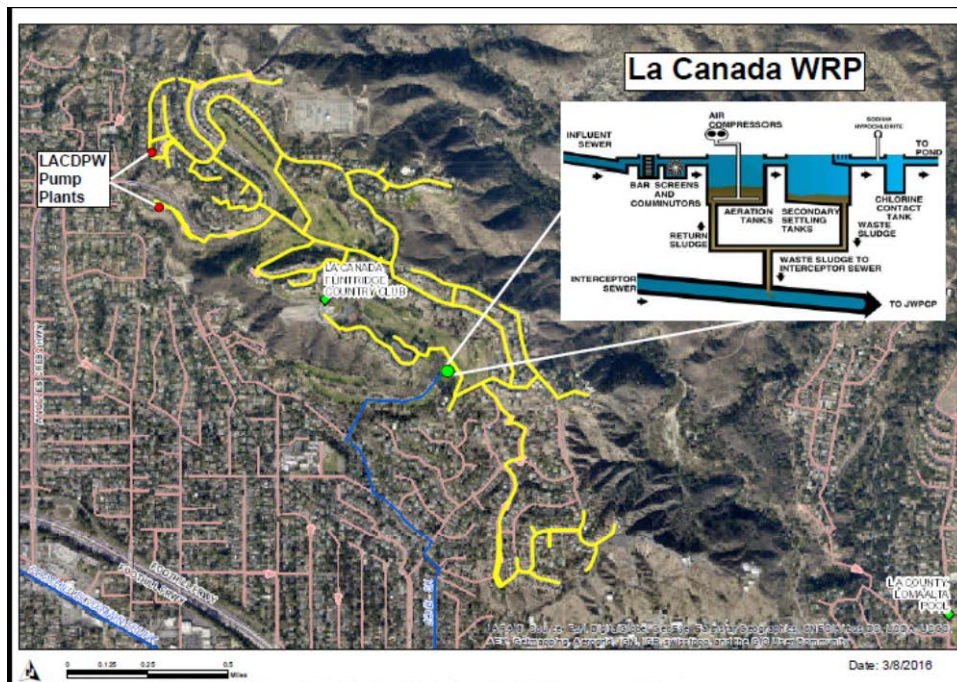
Figure 4: Sewer trace diagram indicating the area influent to the La Cañada WRP. Note that the area is essentially limited to approximately 425 residences surrounding the La Cañada golf course and the IW discharge permitted country club facility with a restaurant and large swimming pool associated with the golf course.

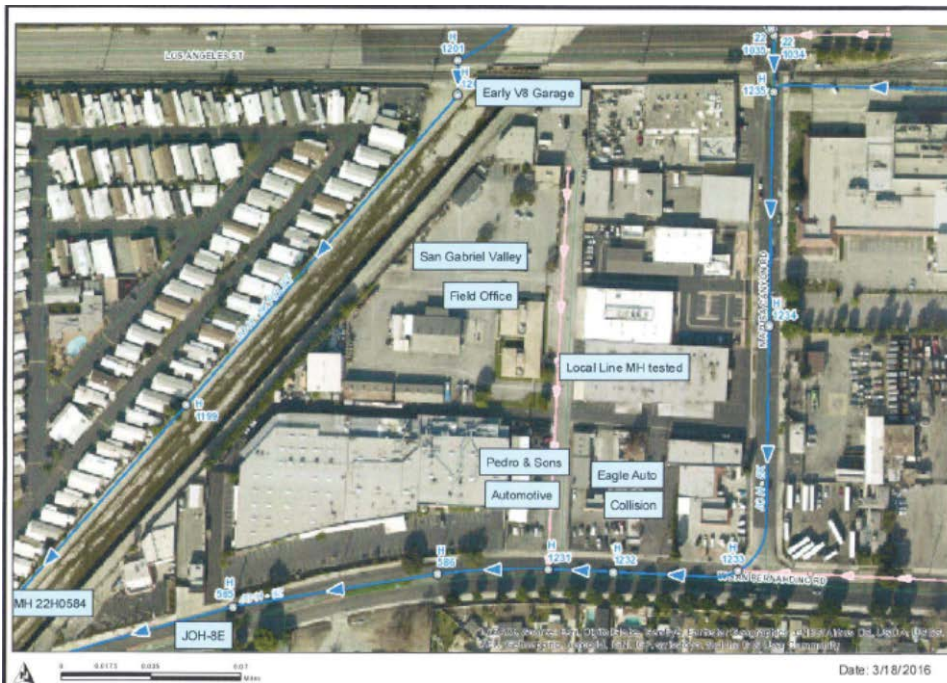
Figure 5: Area diagram showing the San Gabriel Valley Field Office in West Covina, as well as area sewer lines and nearby businesses that were considered potential sources for the diesel fuel odor reported emanating from shower drains at the SGVFO on the afternoon of 3-16-16.

Approximately 10 industrial and commercial users located near the SGVFO were inspected during the investigation. IW Inspectors did not note the presence of any unusual or diesel fuel like odors at any time during the investigation. No source for the odor reported was identified. It was noted during the investigation that there was a gas trap valve installed on the SGVFO sewer line where it joins the downstream local sewer line (see Figure 6). However, inspection of the valve found it had been wired open due to its having caused flow back-ups into the building. Unfortunately, wiring it open made it easier for sewer gas odors to make their way back into the building. Filling the shower drain line P-trap with water appears to have helped stopped sewer gases from getting into the building, thus addressing the immediate issue of foul odors entering the building's shower area.

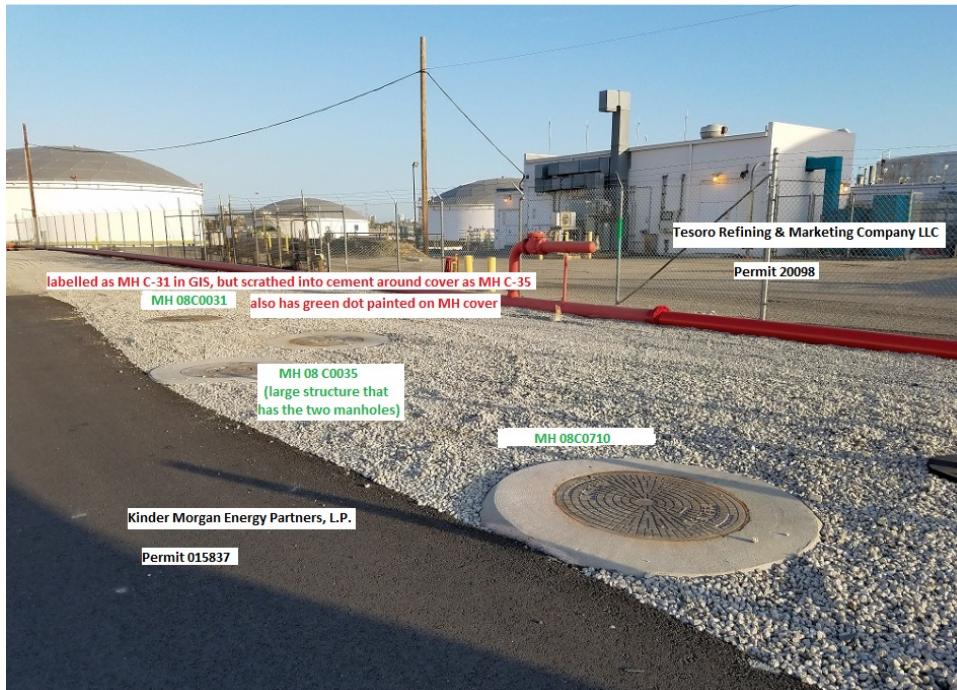
*On Monday, 4-4-2016, Albert Steele confirmed (via e-mail) with Night Team Supervising Team IW Inspector Barbara Jenkins that the reported MH C-35 with the high LEL was actually MH C-31 (See Figure 8 diagram below which indicates 4 manholes are located within a very small area, causing the confusion as to which manhole is which).

Figure 8: J.O. 'C' trunk sewer manhole cluster adjacent to the Tesoro Wilmington refinery outfall in Carson.

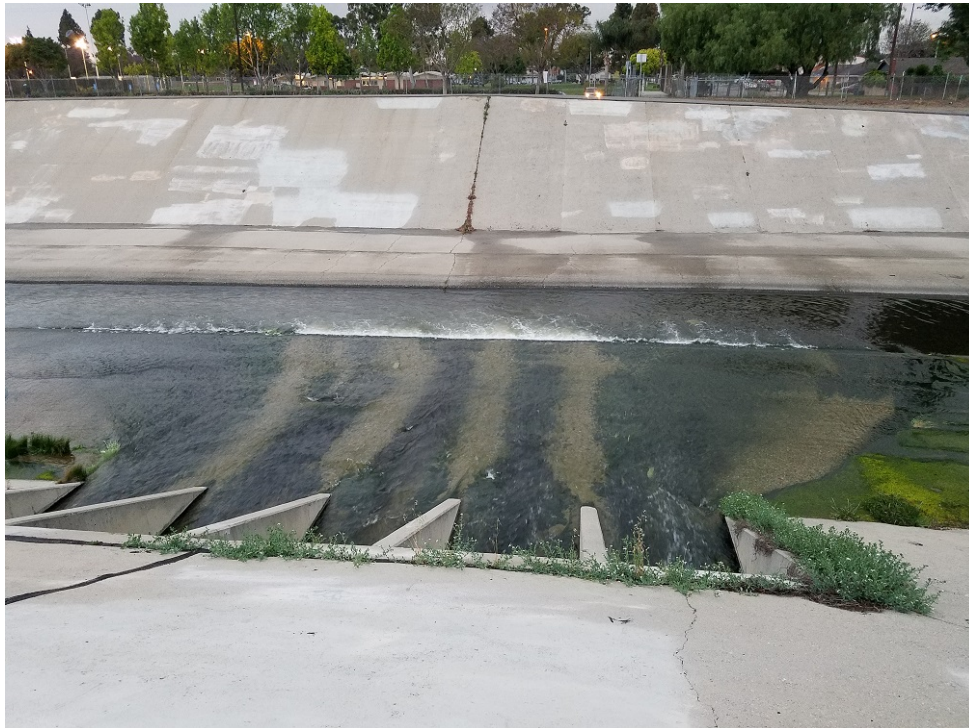
Figure 2: April 8, 2016, 7:11 pm photo of LCWRP entering the San Gabriel River. Note lack of foam.

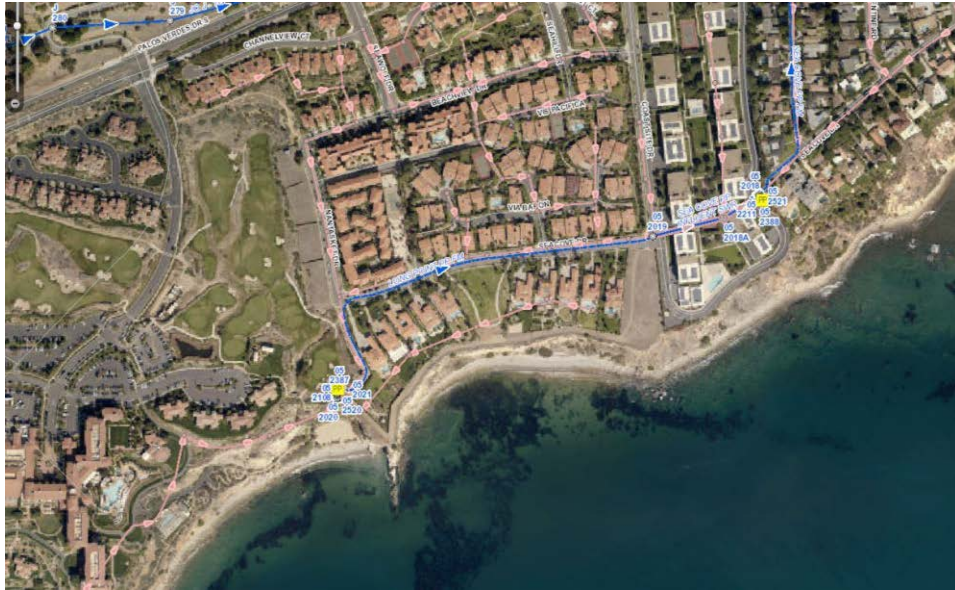
Figure 4: Geographic information system diagram/photo showing the Terranea Resort at the lower right corner of the photo and the adjacent Districts Pumping Plants (Long Point closest to the resort and Sea Cove further east).

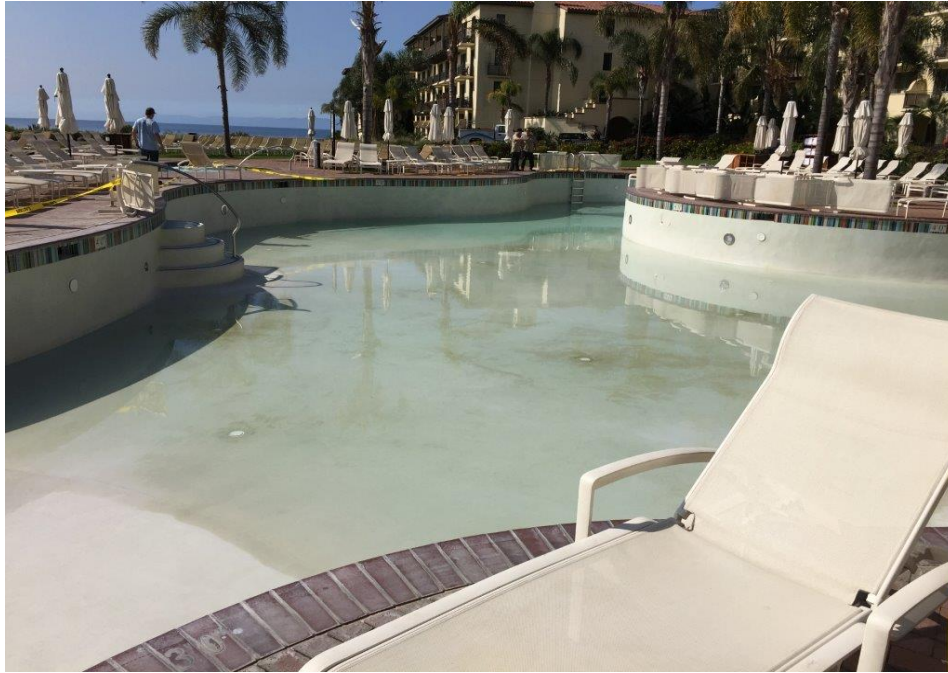
On April 12, 2016, Area IW Inspector Shawn Cleaver, as well as Team 3 Inspectors Tingting Wei and Chris Mendoza, conducted an inspection at the Terranea resort facility. Cleaver ultimately issued the facility a Notice of Violation for violating Districts' Wastewater Ordinance Section 305: Discharge of rainwater, stormwater, groundwater or any other uncontaminated or contaminated water without prior approval. It was determined that Terranea had discharged approximately 120,000 gallons of pool water to the sanitary sewer without an industrial wastewater discharge permit or prior Districts' approval. It was stated by Roye Mbarah, Director of Engineering at Terranea, that a resort guest had cut themselves on broken glass in the main pool on April 11, 2016. Resort personnel wanted to locate and remove the broken glass and decided they needed to drain the pool to do so, as the glass was virtually impossible to see through the pool's water column. As such, but not knowing what proper notifications to make, resort personnel pumped the pool water to the sanitary sewer using their existing pool cleaning equipment with the end goal of removing any broken glass from the emptied pool. During this process, the Long Beach Main Pumping Plant received excessive flow alarms at both Districts' Long Point Pumping Plant and Sea Cove Pumping Plant. At the direction of Districts' Pumping Plant Operator Armando Torres, Mr. Mbarah ceased the discharge of pool water to the sewer at 2100 hours on April 11 until off-peak hours that night. Terranea resumed discharge to the sewer at 2300 hours on April 11. On April 12, IW inspectors observed resort personnel pumping residual pool water into surface drains around the pool area that connect to the storm water system with no pool water being discharged to the sanitary sewer. As a point of interest, note that The Terranea resort is located on the land once occupied by Marineland of the Pacific on the Palos Verdes Peninsula. Marineland closed in February 1987.

Figure 5: Main Pool area at the Terranea Resort on April 12, 2016.

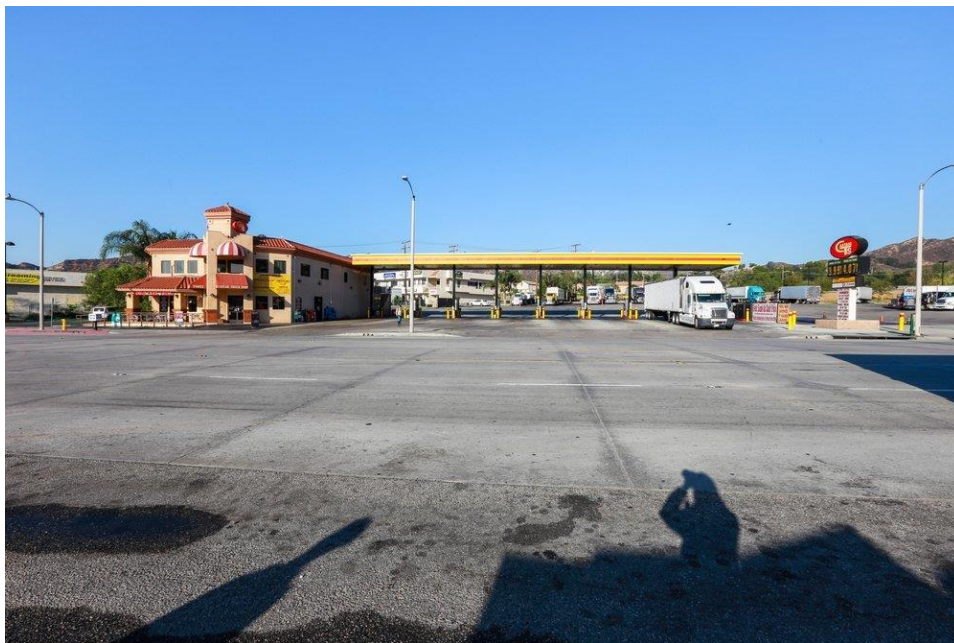
Figure 6: Castaic Truck Stop in Castaic, CA on April 14, 2016.

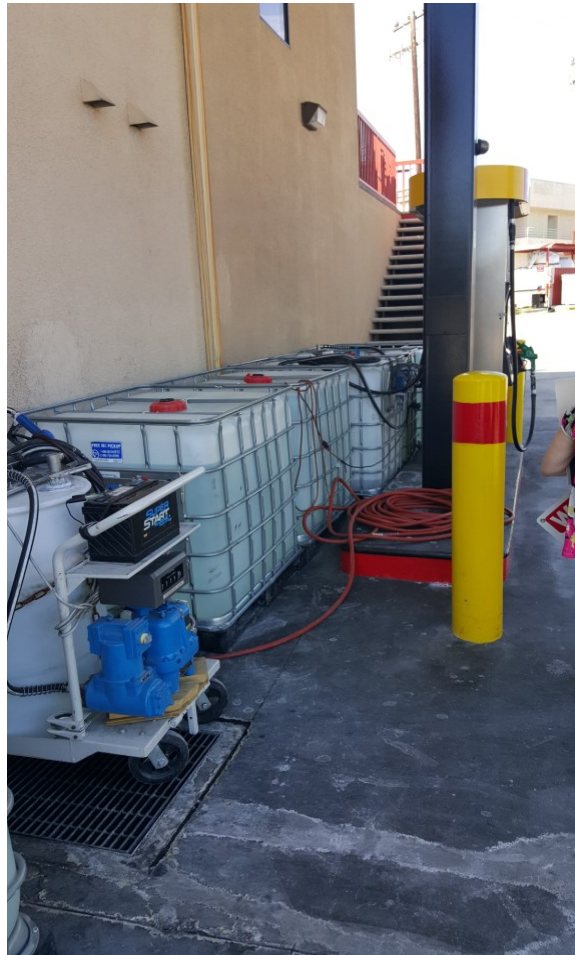
Figure 7: DEF storage tanks at the Castaic Truck Stop.

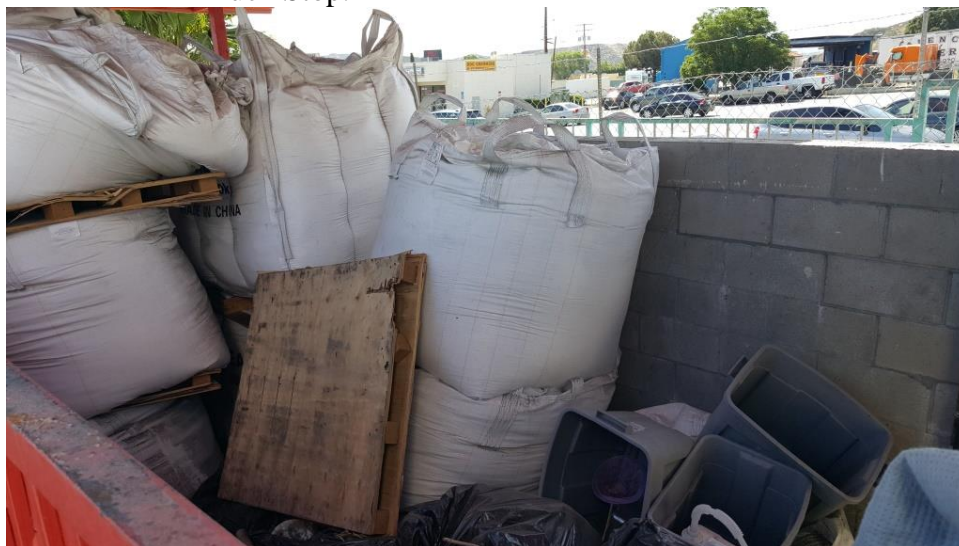
Figure 8: Large super-sacks of dry urea stored on-site at Castaic Truck Stop.

Senior IW Inspector Steve Sealy and Area IW Inspector Anie Kellzi investigated the tip on April 14, 2016. Their investigation found no evidence that DEF was being discharged to the sewer although it does appear DEF was being illicitly made and sold on-site. The tip appears to have been sent to multiple agencies. The owner stated he has been inspected by "everyone under the sun" including the Los Angeles County Department of Public Works (LADPW), and County building inspectors in the past weeks. The investigation revealed the facility has a previously undocumented recreational vehicle (RV) disposal station, which is required to be permitted both by the LADPW and the Districts. Per standard procedures, Kellzi issued the facility a permit for the disposal station and required that equipment deficiencies at the station be corrected. These

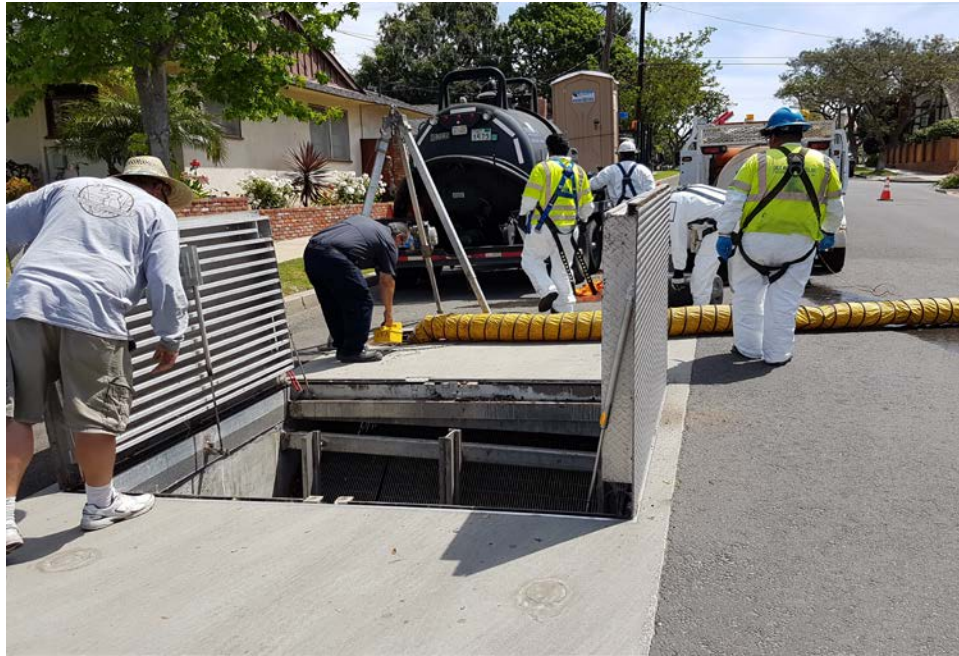
Figure 10: April 22, 2016 at 1129 hours. Ocean Blue Environmental Services contract crew cleaning up stormwater vault located just upstream of the Colorado Lagoon in Long Beach.

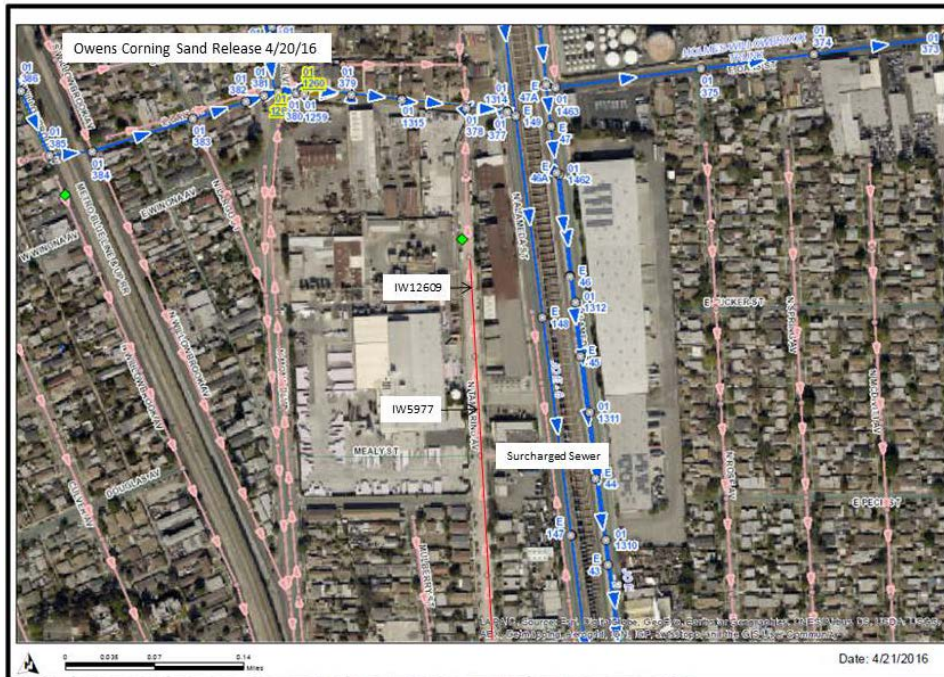
Figure 11: Districts' Geographic Information System diagram/photo of the Owens Corning Compton facility and nearby sewer lines.

Senior IW Inspector Bill Barnum and IW Inspector Shawn Cleaver arrived at the Owens Corning facility on April 20, 2016 at 1430 hours. The inspection determined that a long term accumulation of sand discharged into the sewer by the facility had gradually built up in the both in the company's own lateral and the downstream 8" city local sewer line. Approximately 6-8" of sand was noted in the local line manhole by Barnum and Cleaver. Fortunately there was no indication the local sewer was in danger of an immediate overflow. However, it took multiple direct calls by Barnum to Compton's sewer maintenance department to get them to take action to clean the local sewer line. This was eventually completed by the evening of April 22, 2016. The several cubic yards of sand removed from the local sewer line was hauled to the JWPCP grit collection area for drying and disposal (see figure 12 below). Inspectors found no evidence of any sand accumulation in the Bullis Road-Temple Street Relief Trunk. The cause of the long term accumulation of sand in the sewer lines was determined to mostly be due to the fact that the company never installed a cyclone separator unit designed to remove sand from the industrial wastewater discharge. The cyclone separator was intended to assist the current sand interceptor in removing granules that are typically in the wastewater from the roofing shingle manufacturing process. The separator was required to be installed in 2005. Inspectors were unable to determine why the installation was not completed, but the actual separator unit was found mothballed on-site. Company managers said they would install it as soon as possible to mitigate the sand accumulation issue. Owens Corning was issued two violation notices for sections 309 and 412 of the Ordinance for causing excessive sewer maintenance and failing to install required pretreatment equipment. The city was able to remove all the sand from the local sewer but it is uncertain if they will seek compensation from the company for the work. There was no surface spill caused by the blockage and there was no impact to the Districts' collection system. Note that Night Team IW Inspector Kristopher McGinnis also participated in this investigation by standing by at the Owens Corning facility for several hours on the evening of April 20, 2016 as insurance in case any local line sewer surcharging or overflows were to occur.

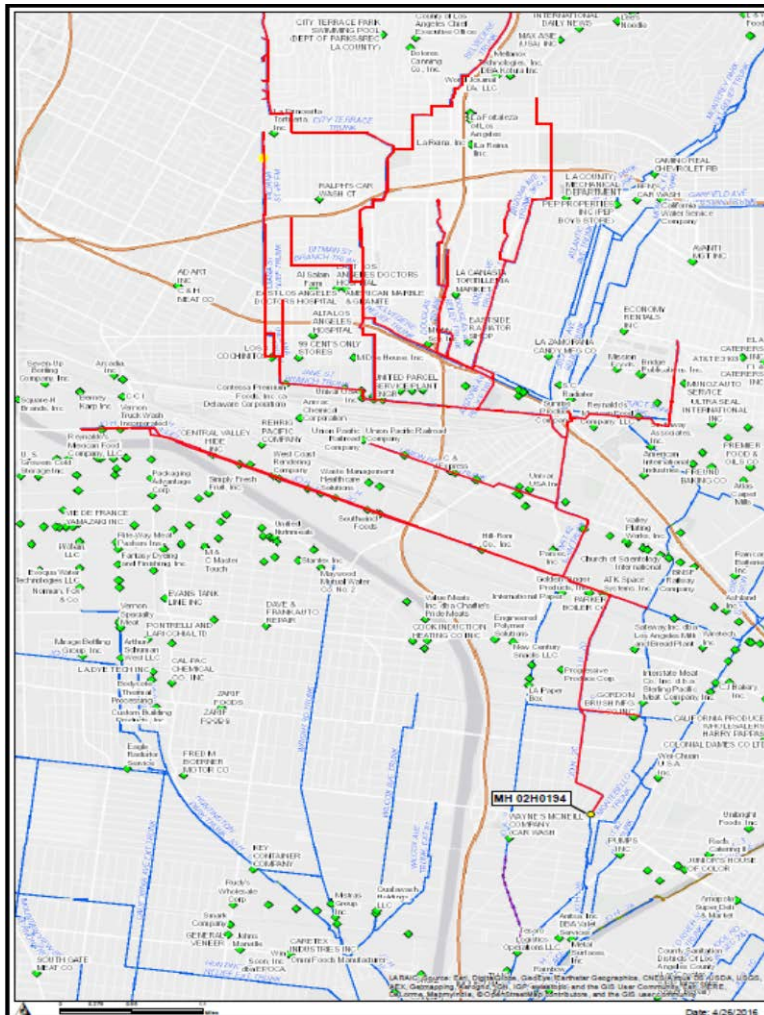
Figure 13: Districts' Geographic Information System diagram indicating the extensive area upstream of MH 02H0194 which contains many permitted large industrial wastewater dischargers.

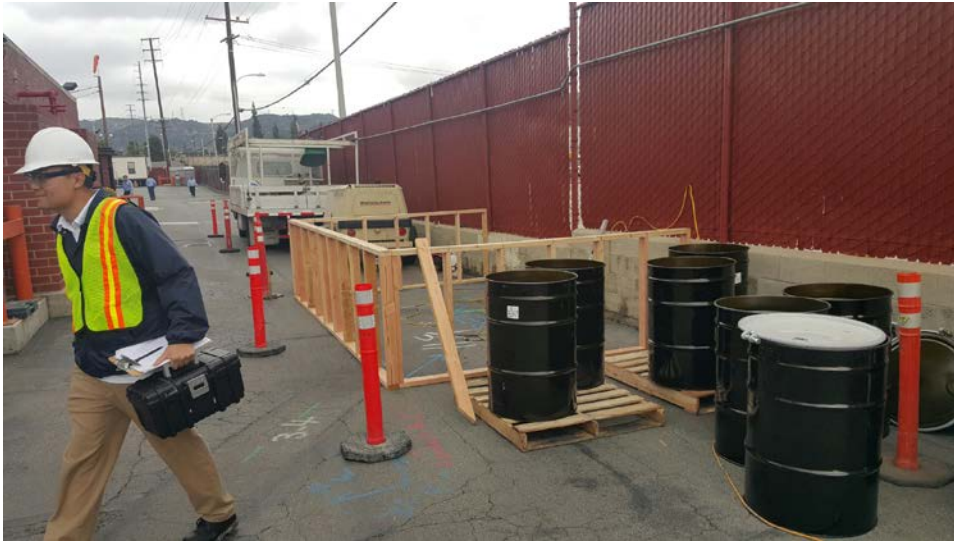
Figure 1: IW Inspector Nguyen Dang at the Quemetco sewer excavation site on 5-5-16 prior to excavation commencing.

A site inspection at Quemetco, Inc. was conducted on 5-5-16 at 0930 hours by Senior IW Inspector Steve Sealy, Area IW Inspector Nguyen Dang, and IW Inspector Tanna Pekin. The inspection found that the sewer blockage and repair at the Quemetco facility reported by AQMD was for a sewer lateral on the west side of the facility containing only sanitary wastewater and away from any industrial operations. Workers indicated that the blockage was caused by dirt and debris in the line that was unrelated to industrial wastewater discharge at the facility. Portable toilets were used during the repair and minor amounts of shower and hand washing wastewater were rerouted to another discharge line. No industrial operations including discharge of the treated industrial wastewater were affected by this incident.

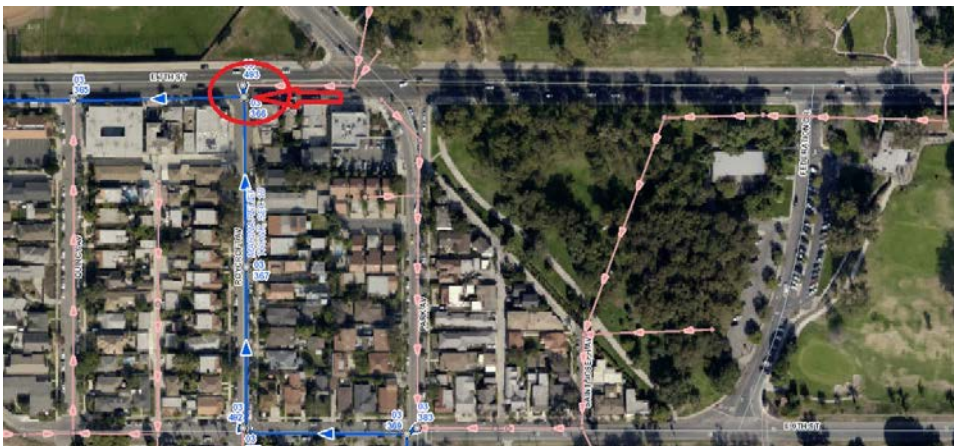
On Wednesday, 5-11-16 at 1135 hours, Compton Field Office Supervisor of Sewer Maintenance William Foley contacted Supervising IW Inspector David Sanchez. Foley notified Sanchez of a heavy grease blockage encountered by a Districts' sewer maintenance crew in the Marina Relief Trunk, Section 1B, at the intersection of 7th and Roycroft St., in the City of Long Beach. Foley informed Sanchez that City of Long Beach Water Department inspectors were also aware of the grease finding and may be conducting their own investigation.

Figure 2: Geographic Information System diagram showing location of the grease.

Senior IW Inspectors Andy Woods and Kent McIntosh, as well as Area IW Inspector Sanjay Patel, investigated the report. Inspections at four oil field operations upstream of the greasing location found no evidence that any contributed to the grease incident. Based on its appearance the grease was determined to be essentially cooking grease likely from restaurant or residential sources in the area. Additionally, Foley subsequently reported his crew

had also found sand, concrete pieces and sewer lining fragments in the sewer location previously reported to have the heavy greasing present. Foley said he now believed there was some sort of structural damage to the sewer line and that the grease reported earlier was probably of a normal amount that had adhered to the debris in the line over time. As a result, Foley changed his assessment from being a problem from unknown discharger(s) putting excessive amounts of grease into the sewer to a line in need of repairs. He said he intended to notify Districts' engineers of his findings. As such, IW Inspectors conducted no further investigation of the report.

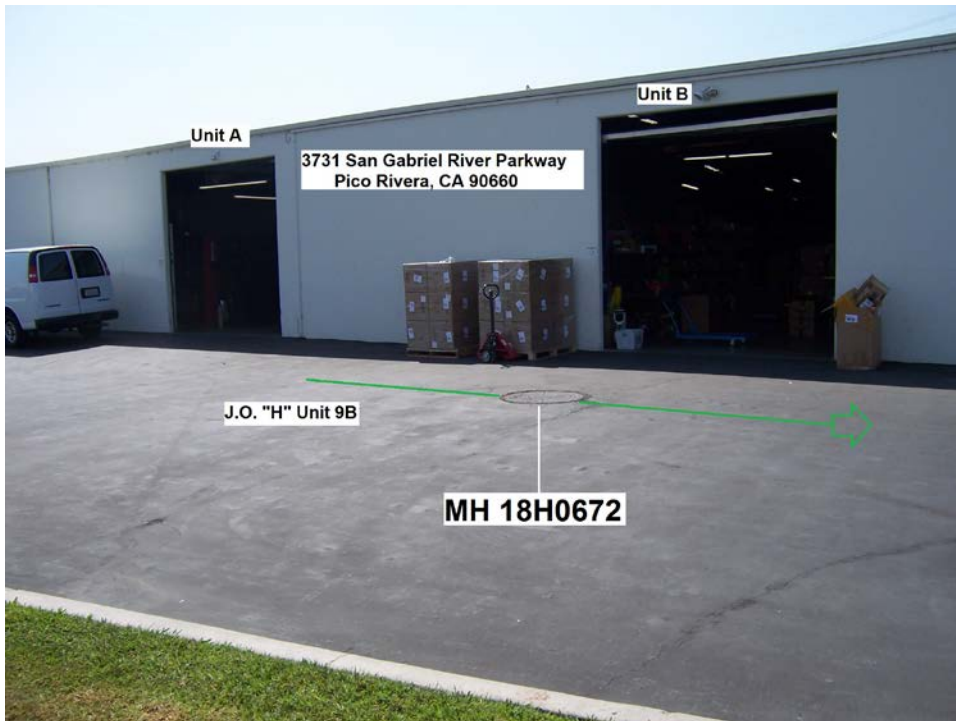
presence of the foul odor, which appeared to be coming out of the MH H0672, as well as other upstream manholes on the line. The crew corked and sealed a number of these manholes in an attempt to resolve the issue, but a second call from the same citizen reporting the odor again came in at 0900 hours on 6-13-16, which resulted in the second visit to the site by the crew documented above. Balas added that it appeared the odor was not only coming out of the manholes, but also out of cracks in the street pavement above the line. Balas said the crew had taken a sample of the flow in the line. The sample contained the foul, heavy sulfide odor noted above and was also purple colored, though it was unclear if the purple color was related to the foul odor. Balas stated that MH 18H0678 was a siphon structure downstream manhole with 18H0679 being the upstream manhole on the siphon. He said this location has previously had strong foul odors noticed during semi-annual cleaning events, but his crew reported the odor now was well beyond what they had previously noted. Balas said he was having the crew standby at MH 18H0679 in the hope that IW Inspectors could come by to help investigate the cause of the odor and color. Boyd contacted North teams Supervising IW Inspector Dave Lee, who coordinated the response.

Figure 2: Location of MH 18H0672, note its close proximity to the adjacent business. The manager of this business was the reporting party for the odors.

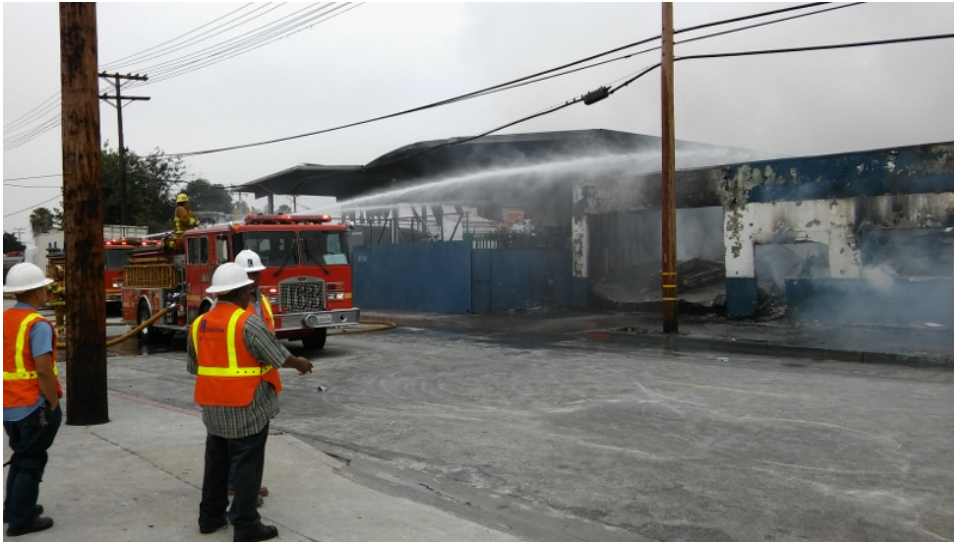
Figure 5: L.A. County firefighters pour water on the 6-14-16 fire at Panda International Trading Company in Maywood.

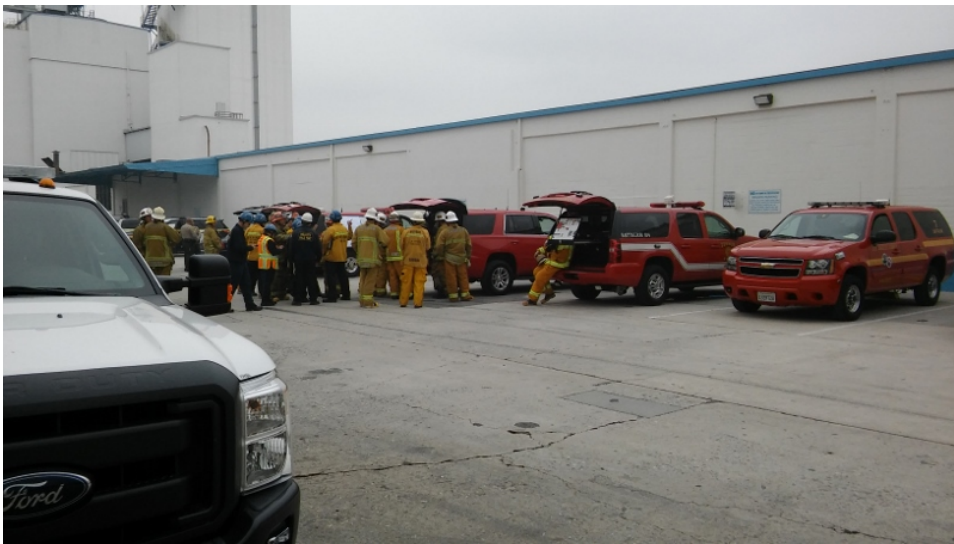
Figure 6: L.A. County firefighters and hazardous materials specialists convene at the incident command center on 6-14-16 to discuss ongoing issues related to the possible presence of hazardous materials at Panda International Trading Company in Maywood.

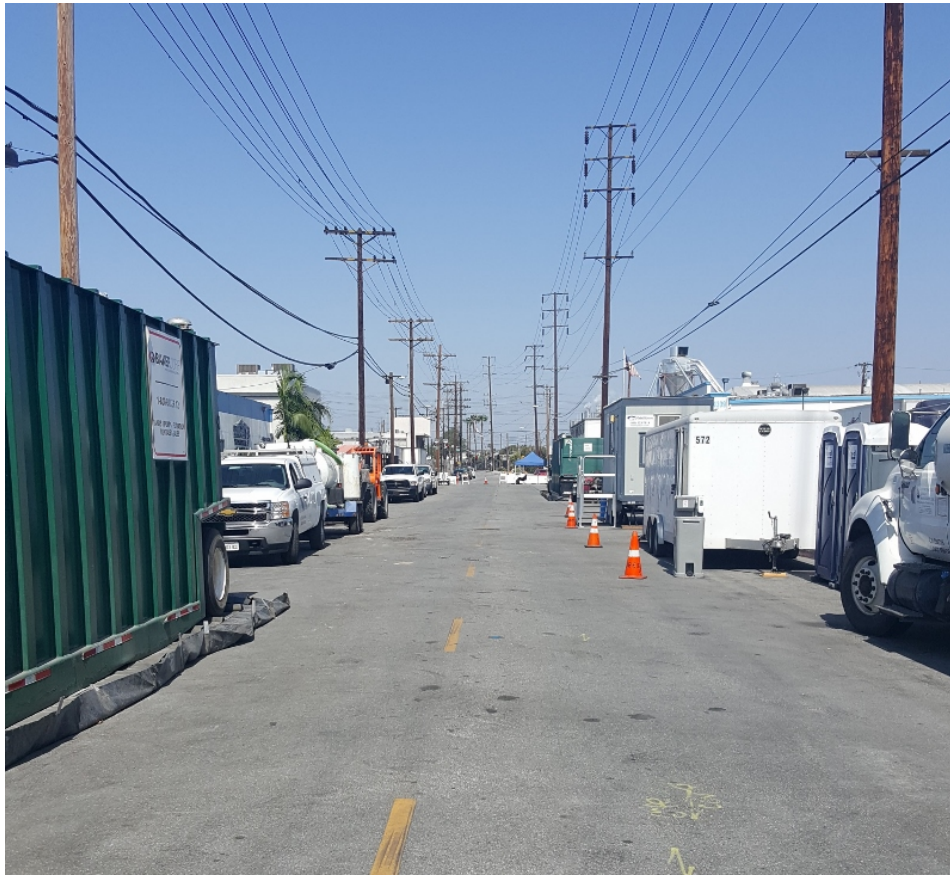
Figure 7: June 23, 2016 photo of two Baker tanks being used to store “clean-up” water generated as a result of the 6-14-16 fire at Panda International Trading Company in Maywood.

Firewater generated from initially fighting the fire and protecting nearby structures flowed to the storm drain and nearby Los Angeles River. According to EPA responders there was no requirement made to collect this water and it was allowed to flow to the ocean in Long Beach. However, a total of about 30,000 gallons of “clean-up” water subsequently generated from washing down nearby homes and structures, as well as what was left of the facility that burned, to remove possibly heavy-metals contaminated ash was collected in two Baker tanks

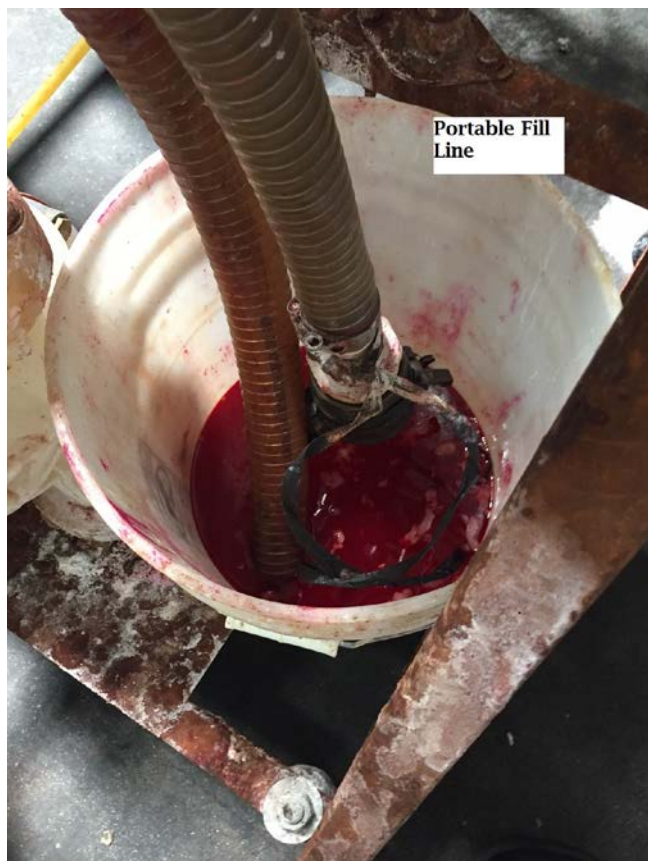
The investigation, which included Woods, as well as IW Inspectors Traci Stahl and Jason Finn, determined that the source of the red color was Orange County Chemical Supply (OCCS) located in Santa Fe Springs. Stahl's initial inspection of OCCS on 6-16-16, as well as a joint second inspection of the facility with Finn later that same day, noted the company uses dyes to make various colored carwash wax foams, detergents, shampoos, and related materials used in automated car wash machines. The dyes can be brightly colored and despite company claims that none of the dyes were discharged into the sewer, the inspections found conclusive evidence that significant amounts of highly pink colored waste had recently been discharged through the company's industrial wastewater sample box to the sewer (see photos below). Subsequent GC/MS analysis of samples of pink dyes taken at the company during the inspections indicated the dyes matched the dye present in the primary effluent sample taken earlier by WRP operators. The company was unwilling or unable to provide explanation as to why or how the discharge of the highly colored material had occurred. A Notice of Violation was issued to the company for the discharge of highly colored waste which impacted the downstream WRP (Section 406V of

Figure 9: Residual pink solution in fill-line bucket at OCCS on 6-16-16.

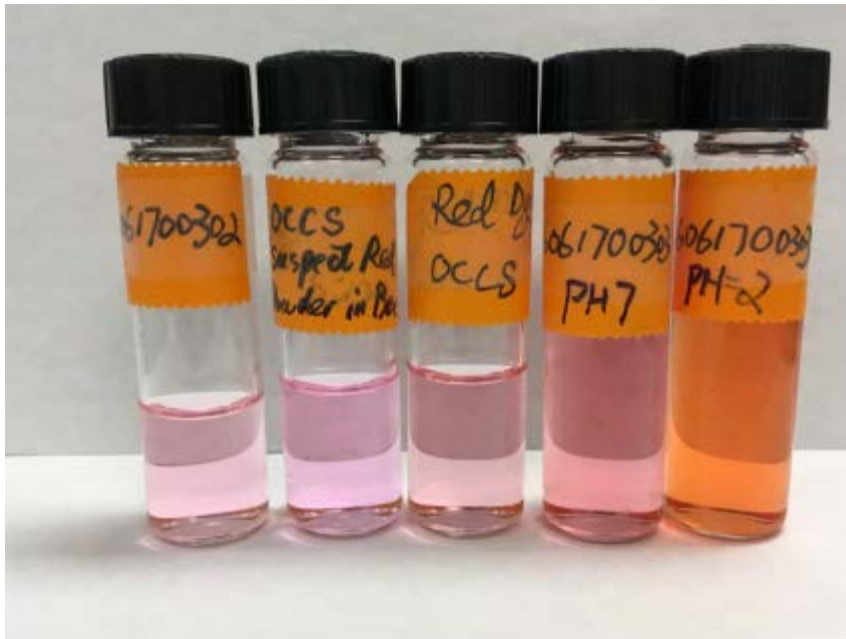
Figure 12: Laboratory photo of the SPE methanol eluent from Los Coyotes WRP primary effluent sample 16061700302 taken on 6-15-16 (the first vial on the left), as well as methanol solutions of red dyes found and sampled by IW Inspector Stahl at OCCS on 6-16-16. GC/MS analysis indicated matches for the dyes taken at OCCS with the WRP sample.

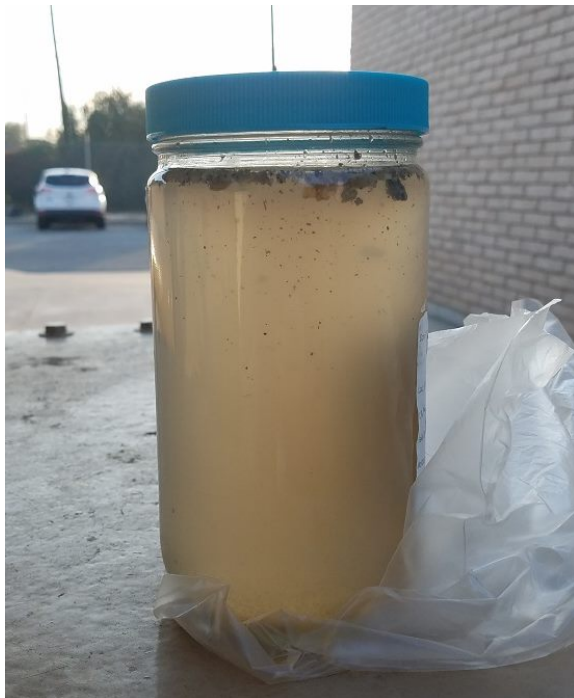
On Tuesday, 6-28-16 at 1650 hours, Los Coyotes WRP TPO II Rudy Fernandez called Supervising IW Inspector Barbara Jenkins and reported that a reddish color was just found in the first quarter of the primary tanks. No color was observed at the primary influent pH box or the rest of the primary tanks. It was estimated that this colored "slug" discharge entered the plant at 1600 hours. The pH was again normal at 7.0 and no unusual odors were noted. WRP operators took samples for IW inspectors to pick up.

Figure 13: Los Coyotes WRP colored primary sample taken on 6-28-16.

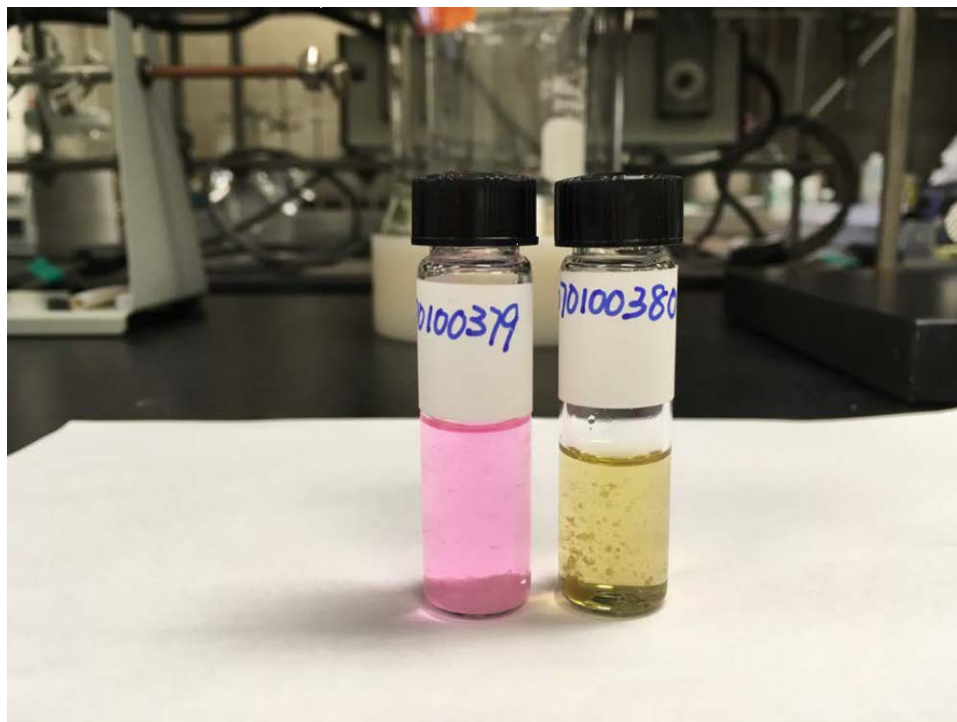
pink wastewater in their sample box and pink-colored product in filling equipment on-site. Grab samples were again taken from the company and submitted to the lab, along with the pink LCWRP primary sample, for GC/MS analysis. Districts' laboratory staff performed the analyses and provided a report which indicated the dye in the wastewater from the OCCS samples did not match with the color observed at LCWRP (see Figure 14). LCWRP operators only observed the color in the primary tanks and WRP operations remained normal. The IW investigation was unable to determine the source of the color for this incident.

Figure 14: Laboratory photo of the SPE methanol eluent from Los Coyotes WRP primary sample on 6-28-16 (on the right), and the methanol solution of red dye from a sample taken at OCCS on 6-29-16. GC/MS analysis indicated the samples did not match.
