2016 ANNUAL REPORT

INDUSTRIAL WASTE PRETREATMENT PROGRAM

COUNTY SANITATION DISTRICTS OF LOS ANGELES COUNTY

APPENDIX H
INDUSTRIAL WASTE REPORTS ON INCIDENTS

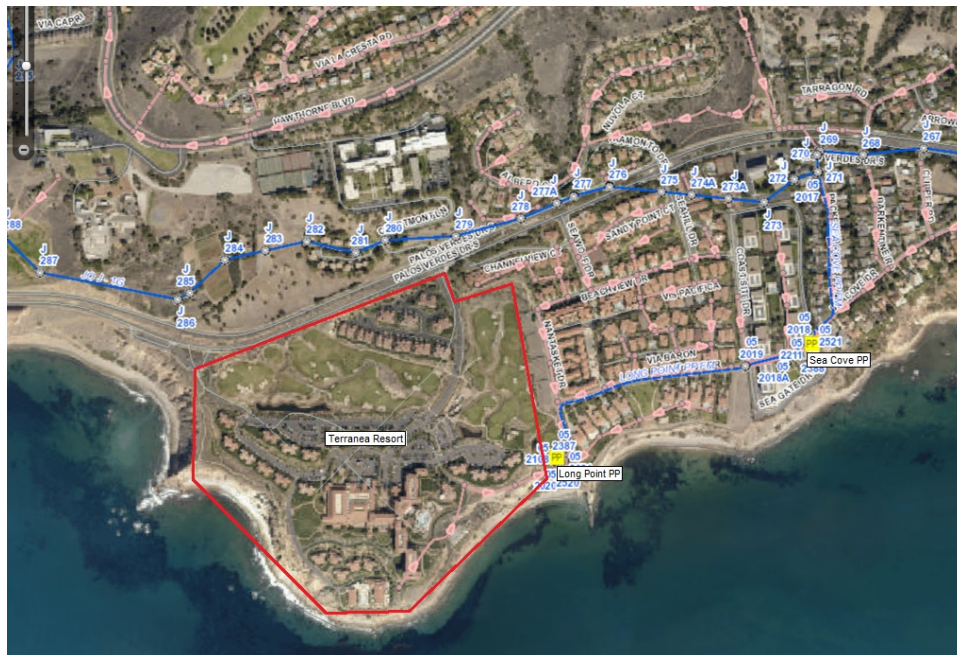
On Thursday, 6-16-16 at 0720 hours, Long Beach Pumping Plant Alarm Center Operator Carlos Moreno called Supervising IW Inspector John Boyd and reported that at 2252 hours the previous evening LBPP alarm center operators had noted a "control failure" alarm at the Sea Cove pumping plant in Rancho Palos Verdes. Such an alarm occurs when the backup pump at the pumping plant activates, generally indicating either the primary pump has failed or so much flow is coming into the plant, that in order to keep up, both pumps have come on. Moreno said that knowing the location well and its proximity to the Terranea resort, Districts' Pumping Plant Operator Martin Ramirez called the Terranea resort directly at 2330 hours and spoke with facility Engineer "Justin" (310-494-7891), who confirmed that the resort was in the process of draining one of their large pools for maintenance purposes. Ramirez ordered the resort to reduce their discharge rate. Moreno said he was calling the report in to make Industrial Waste section staff aware of the event in case they were concerned about "any chemicals" that might be in the pool water. Boyd conveyed the information to Supervising IW Inspector David Sanchez. Boyd and Sanchez agreed follow-up by IW Inspection staff was needed and would likely include enforcement action being taken against the resort for the discharge, which clearly impacted pumping plant operations and was done without obtaining prior approval from the Districts. This is the second high flow event from draining a pool at the Terranea resort facility that has occurred in about the last 2 months. The initial event occurred on 4-11-16. Note that the Districts' pumping plant immediately downstream of the Terranea facility is not the Sea Cove PP where the control failure alarm occurred on 6-15-16, but actually the Long Point PP. However, the Long Point PP was significantly upgraded several years ago and had the ability to handle the flow from the Terranea facility pool draining without alarming on the evening of 6-15-16,

whereas the Sea Cove PP, which is scheduled for upgrading, could not. This explains the alarm occurring at the Sea Cove PP and not the Long Point PP.

Figure 15: GIS photo/diagram indicating the location of the Terranea resort, as well as the Districts' Long Point and Sea Cove pumping plants on the Palos Verdes Peninsula.

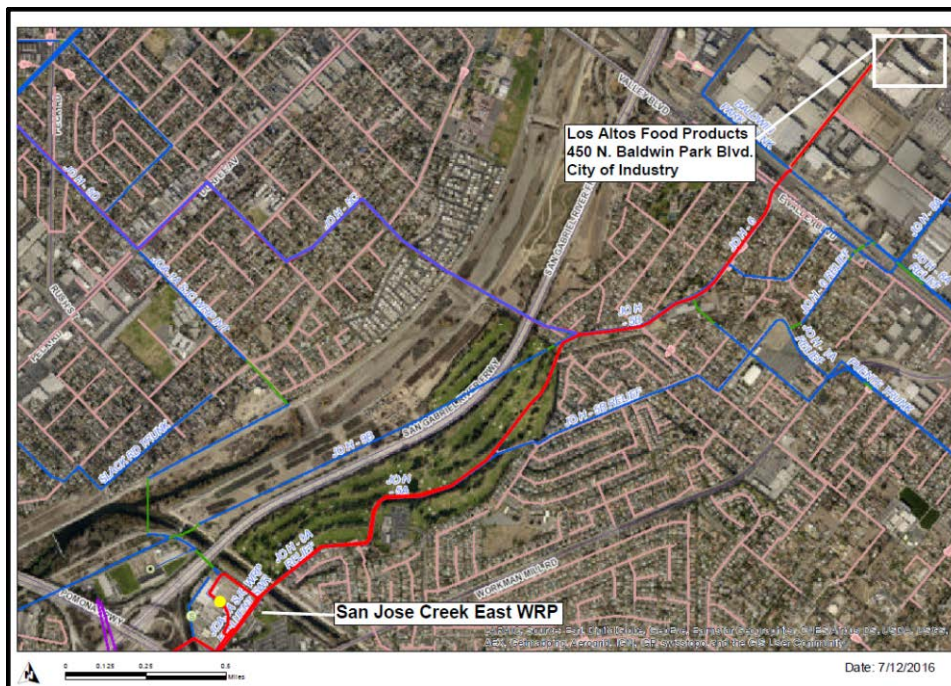
Figure 1: GIS map showing the location of the Los Altos cheese plant and its location about 3.5 miles upstream of the SJC-East WRP.

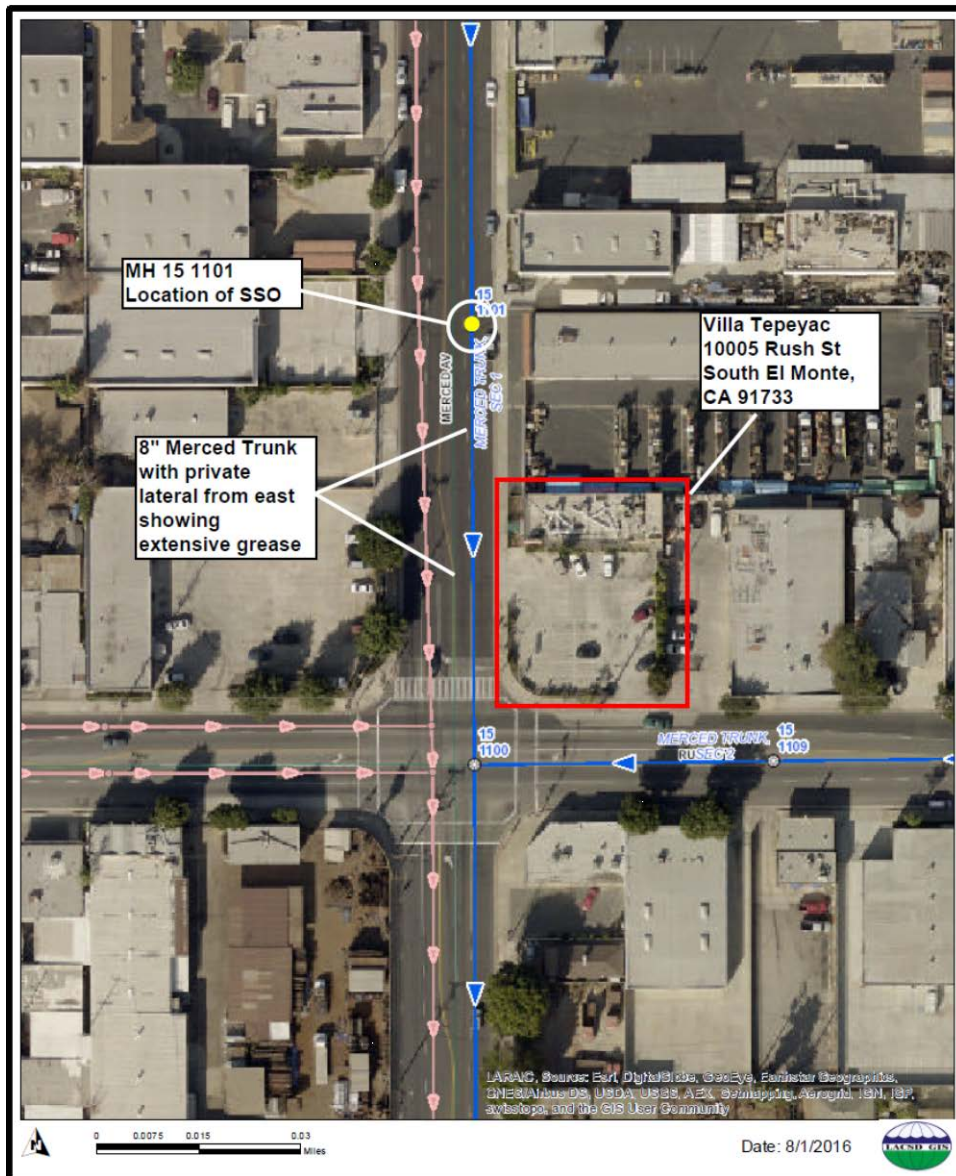
Figure 1: Districts' GIS diagram of the SSO location in South El Monte.

The investigation, led by area IW Inspector Jim Percy, determined that the likely source of the grease which caused the SSO was the Villa Tepeyac restaurant. A joint inspection of the restaurant conducted on 8-2-16 at 1330 hours carried out with the local sewer agency contractor inspector, Jose Rodriguez of John Hunter and Associates; found that the restaurant lacked a grease interceptor on its wastewater discharge line. Additionally, the inspection found its likely employees were only partially following established and required procedures to control the discharge of grease into the sewer. The restaurant will be required to install a grease interceptor and implement all required grease control procedures.

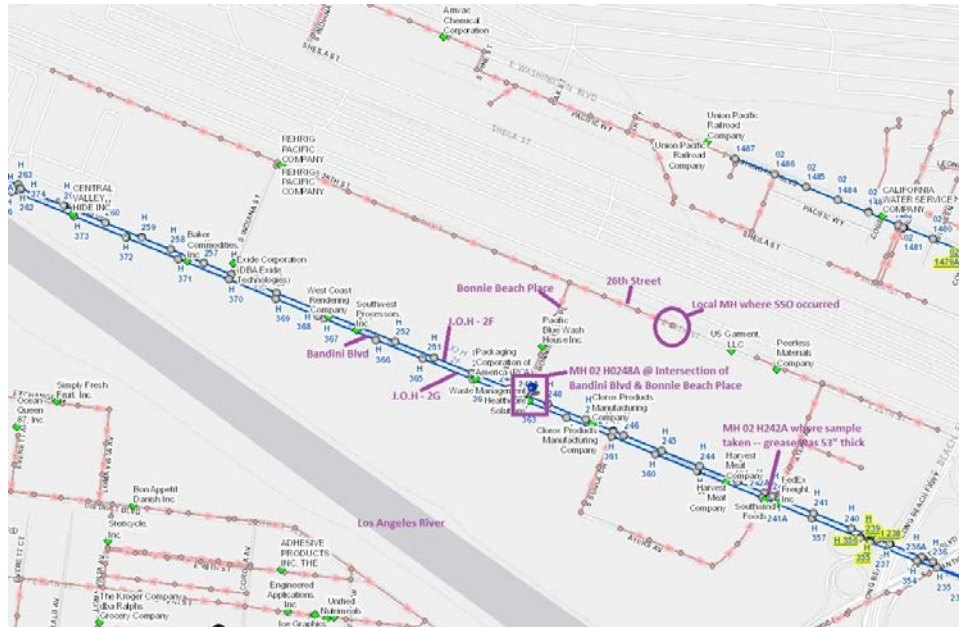
Figure 4: GIS diagram of the SSO location in the City of Vernon.

Additionally, day team IW inspectors led by Senior Steve Sealy also responded the next day. The overflow occurred at a local line manhole located near 4366 E. 26th Street just east of Bonnie Beach Place and north of Bandini Boulevard (see Figure 4). Initially a city of Vernon sewer maintenance crew, led by Elias Zepeda, responded to the SSO report and attempted to berm the area. By 1600 hours the flow from the sewer had increased greatly, overwhelming the berms, allowing an estimated 10,000 gallons of sewage to reach the storm drain system and Los Angeles River. The Districts' Albert Steele, Supervising Engineering Technician, and his crew, who were part of the Districts' response teams called to the scene, proceeded to the Los Angeles River channel where the storm drain would discharge the SSO wastewater should it be reached. A sand bag berm was constructed on the northeastern edge of the river, which subsequently was able to successfully contain the relatively limited amount of SSO material that did reach there and prevent it from entering the River's main channel (see Figure 5).

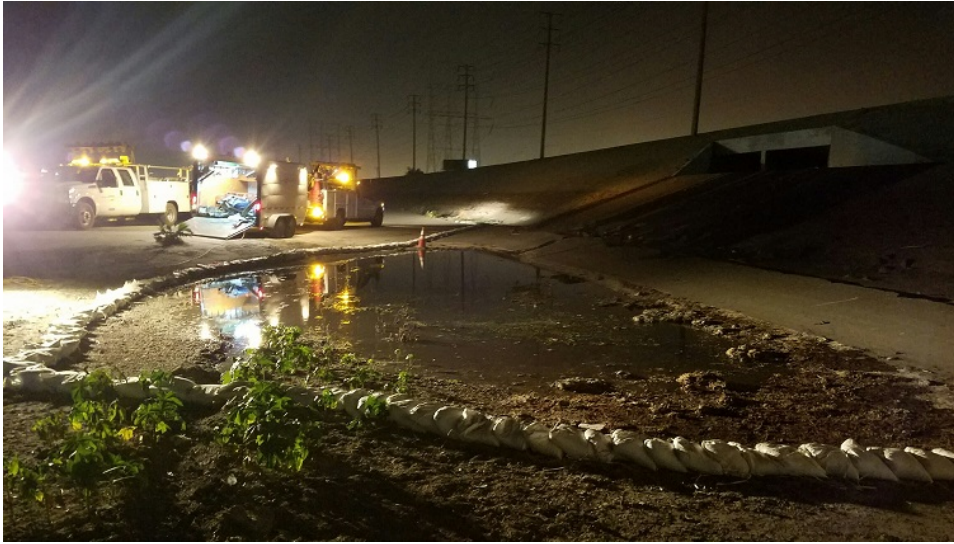
Figure 5: Districts' crew from the Compton Maintenance Yard on-site in the Los Angeles River Channel at about 2200 hours on 8-17-16 performing containment of the wastewater that entered the river.

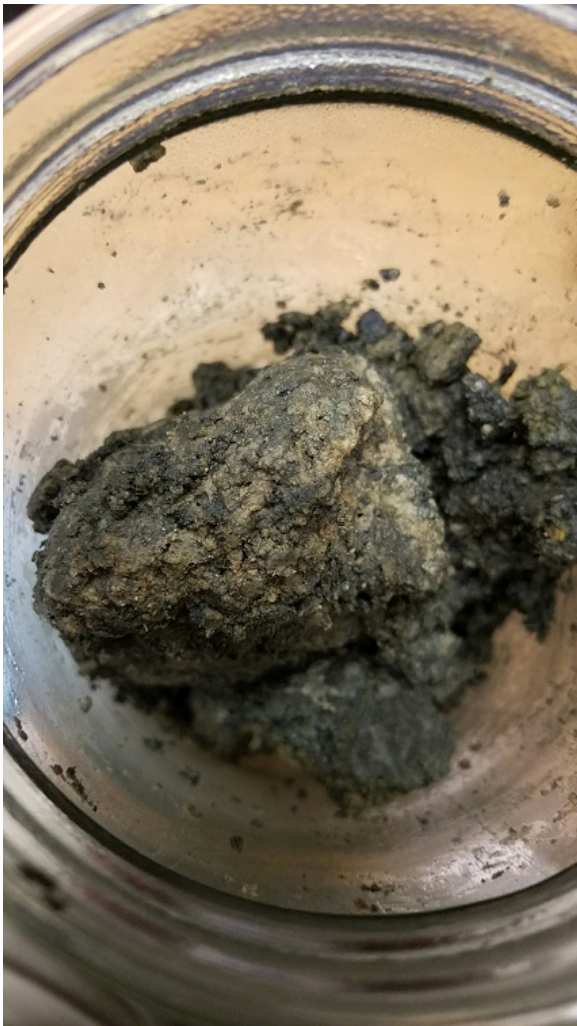
Figure 6: Fist sized chunk of grease removed from MH H 242A on 8-17-16.

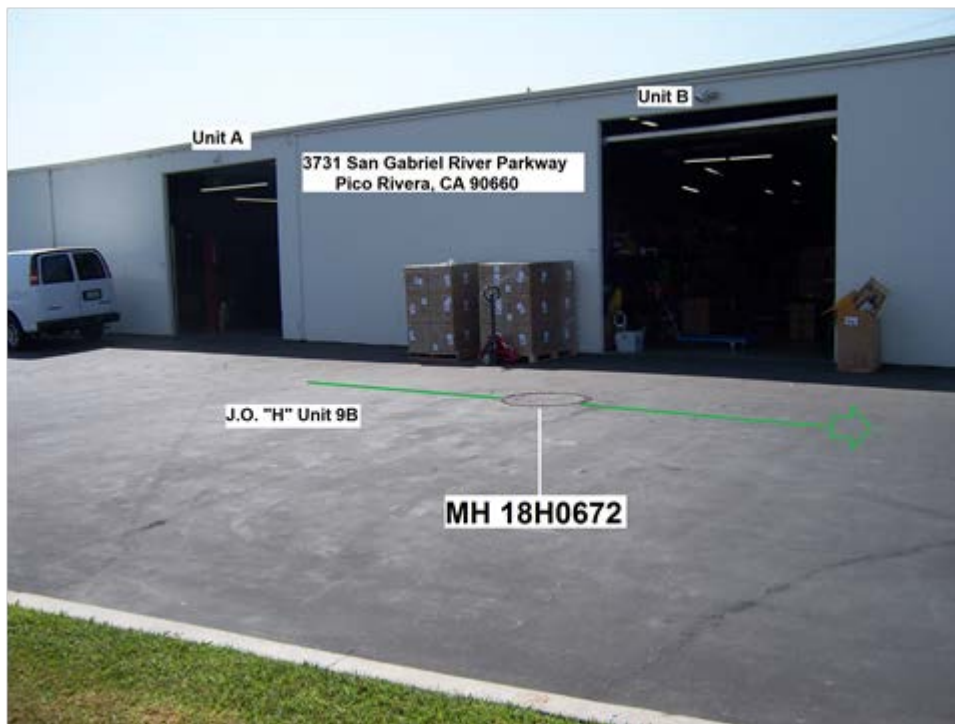
Figure 1: Location of MH 18H0672, note its close proximity to Industrial Specialty Products, Inc. Mr. Mullan is the manager of this business.

Sanchez and McCurdy arrived on-site at 1035 hours on 9-1-16 and surveyed the J.O. 'H' line from MH 18 H0691 down to MH 18H0672, confirming the presence of the foul odor as had been reported. Their survey found normal headspace hydrogen sulfide gas concentrations ranging from 38 to 42 ppm. The odor was similar to that noted in the past, essentially that of "old" sanitary waste, with an additional slight beer "hops" odor due to the presence of large amounts of industrial wastewater from the upstream MillerCoors beer brewery in Irwindale. Samples of wastewater taken from the line were dark, with a slight purple hue, containing finely dispersed black solids which settle readily. The purple color is unrelated to the odor issue and is due to industrial wastewater discharged by an upstream textile dyehouse in Baldwin Park (Hitex

It was noticed that one of the corks placed previously into one of the pick holes on MH H0672 was damaged and partially torn out, allowing odorous sewer headspace gas to escape due the normal presence of positive pressure in the sewer line. The cork was replaced and new silicone sealant was added, immediately causing the odors in the area around the manhole to dissipate. From prior responses to similar odor complaints at this location, it's known that the Districts' long-term planned solution to this problem is to have a CFO crew install a bolted pressure plate inside the manhole riser to more effectively prevent sewer gases from escaping.

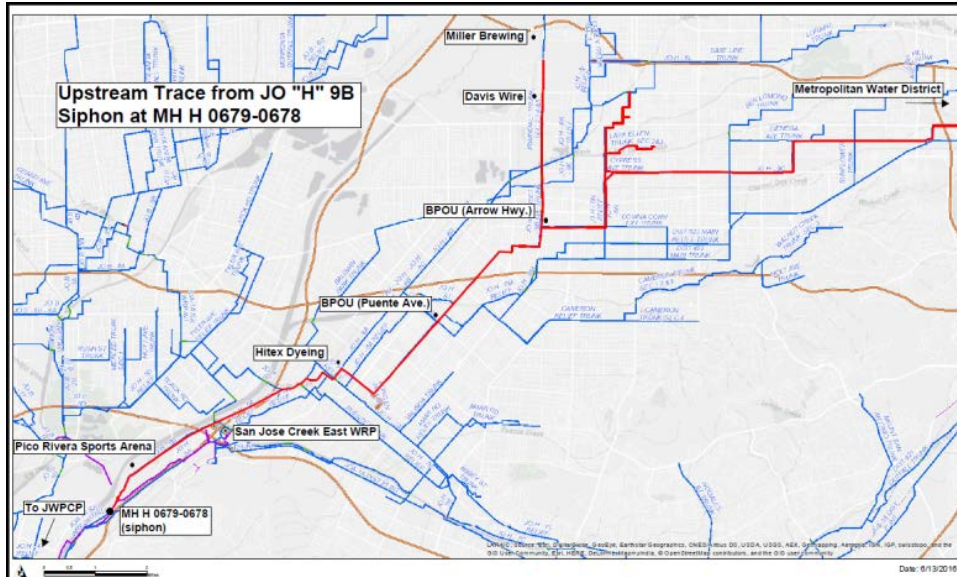
Dyeing, see Figure 2 below). The pH of the wastewater was measured and found to be at expected levels of 6.1 to 6.4. A dissolved sulfide test was conducted on a sample of wastewater taken at MH 18H0691 with the result being non-detect concentration (i.e., <0.1 mg/l).

Figure 2: GIS upstream trace diagram indicating the area which is influent to the manhole where the foul odor was reported on 9-1-16.

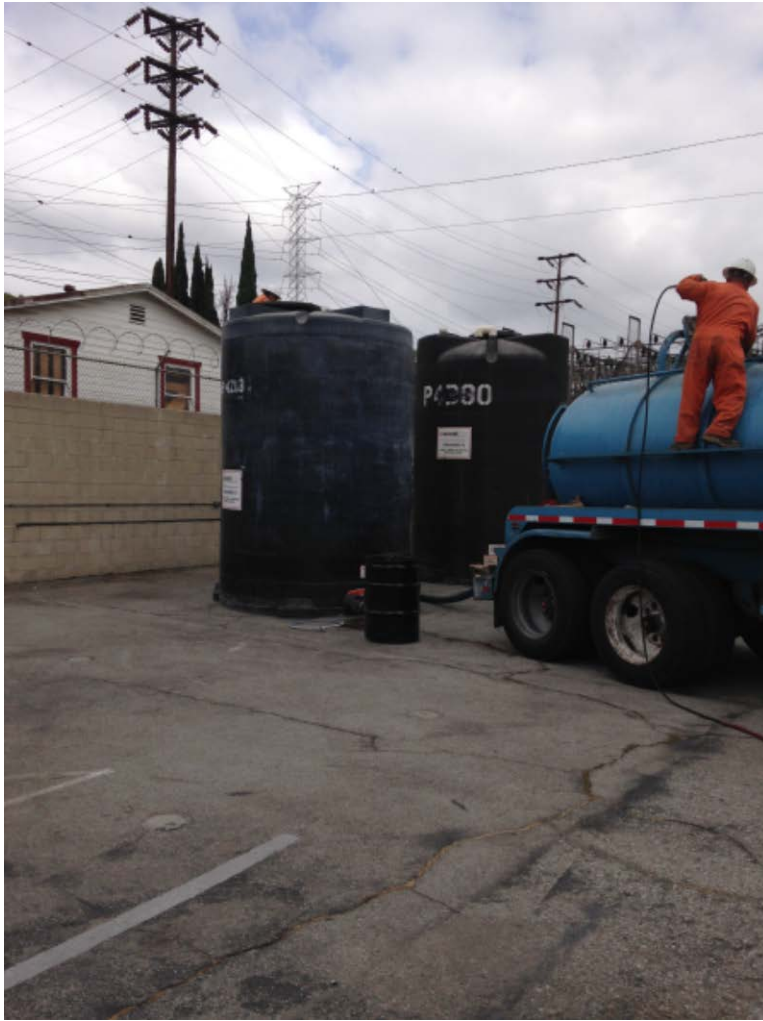
Senior IW Inspector Andy Woods performed a follow-up investigation at the Bodycote facility on Sunday, 9-4-16, arriving on-site at 0945 hours. Area IW Inspector Steve Wittmer also inspected the facility on 9-6-16. The company processes metal parts, primarily for aircraft manufacturers. Operations on-site include multiple electroplating, passivation and cleaning/stripping lines that use acid, alkaline, as well as heavy metal and cyanide based solutions. Woods spoke with Los Angeles County Fire Department Hazardous Materials Specialists Ismael Gonzales and Beverly Migues, who stated that LACFD firefighters and HAZMAT arrived on-site at approximately 1700 hours on Saturday, 9-3-16 and extinguished the fire in about 30 minutes. The fire originated in, and was confined to, a passivation and plating building located at the southeast corner of the facility (see Figure 4). The plating and passivation area contained tanks of hydrochloric acid, hydrofluoric acid, nitric acid, copper cyanide, nickel (nickel strike) and alkaline cleaners. All fire water that was used to extinguish the fire, as well as some water from a ruptured water line in the building, was captured and put into two 4000-gallon portable Baker tanks brought on-site (see Figure 5). It did not appear that any of the contaminated firewater was discharged either purposely or inadvertently into the sewer or storm drain systems. The firewater was

Figure 5: Portable 4000-gallon Baker tanks on-site at Bodycote Thermal Processing on 9-4-16.

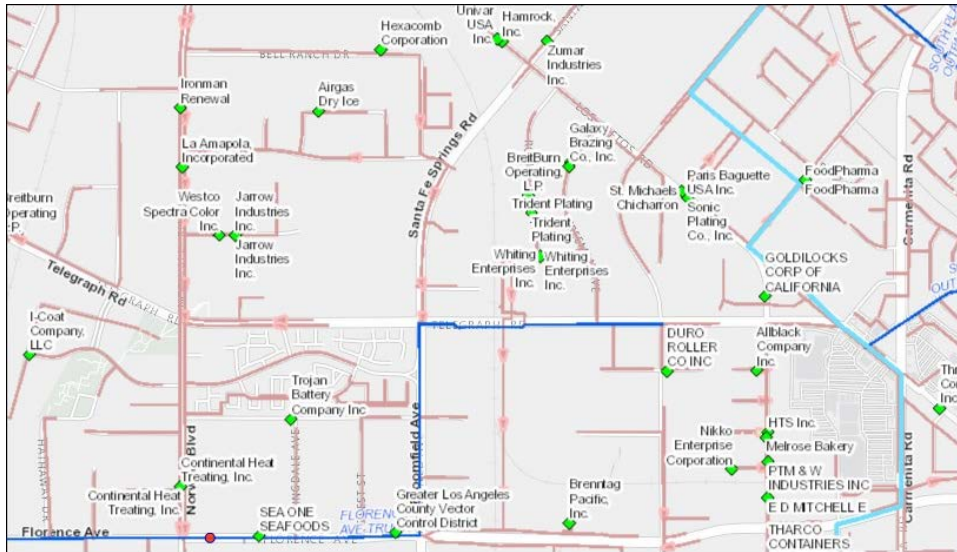
Figure 6: GIS diagram showing upstream trace from MH 18 044 (red dot) in Santa Fe Springs. Permitted industrial wastewater dischargers are identified by a green diamond.

Team 2 IW Inspectors conducted inspections at industrial facilities tributary to the Florence Avenue trunk sewer upstream of MH 18 0444. These inspections included both permitted and unpermitted industrial facilities. All facilities inspected were found in compliance with all applicable limits and permit requirements, including at the prime suspect, Breitburn Operating L.P., a relatively large oil production facility (see Figure 6 above).

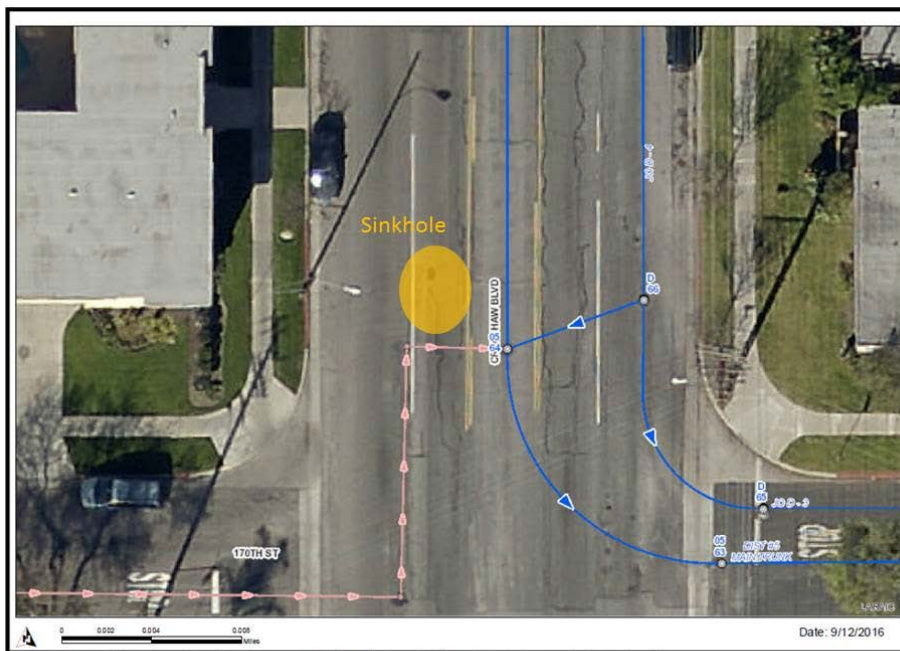
On Sunday, 9-11-16 at 0740 hours, Senior IW Inspector Bill Barnum received an automatic alert to his personal cell phone from the City of Torrance Public Alerts system reporting a sinkhole and road closure on Crenshaw Blvd between 168th and 170th Streets. Barnum noted that the location was in close proximity to two Districts' trunk sewer lines. The message he received gave no further information as to the cause and extent of the sinkhole. Barnum immediately notified Supervising IW Inspector John Boyd, as well as Districts' Operator Walter Hodgson at the Long Beach Main Pumping Plant Alarm Center. Hodgson reported that, to his knowledge, the Districts were previously unaware of the report and he would notify Compton Field Office sewer maintenance staff of the report. Boyd and Barnum decided that Barnum would respond to the location to determine the cause of the sinkhole and evaluate if there were any impacts to the Districts' sewers.

Figure 7: Districts' GIS diagram indicating the location of the 9-11-16 sinkhole on Crenshaw Blvd in Torrance.

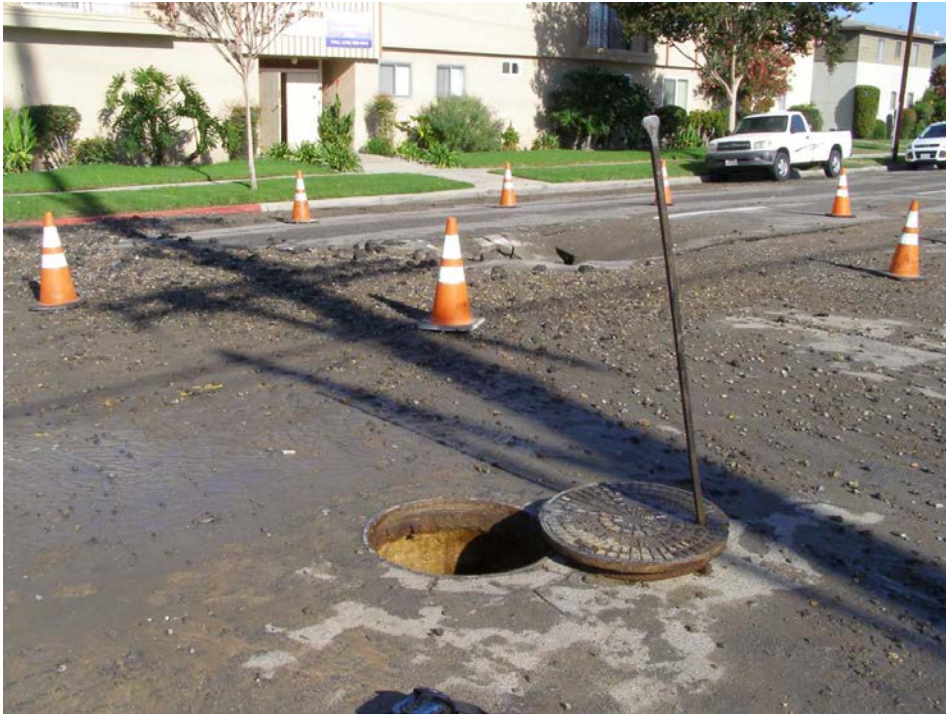
Figure 8: 9-11-16, 0830 hours MH 05 0064 on the 36" District #5 Main Trunk. Note sinkhole in the background.

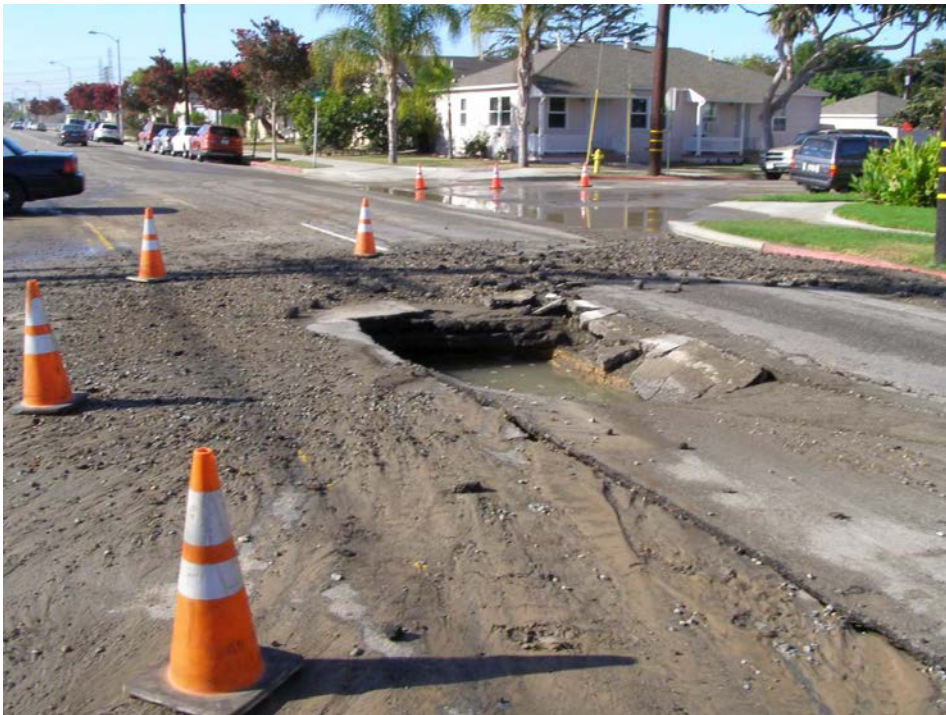
Figure 9: 9-11-16, 0830 hours sinkhole on Crenshaw Blvd.

At 0820 hours on 9-11-16 Barnum arrived at the location and met with Lighting & Traffic Department Supervisor Richard Hall of the City of Torrance who was on-site to implement traffic control with the Torrance Police Department. Mr. Hall stated that he was notified of the situation at 0710 hours that morning when he had received a call from the Torrance Police Department of water flooding Crenshaw Blvd from a what appeared to be 8" water main break just north of 170th Street on the west side of Crenshaw Blvd. Prior to Barnum's arrival, the Torrance Water Department had already shut off flow to the water main. The pressure from the broken main caused a 5' x 5' foot hole 4' deep, resulting in mud and gravel spewing around the hole and the surrounding street (see Figure 9 above). The pipe rupture is

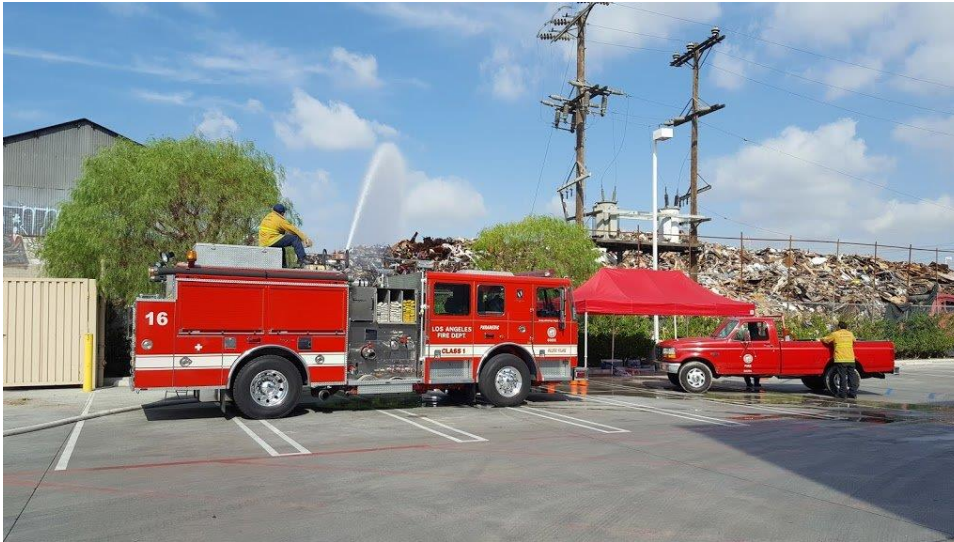
The debris/waste pile caught on fire in mid-September 2016. Firefighter's initial attempts to extinguish the fire were only partially successful due to the fire going "underground" in the pile. Firewater contaminated with fecal material from the portable toilet waste was running off into the stormdrain, causing the firefighters to reduce their use of firewater and to collect the water in portable Baker tanks brought on-site for proper disposal, which initially consisted of hauling it to the nearby Southwest Processors facility. However, this disposal method was relatively expensive, and eventually the City's Bureau of Sanitation allowed the contaminated firewater to be pumped directly into an adjacent sanitary sewer line manhole (MH) where it then flowed to the City's Hyperion Treatment Plant. Examination of hauling records and manifests at Southwest Processors on 10-6-16, as well as sampling and lab testing of their industrial wastewater discharge, indicated compliance with all applicable regulations and limits. On 10-26-16 Neunsinger noted that the fire was still smoldering, but excavators were actively removing the accumulated debris for disposal at a Riverside County landfill and it was anticipated by regulators that the fire would be completely extinguished shortly. Ultimately, the event had no negative impact on Districts' facilities and Southwest Processors was found to be in compliance with all applicable regulations.

Figure 1: 10-5-16 photo of a City of Los Angeles Fire Department truck pouring firewater onto the large waste and debris pile at Clean Up America.

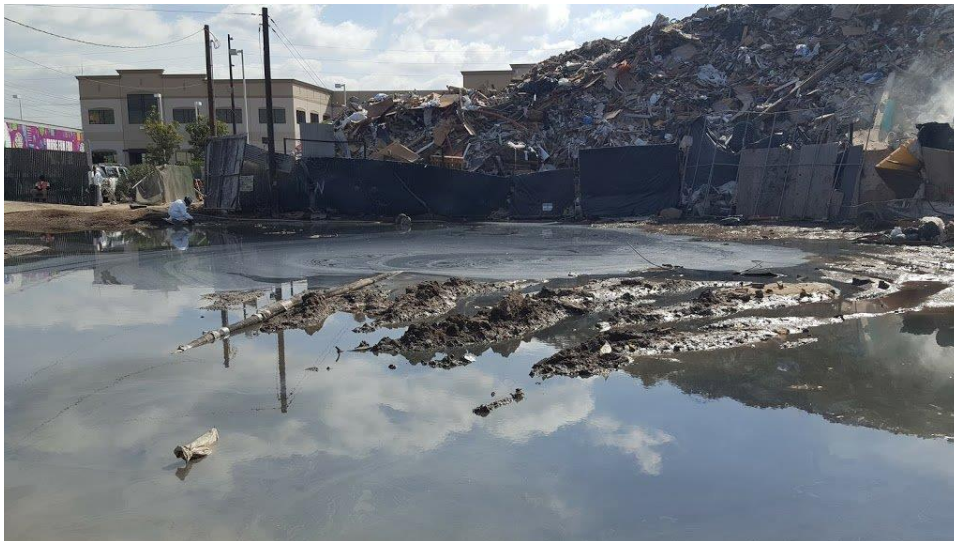
Figure 2: 10-5-16 photo of 20' tall debris/waste pile and ponded firewater.

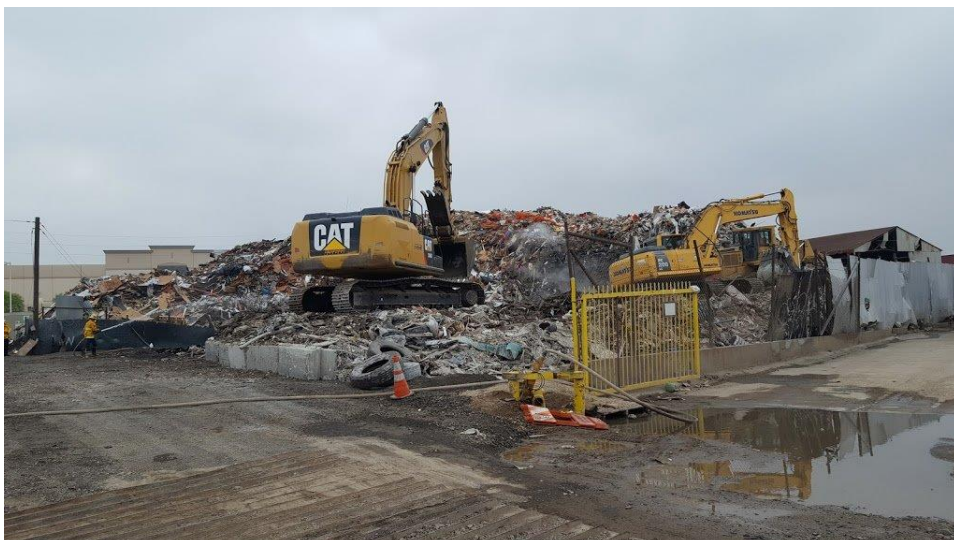
Figure 3: 10-11-16 photo of debris/waste pile being slowly removed by excavators.

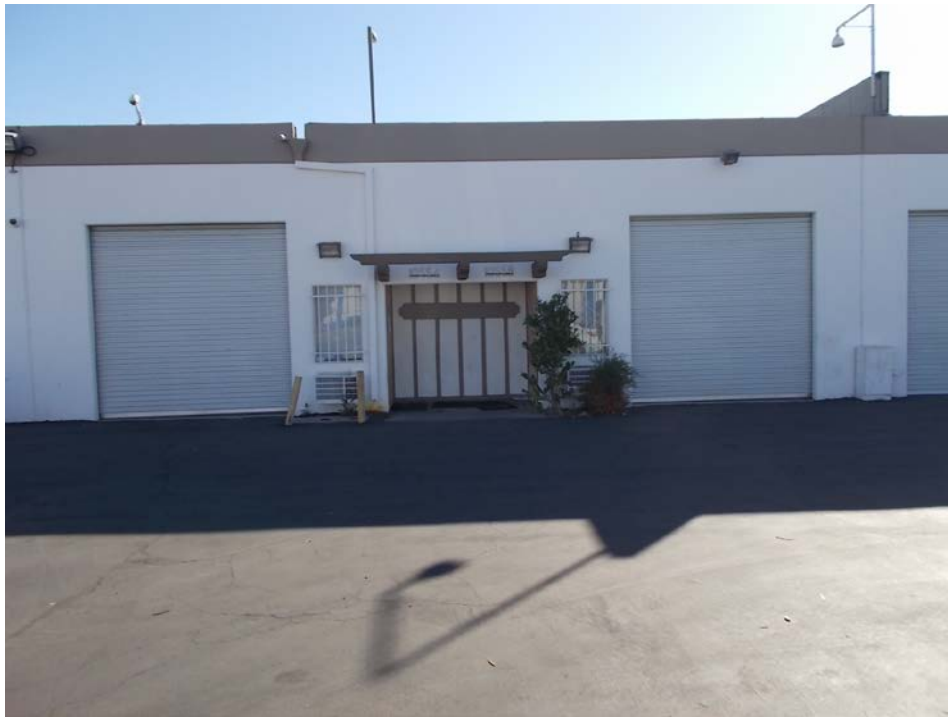
On 10-19-16 Finn inspected the facility with Hall. An extensive hydroponic growing operation utilizing fertilizer and pest/fungus control chemicals, as well as water conditioning and recycling equipment was found in six buildings within a small industrial complex. Finn noted several illicit sewer connections existed, where limited amounts of industrial wastewater from the growing operations were being discharged into toilets, sinks, or had been hard plumbed to existing drains. All the chemicals found were in small volumes of less than 5 gallons. Finn collected samples from a wastewater sump in one of the larger grow rooms and from a 55-gallon barrel found onsite. There was no continuous discharge to the sewer from any of the watering or operation systems. It did not appear that was any detrimental impact to the local or Districts' collection system, nor was there any evidence found that there had been any discharge of restricted materials into the sewer. The violations noted were of municipal plumbing codes, not Districts' regulations. It is not anticipated the Districts will have further involvement in the legal case that will result from the raid.

Figure 3: 10-19-16 exterior photo showing two of the six industrial complex units being used for illicit marijuana growing operations. Note the presence of the video surveillance cameras.

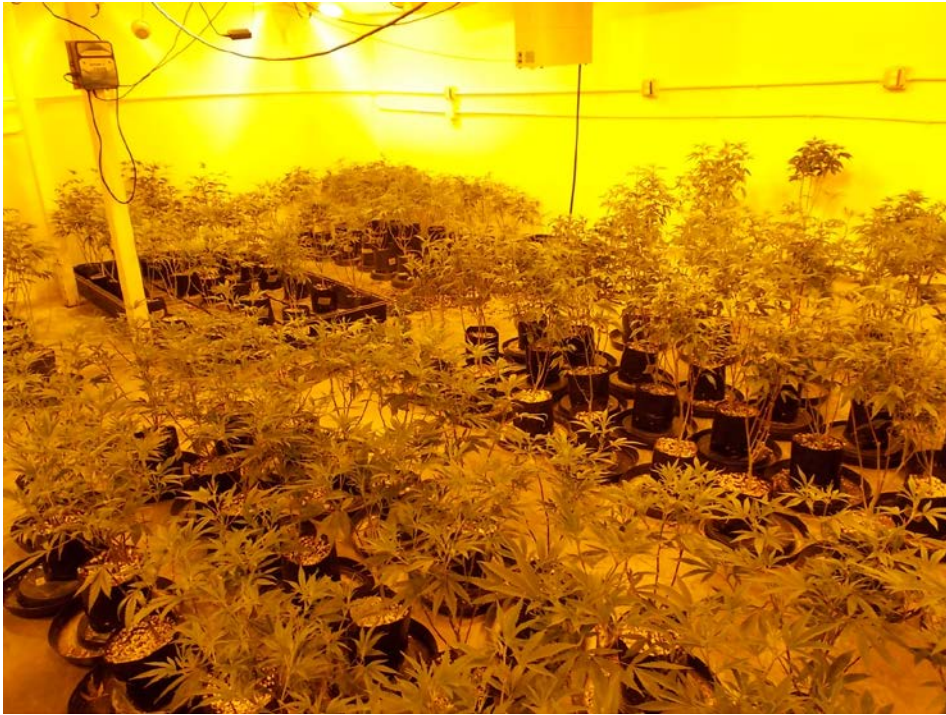
Figure 4: 10-19-16 photo showing interior of one of the units with ongoing marijuana growing operations.

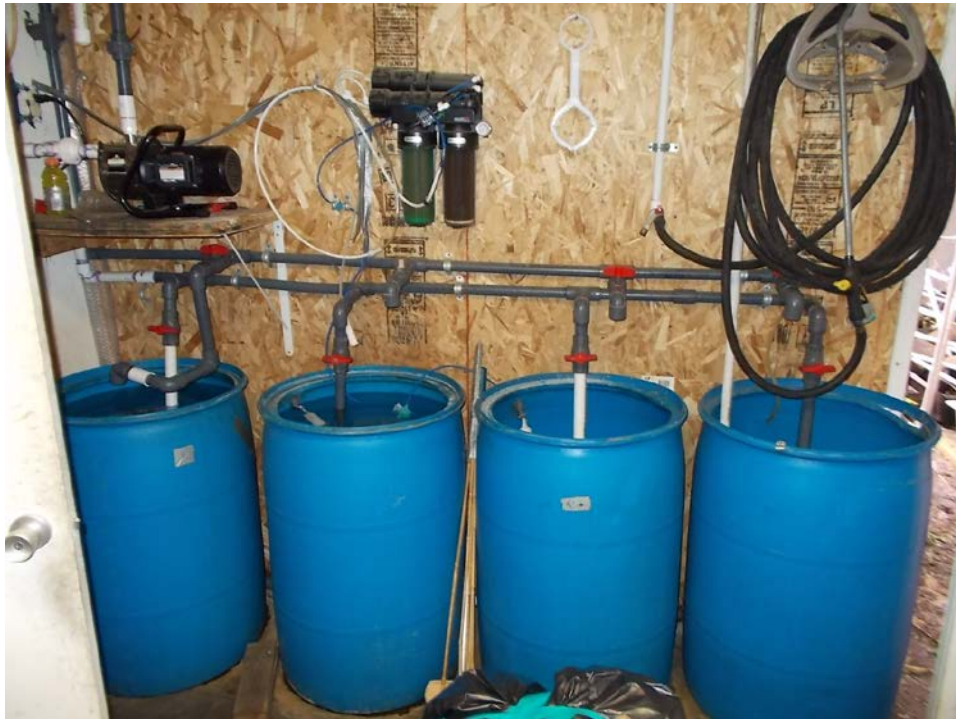
Figure 5: Jury-rigged water distribution system showing water barrels, pumps, and filters used to distribute water and fertilizer to the plants.

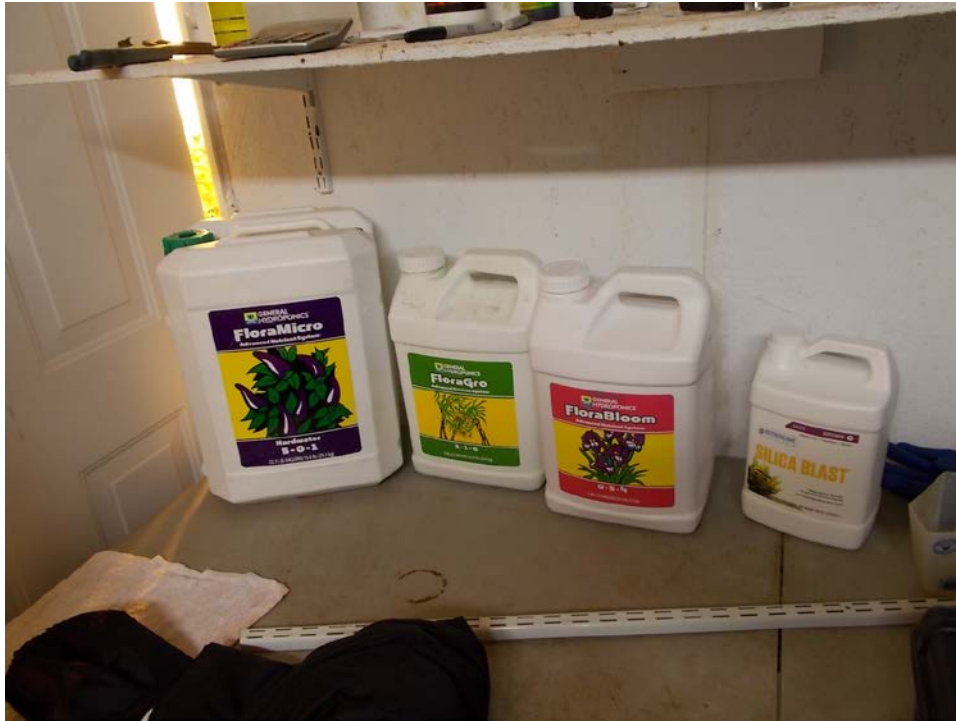
Figure 6: Some of the fertilizer chemicals used at the grow operation.

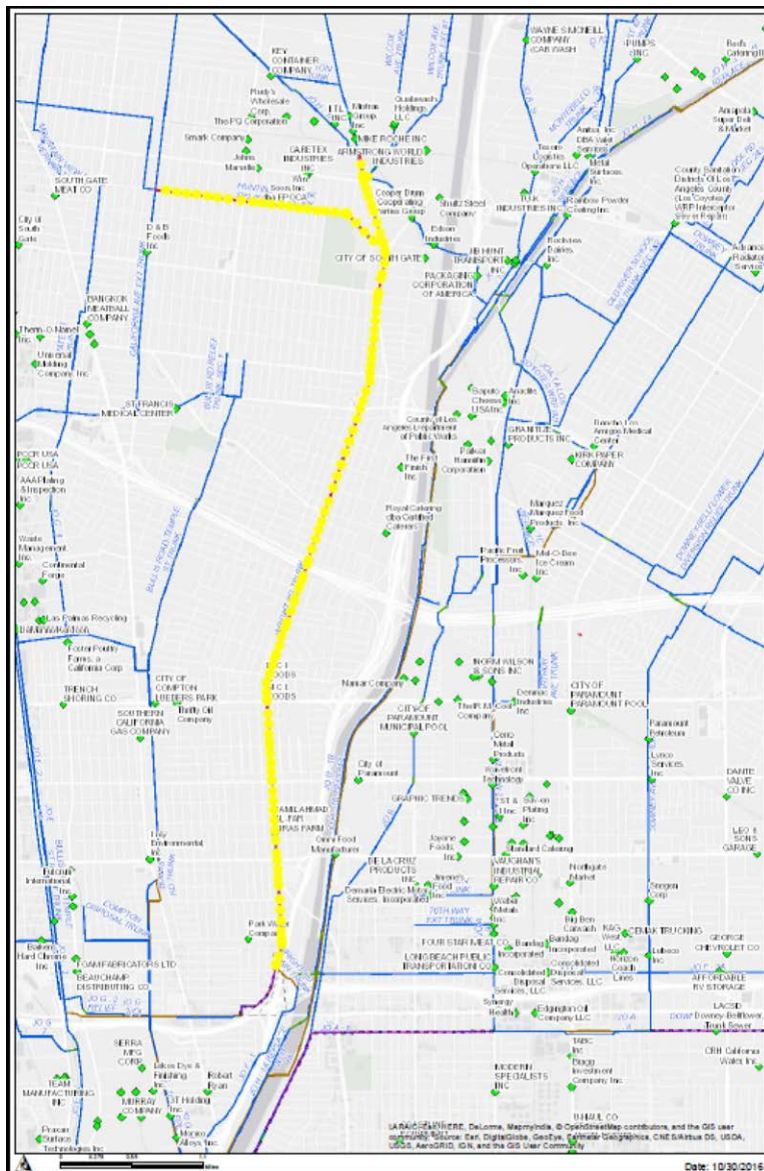
Figure 7: Upstream trace showing trunk sewers and permitted industrial waste dischargers from the manhole on the Wright Road trunk sewer where an ammonia odor was observed on October 28, 2016.

Both day and night team IW inspectors, led by Senior IW Inspectors Kent McIntosh, Bill Barnum, and Andy Woods, participated in the investigation into finding the source of the ammonia odor. However, no source was identified. IW inspectors investigated the primary known suspects, which consist of industrial operations with large ammonia-based refrigeration systems, including cold storage and food manufacturing facilities. No indication of recent problems or issues with these systems was noted. IW Inspectors remain vigilant to locating the odor source as part of their normal inspection activities in the area upstream of MH 01 0845.

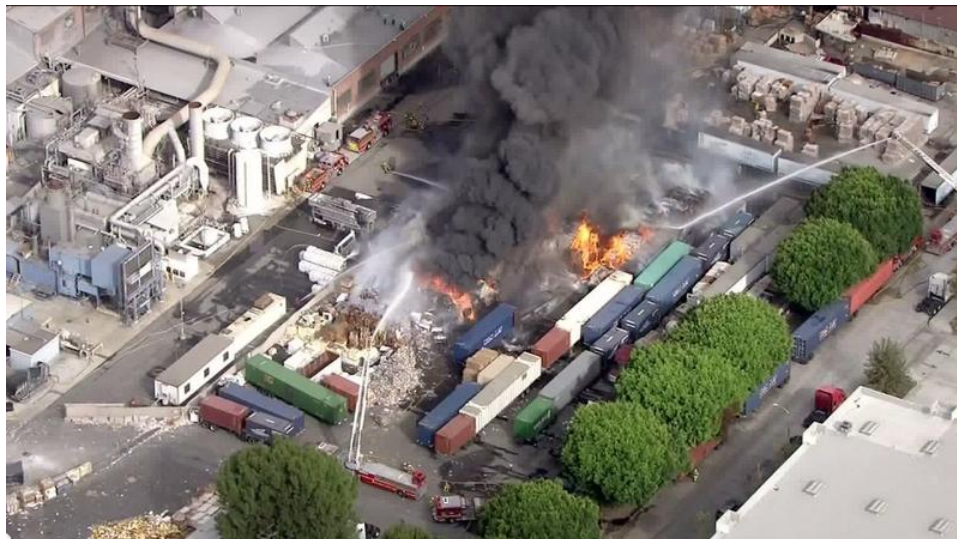
Figure 8: News helicopter photo of the 10-28-16 fire at Golden State Fibres Recycling in the city of Commerce.

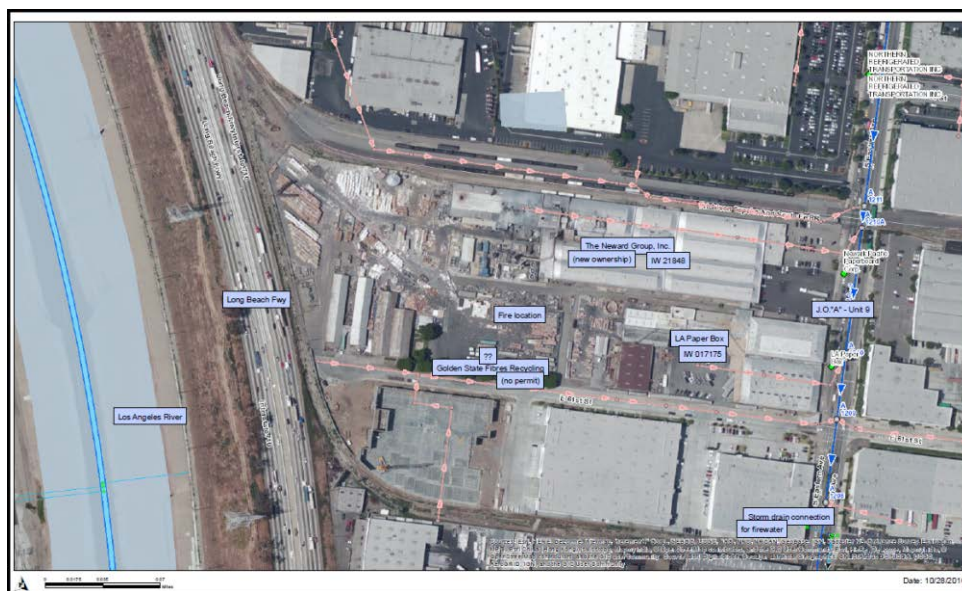
Figure 9: Districts' GIS diagram showing the fire location (Golden State Fibres Recycling) in relationship to the adjacent industries which make paper products, The Newark Group and LA Paper Box.

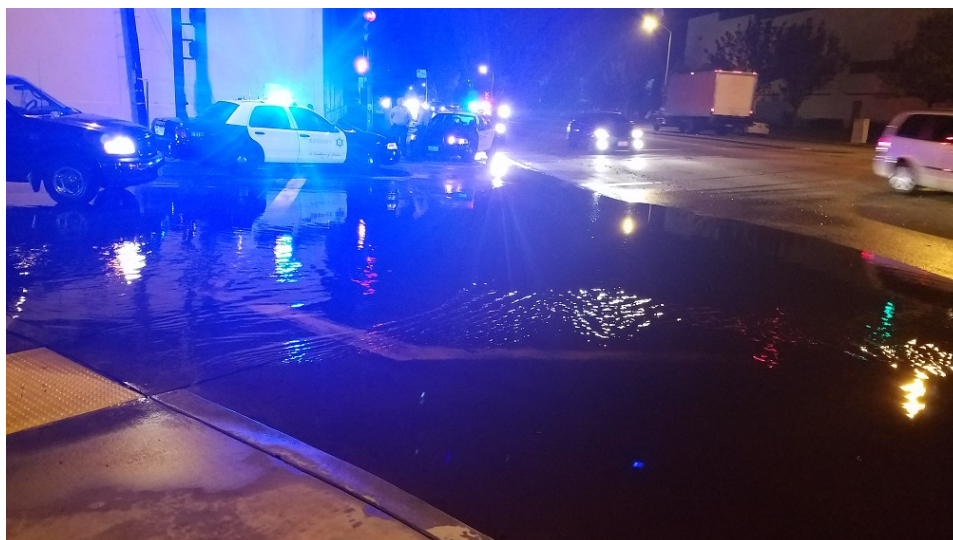
Figure 10: 10-28-16 1930 hours firewater running off into Eastern Avenue and the stormdrain collection system.

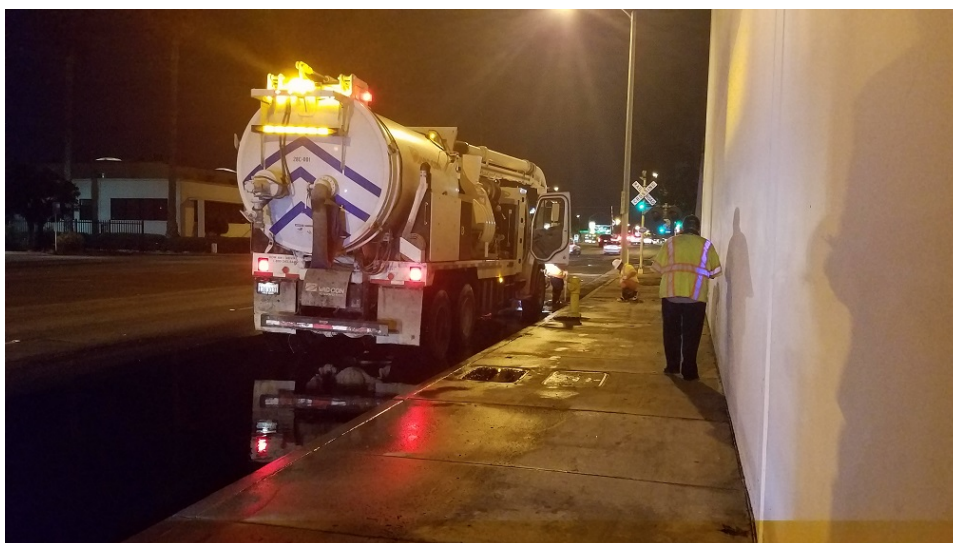
Figure 11: 10-28-16 1930 hours Vactor truck operations on Eastern Avenue removing firewater from the stormdrain system.

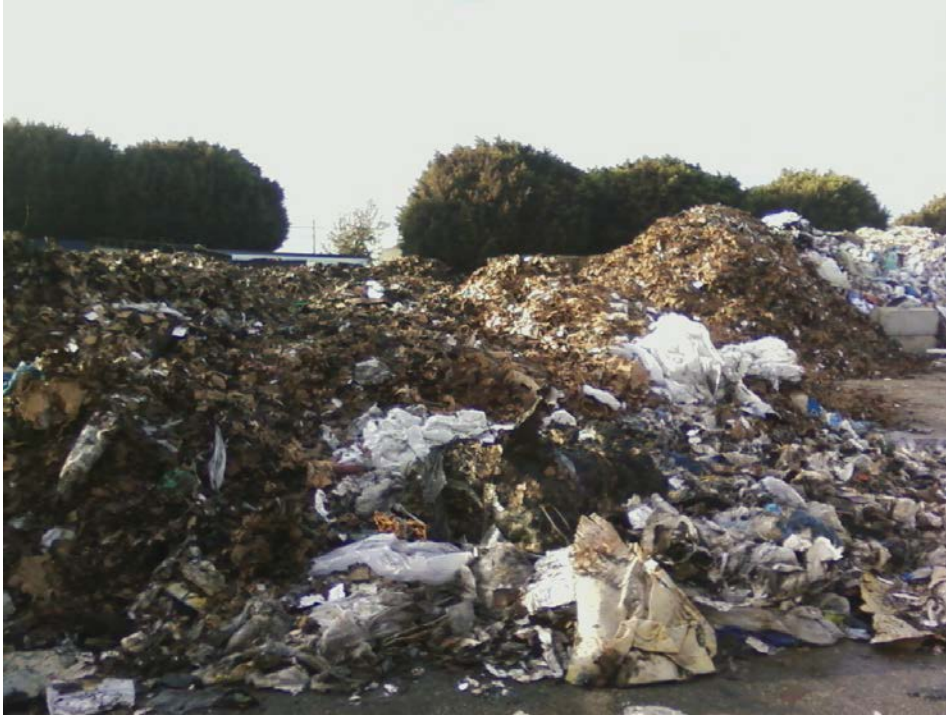
Figure 12: 10-31-16 photo showing paper debris still on-site at Golden State Fibres Recycling following the 10-28-16 fire.

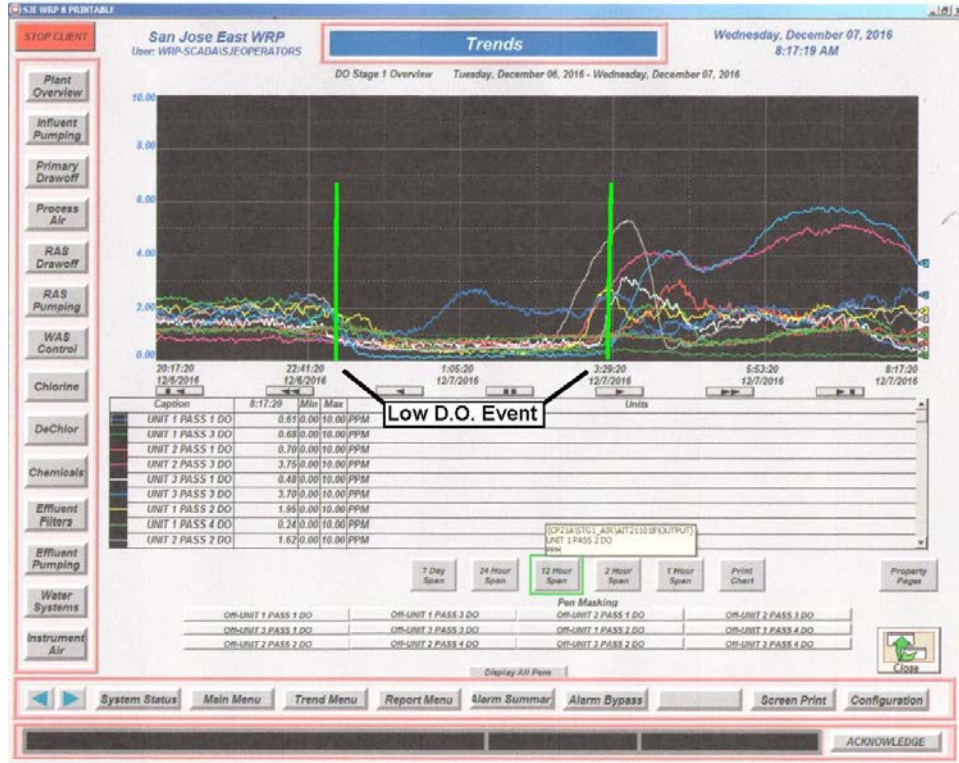
On Wednesday, 12-6-16 at 0113 hours, San Jose Creek Treatment Plant Operator Abel Martinez telephoned Senior IW Inspector Kent McIntosh and reported that at approximately 2300 hours earlier that evening SJC East WRP operators noticed a drop in dissolved oxygen concentration in the secondary aeration tanks. Even with the normal diurnal flow decrease present at the time, from 47 MGD during the day to 37 MGD at night, operators still had to increase the output of the air compressors from 45,000 cfm to 79,000 cfm to maintain reasonable dissolved oxygen levels in the tanks. Although there was a very small drop in the influent pH (to pH= 6.9), Martinez doubted that this was related to the dissolved oxygen issue. Samples of the primary effluent were taken by the operators. Martinez added that there were no other abnormalities or problems at the plant, although because of cross-connections with the SJC West WRP, that plant also experienced a drop in the dissolved oxygen concentration. Night Team IW inspectors responded to the incident, collecting the samples from the operators and inspecting upstream suspect companies as possible sources for the incident.

Figure 1: 12/6-7/16 SJC-East WRP aeration tank dissolved oxygen trend screen shot.
