2016 ANNUAL REPORT

INDUSTRIAL WASTE PRETREATMENT PROGRAM

COUNTY SANITATION DISTRICTS OF LOS ANGELES COUNTY

APPENDIX H
INDUSTRIAL WASTE REPORTS ON INCIDENTS

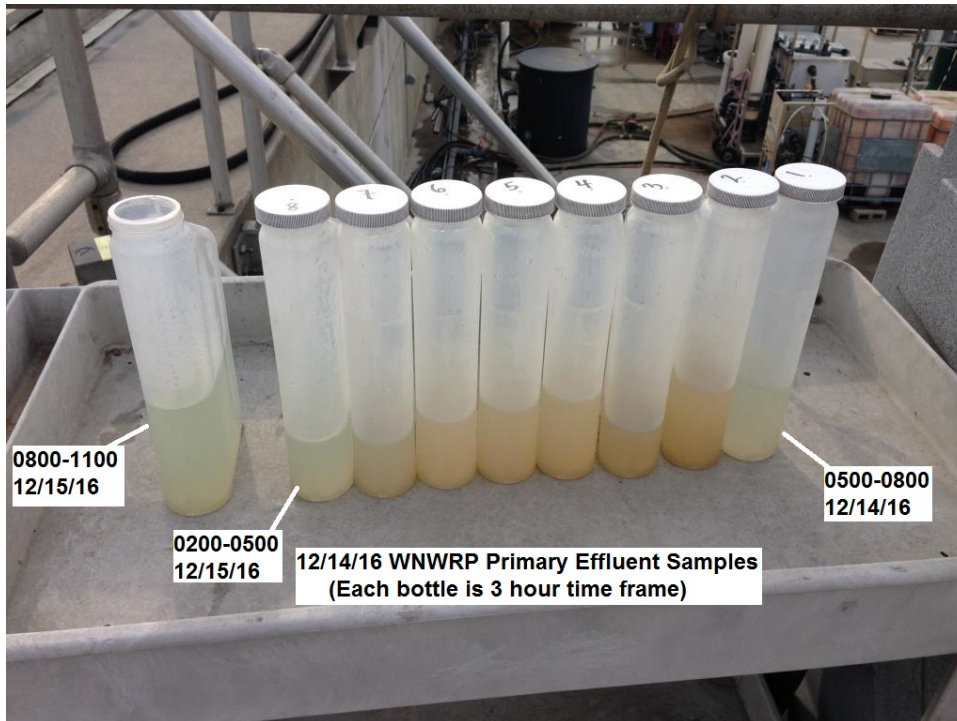
On Wednesday, 12-14-16 at 1000 hours, Whittier Narrow WRP Supervising Treatment Plant Operator Carlos Alfaro notified IW Inspector Jim Percy by telephone that the laboratory technician at the WNWRP had stated that he noticed a "blue color" in one of the primary effluent sample bottles from the day before (12/13). Also Alfaro stated that the day before operators reported seeing a "blue tint" in the water in the final tanks.

Figure 3: WNWRP primary effluent composite samples for 12/14-15/16.

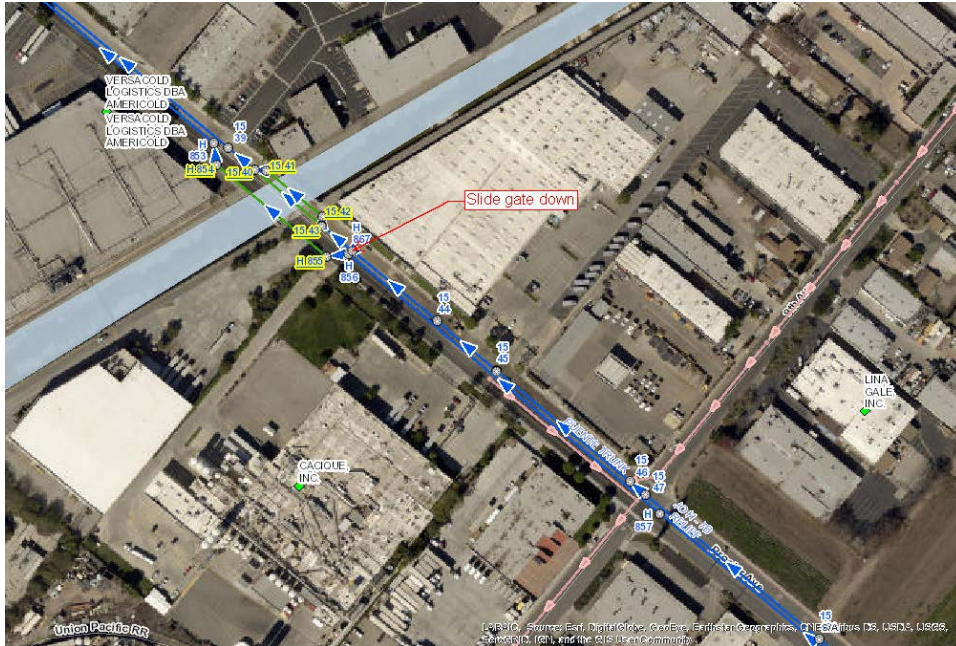
Trunk sewer on Proctor Avenue in the City of Industry between 8th and 9th Avenues where the trunk crosses under Puente Creek. He stated that the greasing had completely blocked one of the barrels and nearly blocked the other. A vactor truck had to be called to location to remove the grease and the crew was at the location all day clearing and cleaning the lines. He said usually the cleaning there takes about 2 hours. He also stated that the siphon is cleaned every 2 months, stating that it was last cleaned in October, 2016. Finally, he reported that his crew had mentioned they thought there was a likely source for the grease, a chicharones (fried pork rinds) manufacturer, located close to the siphon. This information was forwarded to Supervising IW Inspector Dave Lee for follow-up investigation.

Figure 6: Geographic information system (GIS) map showing the location of the heavily greased double barrel siphon.

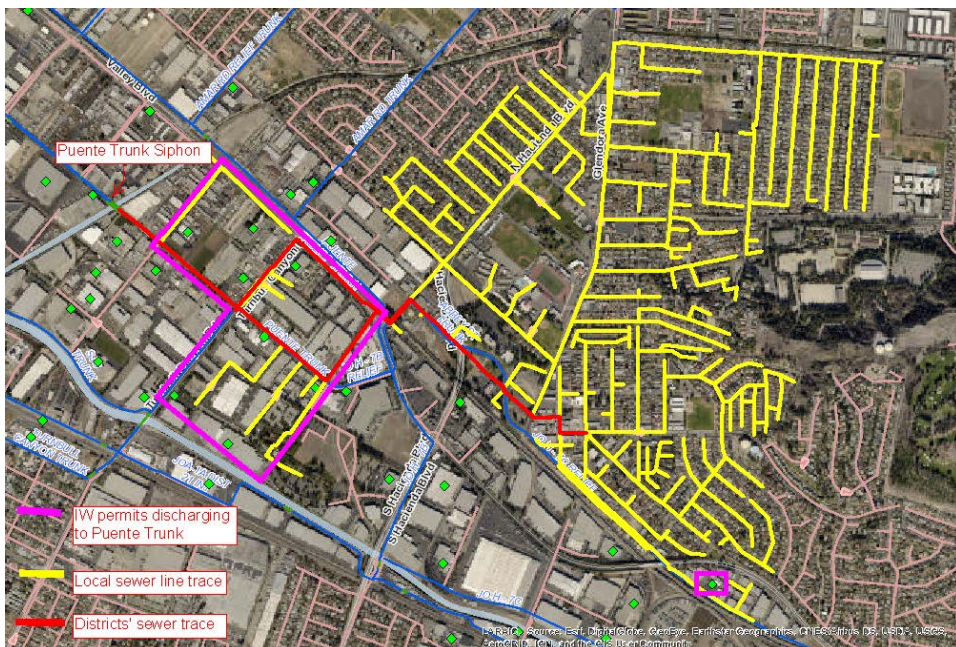
Figure 7: GIS map showing upstream sewer trace results. Permitted industrial wastewater permittees are indicated by green dots. Note that not all the IW facilities shown are upstream of the greased siphon structure.

IW inspectors Ken Hanks and Peter Carlstrom investigated this incident. They inspected the seven industrial facilities located upstream of the siphon structure in question thought to have some potential to cause the excessive greasing. These facilities included food manufacturers, a pharmaceutical compounder and a catering yard. No source for the greasing incident was found. The large pork rind processing facility noted by the Districts' sewer maintenance crew as a possible source was investigated, but after reviewing sewer maps and site plumbing plans, inspectors were able to confirm that the facility's wastewater does not go to the siphon in question, thus eliminating the company as a possible source. The inspectors' investigation also included contacting the Los Angeles County Department of Public Works' sewer maintenance supervisor for this area to inquire about any recent sewer maintenance of the local sewer lines in the area that could have resulted in grease being pushed downstream in to the Districts' siphon. The supervisor reported that there had been no recent cleaning events in the areas upstream of the siphon. During this discussion the LADPW Supervisor was reminded that all contents of any local line sewer cleaning should be removed from the sewer and not forced downstream into Districts' trunk lines. IW inspectors will maintain contact with San Gabriel Yard personnel regarding future siphon cleaning activity in the area and respond if warranted.

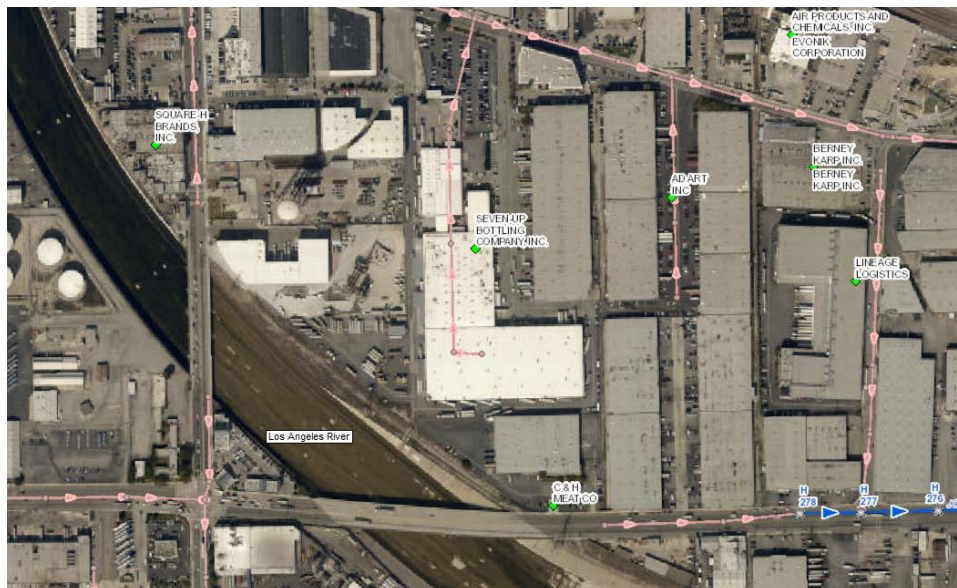
Figure 9: GIS aerial photo of the Seven-Up Bottling facility in Vernon. Note that the facility is located immediately adjacent to the Los Angeles River.

McGinnis, as well as night shift Senior IW Inspector Kent McIntosh, and IW Inspectors David Joh and Helen Luu all responded to the incident report. Their investigation revealed that two newly installed air compressors at the facility had failed late on 12-24-16, causing air actuated valves throughout the facility to be locked into whatever orientation they were in when the compressors failed. This ultimately resulted in the overflow of industrial wastewater in their pretreatment system into the storm drain system, including the adjacent Los Angeles River. At the time of the incident, the only person on-site at the 7-Up facility was a security guard. A high level alarm located in a spill containment area did activate and the guard heard the alarm, but he only noted it in his log and did not contact anyone or investigate further. Fortunately, Vernon Police Department officers subsequently heard the alarm while routinely driving past the facility and investigated. The police then contacted the Vernon Fire Department who ultimately contacted the 7-Up Plant Manager. Corrective action was quickly taken, but not before the estimated 14,850 gallons of spilled wastewater had left the site. The company is altering their standard operating procedures to ensure that a spill of this nature and cause will not happen again. There was no impact on the Districts' sewer system or downstream treatment facilities (i.e., JWPCP) due to the spill. Also, due to the volume of rainwater runoff already in the stormwater collection system and river from a recent series of rainstorms, there was no attempt made to capture any of the spilled wastewater that reached the storm drain collection system and river.
