**2015 ANNUAL REPORT**

INDUSTRIAL WASTE PRETREATMENT PROGRAM

COUNTY SANITATION DISTRICTS OF LOS ANGELES COUNTY

**APPENDIX H**  
INDUSTRIAL WASTE REPORTS ON INCIDENTS

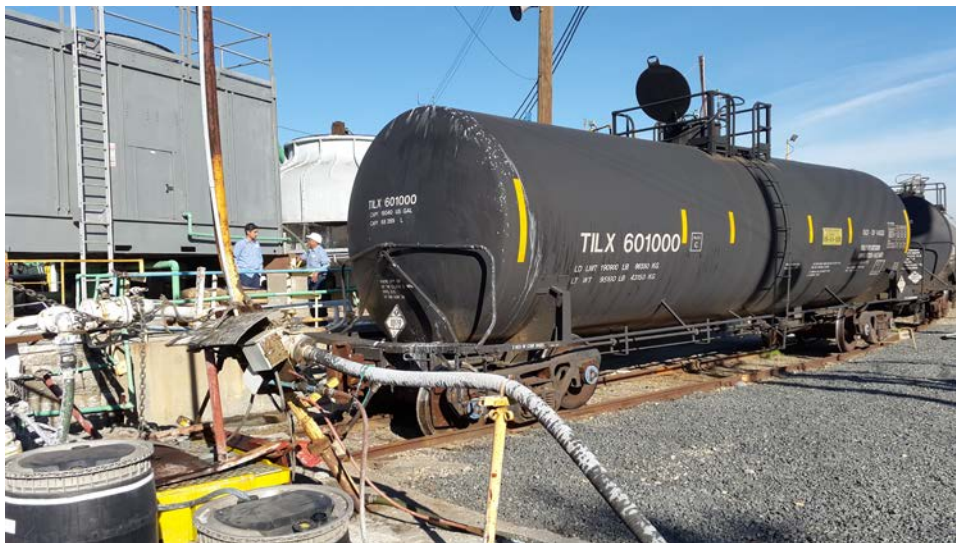
On Friday, 1-16-15 at 0836 hours, Supervising I.W. Inspector David Sanchez observed a spill report on the California Emergency Management Agency website indicating 394 pounds of 50 percent sodium hydroxide solution was released at JCI Jones Chemicals in the Harbor Gateway area of Los Angeles adjacent to Carson. The report indicated the spill occurred due to a damaged pipe caused by engineer error during the switching of rail cars at 1514 hours on Thursday, 1-15-15. The report stated the cleanup was in progress.

Area I.W. Inspector Michael Placencia inspected the JCI Jones Chemicals facility on 1-16-15. The facility receives 50 percent sodium hydroxide solution (aka "caustic") where it is reacted with chlorine gas to produce sodium hypochlorite ("bleach"). In this manner, they produce 30 million gallons of bleach per year, placing them among the two top manufacturers nationwide. The spill was the result of a railroad tanker car rolling about 5' past a track end barrier (see attached photos), where it broke a length of 3" diameter caustic pipe along with a potable water pipe. This was about 22 feet past the usual stopping point where the cars are chocked and loaded/unloaded. About 30 gallons of caustic solution spilled and all of the spilled material, including the potable water, was only about 300 gallons. The entire spill was successfully contained within the existing spill containment system. The limited size of the spill was primarily due to the quick reactions of an operator who turned off the supply valve to the broken water line. An outside contractor, United Pumping Services, was brought in to remove and dispose of the spilled material. The spilled material was neutralized with citric acid before it was vacuumed up and hauled for proper disposal. The emergency spill response included several agencies, including the Los Angeles County Fire Department. There was no impact to the sanitary sewer and none of the spilled material ran off the property. No further follow-up is anticipated.

**Figure 5: 1-16-15 photo taken by Inspector Placencia showing the railroad tanker car that overran its normal stopping point where it smashed into a 3" caustic transfer line and potable water pipe.**

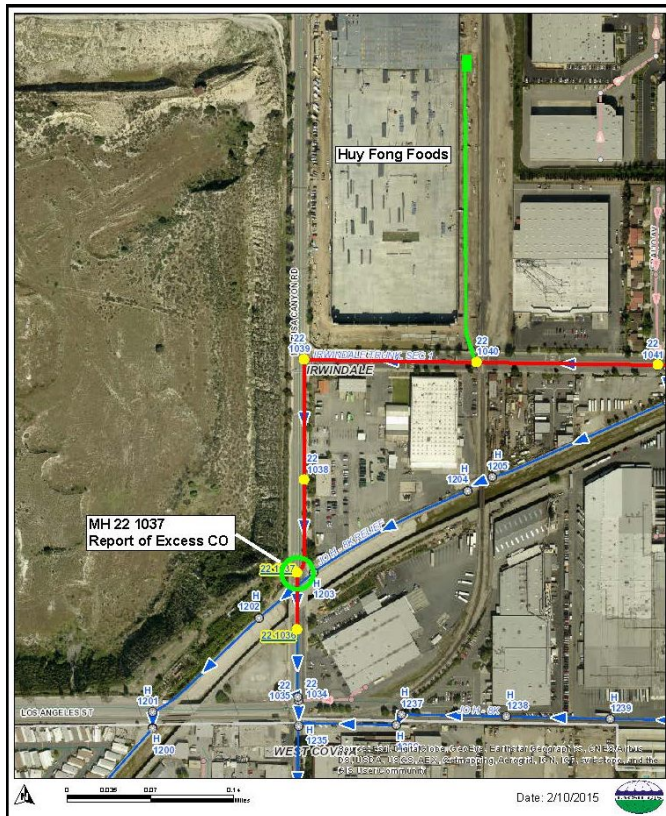
Field investigation by Senior I.W. Inspector Steve Sealy and area I.W. Inspector Nguyen Dang traced the elevated CO concentrations to an industrial source located immediately upstream, Huy Fong Irwindale, LLC. Further research revealed that the CO, LEL, and sulfide detectors of the 4-gas meter used to test the sewer headspace gas concentrations by the Districts' sewer maintenance crews are subject to known interferences from mercaptan and similar organic molecules, including capsaicin. Huy Fong Irwindale is a large sriracha sauce manufacturing company. The sriracha sauce's main ingredient is chili peppers which contain high concentrations of capsaicin. Industrial wastewater containing residual sauce from the washing of sauce blending tanks and bottling line equipment is discharged into the sewer as allowed under the company's active industrial waste discharge permit. Testing of the headspace gas in the industrial wastewater sampling box at Huy Fong Irwindale indicated a positive reading for CO which corresponded to the finding of high CO concentrations downstream in the trunk sewer. A direct test of the chili sauce from a bottle also set the meter's CO alarm off. There is no other evidence that actual CO, normally a byproduct of incomplete combustion, was present in the sewer headspace gas. Balas was advised of these findings. No further investigation to this unusual incident is anticipated.

**Figure 8: GIS sewer diagram/map showing relationship between the manhole location with high carbon monoxide headspace gas concentration and Huy Fong Irwindale, LLC.**

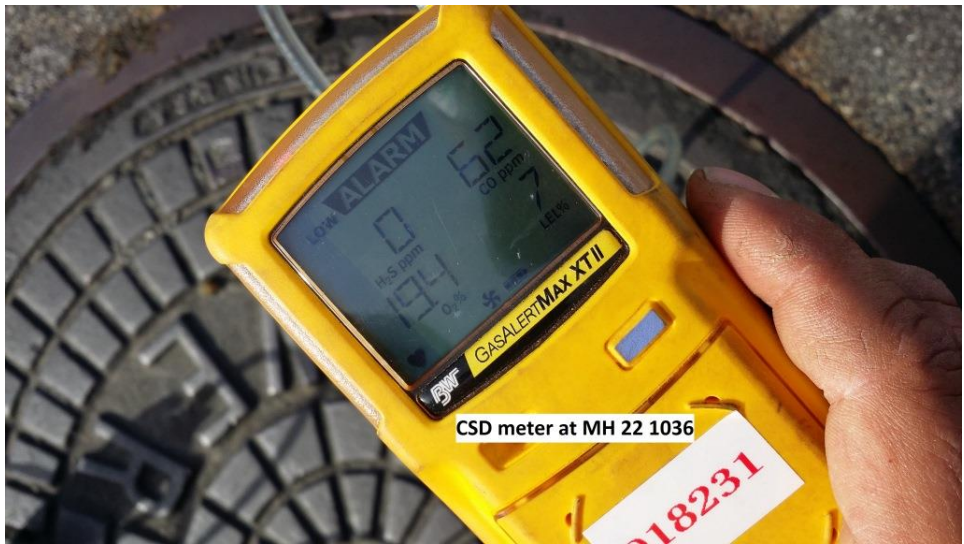
**Figure 9: Districts' sewer maintenance crew 4-gas meter indicating 62 ppm of carbon monoxide in the headspace gas in Irwindale trunk sewer Manhole 22 1036.**

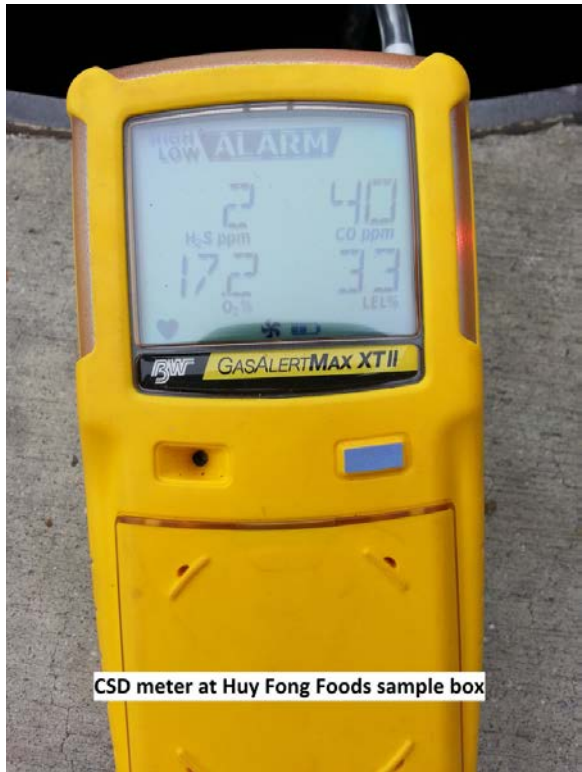
**Figure 10: Districts' 4-gas meter indicating 40 ppm of carbon monoxide, along with elevated LEL and hydrogen sulfide concentrations in the headspace gas of the industrial wastewater sampling box at Huy Fong Irwindale, LLC in Irwindale.**

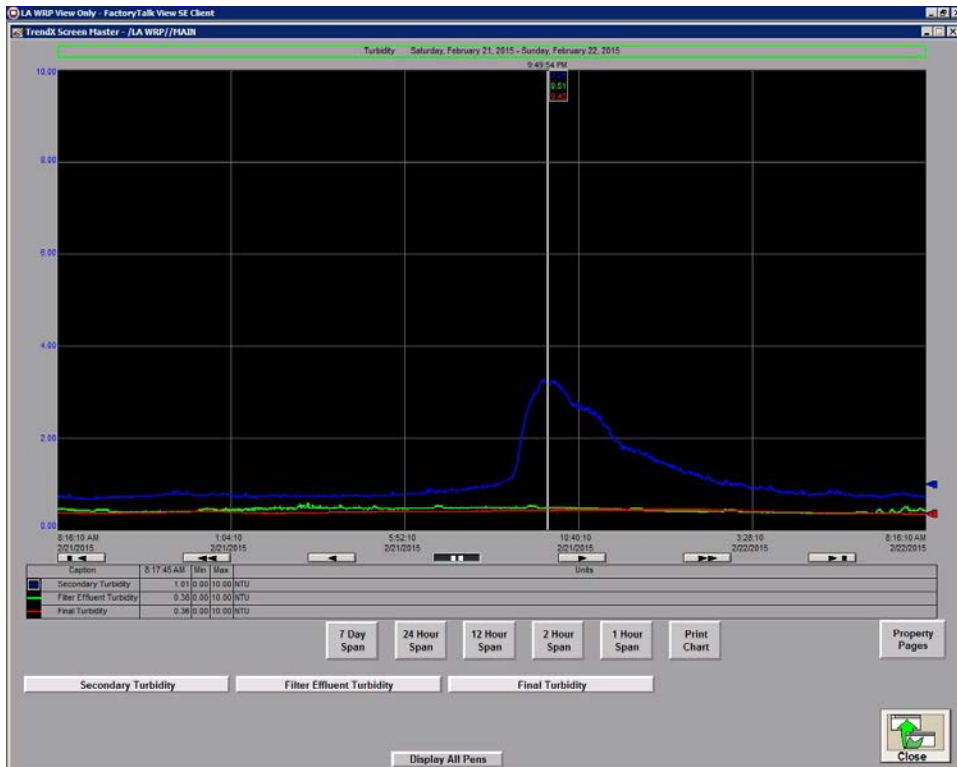
On Monday, 2-23-15 at 0707 hours, Lancaster WRP Supervising Treatment Plant Operator Dan Shubin called John Boyd and reported that the treatment plant had experienced two elevated secondary turbidity and high dissolved oxygen level incidents on the evenings of Saturday, 2-21-15 and Sunday, 2-22-15. He said the secondary turbidity rose both evenings at 2035 hours, reaching 5 NTU. No operators were onsite either day so it is unknown if the material that caused the incidents had any unusual odors or color. The plant has no influent pH meter so it's also unknown if there were any pH excursions associated with the incidents. Shubin stated the elevated turbidity lasted about 2-3 hours. He estimated the material causing the incidents entered the plant 6-8 hours prior to the turbidities rising. He referenced a similar series of incidents that occurred about a year earlier that were reported to the I.W. inspection staff but for which no source was identified. Shubin reported final effluent turbidity levels were unaffected and there were no violations of any waste discharge requirements.

**Figure 6: 2-21-15 through 2-22-15 Lancaster WRP secondary turbidity chart.**

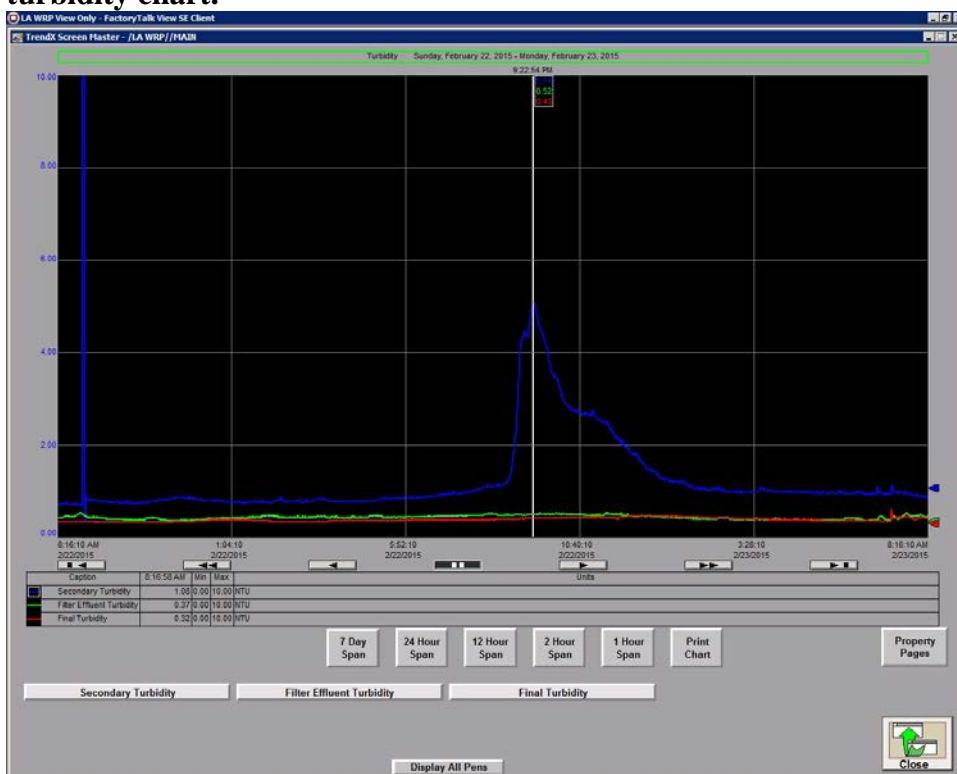
**Figure 7: 2-22-15 through 2-23-15 Lancaster WRP secondary turbidity chart.**

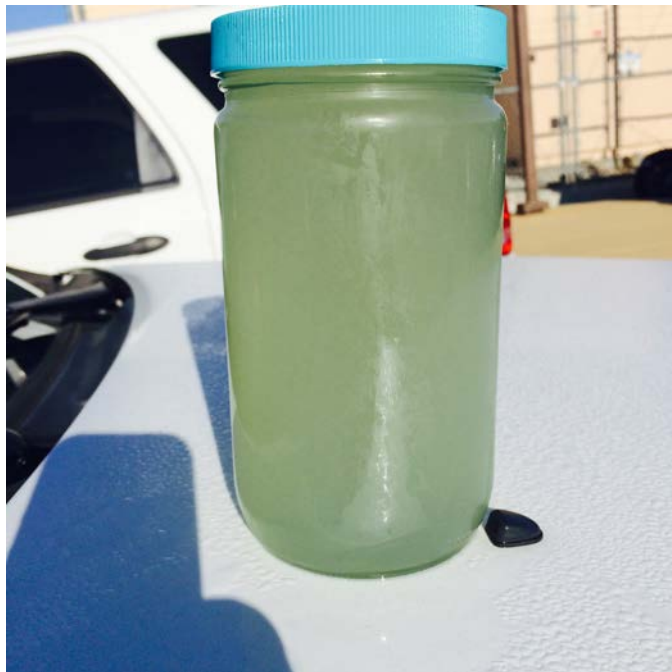
**Figure 10: Green color sample taken on 2-27-15 from a Lancaster WRP primary tank.**

The investigation by current area I.W. Inspector Jonathon Powell and former area I.W. Inspector James McCurdy to find the source of the green color included site inspections at multiple upstream industrial dischargers as well as laboratory comparison analysis of the colored wastewater with various dyeing agents. However, no definitive source was identified. It was

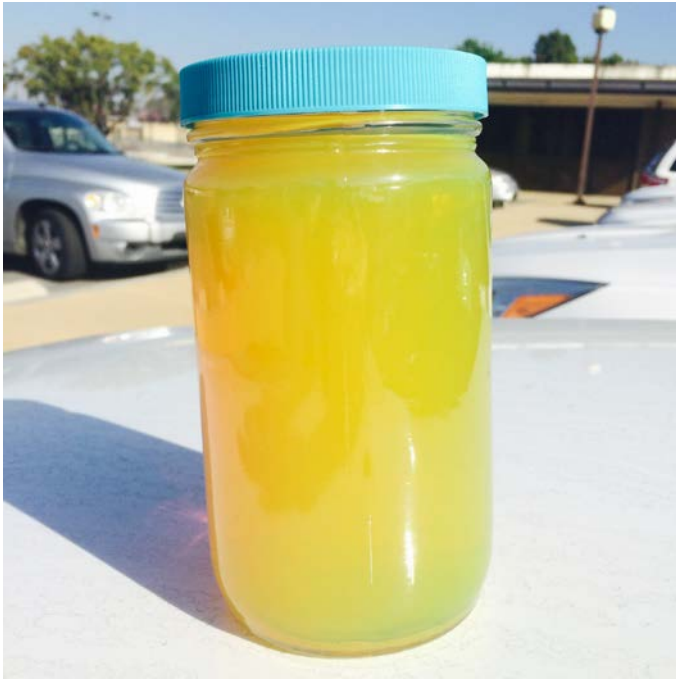
noted that a large (approximately 10,900-gallon) accidental discharge of somewhat similarly colored chilling system coolant water from a Lockheed Martin Corporation facility (Plant 10) in north Palmdale had occurred at a time that corresponded well with the color incident at the WRP. But extensive follow-up and investigation of this discharge ultimately indicated the chiller coolant would have flowed to the Palmdale WRP, not the Lancaster WRP. Palmdale WRP operators did not report or observe any green-colored material coming into their plant on 2-27-15. Lab analysis indicated the color seen in the treatment plant had chemical characteristics matching those seen in fluorescein dyes typically used for water/sewer pipe testing. Multiple sewer agencies including those at the Districts' Sewer Maintenance, the City of Lancaster, the Los Angeles County Department of Public Works, and the City of Palmdale were contacted regarding possible maintenance projects involving the use of colored dyes, but all denied any activity was performed during the suspected time of the event. I.W. Inspectors continue to monitor the operations at the treatment plant and upstream dischargers in case the issue is reported in the future.

**Figure 11: Sample of the chiller coolant solution used by Lockheed Martin Corp, some of which was accidentally discharged into the sewer on 2-27-15.**

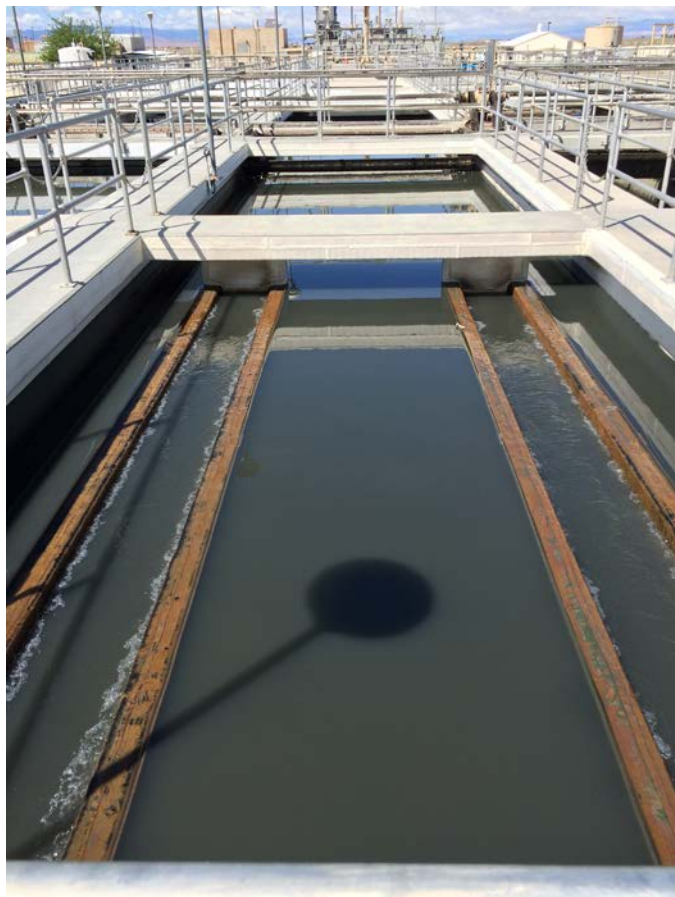
**Figure 2: 4-8-15 photo of a primary tank at Lancaster WRP. Note the dark color present.**

An investigation by area I.W. Inspector Jonathon Powell concluded that the black color reported in the grit chambers at 0830 hours on 4/8/2015 was most likely caused by a dark-colored load of septic tank waste received at Lancaster LWDS earlier in the day at 0732 hours. Samples were collected from the grit chamber and the LWDS for comparison, revealing a close match. The exact nature of the dark material is unknown, but it did not pass through into secondary treatment tanks and WRP secondary treatment operations were not impacted. No final effluent exceedances resulted from the incident. No further investigation is anticipated.

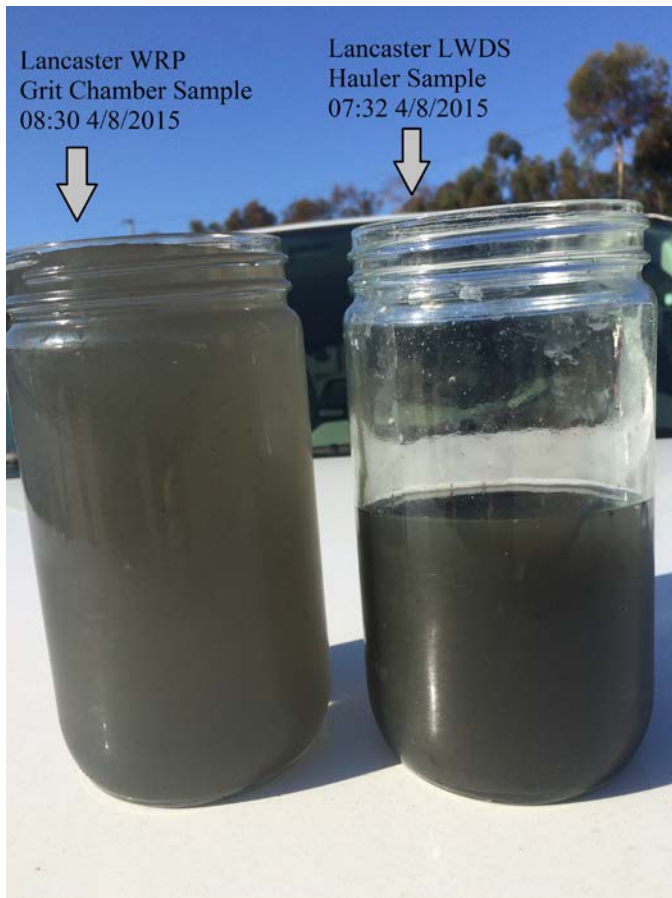
**Figure 3: 4-8-15 photo comparing the color and appearance of samples taken from the grit chamber of the Lancaster WRP and from a load of septage dumped at the Lancaster LWDS immediately upstream of the WRP.**

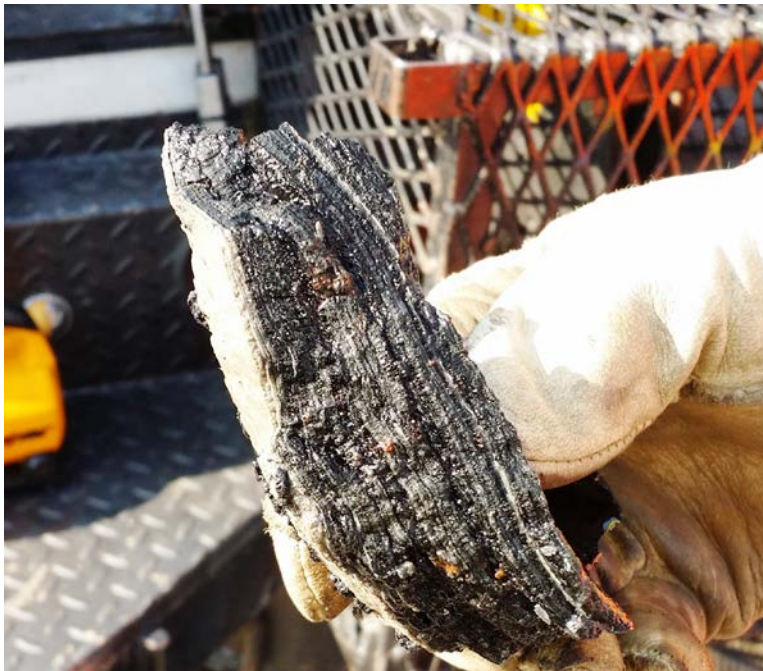
I.W. Inspectors Peter Carlstrom, Nguyen Dang and Senior Inspector Steve Sealy met with sewer maintenance crew lead Robert Benevides at MH 22 1214A at 0830 hours on 4-13-15. Benevides showed inspectors the large scale chunk in the sewer at the connection of the Davis Wire sewer line to the Districts' trunk (see Figures 7 and 8 below). The scaling material was found in the eddy area of the connection of the 2 sewers and trails back up into the Davis Wire connection. It was confirmed there was no scaling present in the trunk downstream of MH 22-1214A.

**Figure 8: Piece of the scale removed from MH 2214A on 4-13-15. Note the layered appearance indicating it likely built up over a period of time.**

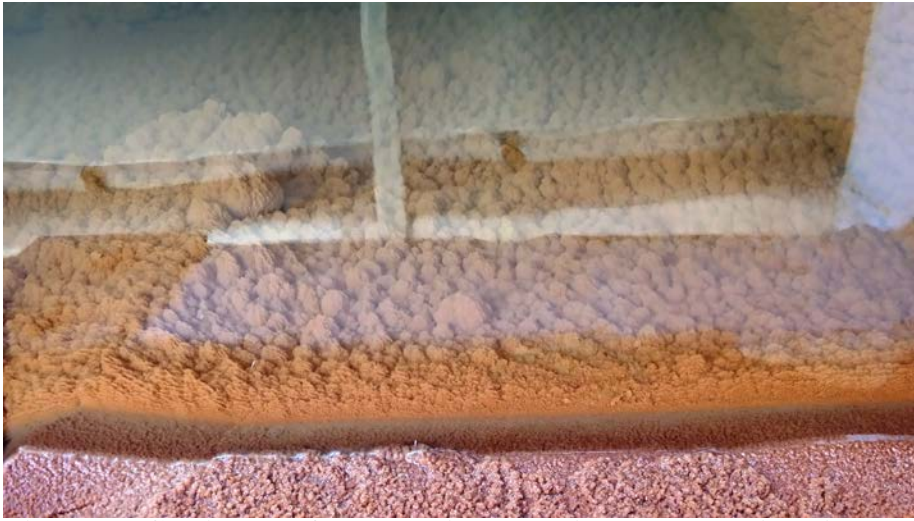
The investigation inspection at Davis Wire found heavy scaling in the company's flow metering weir box (see Figure 9) and other locations in the company's discharge line. The scale was analyzed and determined to be calcium sulfate which chemically matched that of a chunk of the material removed from MH 22 1214A. Davis Wire contact Nancy Felix agreed that the scaling found in the trunk is from her company. She was instructed to clean the sewer on their property as soon as possible to prevent further scaling in the Districts' trunk downstream. A verbal warning was issued to the company for causing the incident. The calcium source is from the company's use of lime slurry (calcium carbonate) for industrial wastewater pH neutralization. A possible solution to this issue may be switching the neutralization solution used at Davis Wire's pretreatment system from lime slurry to sodium hydroxide.

**Figure 9: Calcium sulfate scale in the weir box at Davis Wire on 4-13-15.**

Per a 5-1-15 email from Felix, the company contracted with Pro Pipe Professional Pipe Services to clean the site discharge sewer pipe. There have been no reports of any further issues in the Irwindale Avenue Relief Trunk since the 4-13-15 incident.

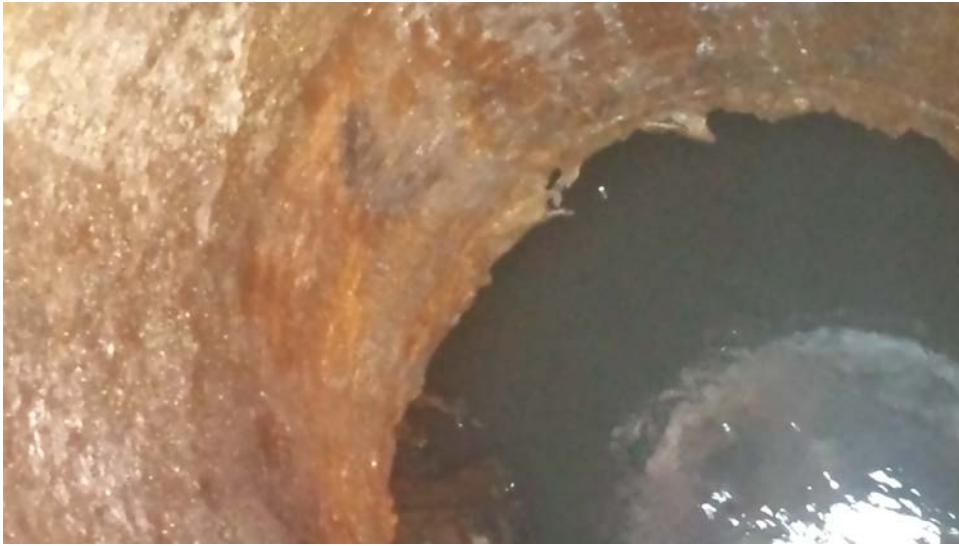
**Figure 11: 4-27-15 photo of the interior of manhole 03 0427 on the Water Street trunk in Long Beach. Note the orange tint of the epoxy liner.**

Area Inspector Sanjay Patel and Senior I.W. Inspector Andrew Woods inspected MH 03 0427 on Monday, 4-27-15 and observed epoxy resin and liner material on the sides of the manhole riser that matched a photograph of the material removed from the manhole taken by sewer maintenance workers at the Compton Field Office (see Figure 11 above). Patel and Woods concluded it was very likely the liner and epoxy resin adhesive fell off from the manhole shaft.

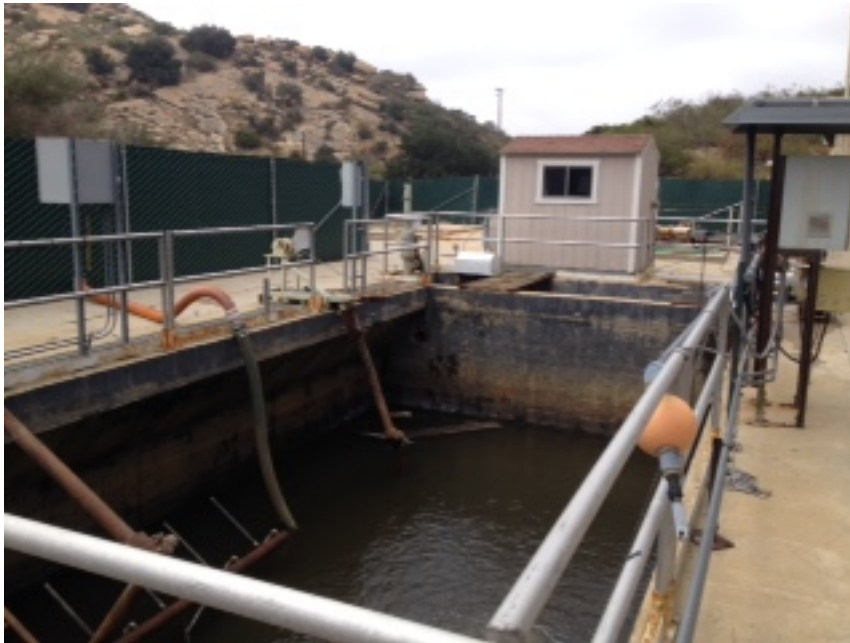
A field inspection was conducted at the Santa Susana Field Laboratory (SSFL) by Senior I.W. Inspector Bill Barnum on 5-27-15. SSFL is a former rocket testing and nuclear energy research facility that is a current Superfund site owned by Boeing and NASA with surface soil and groundwater remediation conducted by Boeing, NASA and the Department of Energy. The inspection confirmed the source of the "septic tank" waste hauled to the JWPCP LWDS is from a decommissioned "pocket" sanitary wastewater treatment plant. According to Boeing Facilities Manager Bill Gruener the septic tank is connected to existing office structures and temporary

**Figure 1: 5-27-15 photo of the old pocket wastewater treatment plant at the Santa Susana facility that now functions as a septic waste collection tank.**

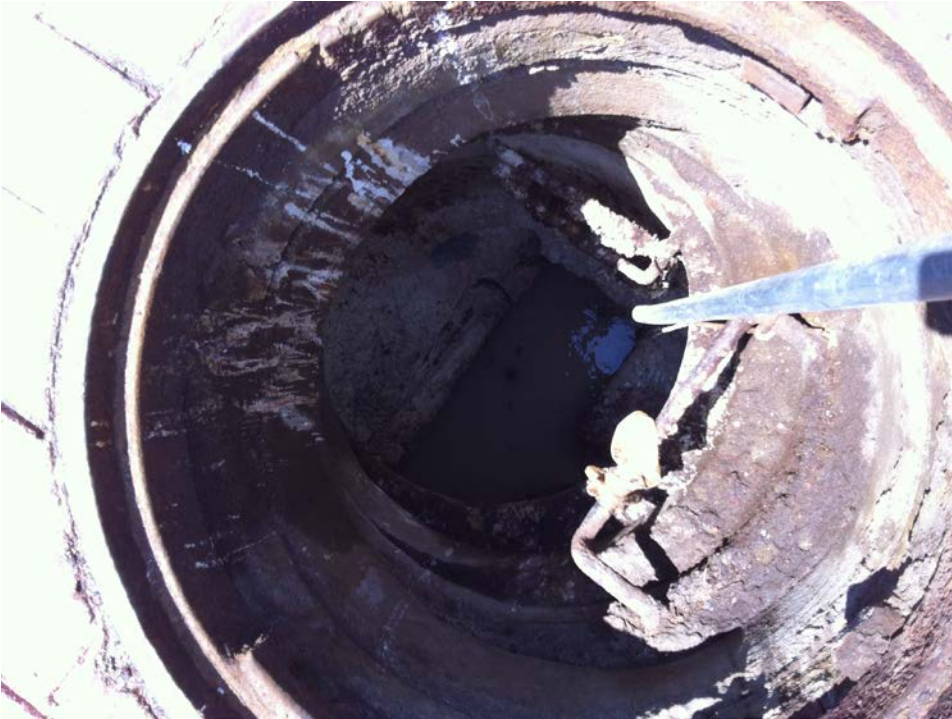
**Figure 3: 5-20-15 photo of MH 18 1083.**

Area I.W. Inspector Jason Finn and Senior I.W. Inspector Bill Barnum participated in this investigation. The sample collected by the driver was examined by Laboratory Supervisor Steve Carr. Analysis of the floating black goeey material collected by the driver indicated it did not contain petroleum oil as was initially suspected. The material had a fibrous consistency and was dark in color. Carr stated that the fibrous material is commonly seen in samples collected from the Districts' collection system and is essentially bio growth. A sample of the grey and white gritty solid material that was sitting in the bottom of the line at MH 18 1083 was also analyzed. This material reacted with hydrochloric acid in an effervescent manner, indicating it was a calcium or magnesium carbonate material. When Carr was informed that calcium hydroxide was used as a treatment chemical at the manhole, he said he believed what was occurring is the calcium hydroxide is acting as a precipitating agent, causing excessive calcium

carbonate ( $\text{CaCO}_3$ ) solids to precipitate out of solution with other material already present in the line, thus causing the floating viscous material and carbonate particulates observed at the manhole. 5-22-15 inspection of the trunk sewer upstream of MH 18 1083 by Supervising I.W. Inspector David Sanchez found no evidence of any solid or viscous material similar to that found at MH 18 1083, indicating no upstream source for the material.

Results of the metals test analysis of the solids revealed that it is primarily calcium carbonate based on a calcium result of 111,000 mg/kg. It is believed that the weekly dosing of calcium hydroxide solution caused  $\text{CaCO}_3$  to buildup, this combined with the slow velocity in the line, gradually resulted in partial line obstruction and the observed surcharging to occur.

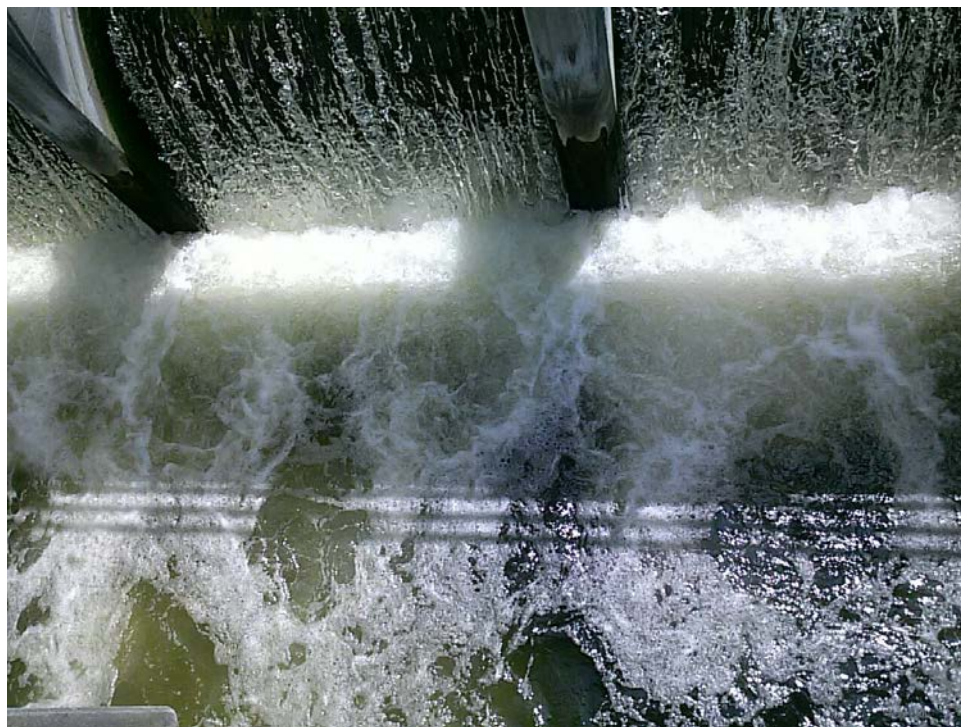
On Thursday, 5-28-15 at 1055 hours, Los Coyotes WRP TPO II Will Moriarty notified Supervising I.W. Inspector David Sanchez of yellow colored wastewater in final effluent forebay. The color was noticed at about 1030 hours. With the 10-hour retention time in the plant, it was estimated the colored material may have entered the plant at about midnight on 5-27-15.

**Figure 4: LCWRP effluent at the forebay at 1140 hours on 5-28-15.**

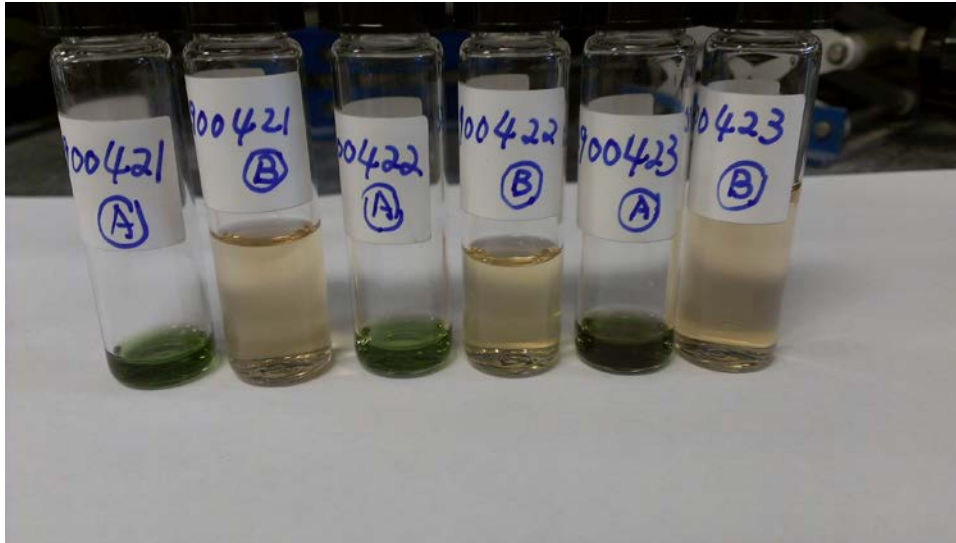
It was also noted that when samples of the yellow color in the final effluent were extracted using methanol, the color changed to green (see Figure 5 below), indicating investigators may need to search for industrial sources with green-colored discharge if a similar yellow color is observed at the WRP in the future. Inspectors are also working to develop a library of colors from dye companies to assess and investigate future similar incidents. According to the WRP operators, there were no adverse effects on treatment plant operations and no NPDES violations occurred due to this incident.

**Figure 5: Methanol eluents A and B for 3 LCWRP yellow colored effluent samples.**

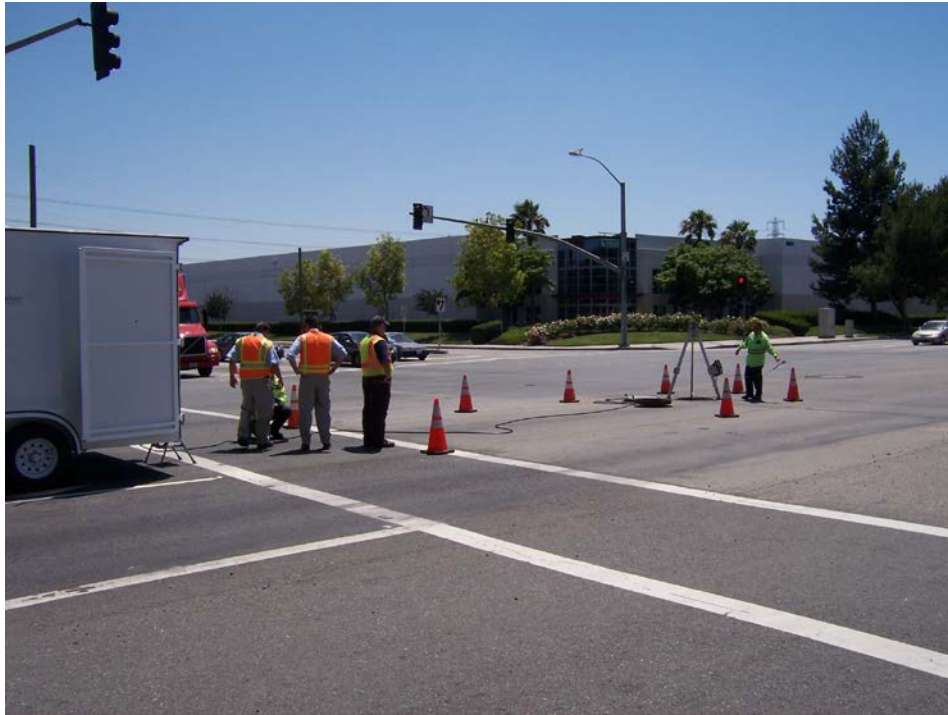
On Wednesday, 6-17-15 Districts' and IEUA I.W. Inspectors met with IEUA sewer maintenance personnel at the local sewer connection manhole utilized by Starlite Reclamation for the discharge of industrial wastewater. As a result of the previous violations and the violations noted during the search warrant issuance, the company's I.W. permit was revoked and their connection to the sewer was sealed. As a result, the company is currently no longer discharging industrial wastewater to the sewer.

**Figure 2: IEUA sewer maintenance personnel preparing to enter the manhole where they sealed the I.W. connection line from Starlite Reclamation Environmental Services, Inc. on 6-17-15.**

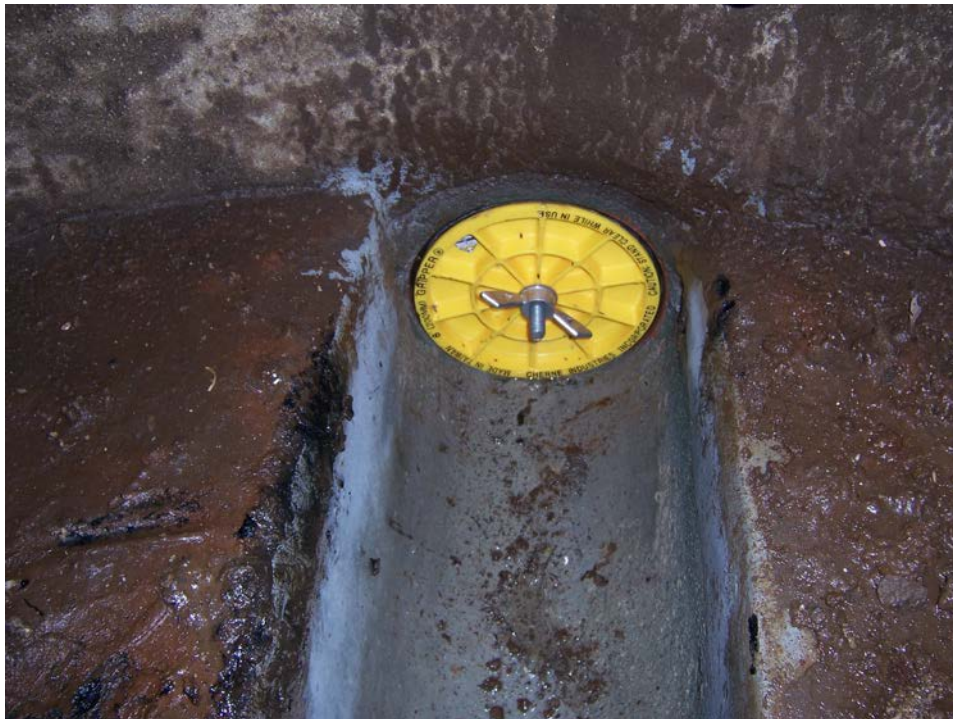
**Figure 3: 8" diameter sewer line expansion plug installed by IEUA on 6-17-15 which effectively sealed Starlite Reclamation's I.W. connection.**

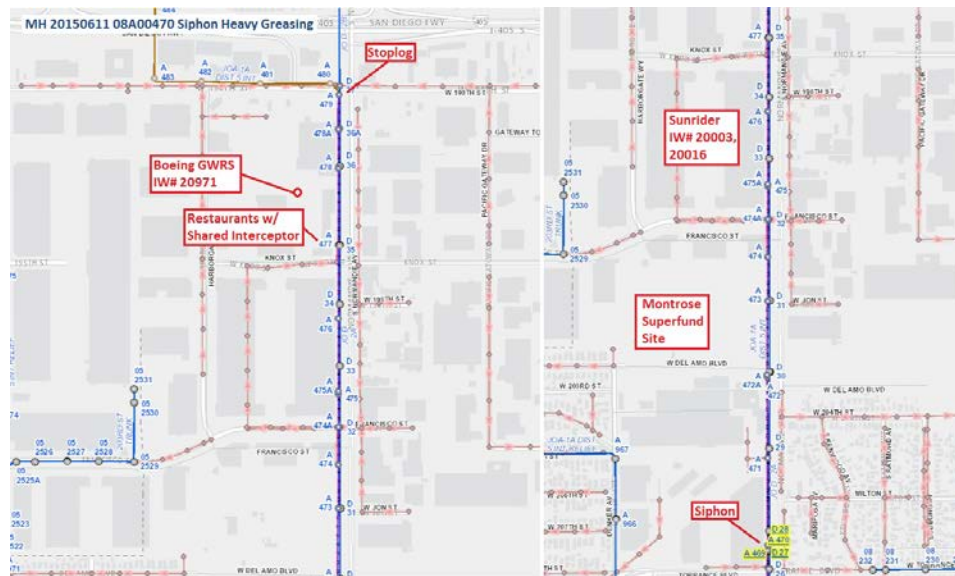
**Figure 5: Sewer line diagrams indicating the area upstream of MH 08A0470 where heavy greasing was found on 6-11-15 by a Districts' CCTV crew.**

While there was accumulated grease observed at the siphon in question, the investigation did not identify any single source as being responsible for this FOG. Due to the installation of a stoplog at MH 08A0479, which diverted tributary flows upstream of this manhole into J.O. 'D' (which runs parallel along Normandie Avenue), the length of the contributing sewer was limited to 1.2 miles upstream from the siphon during the two months following the trunk sewer cleaning. Industrial users tributary to this reach of trunk sewer were inspected by Barnum and Placencia. Additionally, the conditions in manholes upstream of the affected siphon were also inspected. Despite the extremely low volume flow volumes observed in the trunk, which were as low as ~5 gpm, there was no observable accumulation or deposition of grease in any of these structures with the exception of the reported floating mass of grease immediately upstream of the MH A470-A469 siphon. The likely cause of the FOG accumulation found there is that the very low flowrate in the trunk allowed the previously insignificant grease contributions from restaurants and industrial users along this reach to accumulate at the siphon. Instead of this material being flushed through by previously-typical 60" trunk velocities, grease accumulated at the upstream side of the siphon.

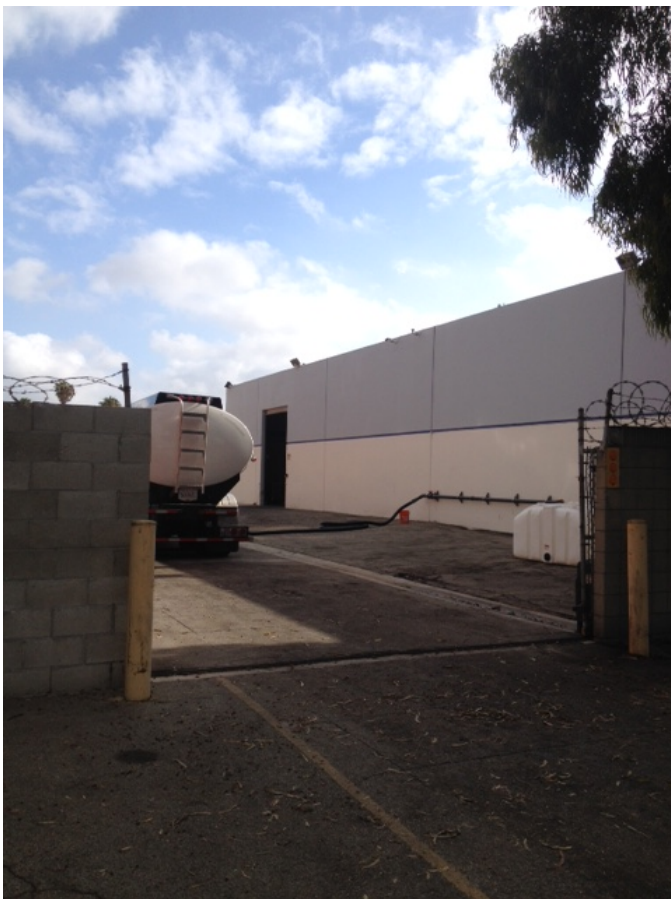
blends and packages dry urea mixed with purified water to make diesel exhaust fluid (“D.E.F.”) for distribution in bulk and sale in small containers. There were no industrial wastewater drains or connections found at the facility and no evidence of illicit sanitary sewer discharge. The CEO of the company, Mr. Robert Balov, was interviewed during the inspection. However, he claimed no knowledge of the day-to-day operations of the facility and that any waste derived from the blending operation or the reverse osmosis/electronic deionizer is stored in outdoor totes which are picked up by his "customers." Based on the elevated pH found in standing water in an adjacent storm water sump, which is located downstream of a swale where the totes are stored, it appears likely the company is periodically discharging urea laden water and possibly R/O reject into the storm water collection system. Since this is a storm water concern, a referral letter was sent on July 23, 2015 to the Los Angeles Department of Public Works and Los Angeles County Fire-Health/Hazmat for follow up. Barnum will periodically drive by the facility in an effort to document any activities indicating illicit storm water discharges are occurring.

**Figure 1: 7-9-15 photo of tanker truck loading/unloading Area at SPF Terminals in Compton. Note the white tote used for wastewater storage against the building and adjacent storm water swale which was found to have small amounts of alkaline (pH=9) water.**

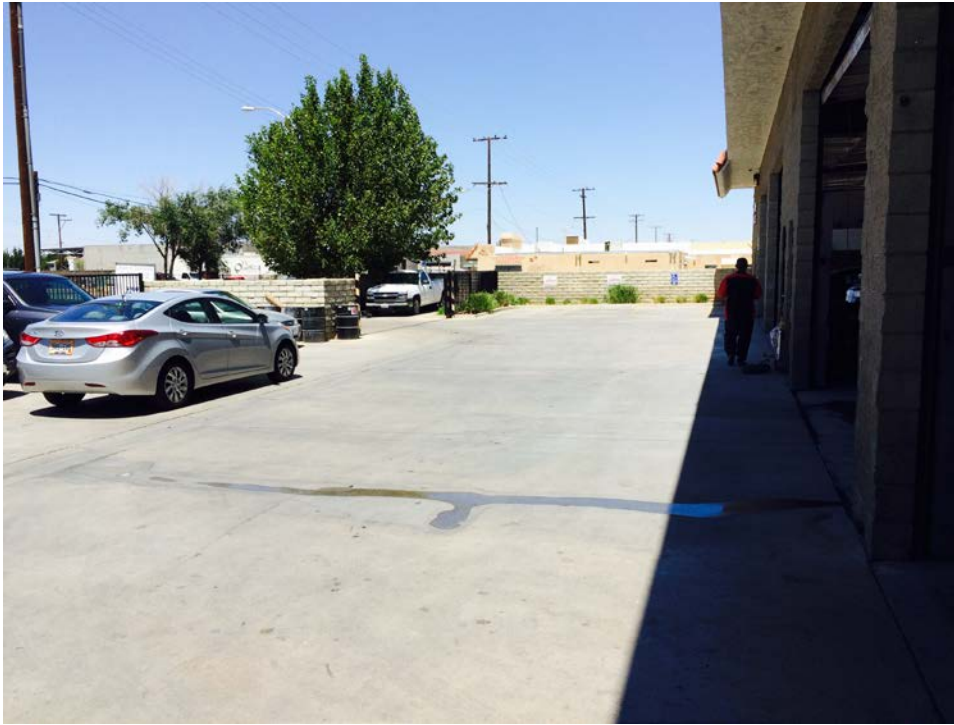
Area I.W. Inspector Jonathon Powell investigated the report, arriving onsite to conduct a site inspection at 1200 hours on 7-28-15. Precision Carstar Auto Body Repair conducts auto body repair and painting operations at this facility. Body work is done in one unit with sanding, dent repair, and other dry operations, and then taken to an adjacent unit for painting and finishing work that includes washing the vehicles. The company has a paint station and spray booth, but no floor drains observed in either unit. Inspection of the facility's restrooms found no evidence of illicit discharges of industrial wastes. The company contact, Owner Mr. Karn Bryan, stated the company generates some waste oil, coolant, and solvent, but said they store it in drums and haul it off-site for proper recycling/disposal. Review of waste manifests subsequently submitted by the company appears to verify this claim. At the time of the inspection some washing operations from wet sanding was observed flowing to a driveway swale (see Figure 3 below), although it appeared to be evaporating prior to entering the offsite storm drain. A contact at a neighboring company, Advanced Mufflers, stated that this occurs frequently. Powell also noticed stains of dried residue leading from the swale to the storm drain. Powell verbally warned Precision Carstar Auto Body not to discharge any industrial wastewater into the storm drain. The owner agreed to look into containing their washing operations to prevent runoff from getting into the storm drain. Powell explained Districts' permit requirements and regulations for such operations. Powell will conduct follow-up inspections to monitor the company's coming into compliance with all applicable industrial wastewater and storm water regulations. Failure to correct storm water violations will result in referral to the City of Palmdale.

**Figure 3: Minor amount of wastewater in front of Precision Auto Body Repair observed by I.W. Inspector Jonathon Powell on 7-28-15.**

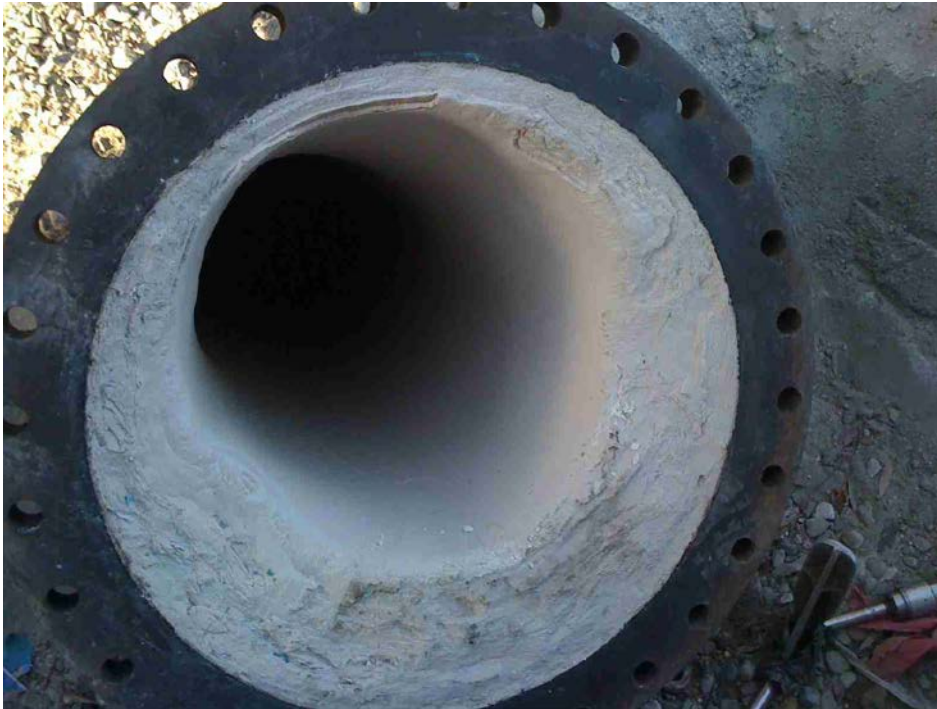
**Figure 1: Example of the scale that typically builds up in the Tesoro refinery's 30" diameter I.W. discharge line. This photo was taken of the line in 2009.**

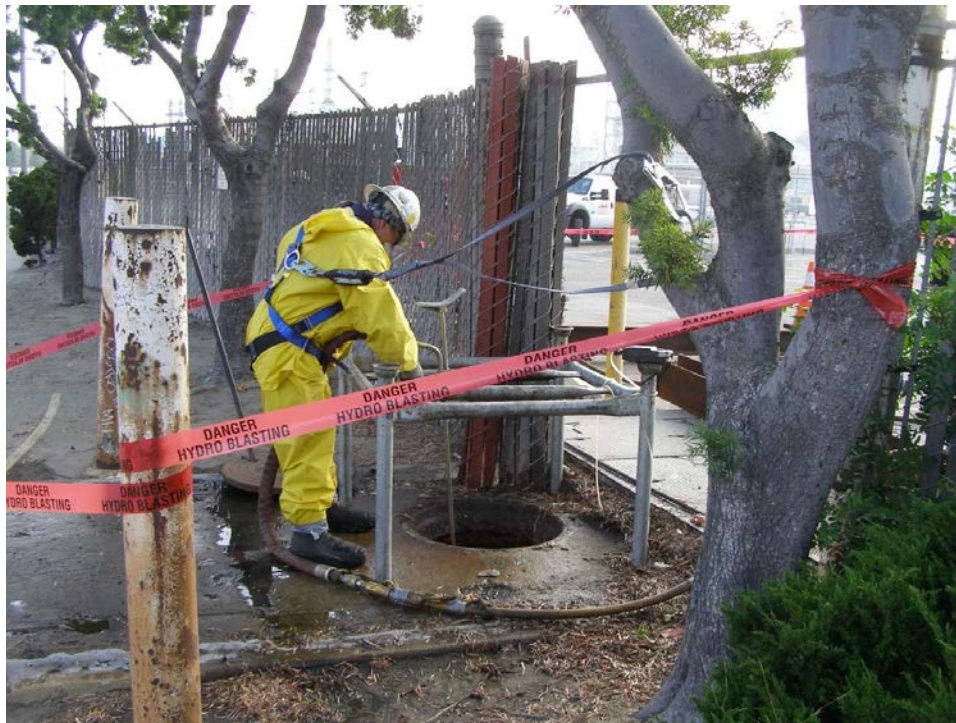
**Figure 3: Worker accessing manhole B18A on 8-24-15 to hydrojet the Tesoro Refinery's line where it connects to the J.O. 'B' trunk (Photo by Districts' I.W. Inspector Shawn Cleaver).**

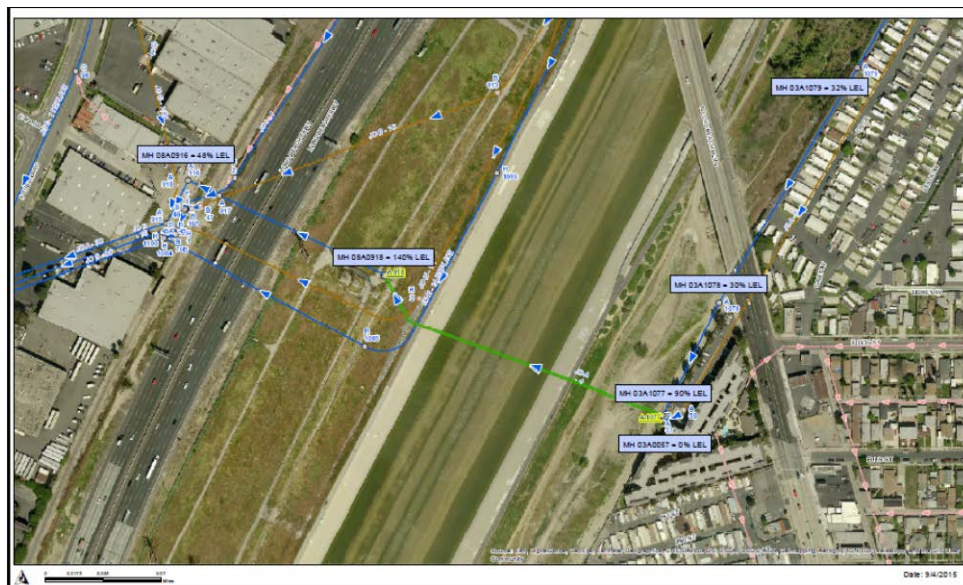
**Figure 4: Sewer diagram indicating I.W. inspector explosivity levels found at various manholes during their investigation on 9-2-15.**

Night Team Senior I.W. Inspector Kent McIntosh, along with I.W. Inspectors Kristopher McGinnis and Tanna Pekin investigated the report. They confirmed the presence of high LEL conditions at MH 03A1077 (See Figure 4 data above). The night inspectors investigated the two upstream oil refineries, Edgington Oil Company LLC (Permit 20088) and Paramount Petroleum (Permit 17236); both were found to have 0% LEL per shake jar tests at their outfalls and were ruled out as being the source of the explosive conditions in and around MH 1077.

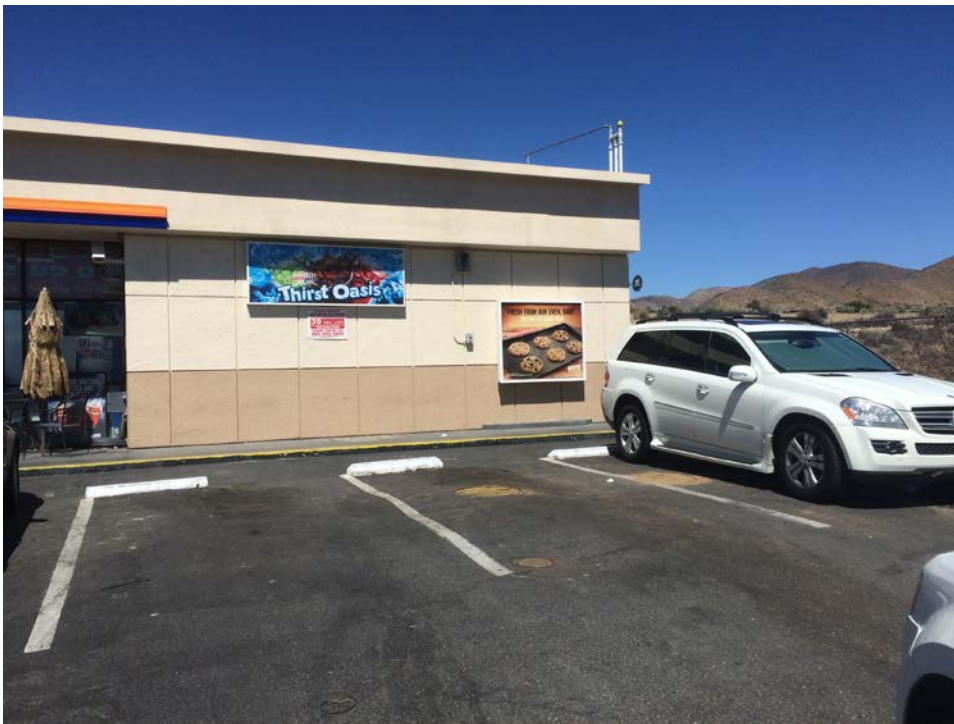
**Figure 6: 1500 gallon septic tank system located in the parking lot of the Arco AM/PM facility on 9-17-15.**

Powell inspected the Arco AM/PM facility on Thursday, 9-17-15. He confirmed the presence of a 1500-gallon septic tank on-site that is serviced every 6-8 months according to the owner, Mr. Hossein Shoar. Powell reviewed all operations at the facility. The inspection did not reveal any evidence of wrongdoing or illicit activity either at the facility or on the part of the waste hauler. A bottle of high pH drain cleaning solution "Pro Power Drain Cleaner" was noted at a mop sink inside the building, but Mr. Shoar stated it hadn't been used recently. Despite this, Powell thinks it likely the use of the cleaner was the source of the high pH found in the load brought to the Lancaster LWDS on 9-14-15. No further investigation or follow-up action is anticipated.
