**2015 ANNUAL REPORT**

INDUSTRIAL WASTE PRETREATMENT PROGRAM

COUNTY SANITATION DISTRICTS OF LOS ANGELES COUNTY

**APPENDIX H**  
INDUSTRIAL WASTE REPORTS ON INCIDENTS

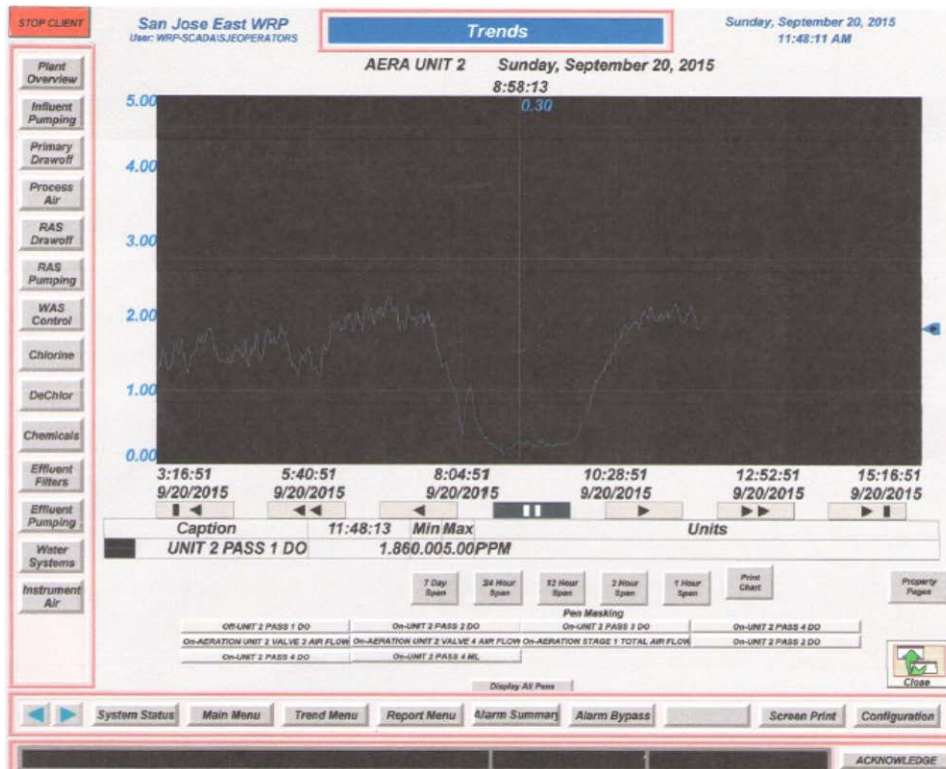
At 0915 hours on 9-20-15 Boyd contacted operators at the SJC East WRP to get a situation report on plant operations. Boyd spoke with TPO II Courtney Clark. Clark reported that earlier that morning he had noted a decrease in the dissolved oxygen concentrations in the first passes of the secondary tanks. He said he responded to this by turning up the process air compressor (PAC) blowers. Subsequently, the dissolved oxygen levels quickly returned to normal. Clark said he was glad to know what had caused the decrease in D.O. concentrations. Ultimately, the WRP was able to handle the extra load without difficulty and final effluent quality was unaffected.

**Figure 7: SJC East WRP SCADA system screen shot of Aeration Unit 2 dissolved oxygen data trend on 9-20-2015.**

A follow-up site inspection at Zausner Foods on 9-21-15 by Area I.W. Inspector Pat Cashen confirmed that a brief power failure in the overnight hours at the facility the previous day caused a computer malfunction which led to the release of approximately 3500 gallons of milk to the sewer. Representatives at Zausner Foods said that they were investigating the plant computer programming to find a solution which would prevent the situation from recurring. In the meantime they will be manually closing all valves on storage tanks during the overnight hours.

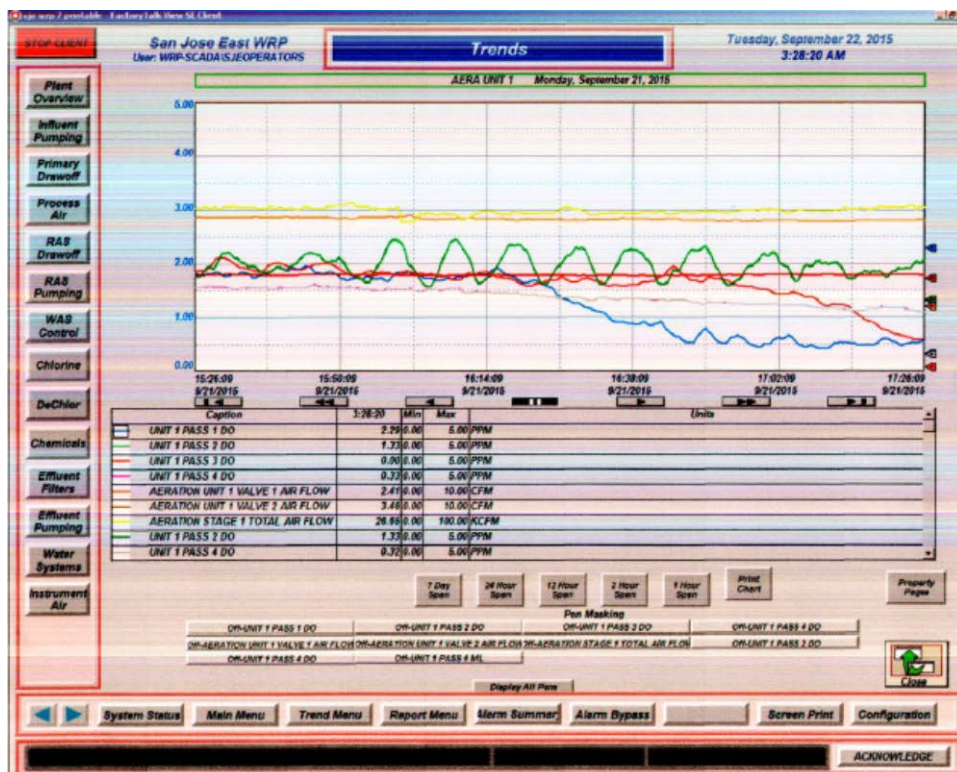
On Tuesday, 9-22-15 at 0800 hours, San Jose Creek East Supervising TPO Jeff Valdes left a voice mail message for I.W. Inspector Pat Cashen reporting that at approximately 1615 hours on the previous day (Monday, 9/21) the SJC East WRP saw a drop in dissolved oxygen concentrations in the first passes of the aeration tanks. Operators responded by increasing PAC output which quickly compensated for the demand and by 1815 hours the levels were back to normal. Valdes indicated that the event was “definitely less than the earlier event on Sunday, 9/20” caused by the accidental discharge of 3500 gallons of milk from Zausner Foods (see incident notes above). On 9-21-15 WRP operators saw no visual evidence of any abnormalities in the wastewater, the pH was normal and there were no lasting effects on operations. Valdes wanted to notify the I.W. Section of this most recent incident in case there was some relation to the 9/20 event.

Figure 8: SJC East WRP SCADA system screen shot of Aeration Units 1-5 dissolved oxygen data trends on 9-21-2015.

Investigation inspections were conducted by I.W. Inspectors Cashen and Nguyen Dang at multiple (9) suspect upstream industrial waste dischargers, including Zausner Foods LLC. These inspections failed to identify a likely source for the of the 9-21-15 incident. I.W. inspectors will continue to monitor WRP operations and respond to any future incidents.

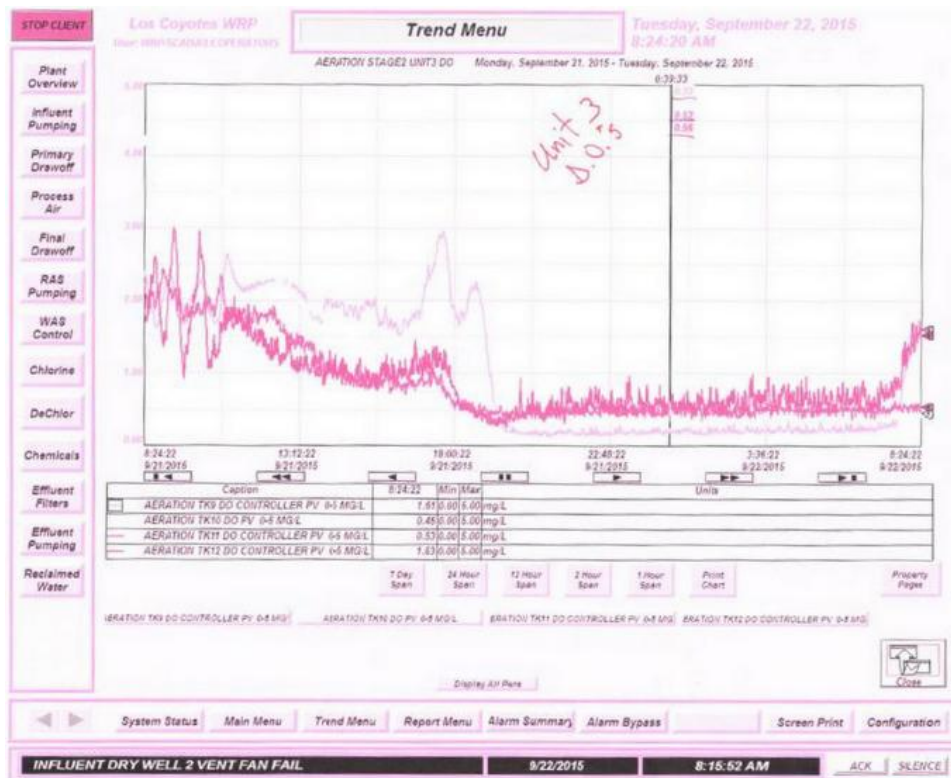
On Tuesday, 9-22-15 at 0735 hours, Los Coyotes WRP TPO I Ryne Shay, notified Supervising I.W. Inspector Barbara Jenkins that operators had noted low dissolved oxygen levels in the secondary tanks beginning at about 2100 hours the previous evening. Operators believed the material causing the low dissolved oxygen levels was still entering the plant as of 0900 hours on 9-22-15. They reported they had increased the PAC's output to their maximum in response to the condition.

On Wednesday, 9-23-15 Jenkins was contacted by LC WRP Supervising TPO Michael Barker. Barker reported that the WRP was experiencing another drop in secondary tank dissolved oxygen concentrations starting at 1445 hours that day. He stated there were no other plant operation problems. Influent pH was within the normal range and there was no color in the wastewater. Barker also stated the low dissolved oxygen levels from the 9-22-15 incident had returned to normal by 0950 hours on the 23rd and he considered it is likely that the latest low dissolved oxygen levels were occurring in response to a separate slug of high strength waste material coming into the WRP.

**Figure 9: Los Coyotes WRP SCADA system screen shot of dissolved oxygen, PAC, pH and ammonia trends 9-22-15.**

samples taken at the WRP essentially found no evidence that any high strength material had entered the plant. Samples tested included; raw composite (595 mg/l), primary grab on 9-21-15 at 2200 hours (473 mg/l), and a sewer grab taken from MH A0157 on the Los Coyotes interceptor trunk upstream of the plant (657 mg/l).

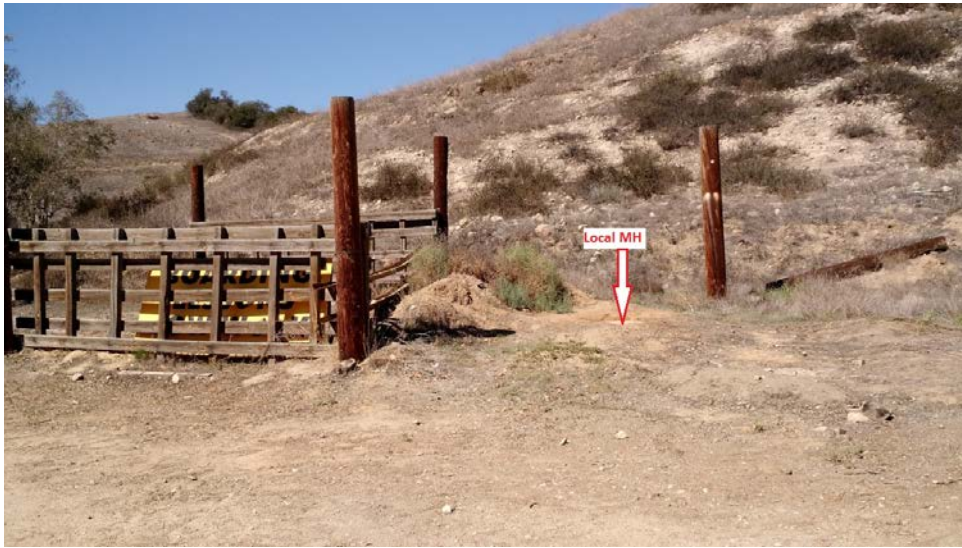
Area I.W. Inspector Peter Carlstrom and Senior I.W. Inspector Steve Sealy responded. Carlstrom arrived on-site at 1400 hours on 10-2-15. He observed the local line manhole where the alleged dumping occurred (see Figure 2). He reported there was a minor amount of what appeared to be horse or animal manure near the manhole (see Figure 3), but nothing else that would constitute a need for a raw sewage spill cleanup. At 1515 hours Sealy called Boyd and reported that their initial investigation had found that a small sewage pumping plant located near the RV Park inside the park had failed due to an ongoing power outage. Apparently, the pumping station is maintained by a private operator under contract to L.A. County Parks and Recreation department. The investigation revealed a manager at the L.A. County Parks headquarters authorized Quality Pumping Service to periodically remove the accumulating wastewater (raw sewage) from the pump station wet well and haul the wastewater to the manhole located by the horse stables and dump it there. Given these findings, no further follow-up was performed or is anticipated.

**Figure 2: Local line sewer manhole adjacent to the horse stable area inside the park where the dumping activity was observed by a citizen.**

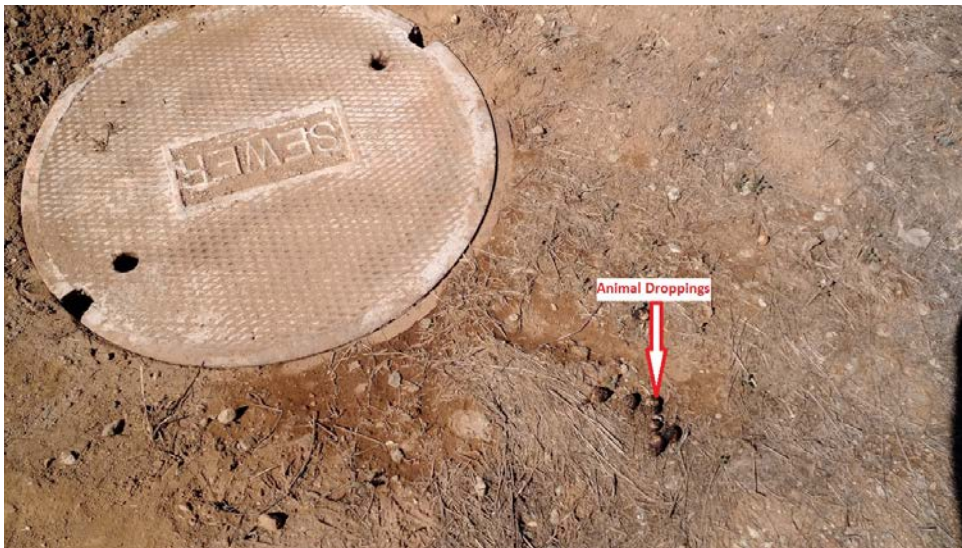
**Figure 3: Close-up photo of the local line manhole where the dumping was observed. Note the lack of sanitary sewer solids or debris.**

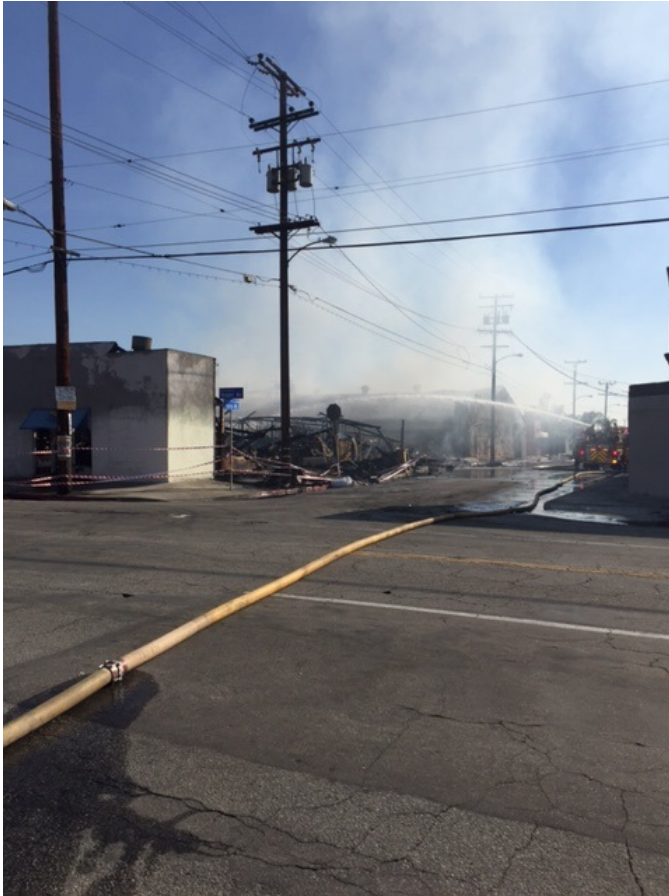
**Figure 8: Photo taken by Senior I.W. Inspector Bill Barnum upon arrival at the scene of the 10-7-15 fire that occurred in an unincorporated area of Los Angeles County west of the city Huntington Park known as “Florence.”**

At 0845 hours Barnum arrived on scene and checked into the command post located on Hooper Avenue south of 58th Place. Barnum determined the fire was within the District's service area with its location south of Slauson Avenue, not north as originally reported (see Figure 7). The Incident Commander, Assistant L.A. County Fire Chief Chris Bundesem, stated the fire started at 0100 hours that morning at a furniture company. The fire quickly spread to surrounding businesses which included a metal fabricator, a mattress company, another furniture company, a masonry supply company, a residence and a bar. A total of five structures were lost and two were partially damaged as a result of the fire. At the time of Barnum's arrival “mop up” on some smoldering hot spots was occurring, but for all intents and purposes the fire had been extinguished. Firefighting water ran off into the storm drain. L.A. County Hazmat Specialists were on-site taking field tests for pH and metals from the runoff and according to L.A. County Fire Department Health/Hazmat Specialist Gerhardt Trippel all the runoff had a neutral pH (i.e., 7) and no significant readings for heavy metals. As such he anticipated none would be captured for disposal into the sanitary sewer system. Inspection of downstream local sewers found no evidence that any firefighting water had entered the sewer. There was no impact on Districts' facilities or operations as a result of the fire. It was noted that Federal Bureau of Alcohol, Tobacco and Firearms and Explosives agents, as well as the L.A. County Bomb Squad, were on-site investigating this fire due to the recent trend of suspicious fires in the Los Angeles/Huntington Park area.

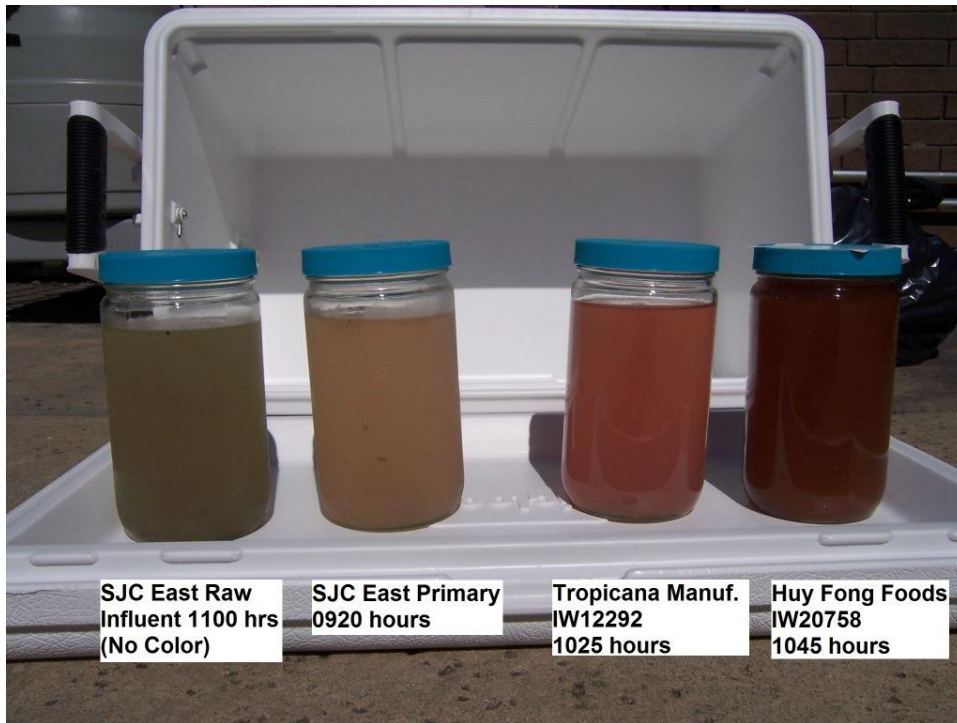
Inspections conducted at multiple industrial facilities (7) upstream of SJC East WRP failed to identify a definitive source of the red color. Samples of wastewater found at two industrial users did have a somewhat similar color (see Figure 10), but the amount of flow from these dischargers individually would not generally have the ability to cause the WRP influent color. I.W. Inspectors believe that the brief period of red color at the WRP on 10-7-15 was due to a coincidental combination of colored water discharged from multiple sources. The only lasted less than 15 minutes and was not seen beyond the influent building and primary settling tanks. WRP Operators reported no abnormal effects on any treatment processes.

**Figure 10: Comparison of samples taken at the SJC-East WRP and upstream I.W. discharge sources on 10-7-15.**

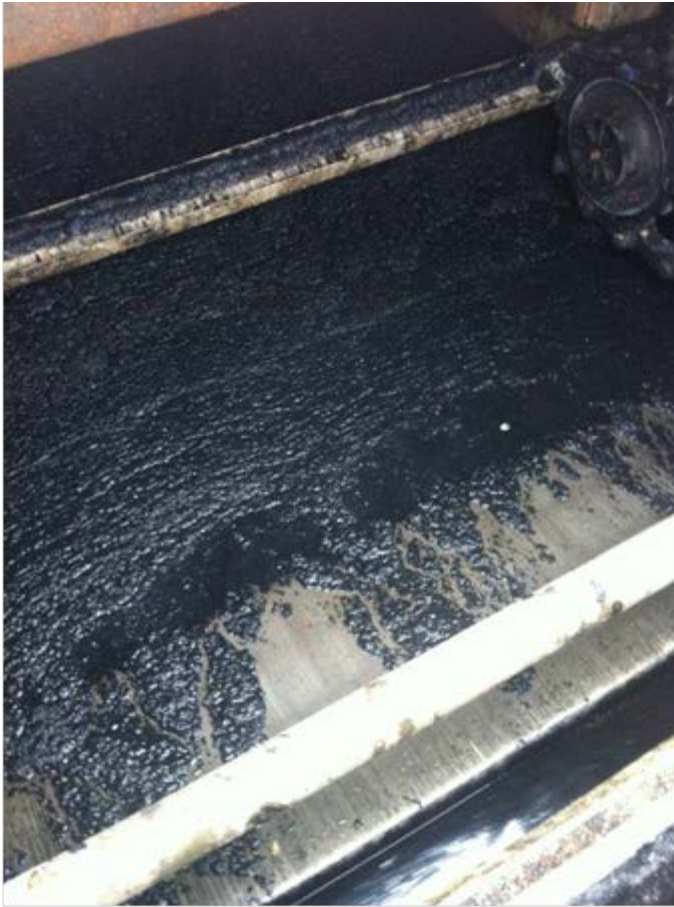
**Figure 11: JWPCP Primary skimmer black solids observed on 7-30-15. Note how the solids, which come from the JWPCP Solids Processing Unit appear essentially visually identical to that of a black oily material.**

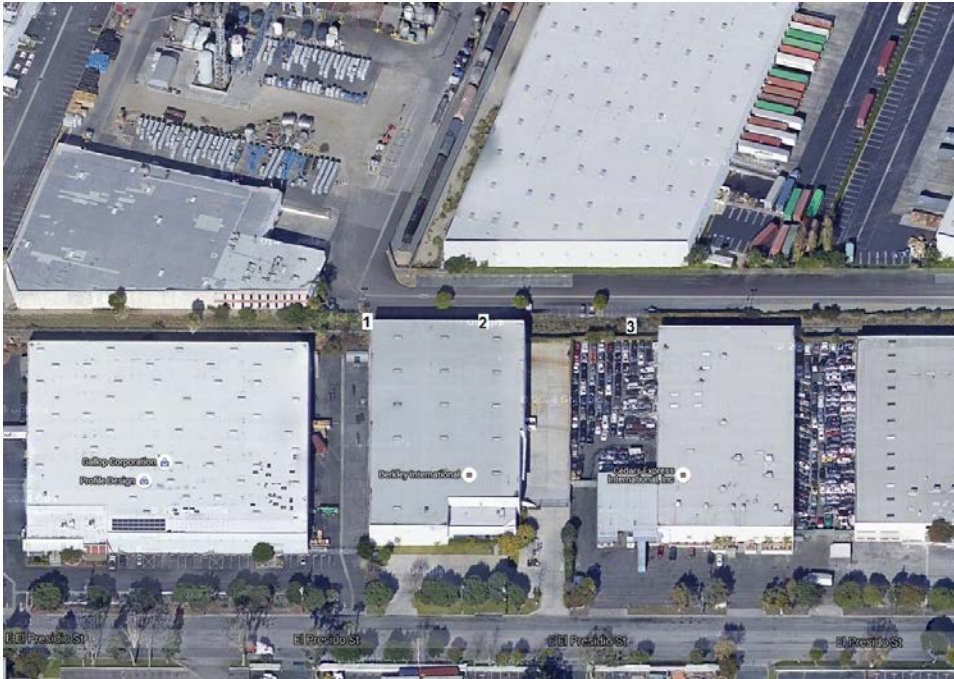
**Figure 6: GIS map showing the area where the sludgy pulp waste was found in the open area north of the building occupied by Berkley International Packaging. The flex hose used to discharge the waste and the start of the waste sludge was located at the area marked as “1”. The sludge extended east through the area marked as “2,” until it ceased at the area marked as “3.”**

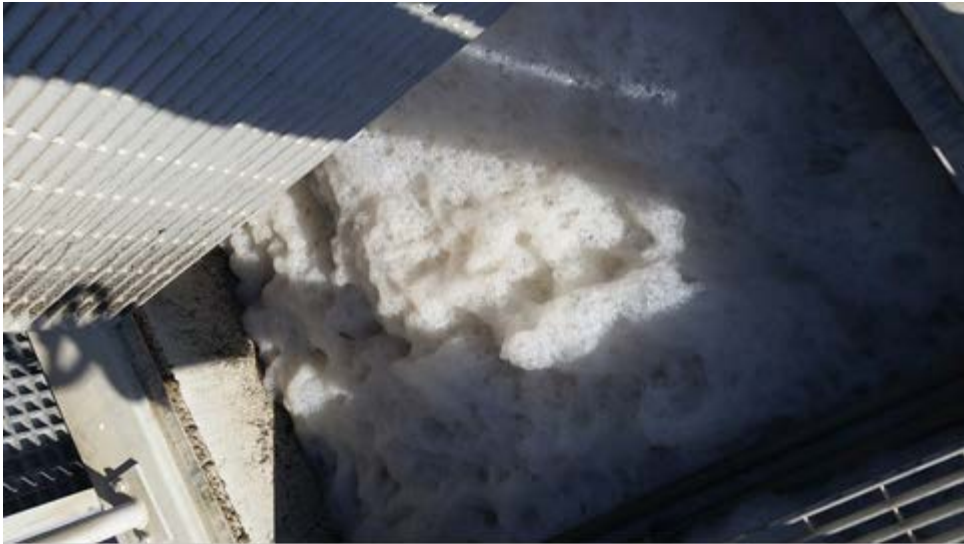
**Figure 7: White foam in a Lancaster WRP grit chamber on 11-18-15 at 0815 hours.**

Upon being notified of the report of white foam at the Lancaster WRP, Powell immediately realized the likely source was the Northrup Grumman Site 3 aircraft facility in Palmdale. On the previous day, 11-17-15, at 1230 hours, during a routine inspection at the facility, Powell noticed several feet of white foam in an industrial wastewater sampling/monitoring flume vault manhole (IW#14934). Questioning of his contact about the foam revealed it was from the company discharging approximately 20,000 gallons of aqueous film forming foam (AFFF) solution that day to the sewer as part of required testing of the facility's fire suppression system. At the time of the discovery, Powell was unaware the foam would impact the downstream Lancaster WRP. Follow-up by Powell on 11-18-15 resulted in the issuance of verbal warnings to Northrup Grumman for the discharge. It was agreed that any further wastewater generated from testing of the fire suppression system at the facility would be collected and hauled offsite for proper disposal at a centralized waste treatment facility where it would not impact Districts' WRP operations. The fire suppression systems at the facility are required to be tested every 5 years. A sample of the AFFF solution was analyzed using an HPLC and compared to the foam sample taken at the WRP on 11-18-15. Test results indicated a near-exact match, thus confirming the source of the foam found at the WRP.

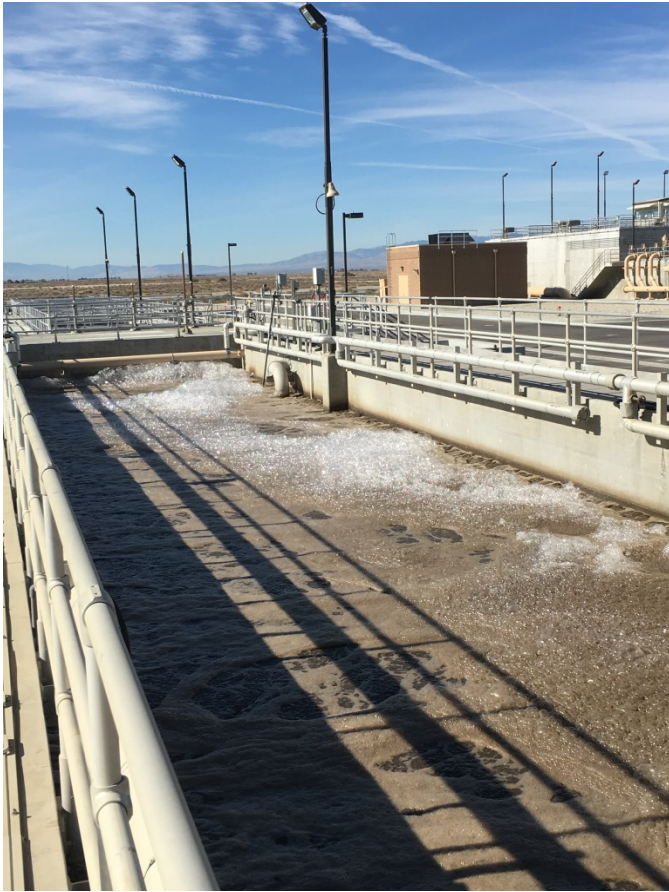
**Figure 8: White foam lingering in the secondary treatment aeration tanks at the Lancaster WRP on the morning of 11-19-15.**

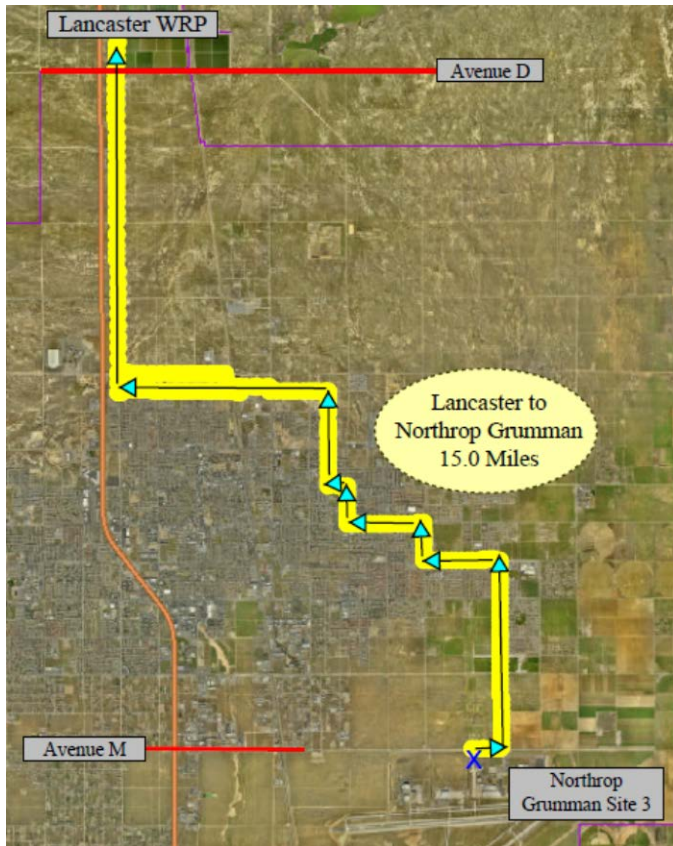
**Figure 10: GIS Diagram indicating the 15-mile long path the AFFF laden wastewater discharged by Northrup Grumman took to the Lancaster WRP.**

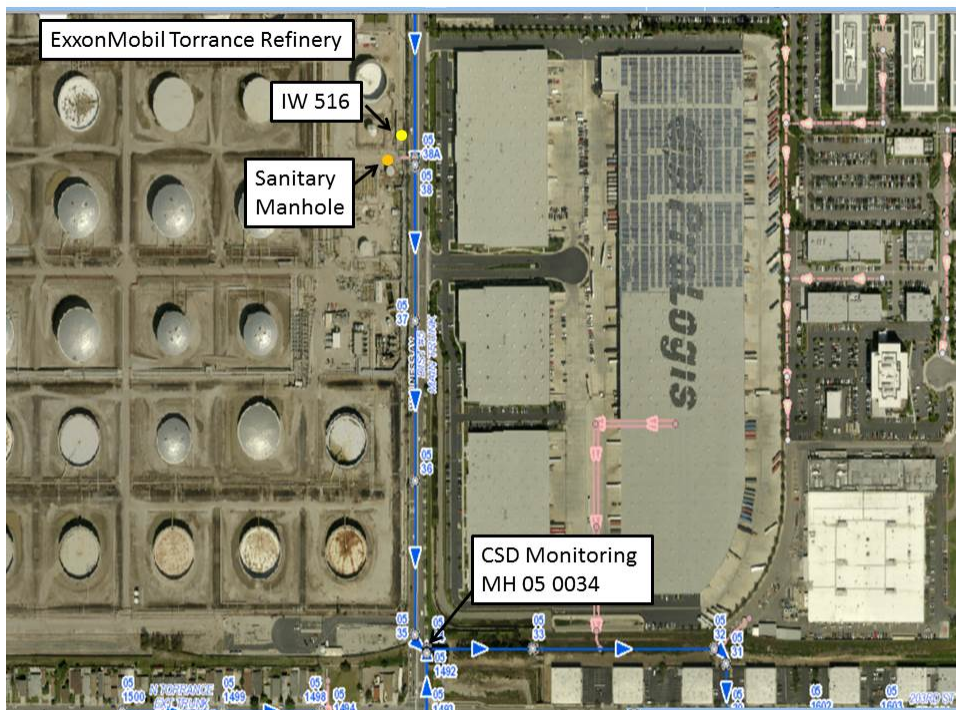
**Figure 11: GIS diagram indicating the location of the IW#516 monitoring location (“Van Ness outfall”) and the nearby sanitary line manhole where high explosivity was detected on 11-19-15. Note that although very close together, the two connect independently to the adjacent 48” District 5 Main trunk.**

McGinnis and Pekin arrived at the ExxonMobil facility at 1545 hours on 11-19-15 and found refinery operators had flushed the facility’s main sanitary line with water, reducing the explosivity level in the sanitary line headspace to 17%. No hydrocarbon or gasoline odors were noted in the sanitary line headspace gases. The refinery was operating normally and discharging industrial wastewater through the Van Ness outfall at 2552 gpm. Field tests indicated compliance with industrial wastewater discharge limits. It should be noted that in 2001-2002, over a period of many months high explosivity levels were noted in the District 5 Main trunk sewer just downstream of the ExxonMobil Torrance refinery. An exhaustive investigation eventually traced the source of the explosivity levels to the same sanitary line noted above. ExxonMobil operators determined the source of the explosivity was a leaking underground gasoline product line that was periodically leaking gasoline into the sanitary line, thus causing explosive conditions both in their own sanitary line and in the downstream Districts’ trunk. As a result of that incident the facility now checks explosivity levels in the sanitary line weekly. This monitoring has found the occasional high explosivity conditions caused by degrading sewer

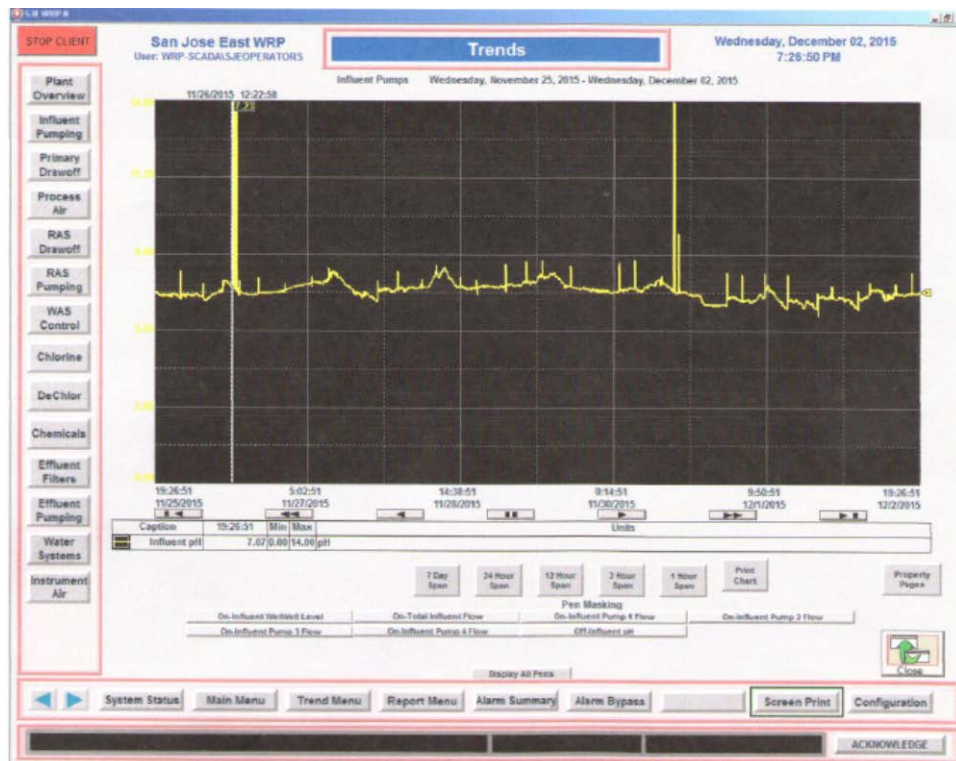
**Figure 2: SJC East WRP Influent pH trend for 11/25/15-12/2/15. Note the lack of any significant low pH readings.**

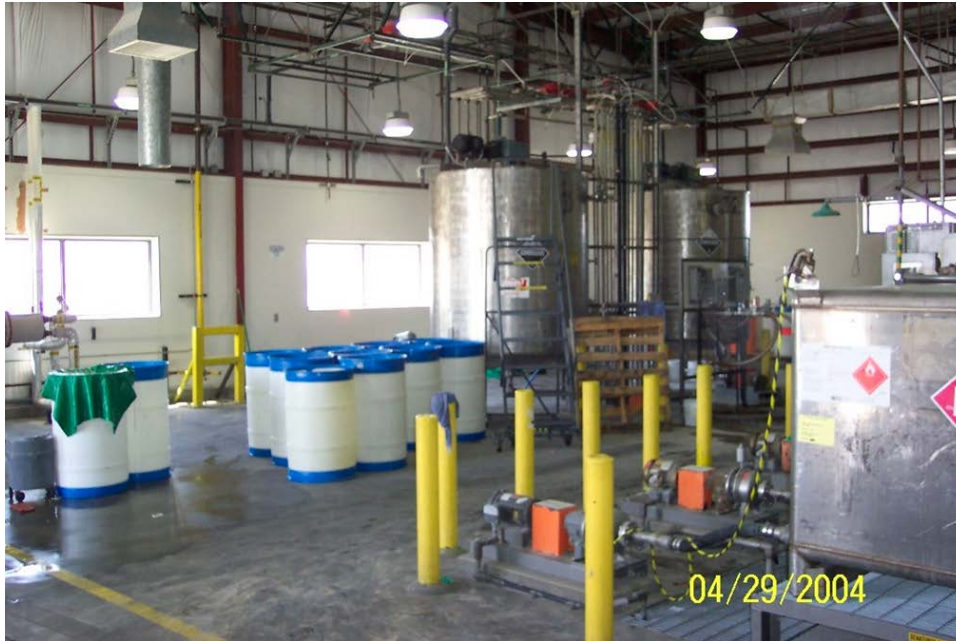
Powell's investigation centered on the major industrial wastewater dischargers upstream of the WRP. He determined that the likely source of the odors was the periodic discharge of wastewater generated from a soap and detergent manufacturing operation at the California State Prison in Lancaster (see Figure 6). Normally the wastewater generated from the prison's Prison Industry Authority or "P.I.A." soap and detergent manufacturing operation is blended with the sanitary flow from the prison which tends to dilute any soap/detergent odors. However, a recent reduced inmate population has reduced the sanitary flow, thereby decreasing the dilution effect of sanitary flow on the P.I.A. industrial wastewater discharge. As a result of this incident, the prison is being required to reduce the discharge rate of the P.I.A. industrial wastewater to allow

**Figure 6: 2004 photo of the Prison Industry Authority soap and detergent manufacturing facility at the Lancaster State Prison facility.**
