2014 ANNUAL REPORT

INDUSTRIAL WASTE PRETREATMENT PROGRAM

COUNTY SANITATION DISTRICTS OF LOS ANGELES COUNTY

APPENDIX H
INDUSTRIAL WASTE REPORTS ON INCIDENTS

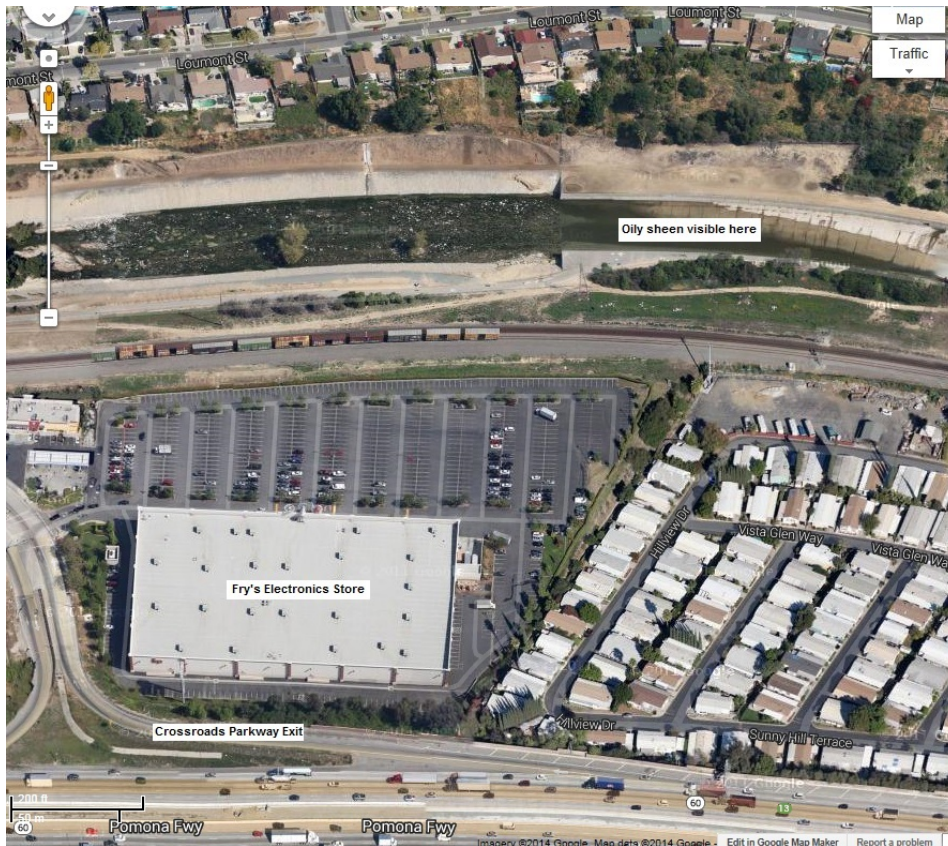
On Thursday, 2-6-14 at 1125 hours, Sanitation Districts' Supervising Biologist Carlita Barton called John Boyd and reported that her crew members had noticed an oily sheen present in San Jose Creek near the "Pomona Station" sampling location at 1100 hours that day. The sheen was seen just upstream of the location where the creek bottom transitions from being concrete to sediment in the Los Angeles County unincorporated area of Avocado Heights about one-half mile east of the Sanitation Districts' Joint Administrative Office. Barton sent Boyd an email giving the GPS coordinates of this location as N 34° 01' 55.5" W 118° 00' 11.6". The location can further be described as being just north of the Fry's Electronics Store. Boyd and Supervising I.W. Inspector Dave Lee went to the creek to observe the sheen in an attempt to determine its severity and appropriate actions to take. It should be noted that earlier that morning there had been light rainfall in the area. A moderate sheen was seen on the creek surface by Boyd and Lee. The sheen was visible for several hundred yards upstream, at which point Boyd and Lee stopped following it. There was no evidence of a nearby source for the oil. Boyd determined the sheen was significant enough to report to the L.A. County Department of Public Works for possible further investigation. Boyd contacted LADPW Source Control Inspector Corey Mayne at 1230 hours and emailed him the information and photos of the sheen. Sanitation Districts' I.W. Inspectors did not conduct any further investigation. The area where the sheen was observed is more than a half mile upstream of where the effluent from the Sanitation Districts' San Jose Creek East WRP discharges into the creek and it was noted that the oil could not be from the SJC WRP's effluent. It was also noted that operations and final effluent discharge into the San Jose Creek were normal that day at the Pomona WRP, which is located 13.7 miles upstream of the area where the sheen was noted. The most probable cause of the oily sheen was rainwater runoff from streets and roads getting into the creek due to the earlier rainfall.

Figure 2: Satellite photo showing the location of the oily sheen found in San Jose Creek on 2-6-14.

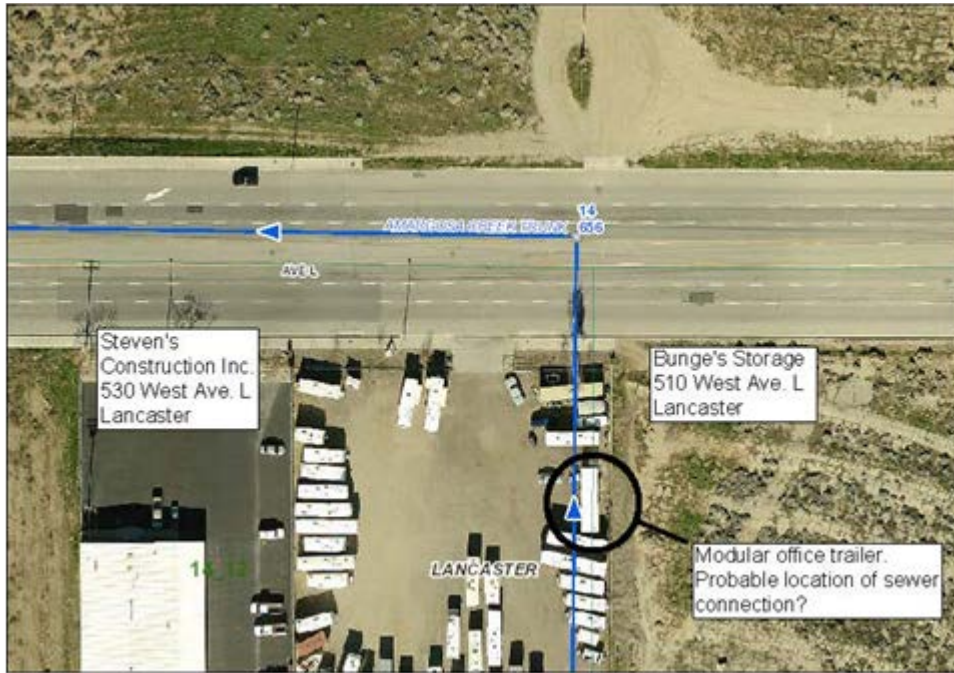
Investigation by area I.W. Inspector James McCurdy determined the connection was indeed made illegally and had been made to accommodate the discharge of sanitary wastewater from a bathroom located inside a modular office trailer at the site of Bunge's Storage at 510 West Ave L in Lancaster. It is planned to issue a notice of violation to the owner of the storage yard on 3-4-14 for violating Section 302 of the Sanitation Districts' *Wastewater Ordinance*, which prohibits making a direct connection of a sewer line 6" or smaller to a Sanitation Districts' trunk without first obtaining a permit from the Sanitation Districts. Following issuance of the notice of violation, the owner will be required to correct the situation as appropriate. This will likely include removal of the illegal connection, repair to the trunk line, and his payment for the costs incurred by the Sanitation Districts in completing this work. The Sanitation Districts may also levy a fine for the violation.

Figure 6: Satellite photo from Sanitation Districts' GIS showing where a modular office trailer was found illegally connected to the adjacent Amargosa Creek trunk sewer line.

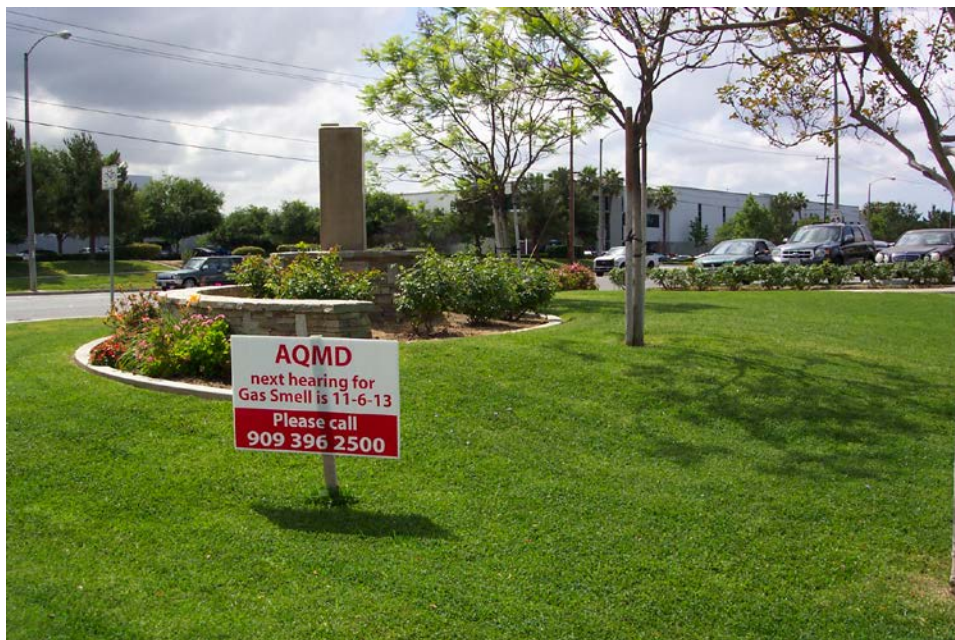
Figure 2: Signage near the Ridgeline facility providing information to residents about odor complaints.

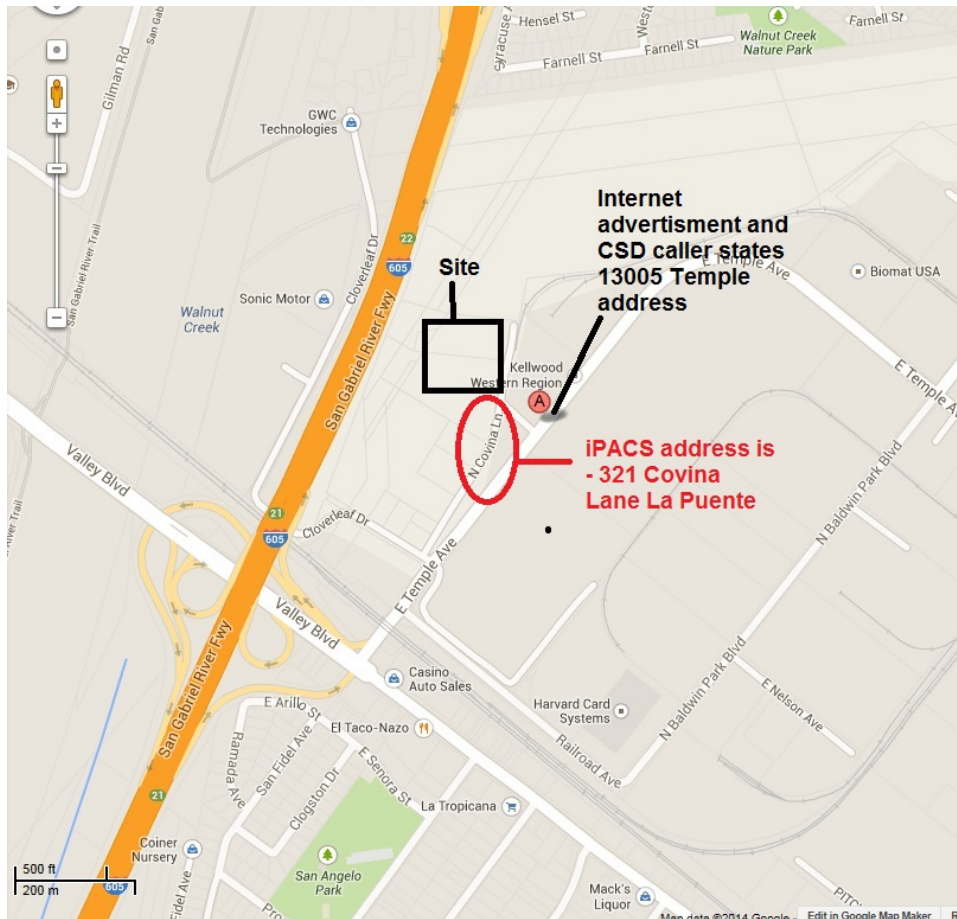
Figure 4: Map showing the two addresses for the single facility in question that has a truck washing operation.

The most recent facility inspection at Saenz Equipment Storage was conducted on 2-6-13 by now retired I.W. Inspector Elaine Myrick. Her inspection comments indicate the facility operates a covered truck wash area where 10-15 trucks are washed daily and that the facility is in compliance with all Sanitation Districts' requirements and limits. No further investigation or follow-up by Sanitation Districts' I.W. inspection staff is anticipated at this time.

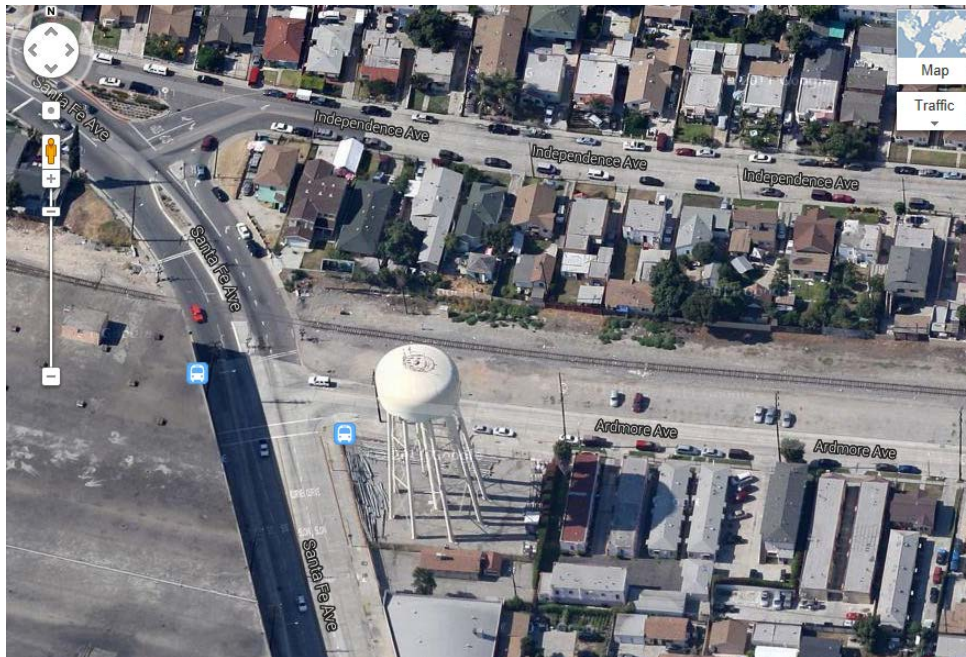
Figure 1: Google maps image of the 0.5 MG potable water tank in South Gate that was drained on 5-6-14.

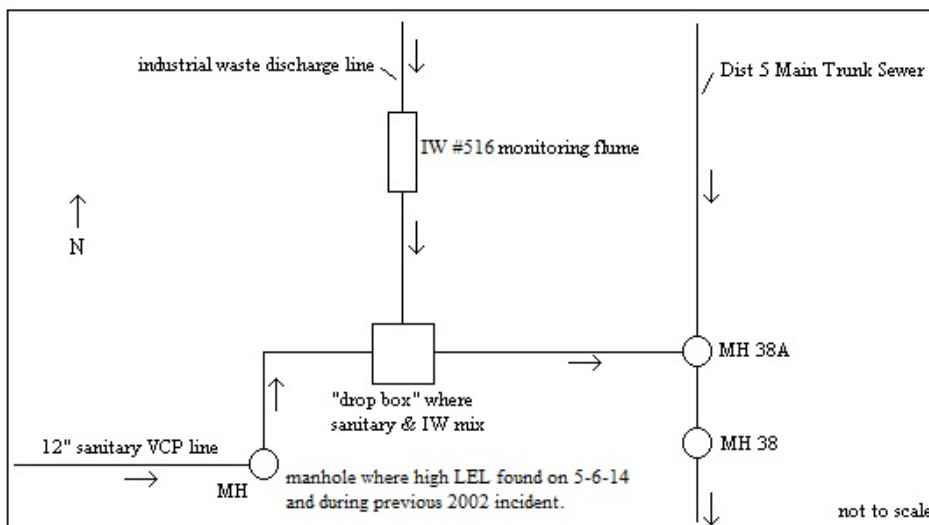
off site access monitoring location (the "Van Ness" outfall) had found LEL=75% at 0930 hours. In response to this finding, refinery operators flushed the sewer line with water and then rechecked the LEL at the manhole at 1030 hours, finding it at its normal 4% level. Nardone stated operators were unsure of the cause of the high reading on 5-6-14, but speculated it was due to a buildup of methane gas associated with degrading sanitary sewage in the line. Boyd asked Nardone to do some further investigation into the matter as a long term high explosivity incident at this same manhole location approximately 12 years ago was eventually traced to an underground gasoline product line within the refinery that had cracked. Gasoline seeping periodically from this product line got into an adjacent sanitary sewer line causing mysterious high LEL conditions for over a year in both the refinery's sanitary line and the downstream Sanitation Districts' trunk sewer before it was finally determined what was causing the problem. See the below old diagram and photo from this incident. Nardone said she would have the LEL at the manhole rechecked in the afternoon on 5-6-14 and if a result above 10% had returned she would notify Boyd immediately. Note that the reason the company checks this sanitary line manhole LEL daily is to prevent recurrence of the incident 12 years ago.

Figure 2: Diagram showing the relationship between the sanitary and industrial wastewater lines at the ExxonMobil refinery's Van Ness connection to the Sanitation Districts 5 Main Trunk sewer.

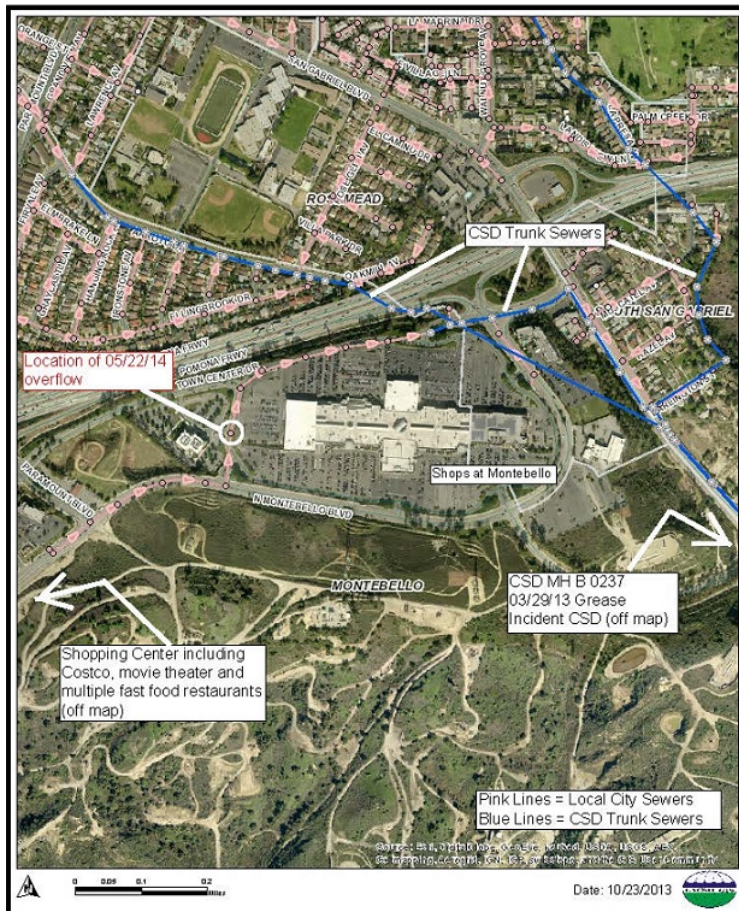
On Tuesday, 6-3-14, I.W. Inspector Jim Percy received a voicemail message from Jesus Salazar, Operations Director for the Montebello Town Center shopping mall. Salazar reported information about a local sewer line blockage and overflow (SSO) on 5-22-14 caused by excessive greasing. The Sanitation Districts' industrial waste inspection staff investigated an incident of excess grease found in a Sanitation District's trunk located downstream of this same area in March 2013. That investigation found no definitive source for the grease, but evidence strongly suggested that restaurants in the mall's food court were the likely source. In response to that finding, Percy gave restaurant grease management posters to Salazar with the understanding they would be distributed to food court restaurant operators in an attempt to curtail the amount of grease entering sewers there.

Figure 1: GIS map indicating the location of the local line SSO on 5-22-14, the excessive greasing in the downstream J.O. 'B' Unit 1D trunk sewer found in March 2013, and possible grease sources in the area.

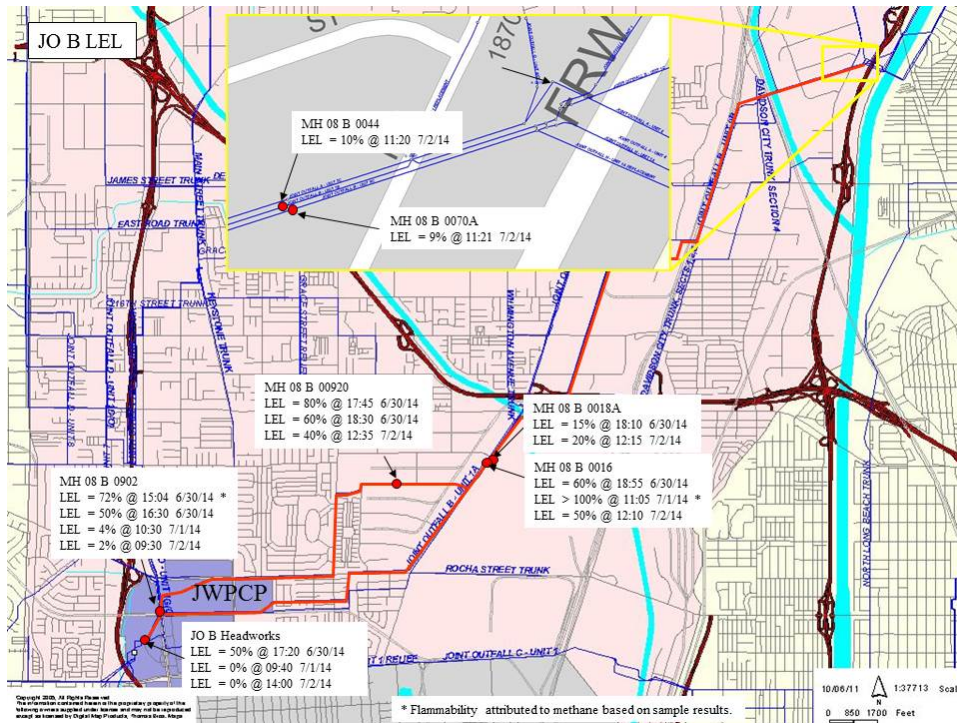
Figure 2: Diagram showing the J.O. 'B' trunk sewer with annotations of explosivity readings obtained at various manholes during the investigation.

It is unknown if the three-hour high explosivity excursion at the J.O. 'B' headworks on 6-30-14 was caused by an industrial source or from methane generated by anaerobic decomposition of sewage solids as seems likely for the high readings at MH B902. The short duration and more unusual high readings at the headworks are more indicative of an industrial source. However, inspections at the large Tesoro petroleum refinery (formerly BP/Arco) and a large oil production field upstream of the headworks that constitute the most likely sources for such an incident were inspected and ruled out as contributors. Though no samples were collected during the incident, an upstream sample collected two hours earlier at MH B902 and a sample collected at MH B0016 the following morning found that methane was the sole constituent causing high explosivity in those structures. An upstream survey of the J.O. 'B' trunk sewer found that explosivity readings from 40% to greater than 100% in the two J.O. 'B' reaches downstream of the Dominguez Channel siphons (see figure 2 above). From this siphon the lines run full for approximately 2 miles upstream to Rancho Dominguez. Upstream of the full pipes the explosivity was from 9% to 10%. It was also noted that both J.O. 'B' lines are currently active: the J.O. 'B'-1A replacement and J.O. 'B'-1A, which is normally out of service. It is not known how long this condition has been present, or what its effect on headspace explosivity levels would be. However, a large diameter trunk sewer running at half its usual flow could potentially accumulate solids that would exacerbate any methane generation.

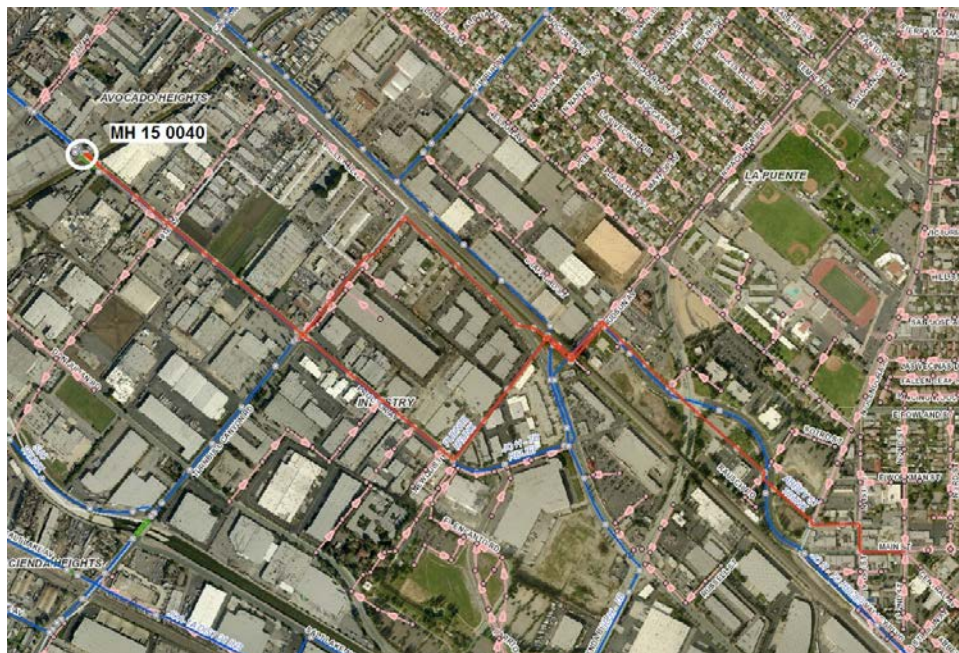
Figure 2: GIS sewer trace indicating the areas tributary to the siphon structure where the scale material was dislodged.

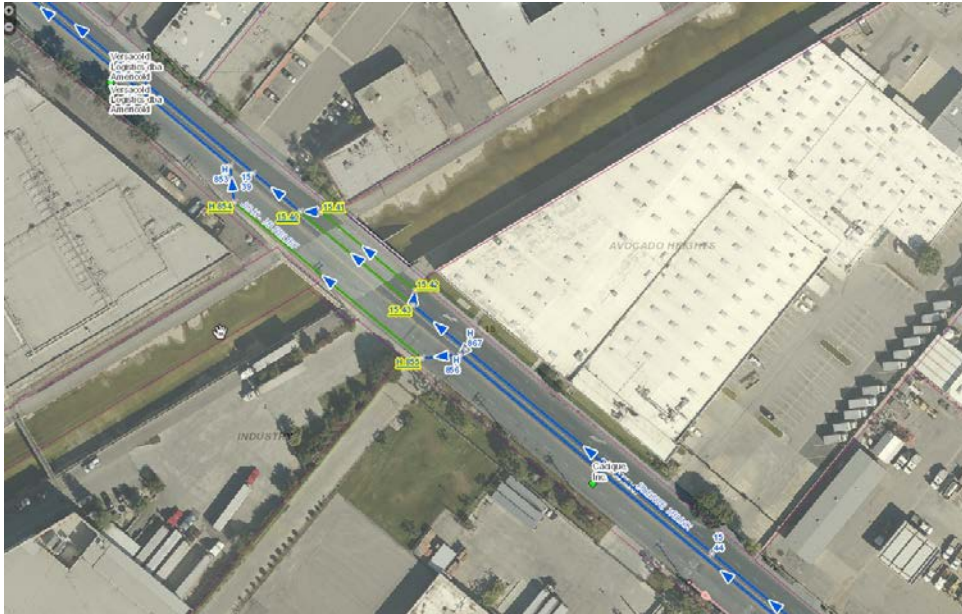
On Wednesday, 7-23-14 at 0755 hours, San Gabriel Yard Superintendent of Sewer Maintenance Bill Balas called John Boyd. Balas reported that on 6-21-14, while conducting routine quarterly cleaning of a 18" double barrel siphon on the Puente trunk in the City of Industry where the lines pass under the Puente Creek on Proctor Avenue (MHs 15 0043-0040, see Figure 3 below), a Sanitation Districts' crew had encountered difficulty cleaning the siphon. The bag being used to clean the siphon encountered higher than expected levels of resistance in the siphon barrels before successfully passing through. Subsequently, on 7-21-14, the crew noted what appeared to be concrete scale-like debris in a manhole downstream of the siphon (MH 15 0029). The material found at MH 29 was ostensibly one continuous piece of material that was lightly adhering to the bottom of the siphon lines that the sewer cleaning bag dislodged and broke up during the line cleaning process.

Figure 3: The double barrel siphon of the Puente Trunk where it passes under Puente Creek in the City of Industry.

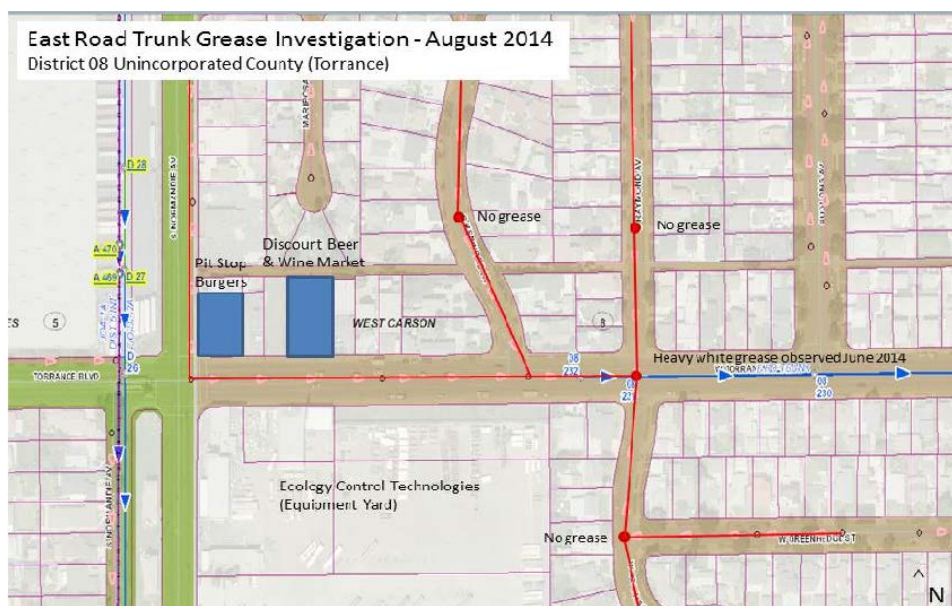
Senior I.W. Inspector Bill Barnum conducted the follow-up investigation, locating two probable sources for the reported greasing. Both sources were restaurants which had no equipment for controlling grease discharges, such as a grease trap or an interceptor. One source, Pit Stop Burgers, had records indicating regular offsite recycling of waste fat and grease. The other source, Discount Beer & Wine Market, was in the process of renovating their kitchen following a change in ownership last month. The new owner claimed all his plumbing was found to be clogged with grease when he acquired the facility. The new owner was given a list of grease recyclers and directed to www.CalFog.org for best management practices for handling fats, oils and grease (FOG) waste. The investigation identified no permitted industrial users upstream of the greasing location and no new sources that would require an I.W. permit. The area is generally residential with some commercial use. Barnum made a telephone referral call to Los Angeles Department of Public Works (LADPW) area Waste Control Engineering Inspector Walter Glowac requesting LADPW evaluate both restaurants for inclusion into their FOG control program. According to Mr. Glowac, Pit Stop Burgers has been inspected for compliance under their storm water permit but there is no inspection or permit history for Discount Beer & Wine Market.

Figure 2: Map diagram indicating the location of the two sources of grease, Discount Beer & Wine Market and Pit Stop Burgers, in relationship to where greasing was found in June 2014 in the East Road trunk sewer.

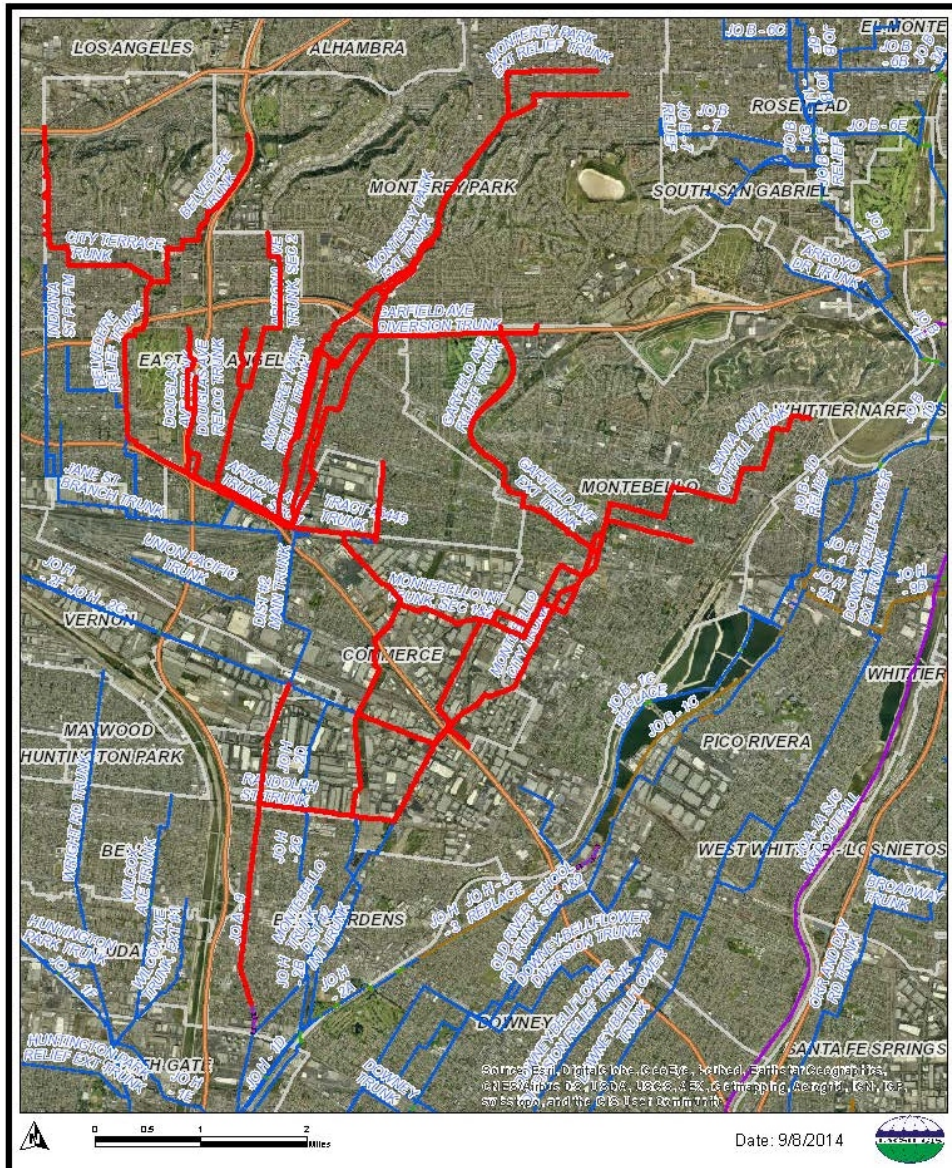
Figure 2: Diagram indicating the trunk sewers (in red) upstream of the reported location of maroon/red color in the J.O.'A' sewer.

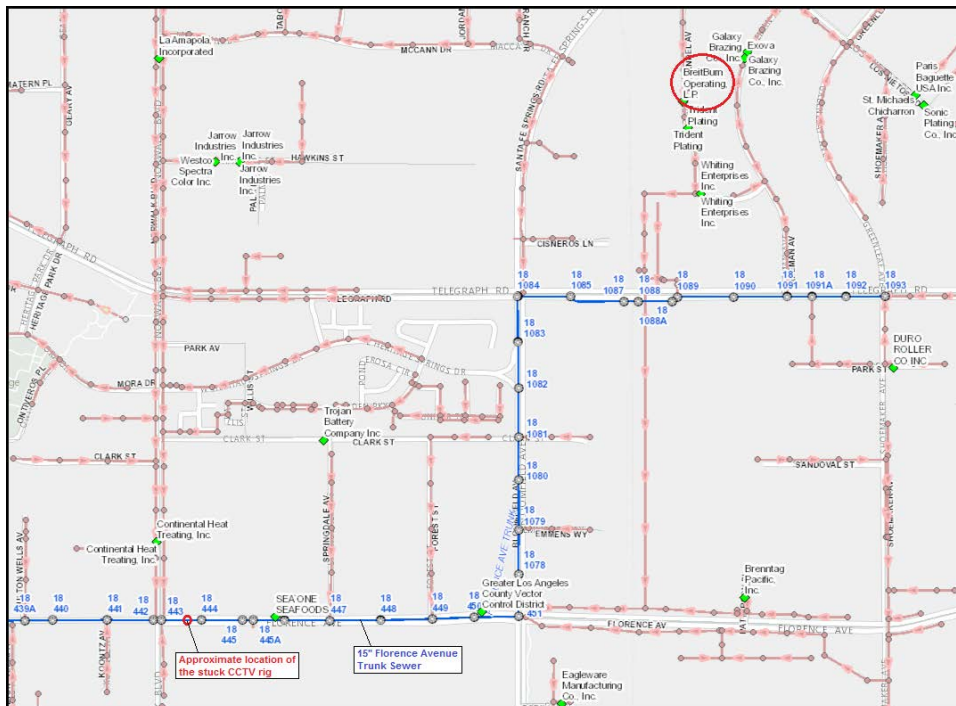
On Wednesday, 9-17-14 at 0730 hours, Sewer Maintenance Superintendent Doug Walton called John Boyd and reported that a Sanitation Districts' closed circuit television (CCTV) camera rig was stuck in the 15" Florence Avenue trunk sewer downstream of Sea One Seafoods in Santa Fe Springs (see figure 7 below). Walton requested the I.W. section staff contact industrial wastewater high flow dischargers upstream and require them to either cease their flow or hold flow to a minimum level for the next 2-3 hours to prevent sewer surcharging and possible overflows while crews attempted to retrieve the stuck camera. It was noted that MH 18 0445A, located just upstream of where the CCTV rig was stuck is the location where Ridgeline Energy Services, LLC connects to the sewer. This discharge can be quite significant (permitted peak flow limit is 1000 gpm). However, Ridgeline is a batch discharger and they had no discharge on 9-17-14. Area I.W. Inspector Jason Finn and Inspector Traci Stahl were apprised of the situation and Walton's request. Finn coordinated the response to Walton's request.

Figure 7: Map diagram showing the 15" Florence Avenue trunk sewer, location of the stuck CCTV rig and the location of Breitburn Operating LP, which ceased flow for 2.5 hours on 9-17-14 to help assist in the recovery of the CCTV rig.

At 0800 hours Inspector Jason Finn contacted Breitburn Operating LP, a large oil field production operation with significant brine discharge to the sewer that was the largest ongoing industrial wastewater source upstream when the CCTV rig got stuck. Finn requested Breitburn cease their discharge to prevent any chance of surcharging the line while the CCTV rig was being retrieved. The company contact, Mr. Jon Beatty, agreed to voluntarily cease their

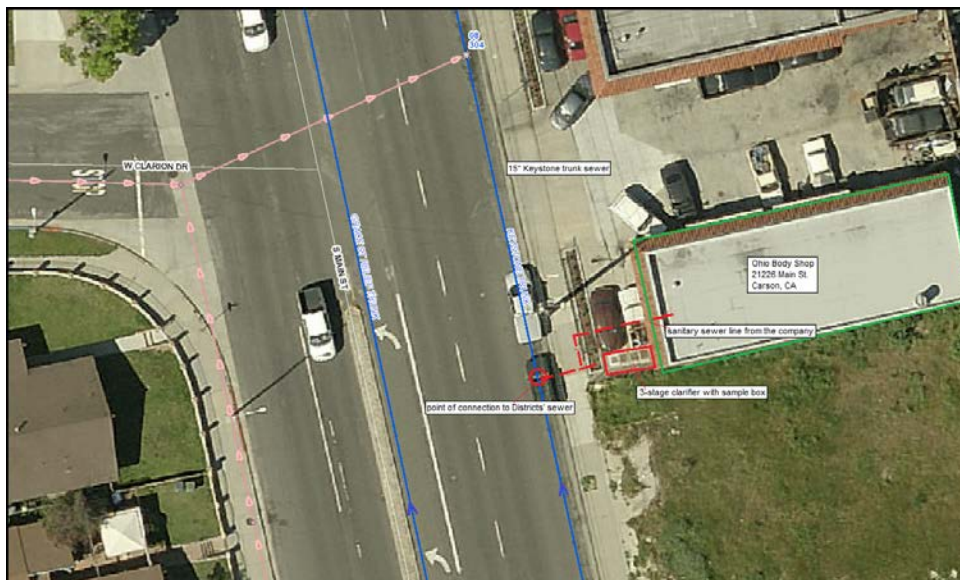
Figure 1: Diagram of the Ohio Body Shop direct connection to the Districts' 15" Keystone trunk sewer in Carson.

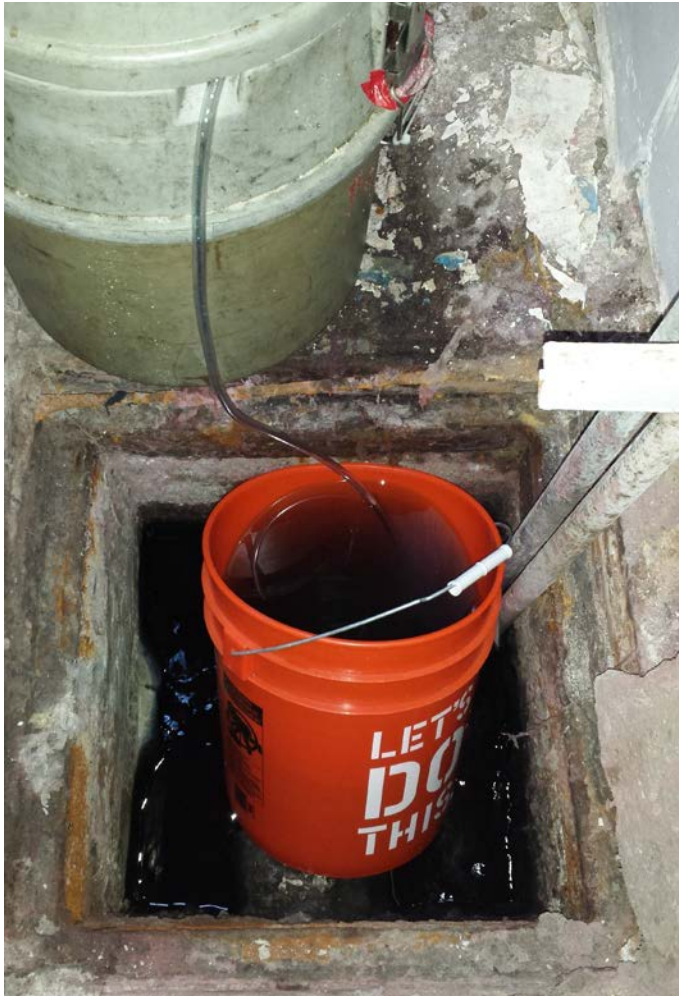
Area I.W. Inspector Chris Mendoza responded to the report, arriving onsite at 1200 hours on 10-7-14. Mendoza found wastewater being discharged with a pH=9.0 in the sample box at 1210 hours, but more significantly also found the Districts' Isco sampler's tube removed from the flow being discharged and instead placed into a bucket of water that had been placed into the sample box (see figure 1 below). The company contacts provided no plausible explanation for this. The company was issued a written notice of violation for discharging low pH wastewater and tampering with Districts' sampling equipment. The Districts considers this type of tampering violation to be extremely serious and any recurrences will likely result in referral for legal prosecution.

Figure 2: photo of Districts' automatic Isco sampler in position at the sample box of United Dye & Wash on 10-7-14. Note that a bucket of water has been placed inside the sample box such that no sample of the actual water being discharged is being taken.

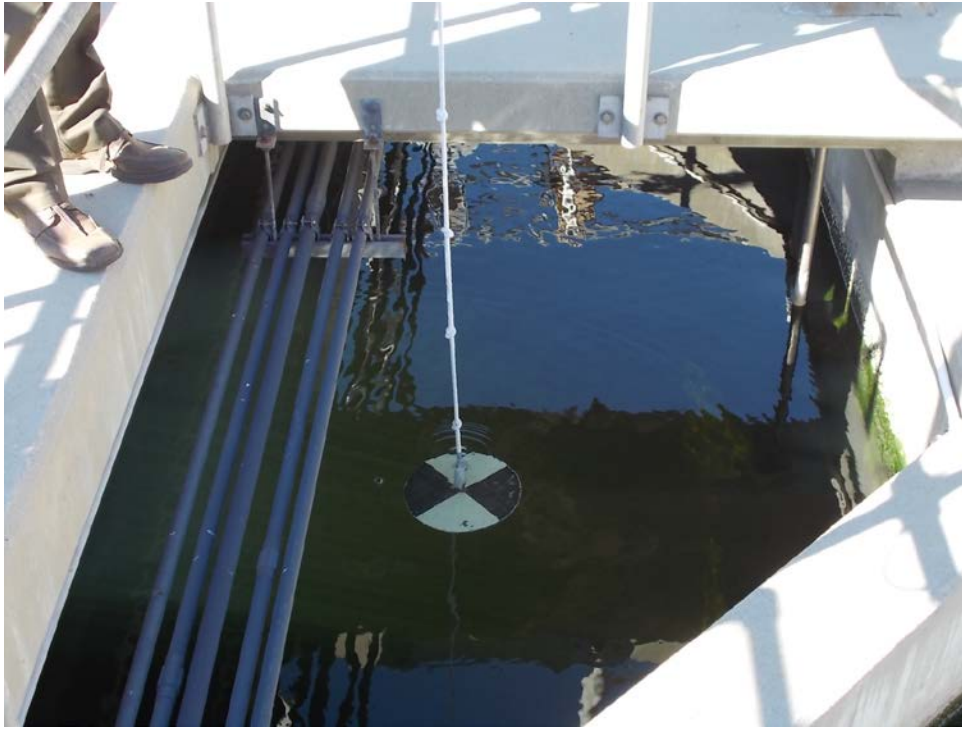
On Thursday, 10-9-14 at about 0930 hours, Supervising Treatment Plant Operator Stephen "Junior" Johnson notified I.W. Inspector Jason Finn that the Los Coyotes WRP final effluent had a light tea color. Finn proceeded to the WRP outfall and confirmed the presence of the light tea color. Finn also measured the clarity of the effluent using the Secchi disk that is kept there, noting the clarity was a normal 8 feet.

Figure 3: Secchi disk being lowered into the final effluent at Los Coyotes WRP. The disk can be used to check for effluent clarity and also can be used to check for color as it appears against the white sectors of the disk. Note the 1' interval knots in the rope that are used to quantify the water clarity. Clarity is determined by lowering the disk into the water column until the black and white sectors of the disk can no longer be visually differentiated.

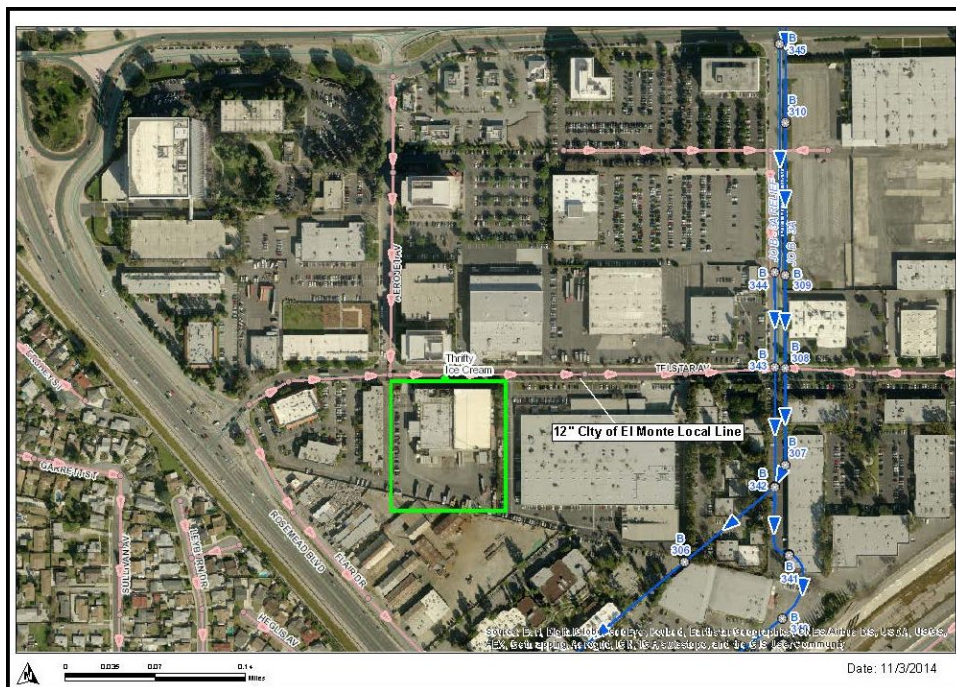
Figure 5: Diagram showing the Thrifty Ice Cream manufacturing facility in relationship to local sewers (pink lines) and Districts' trunk sewers (blue lines).

The Thrifty Ice Cream plant operates a large ammonia-based refrigeration system at their facility in El Monte. Sealy arrived at the Thrifty facility at 1438 hours and found no ammonia or other unusual odors either at the ice cream plant or in sewer lines in the area of the plant. Sealy met with the company's production manager, and both the manager's statements and Sealy's inspection findings indicated nothing had occurred that day which could have caused the reported ammonia condition. There was no evidence that the ammonia refrigeration system had

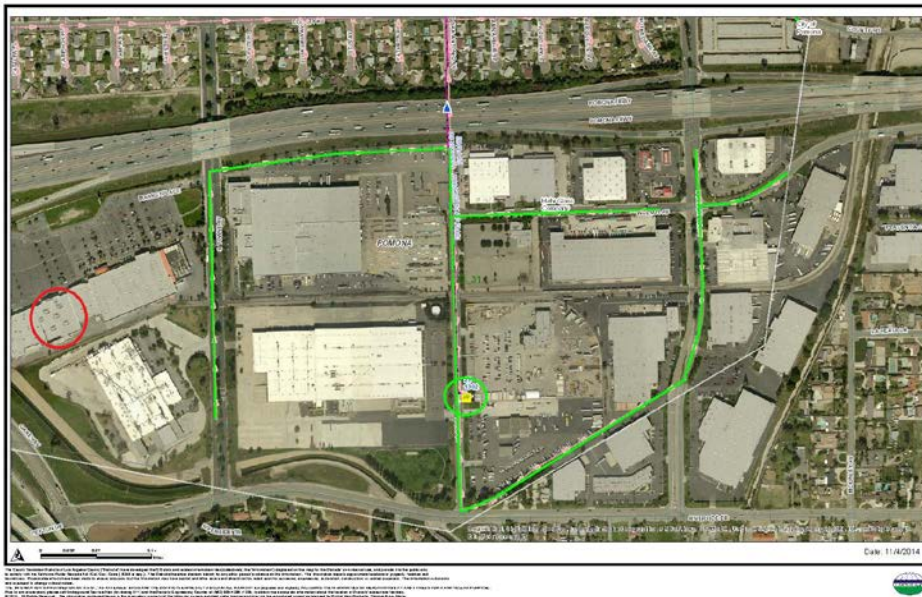
Figure 3: Districts' geographic information system (GIS) photo map showing the relatively limited area influent to the Pomona Pumping Plant No. 4. Note, circled in red, the vacant commercial property at 2727 S. Towne Ave. that was identified as the flow source.

The investigation, including visual tracing of the flow to its upstream source on 11-5-14, was conducted by Senior I.W. Inspector Steve Sealy (Sealy) and I.W. Inspectors Jonathon Powell and Pat Cashen. The investigation revealed the source of high flow into Pomona Pumping Plant No. 4 was a broken toilet inside a vacant commercial building, formerly a Toys-R-Us, located at 2727 S. Towne Ave. in Pomona. Using the realtor information posted on the building, Sealy contacted the building owner on 11-5-14. A plumber was sent to turn off

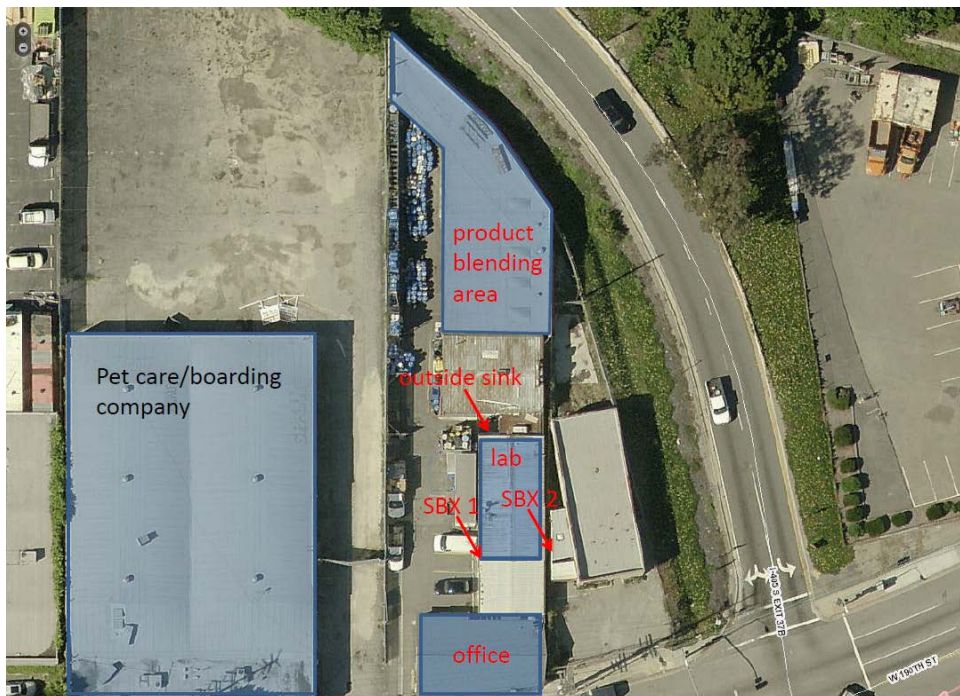
Figure 4: Chem Pro Labs facility photo/diagram.

A field test of water in the west sample box of the south building indicated an acidic pH of 0.3. At the time of the sample was taken, there was no ongoing flow in the sample box, but the box itself was highly etched, indicating acidic discharges at this location are likely common. The wastewater in the east sample box had a pH of 6.0 and was also had no ongoing flow. Although the low pH was found in the west sample box, there was no definitive evidence found indicating it was anything more than that from the disposal of relatively small volumes of acidic lab test wastewater. While it's true this waste should have been neutralized prior to discharge, its presence alone does not necessarily corroborate the tipster's claims that the company is discharging potentially much larger and more illicit amounts of hazardous wastes from the compounding/mixing operations. The company contact denied that any waste from the blending operations were sewered, claiming they are hauled offsite for legal disposal. However, the contact was unable to produce any hazardous waste manifests for hauled wastes from the blending operations dated after July 2012. After reviewing these findings, Boyd and Cleaver agreed to continue the investigation by scheduling one or more Saturday surveillance sampling

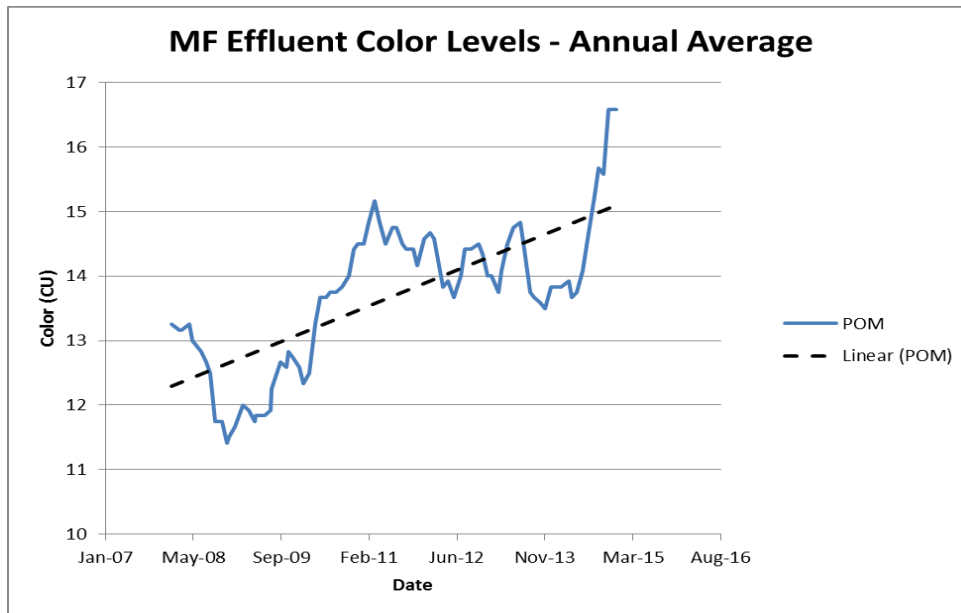
On Friday, 11-21-14 at 1311 hours Districts' Monitoring Section Civil Engineer Monica Gasca sent an email to I.W. Section Head Dave Snyder and John Boyd informing them that the annual average for color in the Pomona WRP effluent samples was likely going to exceed the drinking water secondary maximum contaminant level (MCL) limit of 15 color units for 2014 that the Districts tries to meet. Gasca stated that in November 2014 the result was 23 color units (CU) with the annual average over the MCL of 15 CU in October and November. Because the values have been at or above 15 CU since March 2014, Monitoring Section staff are anticipating continuing exceedances of the 15 CU limit.

Figure 5: Montebello Forebay (MF) effluent color data showing the Pomona WRP color levels from 2008 to 2014. Note the increasing trend.

Investigation of this report, and a similar one in May 2013 by the I.W. Inspection staff remains ongoing, but has yet to identify any unusual or new industrial sources of color upstream of the Pomona WRP. The color test in question is non-specific as to wavelength, resulting in matching of known industrial source wastewater with low to moderate amounts of color to the colored treatment plant effluent samples difficult or impossible. Inspectors remain vigilant as they continue to be on the lookout for any industrial sources that could account for the color in the treatment plant effluent.

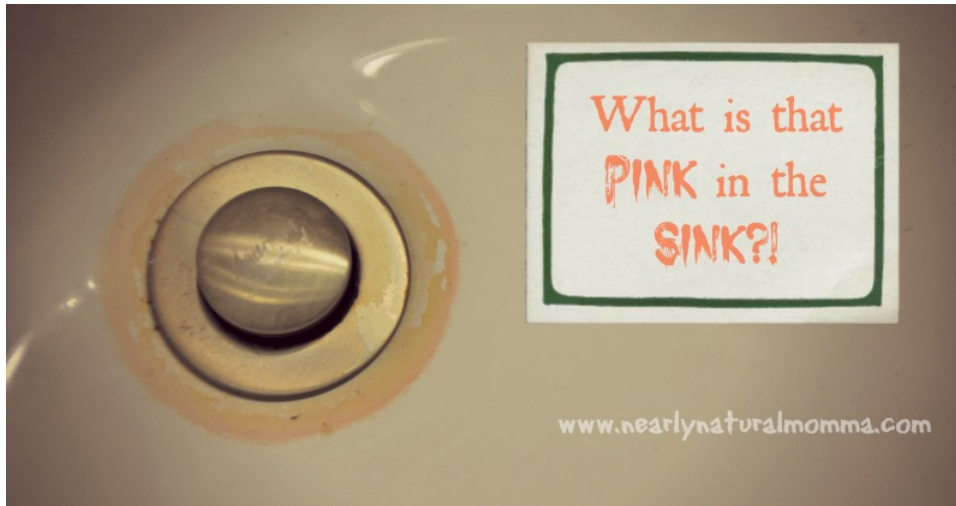
I.W. Inspectors Steve Wittmer, Pat Cashen, and Ken Hanks investigated. Inspections were conducted at 7 industrial facilities capable of discharging colored wastewater to the WNWRP but no evidence was found that implicated any of them in causing the red color in filter foam and wall staining. It was verified that the color was never seen in the water at any point of the treatment process and was limited to the foam residue on the walls of the filters. Visually, the color appeared to be made up of small particulate (solid) matter in the foam and was more pink than red. A similar issue was reported at the Valencia WRP approximately 15 years ago and although no source was found for the color, analysis done by CSD Microbiology suggested the color was caused by bacteria growth on the water surface/foam in the filters. In that case, *Serratia marcescens* was offered as a possibility considering its ability to produce a red pigmented substance “prodigiosin.” The bacteria is ubiquitous in the environment and has a preference of damp conditions (commonly in bathrooms-see figure 4 below, as well as numerous other photos which can be viewed on the internet if one searches for images of “pink bacterial scum in bathroom”) where it manifests as a pink discoloration and slimy film feeding off phosphorus-containing materials or fatty substances such as soap and shampoo residue. It should also be noted that the local area received the first substantial rain (approximately 2 inches) in over a year in the three days just prior to the color report. This “flush” of water may have washed out a variety of pollutants not normally seen in the sewers. Operators at WNWRP reported that there appeared to be no ill effects on the treatment process at any time and no color was reported in the final effluent. I.W. Inspectors will continue to monitor WRP operations and respond if needed.

Figure 4: Internet photo of pink bacterial film in a bathroom sink.

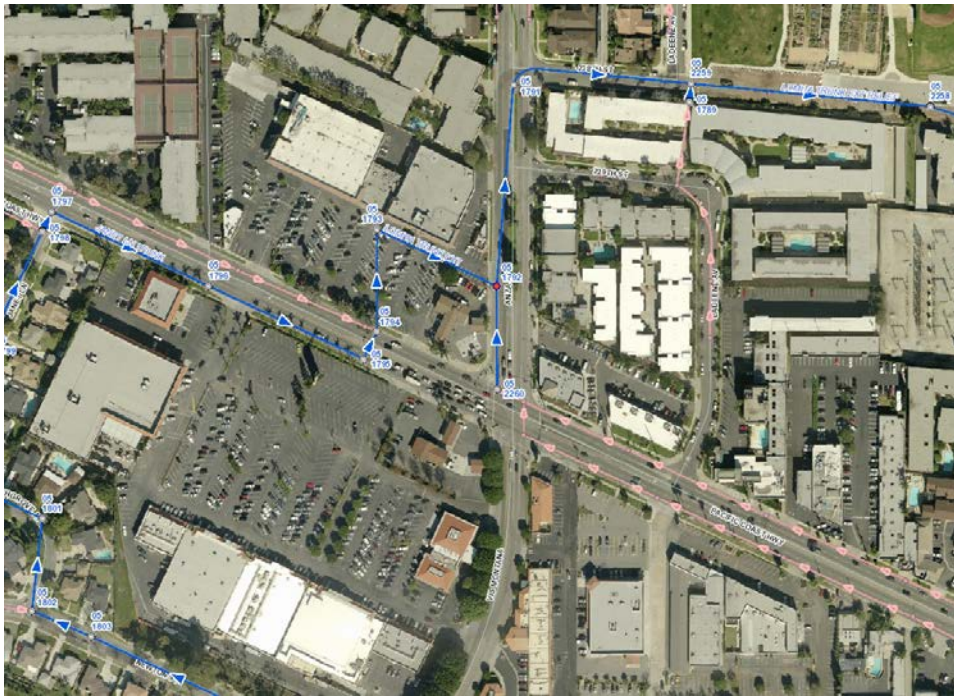
I.W. Inspectors Shawn Cleaver, Chris Mendoza, and Tingting Wei immediately responded to the manhole location and investigated the report. They quickly determined that the source of the gasoline odor was an Arco gas station/auto repair facility located immediately upstream of MH 05 1792 that had a direct connection to the trunk sewer. The station manager admitted to discharging small amounts of gasoline into a sink that morning. He said he had rinsed gasoline residues from a small container used when changing fuel filters on vehicles. He was informed by I.W. Inspectors that no gasoline or gasoline residue should be rinsed into the sink because it could cause explosive conditions in the sewer that could put Districts' workers in danger. The contact agreed to no longer rinse any gasoline residue into the sink. The volume of gasoline discharged was estimated to be less than one liter. The manager was given a verbal warning to not dispose of any gasoline or associated residue into the sewer.

Figure 13: Photo map showing the manhole location of the gasoline odor Report (MH 05 1792) and the adjacent Arco service station that was found to be the source.
