Audit of Sanitary Sewer Overflow (SSO) in the City of Carson

Los Angeles County Sanitation Districts

4 May 2022

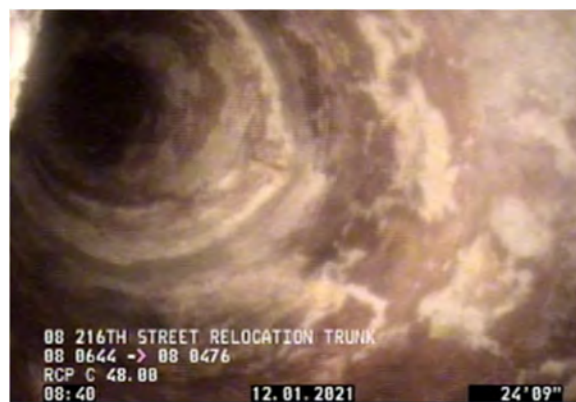
Photo 3-3 CCTV Inspection Photograph 3

Specific inspections, CCTV or physical entry, of the manhole were not performed. However, at the end of a CCTV run, the camera pans up to show the inside of the ending manhole. **Photo 3-2** and **Photo 3-3** show screenshots from the December 2021 inspection showing significant corrosion including visible aggregate, discolored walls, and exposed reinforcement in manhole 476.

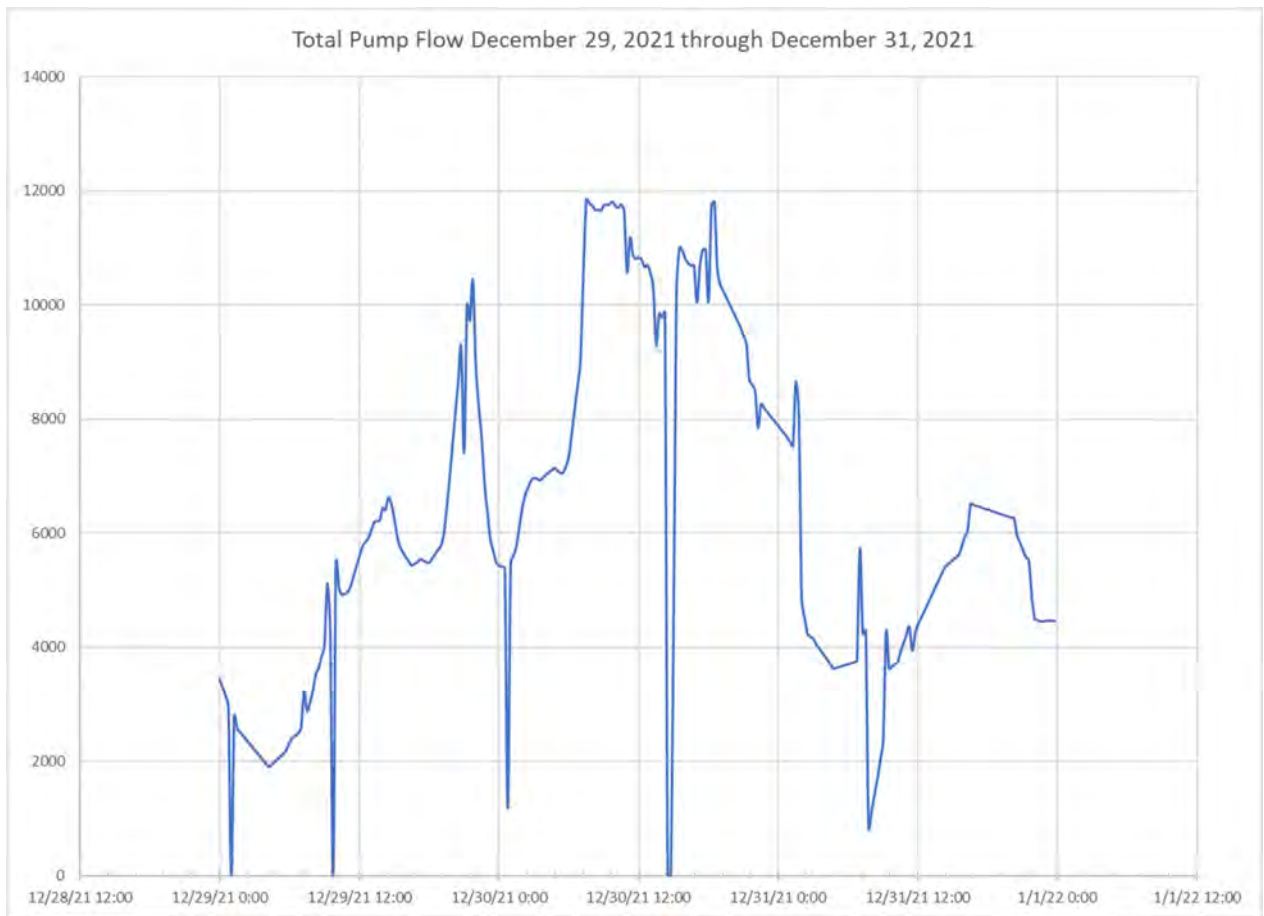
Figure 3-3 MSPP Discharge from December 29, 2021 to December 31, 2021

Figure 3-2 shows the discharge from the Main Street Pumping Plant from November 1, 2021 through January 10, 2022. This graph shows the typical daily peak discharge is 6,000 to 7,000 gallons per minute (gpm). In fact, during peak dry weather, flow is consistently at or slightly below 6,000 gpm. The spikes in flow above 6,000 gpm are typically due to pumping down the wet well for daily cleaning. During storm events, the peak discharge increases to approximately 12,000 gpm. One data point on the graph shows a peak of approximately 15,550 gpm on November 16, 2021, at 11:15 AM. This was not associated with a storm; rather, it appears pump station operations caused this flow for a short period of time, approximately 15 minutes. Figure 3-3 shows discharge on and around December 30, 2021, the day of the failure, the peak discharge was approximately 11,856 gpm at 7:30 AM. The average discharge for the morning hours of December 30, 2021, once the storm started, was approximately 11,300 gpm.

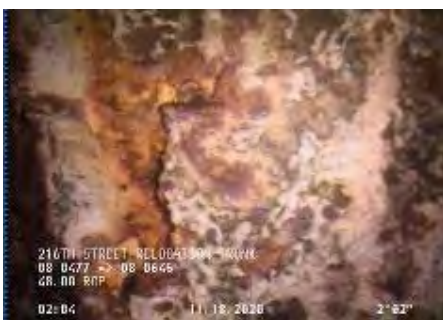
Photo 6-1 216th Street CCTV View

Photo 6-1 and **Photo 6-2** show a comparison of a close-up CCTV view from a recent inspection of the Districts' 216th Street Relocation Trunk and an image from a vendor's HD video.
