**2023 ANNUAL REPORT**

INDUSTRIAL WASTE PRETREATMENT PROGRAM

LOS ANGELES COUNTY SANITATION DISTRICTS

**APPENDIX H**  
INDUSTRIAL WASTE REPORTS ON INCIDENTS

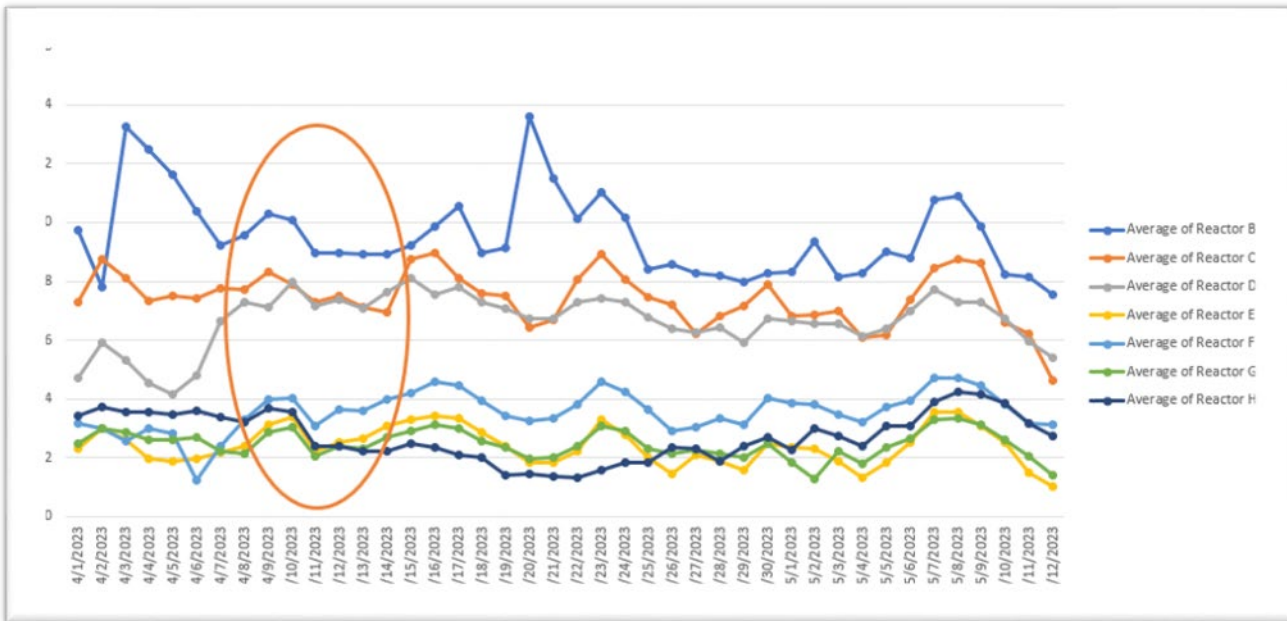
**Figure1. Daily average DOS FOR ALL Reactors. Dip in DO for all reactors circled in orange**

The Industrial Waste Staff inspected nine significant industrial users having an oxygen demand risk for

JWPCP. None were found to have any adverse discharges that might have contributed to this incident. The D.O. concentrations have since returned to normal and there were no adverse impacts to plant operations. The Industrial Waste Inspectors will closely monitor the situation and provide any follow up investigation as deemed necessary.

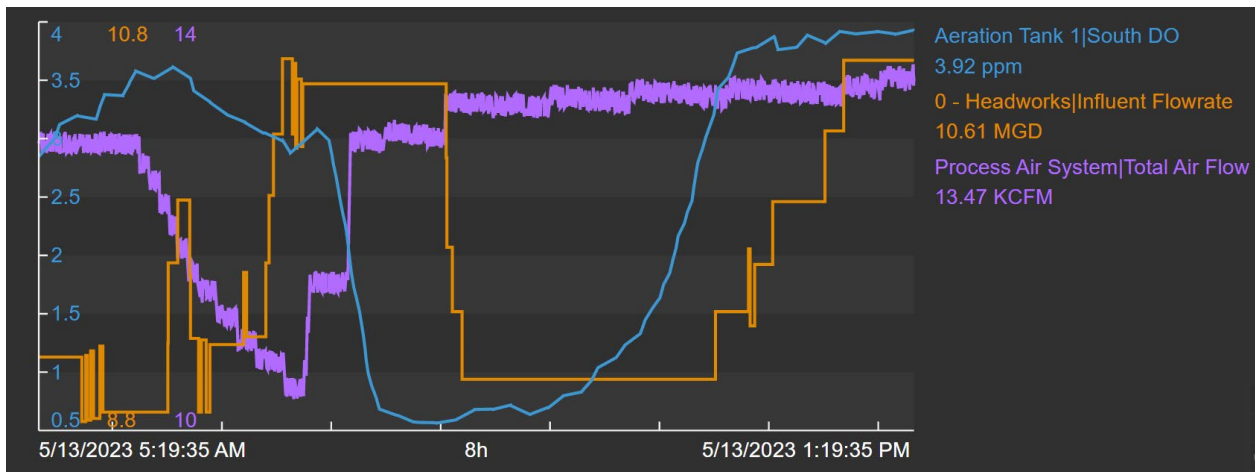
Figure 6. WNWRP Aeration D.O. Concentration, Air Flow & Influent Flow (PI Vision)

On Monday, May 15, 2023, Whittier Narrows WRP operators again reported to the IW Section that there had occurred another low dissolved oxygen (D.O.) concentration event in the aeration tanks. This is the third low D.O. incident since January 01, 2023. This incident occurred during the weekend on Saturday, May 13, 2023, and again Sunday, May 14, 2023. Both incidents occurred during the morning hours between 0800 hours and 1100 hours.

Operations stated that in this latest incident the D.O. concentrations dropped to 0.50 mg/l on Saturday, May 13, and 0.40 mg/l on Sunday, May, 14. In addition to the low D.O. concentrations, WRP operators are observing some ammonia "bleed through" in the secondary effluent that is likely caused by the low D.O. condition. The D.O. concentrations recovered to normal as the plant increased air flow and decreased influent flow. There were no other indicators associated with this incident, such as color, pH, odor, or oils.

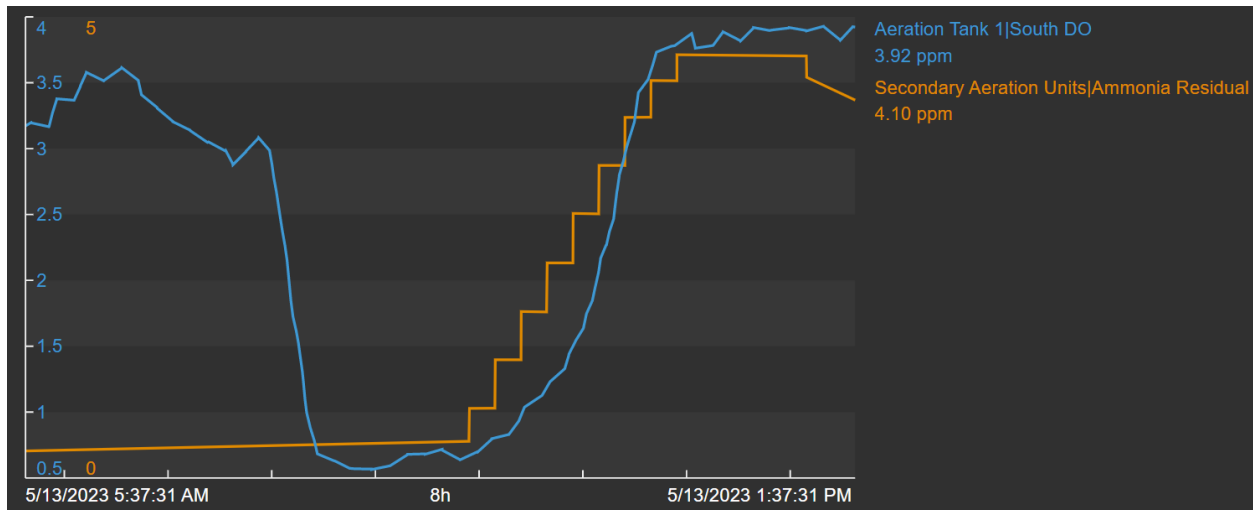
Figure 7. LCWRP Dissolved Oxygen Concentration & Ammonia Residual

Investigating IW Inspectors didn't identify any industrial source(s) as having evidence that they caused this incident. Nothing unusual was noted at upstream industrial wastewater dischargers that were inspected including the Thrifty Ice Cream manufacturing facility, the United Site Services portable toilet dumping facility, and the Ted Levine drum reconditioning company. IW Inspectors continue to monitor this situation very closely and are working closely with WNRWP operators and plant lab personnel.

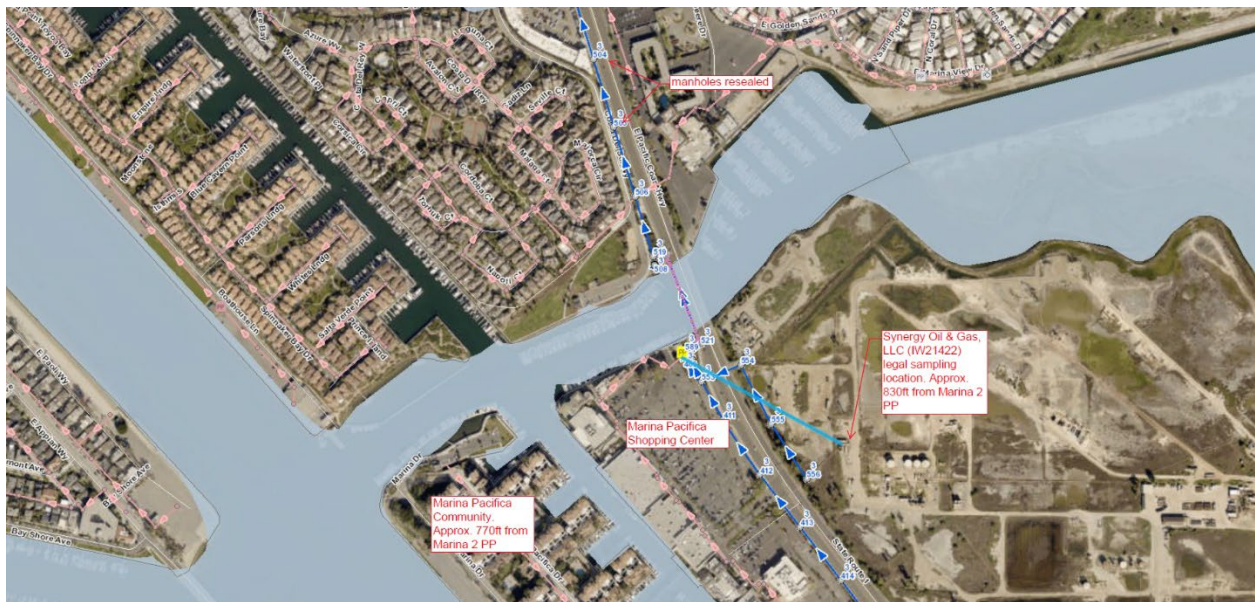
Figure 16. Marina Pacifica GIS Map

On Wednesday June 21, 2023, at 1305 hours, Industrial Waste Section was notified of an odor complaint made by a Marina Pacifica Community Resident. The resident filed a complaint on Wednesday June 21, 2023, at 1133 hours that described the odor as an "overwhelming" chemical odor during "mild" wind strength and most prevalent around midnight to 0300 hours for the past four weeks. The odor was reported near the Marina Pacifica 2 pump station on 2nd and Pacific Coast Highway intersection.

IW Inspectors investigated four permitted industrial facilities in the vicinity of the Marina Pacifica 2 Pump Plant. No direct cause of the odor was identified. However, a possible odor source may be the removed equipment and/or open boreholes at Synergy Oil & Gas, LLC (FID9247862, IW21422). The facility is currently conducting maintenance on two different oil wells, both of which are approximately 10,000 feet deep. The boreholes are left open to the atmosphere during maintenance. Wastewater samples were taken at facility's legal sampling location for benzene, toluene, ethyl benzene, and xylene. The facility was made aware of the odor complaint. In addition, IW Inspectors resealed manholes within the vicinity of Marina Pacifica Pump Plant 2 with caulk to minimize any odor dispersion.

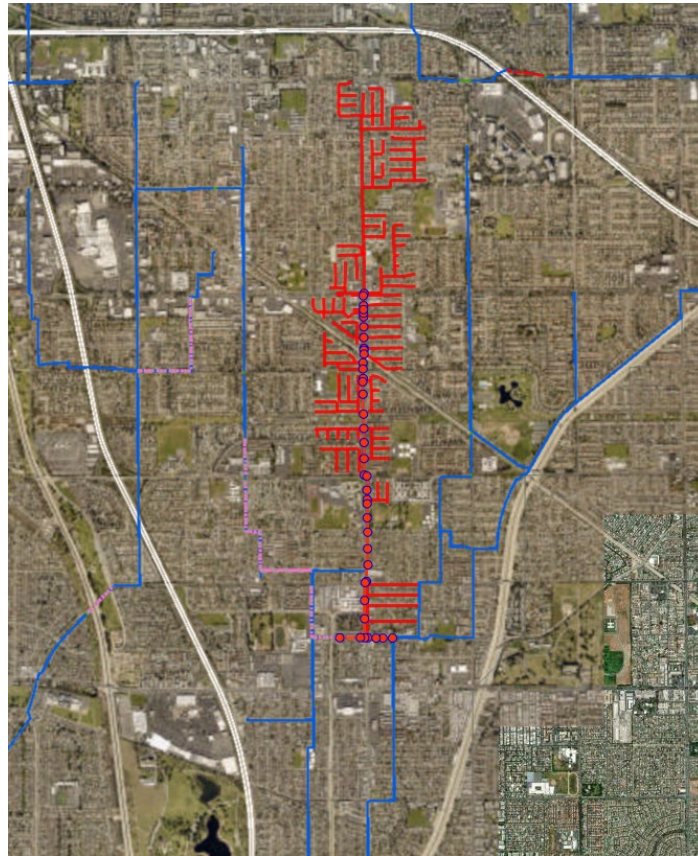
*Figure 1. GIS map of the tributary area upstream of manhole 19 0081*

The East Artesia Sections 1,2,3 & 5 21” VCP siphon located between manholes 19 0080 and 19 0081 in Hawaiian Gardens has been experiencing heavy greasing requiring frequent cleaning. The preliminary investigation did not reveal a point source of the grease but determined the cause is likely from an aggregate of residential and commercial food service establishments (FSEs) along Pioneer Blvd. Industrial Waste will work in cooperation with the Los Angeles County Department of Public Works, which has local jurisdiction over the fats, oils, and grease (FOG) control program for FSEs in the city, to control the amount of grease accumulating in the siphon.

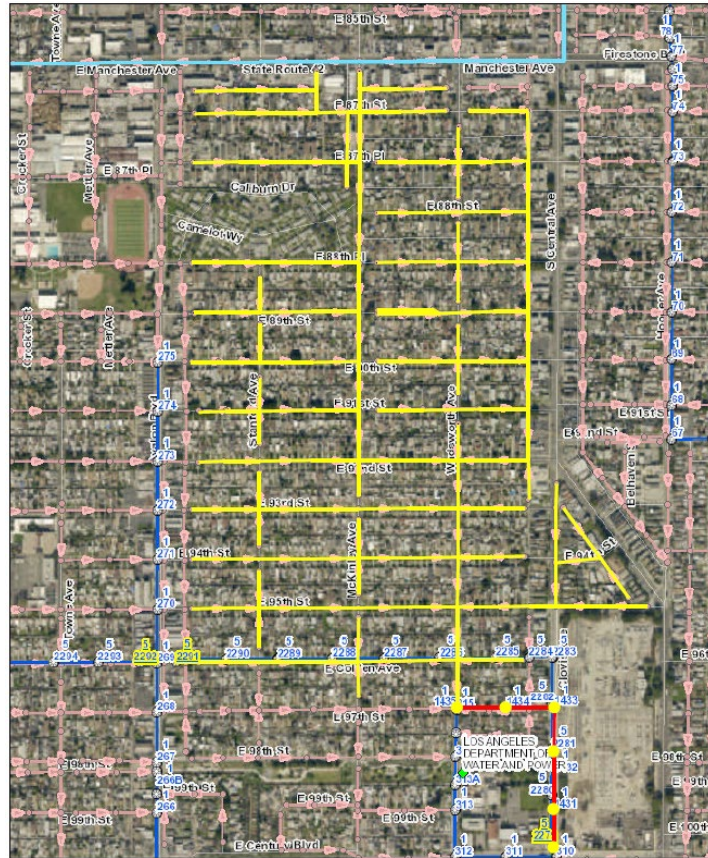
Figure 2. GIS map of the tributary area upstream of manhole 01 1430.

The Wadsworth Avenue-Long Street Trunk Replacement 12" VCP siphon located between manholes 01 1430 and 01 1429 in Los Angeles has been experiencing heavy greasing requiring frequent cleaning. The preliminary investigation did not reveal a point source of the grease but determined the likely cause is from domestic sources and a few FSEs. Industrial Waste will work in cooperation with the City of Los Angeles, which has local jurisdiction over the FOG control program for FSEs in the city, to control the amount of grease accumulating in the siphon.

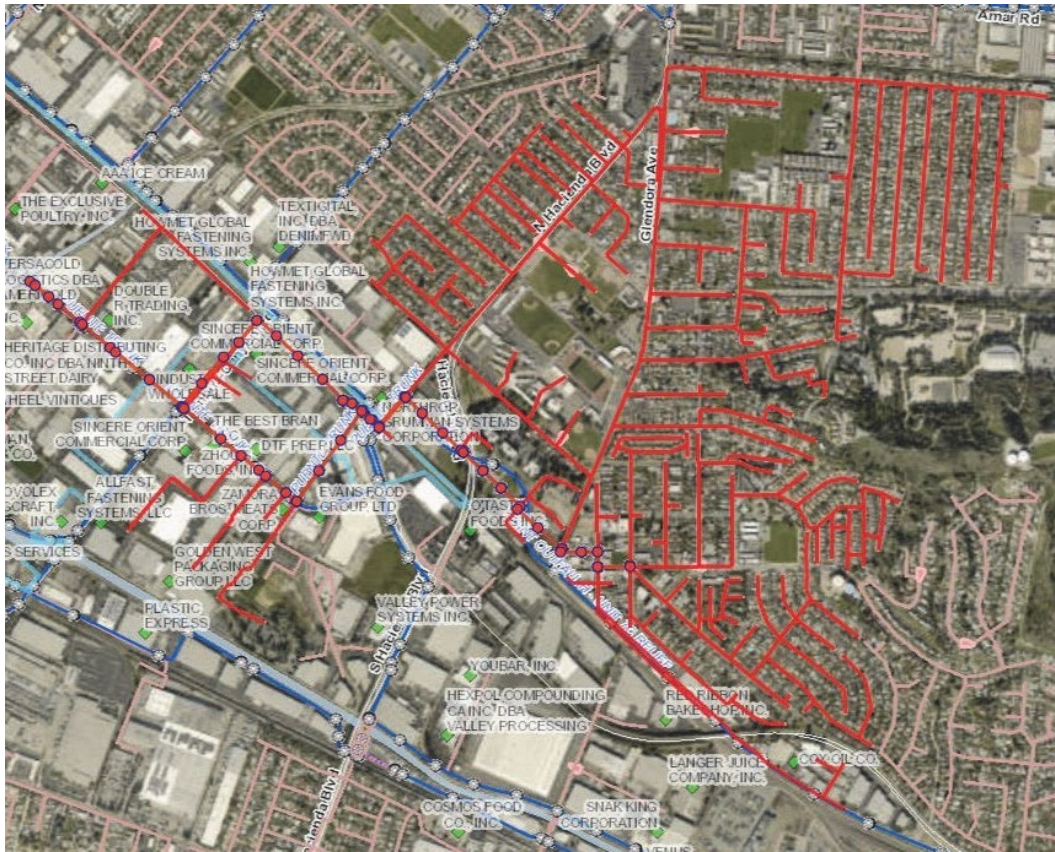
Figure 3. Tributary Area of Siphon at MH 15-0043 to MH 15-0040

The Puente Trunk siphon between manholes MH 15-0043 to MH 15-0040 (2-18") located at the intersection of Proctor Ave and the Puente Creek has been experiencing heavy greasing requiring frequent cleaning. Industrial Waste Inspectors identified seven (7) Industrial Waste permitted facilities having the potential to contribute to the FOG problem at this siphon. These facilities were inspected and found to be in compliance with pretreatment requirements, and all waste manifests documented regular hauling of clarifier grease for offsite disposal. Nevertheless, one of these facilities, Evans Food Group, LTD (IW#22180), has a history of contributing excessive FOG into the collection system. Evans was investigated multiple times for sewer grease. The most recent incident was in January 2022, for a Partial Blockage in Puente Trunk Line.

IW Inspectors will continue to monitor and sample Evans Food Group for compliance. In addition to the I.W. permitted dischargers, this siphon receives wastewater from an aggregate of residential and commercial food service establishments (FSEs) in the area. Industrial Waste will work in cooperation with the local jurisdiction regarding the fats, oils, and grease (FOG) control program for FSEs in the city.

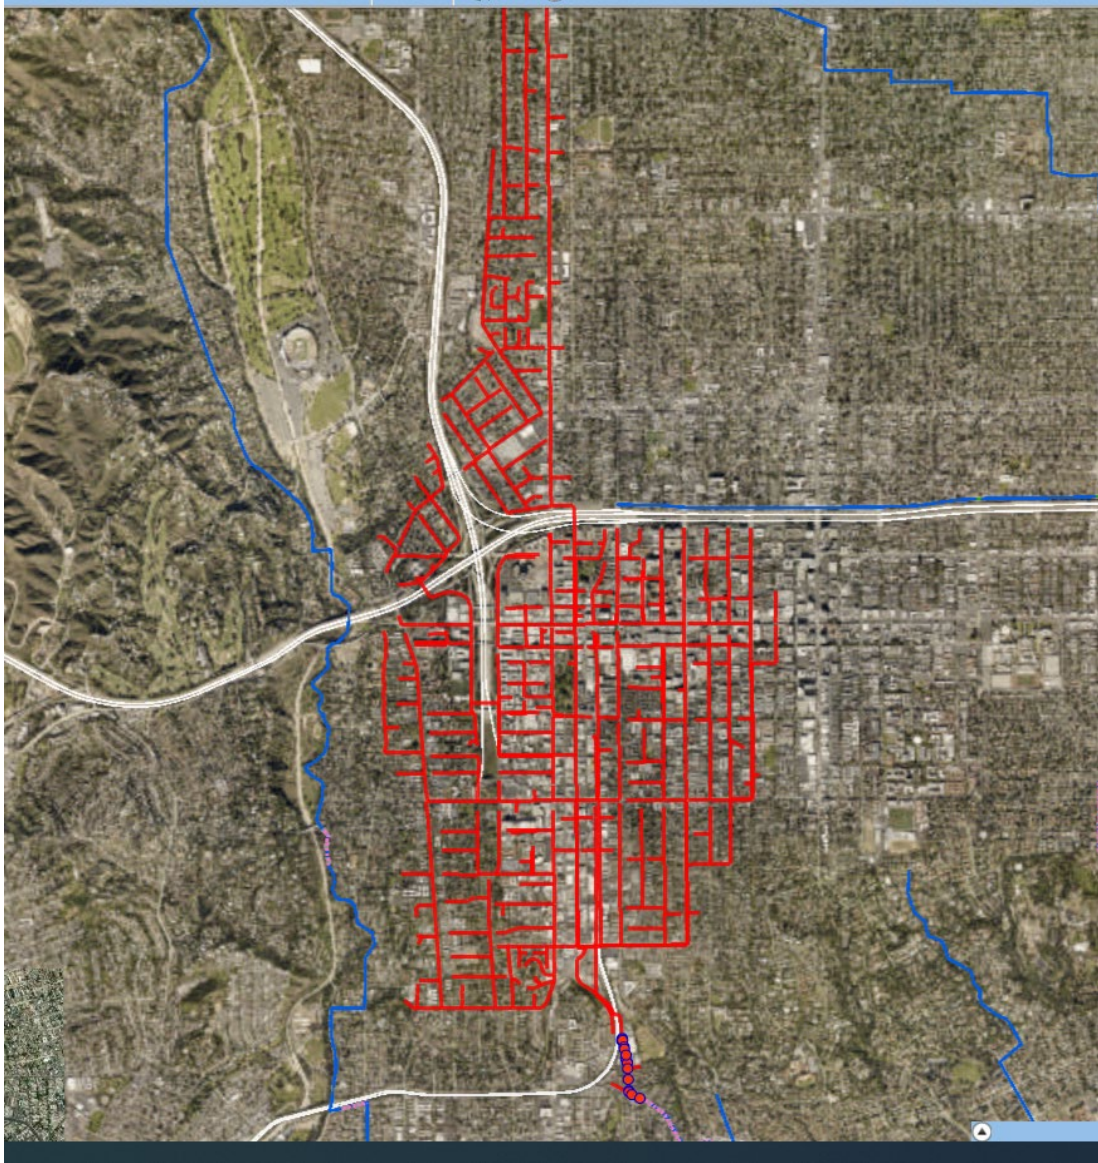
*Figure 4. Tributary Area for MH 16 0192*

The Arroyo-Secco Trunk Section 3 Trunk siphon between manholes MH 16-0191 and MH 16-0192 located at the intersection of Clark Place and Stratford Lane has been experiencing heavy greasing requiring frequent cleaning. Industrial Waste Inspectors identified four (4) Industrial Waste permitted facilities immediately tributary to this siphon. These facilities (a linen launderer, hospital, power plant, and a food manufacturer) were inspected and found to be in compliance with pretreatment requirements, and manifests at the food manufacturer documented regular hauling of clarifier grease for offsite disposal. Moreover, there was no evidence that any of the subject industries had recently or consistently been discharging excessive amounts of grease. In addition to the I.W. permitted dischargers, this siphon receives wastewater from an aggregate of residential and commercial food service establishments (FSEs) in the area. The preliminary investigation did not reveal a point source of the grease, but Industrial Waste will work in cooperation with the city of Pasadena regarding the fats, oils, and grease (FOG) control program for FSEs in the city.

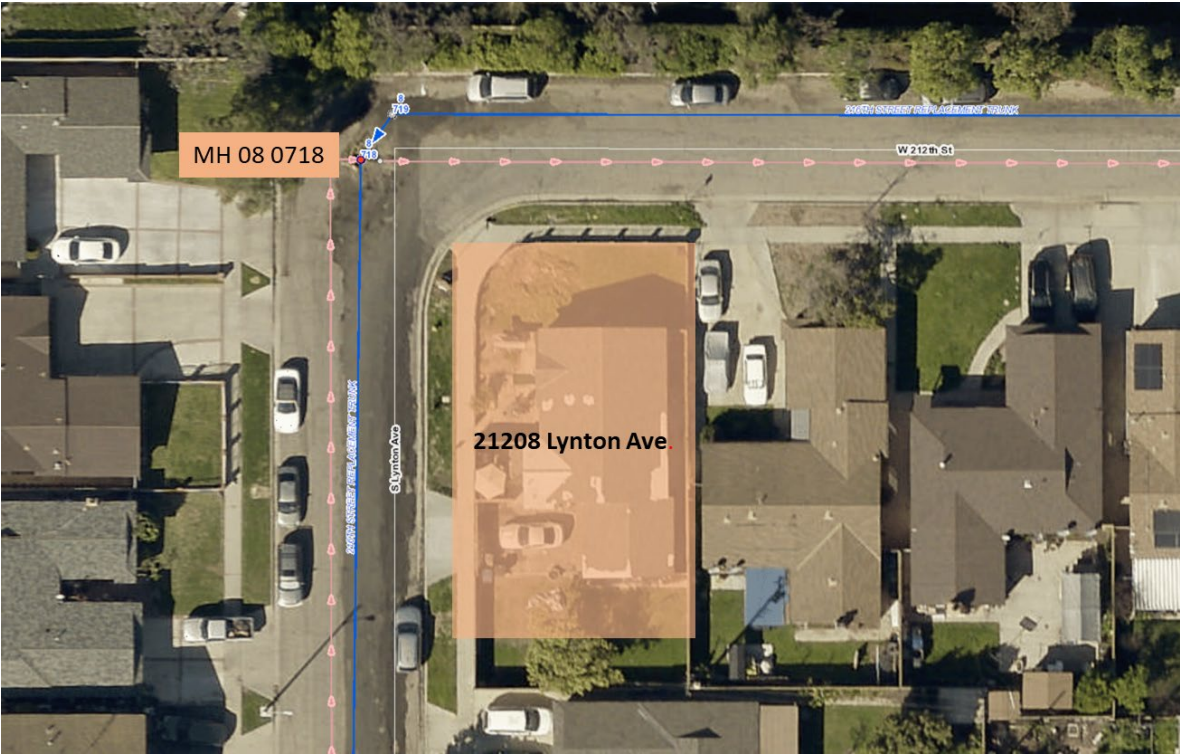
*Figure 5. GIS map of the residence complaint and manhole 08 0718 on the 216<sup>th</sup> Street Replacement Trunk.*

On Saturday, July 15, 2023, at 1817 hours, the Industrial Waste Section received an email from Wastewater Collections Systems (WCS) reporting an odor complaint from a resident at 21208 Lynton Avenue, Carson. A Districts swing shift pumping plant operator, who was dispatched to the location, confirmed a strong odor at the nearby manhole 08 0718, and eliminated the odor by sealing the manhole. Industrial waste inspectors responded on the following Monday performing inspections at a centralized waste treatment facility, a fuel terminal, an oil production facility, and a cold storage facility, which have the potential for discharging highly odorous waste and were all in operation on Saturday, but no irregularities were observed. In addition, the local sewers and the nearby commercial plaza were inspected but no unusual odors were detected. It is unclear what the nature of the odor was, or where it originated, but industrial waste inspectors will remain vigilant for odorous discharges upstream of the 216<sup>th</sup> Street Replacement Trunk.

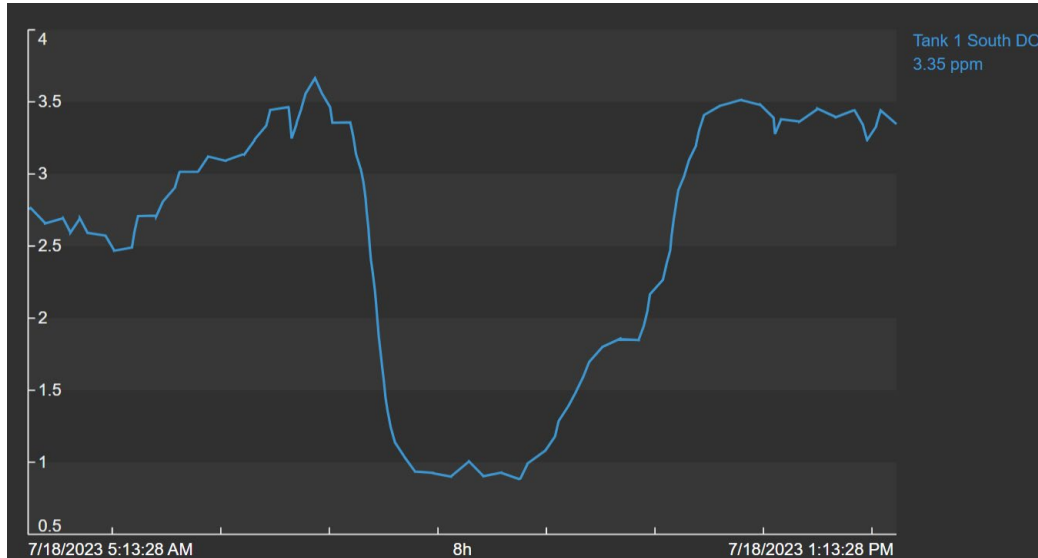
*Figure 7. OSI PI Graph Low DO 07-18-23*

1. On Tuesday, July 18, 2023, at 0912 hours, Whittier Narrows WRP Operations called the Industrial Waste Inspection staff to report the WRP was experiencing sharply declining dissolved oxygen concentrations in the aeration units to a point below the 1.0 mg/L alarm. The dissolved oxygen concentrations declining to a base of 0.9 mg/L before reversing to normal concentrations. The incident began at approximately 0800 hours and was ongoing when the IW inspectors arrived at WNWRP at 0935 hours. It was also indicated by

operations that a similar incident occurred on Monday, July 17, 2023, at approximately the same time. Low D.O. conditions contributed to a slightly higher ammonia concentration in the secondary effluent. There were no other operational anomalies (pH, Color, Odor, turbidity, etc.) reported by WRP staff for this incident.

The IW Inspectors collected raw and primary-effluent grab samples during the incident and requested rush COD analysis for both samples. Laboratory analysis revealed Raw COD = 654 mg/L and Primary effluent COD = 320 mg/L: both within normal values. Despite these results, IW Inspectors conducted investigatory inspections at industrial facilities located upstream of the WNWWRP. Inspections found no evidence of any unusual discharges that might be contributory to the low dissolved oxygen incident at the WRP.

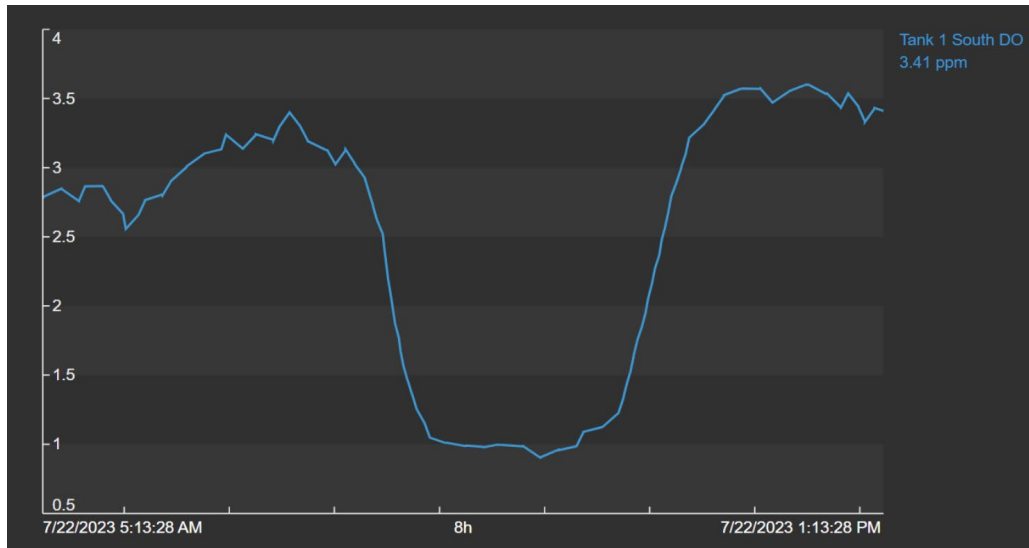
**Figure 8. OSI PI Graph Low DO 07-22-23**

2. On Saturday, July 22, 2023, at 1000 hours, Whittier Narrows WRP Operations called the Industrial Waste Inspection staff again to report sharply declining dissolved-oxygen concentrations in the aeration units to a point below the 1.0 mg/L alarm, which declined to a base of 0.9 mg/L in South Aeration Unit 1. Operations stated that the dissolved-oxygen concentrations began declining at approximately 0850 hours and lasted until approximately 1100 hours. There were no other operational anomalies (pH, Color, Odor, turbidity, etc.) reported by WRP staff for this incident. No samples were taken during this incident.

IW Inspection staff responded immediately by conducting Saturday inspections of high-COD dischargers upstream of WNWRP known to be operating on weekends. There was no evidence of any unusual discharges or non-compliant activity that might have caused the D.O. drop at the WRP.

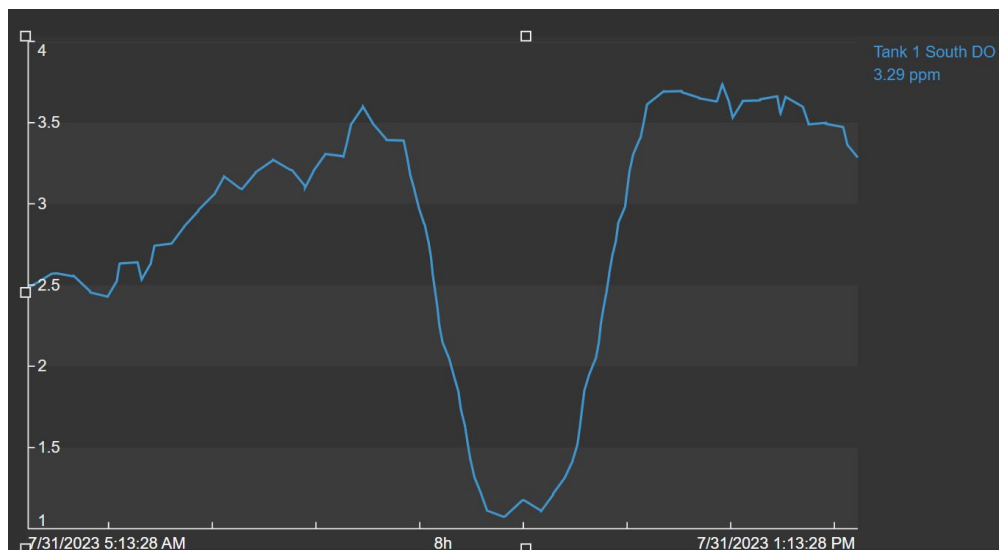
**Figure 9. OSI PI Graph Low DO 07-31-23**

- On Monday July 31, 2023, at 0945 hours, Whittier Narrows WRP Operations called the Industrial Waste Inspection staff to report sharply declining dissolved-oxygen concentrations in the aeration units to a point at the 1.0 mg/L alarm. There were no other operational anomalies (pH, Color, Odor, turbidity, etc.) reported by WRP staff for this incident.

The IW Inspectors collected raw and primary-effluent grab samples during the incident and requested rush COD and Oil & Grease analysis for both samples. Laboratory analysis revealed Raw COD = 519mg/l, oil & grease = 58.6mg/l and Primary COD = 249mg/l, oil & grease = 27.7mg/l. These analyses are within normal values for WNWRP. IW Inspectors conducted investigatory inspections and found no evidence of any unusual discharges.

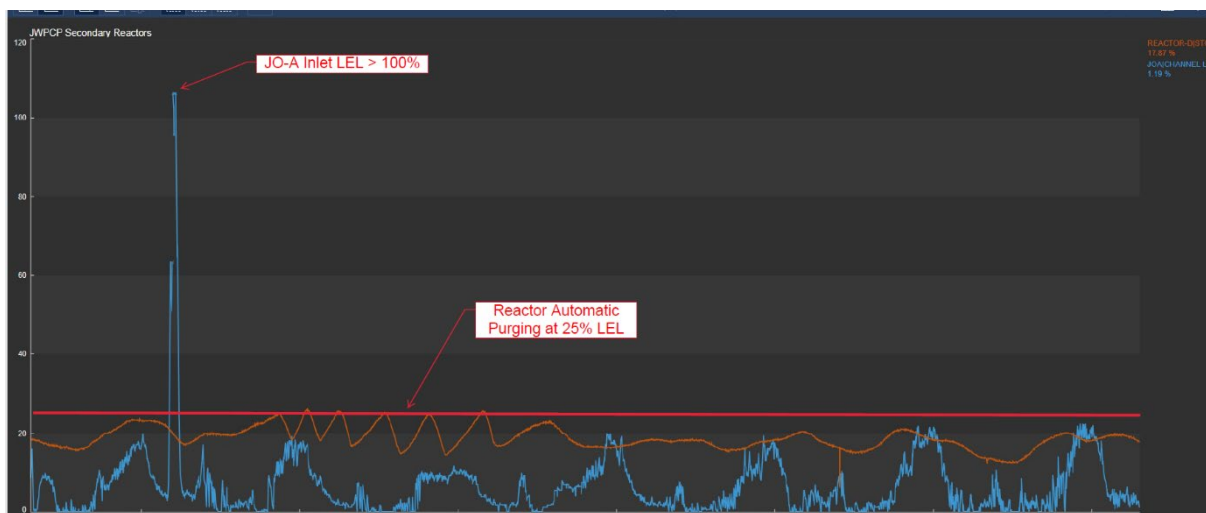
Figure 20. PI Vision chart displaying J.O. "A" Inlet and Reactor D combustible gas levels the week of August 11,

Evidence strongly supports the notion that Phillips 66 is likely the source of the elevated LEL readings at the JO-A Inlet and the subsequent purging of Reactor D. The operator's logbook, which documents water

quality issues, strongly implies that Phillips 66 was encountering challenges with their pretreatment processes and might have been falling

short of meeting permit restrictions. The chronological correlation between the occurrences of excessive oil and grease levels and the persistent elevated LEL at JWPCP's Reactor D, further reinforces this concept, particularly since the sample results indicated a violation of permit limits.

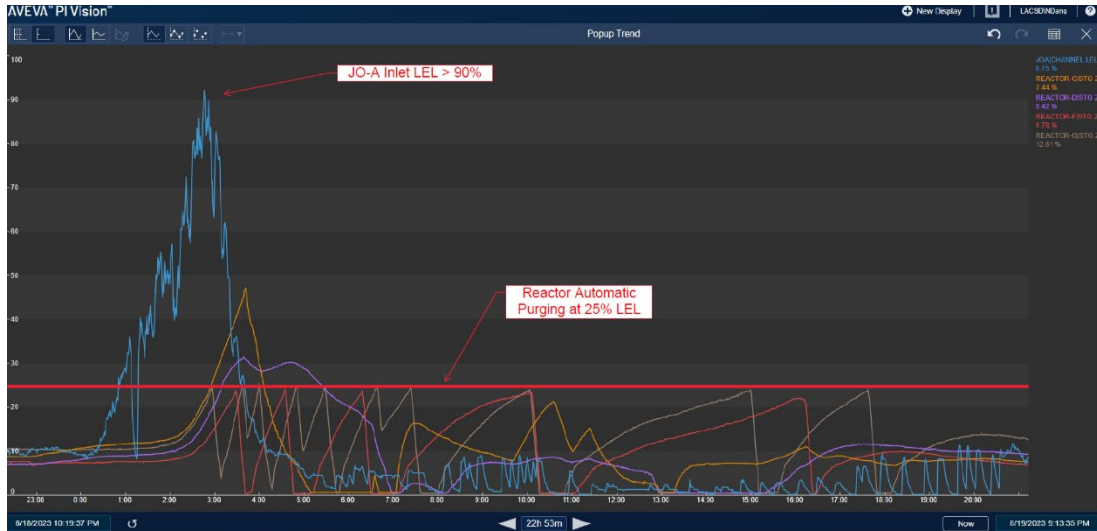
Figure 4. PI Vision chart displaying J.O. “A” Inlet and Reactor combustibility gas levels on August 19, 2023.

On Saturday, August 19, 2023, at 0247 hours, JWPCP Operations called the Industrial Waste Section to report elevated combustible gases and a diesel odor at the plant. High combustible gas readings and odors were initially detected at JO "A" inlet to the headworks. Operations expected the rising LEL in the secondary reactors would necessitate purging.

Industrial Waste Inspectors immediately began an investigation of four petroleum refineries tributary to JO "A". Of the four refineries investigated, Phillips 66 demonstrated evidence of abnormal wastewater quality resulting in wastewater impoundment during the incident timeframe. I.W. Inspectors collected samples from the refinery's carousel, which had visible excessive oil and a strong fuel odor. Laboratory analysis revealed samples collected from sampler bottles taken at 03:00 hours and 05:00 hours on August 19, demonstrated excessive oil content in exceedance of permit limits. Evidence strongly supports the notion that Phillips 66 is likely the source of the elevated LEL readings at the JO-A Inlet and the subsequent purging of Reactors C, D, E, F, and G. A compliance meeting will be scheduled with Phillips 66 to ensure future operations result in their discharge requirements being met.

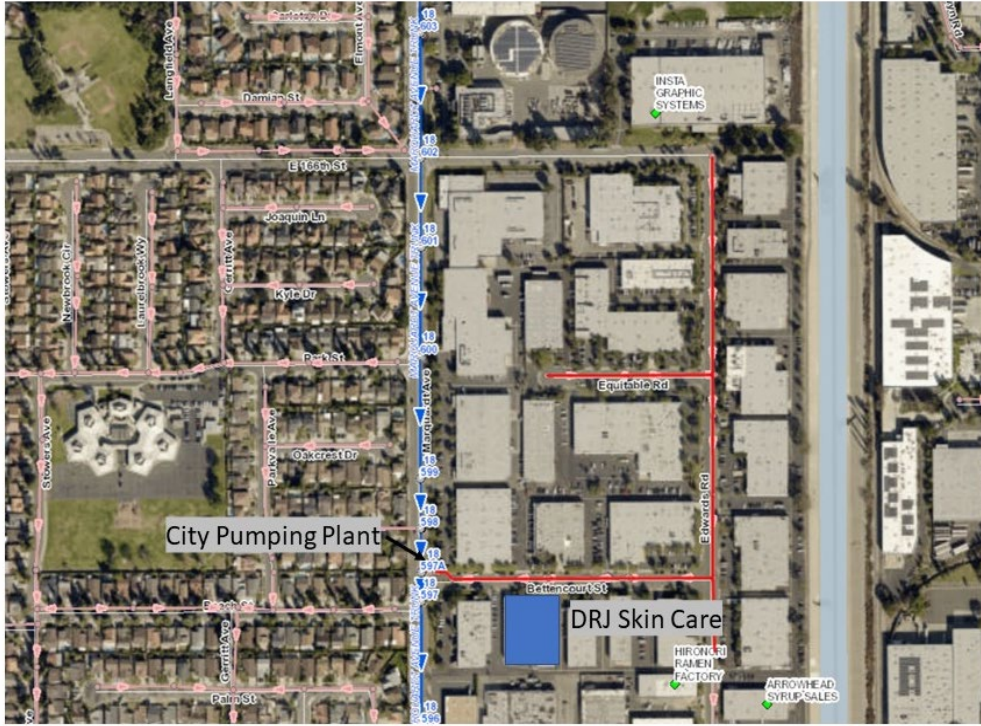
Figure 6. GIS map showing the City of Cerritos Pumping Plant and the upstream sewer.

On Monday, August 21, 2023, at 1545 hours, the City of Cerritos contacted the IW Section requesting assistance in identifying and controlling foam that was impacting the ultrasonic level sensors in a city pumping plant located on the northeast corner of Marquardt Avenue and Bettencourt Street in the City of Cerritos. An

investigation of the upstream sewer found that DRJ Skin Care, a non-permitted detergent manufacturer specializing in skin care products, was generating highly foaming wastewater. To control the foam the company was requested to purchase a defoaming chemical and bleed it into their waste stream. Industrial waste inspectors have started the permit process to issue the company an industrial wastewater permit which will have requirements to control foam.

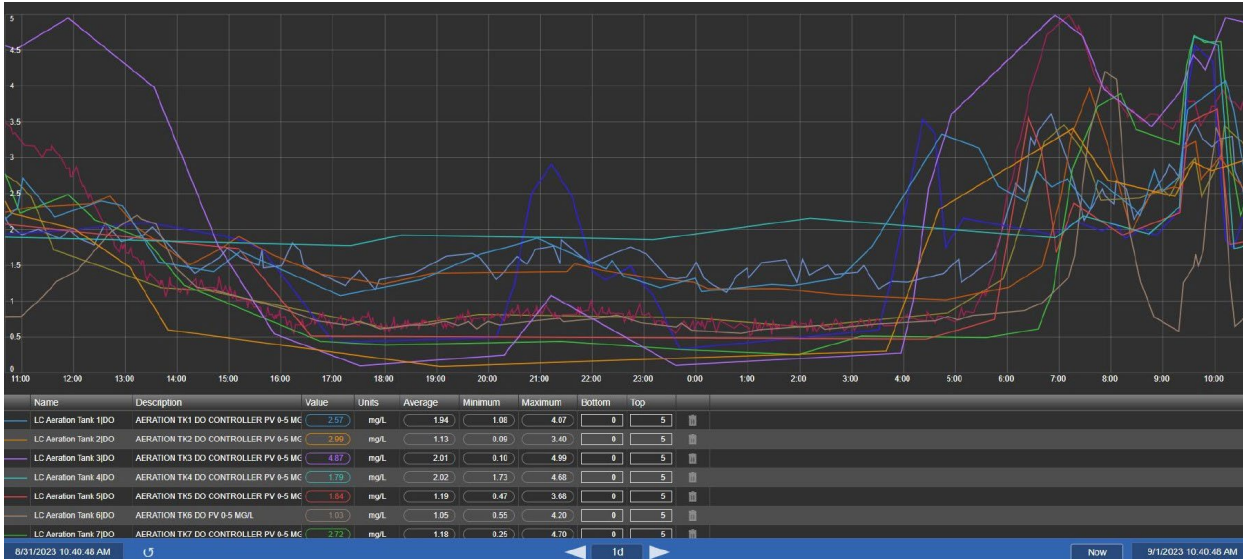
Figure 21. LCWRP DO Trends From 08-31 to 09-01

On Friday, September 01, 2023, at 0700 hours, LCWRP Operations reported to the Industrial Waste Section of low dissolved oxygen conditions in the aeration units. There were no other adverse impacts (pH, color, turbidity, odor, etc.) reported by operations during this incident. According to operations, dissolved oxygen conditions began to decline at approximately 1600 hours on Thursday, August 31, 2023, and remained below 1.0 mg/L until 0600 hours on September 01, 2023. Operations did not provide incident samples to Industrial Waste.

IW Inspectors from both day and night teams investigated 11 dischargers having significant COD risks to LCWRP. The investigation did not identify a likely source of the incident. All inspected dischargers were operating normally and had no substantiated spills or pretreatment mishaps. Brenntag Pacific, Inc. was found to have a minor, non-incident-related violation. Ultimately, the incident did not materially impact WRP treatment operations or effluent quality. IW inspectors continue to be watchful for excessive organic loading at facilities upstream of the WRP.

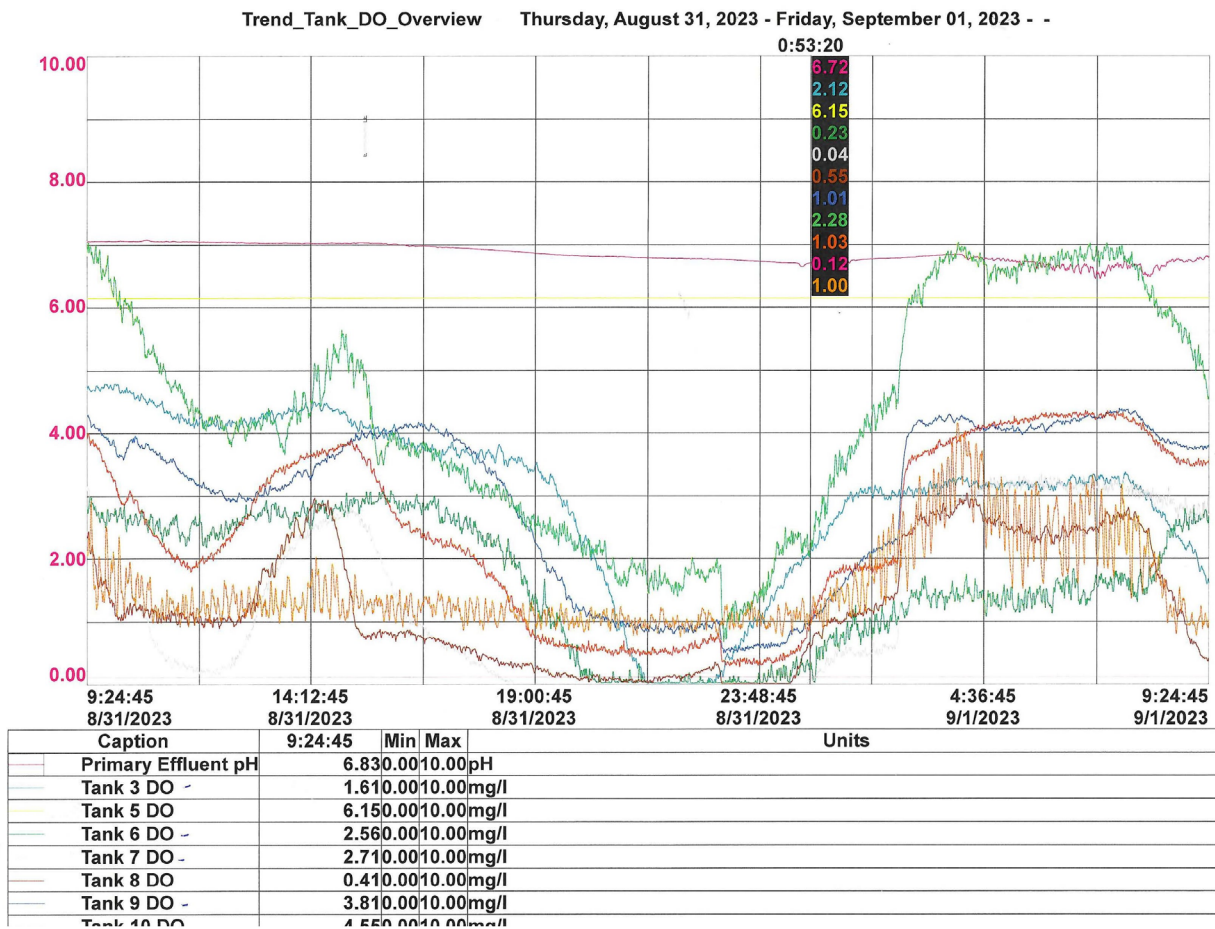
Figure 22. VWRP DO Trends From 08-31 to 09-01

On Friday, September 1, 2023, at 0750 hours, Valencia WRP Operations reported to the Industrial Waste Section of low dissolved oxygen conditions in the aeration units followed by elevated effluent turbidity in the effluent filters. Operations stated that the dissolved oxygen concentrations began declining at approximately 1800 hours on August 31, eventually reaching 0.0 mg/L at 2000 hours. Operations responded to the low dissolved conditions by increasing the air compressors to maximum output to counteract the oxygen demand, which began to recover at 0053 hours the next day, September 1. At approximately 0130 hours on September 1, 2023, the effluent filter turbidity climbed to 2.87 NTU, and the turbidity in the UV train was too high and had to be turned off in favor of conventional disinfectant using contact tanks. Operations noted no other adverse impacts regarding color, odor, or pH during the incident. At the time of the notification to the IW Section, the plant had returned to normal operations. Operations collected and provided incident-specific plant samples to IW.

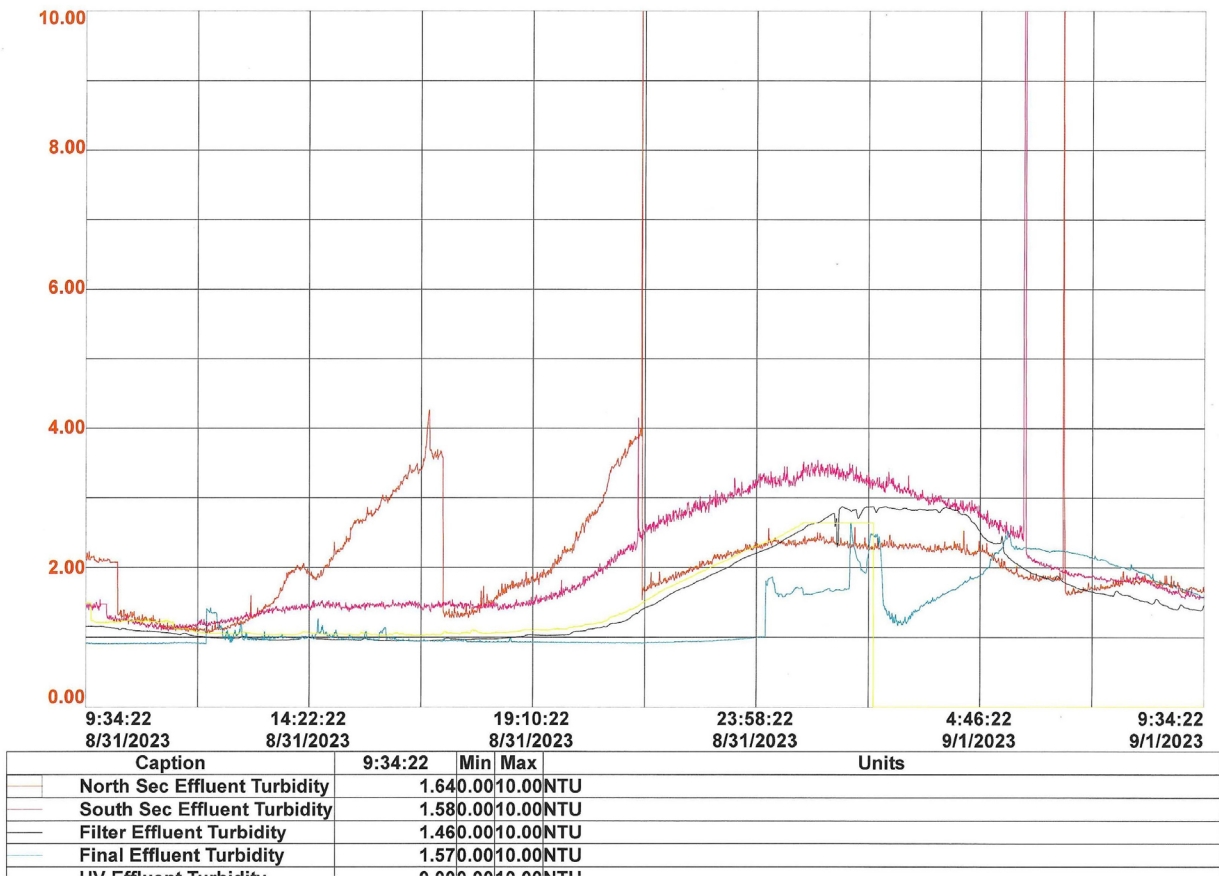
Figure 23. VWRP Turbidity Trends From 08-31 to 09-01

Having the benefit of composite samples taken during the incident window, the Laboratory MSO (monthly summary of operations) report revealed primary, secondary, and tertiary composite samples were elevated for COD and turbidity. The primary effluent COD concentrations were three times higher than normal (1520 mg/L vs 400-500 mg/L). Sample results substantiate the idea that a slug organic load impacted the plant.

Though there was no direct evidence such as a spill or records of a release of off-spec product that would point directly at DrinkPak, LLC at the time of the upset at the Valencia WRP, the high flow rate on September 1, 2023, and evidence of high COD water that has been sampled multiple times in the past 8 months make the company a strong suspect for having caused the high oxygen demand.

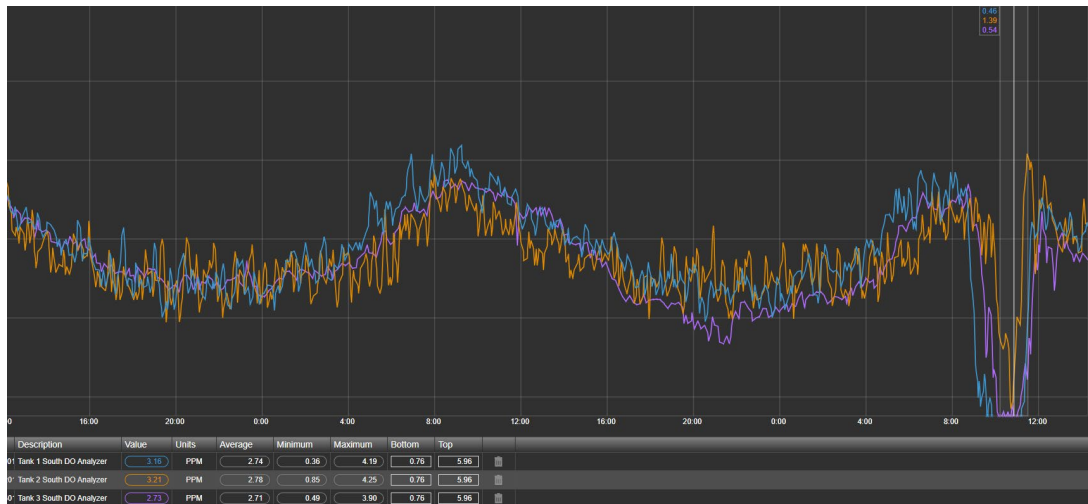
**Figure 25. OSI PI Graph WNWRP D.O. at Aeration Units Oct. 30, 2023**

On Monday, October 30, 2023, at 1019 hours Whittier Narrows WRP Operations called the Industrial Waste Section to report low-dissolved oxygen conditions in the secondary aeration units. Operations stated that the dissolved-oxygen concentrations began sharply declining at approximately 0900 hours and reached a minimum value of 0.42 ppm at 1048 hours. Dissolved-oxygen concentrations recovered above 1 ppm in all secondary tanks by 1120 hours. There were no reported abnormal odors, color, or foam associated with the event, but Operations noted slightly elevated grease at the end of the primary channel. Plant operators obtained raw influent grab samples at 0950 hours and primary effluent grab samples at 0953 hours. IW Inspectors received the samples, which were subsequently submitted to the SJC water quality laboratory for total COD analysis.

Despite extensive efforts by IW inspectors to determine a source for these incidents, no definitive source has yet been identified. IW Inspectors immediately responded to the call and investigated three significant dischargers tributary to WNW RP. These inspections revealed no wastewater data or observations associating discharges from those facilities as the source of the incident. The WRP Laboratory collected a weekly “Primary Effluent” composite sample on the day of the incident (October 30, 2023), which had a normal range result of 394 mg/l. The low dissolved-oxygen incident did not cause an NPDES violation.

IW Inspectors have developed an extensive effort to try to locate and identify the source(s) of these incidents and the investigation remains ongoing. In effort to better characterize the issue causing intermittent low dissolved-oxygen conditions at WNW RP, IW inspection staff requested further primary effluent C.O.D. sampling by CSD lab personnel using an existing ISCO sampler at WNW RP. The ISCO sampler was programmed to collect 24 discrete bottles every day from August 07, 2023, through August 24, 2023. Multiple low D.O. incidents were reported during this sampling period, but all sampling results for primary effluent C.O.D. were within WNW RP normal ranges, before, during, and after each incident. The profile of the C.O.D. concentrations during these incidents failed to verify that the wastewater causing these incidents is in fact high organic strength. Nevertheless, the IW Inspection staff will continue to monitor the upstream industrial users to ensure they remain in compliance with permit requirements.

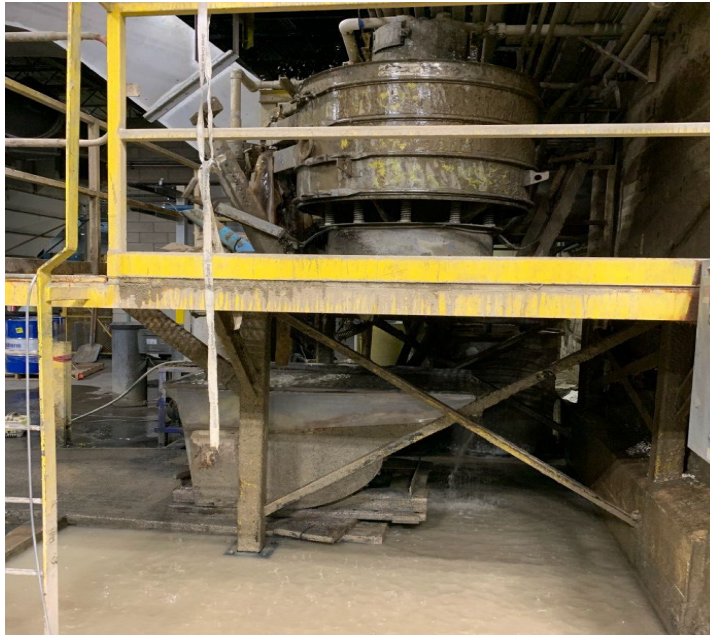
On Tuesday, October 24, 2023, at 1236 hours, the Industrial Waste Section received a call from the Street Superintendent for the City of Compton Public Works reporting that a city contractor removed 10 cubic yards of sand from the 8” local sewer downstream of Owens Corning (FID 2065373, IW 5977 and IW 12609). This Owens Corning facility is located at 1501 Tamarind Avenue in the city of Compton and uses sand in the manufacturing of asphalt roof shingles. The subject 8” local sewer line connects to the Districts’ Bullis Road - Temple Street Relief Trunk at manhole 01 0378, approximately 1,000 feet downstream of the facility’s point of connection.

**Figure 3. Sand removal equipment at Owens Corning**

In an effort to prevent sewer backups and surcharging in the local sewer, the city has increased its maintenance on the affected reach. Although no sewer system overflows were caused by this sand release, the city of Compton may pursue cost recovery for the increased maintenance expense. In response to the excessive sand loading in the local sewer, Industrial-waste Inspectors issued a Notice-of-Violation to the company for violating two sections of the *Wastewater Ordinance*: Section 309 for causing increased maintenance in the local sewer, and Section 412 for not adequately maintaining their pretreatment equipment. There was no adverse impact to the Districts' sewers from this sand release.

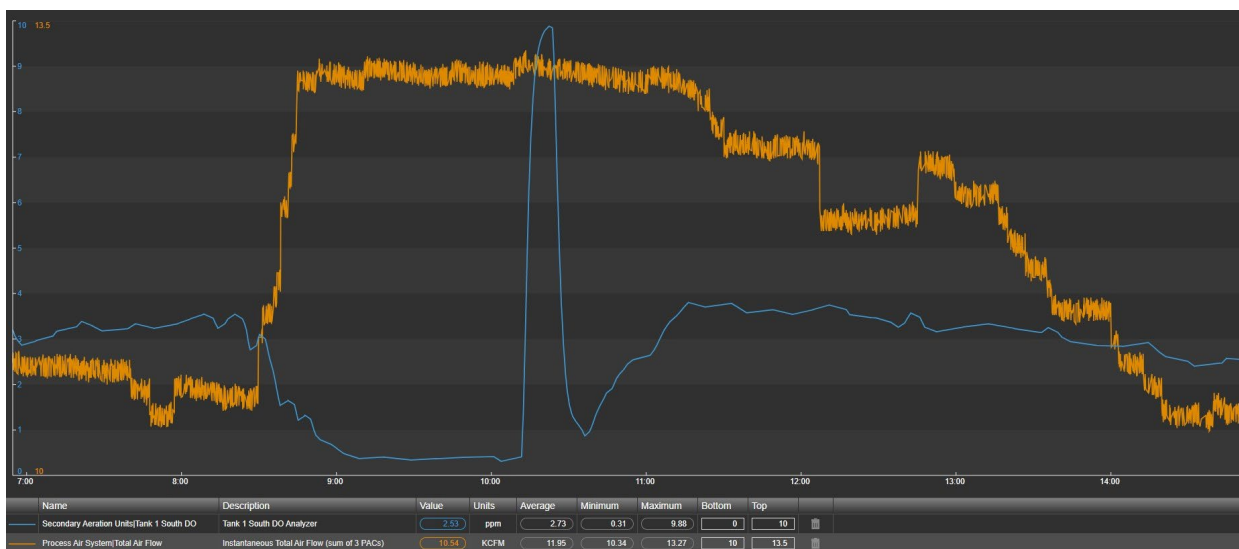
**Figure 26. WNWWRP Aeration Unit 1 DO and Total Air Flow November 2, 2023**

Whittier Narrows WRP experienced three, low dissolved-oxygen incidents in November. On Thursday, November 2, 2023, at 0912 hours, Whittier Narrows WRP Operations called the Industrial Waste Section to report low dissolved-oxygen (DO) concentrations in the aeration units. Operations reported that the DO began declining at approximately 0845 hours and reached a minimum of 0.31 ppm at 1004 hours. It was noted that all other parameters were normal such as odor, color, and pH. Operations provided IW Inspectors grab samples of primary effluent taken at 0925 hours and raw influent at 0920 hours. The samples were submitted to SJC water quality laboratory for total COD analysis.

Nevertheless, IW inspectors investigated facilities that have a potential of discharging high COD wastewater to the plant but found nothing that could explain the period of low DO in the secondary aeration units. Thus far, the DO drop offs have not resulted in any impact to final effluent quality at the WRP.

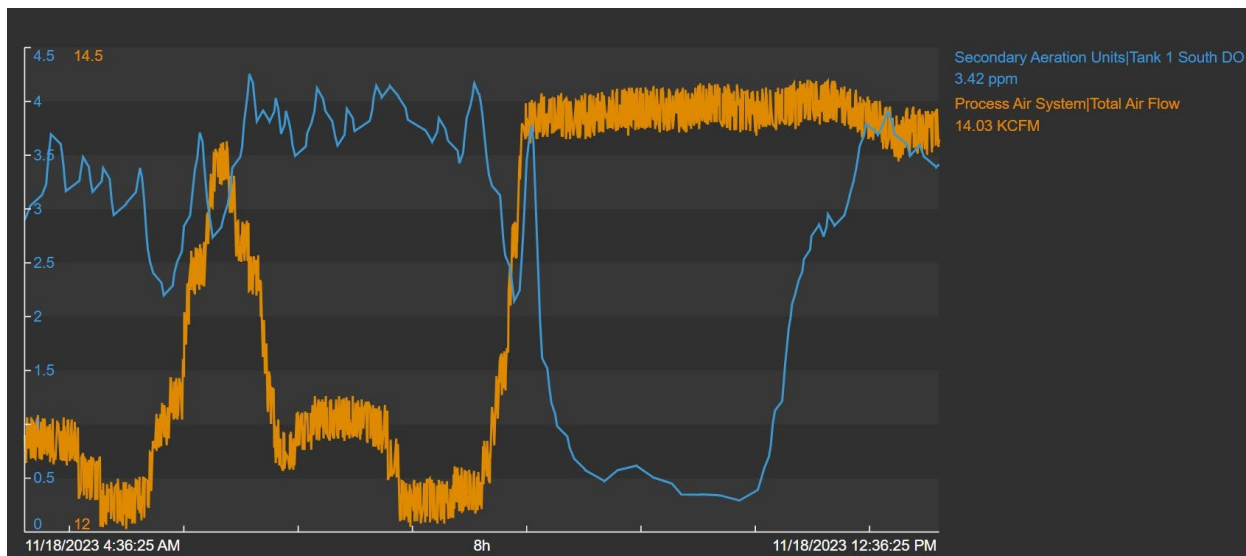
Figure 27. WNWRP Aeration Unit 1 DO and Total Air Flow November 18, 2023

On Monday, November 20, 2023, the IW Section received a third call from WNWRP Operations reporting low DO concentrations in the aeration units that occurred on Saturday, November 18, 2023. The DO began dropping sharply around 0900 hours and reached a minimum value of 0.24 ppm at 1055 hours. The DO recovered above 1 ppm in all tanks by 1118 hours. Operations staff reported that there were no abnormal odors, color, or foam associated with the event, and influent pH remained within normal parameters. Operations mentioned unusual grease loading in primary treatment prior to the low DO event. Plant operators took raw influent and primary effluent grab samples at 0950 hours and 0953 hours, respectively. The samples were submitted to SJC water quality laboratory for total COD analysis.

Again, sample results did not indicate high COD wastewater impacting the plant during this incident. However, the IW Inspection staff will continue to monitor plant operations and inspect tributary industrial dischargers that have a potential to discharge high-strength wastewater. The low DO condition did not adversely impact the final effluent quality at the WRP.
