**2023 ANNUAL REPORT**

INDUSTRIAL WASTE PRETREATMENT PROGRAM

LOS ANGELES COUNTY SANITATION DISTRICTS

**APPENDIX H**  
INDUSTRIAL WASTE REPORTS ON INCIDENTS

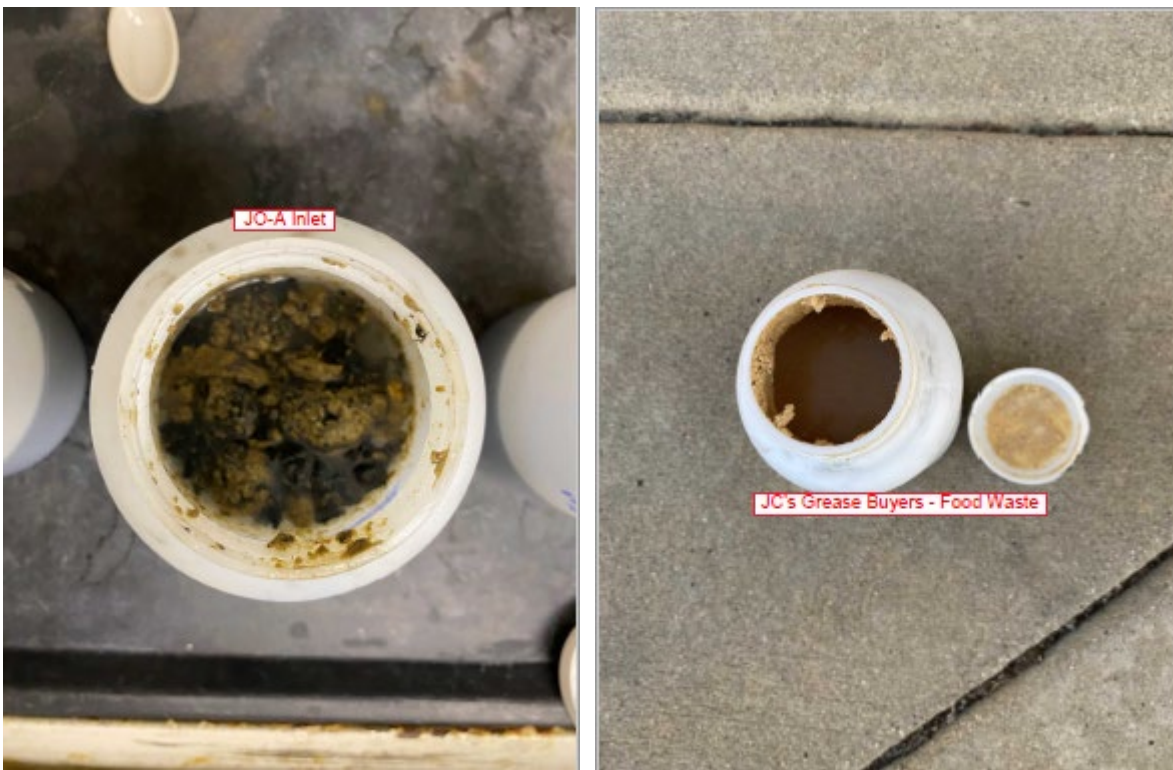
On Thursday, November 30, 2023, at 1445 hours, a supervising treatment plant operator at the Warren Facility contacted the Industrial Waste Section requesting an investigation into the source of grease fouling the headworks. Samples were collected by Operations from each of the three inlets at 1000 hours in the morning

Figure 4. Samples collected from the JO-A inlet and a load of food waste at the Carson liquid waste disposal station.

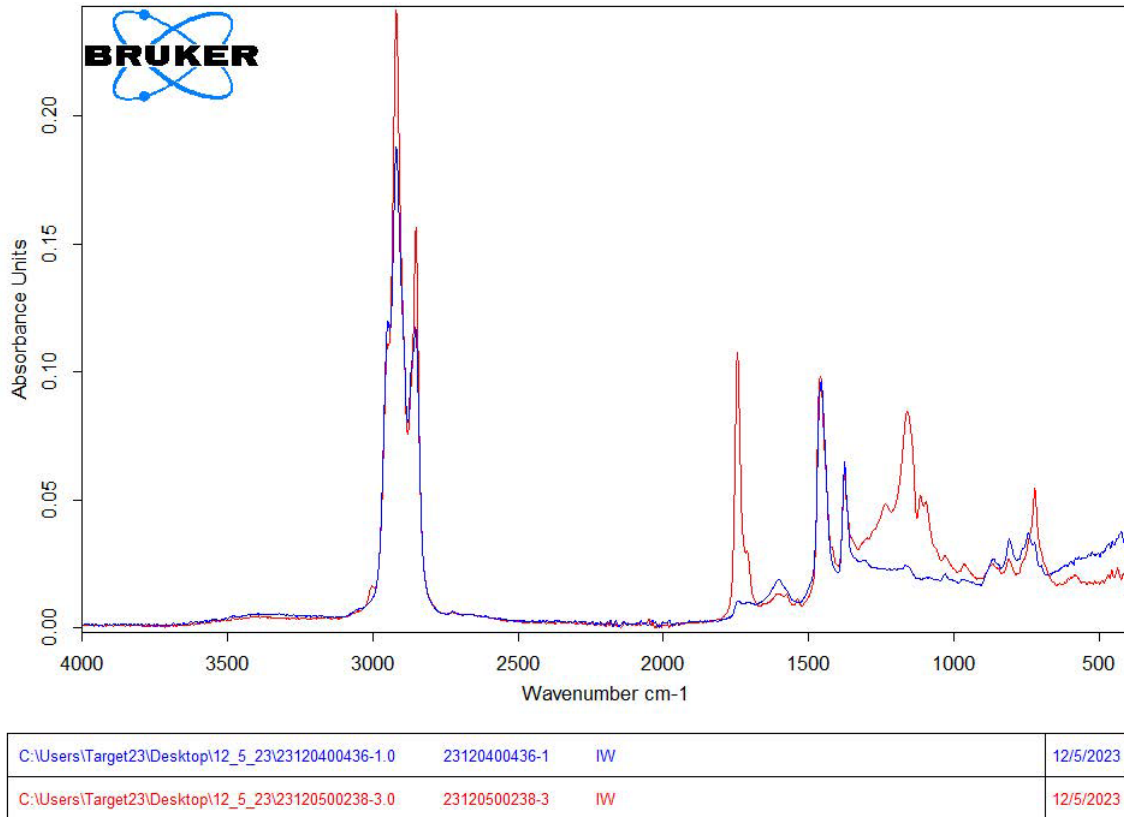
Industrial Waste inspectors investigated several tributary industrial users with possible petroleum oil operations and found Pacific Palms Petroleum, LLC (FID 9244214) to be the only active oil producer upstream of SJCEWRP. Inspections performed at the facility found significant oil in the clarifier, discharge piping, and legal sample point (Figure 1). IW inspection dialogue with the consulting firm (Allenco Co), which operates and maintains the Pacific Palms oil lease, revealed that they were aware of oil at the situs. A boiler malfunction created a cascade of events resulting in a reduced capacity to phase separate the oil from the formation brine water, which allowed an excessive amount of oil to flow to the sewer. The consulting firm acknowledged the facility was at fault for the oily discharge to the sewer and surface soil at the situs. A sample collected from the Pacific Palms legal sample point and a SJCEWRP raw influent sample were submitted for Infrared (IR) Scan analysis with results showing similar peaks (Figure 2).

Figure 2. IR Scan of WRP and Pacific Palms Petroleum, llc samples

Pacific Palms Petroleum LLC was found to be the source for the oily water at the SJCEWRP based on inspection observations, discussions with the facility’s consulting firm, and IR scan results. A Notice of Violation was issued to the company citing LACSD Wastewater Ordinance Sections: 406H (Discharge of petroleum), 406 (Discharge of any waste that would adversely affect treatment processes), 412 (failure to maintain pretreatment systems), and 206 (interfering with entrance to authorized districts inspectors. There was no impact to District facilities or operations.

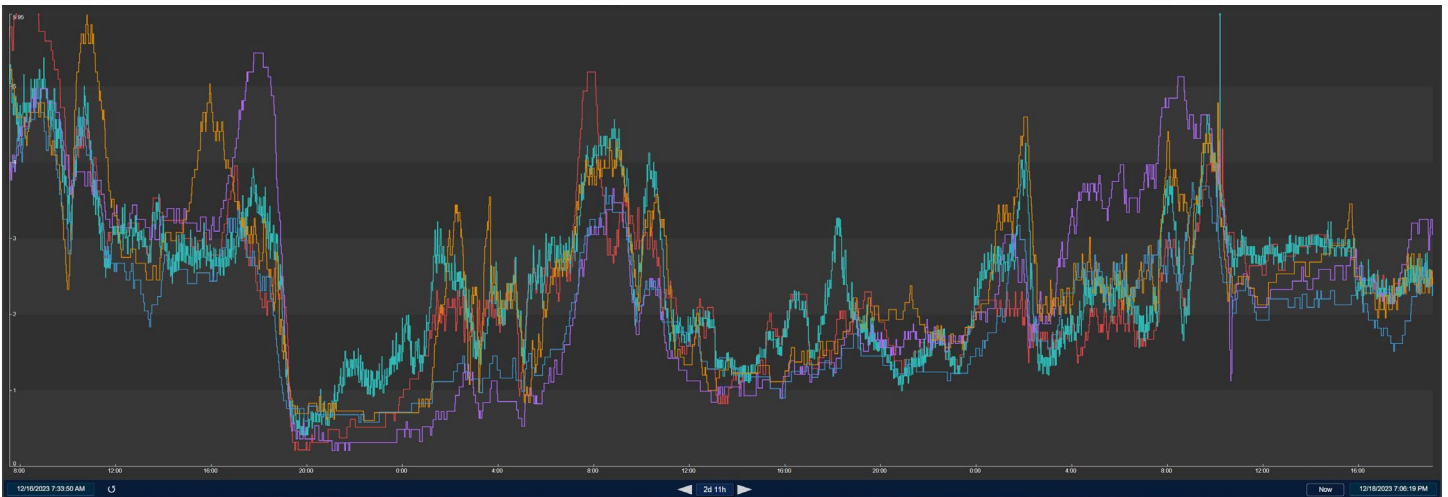
On Saturday, December 16, 2023, at 2014 hours, SJC WRP Operations notified the Industrial Waste Section that the east (SJCE) and west (SJCW) plants were experiencing low dissolved oxygen in the secondary aeration tanks (Figures 1 & 2). The influent was diverted into empty primary tanks to moderate the effects of the suspected high COD wastewater. SJCE & SJCW continued to experience a pattern of low dissolved oxygen for the next two consecutive days. The influent exhibited no abnormal characteristics in color, odor, pH, and viscosity. Operations collected raw influent and primary samples throughout event. Subsequent analysis of the SJCE primary-effluent grab samples collected on December.15, 2023 and December 16, 2023, by operations, found slightly elevated Chemical Oxygen Demand (COD) concentrations at 525 mg/L and 633 mg/L, respectively.

Figure 1. SJC East D.O. Drop December 16, 2023, 1835 hours.

Industrial users tributary to both SJCE and SJCW having a potential to discharge high COD wastewater were inspected. Several facilities, such as Alta Dena (FID 9256634), Driftwood Dairies (FID 9242424), Tropicana (FID 1922151), and Langers Juices (FID 1901732), had operations during the timeframe of the incident, but there were no observed or reported significant spills or operational anomalies at these facilities. In total, 34 inspections were completed in response to this event by day and night inspection staff. Inspection staff will continue to keep industrial users in compliance with permit limits and educate/remind those users to notify the Districts when/if spills of product occur that could adversely impact the downstream water reclamation plant. There was no NPDES violation because of this incident.

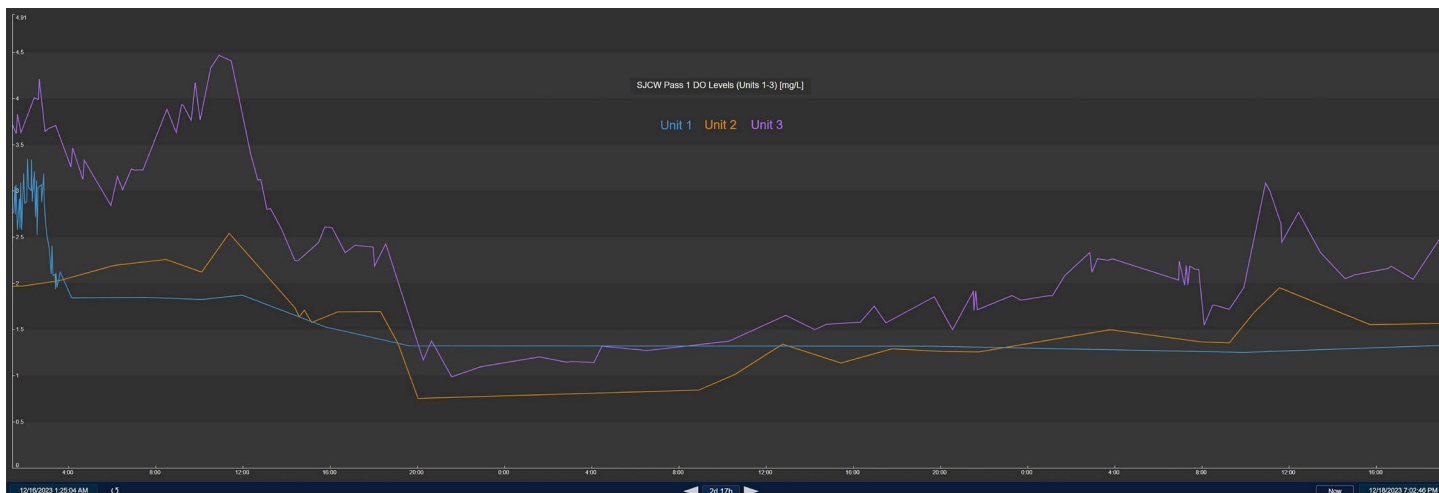
Figure 2. SJC West D.O. Drop December 16, 2023, 1835 hours.
