# ANNUAL REPORT, 2023

## WHITE POINT OUTFALL SYSTEM INSPECTION

**LOS ANGELES COUNTY  
SANITATION DISTRICTS**

**A.K. Warren Water Resource Facility  
White Point Outfall System Inspection Annual Report, 2023  
Order No. R4-2023-0181, NPDES No. CA0053813, CI-1758**

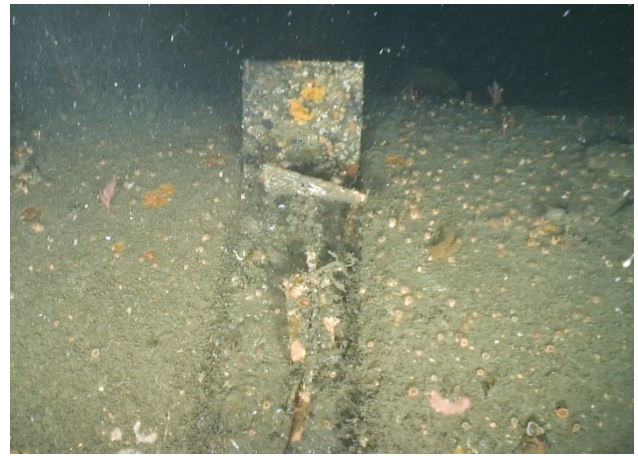
**Figure 8: A cast iron joint wrapped with a hard rubber gasket and attached anode cable on the 90-inch outfall.**

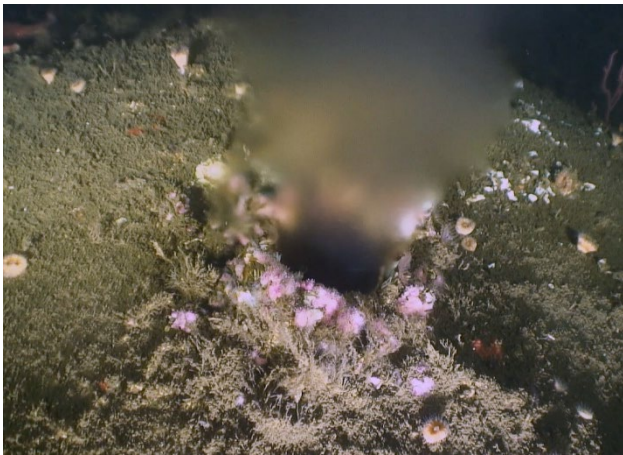
The 90-inch outfall main barrel terminates at the offshore wye structure where the flow splits into two 60-inch diameter diffuser legs. The wye structure has a vertical port encrusted with barnacles and other fouling animals (**Figure 11**). Each diffuser leg is composed of fifty 24-foot long pipe sections. There is a single discharge port, with diameters of 6.5 to 7.5 inches, per pipe section on alternating sides with each subsequent section (**Figure 12**), except for two pipe sections on the east diffuser leg that have two ports each. Each end structure has a visible bulkhead with a single 15-inch port. There is a total of 105 ports along the outfall.

**Figure 11: Vertical port with barnacle collar on the 90-inch outfall.**

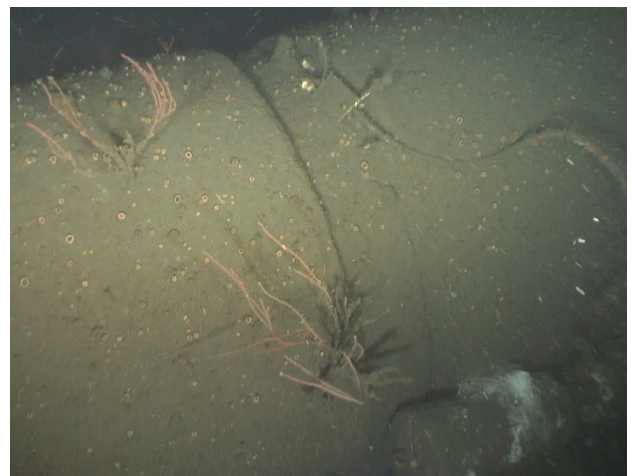
**Figure 13: A cast iron joint with a concrete collar on the 72-inch outfall.**

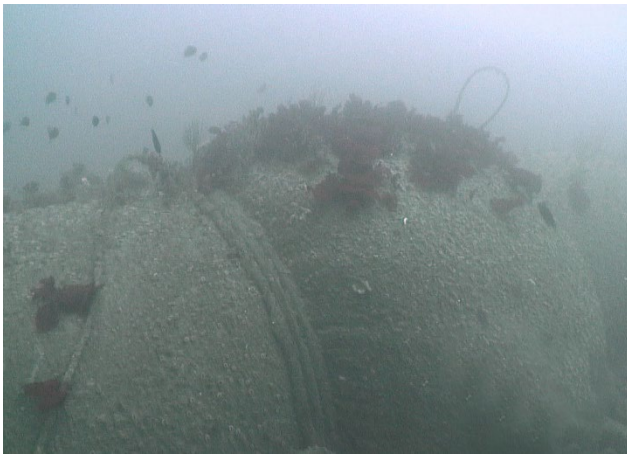
**Figure 14: Encapsulated joint on the 72-inch outfall.**

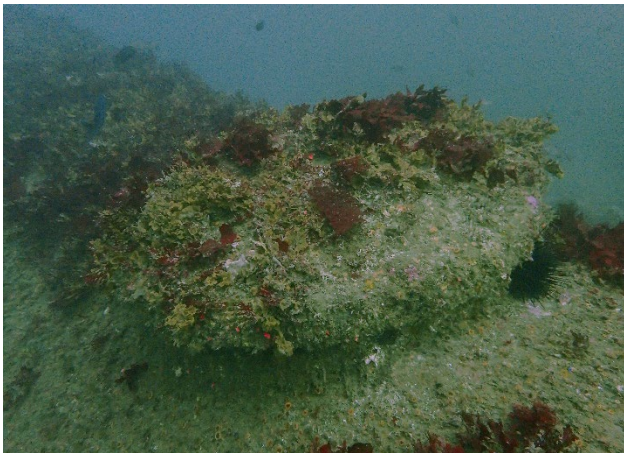
**Figure 15: A raised manhole cover on the 72-inch outfall. This type of manhole cover is also on the 60-inch outfall.**

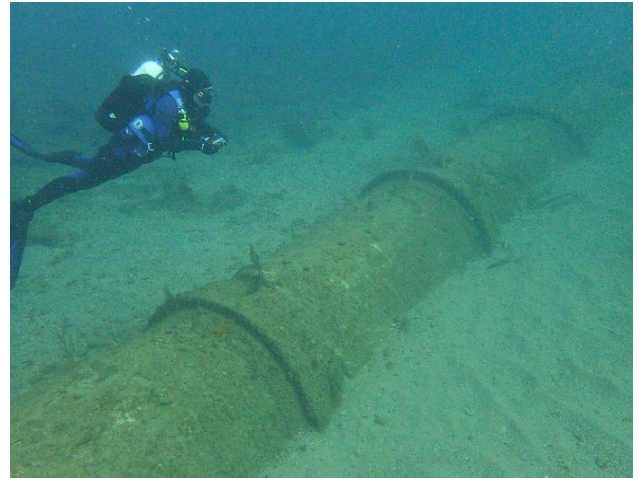
**Figure 16: Cast iron joints on the 60-inch outfall.**

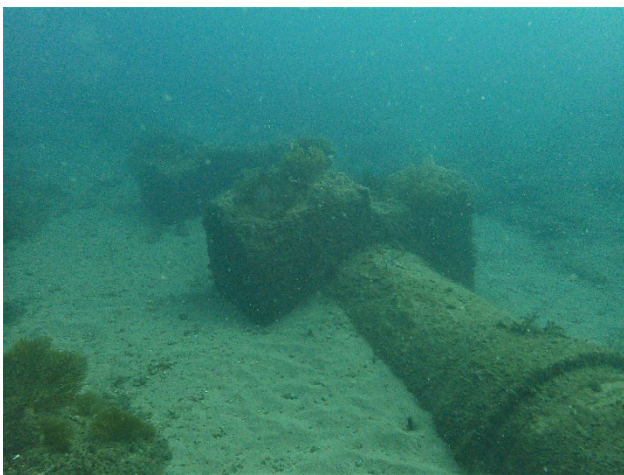
During the 1950s, United States Army personnel disposing of ordinance at sea set off explosions near the 60-inch outfall that accidentally caused minor superficial cracks in the concrete overlying nine of the cast iron joints. To reinforce the damaged areas, concrete was poured into a form around the nine joints forming a large block over each of them (**Figure 19**). The blocks have since deteriorated and are now in various stages of collapse. However, the underlying joints appear to be in a similar condition as the other joints on this outfall. The end structure has been undercut over the last 60 years. Small sized ballast rock material was added to this section in 1966 to help stabilize the pipe.

**Figure 19: Joint block repairs on the 60-inch outfall.**

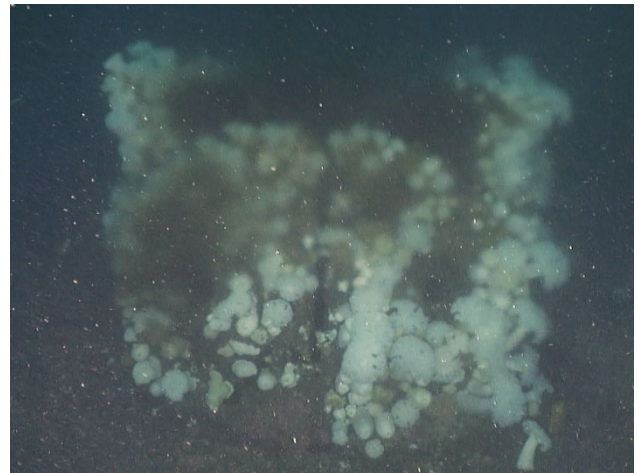
All 747 ports were inspected, of which nine had no flow, reduced flow, or another anomalous condition (**Table 1, Figures 22-30**). Both termini ports located within the gravity doors of the end structure were unobstructed (**Figure 31**). Several of the ports had various sized barnacle collars (ports encrusted with barnacles and other fouling animals forming a collar around the port; **Figure 32**). The barnacle collars on the west side of the outfall were more numerous and robust than those on the east side of the outfall. Effluent flow out of these ports did not appear altered by the collars. The vertical port (**Figure 33**), with barnacle collar, was encountered in 179 feet of water and the shallowest ports were observed in 165 feet of water.

**Figure 31: Terminus ports located within the gravity door of the end structure on the 120-inch outfall.**

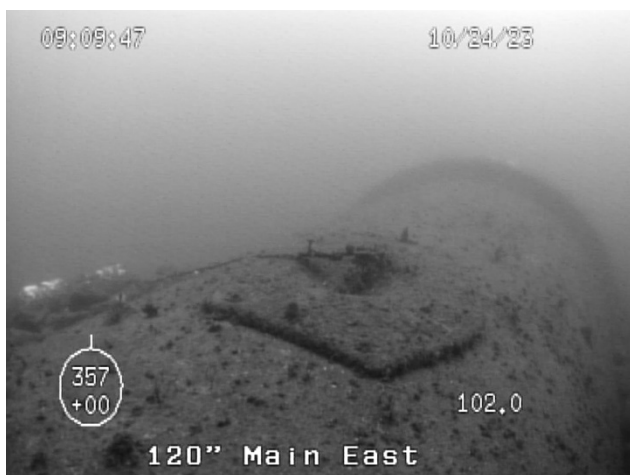
The flush manhole covers and joints appeared to be in good condition with no evidence of corrosion. Of the 28 cast iron manhole covers, ranging in water depth from 194 to 48 feet, that were outfitted with aluminum anodes in 2015 (Figure 34), 23 were observed having detached cable connections (Appendix B, Figure 35). Three of those occurrences were new observations made during this survey.

**Figure 34: Attached anode on the 120-inch outfall.**

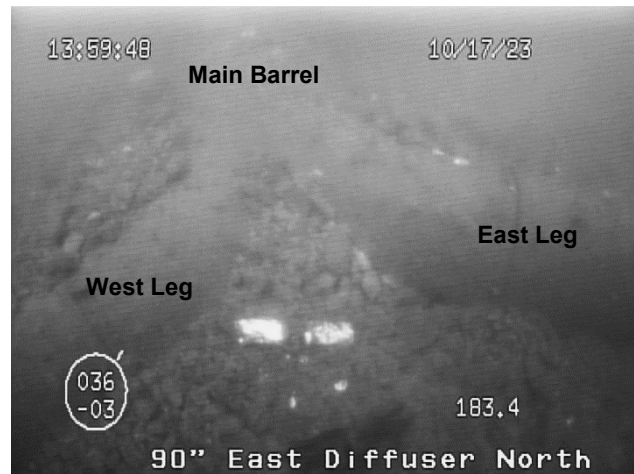
**Figure 36: Wye structure on the 90-inch outfall.**

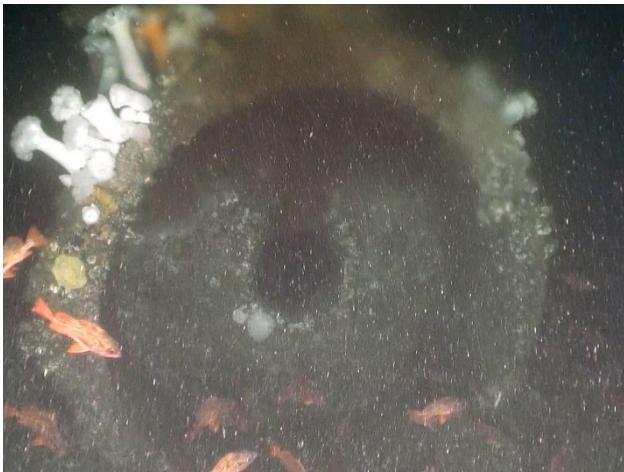
All 105 ports were inspected, of which one had reduced flow caused by an internal obstruction (**Table 2, Figure 37**). Both termini ports located at the end of the diffuser legs were unobstructed (**Figures 38 and 39**). Several of the ports, including the vertical port located on the top of the wye structure, had various sized barnacle collars (**Figure 40**). Effluent flow out of these ports did not appear to be altered by the collars.

**Figure 38: Terminus port with flow on the west diffuser leg of the 90-inch outfall.**

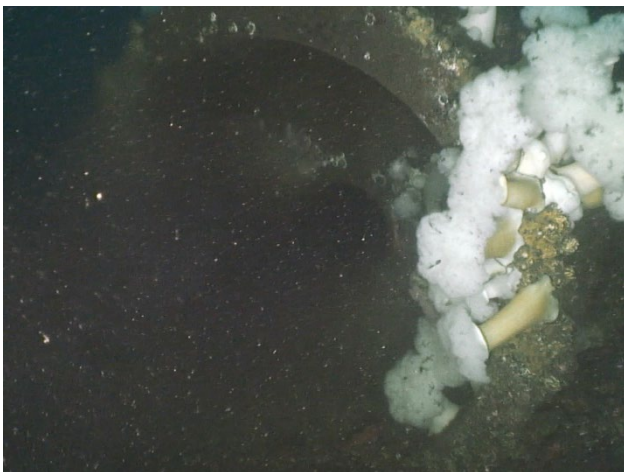
**Figure 39: Terminus port with flow on the east diffuser leg of the 90-inch outfall.**

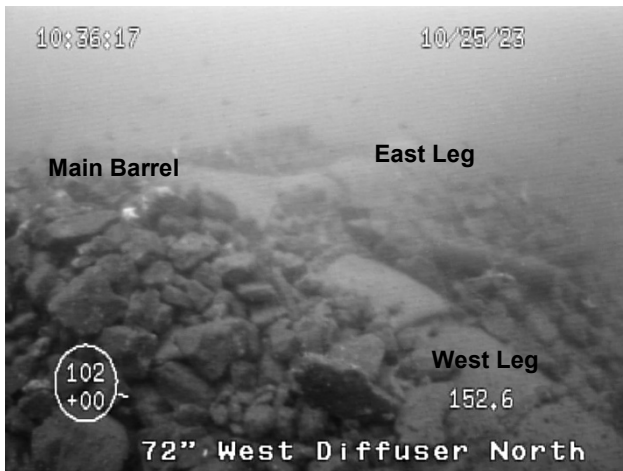
Figure 51: Wye structure of the 72-inch outfall.

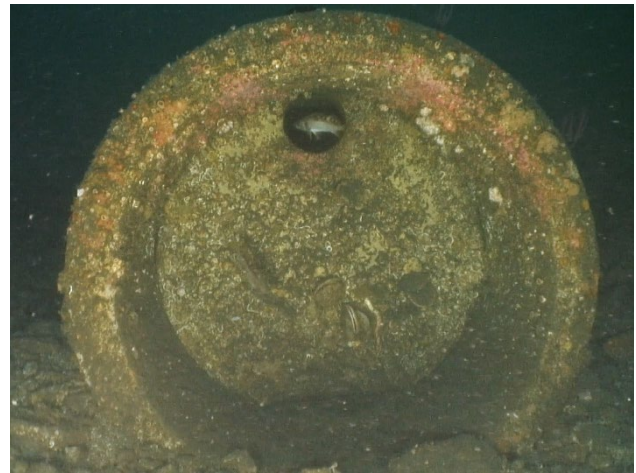
All 56 ports were inspected, including the west and east diffuser leg termini ports (Figures 52 and 53, respectively), of which none had internal obstructions. Several of the ports had various sized barnacle collars. Without continuous effluent flow out of the ports, as seen in the 120- and 90-inch outfalls, the barnacle collars can develop over the ports causing differing degrees of external blockage. The shallowest ports were observed in 150 feet of water.

Figure 52: Terminus port on the west diffuser leg of the 72-inch outfall.

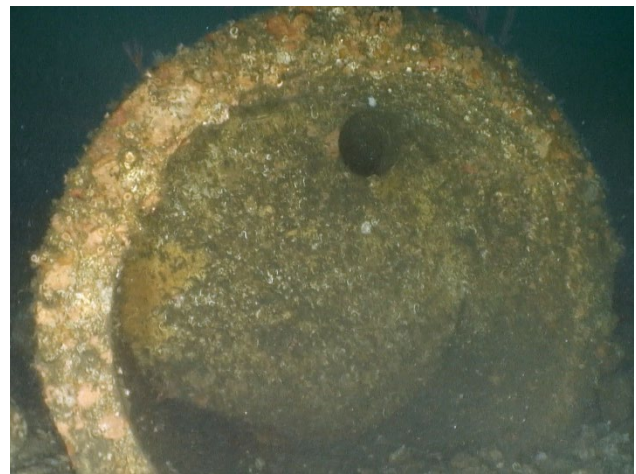
Figure 53: Terminus port on the east diffuser leg of the 72-inch outfall.

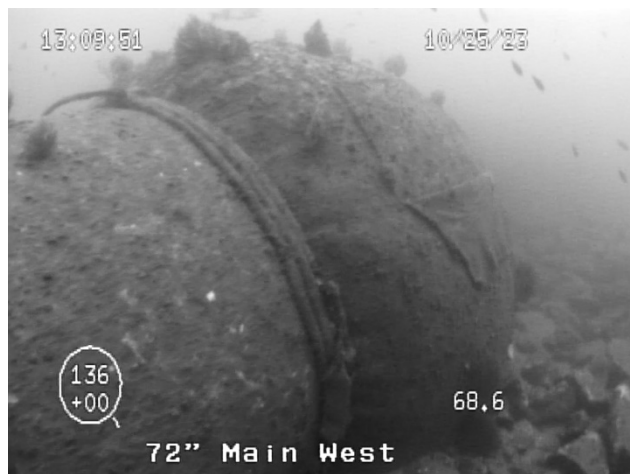
Deterioration of the joint collar, where portions of the concrete collar has spalled away from the joint, was observed in 33 joints (**Figure 55**, Appendix D). The deterioration of the concrete collars does not appear to affect the structural or functional integrity of the joint. All the encapsulated joints appear to be in good condition (**Figure 56**). Of the 214 cast iron joints and 10 cast iron manhole covers, ranging in water depth from 161 to 48 feet, that were outfitted with aluminum anodes in 2015, 54 joints and 7 manhole covers were observed having detached cable connections (Appendix D). Ten detachments from joints and one detachment from a manhole cover were new observations for this survey. Four manhole covers not listed in Appendix C were observed as not having anodes installed, located on two consecutive pipe sections between MH-72-009 and MH-72-010. Several pieces of anode cable debris and rope were seen at various locations on the outfall and within the ballast rock. A fishing pole was observed adjacent to the east diffuser leg terminus. Two moderately sized tires, which have been encountered in previous surveys, were again located within the ballast rock in 108 feet of water.

**Figure 56: Encapsulated joint on the 72-inch outfall.**

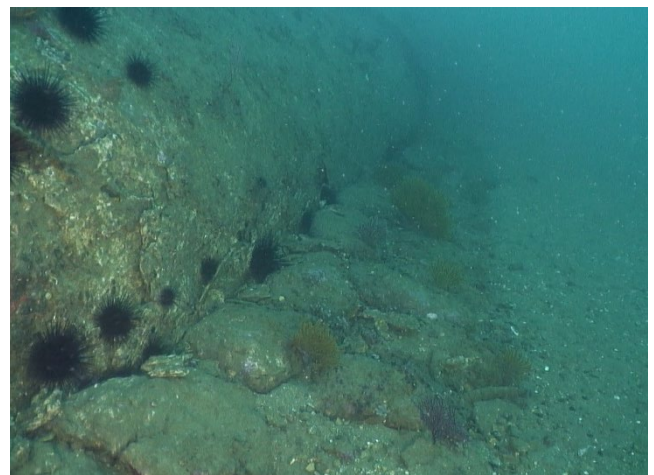
Ballast rock and/or sediment height generally fluctuated between the springline and below the lower quarter point of the outfall, except for the farthest offshore portion of the tri-jet end structure. As seen for several decades, little to no ballast material remains supporting the tri-jet end structure (**Figure 57**). The sand/cement bags that were placed along the outfall during the 1997 reballasting project to maintain outfall alignment and prevent undercutting (**Appendix A**) were encountered along both sides of the outfall and appeared to be in good condition (**Figure 61**). There was no evidence of undercutting along the main barrel of the outfall.

**Figure 61: Sand/cement bags placed along the 60-inch outfall during the 1997 reballasting project.**

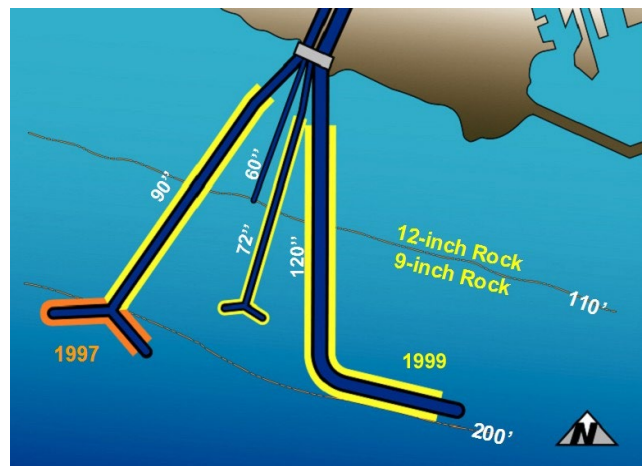
Several of the submersible and diving surveys in the 1990s detected various sites or lengths of pipe on all four outfalls that had lost significant amounts of small sized ballast rock originally placed next to the outfalls to maintain their alignment and prevent undercutting. Ballast rock losses were likely caused by long-term erosion from storm wave action. In response to these observations, the Sanitation Districts performed numerous outfall repair projects in 1992, 1997, and 1999 at a cost of approximately four million dollars (**Figure A1**). Those projects involved placing thousands of tons of small rock and/or bags of sand/cement along the outfalls, repairing minor joint fractures, and obtaining concrete core samples.

**Figure A1: The ocean outfalls and portions reballasted in 1997 (orange) and 1999 (yellow), two of the more extensive reballasting projects.**

In 1992, ballast material was added to the wye-shaped diffuser legs of the 72- and 90-inch outfalls. In 1997, most of the diffuser leg sections of the 90-inch outfall were again reballasted. Also in 1997 and separate from the 90-inch reballasting project, select pipe sections along the 60- and 72-inch outfalls received diver placed rock overlaid by sand/cement bags. In 1999, the most extensive of these repairs placed 36,000 tons of 9-inch and 12-inch minus rock along almost 21,500 linear feet of pipe on the three largest outfalls. Nearly the entire 120-inch outfall, with the exception of the last several hundred feet of the offshore section of the diffuser leg, was reballasted. The end of the diffuser section had an abundance of original ballast rock overlaid with sediments (grit mound area) and was therefore not reballasted. Sediments around individual ports in the grit mound area were excavated during the reballasting. During the same project, the entire length of the 72-inch outfall deeper than a depth of 50 feet and the 90-inch outfall inshore of the wye structure to a depth of 50 feet were reballasted.

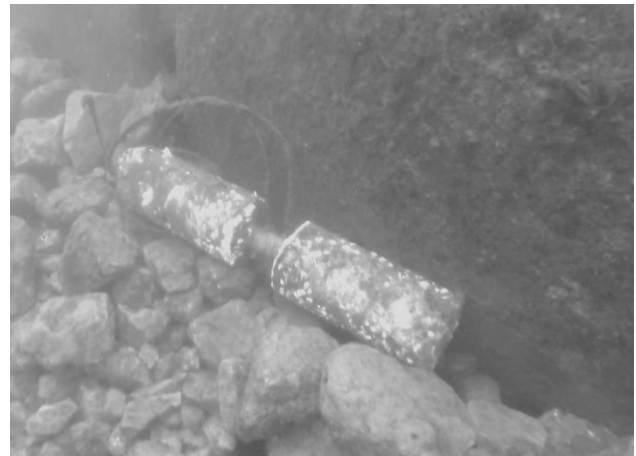
In an effort to extend the life expectancies of the outfalls, Sanitation Districts' engineers designed and tested the feasibility of adding cathodic protection. In late February of 2014, a contractor attached a single test aluminum anode approximately four feet in length to the cast iron component of a joint on the 90-inch outfall in approximately 52 feet of water (top of pipe). The joint connection is located on the top of the outfall, while the anode resides within the ballast rock along the west side of the outfall (**Figure A2**). With the success of the test anode installation, additional anodes were installed.

**Figure A2: Aluminum anode, approximately four feet in length, residing within ballast rock along the west side of the 90-inch outfall. The joint connection is located on the top of the outfall.**

In late 2015, a contractor attached 634 aluminum anodes to the cast iron components of the joints and manhole covers of the 72- and 90-inch outfalls and the cast iron component of the manhole covers of the 120-inch outfall to provide cathodic protection. The anode connections are located on the top of the outfall centered within the joint or centered on the manhole cover while the anodes, approximately four feet in length, reside within the ballast rock along the side or in a few cases, on top of the outfalls. Based on conservative assumptions, the anodes are expected to last for 50 years, at which point, they could be replaced. During this time and when functioning properly, there should be little to no corrosion occurring on the cast iron joints or manhole covers.
