2019 ANNUAL REPORT

INDUSTRIAL WASTE PRETREATMENT PROGRAM

LOS ANGELES COUNTY SANITATION DISTRICTS

APPENDIX H
INDUSTRIAL WASTE REPORTS ON INCIDENTS

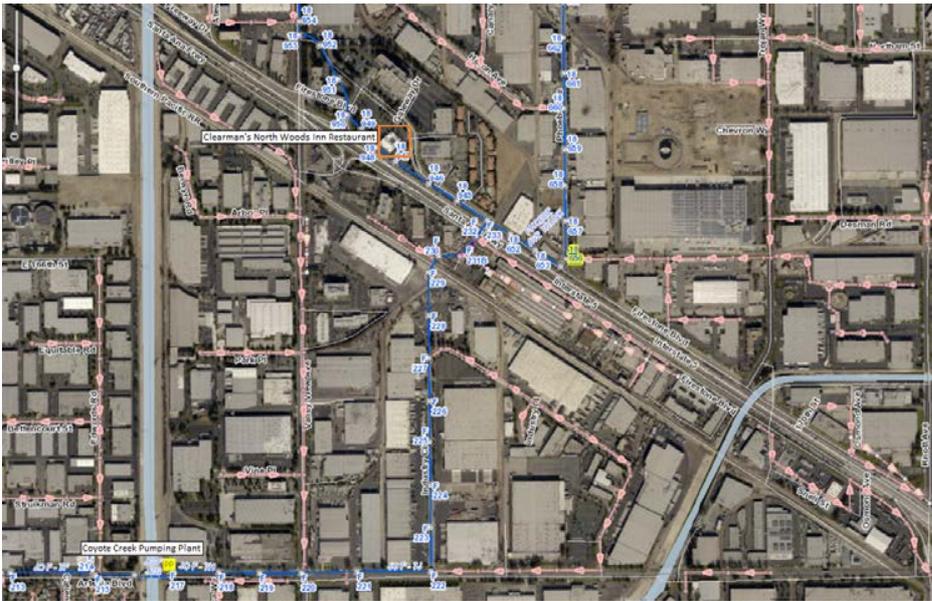
Figure 2: GIS diagram showing the Coyote Creek PP and its upstream Area which includes the Clearman's North Woods Inn restaurant.

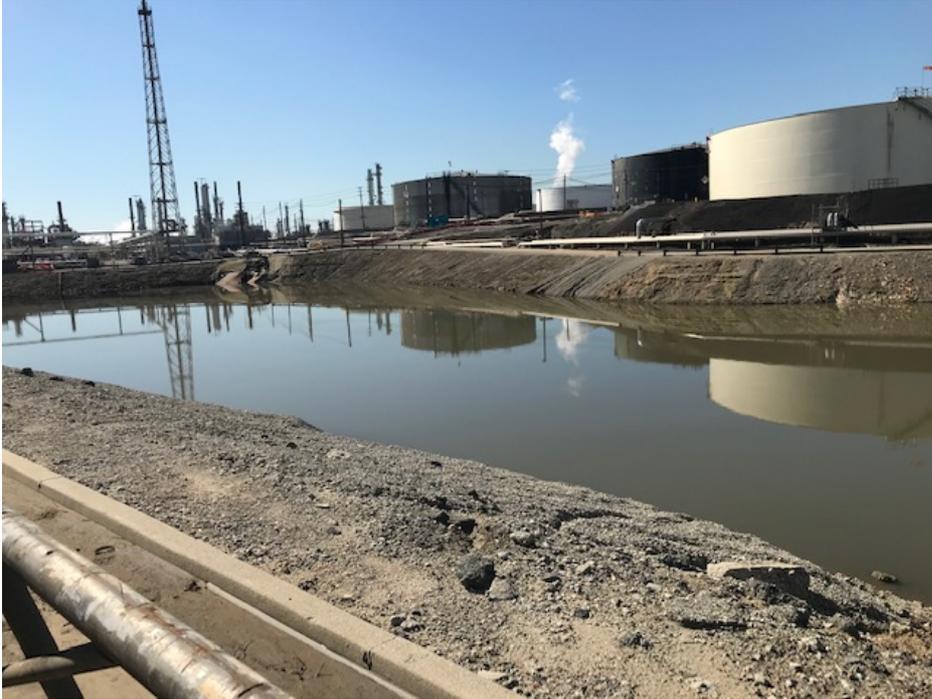
Figure 2: Photo taken by Chris Mendoza on 2-19-19 of pond#2 at the Tesoro Carson Refinery.

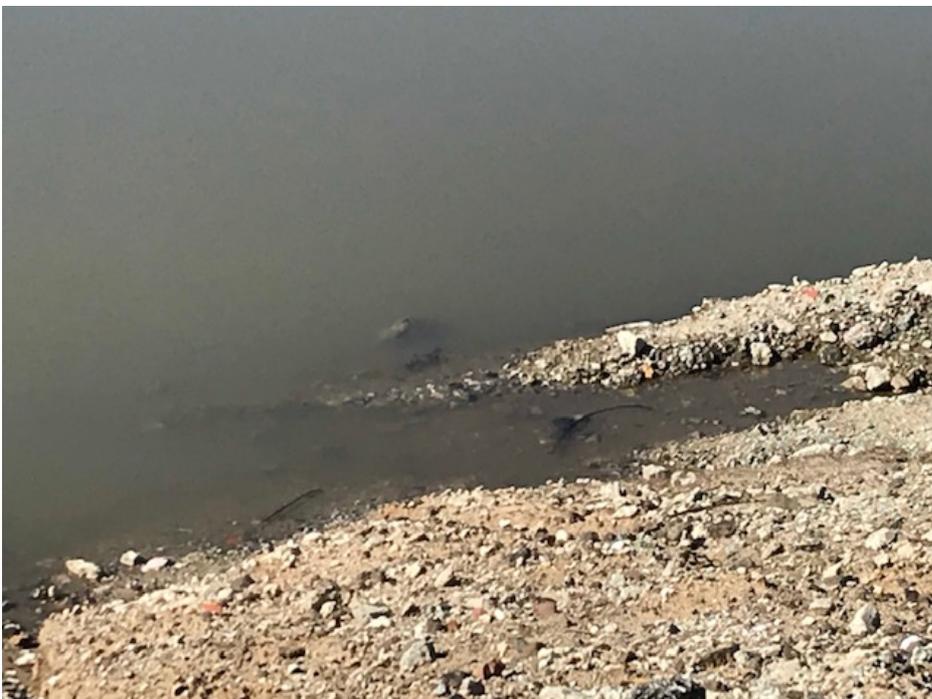
Figure 3: Photo taken by Chris Mendoza on 2-19-19 of the edge of pond#2 at the Tesoro Carson Refinery. Note the lack of any floating oil or oily sheen.

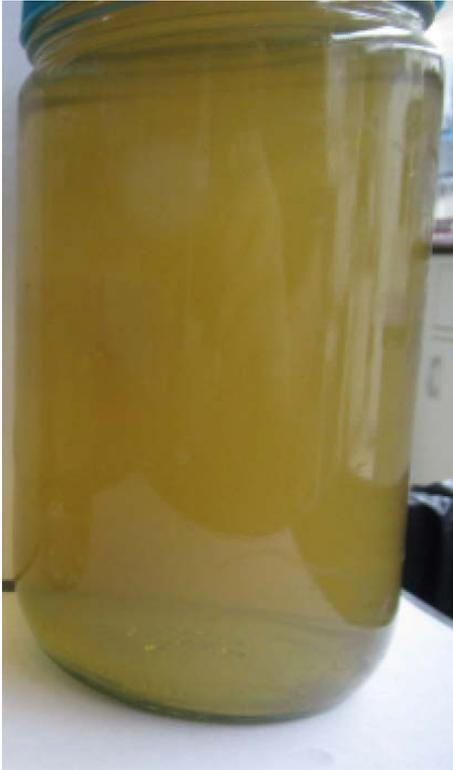
Figure 2: 1825 hours 3-3-19 grab sample of the discharge at Tri-Star Dyeing and Finishing.

The laboratory results for matching the color of the LCWRP final effluent sample and the Tri-Star sample were inconclusive. The absorbances at variable wavelengths resulted in generally lower absorbance measurements for the Tri-Star sample compared to that of the LCWRP final effluent sample (see Figure 3). Even though the analysis wasn't conclusive enough to cite Tri-Star for causing the incident, there are really no other industrial sources known to the inspection staff that are likely to have caused this incident. Inspectors are continuing to monitor Tri-Star closely. Fortunately this incident did not result in any NPDES violations at the WRP and plant operations were otherwise unaffected.

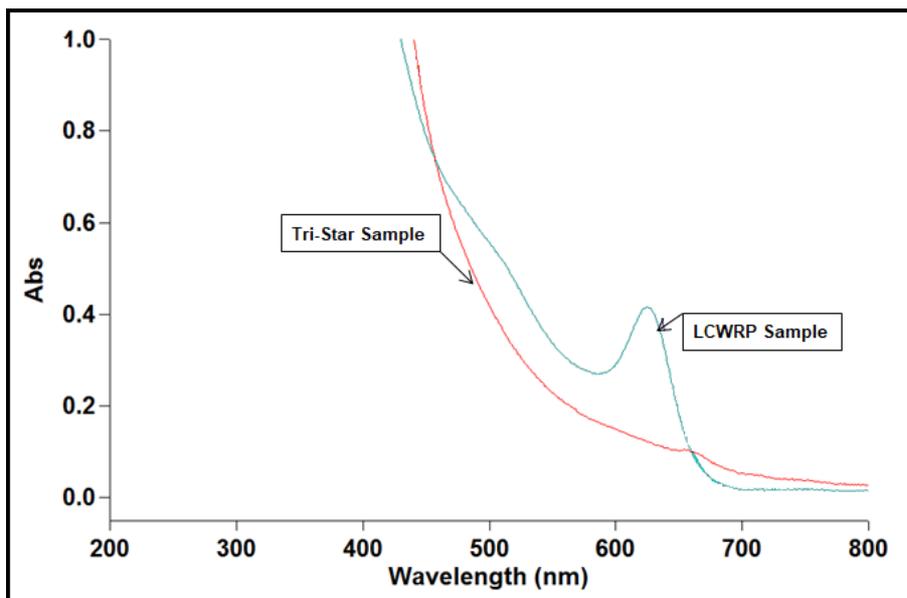
Figure 3: UV spectra of the SPE methanol extracts of the samples taken at LCWRP and Tri-Star Dyeing and Finishing on 3-3-19.

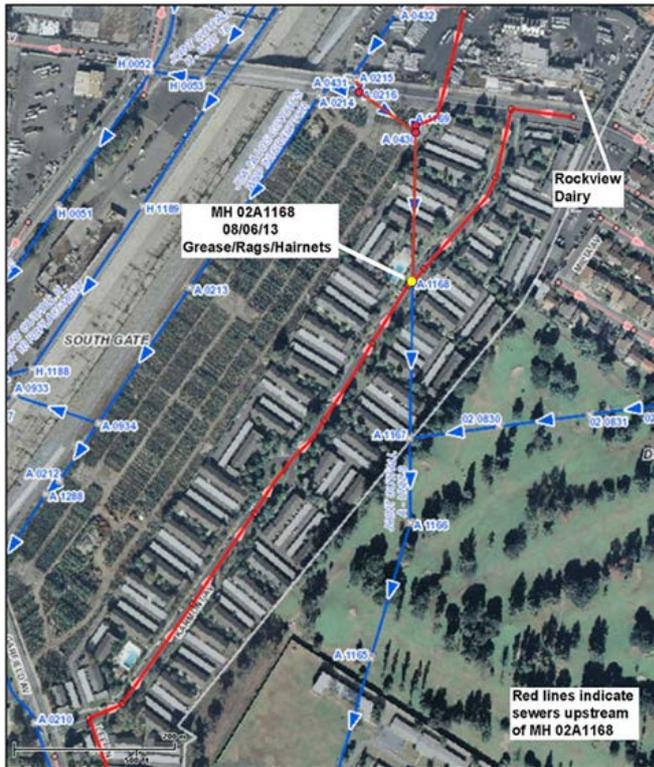
On Friday, 3-8-19 at 0806 hours, Supervisor of Sewer Maintenance Rick Pearce reported to Senior IW Inspector Bill Barnum that one of his sewer maintenance crews was again seeing large amounts of rags, including what appear to be hairnets, in the 42" J.O. 'A' Unit 9 trunk sewer just downstream of Rockview Dairies in South Gate. Similar rags were reported by Pearce in August 2013. At that time, Rockview Dairies was determined to be the source of the rags and they were issued a written Notice of Violation (NOV) for discharging waste that causes the sewer to plug. On 3-8-19 Pearce told Barnum that his crew had brought back a bag of the rags found in the section of trunk sewer line in question (MHs A1169-A1167).

Figure 5: Satellite photo with sewer line map overlay showing the area where rags/hairnets continue to be found in the J.O. 'A' Unit 9 trunk sewer.

Team 4 Senior Inspector Steve Sealy and Area IW Inspector Neil Tran investigated the report. They met with Pearce at the Compton Field Office on 3-18-19 to see the rags. Pearce stated that the ragging issue continues to be a problem between MH 1168 and MH 1169 and that this issue has been ongoing for many years. He reiterated the issue has never changed since the first reports in 2013. He stated the normal flows in this section of sewer are inconsistent and far too low for a 42" line in order to move any bulky items such as rags, which end up piling up and staying in the line. It was noted that the only flow sources in this section of the line are 27 homes and Rockview Dairies. Pearce stated they are currently cleaning the line every 6 months and that he has requested permission from collection system managers to allow the regular partial opening of the stop-log at MH A 0215 upstream which would help clear these rags and associated debris from the line. Inspection of the rags collected found that a large portion were indeed hair nets, indicating Rockview Dairies remains the problem source. It is speculated that company employees are continuing to flush them regularly. Some of the now ubiquitous "flushable" non-woven plastic fabric wipes were also present in the rags. These are unlikely to have come from dairy, more likely they came from one or more of the residences located upstream.

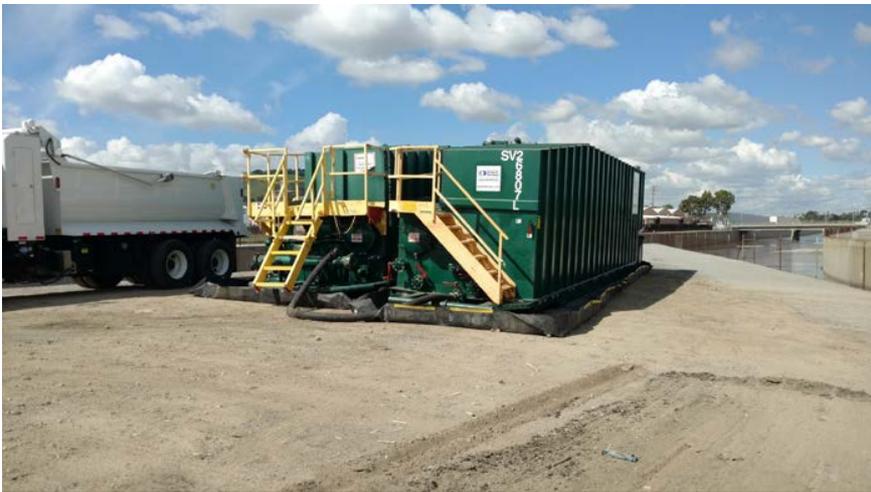
Figure 11: Two 20,000-gallon capacity ‘frac’ tanks used to hold the spilled wastewater and associated cleanup water. Note San Jose Creek in the background.

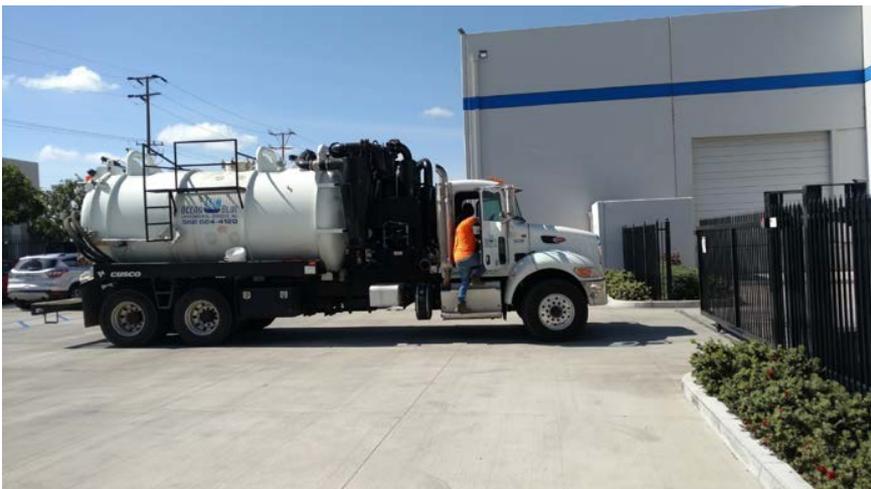
Figure 12: Ocean Blue Environmental vacuum truck used to haul the stored wastewater in the frac tanks back to the Ninth Street Dairy facility for discharge to the sewer after approval was gained from the Districts to do this.

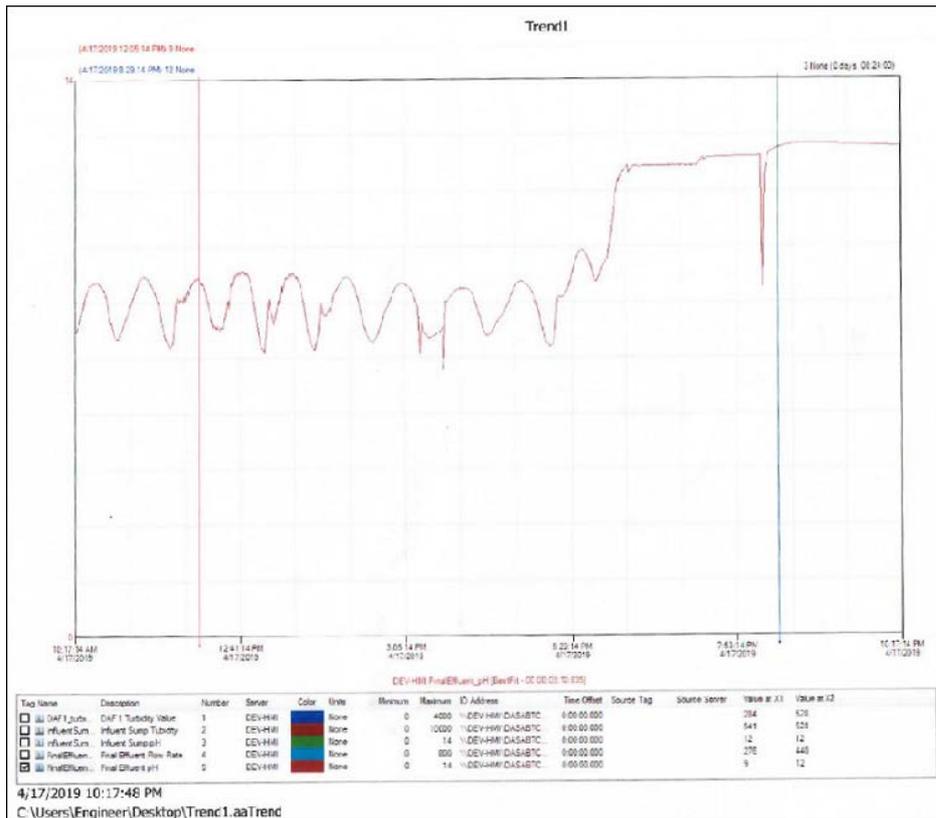
Night Team Senior IW Inspector Kent McIntosh and Inspector Jose Ruiz followed-up on the call, arriving on site at WWF Operating Company at 2140 hours on 4-17-19, where they met with Correa. Although no operators had been on site when the high-pH discharge began, Correa stated he had been remotely notified by an automatic call system at about 1800 hours of a rising pH in the final effluent (see Figure 1). He said the final effluent pH monitor alarms at pH=11.50. A check of the effluent pH upon arrival found the pH at 12.39. Operators were actively allowing the pretreatment system acid addition pumps to pump at their maximum addition rate to neutralize the wastewater. The high pH incident was caused by a combination of, for unknown reasons, sanitation shift workers using the wrong a cleaning solution in the Clean-In-Place process and a valve getting stuck open. The company is investigating why the wrong solution, which was more concentrated than the one that should have been used, was used instead.

Figure 1: Final Effluent pH trend at WWF Operating Company on 4-17-19.

Company operators were able to quickly fix the stuck valve, remove the wrong cleaning solution from use, and prevent the final effluent pH from going above 12.5. The incident had no known adverse effects on either the downstream collection system or Districts’ treatment plant (San Jose Creek East WRP) operations. No enforcement action was taken against the company.

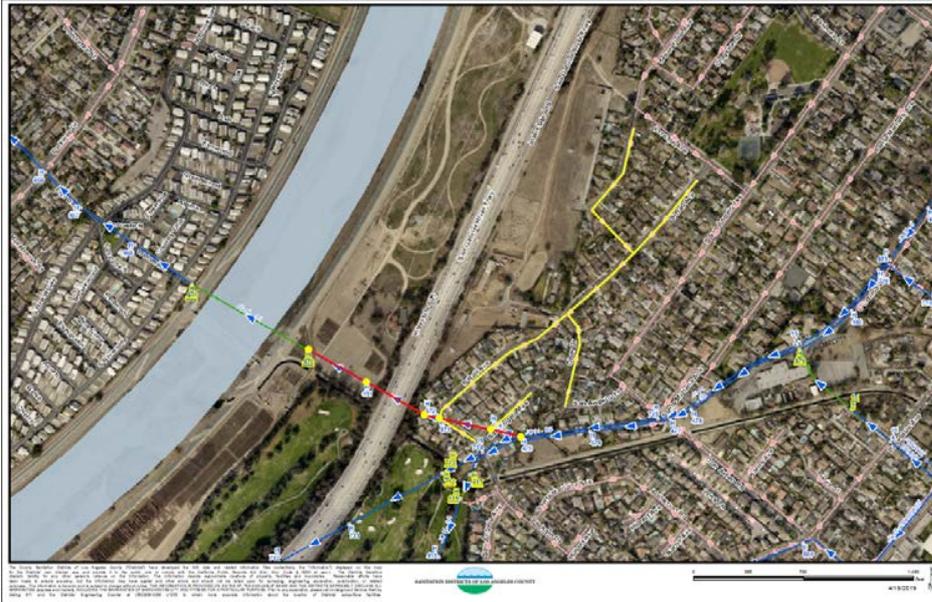
On Friday, 4-19-19 at 1100 hours, Coordinating IW Inspector Tingting Wei received a call from San Gabriel Valley Field Office Supervisor of Sewer Maintenance Bill Balas regarding "rags" found at the 30" diameter, unusually long, 735' siphon structure on J.O. 'H' unit 5C between manholes H 0470 and H 0469 in El Monte where the line crosses under the San Gabriel River (see Figure 2). The normal volume of flow into the siphon is very low as the tributary area is small and essentially entirely residential in nature, with about 100 homes in the area. Note that a bulkhead is installed upstream at Manhole (MH) 0475 which effectively limits the flow into the siphon to the residential area that discharges into the local sewer lines shown in yellow in Figure 2. Balas stated the rags being encountered have been present for 10+years and were, in his opinion, not flushable wipes, having more of a "felt-like" texture. He said he had saved a pile of the rags at the San Gabriel Field Office (see Figure 3) and was notifying the Industrial Waste Section now of this situation because he felt it was getting worse. He was hopeful an industrial source for the rags could be identified and controlled.

Figure 2: GIS influent area map. The sewer lines influent to the H470-H469 siphon structure are colored yellow.

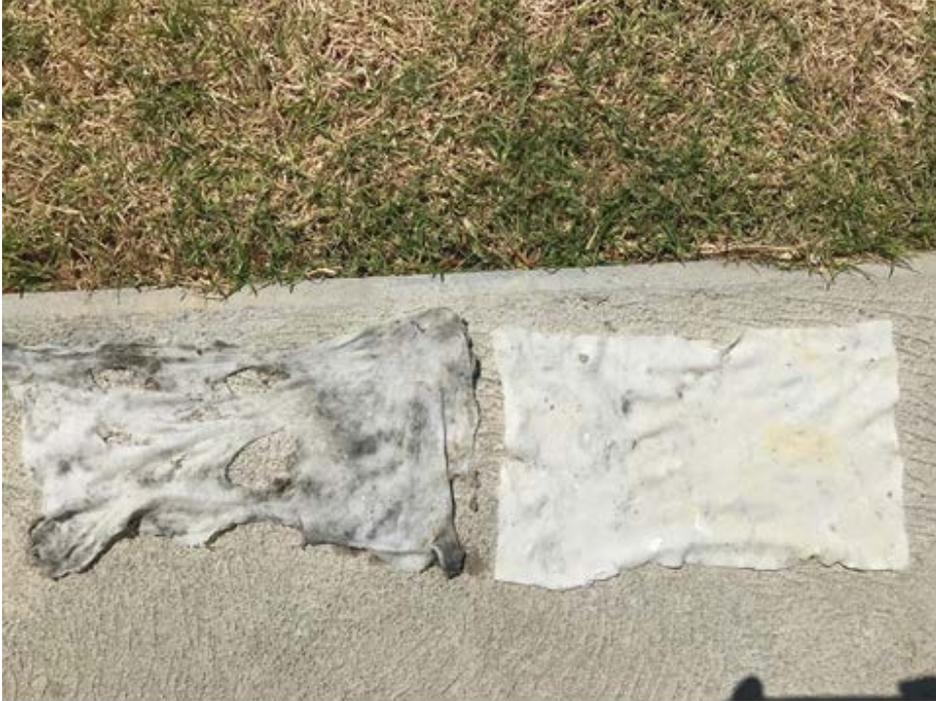
An investigation into this report, led by Senior IW Inspector Steve Sealy, included a close examination of the rags. Sealy concluded the rags are non-woven wipes (see Figure 4). Sealy concluded the wipes are not from an industrial source but from the residential area upstream of MH H469. No further action from the inspection staff on this issue is anticipated at this time.

Figure 4: Comparison of a rag from MH H469 (on the left after being cleaned-up a bit) and a rag removed recently from the Long Beach WRP headworks.

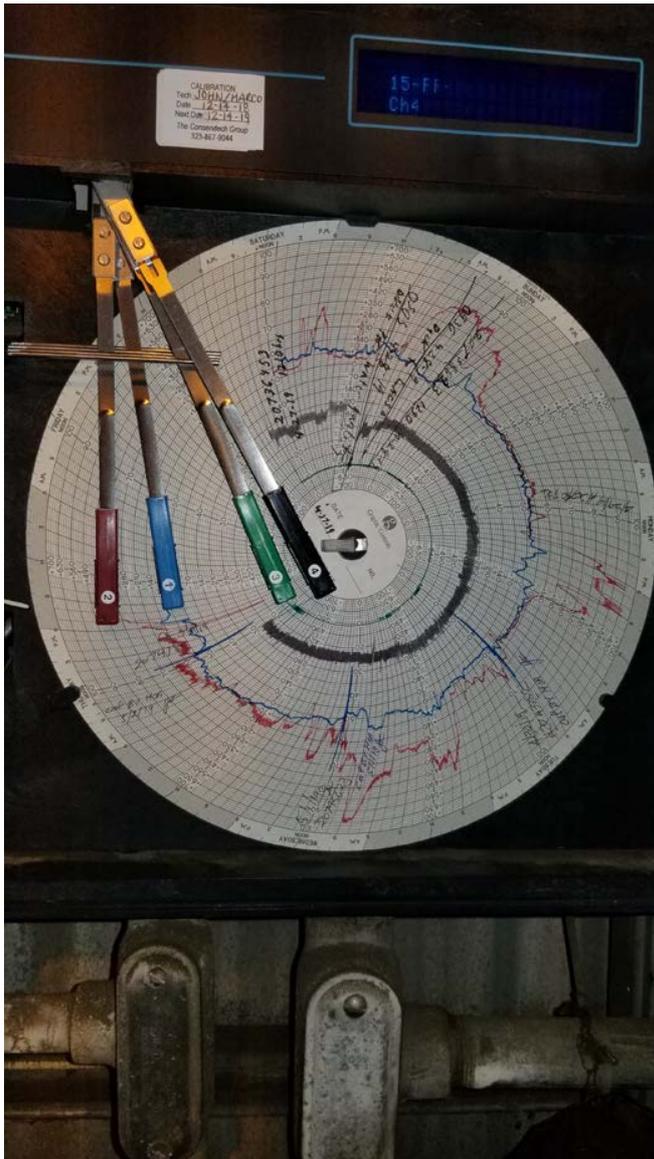
Further follow-up inspections conducted later that evening, and in following days and evenings by the Night Team inspectors, Team 3 Senior IW Inspector Bill Barnum, and Area IW Inspector Chris Mendoza found that normal IW discharge had resumed at midnight, about 6 hours after the fire. The firewater from this incident was eventually comingled with normal refinery process wastewater, treated, and discharged to the sewer as is allowed in their discharge permit. There were no known negative impacts on either the sewer system or the downstream Districts’ treatment facility, JWPCP, from this incident.

Figure 1: Phillips 66 Refinery industrial wastewater effluent monitoring chart recorder. The one-week circular chart was installed on 4-27-19 and recorded the IW flow shut down due to the 5-2-19, 1645 hours fire. Note pen #4 with the black ink trace on the chart, this is the flow recorder trace.

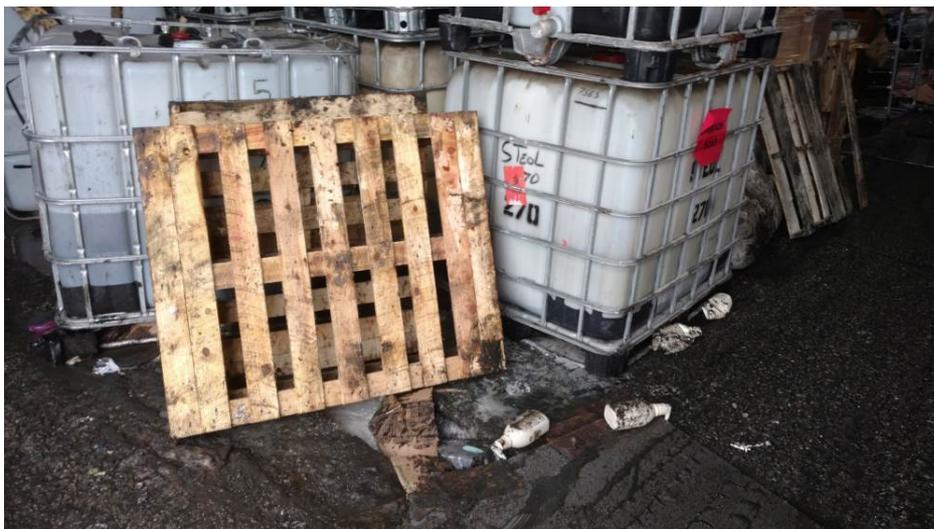
Figure 6: 5-23-19 photo at Master Recycling Center in their main processing area of one empty and one partially full (about 1/3) IBC labeled as “carwash soap.”

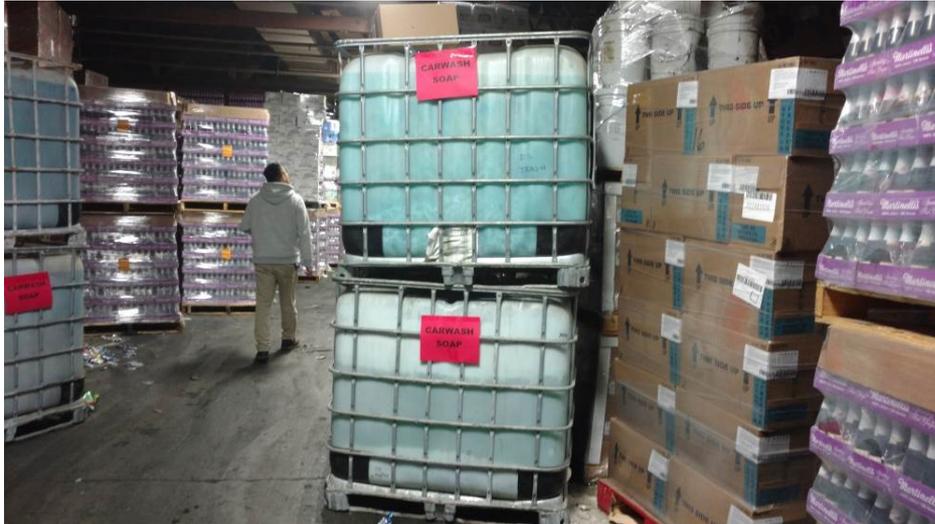
Figure 7: 5-23-19 photo of the warehouse at Master Recycling Center where approximately 40 IBCs labeled as carwash soap or similar were found. The figure in the photo is LACSD IW Inspector Nguyen Dang.

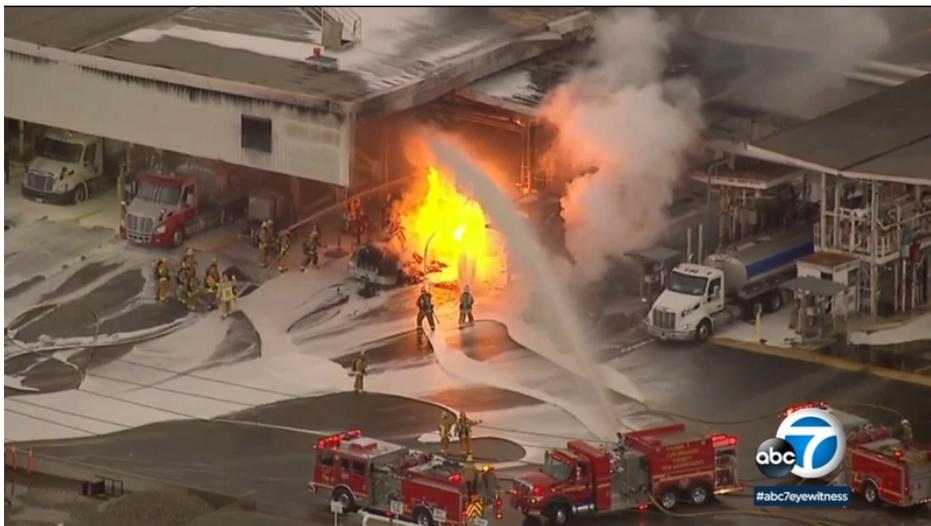
On Monday, 6-3-19 at 0530 hours, Team Senior IW Inspector Bill Barnum noted morning news reports of an ongoing large fire at the Kinder Morgan Energy Partner Facility located on Sepulveda Boulevard in Carson. He forwarded this information to area IW Inspector Chris Mendoza for follow-up. Mendoza then saw ongoing local TV news station reports showing photos and video of a fire in the loading rack at the facility's tank farm with a high volume of firefighting foam on the ground and the loading rack area (see Figure 1). He noted the facility had not, as of 0700 hours, notified the Districts of the fire and a check with JWPCP operators revealed the plant was not experiencing any unusual conditions. JWPCP is the Districts' treatment facility downstream from the Kinder Morgan Facility.

Figure 1: KABC 7 local news report picture of the truck loading rack fire at the Kinder Morgan Facility fire in Carson on 6-3-19.

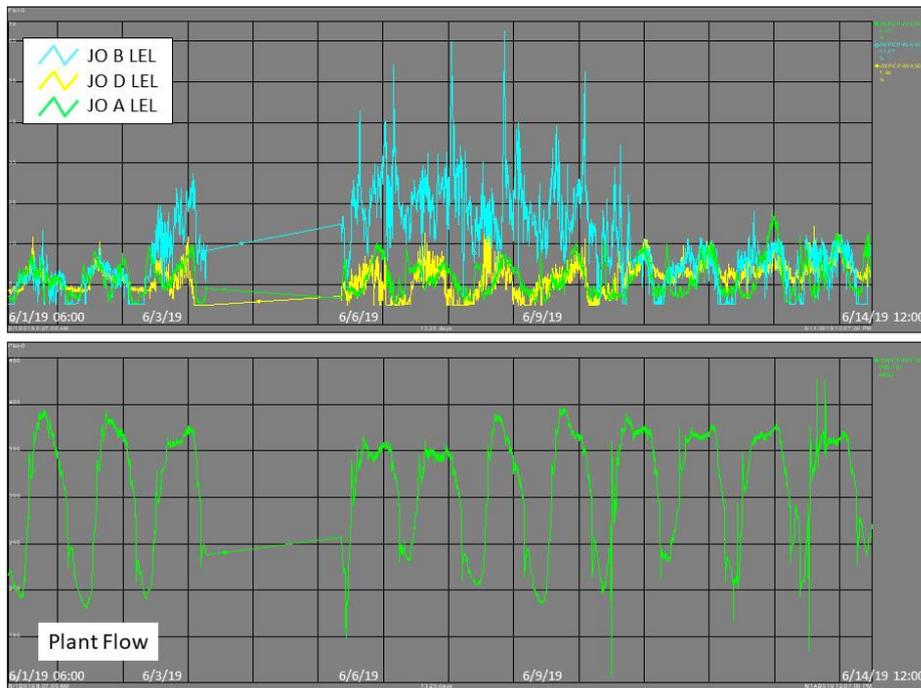
Figure 3: JWPCP Plant Headworks LEL and flow trends 6/1/19-6/14/19. Note that the J.O. ‘B’ high LEL returned to “normal” levels on 6-11-19 after appearing to be elevated for about a week. The cause of the elevation remains unclear, but it did not affect treatment plant operations.

Industrial waste inspectors were unable to confirm elevated explosivity conditions (LEL) at the J.O. ‘A’ inlet to the headworks but were able to confirm there was elevated explosivity at the J.O. ‘B’ headworks that had been occurring since Monday, 6-3-19 (see Figure 3). The report of 11% LEL at the J.O. ‘A’ inlet at 1000 hours on 6-4-19 fits within normal trends for this location. It is known that the J.O. ‘B’ inlet can trend higher for LEL especially when the temperatures increase in the summer months. Inspectors detected no significant concentrations of volatile organic compounds in a J.O. ‘B’ inlet headspace gas sample taken on 6-4-19 using a hand-held photo ionization detector (PID) unit. A simultaneous measurement of 1.09% methane by volume of air using a portable flame ionization detector confirmed the 22% LEL measured on 6-4-19 at 1305 hours was essentially all due to methane, indicating the explosivity wasn’t from an industrial source. According to JWPCP operators, there was no disruption in the odor control system, but grit chamber #3 was taken out of service on Monday, 6-3-19, coinciding with the upward trend in LEL at the J.O. ‘B’ inlet. The treatment plant, including the secondary reactors, continued to operate normally despite the elevated LEL condition. It is known that the lower reaches of the J.O. ‘B’ sewer just upstream of the JWPCP is typically high in biogenic methane. IW inspectors continue to monitor this situation.

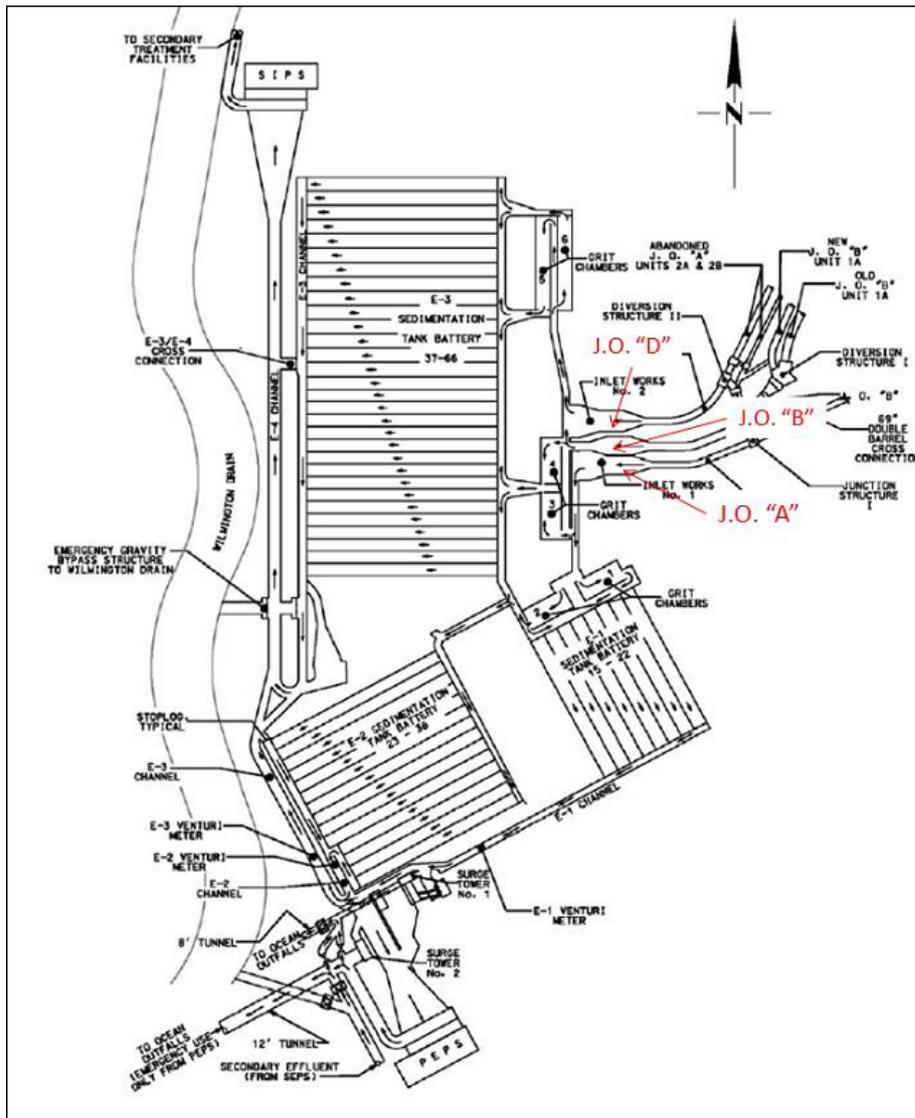
Figure 4: JWPCP inlet and primary treatment system diagram.

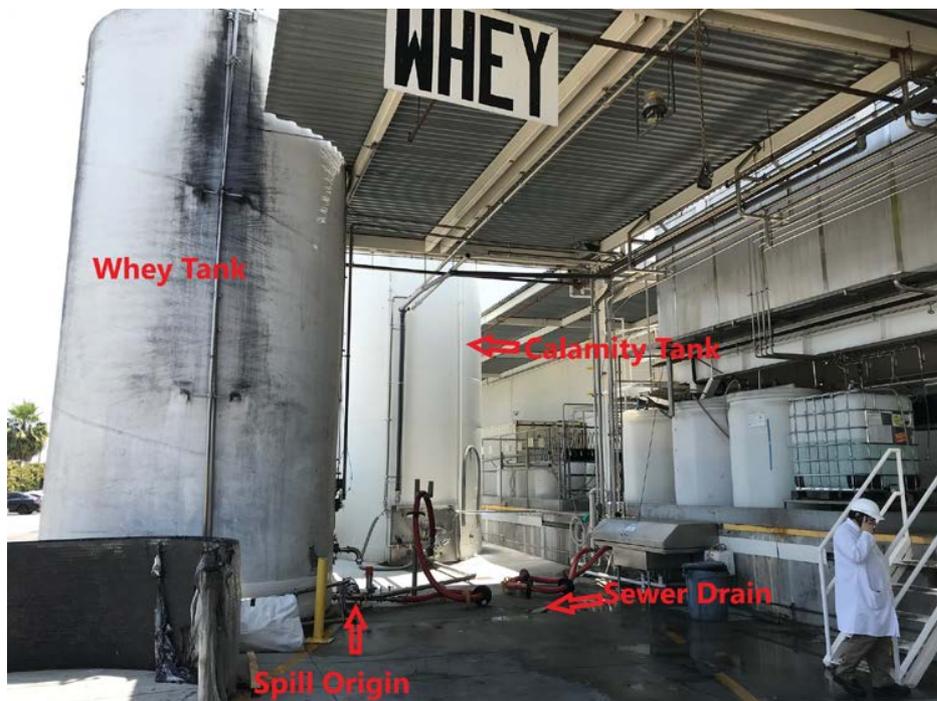
Senior IW Inspector Peter Carlstrom responded to the spill report, arriving on-site at Los Altos Foods at 1220 hours. The company manufactures various fresh Mexican style soft cheeses and creams from whole milk. During the manufacturing process curd is separated from whey and used to make cheese. The whey is a byproduct with value as animal feed or it can be turned into protein powder for human consumption. Whey is thus stored in silos and hauled daily to others for use or further processing. One whey silo with 17,000-gallon capacity, located on the east end of loading dock, is used to store whey hauled to an animal farm. The contact confirmed that around 0930 hours that morning a truck was backing in for pickup and ran over a pipe at the bottom of tank, breaking it off above the shutoff valve. With the loss of the valve, operators were unable to stop the resulting spill, resulting in the loss of the 6,000 gallons in the tank to the sewer through an adjacent drain. By the time Carlstrom arrived, the pipe and valve had already been repaired and operations were back to normal. He noted that although the company had a slug discharge control plan in place designed to prevent such a catastrophic discharge to the sewer, the plan included a diversion valve and pumping system that also failed when operators tried to use it to send the spilled material to a 33,000-gallon “calamity” holding tank (see Figure 5). To prevent a similar event in future, the company plans to install additional barriers to prevent trucks from backing in too far. Additionally, the diversion valve and pump system will be added to a preventative maintenance check list and tested monthly.

Figure 5: Area at Los Altos Foods where the spill on 6-6-19 occurred.

On 6-7-19 at 0730 hours, Carlstrom spoke with Courtney Clark, who reported that there had been no noticeable effect(s) on WRP operations following the spill. A verbal warning was issued to the Los Altos Foods for non-compliance with the slug discharge program due to the equipment failure. Carlstrom will follow-up in 30 days to verify the company has repaired all equipment and updated the preventive maintenance schedule to include testing the diversion valve and pump system.

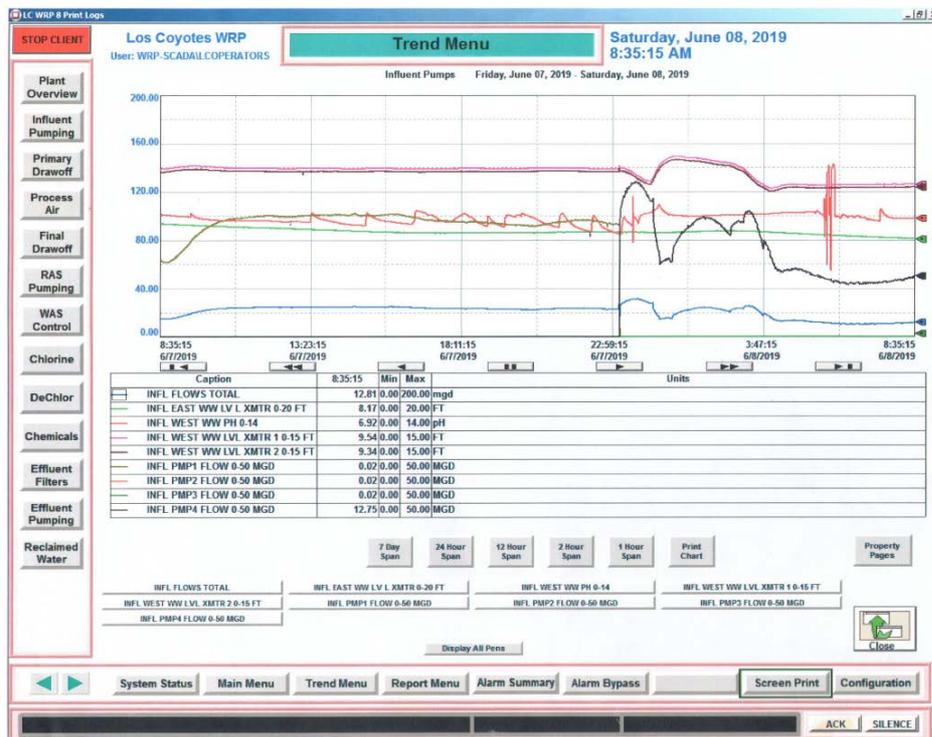
Figure 6: LCWRP 6/7/19-6/8/19 trend data (red is influent pH).

The investigation found no industrial source for the low pH and a lack of any low pH wastewater in sewers influent to the WRP. Examination of the WRP influent pH data does indicate the influent pH was a little below normal (see Figure 6). However, its cause may have been due to meter probe drift/fouling, and/or other plant operational issues. It was noted that on 6-8-19 Districts' Electrical and Instrumentation technicians attempted to calibrate the WRP's influent pH meter and determined that it needed to be replaced.

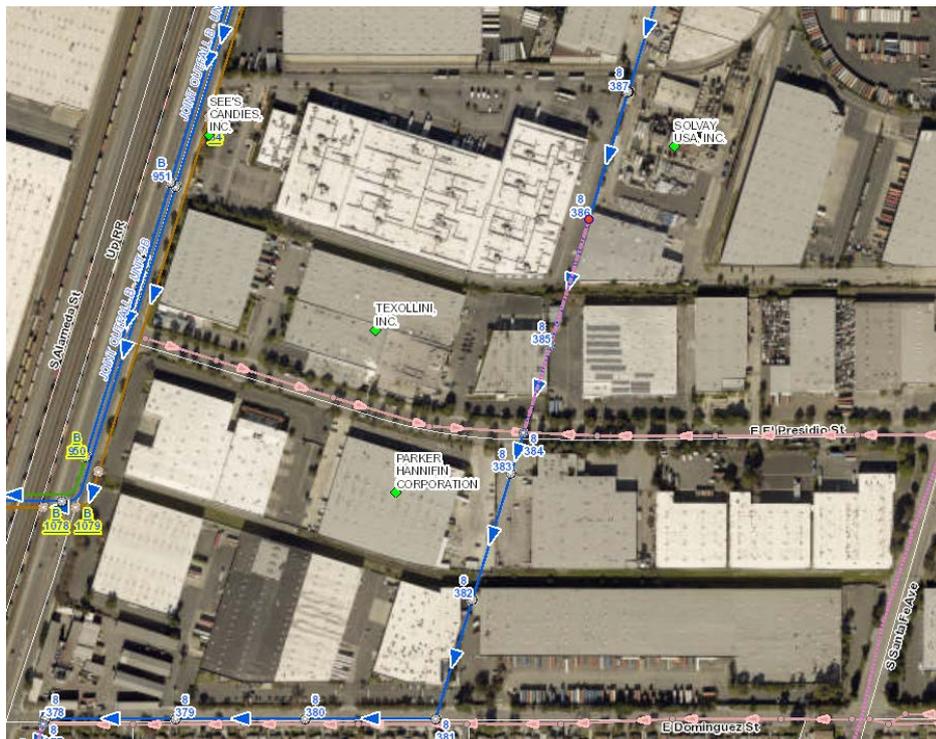
Figure 7: GIS screen grab showing MH 08 0386 on the 18" diameter Davidson City Trunk in the City of Carson and the Solvay USA Inc facility located immediately upstream of the manhole.

A follow-up investigation was conducted by Team 3 IW Inspectors Chris Mendoza, Nattapong Pengphol and Sophia Luu. Their investigation determined that Solvay USA was indeed the source of the chemical/solvent odor and light white foam observed by the CIPP crew. Solvay USA manufactures fracking and other chemicals used in the oil extraction industry. The material causing the odor was determined to residual amounts of "Foamer 1026," a surfactant solution manufactured by Solvay. The material was discharged as a part of the process of cleaning the reactor vessel where it was compounded. Inspector examination of the Safety Data Sheet for Foamer 1026 determined that the residual amounts of this material discharged to the sewer, which has an "ammoniacal" (i.e., ammonia-like) odor did not represent a health threat to the CIPP crew. Nor did this discharge represent a violation of any of the requirements or limits imposed under their industrial wastewater permit. This information was conveyed by Sanchez to Manesh, as well as Districts' Construction Inspector Steven Derleth who was assigned to the project, and the CIPP crew. The CIPP project was subsequently completed without further incident.

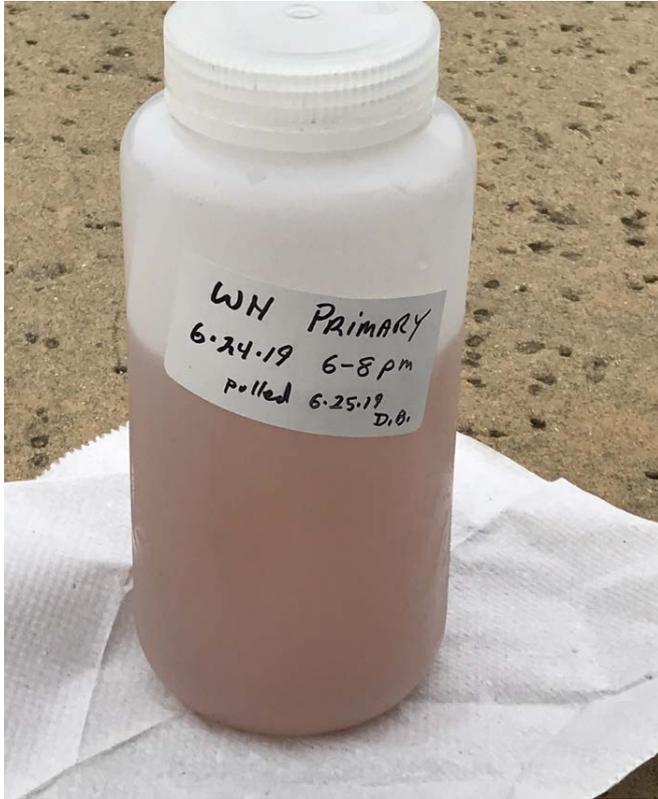
On Tuesday, 6-25-19 at 0830 hours, Whittier Narrows WRP Supervising TPO Carlos Alfaro called Team 4 IW Inspector Greg Neunsinger to report red colored wastewater had been noticed in bucket #4 of the primary effluent sample bottles, which corresponds to the previous day (6-24th) from 1800-2000 hours (see Figure 8). He also said the other daily primary effluent sample buckets appeared to have normal color and there were no adverse effects on WRP operations.

Figure 8: 6-24-19 WNWRP primary effluent bucket #4.

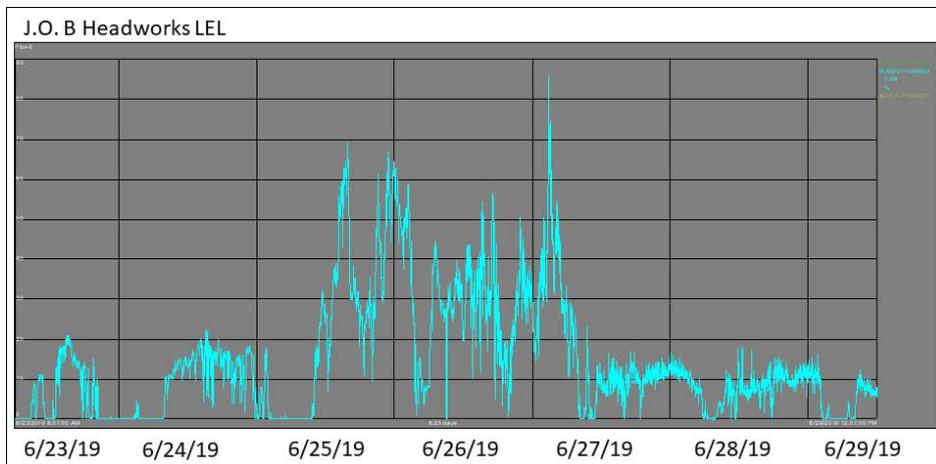
On the morning of Wednesday, 6-26-19 at 0800 hours, Team 3 Industrial Waste inspectors took further explosivity measurements at the headworks using both their portable explosimeters and the PID unit. Results indicated normal LEL levels and very low concentrations of non-methane gases present. It was also noted that the plant J.O. 'B' headworks LEL sensor was continuing to indicate elevated explosivity levels. An examination found that there was no headspace gas from the J.O. 'B' headworks actually flowing past the J.O. 'B' headworks LEL sensor due to a blocked line. This information was conveyed to JWPCP Supervising TPO II Donald Gulley and TPO II Jowyn Villanueva-Tu, who said they would have the Districts' Electrical and Instrumentation Section technicians evaluate the combustible gas monitoring equipment. On 6-28-19 the J.O. 'B' LEL sensor was again operating normally, pumping headspace gases through the sensor and the J.O. 'B' headworks LEL trend was back to normal levels (see figure 9). IW Inspectors' think the high LEL reported on the evening of 6-25 may have been from foul air trapped in the LEL sensor chamber and not representative of the condition in the J.O. 'B' headworks. It was noted that the treatment plant, including the secondary reactors, continued to operate normally throughout the incident period. No further investigation of this incident is planned by the IW inspection staff.

Figure 9: JWPCP J.O. 'B' headworks LEL data trend for 6/23/19-6/29/19. The LEL scale is 0-90%.

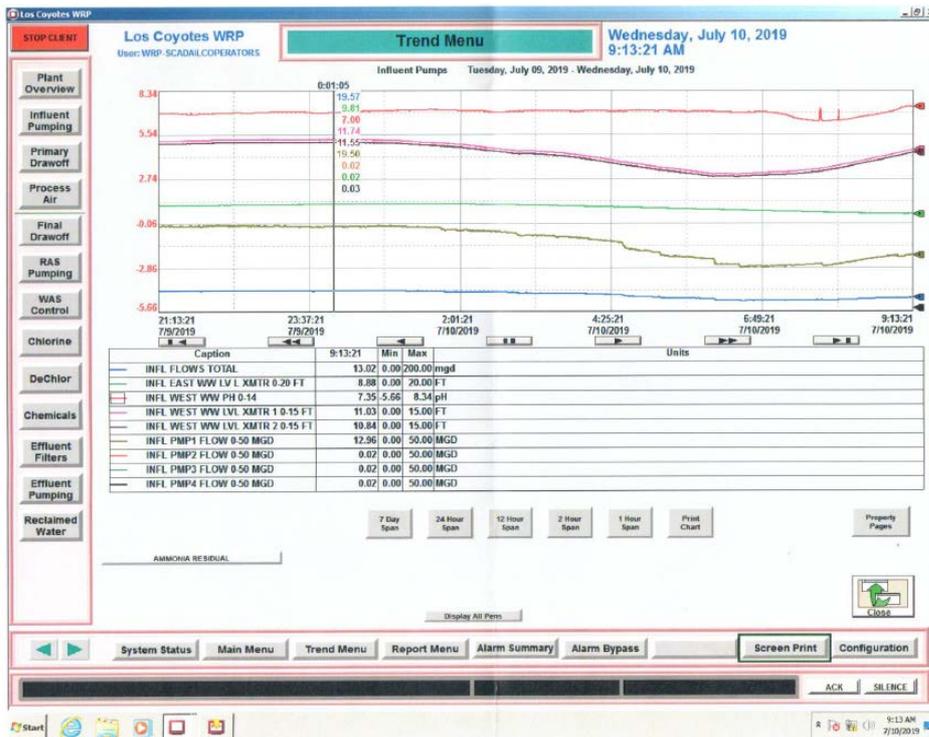
On Wednesday, 7-10-19 at 0815 hours, Los Coyotes WRP TPO II Tom Jauregui walked into the Industrial Waste Inspectors' office trailer at LCWRP. He notified the Senior IW Inspector Jim Percy and Inspector Tingting Wei that low pH influent was entering the treatment plant at 0750 hours (see Figure 1). He stated a grab sample had been collected by WRP operators and the pH was currently about 6.4, which had been confirmed by the on-site laboratory personnel.

Figure 1: 12-hour, starting at 2113 hours, Los Coyotes WRP influent pH trend on 7/9/19-7/10/19 (red data trend line).

The investigation of this incident, though resulting in a significant number of inspections being conducted at possible industrial source upstream of the WRP (10), did not ultimately result in a likely source for the incident being identified. Both day and night team inspectors conducted these inspections. The incident did not impact WRP treatment operations or effluent quality.

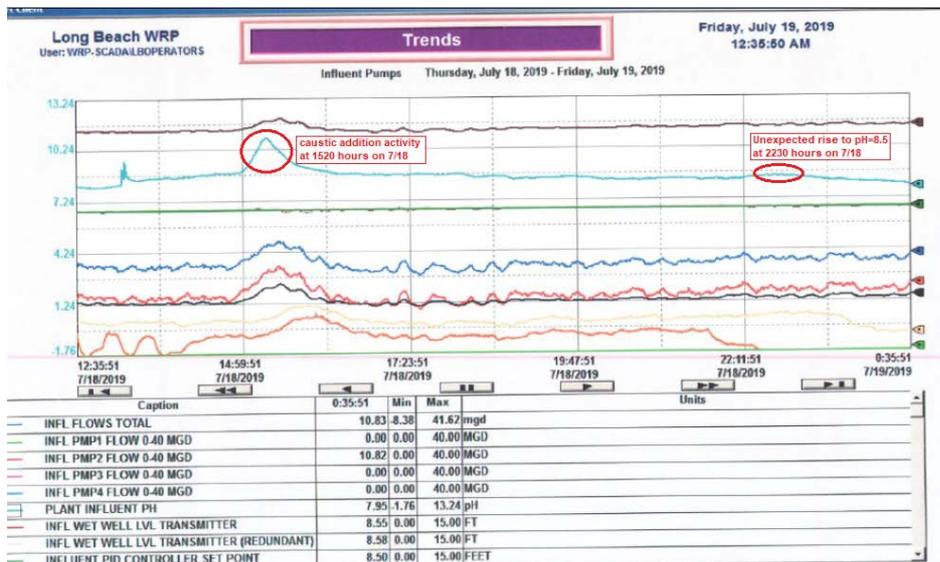
On Thursday, 7-18-19 at 2324 hours, TPO II Will Moriarity, who is stationed at the Los Coyotes WRP, called Night Team Senior IW Inspector Kent McIntosh and reported that telemetry data from the Long Beach WRP indicated that the treatment plant was having high pH influent. Moriarity stated that the LBWRP operators had been expecting, and did, see some high influent to the WRP earlier in the day due to scheduled caustic addition activity (the influent pH rose to 10.94 at 1520 hours-see Figure 2). However, the influent pH then rose again very modestly, but unexpectedly, later in the evening, reaching the alarm level of 8.5 at 2230 hours, prompting his call to McIntosh about an hour later. Moriarity stated that operators were unaware of any scheduled crown spray activity upstream of the Long Beach WRP which could have caused this second rise in pH. Night team IW inspectors responded to the call until going off shift at 0130 hours.

About an hour later, at 0243 hours on Friday, 7-19-19 Moriarity called Supervising IW Inspector John Boyd at home and reported that a third high pH influent spike had occurred just prior to his call. He stated that the influent pH monitor had again alarmed when it reached 8.5 and was currently at 8.73 as of the time of his call. He said he had dispatched an operator to the Long Beach WRP and that the operator had confirmed the high pH using a manual pH meter. It was agreed IW inspectors would respond again, after the initial response from Night team inspectors earlier in the evening, first thing the in the morning and that Moriarity would call Boyd back if the influent pH reached 9.0. As of 0700 hours no such follow-up call was received and Team 2 Day shift inspectors, led by Supervising IW Inspector David Sanchez, had begun their follow-up investigation.

Figure 2: 12-hour, starting at 1235 hours, Long Beach WRP influent pH trend on 7/18/19-7/19/19 (light blue data trend line).

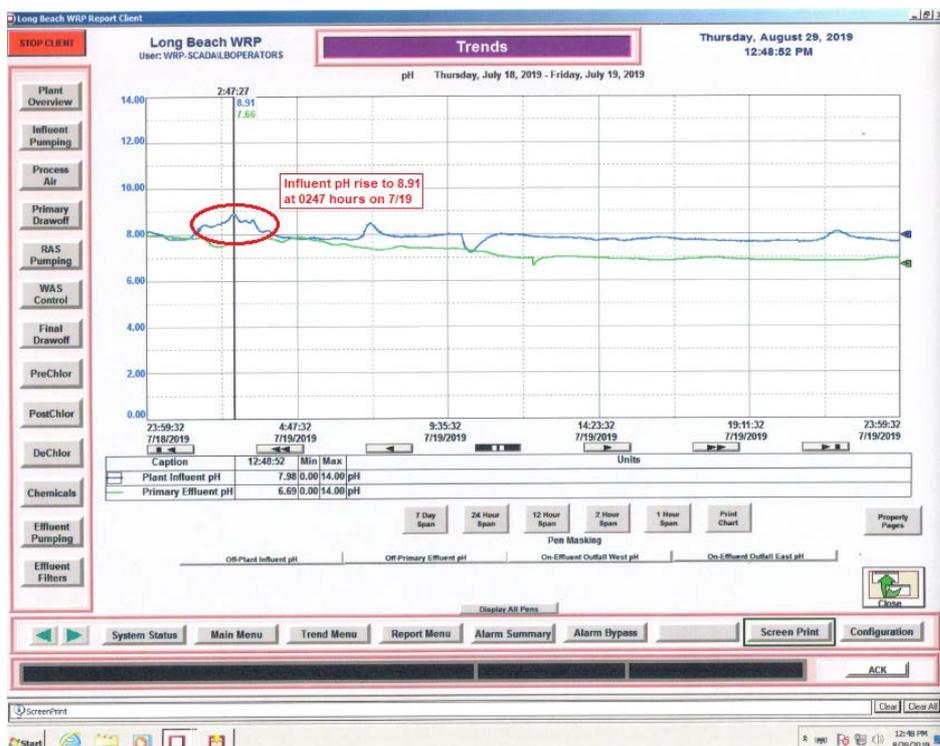
Figure 3: 24-hour pH trend at the Long Beach WRP influent pH trend for 7/19/19 (dark blue data trend line). Note the pH=8.91 spike at 0247 hours.

The investigation of these incidents did not ultimately result in a likely source for either incident being identified. Both day and night team inspectors conducted these inspections. The high pH influent did not materially impact WRP treatment operations or effluent quality. IW inspectors continue to be vigilant as to the possible source(s) for these incidents.

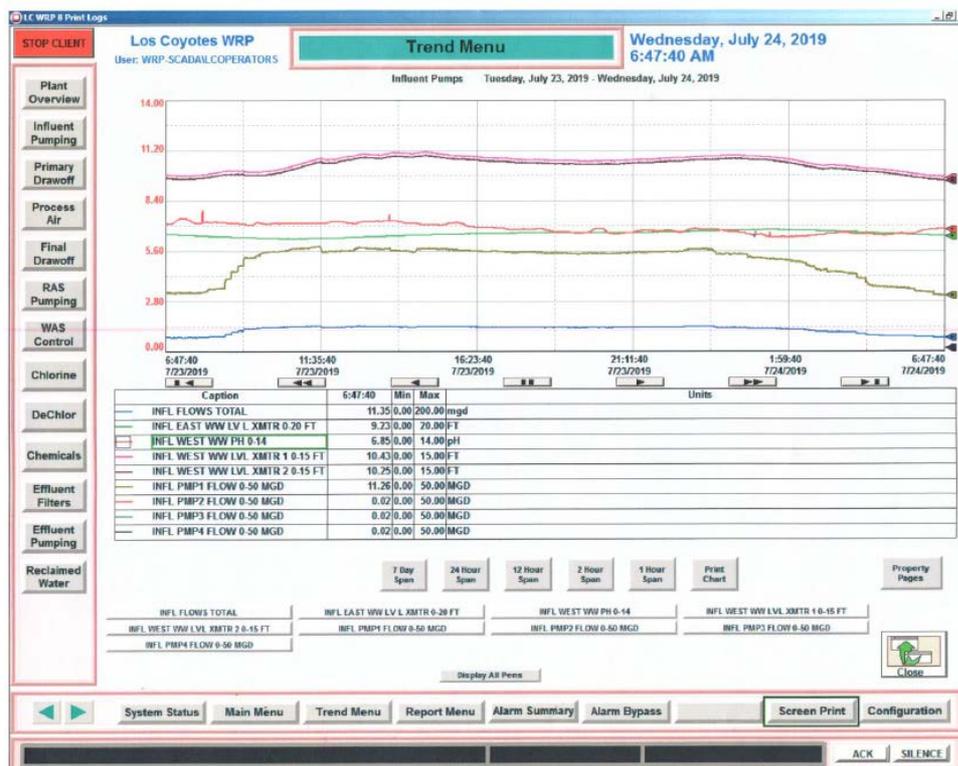
On Wednesday, 7-24-2019 at 0130 hours, Los Coyotes TPO II Diana Torres called Night Team Senior IW Inspector Kent McIntosh and reported that the influent pH at the Los Coyotes WRP had dropped to 6.43, setting off the low pH alarm. McIntosh took the information and then

Figure 4: 24-hour, starting at 0647 hours, Los Coyotes WRP influent pH trend on 7/23/19-7/24/19 (red data trend line).

The investigation of this incident, though not resulting in a definitive source being identified, did indicate that one of the more likely sources, Shasta Beverages, Inc. in La Mirada, had apparently inadvertently switched off their industrial wastewater pH treatment system caustic addition pump and their effluent pH recorder. When the system was immediately brought back online in the presence of IW Inspector Tingting Wei, she noted the recorder pH and flow data retrieved from the memory unit indicated they had discharged about 230,000 gallon of wastewater over the previous 24 hours with an average pH of about 5.7. However, when she checked the pH meter's accuracy, she found that it was considerably off, indicating a pH of 5.2 when the actual pH, according to her handheld meter, was 7.16. Due to this discrepancy, it is unknown if the company caused or contributed to the WRP incident reported on 7-24-19. However, Wei issued Shasta Beverages a NOV for failing to properly operate both the pretreatment system and the required effluent pH meter/recorder. The incident did not impact WRP treatment operations or effluent quality.
