2019 ANNUAL REPORT

INDUSTRIAL WASTE PRETREATMENT PROGRAM

LOS ANGELES COUNTY SANITATION DISTRICTS

APPENDIX H
INDUSTRIAL WASTE REPORTS ON INCIDENTS

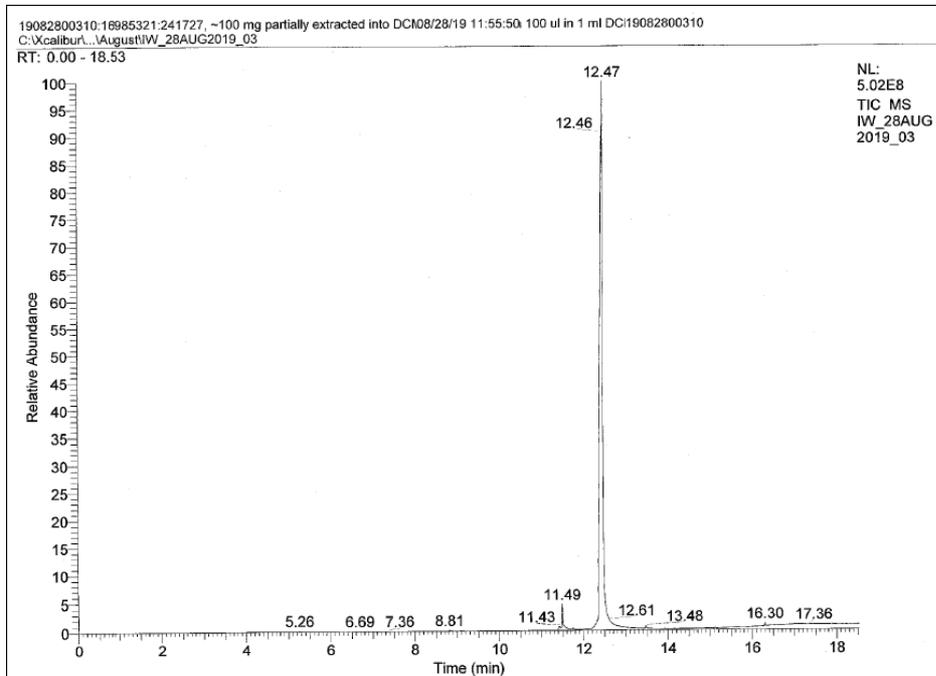
The Districts' sewer maintenance crew was able to successfully clear and clean the line, preventing any overflows from occurring. During this process it was determined that the grease material was not actively flowing into MH 1037 and there was thus no material to trace upstream to a source. GC/MS sample analysis identified the sampled material as being oleic acid (see Figure 3), thus allaying IW Inspector concerns the material was something more exotic or unusual like a resin material which could have presented a more problematic concern to the integrity of the collection system. Oleic acid is a fatty acid that occurs naturally in various animal and vegetable fats and oils. It is common in the production of food products.

Figure 3: Sample extract analysis: GC/MS scan chromatogram indicating a large peak at 12.47 minutes. This peak was determined to correspond to oleic acid.

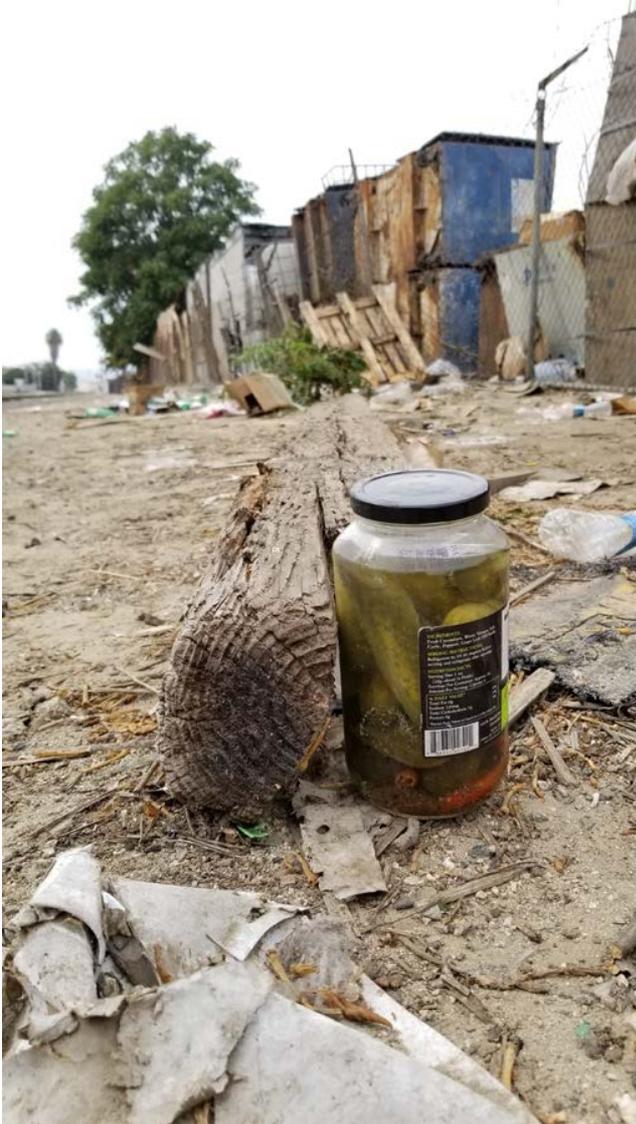
Figure 2: Pickle jar on the property at Master Recycling Center on 8-18-19 at 1000 hours.

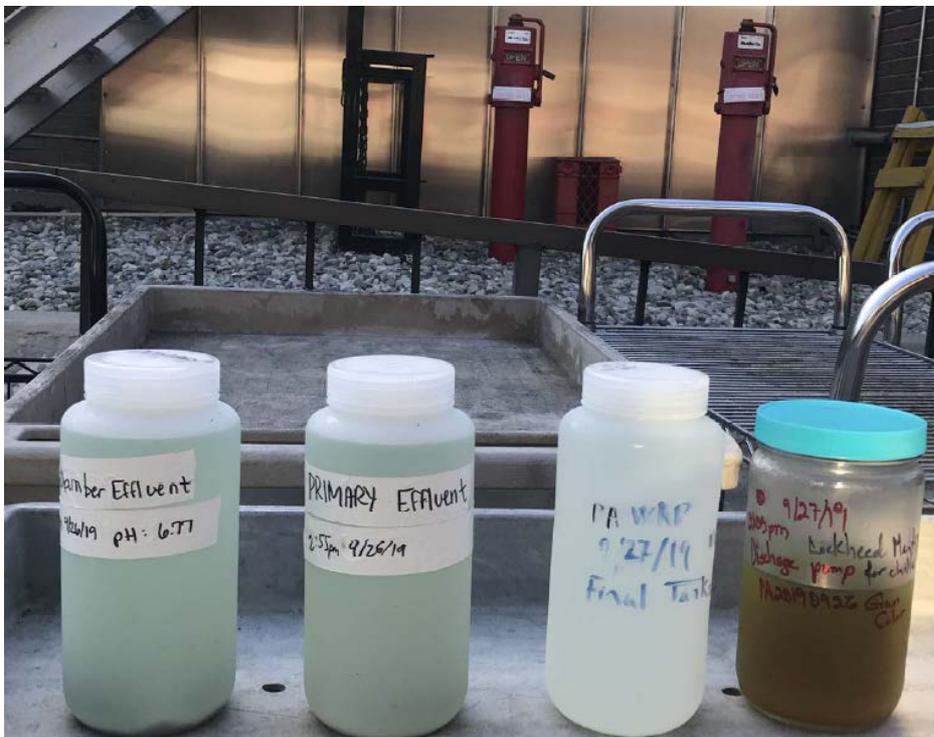
On Thursday, 9-26-19 at 1500 hours, an IW Section office secretary received a phone call from Palmdale WRP TPO II Juan Huerta, who reported dark green colored wastewater was present in the grit chamber and primary tanks. Senior IW Inspector Anie Kellzi spoke to Huerta shortly thereafter. Huerta stated that the green color was first noticed around 1445 hours, with the influent pH normal at 6.77 and no unusual odors present. Huerta collected samples of the green colored wastewater from the grit chamber and the primary tank for possible analysis (see Figure 3 below). As the green color material had yet to enter the secondary tanks it was then unknown if the material would adversely affect the treatment plant operations.

Figure 3: 3 Palmdale WRP 9-26-19 green-colored samples and a green-colored sample of chiller water taken from Lockheed Martin.

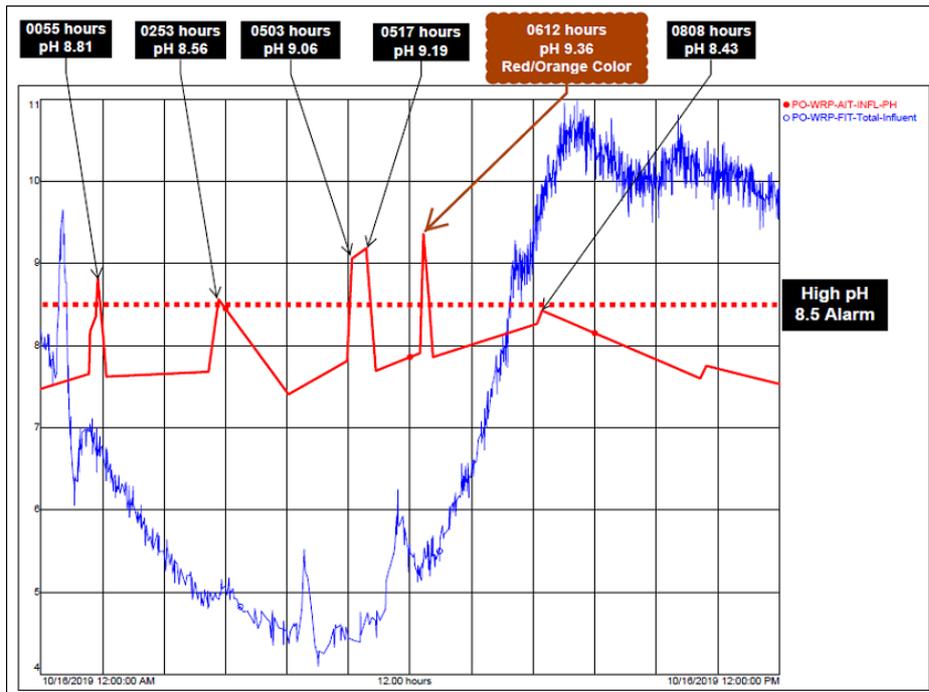
On Wednesday, 10-16-2019 at 0521 hours, San Jose Creek East WRP TPO II Kyle Rodman telephoned Supervising IW Inspector Andrew Woods to report high influent pH at the Pomona WRP. San Jose Creek serves as the alarm center for the Pomona WRP as it is unattended at night. Rodman reported that at 0505 hours the raw influent pH rose above 9 and that he sent an operator to the WRP to collect samples and verify conditions. At 0623 hours, Rodman again telephoned Woods to report a second high-influent pH bump at 0612 hours. The responding operator was by then on-site and collected samples of the second pH bump. The influent high-pH wastewater was observed to have a red/orange color and the pH peaked at 9.36. Both high-pH events were brief, lasting about 15 minutes each. At approximately 0745 hours, Senior IW Inspector Anie Kellzi, as well as IW Inspectors Helen Luu and Steve Lajkowicz, arrived the WRP and received the samples taken earlier for color comparison and potential lab analysis. It was noted that only the 0612 hours pH=9.4 sample had color. At 0805 hours, another high-pH alarm occurred, peaking at 8.66 and lasting about 15 minutes.

Figure 1: Pomona WRP influent flow and pH data (with annotations) for midnight to noon on 10-16-19.

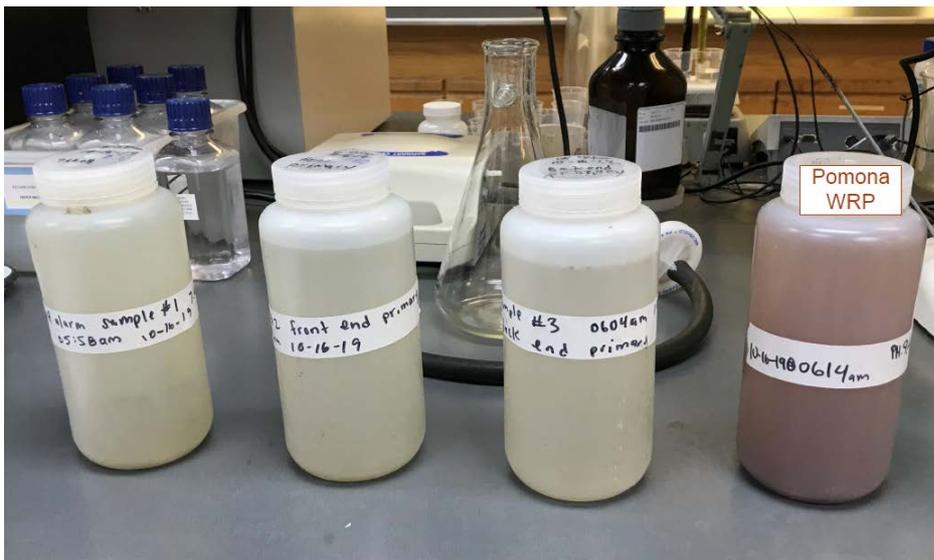
Figure 2: 4 samples from the Pomona WRP taken on 10-16-19. Note the marked red color of the influent sample on the right as compared to the wastewater already in the plant at that same time.

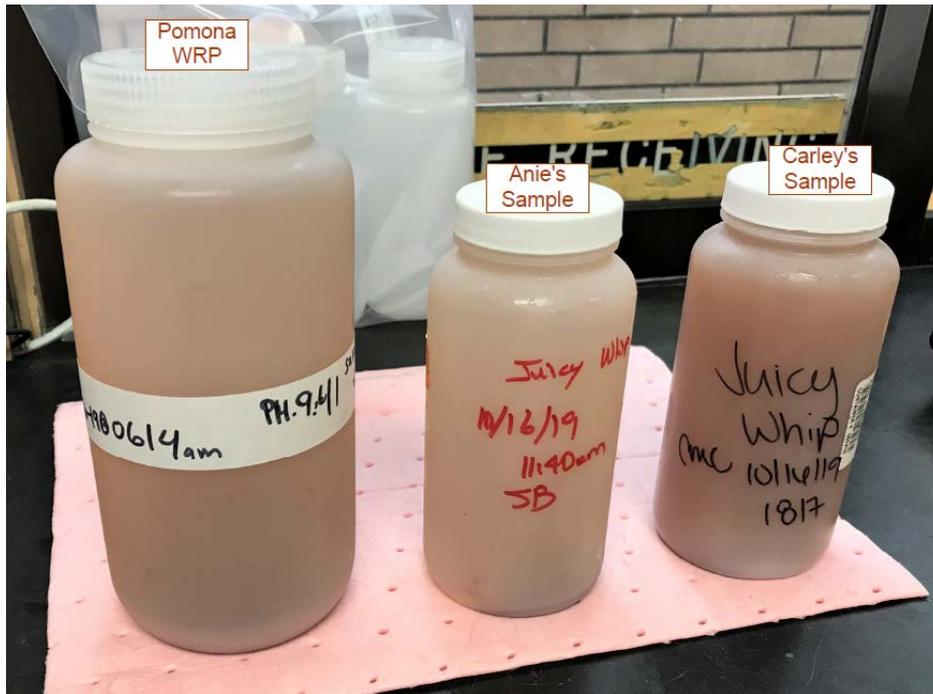
wastewater discharged from the facility matched, per laboratory FT-IR and microscopic analyses, the color and solids characteristics of the wastewater received at the WRP during the high pH incidents. It was also determined that the cause of the high pH discharge at Juicy Whip Inc. were malfunctioning and out-of-calibration pH neutralization system meters and monitoring equipment. Juicy Whip was subsequently cited for discharging wastewater with a high pH and color that impacted the Pomona WRP, as well as for failing to maintain and operate properly their required industrial wastewater pH neutralization and monitoring equipment. Follow-up inspections determined that within two weeks the Juicy Whip facility had affected the needed repairs to all pH equipment and were investigating the potential to install bag filters on the discharges of especially colored wastewater flows to address the issue of discharging highly colored wastewater.

Figure 3: Samples from Juicy Whip (2 on the right) compared to a sample taken from the Pomona WRP. Note the very similar color.

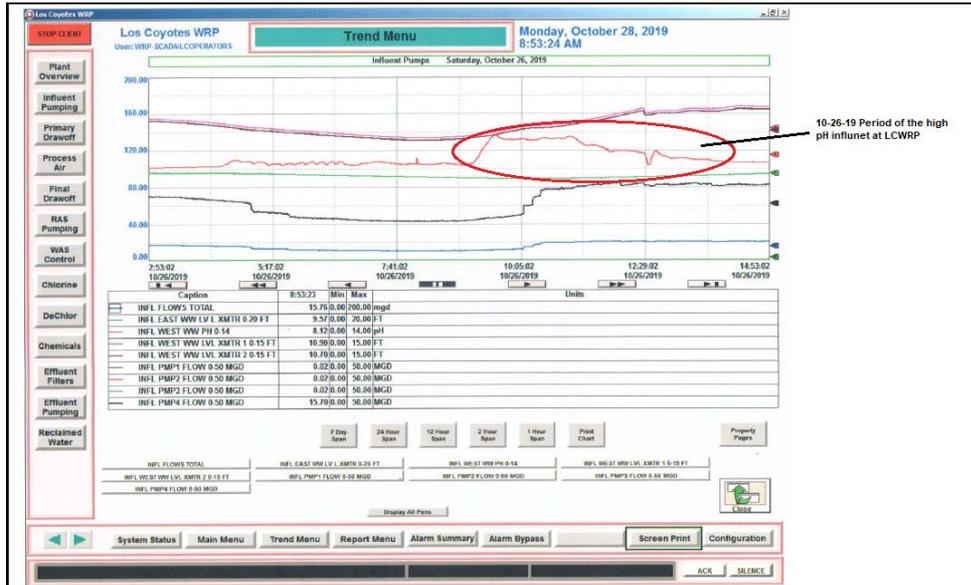
On Saturday, 10-26-19 at 0955 hours, Los Coyotes WRP Treatment Plant Operator II Tom Jauregui notified Supervising IW Inspector David Sanchez that high pH wastewater was entering the Los Coyotes WRP. The influent pH reached a high of 9.66 at about 0933 hours, remaining at about 9.5 for about 75 minutes before slowly tapering off and returning to normal by 1500 hours (See Figure 4 below). Two 1.0-liter samples of the influent were collected by plant operators.

Figure 4: Los Coyotes WRP operational trends of 10-26-19 prior to and during the high pH influent event that started just after 0900 hours.

Team 2 IW Inspectors, led by Senior Inspector Chris Mendoza, investigated this incident. It was determined that the high pH was not due to routine caustic addition and crown spray activity. Seven potential industrial sources were inspected and one, Shasta Beverages Inc. in La Mirada was determined to be the likely source of the incident. The facility makes and bottles beverages. Review of effluent pH meter data at Shasta Beverages by Mendoza revealed that from 0400 hours until to 0800 hours on 10-26-19 a total of 12,205 gallons of wastewater was discharged with a pH range of 8.4 to 11.0. The estimated wastewater travel time from the Shasta facility to the WRP also aligned well with that expected for the discharge to have caused the WRP incident. On the morning of the incident the facility was performing standard operations including clean-in-place (CIP) equipment cleaning which includes the use of alkaline cleaning solutions, thus explaining the high pH of their wastewater discharge.

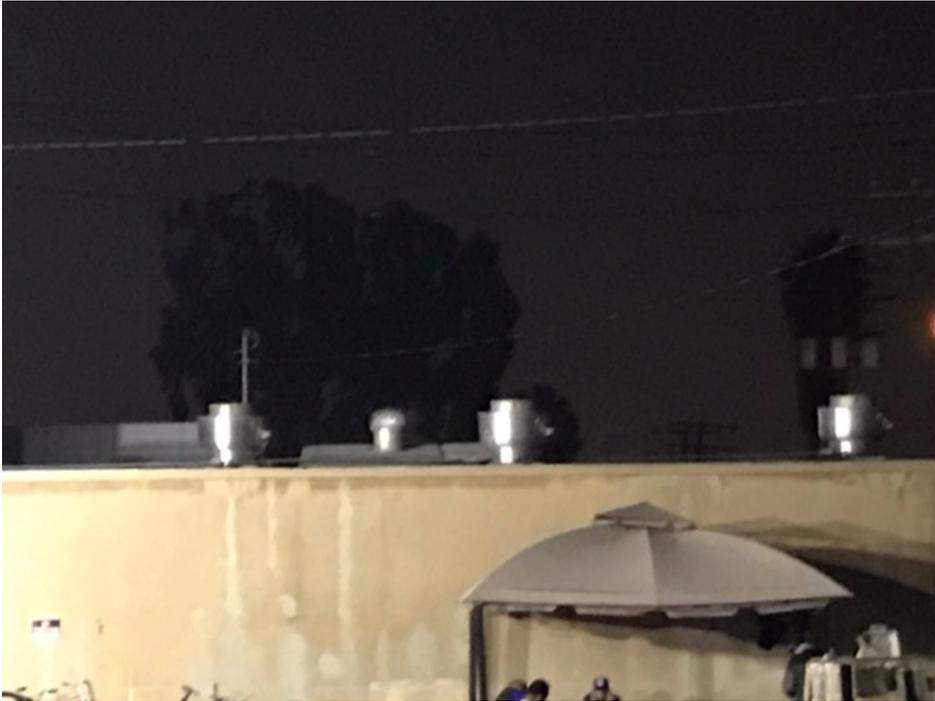
IW Inspectors, led by Night Team Supervising Inspector Steve Sealy, investigated this report, arriving on-site at Rugzy, Inc. the business located at the address given by Mr. Sones, at 1600 hours on 11-7-19. They determined that Rugzy, Inc. was the source of the “chemical” odors reported by Mr. Sones. The facility does rug cleaning, using various cleaners that include acetic acid and alkaline detergents. Inspectors spoke to a Rugzy’s Owner, Mr. Gabriel Nalbandian, who stated they had used bleach earlier in the today, claiming though that this was atypical, around the same time the complaint was reported to the Alarm Center. While the facility was not doing cleaning operations during their inspection, inspectors noted there was still a strong chemical odor present in the production area. The owner stated that workers use respirators to minimize exposure to chemicals and their odors. Inspectors noted the facility also had what appeared to be recently installed rooftop vent fans. While these fans may be helpful to workers inside the facility, its suspected they may increase the intensity of the odor neighbors are experiencing. No violations of the facility’s industrial wastewater permit were noted.

Figure 1: Powered rooftop exhaust vents at Rugzy Inc.

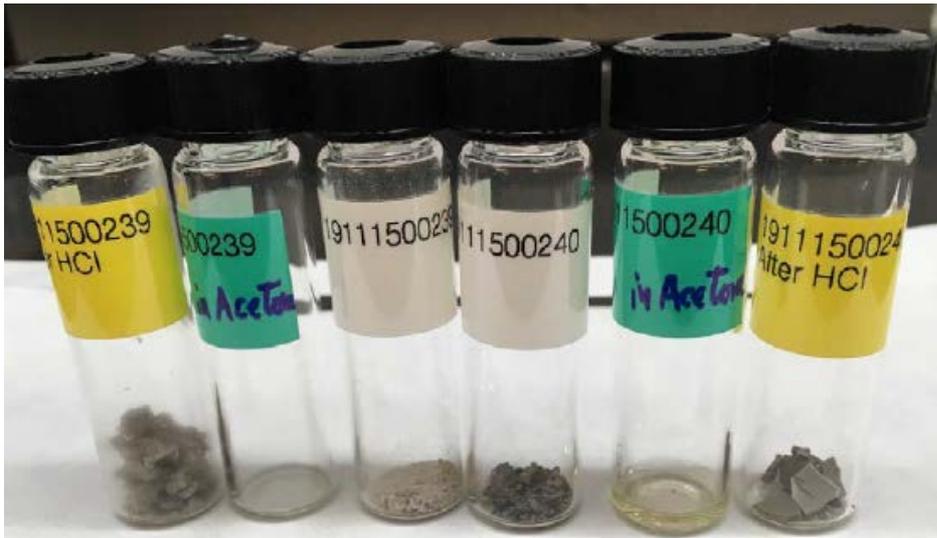
Figure 4: Scale and solids samples submitted for laboratory FTIR analysis (19111500239 and 19111500240).

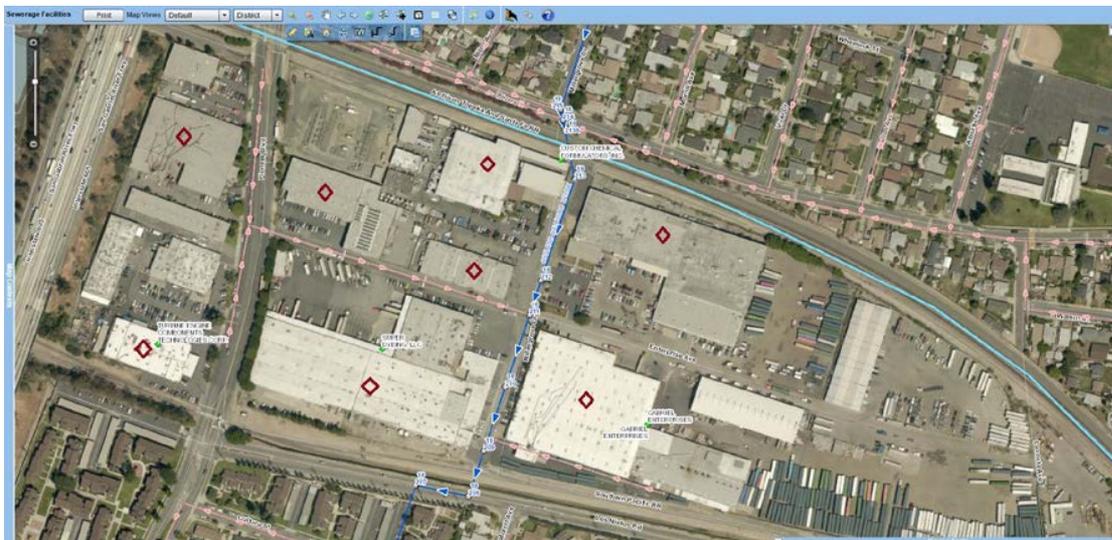
The investigation of this report has thus far not yielded a likely source of the scale and solids despite IW Inspectors on both the day and night shifts performing inspections at 16 industrial facilities upstream of MH 18 0207 (see Figure 5). Several of these facilities were inspected multiple times. Sample analysis indicates the scaling and solids are primarily comprised of calcium carbonate, a common scale encountered in the sewer systems. However, it was noted that silica was also present in the scale. Senior IW Inspector Chris Mendoza found no scaling present at MH 18 0214. This may indicate the source of the scaling is located downstream of MH 0214, but it does not preclude the possibility that the mixing of two or more wastewaters could create the critical conditions for scale-causing material to precipitate. Thus, one of those components could be from a source upstream of MH 0214. Also, review of sewer cleaning records and past incident reports indicates that scaling in this section of the Orr and Day Road Trunk has likely been occurring since at least 2004. IW Inspectors are continuing to investigate this incident at a high level.

Figure 5: Annotated GIS map showing the location of the manhole where sewer maintenance crews noted scale and solids (MH 18 0207), as well as trunk and local sewer lines upstream of that location and the industrial facilities located in the area. A red diamond indicates those industrial facilities inspected as part of this investigation.
