2020 ANNUAL REPORT

INDUSTRIAL WASTE PRETREATMENT PROGRAM

LOS ANGELES COUNTY SANITATION DISTRICTS

APPENDIX H
INDUSTRIAL WASTE REPORTS ON INCIDENTS

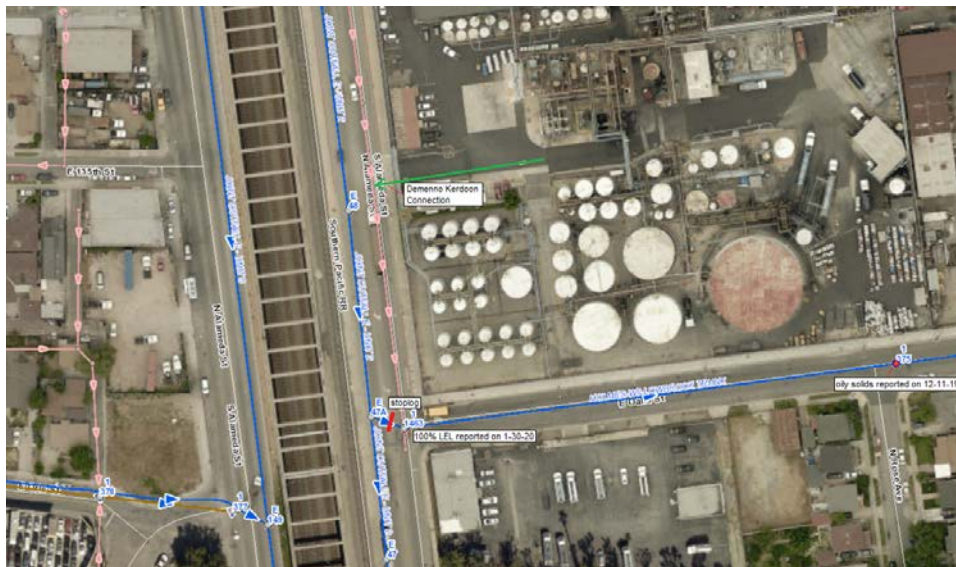
DeMenno/Kerdoon, a large oil recycling facility located just upstream of this location. The situation is complicated by the fact that oily odor complaints coming from the sewers by residents in the area have caused the Districts to effectively seal the sewers here to prevent such odors escaping. Additionally, there is little flow in these lines as the upstream area is very limited and there is a stoplog in place at MH 01E0047A. Lastly, it is of note that on 12-11-2019 Pearce reported oily solids in the line at MH 01 0375 just downstream (see Figure 3). All these issues are related.

Figure 3: GIS map showing the area around the Demenno/Kerdoon facility.

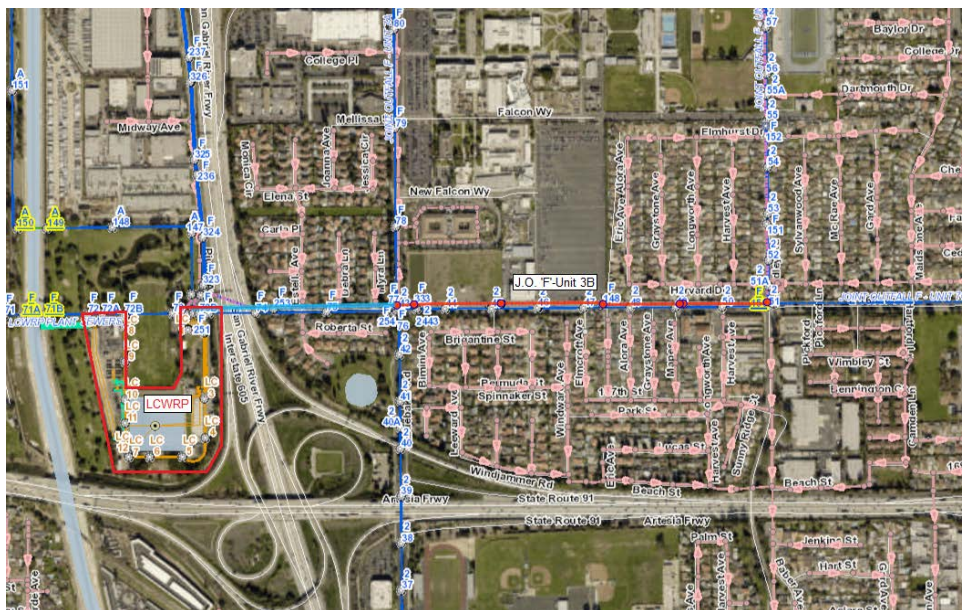
Team 2 IW Inspectors Tingting Wei and Sanjay Patel, as well as Percy, immediately responded to investigate the incident. Their investigation revealed that the cause of the odor in the LCWRP was the release of 470,000 gallons of hot water from the upstream Districts’ sewer relining/curing-in-place pipe (CIPP) project in the 63” diameter J.O. ‘F’-Unit 3B trunk sewer about a quarter mile upstream from the WRP. The hot water, which is discharged into the sewer after its use to cure the resin, generally has the odor of the resin. That odor is what was noticed by operators at the WRP. The odorous material had no adverse impact of the plant’s operational parameters. CIPP project managers said they would try to keep WRP operators better informed as to when to expect these odors.

Figure 1: GIS Map indicating the location of the J.O. ‘F’- Unit 3B trunk sewer located upstream of Los Coyotes WRP where the CIPP relining project operations were being performed on 2-5-2020.

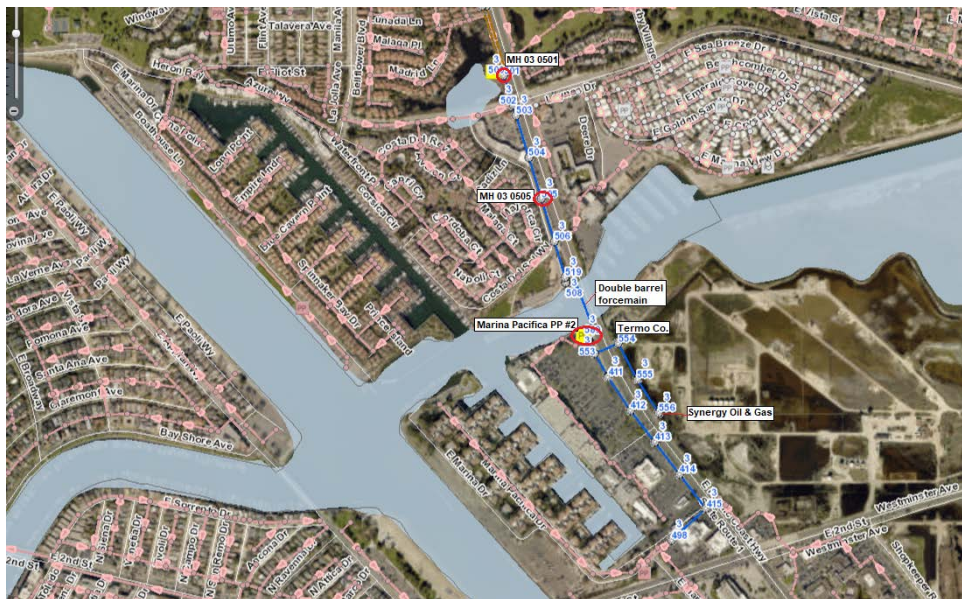
2. Due to previous citizen oily odor complaints in the area, the trunk sewers as well as the pumping plant itself, have been very tightly sealed by Districts' sewer maintenance staff to prevent oily odors escaping into the surrounding area and community. These efforts, while effective in reducing odors in the area, trap methane containing gases in the sewer headspaces. These are then liberated downstream at MH 03 0505 where flow from the pumping plant, after traveling a quarter mile in a double barrel 12" force main line, "breaks out." Monitoring by the inspection staff indicates that the explosive condition in the line quickly abates downstream of MH 03 0505, falling off to a typical reading of 0-15% only a few reaches downstream at MH 03 0501 (see Figure 2).

Figure 2: GIS map showing the manhole location of the elevated explosivity on 2-6-2020, MH 03 0505, along with the locations of the upstream pumping plant, and two large oil field production operations that discharge to the sewers in this area.

As the current priority is to control odor emissions in the area, the sewers will remain well sealed. However, the Districts' IW engineering staff has required Synergy Oil & Gas to provide a proposal to control the discharge of odor causing materials by April 30, 2020, and this may well have a side benefit of reducing the explosivity found in the downstream sewer line. IW Inspectors continue monitor this situation.

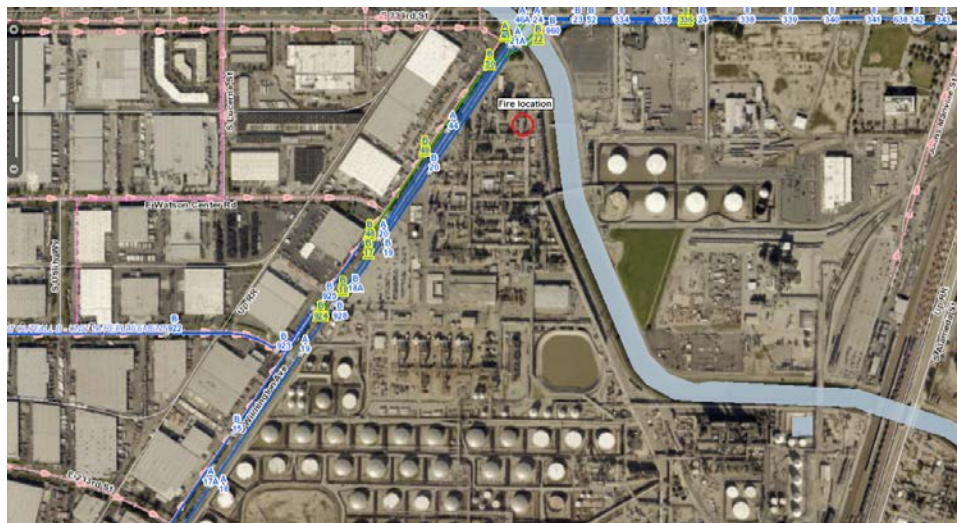
Figure 9: GIS map showing the location of the fire on 2-25-2020 inside the Tesoro Carson oil refinery.

Per Pengphol's company contact, the fire broke out at 2250 hours on 2-25-2020 at a compressor at the hydrocracker unit located at the north side of the facility. The cause of the fire remains under investigation. Firefighting foam was used to control and extinguish the fire. The contact estimated 1,834,000 gallons of firewater was generated from fighting the fire. This firewater is being held in Tank 20 on-site.

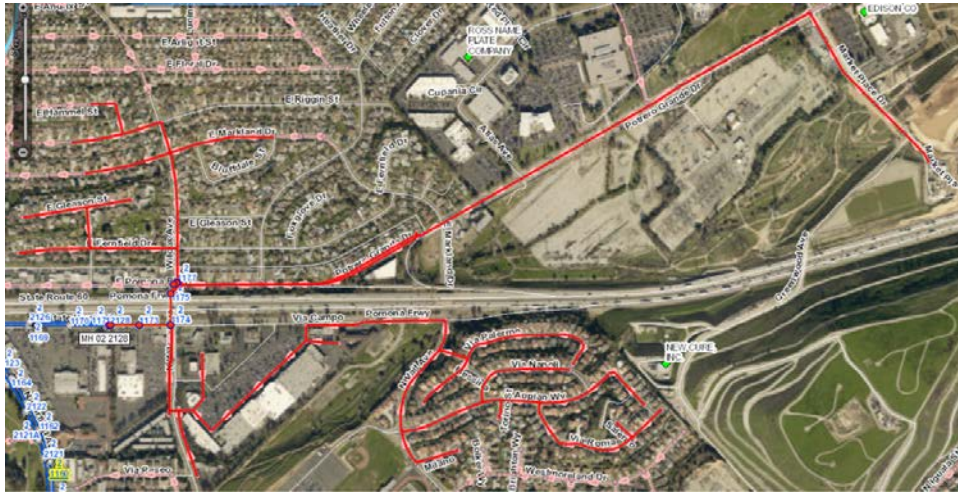
Figure 2: GIS map indicating the area influent to MH 02 2128.

Geographic Information System (GIS) upstream tracing identified the tributary sewer lines and relatively limited influent area that included only two industrial-waste permitted facilities: Ross Name Plate Company and a Southern California Edison facility (See Figure 2). Inspections at both facilities found no evidence that either was a source for this incident. A subsequent survey of the upstream area identified three unpermitted users that were potential sources of the wipes; Two healthcare facilities (a Blue Shield medical office, a HealthCare Partners Urgent Care Clinic), and a 74-unit senior assisted-living facility (Via Campo Senior Villas). Contacts at both the Blue Shield and HealthCare Partners facilities mentioned having historical problems with clogged plumbing due to patients and staff flushing wipes. Both contacts claimed to have applied practices and training to discourage flushing wipes. The senior-housing manager said he would communicate and discourage tenants and staff from flushing wipes. The medical clinics and senior housing are the likely sources of sanitary wipes to the sewer, it is hoped that speaking with the contacts at these facilities and making them aware of the Districts’ problems with wipes in the downstream trunk sewer will encourage them help to mitigate the issue.

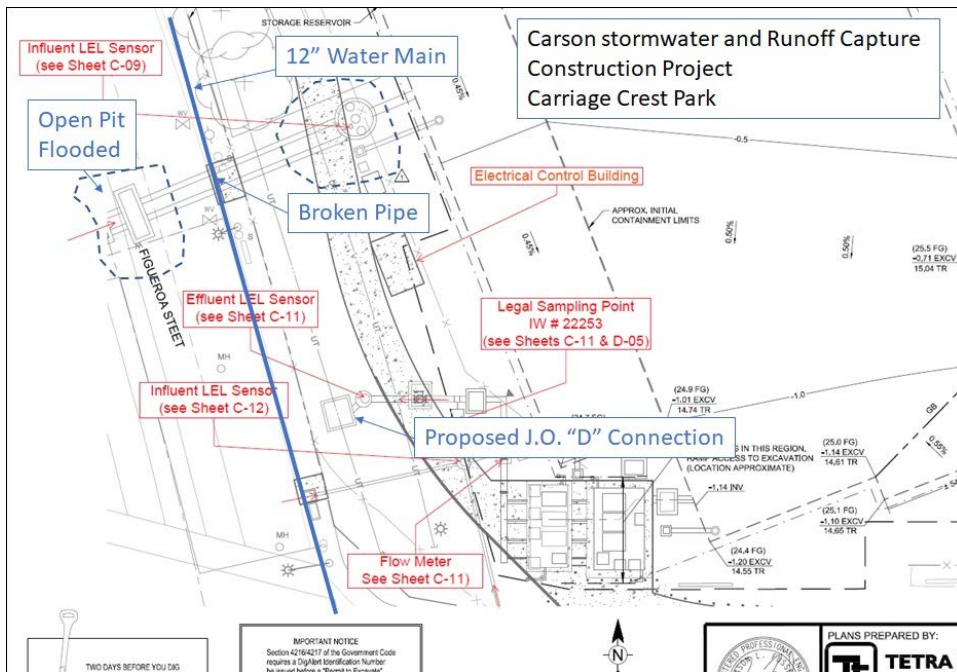
Figure 6: Annotated site diagram of the Carriage Crest Park project.

On Thursday, 3-19-2020 at approximately 0915 hours, a contractor performing work on the Carson Stormwater and Runoff Capture Project adjacent to the City of Carson's Carriage Crest Park ruptured a 12" water main operated by California Water Service while operating an excavator near the pipeline. The water inundated a construction pit associated with the ongoing project located in the middle of Figueroa Street as well as the intersection of Figueroa and Sepulveda Blvd. (see Figures 3-6 above). This water main serves the JWPCP, as well as several businesses along Sepulveda Blvd. including the Target and Home Depot stores. Water service was restored to the JWPCP within an hour and a half by isolating the break at a valve located at a loop in the water main. It was expected that some of the local businesses would be disrupted for at least 12 hours thereafter since they were connected within the area serviced by isolation valve. To keep the water from further inundating the Carriage Crest construction site an earthen containment dike was built between the construction site and the broken water main. It appeared the containment was effective, and the other Carriage Crest construction pits were dry. Barnum required Project Manager Andres Acosta to notify Supervising Inspector John Boyd if anything changed and/or they needed to dewater the construction pit using their permitted industrial

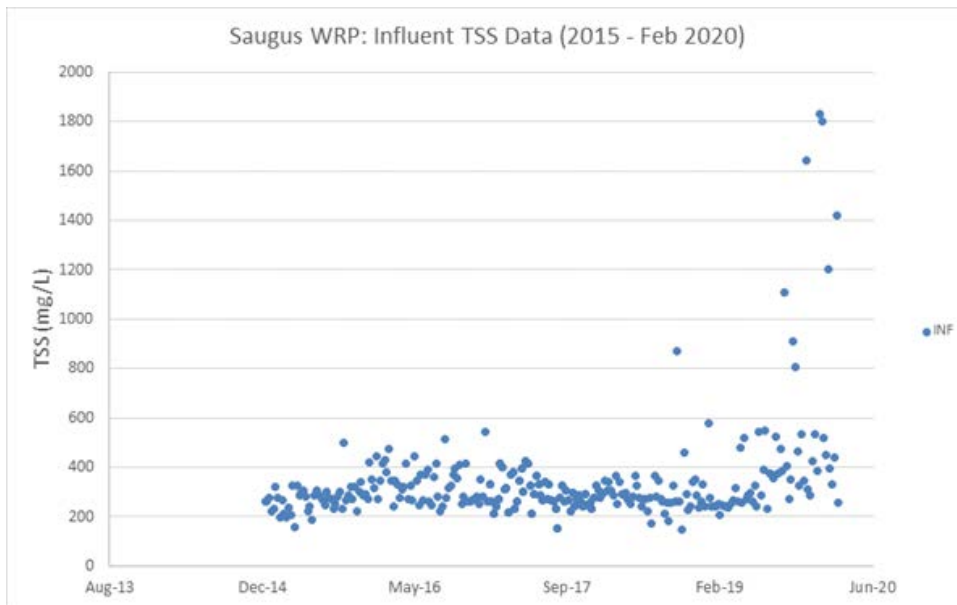
On Wednesday, 4-1-2020 at 1500 hours, Supervising Engineer Naoko Munakata of the Districts' Reuse & Compliance Section called Supervising IW Inspector John Boyd and reported that over the past year or so weekly sampling data from the Saugus WRP indicated unusual variability and a significant overall increase in the total suspended solids (TSS) loading entering the treatment plant. Along with this, testing recently also indicates some final effluent toxicity was present. It is unknown if these two are related. Munakata stated that she was calling to see if IW inspection staff had any idea as to the source of the increased TSS concentrations. TSS concentrations at the Saugus WRP typically range from 200-400 mg/l, but data over the last year have indicated readings of 500 mg/l with occasional spikes to as high as 800-1,800 mg/l. The overall annual average has increased from 300 mg/l to 450 mg/l. She noted that the TSS influent concentrations at the nearby Valencia WRP have also increased over this same period from 400 mg/l to 750 mg/l. But again, it's unclear if these two things are related. She said Valencia WRP is not experiencing any final effluent toxicity. Boyd said that he was unaware of any new or different IW dischargers or discharges upstream of Saugus WRP and/or Valencia WRP that were likely sources for the increased TSS levels, but that IW inspectors would open an investigation into this report immediately.

Figure 1: Saugus WRP raw influent total suspended solids concentration (January 2015-December 2019).

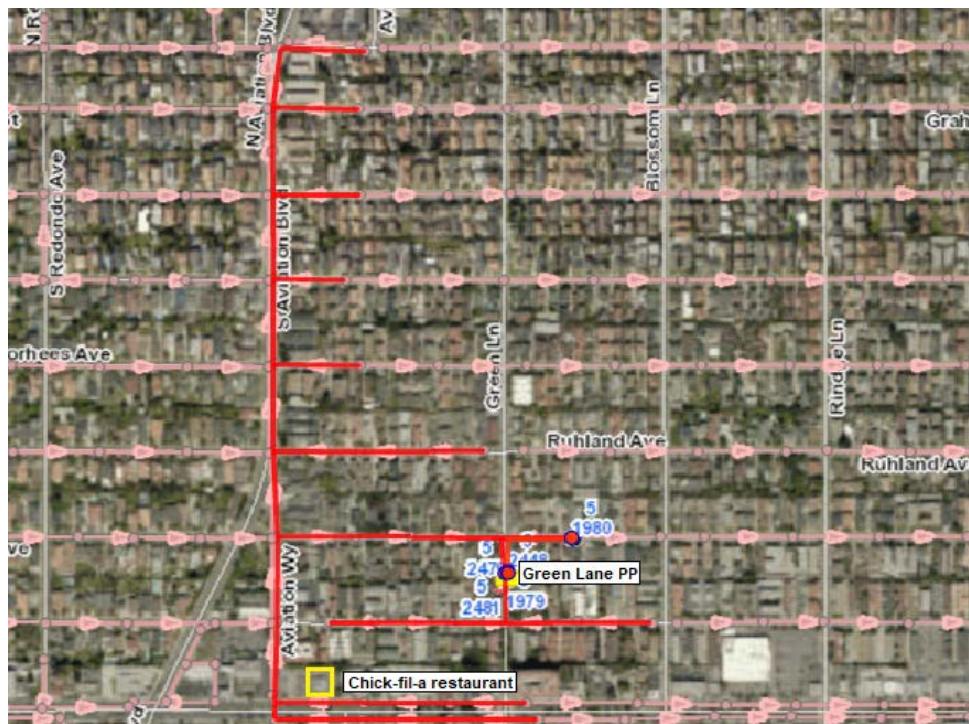
He said they'd been observing the increased grease amounts for the last few months. He requested IW inspectors investigate possible sources, adding that he suspects it may be due to a new Chick-fil-A restaurant that is located nearby at the corner of Aviation Way and Artesia Blvd. Boyd noted that the GIS map of the area indicates the area influent to the pumping plant PP is quite limited (see Figure 7 below).

Figure 7: GIS diagram indicating the area influent to the Green Lane PP.

Area IW Inspector Sophia Luu investigated the report and confirmed that the Chick-fil-A restaurant in question was the likely source of the excessive greasing being observed at the pumping plant. The restaurant opened in September 2019. Although the inspection of the restaurant indicated they do have a grease management program which includes regularly scheduled grease removal, this appears to be insufficient to the task of keeping grease out the sewer. The local agency which administers the fats, oils, and grease (FOG) control program in this area, the City of Redondo Beach, was notified of the excessive grease report and indicated their FOG inspector would look further into the issue. The situation will be monitored, and increased measures will be taken if necessary.

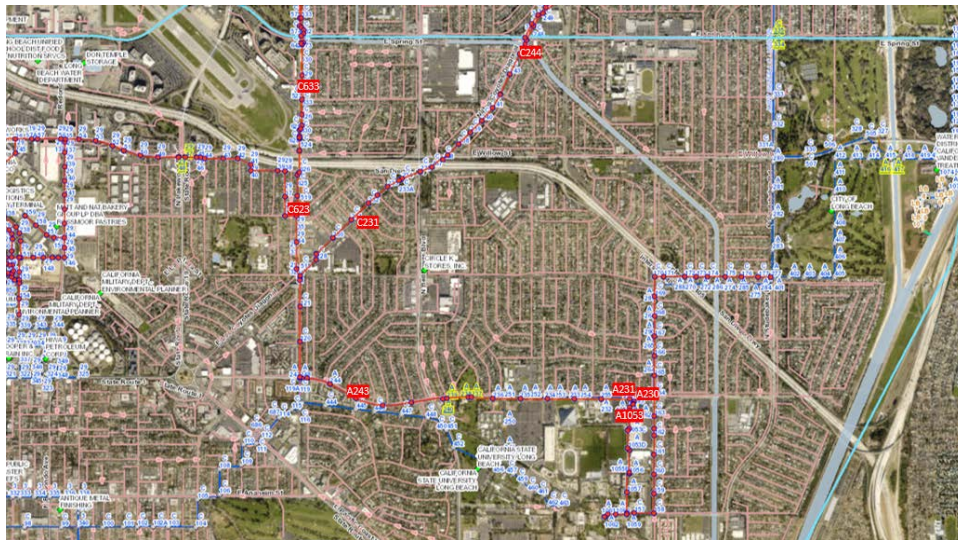
Figure 2: Annotated GIS map indicating the trunk sewer lines upstream Of MH A230 and the manholes checked by IW inspectors on 10-30-2020 for headspace sulfide concentration.

October 30, 2020 H2S readings		
Manhole	Time	Reading (PPM)
C 0480	10:45 AM	0.8
C 0472	11:00 AM	Carbon
C 0258	11:10 AM	0.0
C 0244	11:12 AM	69.8
C 0231	11:30 AM	166.5
C 0623	11:40 AM	79.8
A 0231	11:55 AM	40.0
A 0230	12:00 PM	57.8
A 1053	12:10 PM	0.8
C 0638	12:30 PM	96.3

On 10-30-2020 IW inspectors traced the high sulfide levels in the sewer headspaces into two separate lines upstream of MH C 0619 upstream (see Figures 2 and 3 above). Multiple potential industrial sources upstream of the Long Beach WRP pumping plant were also inspected. The investigation found no evidence that any of the industrial sources inspected caused the high sulfide headspace concentrations reported by the CFO. Additionally, the manhole headspace readings taken by the inspectors indicated high sulfides in both lines upstream of MH C 0619, leading the inspectors to conclude that the high sulfide concentrations are likely being caused by degradation of wastewater in the sewer system and not by industrial dischargers discharging anything unusual or illicit.
