**2021 ANNUAL REPORT**

INDUSTRIAL WASTE PRETREATMENT PROGRAM

LOS ANGELES COUNTY SANITATION DISTRICTS

**APPENDIX H**  
INDUSTRIAL WASTE REPORTS ON INCIDENTS

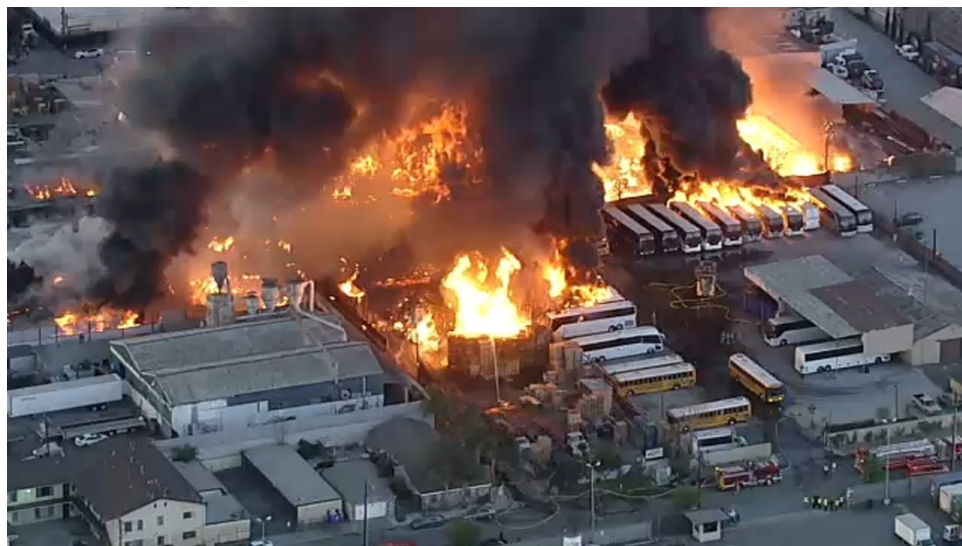
**Figure 10: Local news media (KABC) aerial photo of the fire in Compton on 2-26-2021. Note the buses that are on fire.**

Both day and night Team IW Inspectors responded to the fire out of concern that fire water generated from fighting the fire could be intentionally or unintentionally discharged into the sewer, or that there could be businesses in the affected area in which liquid industrial chemicals or wastes could be spilled into to the sewer as a result of the fire. Fortunately, it was

determined through observation and conversation with the Compton City Fire Department Incident Commander and leaders of the L.A. County Fire Department's Health/Hazardous Materials Unit that was also on-site, that there were no known discharges of liquid toxic materials to the sewer. All runoff from fighting the fire was flowing into the storm drain system where other L.A. County resources were handling it. The fire affected area contained no permitted industrial wastewater dischargers and no known industrial storage or manufacturing facilities with liquid chemicals on-site. There is no evidence that any liquid materials were discharged into the sewer as a result of the fire and the downstream Districts' treatment facility, JWPCP, had no indications otherwise.

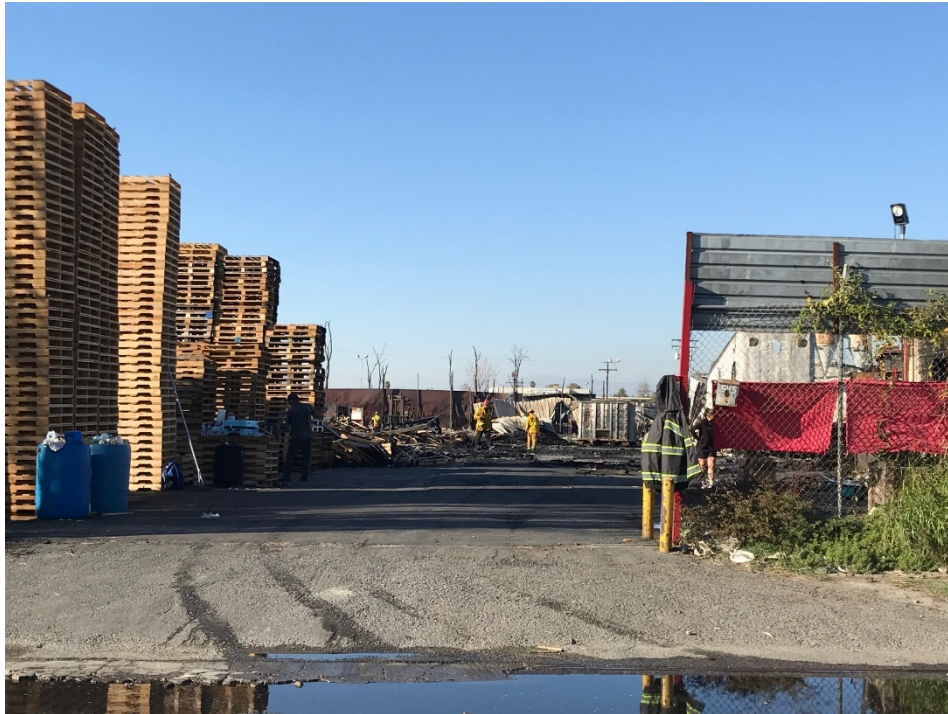
**Figure 11: Late afternoon photo taken by a Districts' IW Inspector on 2-26-2021 after the fire had been extinguished. Photo is of the entrance to the wooden pallet storage yard that burned. Note the puddled firewater in the street gutter.**

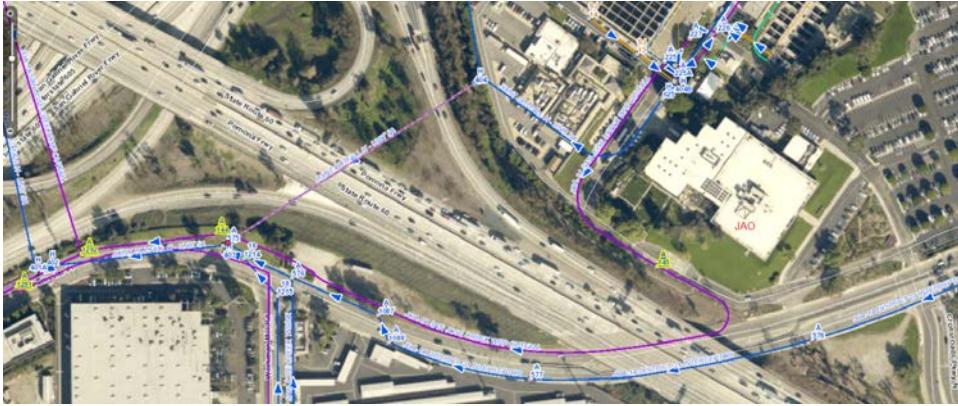
rehabilitation project at the confluence of the J.O.'H' and J.O. 'A' District 21 Interceptor trunk sewers southwest of SJC WRP-East at MH 18 A575 about 0.25 miles west of JAO (See Figures 4 and 5 below). The construction inspector also described "strong sulfide odors" that accompanied confined space alarms for hydrogen sulfide ( $H_2S$ ) gas in the headspace. He stated that the sulfide alarm sounds at 6ppm, and that the incident peaked at 25 ppm  $H_2S$ . Construction workers evacuated the confined space upon the alarm.

**Figure 4: GIS map showing MH 18 A575 and the Districts' Joint Administration Building (JAO) in North Whittier.**

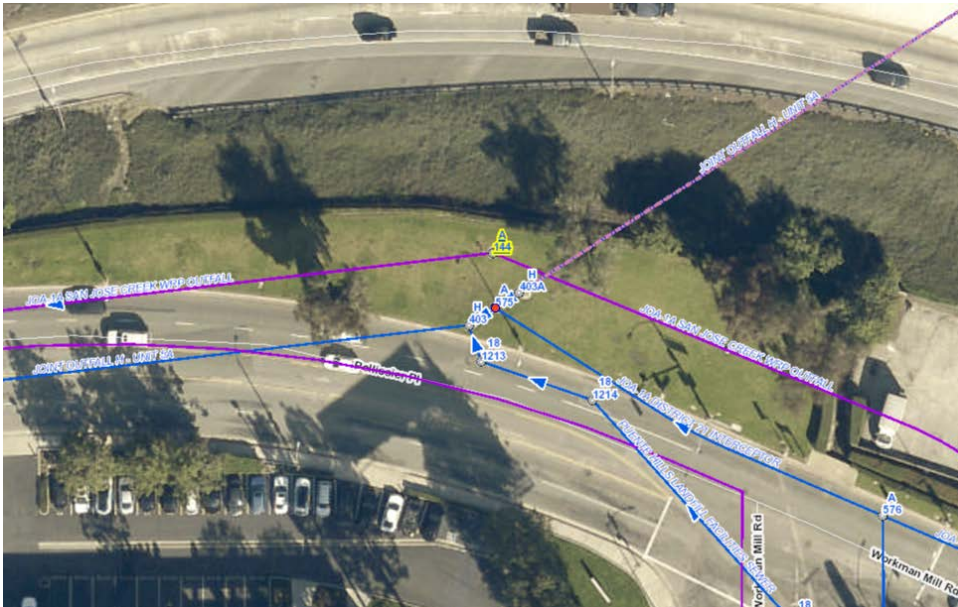
**Figure 5: GIS map closeup view of the area where the District 21 Interceptor joins J.O. 'H.'**

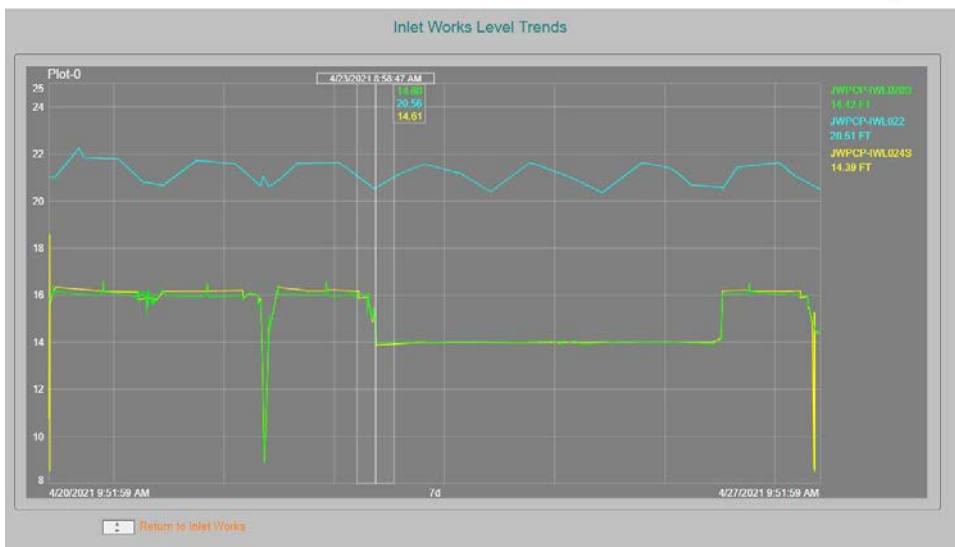
The IW investigation of the report found no likely industrial sources but did reveal that the incident was likely caused by JWPCP operators on 4-23-2021 and 4-24-2021 preparing the plant for a possible rainstorm event predicted to occur on 4-25-2021. This preparation includes lowering the influent levels in the J.O. 'A' and 'D' influent chambers by about 2' (See Figure 5), thus creating more plant capacity to handle stormwater flows that get into the sewer. This activity also causes an increase in the influent flow rate, causing line scour, which also increases the ability of influent lines to handle higher flows. However, this scouring action also results in more solids flowing into the headworks at the JWPCP. As a side note, the storm predicted to arrive on 4-25-2021 turned out to be a minor rain event.

**Figure 5: Note the green and yellow influent level trend lines which indicate operators reduced the level in the lines by about 2' at about 2100 hours on 4-23-2021 and left it there for a little more than 3 days.**

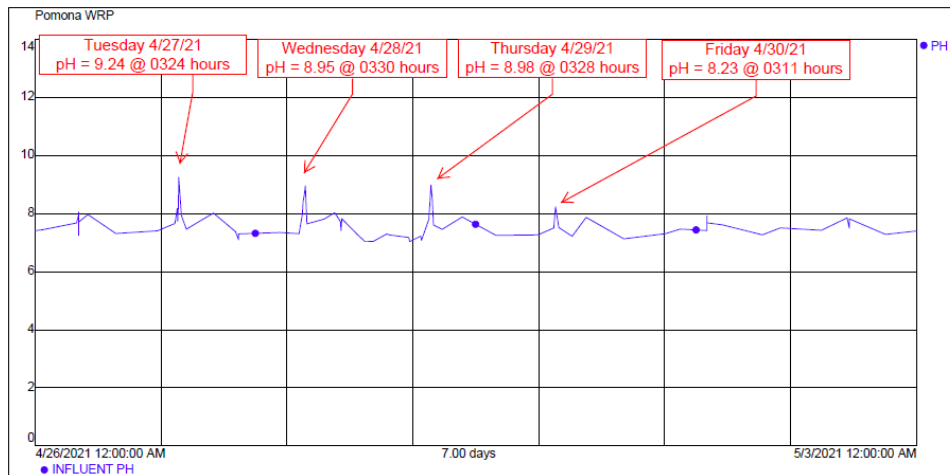
On Wednesday, 4-28-2021 at 0645 hours, Pomona WRP operators notified IW inspection staff that recently the WRP had been seeing periodic short duration spikes of elevated influent pH to about 9 between the hours of 0300-0400 during weekdays (Figure 6). The most recent incident was earlier that same day at about 0300 hours. Operators took a sample of the influent for IW Inspectors to examine or have analyzed.

**Figure 6: Pomona WRP pH trend 4-26-2021 to 5-3-2021. Note the daily high pH spikes at about 0300 hours on working days (i.e., non-weekend days).**

IW inspection staff inspected ten permitted facilities having elevated pH risks and tributary to Pomona WRP. The high pH alarm (9.02) at 0329 hours indicated a suspected operation and discharge between 0100 and 0300 hours. Ling's, a facility that makes Chinese style orange chicken entrees and has an IW permit (IW#17041) and a permitted annual average discharge of 4,200 GPD, was identified as the source of the incident.

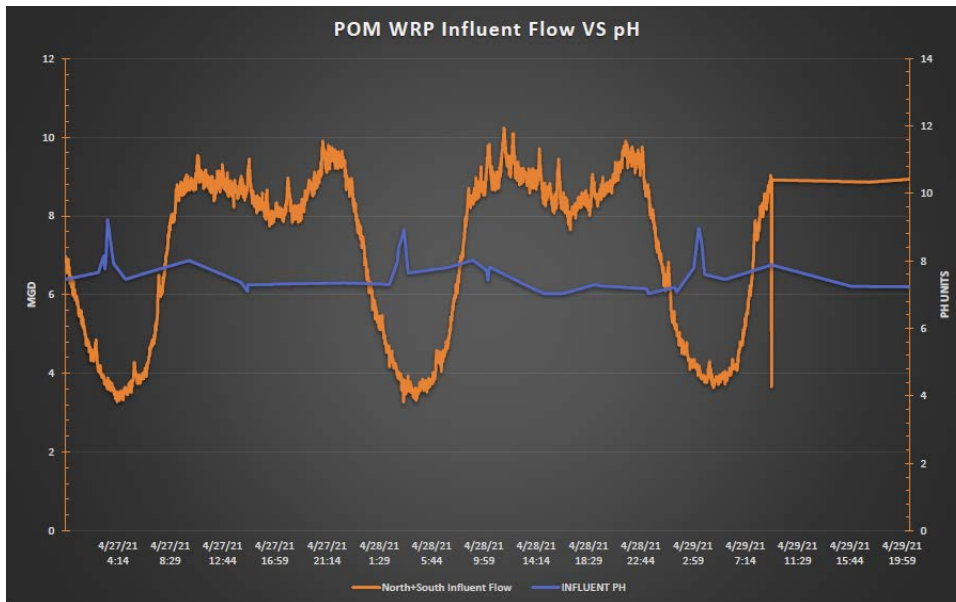
Ling's was also found responsible for a previous series of similar incidents at the WRP in September 2019. In response to the latest series of incidents, Ling's was issued a written Notice of Violation and IW Inspectors are now working with Ling's managers to try to moderate the high pH impact on the WRP by increasing the time over which the high pH wastewater is discharged. The high pH wastewater is generated from the use of highly caustic cleaners used to wash and clean four 500-gallon oil fry tanks once the oil has been removed from the tanks during their nightly graveyard sanitation shift. These discharges reach the WRP between 0300 and 0400 hours when flows into the WRP are lowest (see Figure 7) and thus the plant is least able to handle such a high pH discharge. Note that when Ling's is not in operation, there are no such elevated pH impacts on the plant.

**Figure 7: Pomona WRP 4-27-2021 to 4-29-2021 influent flow (orange trend line) vs. pH (blue trend line). Note that the high pH readings caused by Ling's coincide with the lowest flow rates each day.**

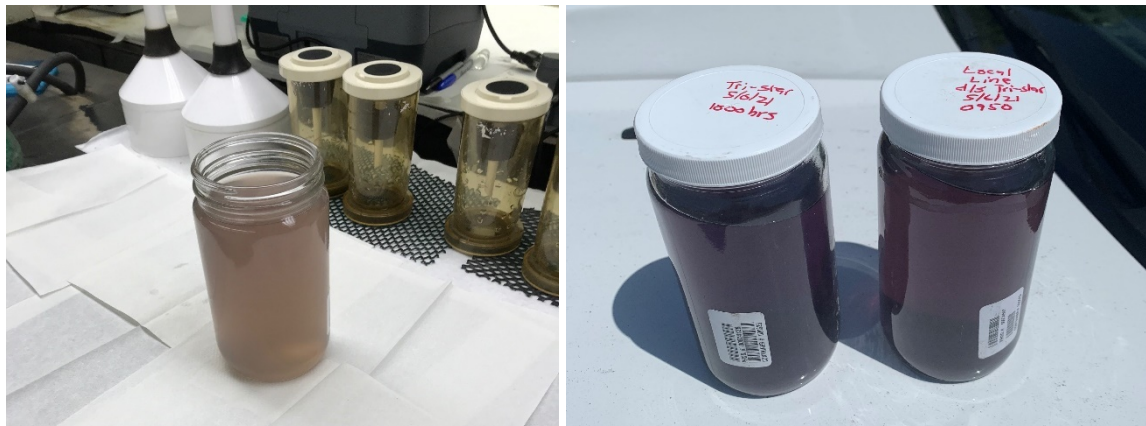
During the month of May 2021 three separate color incidents occurred at the Los Coyotes WRP in Cerritos. The incidents occurred on Thursday, 5-6-2021 (plum color); Monday, 5-10-2021 (brown or "tea" color); and Friday, 5-21-2021 (pink color). None the incidents resulted in a WRP NPDES violation. The source for all 3 incidents was identified as the Tri-Star Dyeing & Finishing facility in Santa Fe Springs. This large facility washes and dyes textiles and has been the source of several color incidents at the Los Coyotes WRP over the past year. The facility has an industrial wastewater discharge permit (#17196) and a permitted annual average discharge of 450,000 GPD.

**Figures 1 and 2: 5-6-2021 photos of the influent sample at LCWRP (left) and discharge effluent at Tri-Dye Dyeing & Finishing (right). Note the red 'plum' color in each.**

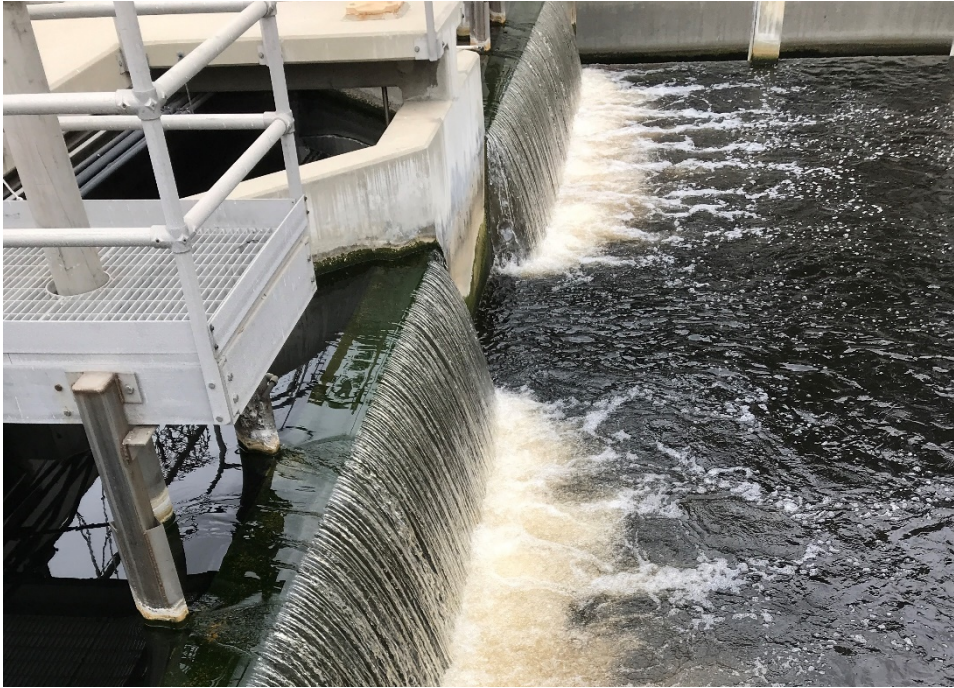
**Figure 3: LCWRP forebay on 5-10-2021 at 1000 hours. Note the brown or “tea” color.**

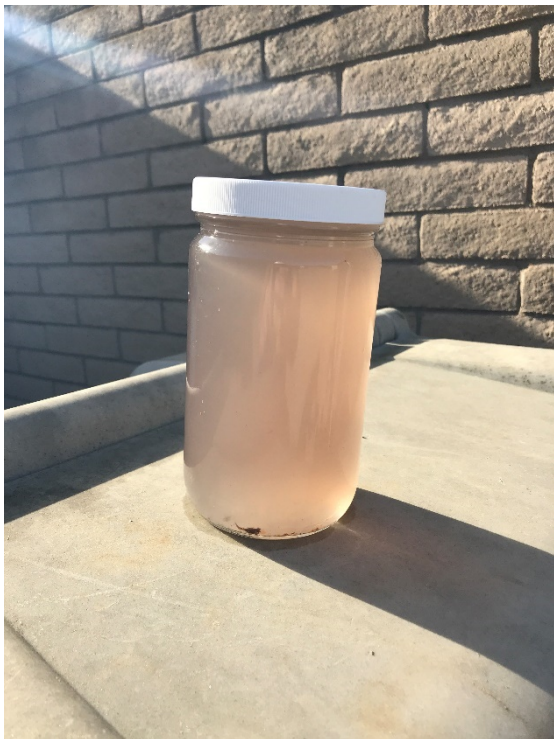
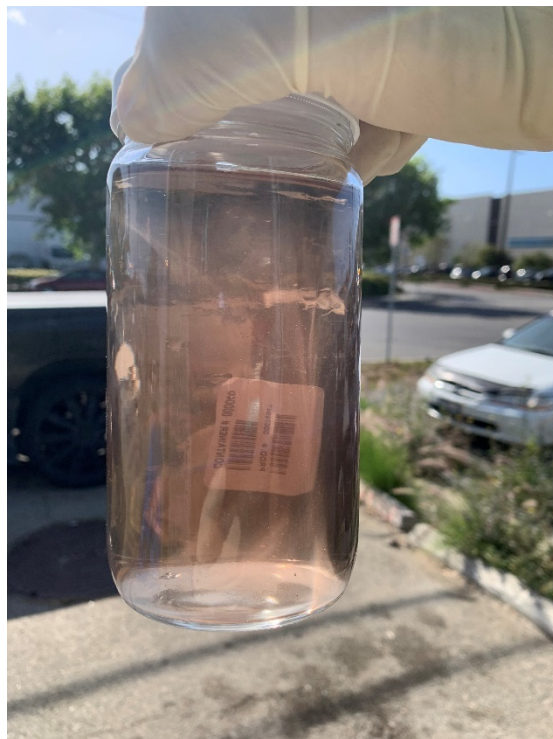
**Figures 4 and 5: Samples of influent wastewater at LCWRP (left) and effluent from Tri-Star Dyeing & Finishing (right). Note the pink color in each.**

The color at the Los Coyotes WRP occurs due to a combination of inadequate treatment to remove it by Tri-Star and reduced flowrates into the WRP that have occurred over the past year. This reduced influent rate at the WRP makes it more susceptible to this type of incident. A virtual compliance meeting with Tri-Star managers was held at 1000 hours on 5-18-2021 in which Districts’ staff emphasized the need for the facility to consistently meet the color limit of a 50:1 dilution test in which no discernable color is visible in the Tri-Star effluent. In response, the Tri-Star managers stated they will be improving their treatment system to remove color by effecting repairs to a broken valve which is causing short circuiting of their existing pretreatment

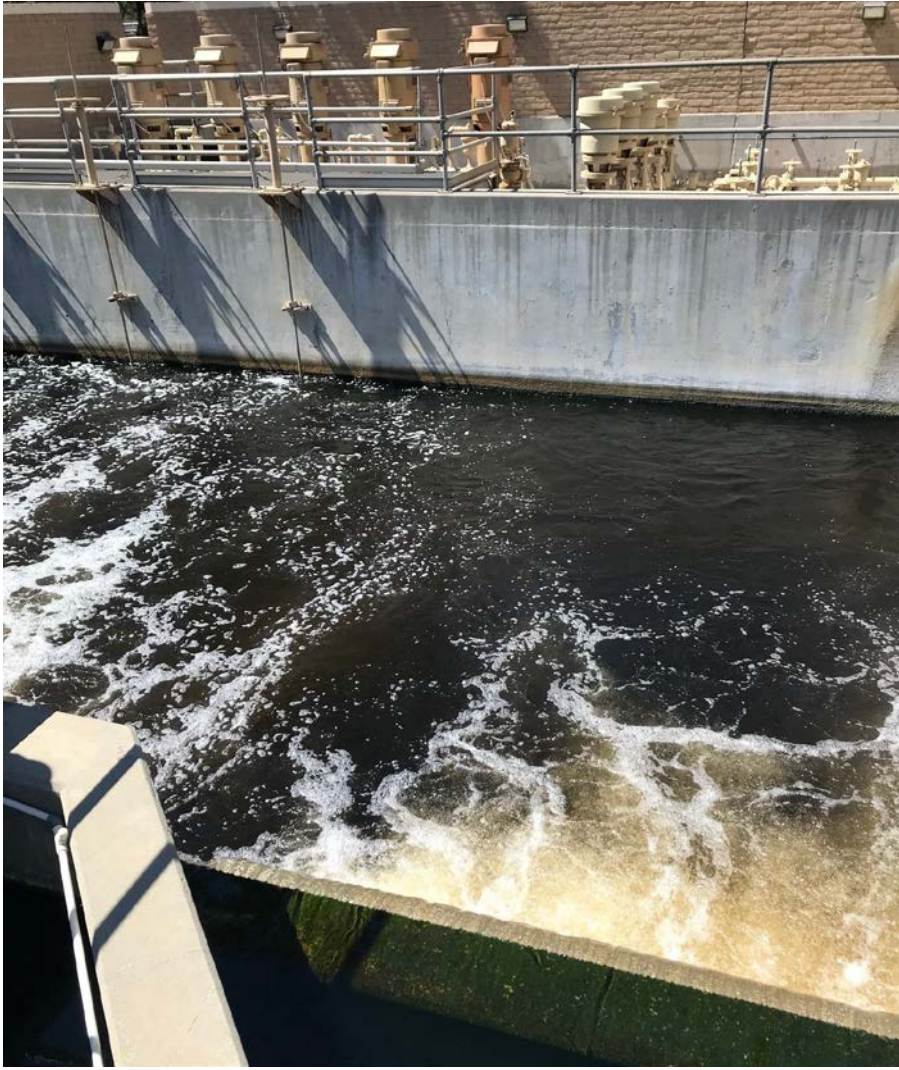
During the month of June 2021 there were two more color incidents at the Los Coyotes WRP in Cerritos. The incidents followed three in the month of May 2021, and several others earlier in the year. The latest were both light orange-brown color in the final effluent forebay and were reported at 1321 hours on Friday, 6-25-2021 and the following day, Saturday, 6-26-2021 at 0857 hours (See Figures 1 and 2 below). Neither of the incidents resulted in a WRP NPDES violation.

**Figure 1: LCWRP forebay on Friday, 6-25-2021 at 1330 hours. Note the light orange-brown color.**

Investigating IW Inspectors again identified the source for both incidents as the Tri-Star Dyeing & Finishing facility in Santa Fe Springs. This large facility washes and dyes textiles and has been the source of many color incidents at the Los Coyotes WRP over the past year. The facility has an industrial wastewater discharge permit (#17196) and a permitted annual average discharge of 450,000 GPD. The Tri-Star facility was issued written NOVs for causing the color incidents at the WRP and discharging at a flow rate above their permit limits.

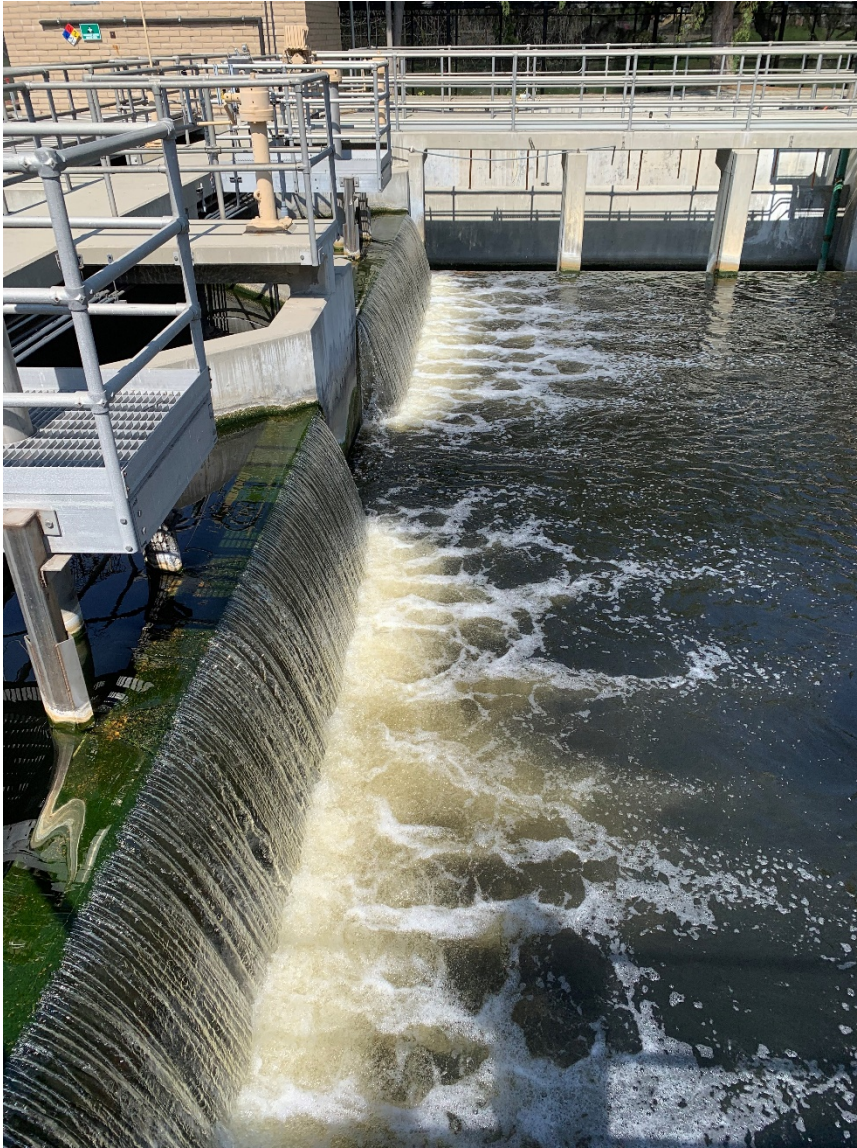
**Figure 2: LCWRP forebay on Saturday, 6-26-2021 at 0900 hours. Again, note the light orange-brown color.**

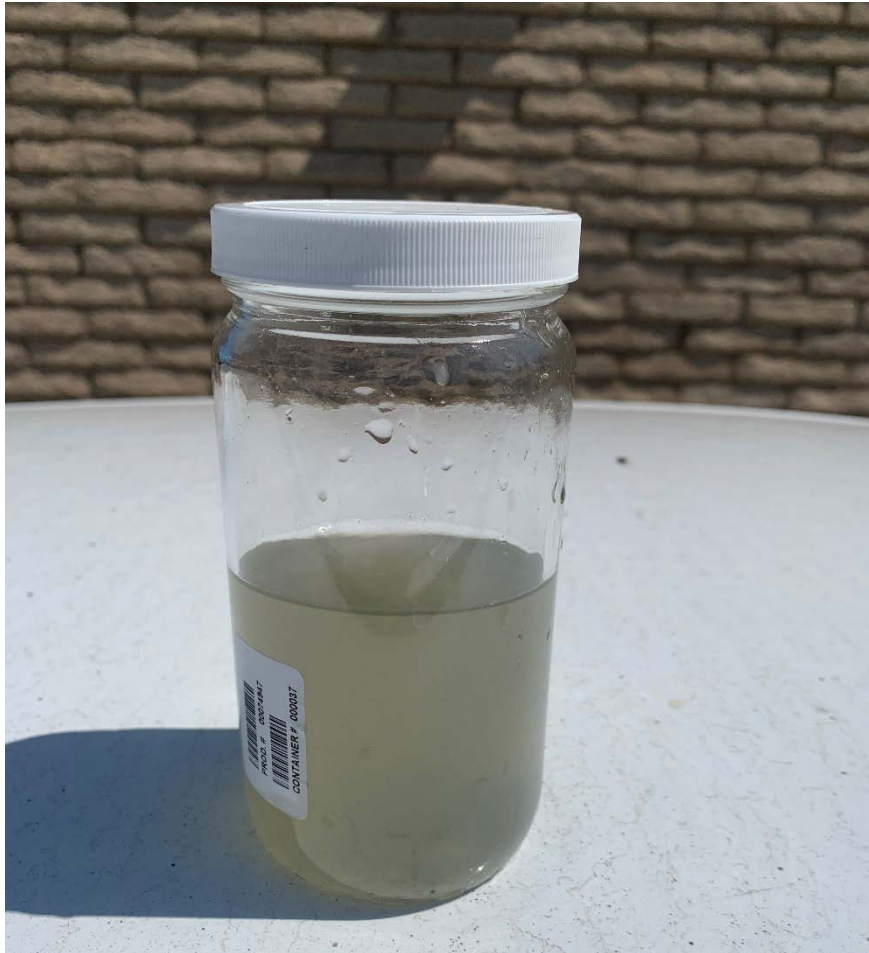
**Figure 3: LCWRP raw influent sample taken on 6-26-2021 at about 0915 hours. Note that the sample contains essentially no unusual color.**

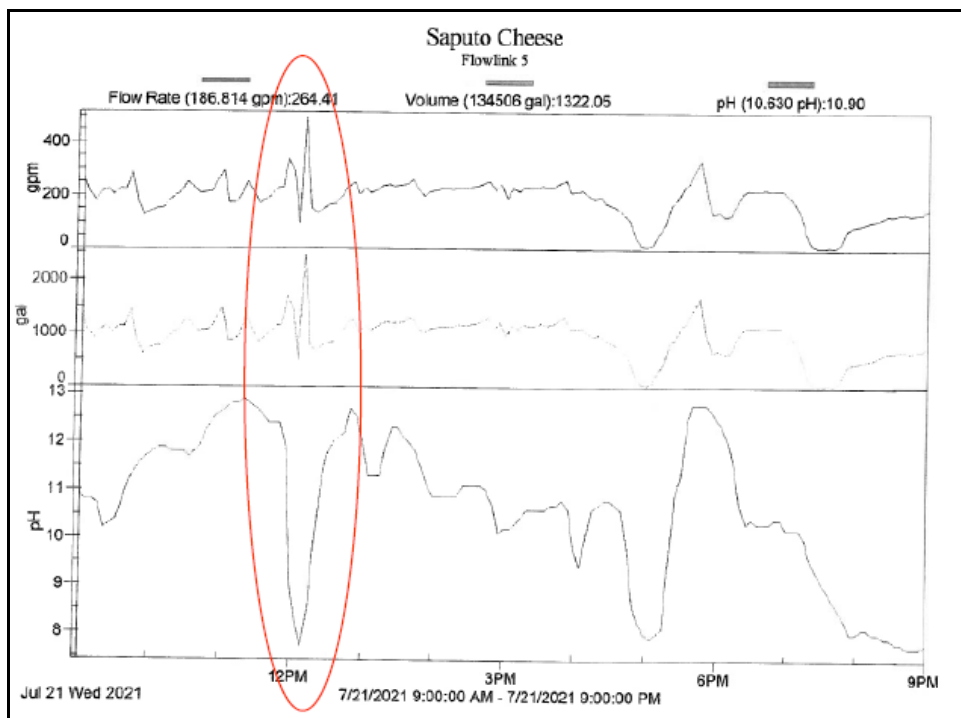
There were no known downstream negative impacts on Districts' facilities due to the spill incident, such as a sewer overflow or treatment plant upset at the JWPCP. While 1,744 gallons represents a large amount of milk, such not enough to cause a loading problem at the JWPCP. Although Saputo managers will try to prevent any future spills of this nature it was noted during the inspection that the company plans to cease onsite production of cheese by the end of calendar year 2021. They plan to move these operations to a new plant in the Central Valley of

**Figure 1: 7-21-2021 Saputo Cheese USA IW discharge flow rate and pH chart. Note the lower pH and high flowrate associated with the spill as circled in red.**

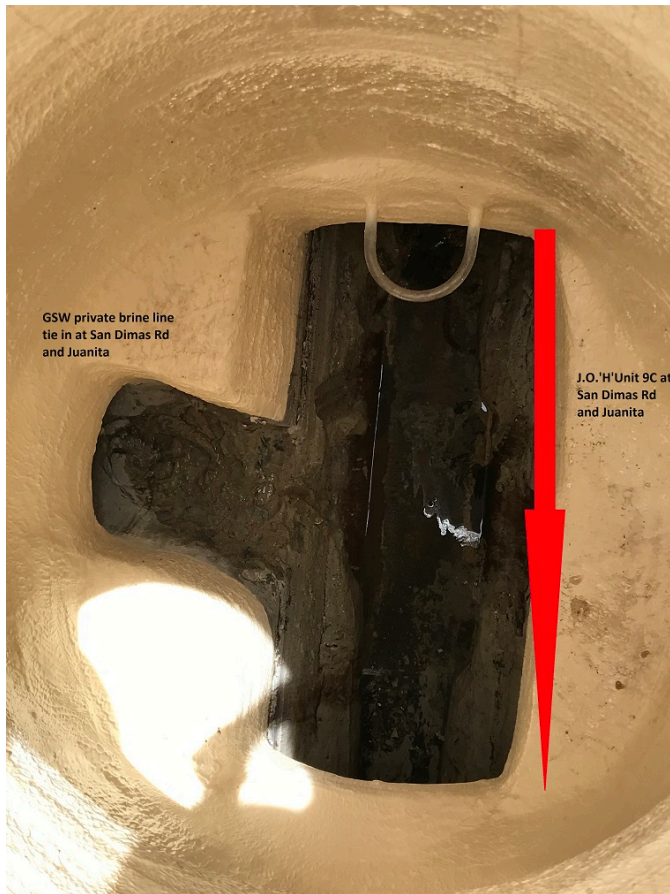
IW Inspectors inspected the manhole and Golden State Water facility on 7-26-2021. It was determined that although the sewer connection for the new private line was complete, there had yet to be any discharges from the water purveyor facility. The facility continues to haul their waste brine to the Pomona WRP Liquid Water Disposal Station. Additionally, there was no sludge observed in the new manhole structure (see Figure 2 below). The J.O. 'H' Unit 9C line at this location carries brine and filter backwash from the MWD's large Weymouth potable water treatment plant (IW#9953). When the permit was issued it was recognized that the MWD had the potential to at times discharge solids laden wastewater to the sewer which could be problematic. A permit requirement was included to hold the MWD responsible for any extra maintenance that would be needed due to this (See Figure 3 below). This facility has a permitted discharge rate of 106,700 GPD and is designed to treat 500 MGD of potable water from the Colorado River Project as well as the California State Aqueduct Product. IW Inspectors will continue to monitor the situation.

**Figure 2:** 7-26-2021 new manhole and connection to the J.O. 'H' Unit 9C trunk sewer, located at San Dimas Canyon Road and Juanita Avenue. Note the lack of solids in the line.

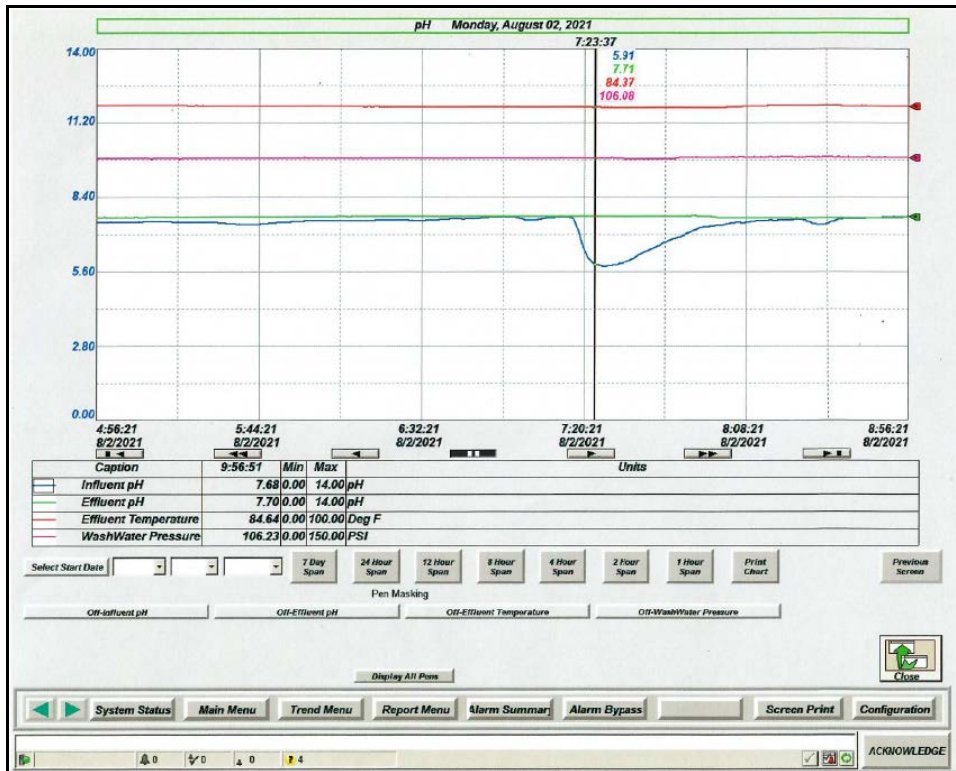
On Monday, 8-2-2021 at 0744 hours, Pomona WRP operators notified the IW Section that low pH wastewater was entering the WRP. It was stated that the influent pH was 5.87 according to the influent meter and that a sample taken to the treatment plant lab had confirmed the low pH, testing at pH=5.86. WRP operators took samples from channels 1 and 2 for IW Inspectors to pick up for possible analysis. In addition to the low pH, it was stated the influent wastewater also was orange-colored, and foamy with a "hard" possible bleach-like odor.

**Figure 1: Pomona WRP influent pH trend (blue line) on 8-2-2021 indicating the drop in influent pH reported.**

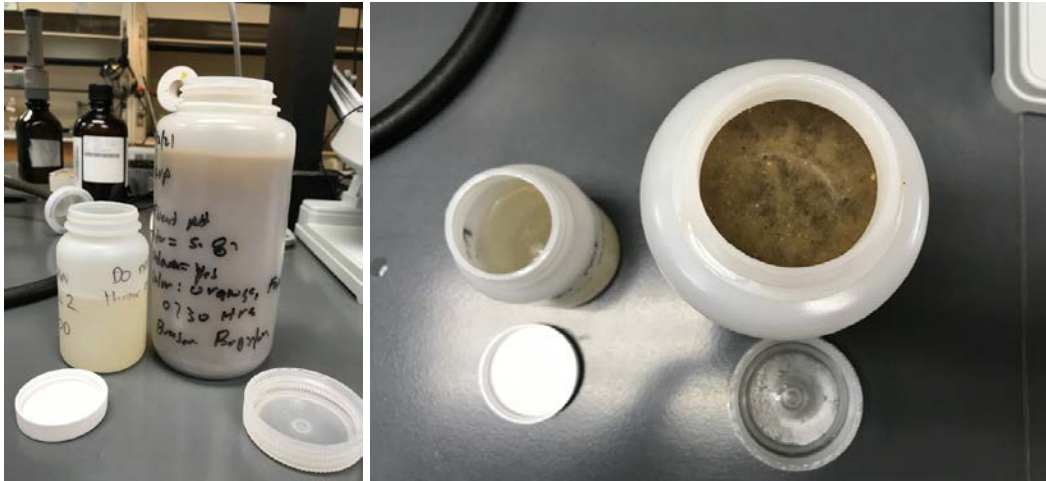
**Figures 2 and 3: Pomona WRP influent sample. Note the orange color.**

Based on WRP observations and lab results, investigating IW Inspectors decided that a food discharger or other high COD discharger was the likely source. Testing of the influent sample noted above did indicate the orange colored, low pH wastewater received during the incident was significantly elevated in chemical oxygen demand (COD) concentration. The sample taken had a COD concentration of 9242 mg/L, normal is 450-650 mg/L. While no definitive source for the incident was identified, investigating IW Inspectors found that a possible primary source, or at least contributing source, for the incident was event clean-up operations associated with the National Hot Rod Association's (NRHA) Winternationals event held at the Pomona Fairgrounds on the Weekend of July 31-August 1, 2021. The event had about 9,000 attendees. The event was delayed by the ongoing COVID-19 pandemic, thus explaining why an event that usually occurs in February was held in mid-summer. Inspectors determined that clean-up operations in the food service areas of the event and the associated wastewater discharge from that occurred in the early morning hours of Monday, 8-2-2021. Odors at the event site encountered on 8-2-2021 were of a very similar nature to that of the raw sample taken by operators at the WRP. Inspectors spoke with Fairgrounds managers to discuss ways to limit the use of cleaning chemicals and the discharge of the high-strength food residual laden wastewater from future clean-up operations.

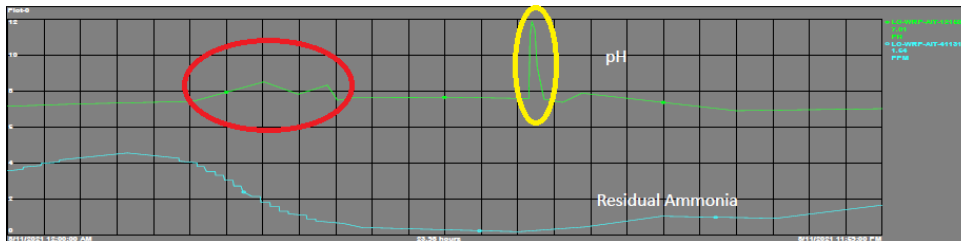
**Figure 4: LCWRP 8-11-2021 trend data showing the elevated pH reported at 0849 hours (circled in red) and pH spike from routine upstream caustic addition activity later that day (circled in yellow).**

Investigating IW Inspectors noted that the high pH incidents on 8-11-2021, 8-12-2021, and 8-24-2021 were not linked to routine caustic addition or crown spray activities upstream of the WRP because they occurred too early in the day (see Figure 4 above). However, the 8-19-2021 event was linked directly to crown spray activity.

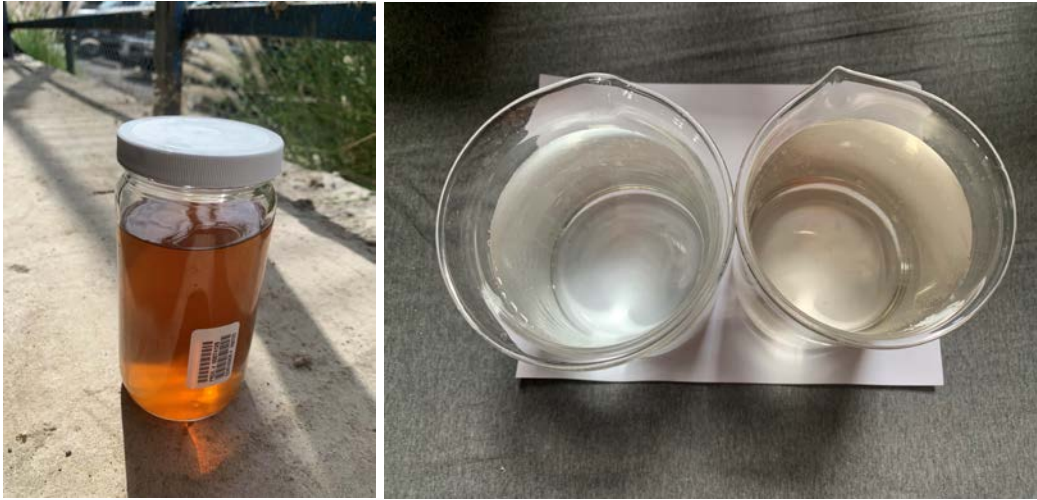
Investigating IW Inspectors again identified the source for both incidents as the Tri-Star Dyeing & Finishing facility in Santa Fe Springs. This large facility washes and dyes textiles and has been the source of many color incidents at the Los Coyotes WRP over the past year plus. The facility has an industrial wastewater discharge permit (#17196) and a permitted annual average discharge of 450,000 GPD. The Tri-Star facility was issued Notices of Violations for causing the August color incidents at the WRP.

The Tri-Star facility continues to struggle with inadequate pretreatment of their industrial wastewater discharge which causes them to violate their 50:1 color dilution limit. Compliance meetings and other meetings with Districts' industrial waste inspection and enforcement staff have emphasized the need for the facility to consistently meet the color limit. Current reduced flowrates coming into the WRP increases the WRP's susceptibility to mildly excessive color coming from the Tri-Star facility. Managers at the Tri-Star facility are aware of the issues and have hired a consultant to assist in addressing them. The company continues to attempt to improve their color removal pretreatment processes by adjusting their production operations and improving their wastewater retention times. IW Inspectors continue to monitor the situation very closely.

**Figures 5 and 6: Tri-Star Dyeing & Finishing discharge sample and sample dilution test results (fail) on 8-11-2021.**

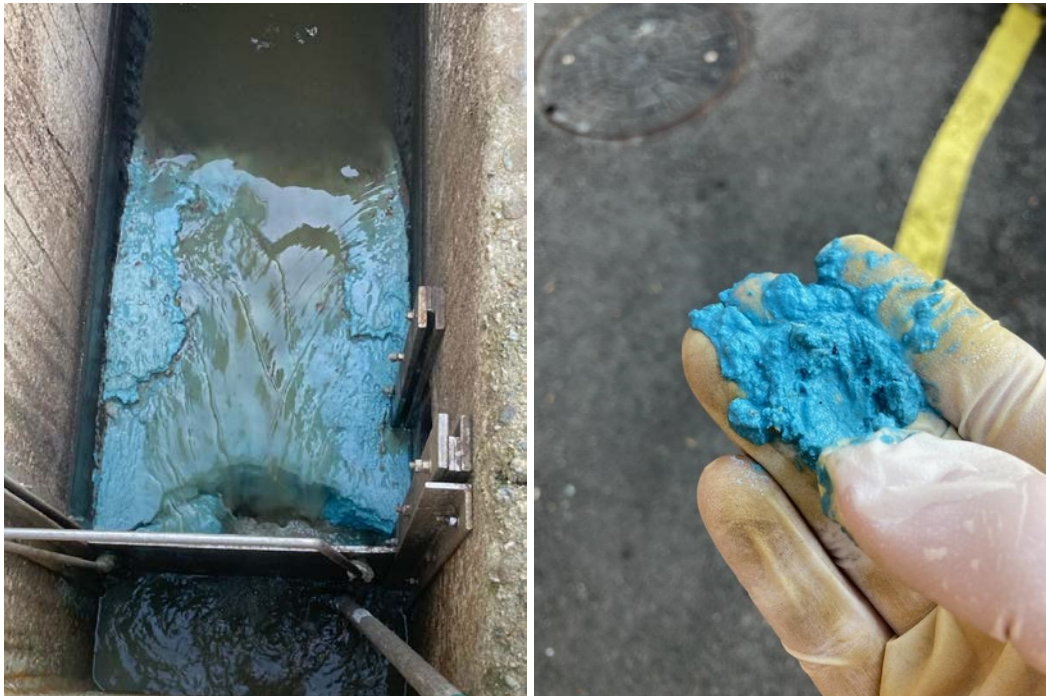
On Friday, 8-13-2021 at 0735 hours, WRP operations staff reported to the IW Section that there was a blue-colored clay like material in the raw channel at the La Cañada WRP (see Figures 7 and 8 below). The blue color solids could have come in anytime in the previous 24 hours. The raw influent pH was 8.7, somewhat elevated, as the normal influent pH is 7.4.

**Figures 7 and 8: The blue solids present in the influent channel at the La Cañada WRP on 8-13-2021.**

The blue solids were identified through laboratory FT-IR analysis as drywall joint compound. Although a specific source was not found, it was likely from a home construction or a similar residential project. The surrounding neighborhood was canvassed the day the material was discovered, but no major construction projects were observed. The lone industrial wastewater source influent to the WRP, the La Cañada Flintridge Country Club, was also inspected, but was determined not to be the source. The area IW Inspector will continue to periodically canvas upstream residential neighborhoods in search for signs of illegal dumping.

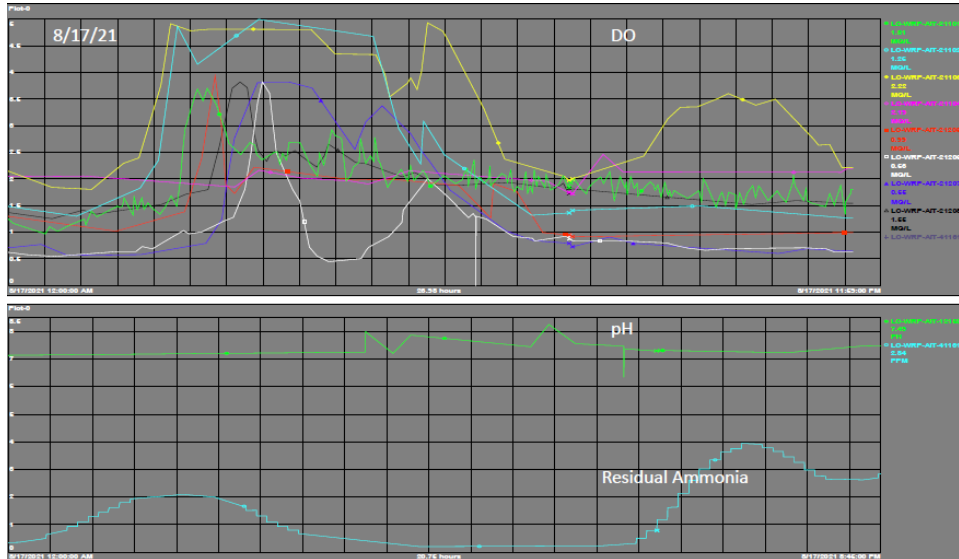
On Tuesday, 8-17-2021 at 1240 hours, Los Coyotes WRP operators reported to the IW Section that the WRP experienced a spike in the ammonia concentration in the secondary effluent at 0330 hours earlier that morning. Operators stated the plant was operating at about 20 MGD and had full capacity of airflow available. Additionally, it was noted that the secondary tank dissolved oxygen concentrations dropped prior to the ammonia concentration spiking, probably indicating that some high strength wastewater entered the plant at about midnight hours to 0100 hours.

**Figures 9 and 10: LCWRP trend data for 8-17-21, including that for influent pH (green trench line on the bottom graph), secondary effluent ammonia concentration (blue trend line of the bottom graph) and secondary aeration tank dissolved oxygen concentration (yellow trend line on the top graph).**

Investigating day and night Team IW Inspectors did not identify a source for the incident despite inspecting 14 large industrial facilities. They did note that the WRP trend data for the 5 days preceding 8-17-2021 also showed similar trends for the dissolved oxygen concentration and residual ammonia concentration levels. Industrial waste Inspectors continue to monitor upstream dischargers that may pose a risk to the WRP.

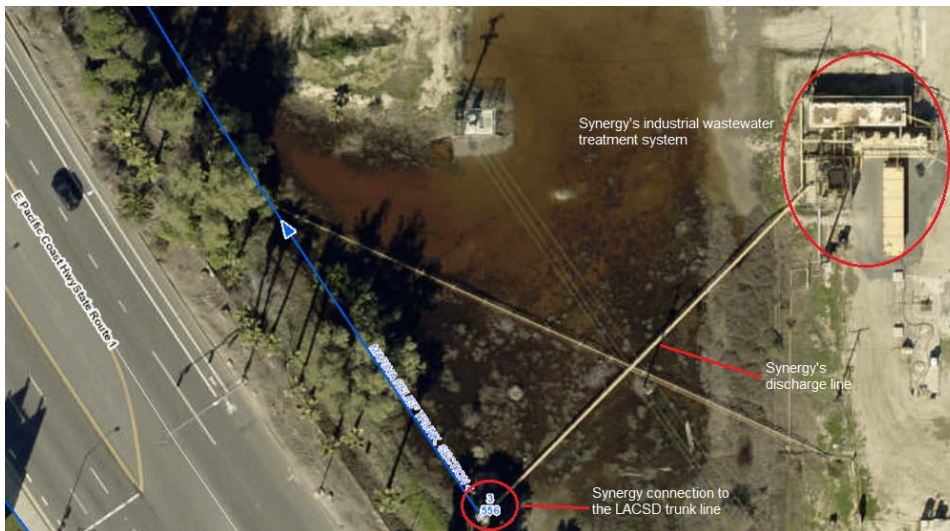
On Friday, 8-27-2021 at 1158 hours, the IW Section received a call from Districts' Wastewater Collection Section (WCS) personnel who reported that at Manhole (MH) MH 03 0556 in Long Beach they had just noticed an approximately 6" wide hole in the ground in which the sound of water flowing could be heard, along with the oily brine odor characteristic of oil production field brine, emanating from the hole. The hole is in the small (1' wide) space between the MH 0556 cover and the 8" vertical pipe that carries the IW discharge from Synergy down into the Districts' 15" diameter Marina Relief Trunk Section 4 trunk sewer where it connects directly to the trunk line manhole riser (see Figure 11). The Synergy facility is a large oil production field which holds IW discharge permit (#21422). Synergy has about 50 operating oil wells at this site and discharges 493,000 GPD of treated brine at a typical rate of 400 gpm. Note that there is no other wastewater, other than that from Synergy, present in the flow at MH 0556 (See figure 12).

**Figure 12: GIS diagram showing the 8" diameter above ground line that runs from Synergy's industrial wastewater treatment system to its connection to the sewer at MH 03 0556.**

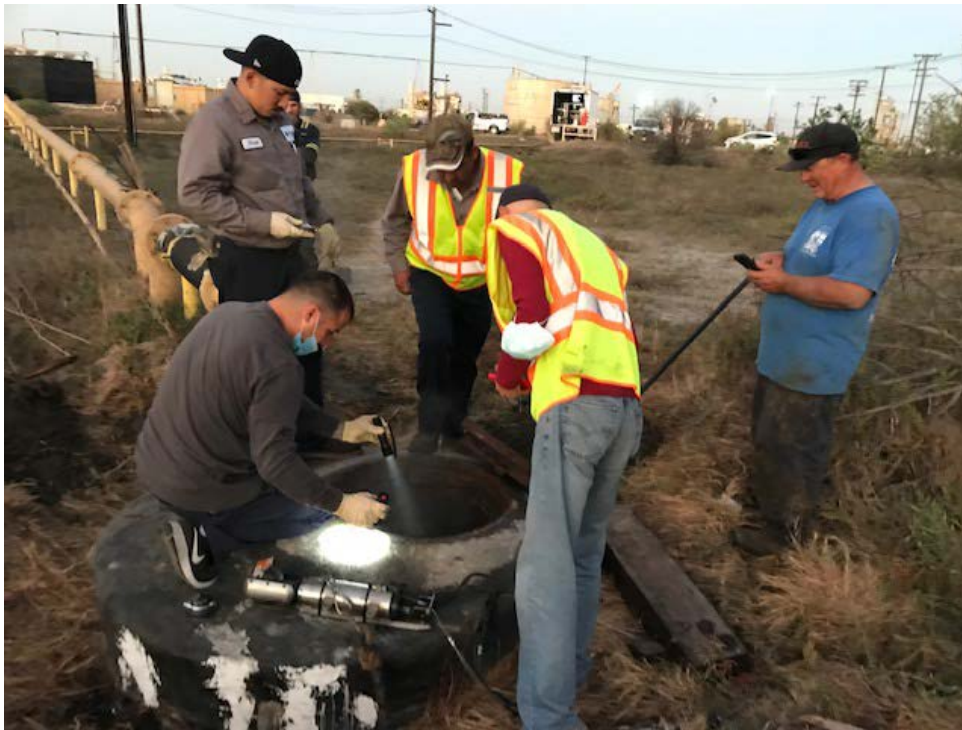
There was concern the sound of flowing water and the odor present may indicate failure of the connection between the Synergy pipe and the manhole riser resulting in the solids underneath washing out. The area under the hole will require excavation to assess the situation. It was initially thought the excavation could wait until Monday, 8-30-2021. However, upon re-evaluation and conversation between IW Inspectors and WCS Managers, and in an abundance of caution, that excavation was carried out immediately during the afternoon and evening of 8-27-2021. To accommodate the need for no ongoing flow at the manhole when the excavation work was done, Synergy facility managers were contacted and agreed to cease the discharge

**Figure 13: WCS personnel examining MH 03 0556 on 8-13-2021. Note the above ground 8" diameter Synergy IW discharge line in the background.**

IW Inspectors were on-site with WCS and Synergy personnel when it was confirmed there was a hole in the Synergy discharge pipe about 18" below grade with some minor soil removal having occurred. The 2" x ½" hole in the line was repaired by Synergy workers, who used EPDM expansion tape and concrete to encase the spot-repair from about 12 inches below and 12 inches above the hole. Final repairs will likely require further work in the future to replace the Synergy line, which was severely corroded, as well as reconstruction of the connection to the MH 556 manhole riser. Also left to be completed is cleaning of the trunk line from MH 03 556 to MH 03 0554 to accommodate CCTV of those two reaches of trunk sewer to assess line condition. IW discharge to the sewer at MH 03 0556 from Synergy resumed at 1000 hours on Saturday, 8-14-2021. IW Inspectors will continue to work closely with WCS and Synergy staff to coordinate the needed future work.

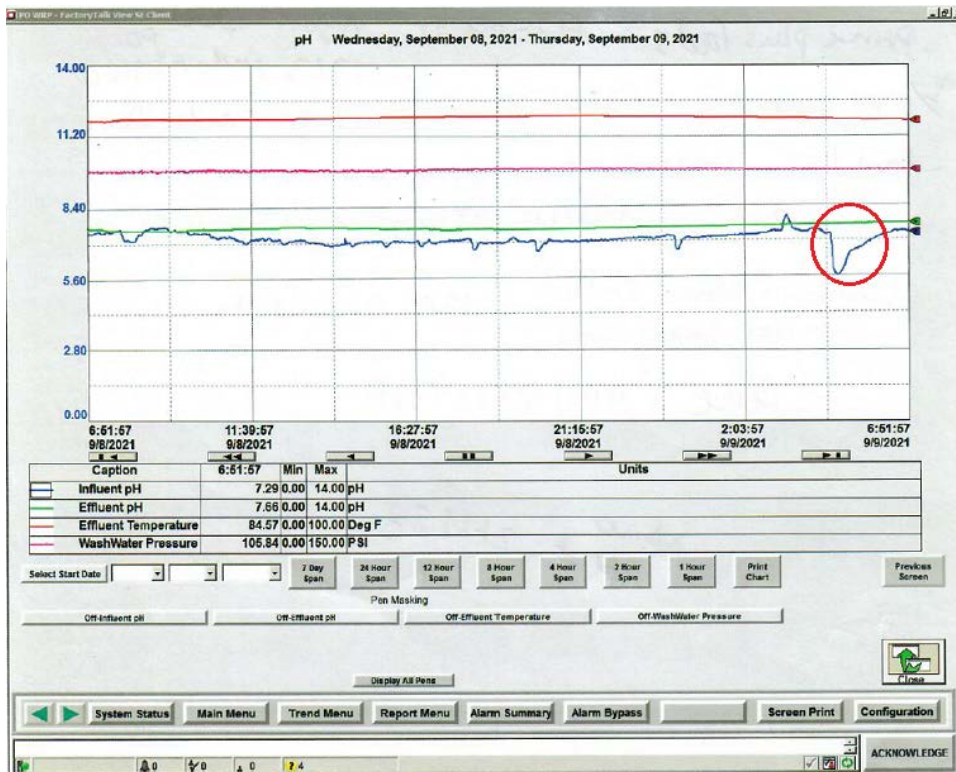
On Thursday, 9-9-2021 at 0514 hours, Pomona WRP Operators notified the IW Section that low pH wastewater was entering the WRP. It was stated that the influent pH was 5.62 according to the influent meter and that a sample taken to the treatment plant lab had confirmed the low pH, testing at pH=5.6. Operators took samples from channels 1 and 2 for IW Inspectors to pick up for possible analysis (see Figure 4 below). In addition to the low pH, the operators stated the influent wastewater also appeared to contain "white chunky" material (see Figure 5).

**Figure 3: Pomona WRP influent pH trend (blue line) for 0700 hours on 9-8-2021 to 0700 hours on 9-9-2021. Note low pH dip at about 0430 hours on 9-8-2021.**

Investigating IW Inspectors were unable to determine a source for this incident. The low pH influent was of a short time duration, only about an hour or less (See Figure 3 above). Fortunately, WRP operations and effluent quality were not adversely affected by the incident. Subsequent analysis of the raw influent sample and the unusual white solids it contained, revealed the solids to be *calcium dirincinoate*, a non-toxic compound derived from castor oil that is also known as Ricinoleic Acid Calcium Salt. This substance has anti-fungal, anti-bacterial, and anti-viral properties, and is used in many anti-fungal creams. Investigating IW Inspectors inspected pharmaceutical manufacturing facilities in the Pomona WRP influent area but have not identified any facilities using this material. Inspectors continue to investigate the incident.

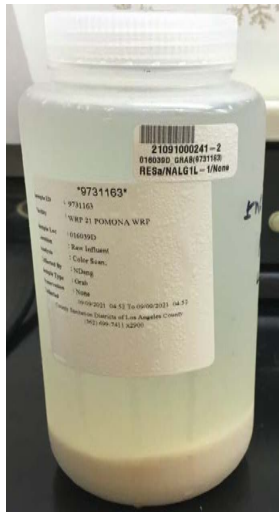
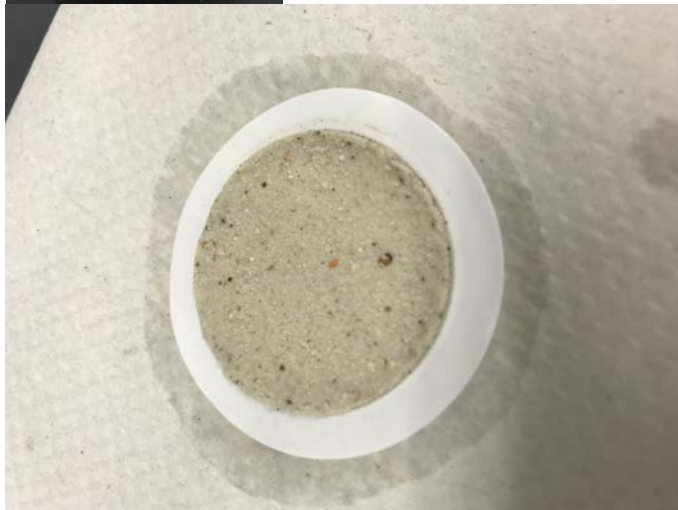
**Figures 4 and 5: On the left is a raw influent sample taken on 9-9-2021 at 0452 hours. Note the unusual fine white *calcium dirincinoate* solids that settled out. On the right is a top view of the solids after they were filtered out from the influent sample.**
