**2021 ANNUAL REPORT**

INDUSTRIAL WASTE PRETREATMENT PROGRAM

LOS ANGELES COUNTY SANITATION DISTRICTS

**APPENDIX H**  
INDUSTRIAL WASTE REPORTS ON INCIDENTS

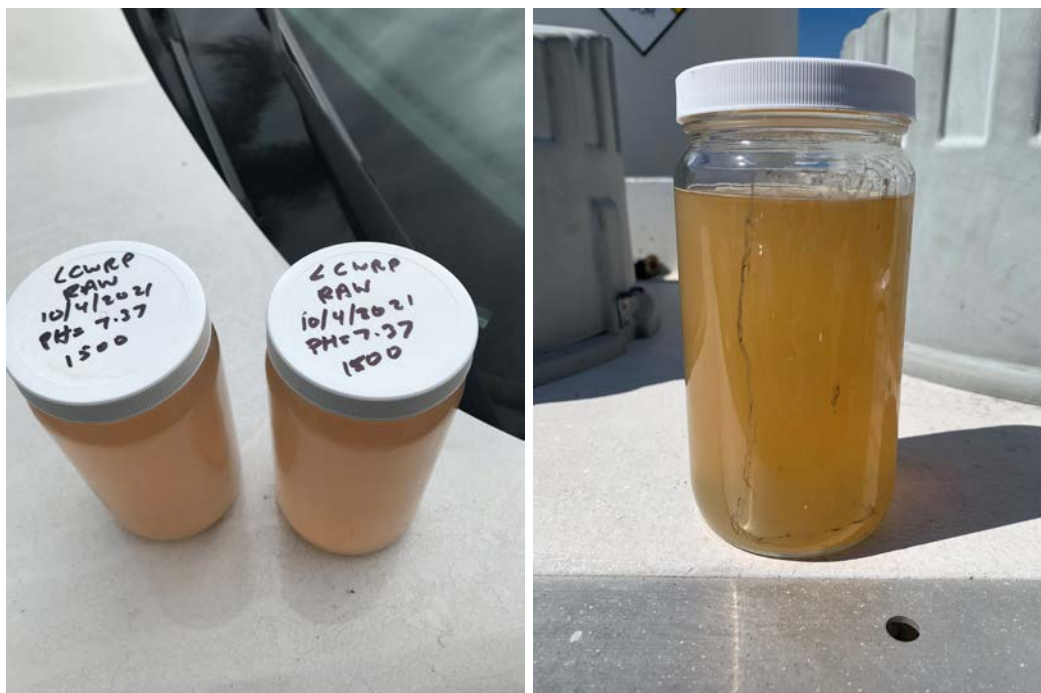
1. On Monday, 10-4-2021 at 1500 hours, operators reported that the WRP influent was orange at the influent pH monitoring station.
2. On Sunday, 10-10-2021 at 0900 hours, operators reported the WRP influent was blue.
3. On Thursday, 10-14-2021 at 0700 hours, operators reported that the WRP influent was blue at the influent pH monitoring station.
4. On Thursday, 10-21-2021 at 0815 hours, operators reported that the influent was purple at the influent pH monitoring station.

**Figures 1 and 2: 10-4-2021 Los Coyotes WRP grab samples and a sample picked up from Shaw Diversified Services on 10-5-2021. Note the color match.**

IW Inspectors from both day and night teams investigated these incidents. They found that the two usual suspects for excessively colored influent to the LCWRP, carpet manufacturer Shaw Diversified Services, Inc. and textile dyehouse Tri-Star Dyeing and Finishing, both of which are located in Santa Fe Springs and which discharge 600,000 gpd and 450,000 gpd of industrial wastewater respectively, were responsible for causing all four incidents. Of note was that Shaw caused only the incident on the 4th and this was due to an equipment failure in their pretreatment system which caused a failure to remove the orange color from their effluent. Tri-Star was the source for the other three incidents with these last three representing only the most recent of many such incidents caused by this facility over the past year. Tri-Star has continued to cause these incidents despite many issuances of notices of violation as well as the holding of compliance meetings called by the Districts. The facility is apparently unwilling to adequately address their failures to meet the 50:1 color dilution limit that is in place. Notices of violation were issued to both Shaw and Tri-Star for causing the color incidents and/or violating their effluent color dilution limits.

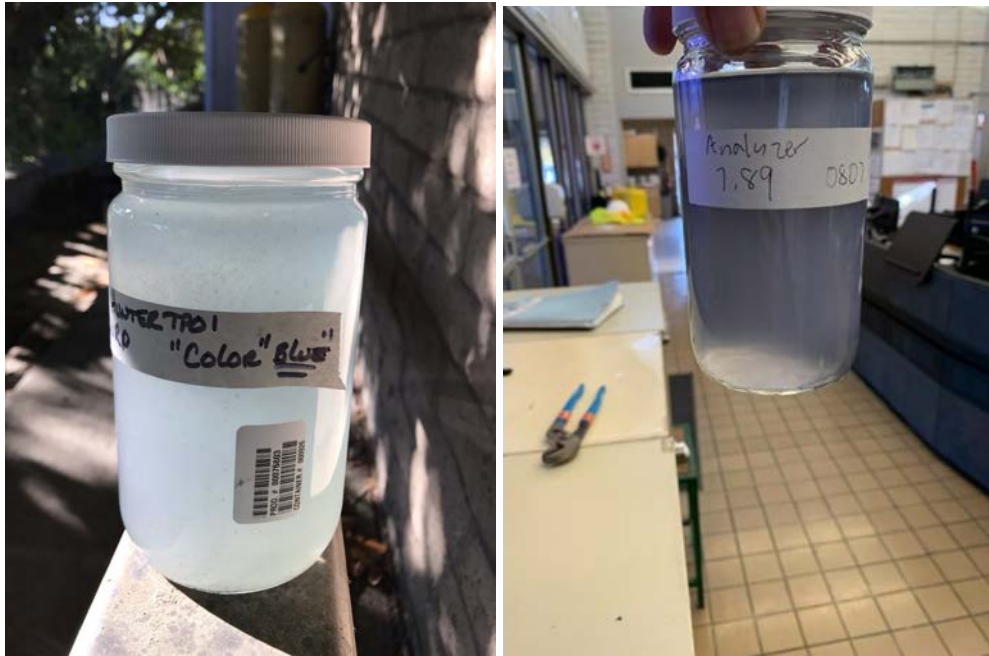
**Figures 3 and 4: Los Coyotes WRP raw influent samples taken on 10-10-2021 and 10-21-2021, respectively showing the blue and purple colors reported on those days.**

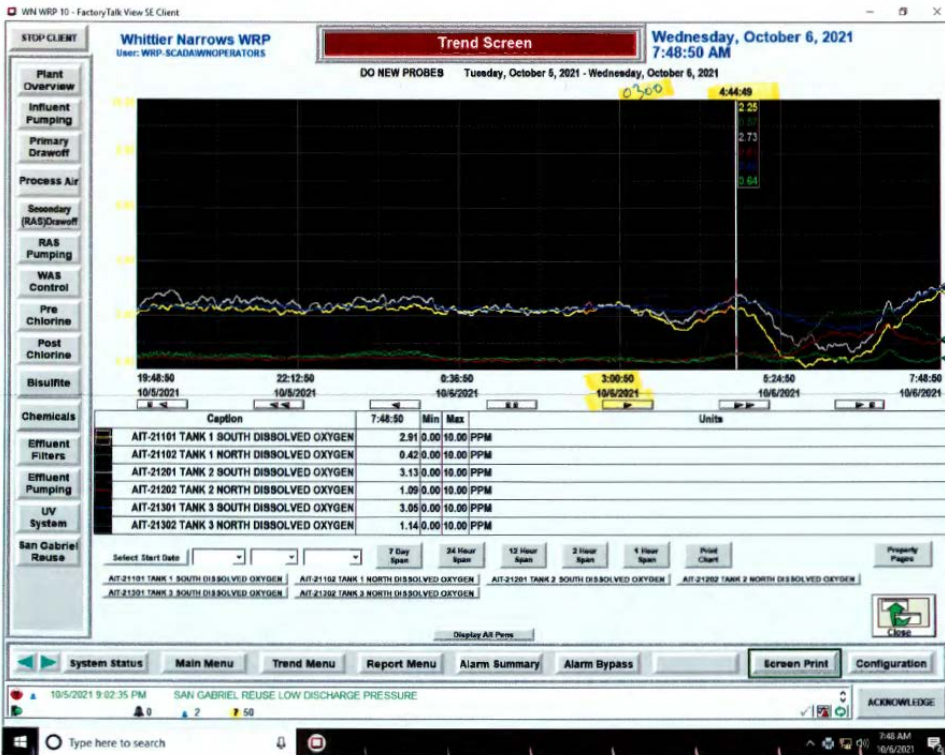
On Tuesday, 10-6-2021 at 0720 hours, Whittier Narrows WRP operators informed IW Inspectors that a low dissolved oxygen (D.O.) condition in the aeration tanks had just occurred. Operators indicated that the plant was slowly recovering at the time of the call. The low D.O. period began at 0500 hours and stayed below 1 mg/L for about 2 hours (see Figure 5 below).

**Figure 5: Whittier Narrows WRP aeration tank dissolved oxygen trend data for 10-6-2021. Note the drop off that started at 0445 hours and lasted about 2 hours.**

IW Inspectors investigated both reports and were unable to determine a likely source. Possible sources included both the Thrifty Ice Cream and United Site Services facilities in El Monte, as well as other known industrial facilities with the potential to discharge high strength wastewater. A total of 24 industrial facilities were inspected as part of the investigation. IW Inspectors continue to be vigilant to possible sources for these incidents.

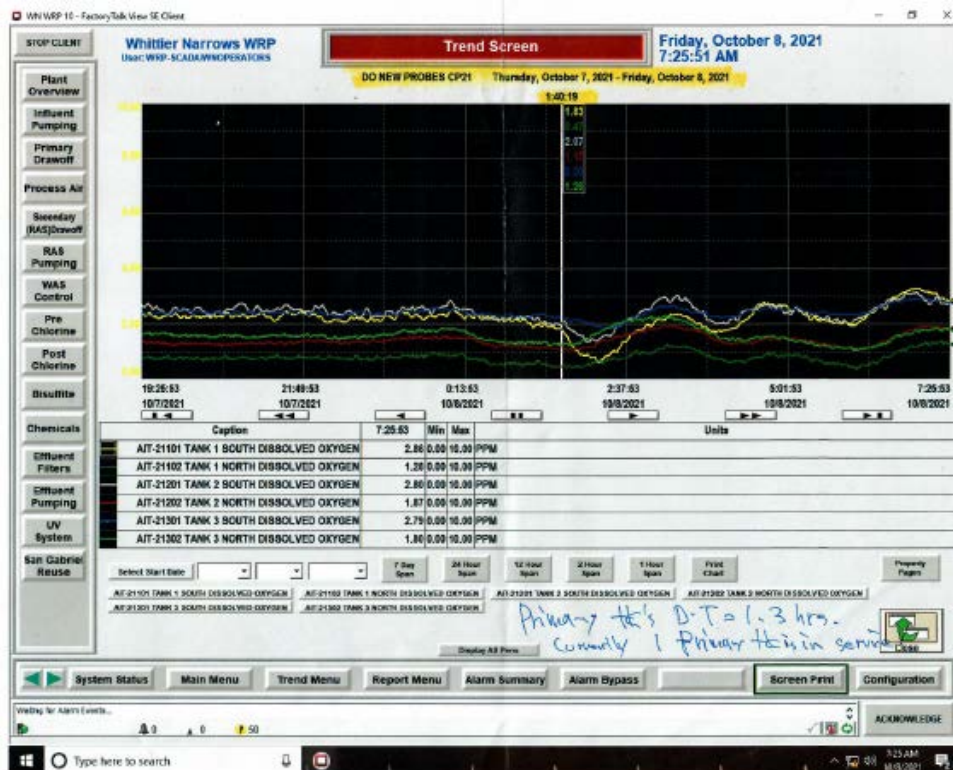
On Friday, 10-8-2021 at 0729 hours, WNWRP operators again reported to IW Inspectors that upon arrival at the WNWRP that morning at 0700 hours they noted on the plant data trend charts that the dissolved oxygen levels in the aeration tanks had dropped earlier that morning at 0137 hours for an approximate 30 minute period before they returned to normal. Other than the drop in D.O. noted, the WRP was running well. Additionally, operators stated that the aeration tanks looked normal during rounds at 0700 hours and there was nothing else unusual evident such as a pH levels, color in the wastewater, or the presence of unusual odors. The information was referred to Team 1 and Team 4 IW Inspectors as part of the ongoing investigation of the initial low D.O. incident reported on 10-6-2021.

**Figure 6: Whittier Narrows WRP aeration tank dissolved oxygen trend data for 10-8-2021.**

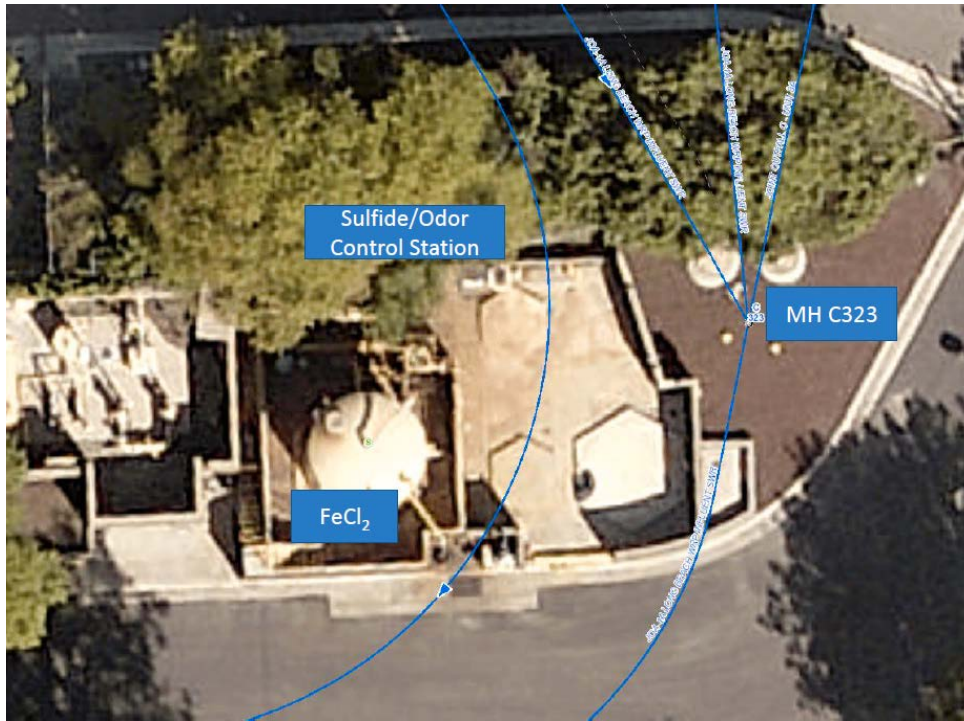
Night Team IW Inspectors were just on shift immediately responded to the report. After inspecting the influent sewers to the WRP it was determined that the faint green color in the secondary clarifiers, as well as rust-orange colored floating mats in the effluent filters and effluent forebay, were caused by a leak of ferrous chloride from the odor control station. The leak of ferrous chloride solution was found to be entering the WRP influent sewer at manhole C-323 from a drain located at the sulfide odor control station (see Figure 7). The Compton Field Office was notified of the finding at 1600 hours and they dispatched a technician immediately who shut off the ferrous chloride dosing pumps, stopping the leak.

**Figure 7: Districts' GIS screen grab photo showing the ferrous chloride addition system at the Long Beach WRP odor control station.**

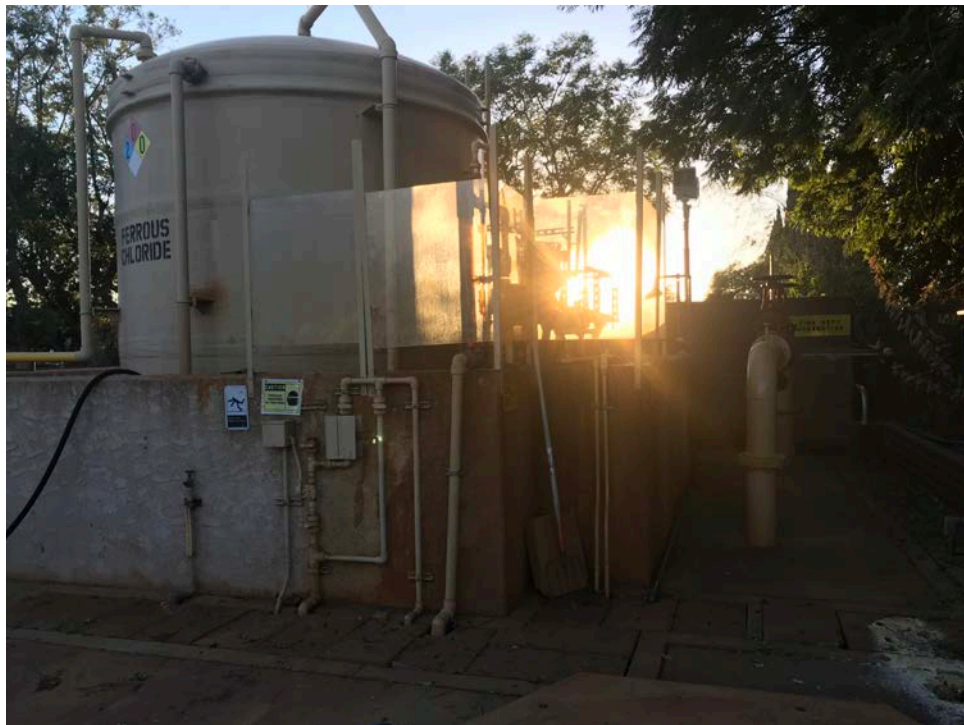
**Figure 8: 10-13-2021 photo of the ferrous chloride addition system at the Long Beach WRP odor control station.**

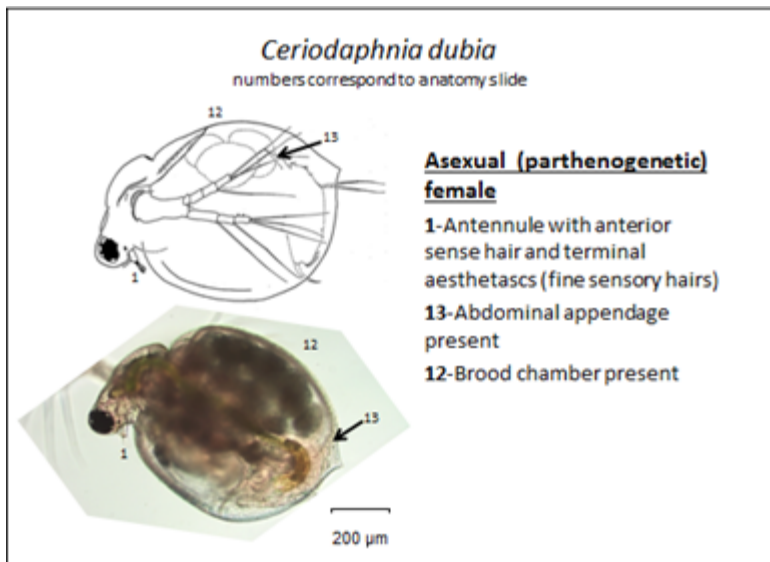
**Figure 12: *Ceriodaphnia dubia***

On Wednesday, 10-27-2021 at 1525 hours, the Districts' San Jose Creek Water Quality Laboratory notified the IW Section that a final effluent 24-hour composite sample taken at the San Jose Creek-East WRP on October 10-11, 2021 from 0700-0700 hours had shown a very high toxicity level, causing 100 percent lethality in the *Ceriodaphnia dubia* ("water flea") test organisms. The lab said they had sent the sample to be further analyzed for pesticides and metals. Preliminary results from the pesticide scan showed the pesticide dichlorvos was present at a concentration  $>300$  ng/L. It was stated that the Districts' Research Section indicated this pesticide had never been found previously in any other Districts' water reclamation plant final effluent samples. It was added that there was a small amount of Azoxystrobin (~50 ng/L) pesticide present in the sample, stating the concentration for that compound is usually found at a concentration of non-detect ( $<10$  ng/l) to 15 ng/L. Lastly, it was stated that similar samples were collected on 10/8-10/9/2021 and 10/9-10/10/2021 at SJC-East WRP, and those samples had no toxicity. It is noted that despite the presence of the pesticides in the final effluent the treatment plant processes at the WRP were otherwise unaffected. The lab asked if the IW Section could shed any light on possible sources for the pesticides detected.

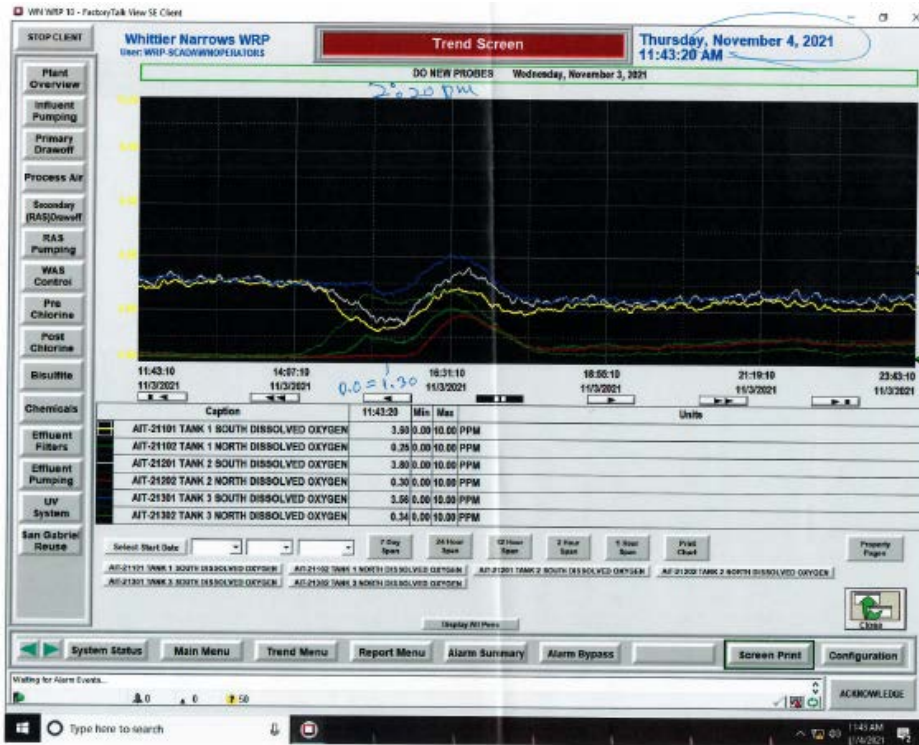
On Wednesday, 11-3-2021 at 1459 hours, and again on Friday, 11-5-2021 at 0703 hours, Whittier Narrows operators notified IW Section staff that they had noticed significant drops in the secondary aeration tank dissolved oxygen concentration values. WRP operators report the episodes typically last around 2 hours and operators increase the process air compressors (PACs or "blowers") from 10,000 cfm to their maximum output of 12,000 cfm to effectively address the issue. It was noted that all other influent parameters such as pH, odor, and color were normal. Samples of the raw influent were collected for possible analysis.

Figure 3: Annotated WNWRP D.O. trend chart for 11-3 1143 hours to 11-3 2343 hours. This shows the incident reported on 11-3 at 1459 hours.

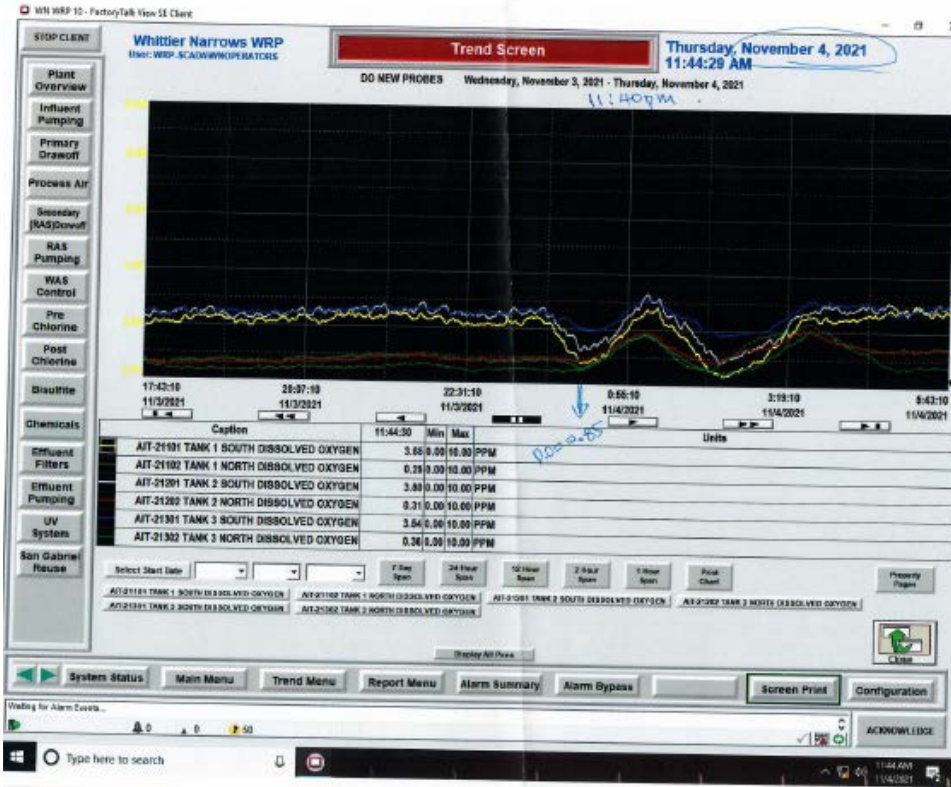
Figure 4: Annotated WNWRP D.O. trend chart for 11-3 1743 hours to 11-4 0543 hours. This shows two 11-4 incidents at midnight and 0200 hours.

These incidents are very similar to a recent incident that occurred on 10-6-2021 at WNWRP. It was noted that there had been other similar drop offs that occurred on 11-4-2021 during the early a.m. hours around midnight and 0200 hours, and then again from 1536-1720 hours.

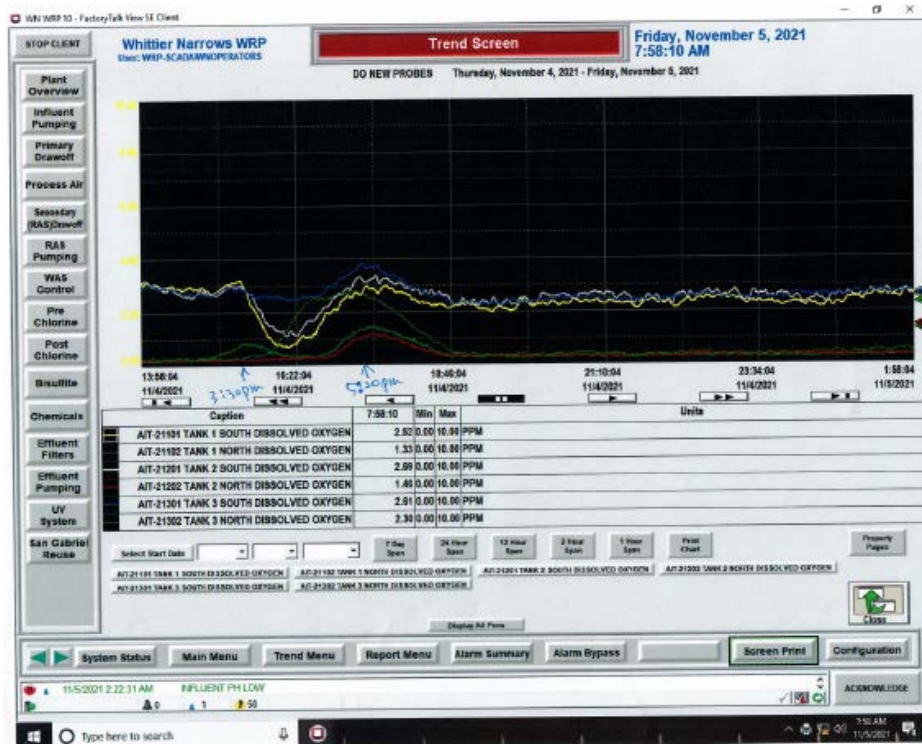
Figure 5: Annotated WNWRP D.O. trend chart for 11-4 1400 hours to 11-5 0200 hours. This shows the 11-4 at 1530 hours incident.

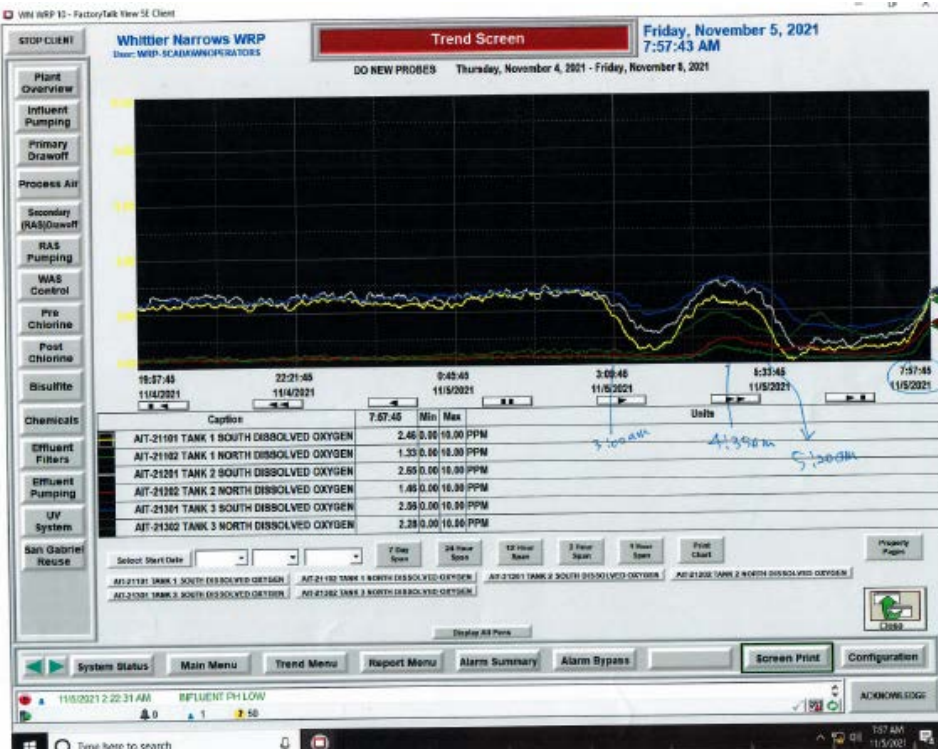
**Figure 6: Annotated WNWRP D.O. trend chart for 11/4 1800 hours to 11/5 0800 hours. This shows incidents on 11/5 at 0300 and 0520 hours.**

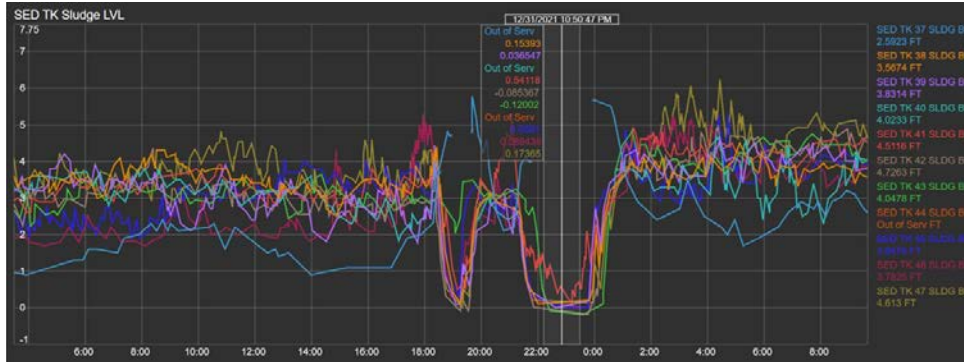
On Monday, 1-3-2022, IW Inspectors responded to the report. The sample taken on 12-31-2021 was observed and found to be runny, rather clean looking, and not having any petroleum characteristics (see Figure 3 below). It didn't look like the black solids observed previously during similar high-level incidents in the E-3 primary tanks, most recently on 11-18-2021. JWPCP managers reported the solids had very little impact on plant operations. Historically, once the level sensors foul, they would stay fouled for an extended period. Trend data on Figure 2 indicates in this case they were only fouled for about 2 hours. This incident may have been caused by high influent flow rates at the plant caused by significant rainstorms that occurred in Southern California on 12/29-12/30/2021. The downtown Los Angeles weather station recorded 1.74 and 2.57 inches of rain on 12/29 and 12/30, respectively. In conversation with JWPCP operators, it was stated that grease balls tend to show up at the JWPCP after such large rainstorms. Inspection at upstream industrial facilities, including the large Tesoro Carson oil refinery (IW#21299), found no evidence that any was the source for this incident. IW Inspectors continue to be vigilant for any industrial sources for this type of incident.

**Figure 2: JWPCP primary tank level data on 12-31-2021 at 2250 hours (vertical timestamp line on the chart) indicating the tank high floating sludge level. Note that the reading drops to zero when the level sensor is covered by sludge floating on top of the skimming tank. The incident lasted about 2 hours according to the chart.**

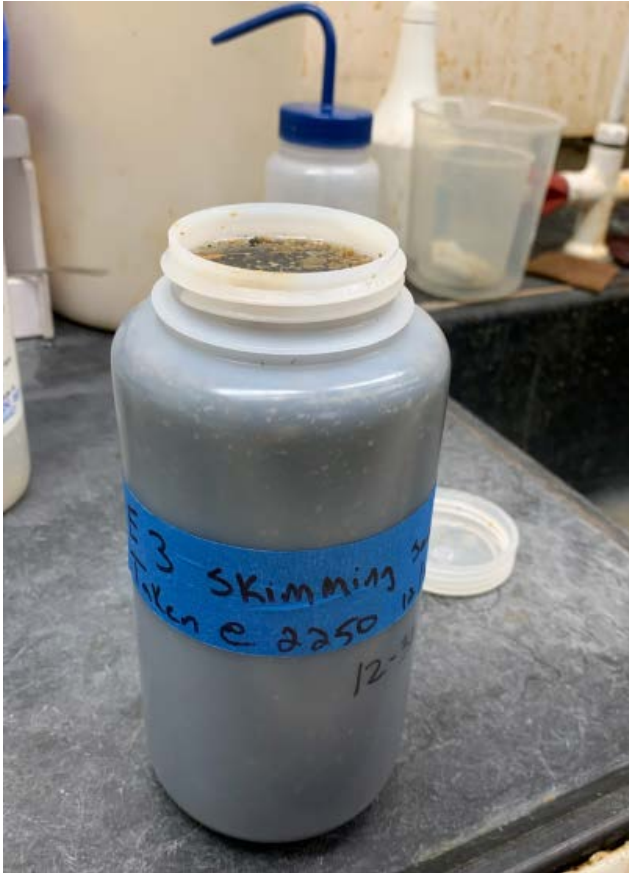
**Figure 3: E-3 skimming tank grab sample taken on 12-31-2021 at 2250 hours.**
