**Audit Report for December 30, 2021**  
**Sewer Collapse and Wastewater Spill in the City of Carson**

4 May 2022

On December 30, 2021, the Districts' 216th Street Relocation Trunk Sewer experienced a critical failure in the City of Carson causing a Sanitary Sewer Overflow (SSO) event that impacted local residents on 212<sup>th</sup> Street and caused closure of some local beaches.

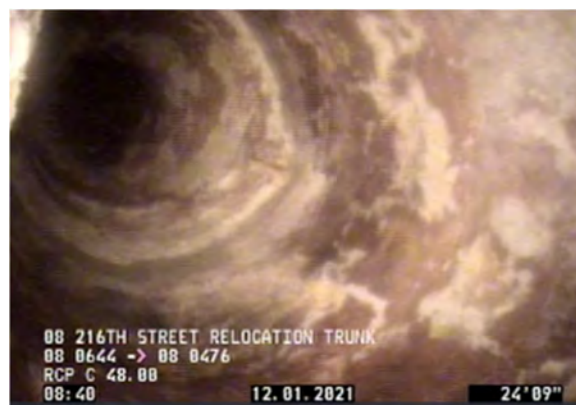
Photo 3-3 CCTV Inspection Photograph 3

Specific inspections, CCTV or physical entry, of the manhole were not performed. However, at the end of a CCTV run, the camera pans up to show the inside of the ending manhole. **Photo 3-2** and **Photo 3-3** show screenshots from the December 2021 inspection showing significant corrosion including visible aggregate, discolored walls, and exposed reinforcement in manhole 476.

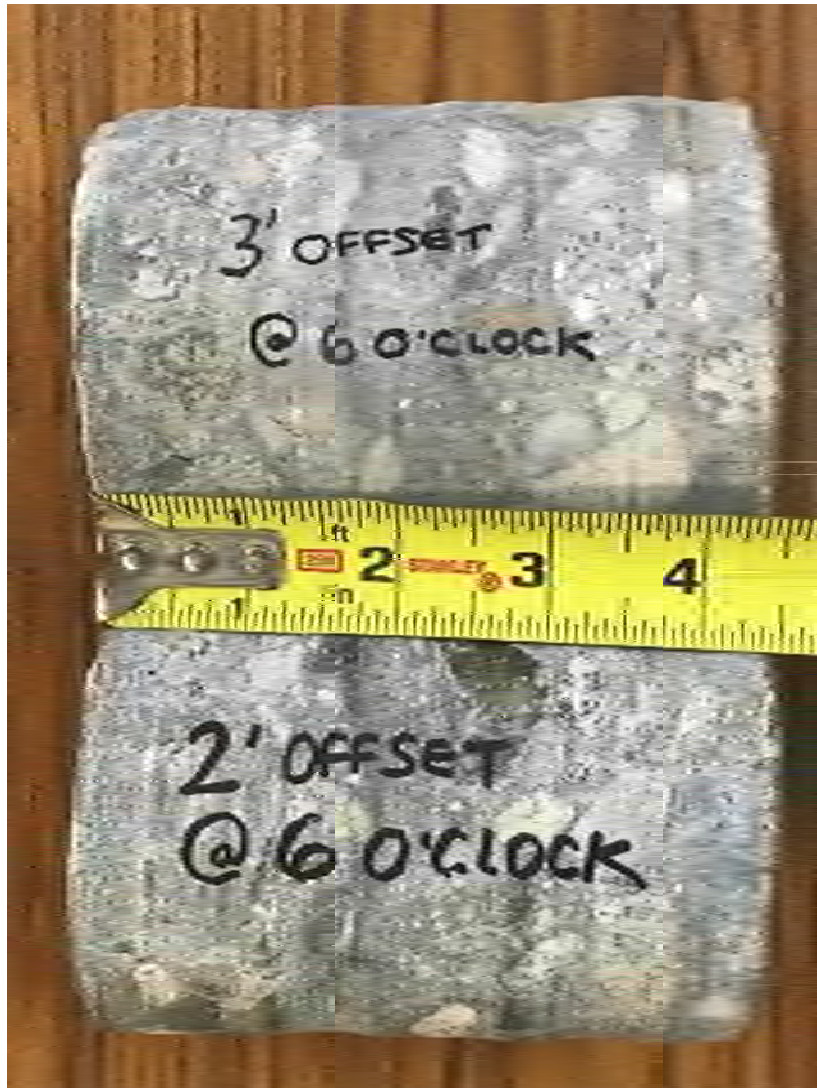
**Photo 3-9** shows a corroded pipe segment that has a wall thickness of under 1-inch. During the repair phase of the project, the CM group drilled a hole in the collapsed pipe below the spring line and measured a thickness of 3.5 inches, leading to a theory that the pipe walls were originally 3.5 inches thick. In an attempt to determine if the concrete debris could have been from the pipe or manhole shafting, two plywood templates were cut with radii of 27.5 inches for a 48-inch pipe with 3.5-inch thick walls and 21.5 inches for a 36" shafting with 3.5-inch walls (refer to **Photo 3-10** ). No definitive determination of the outside wall diameter was established with the templates. Currently, 48-inch RCP typically has 5 to 6-inch-thick walls depending upon the design and manufacturer. None of the pipe pieces at the Compton Yard were found to have embedded reinforcement or rust stains from reinforcement. Later, core samples were taken from below the spring line of the existing 48-inch pipe installed under the same construction contract as the collapsed section and the thickness was measured to be 4.5-inches thick and reinforcement was observed in the samples (refer to **Photo 3-11**). This indicates that the collapsed pipe likely had 4.5-inch thick walls.

*Photo 3-11 Core Samples from 216<sup>th</sup> Street Relocation Trunk from below Spring Line*

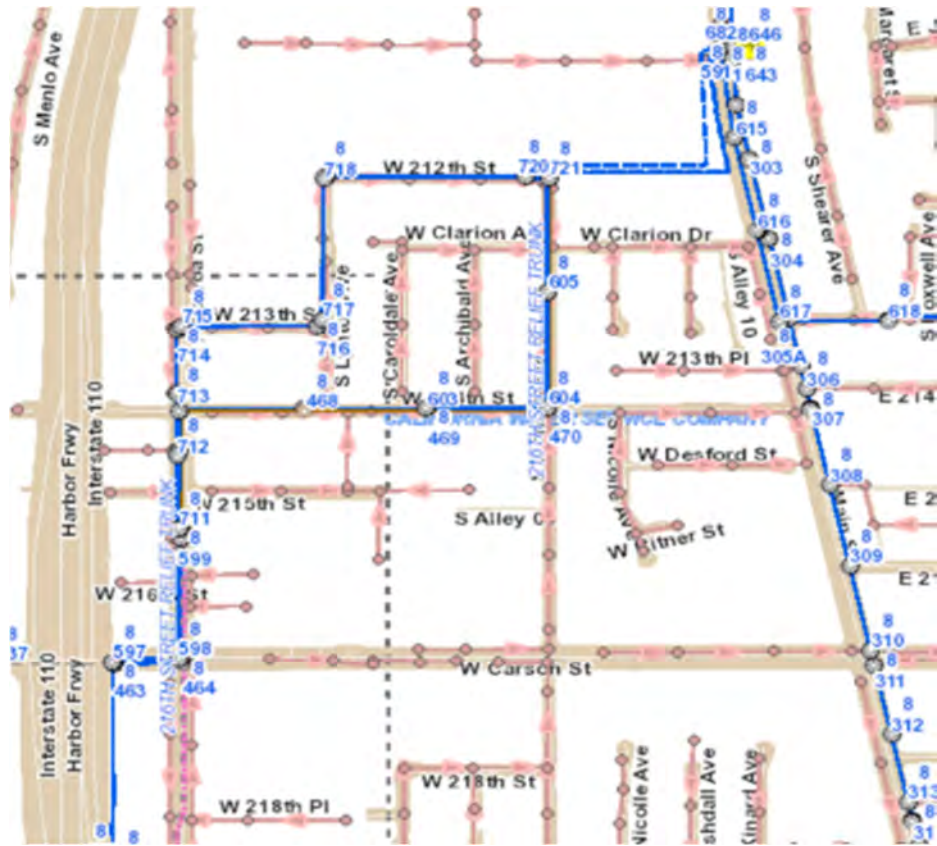
The major contributor of flow into the 216th Street Relocation Sewer is the Main Street Pumping Plant (MSPP). However, the 216<sup>th</sup> Street system picks up flow from approximately 20 additional local sewers between MSPP and the failure location (refer to **Figure 3-1**). Flow data is not available for these local connections but based on tributary sewer shed areas (approximately 9,524 acres upstream of the MSPP and approximately 156 acres between MSPP and the failure location), the flow at the failure location is estimated to be 1.5% to 2% higher than the discharge from the MSPP.

Figure 3-1 Local Lateral Locations between MSPP and Failure Location

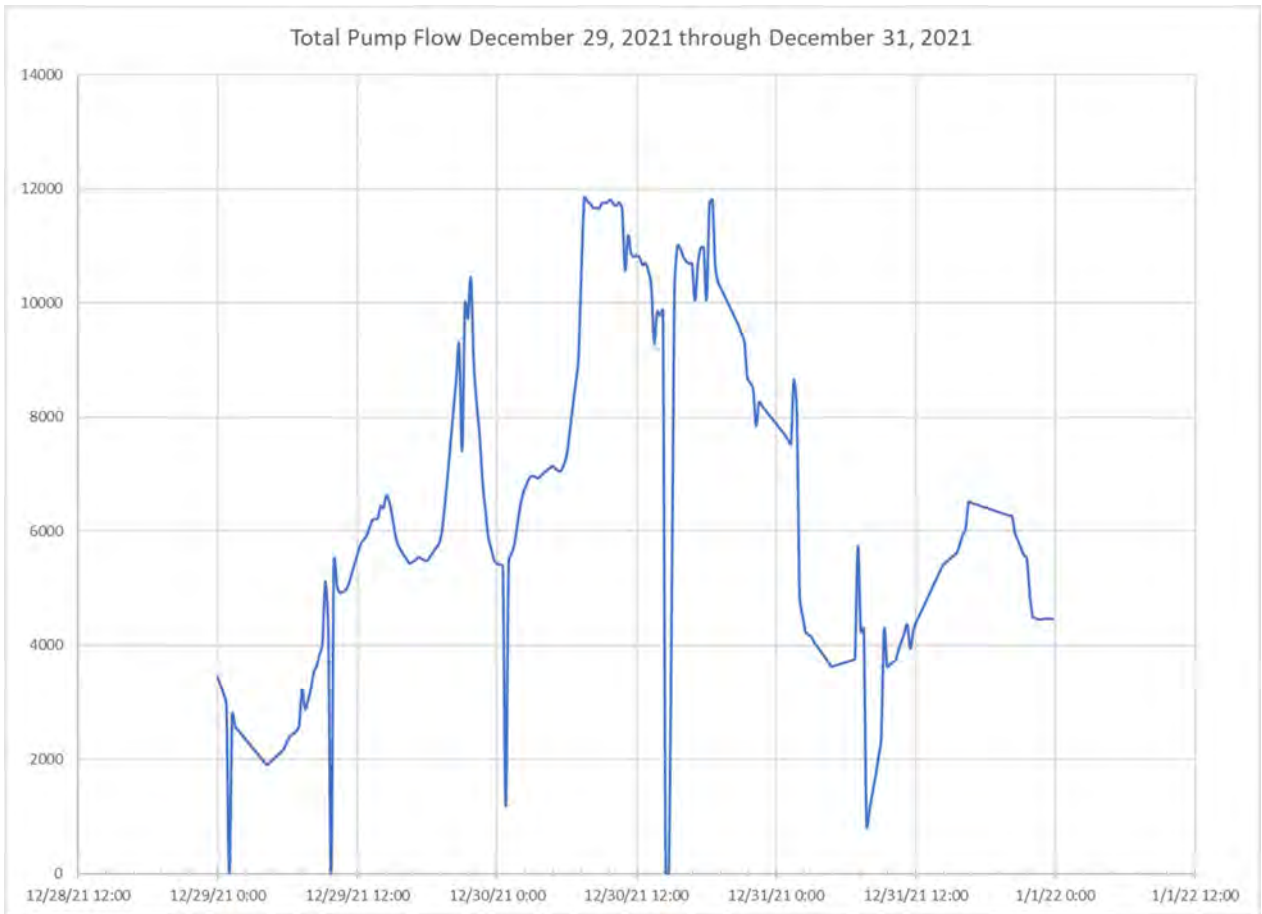
**Figure 3-2** shows the discharge from the Main Street Pumping Plant from November 1, 2021 through January 10, 2022. This graph shows the typical daily peak discharge is 6,000 to 7,000 gallons per minute (gpm). In fact, during peak dry weather, flow is consistently at or slightly below 6,000 gpm. The spikes in flow above 6,000 gpm are typically due to pumping down the wet well for daily cleaning. During storm events, the peak discharge increases to approximately 12,000 gpm. One data point on the graph shows a peak of approximately 15,550 gpm on November 16, 2021, at 11:15 AM. This was not associated with a storm; rather, it appears pump station operations caused this flow for a short period of time, approximately 15 minutes. **Figure 3-3** shows discharge on and around December 30, 2021, the day of the failure, the peak discharge was approximately 11,856 gpm at 7:30 AM. The average discharge for the morning hours of December 30, 2021, once the storm started, was approximately 11,300 gpm.

Figure 3-3 MSPP Discharge from December 29, 2021 to December 31, 2021

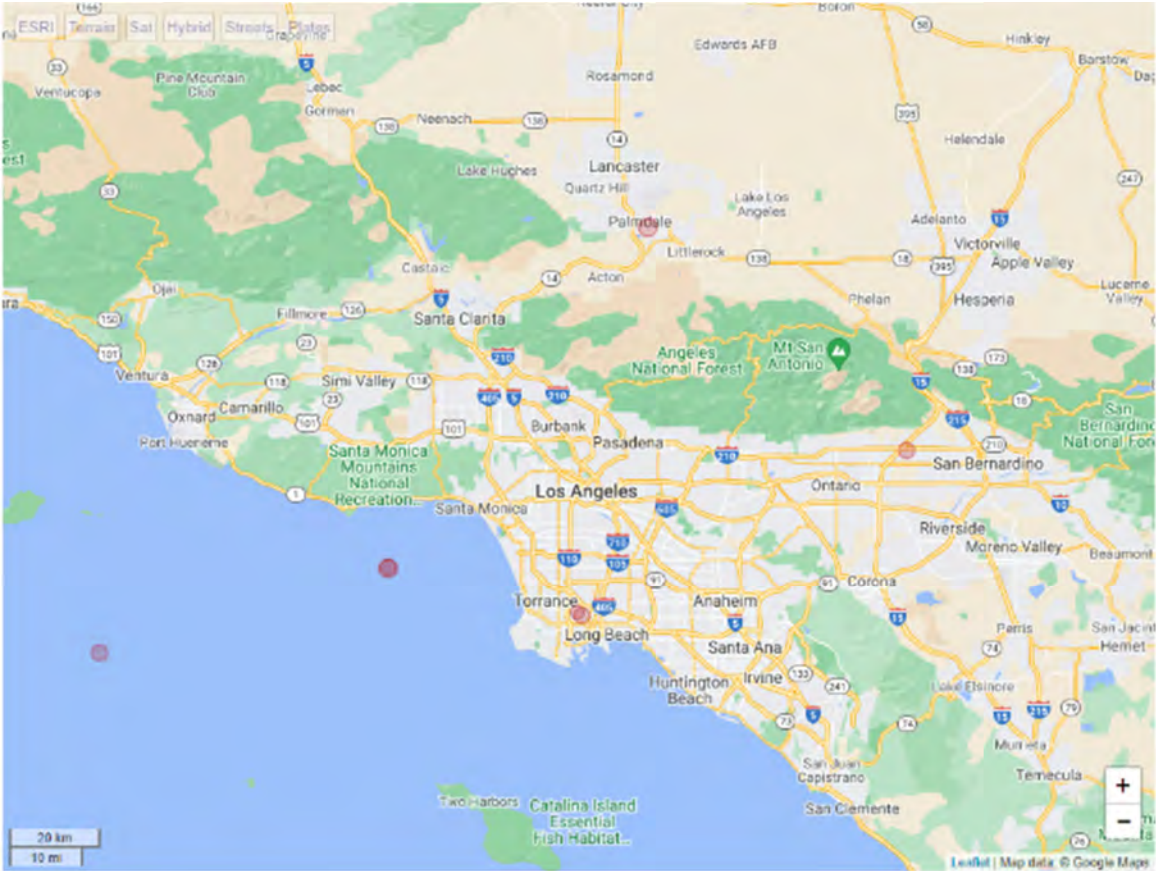
GHD obtained information from the United States Geological Survey (USGS) website for past earthquake information that occurred in Southern California and specifically in the Carson area between December 24, 2021 and December 30, 2021. **Figure 3-6** shows a broad view of earthquakes in Southern California for this period. **Figure 3-7** shows a closer view of the two (2) earthquakes that occurred in Carson during this period.

Figure 3-6 Broad View of Southern California Earthquakes

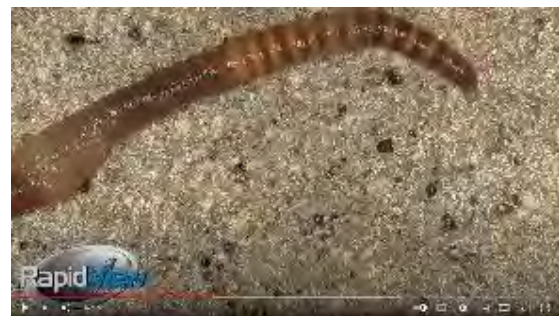
**Photo 6-1** and **Photo 6-2** show a comparison of a close-up CCTV view from a recent inspection of the Districts' 216<sup>th</sup> Street Relocation Trunk and an image from a vendor's HD video.

*Photo 6-2 HD Video View*

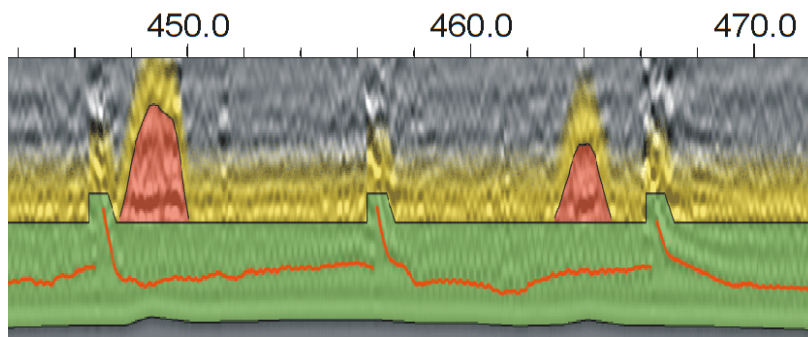
**Figure 6-1** shows the wall of a reinforced concrete pipe as seen with pipe penetrating radar. The green area is the pipe wall, the solid red lines are reinforcement, and the red shaded areas are soft spots or potential voids next to the pipe.

*Figure 6-1 Penetration Radar View*
